Mark-18A Cold Runs

June 2024

SRNL-STI-2024-00171, Revision 0

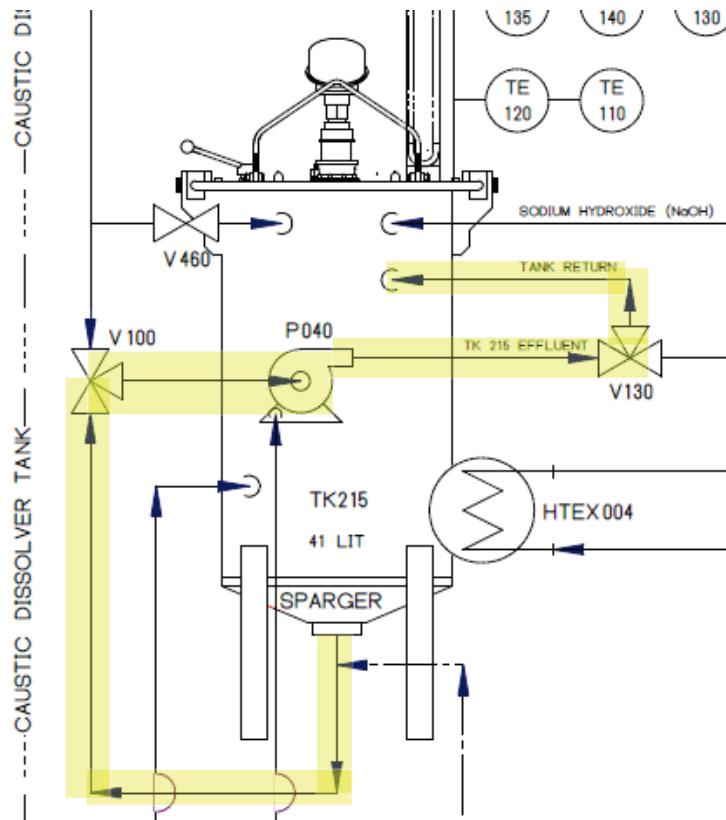
Due to an incorrect interpretation of the P&ID, an attempt was made to recirculate the contents of the caustic dissolver using P-040 and the flow path from the bottom of the dissolver, through V-100, and return to the tank through V-130 as shown in Figure 2-1 below. Upon initiation of this valve alignment and pump operation, a leak was observed from P-040. The pump was stopped, and it was then determined that this valve alignment was not meant for recirculation of the caustic dissolver, and that the tank return from V-130 was meant as a return line from FLT-305, as necessary. Attempts were made to tighten the bolts on P-040 to stop the leak but were unsuccessful. P-040 was replaced with a new pump.

Figure 2-1. Flowpath of attempted recirculation of TK-215

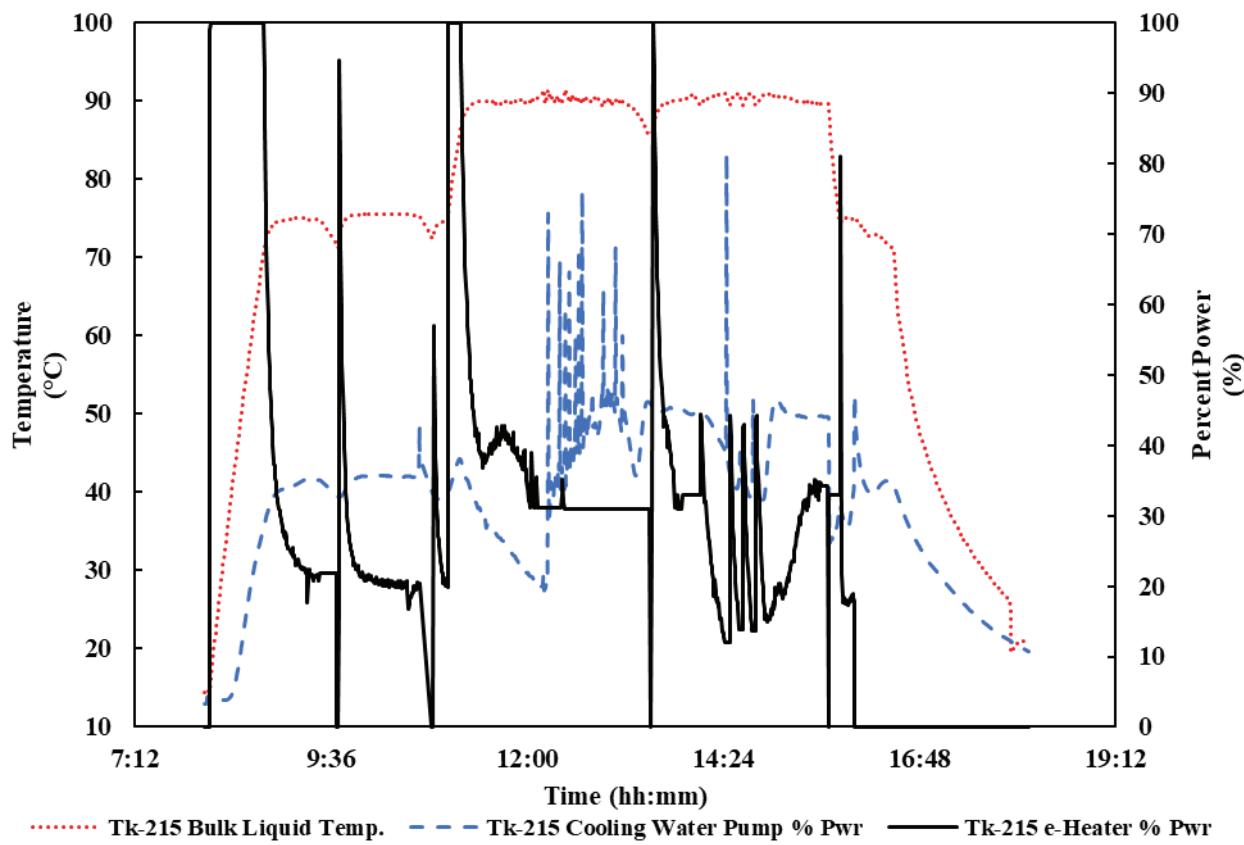
Figure 3-9. Temperature of Caustic Dissolver, Heating, and Cooling through Cladding Dissolution and Filtration

At 90 °C, the LabView program tripped off, under the similar error noted previously causing components to de-energize. The cooling was interrupted during the aluminum dissolution and under the conditions of the Cold Run, the exothermic reaction was insufficient to exceed the 90 °C threshold. However, the cooling system, LabView software, was required to be restarted promptly due to inadequacies. Under similar conditions, 90 °C may be exceeded despite SME or operator action.

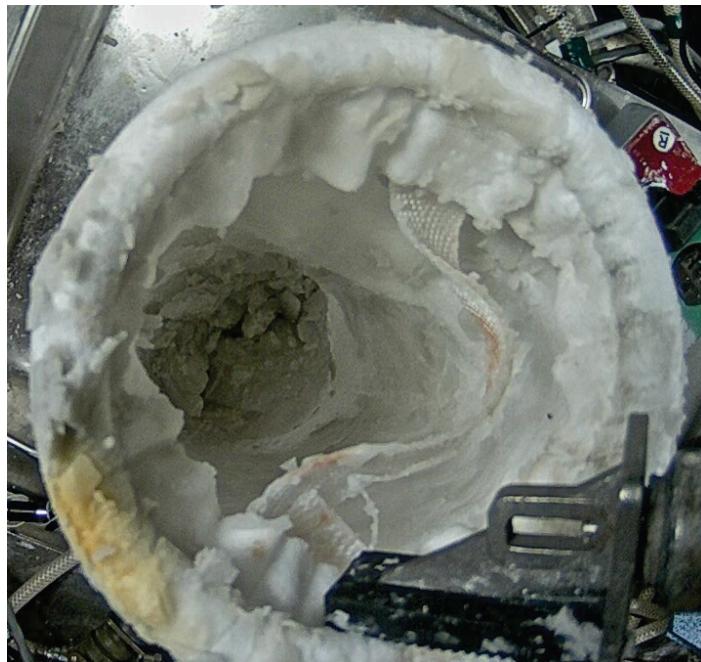
The contents of TK-235 were allowed to cool to ambient temperature and transferred to the anion exchange feed tank, TK-106, via the process sock filter, FLT-315, on 2/11/24. The intent was to transfer the slurry through FLT-310 based on the labels in LabView for the filter housing inlet solenoid valve, V-300, where “off” indicated flow through FLT-310 and “on” indicated flow through FLT-315. These labels were assumed to be correct when the corresponding valve positions for the three-way valve after the filter housing, V-455, were determined. However, upon inspection of the filters, it was discovered that FLT-310 contained only a small amount of debris and FLT-315 contained significant solids. Thus, the LabView labels for solenoid valve V-300 need to be corrected such that “off” indicates flow through FLT-315 and “on” indicates flow through FLT-310. Similarly, the filtration R&D directions require updating such that the V-455 is set to the 9 o’clock position to provide flow through FLT-310 and the 3 o’clock position to provide flow through FLT-315. The contents of FLT-315 after the filtration are shown in Figure 3-17.

Figure 3-17. Contents of FLT-315 after cold run filtration
