The Fabrication of a Vanadium-Stainless Steel Test Section for MHD Testing of Insulator Coatings in Flowing Lithium

**Claude B. Reed, Richard F Mattas, Dale L. Smith, Hee Chung,
and Hanchung Tsai**
Fusion Power Program, Argonne National Laboratory

Presented at the 12th Topical Meeting on the Technology of Fusion Energy
June 16-20, 1996 Reno Nevada

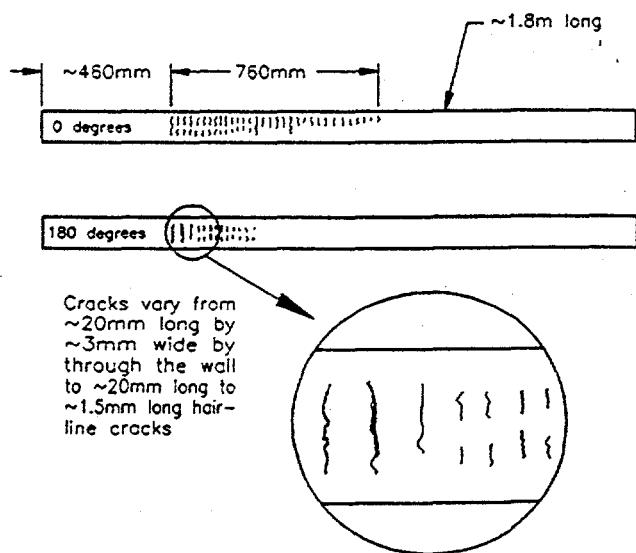
Figure 3. Defect locations in Tube #2 after 2nd anneal.

flaws began to form about 40% into the draw, starting as a series of roughly parallel, small, slightly visible, ~1 mm long, wavy transverse cracks or tears, reaching a maximum size of ~19 mm long by ~3 mm wide at about 60% into the draw, finally decreasing in size to about that of the initial small cracks at about 80% into the draw, and then disappearing. A virtual mirror image of this same cracking pattern was observable on the reverse side of the tube, ~180 degrees away (see Fig. 3). The largest tears had fractured surfaces that were black in coloration and extended from the OD to the ID of the tube on both sides.

Additional visual observations revealed the same "bands" mentioned above, again 180 degrees apart on both sides of the tube, about 25 mm wide extending along the tube from ~1/4 length point to midpoint. The defects of course were within these bands. The bands could have resulted from grain size differences, segregation, impurity banding, etc. The rest of the tube looked very good.

The cracks appeared to be the result of a localized exhaustion in the material's ductility due to a variation in its as-received structure, i.e., a variation in grain size [the grain size of the starting material in the vicinity of the defected areas was large, probably in the range of 2-3 (ASTM)], inclusions, impurity and/or alloying addition segregation, hot work, and/or other difference in microstructure (e.g., some remaining cast structure perhaps). The problem appeared to result from a large inhomogeneity in the starting materials, apparently not present in the other tube blank.

The first difficulty was the appearance and growth of two through-wall crack regions on Tube #2. The two cracks originally were parallel, each at about a 45-degree angle to the tube axis. These cracks elongated through the continued drawing operation from their initial appearance as simple tears to semi-circular and finally approaching circular shaped defects. At the point where cold working operations on that tube were suspended, they were several millimeters wide. Regardless, the surrounding material continued to draw uniformly. The cracks were probably about 10 cm apart axially in the original 1245 mm-long bar (approx. 62 mm x 63.5 mm. cross section).

The cracks are thought to be the result of a localized exhaustion in the material's ductility due to a variation in its as-received structure, i.e., a variation in grain size, inclusions, impurity and/or alloying addition segregation, hot work, and/or other difference in microstructure (e.g., some remaining cast structure perhaps). The problem appeared to result from a large inhomogeneity in the starting material, apparently not present in the other tube blank. This fabrication difficulty was not encountered in Tube #1 and was restricted to about one half of Tube #2.

The drawing operations were stopped at that point. The defects were partially spot-ground, especially the edges of the larger defects, so the tube would continue to draw, and both tubes were cleaned and annealed a second time. Following the second cleaning and annealing operations, both tubes were given a thorough visual examination. As before, Tube #1 still looked good, with many, but only minor longitudinal die marks (e.g., like fine scratches) visible on its surface. The defected tube appeared essentially the same as before cleaning and annealing.
