BDX-613-1757 (Rev.)

EFFECTS OF DEBURRING CONTAMINANTS
ON ELECTROPLATING ADHESION

Final Report

**Kansas City
Division**

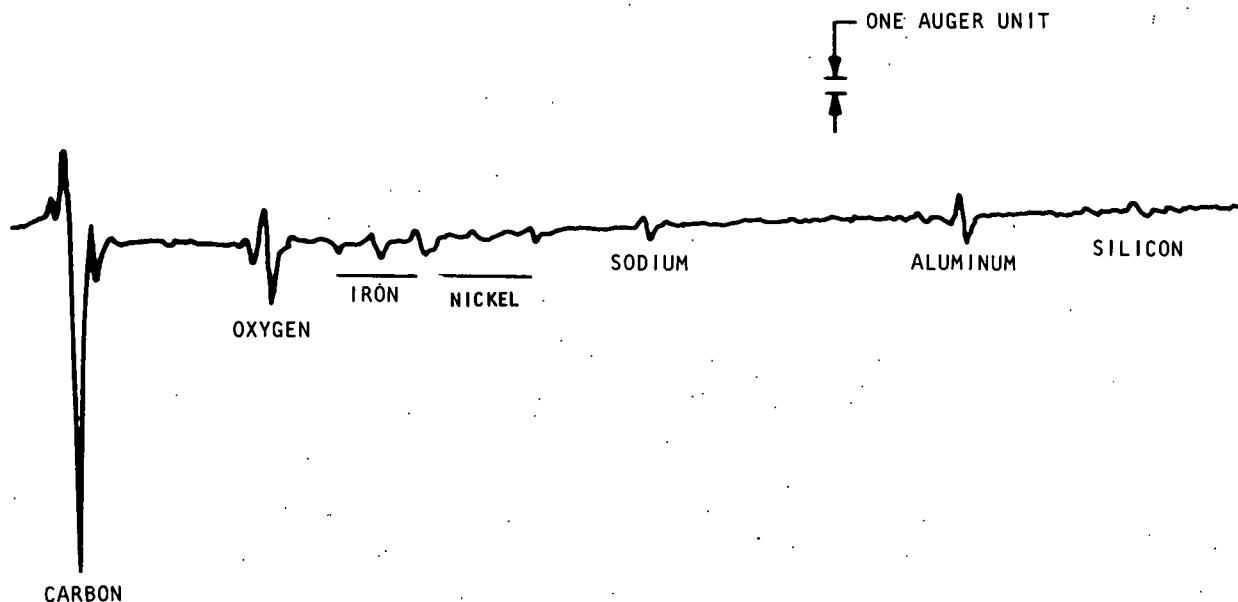
As seen in Figure 1, the AES analysis indicates the presence of carbon, oxygen, iron, nickel, sodium, aluminum, and silicon on the surface of a particular Kovar pin. Table 1 indicates the relative heights of elements found on this pin. Figure 2 illustrates that just below the surface film, aluminum (presumably in the form of aluminum oxide) is present in much greater quantity. In interpreting these charts it is important to note that it is only the relative peak height of contaminants that is significant

Figure 1. Auger Chart of Kovar Pin Centrifugal Barrel Finished in Aluminum Oxide Before Sputtering

The sodium found in these two figures is either due to salt from handling with bare hands or sodium in the deburring compound soaps.

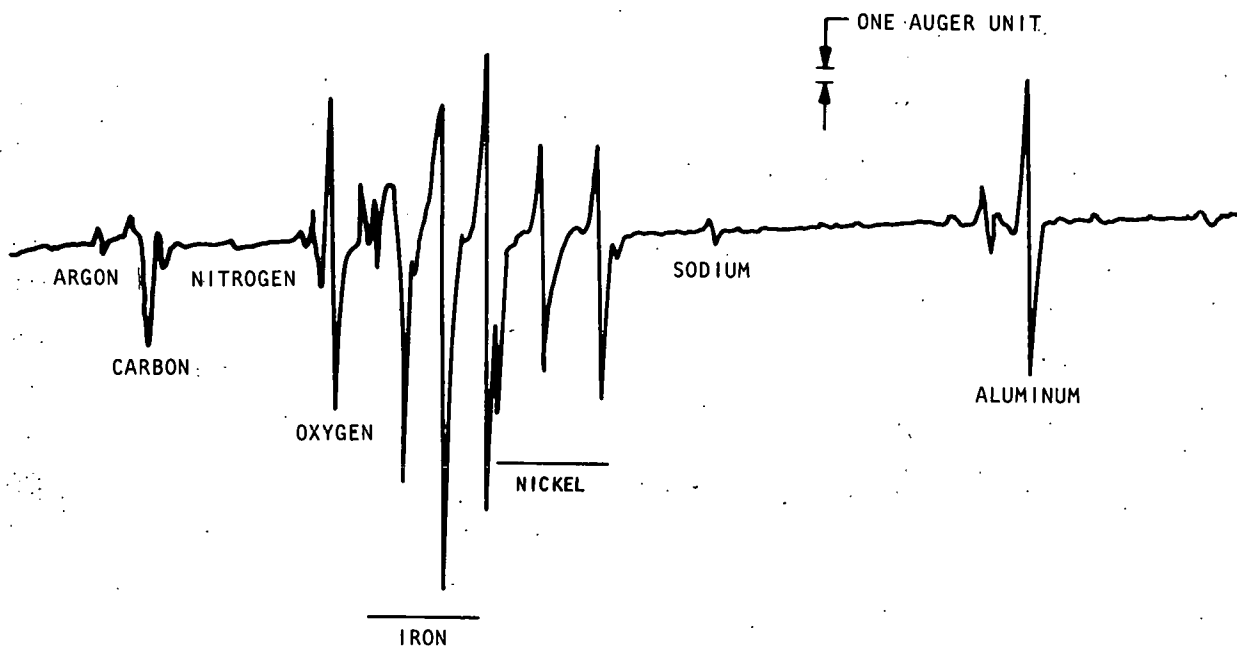
on these charts. This relative height is calculated by summing the primary peak heights of all the elements observed and dividing this into the peak height of the contaminating element. Note that a small secondary peak of iron and nickel occurs in Figure 2. This peak is ignored.

Figure 2. Auger Chart of Kovar Pin After Sputtering 3 Minutes

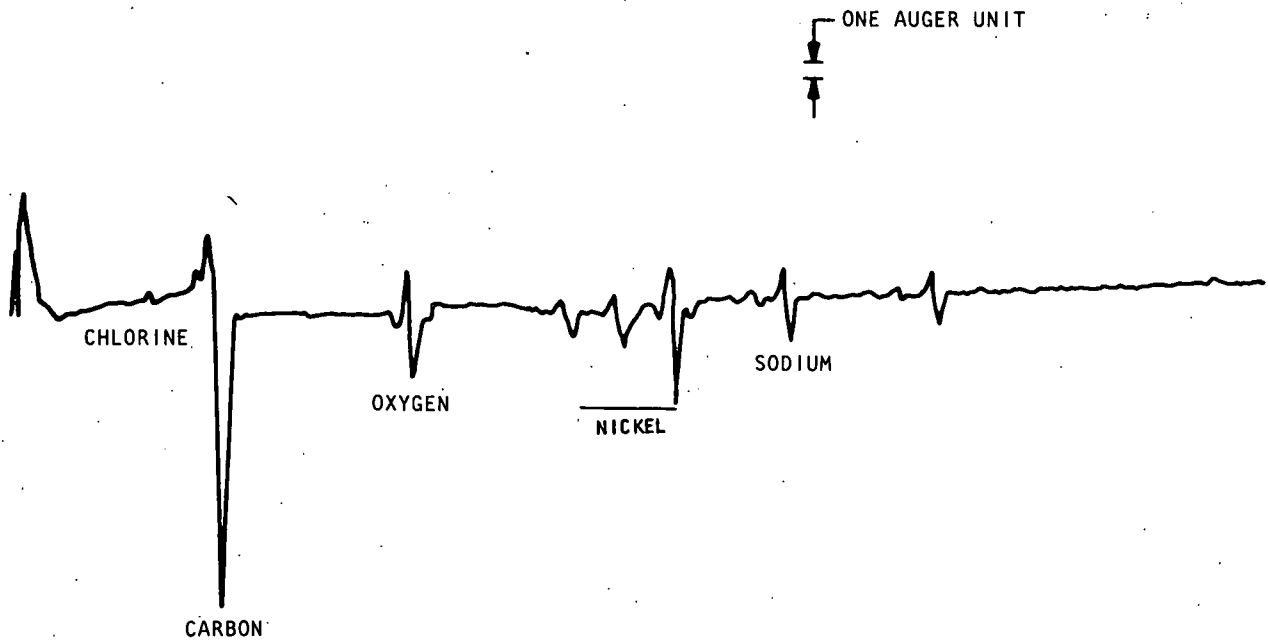
Figure 3 illustrates an AES plot of a Kovar pin which was not subjected to any form of loose abrasives. Figure 4 shows the results for a pin subjected to silicon carbide media. Dolomite was used in Figure 5.

Figure 3. Auger Chart of Kovar Pin Which Was Not Subjected to Abrasives

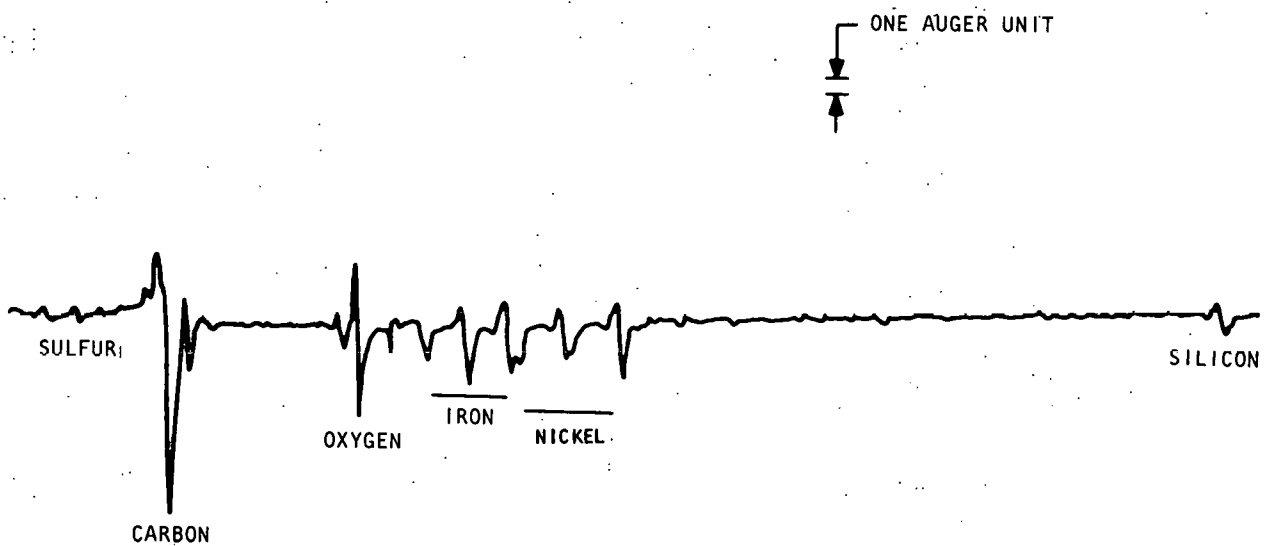
Figure 4. Auger Chart of Kovar Pin Centrifugal Barrel Finished in N8 Silicon Carbide

A comparative analysis of a part deburred without abrasives is shown. Some silicon was observed on parts subjected to silicon carbide media. No foreign material was found on samples which had been centrifugal barrel finished in dolomite.

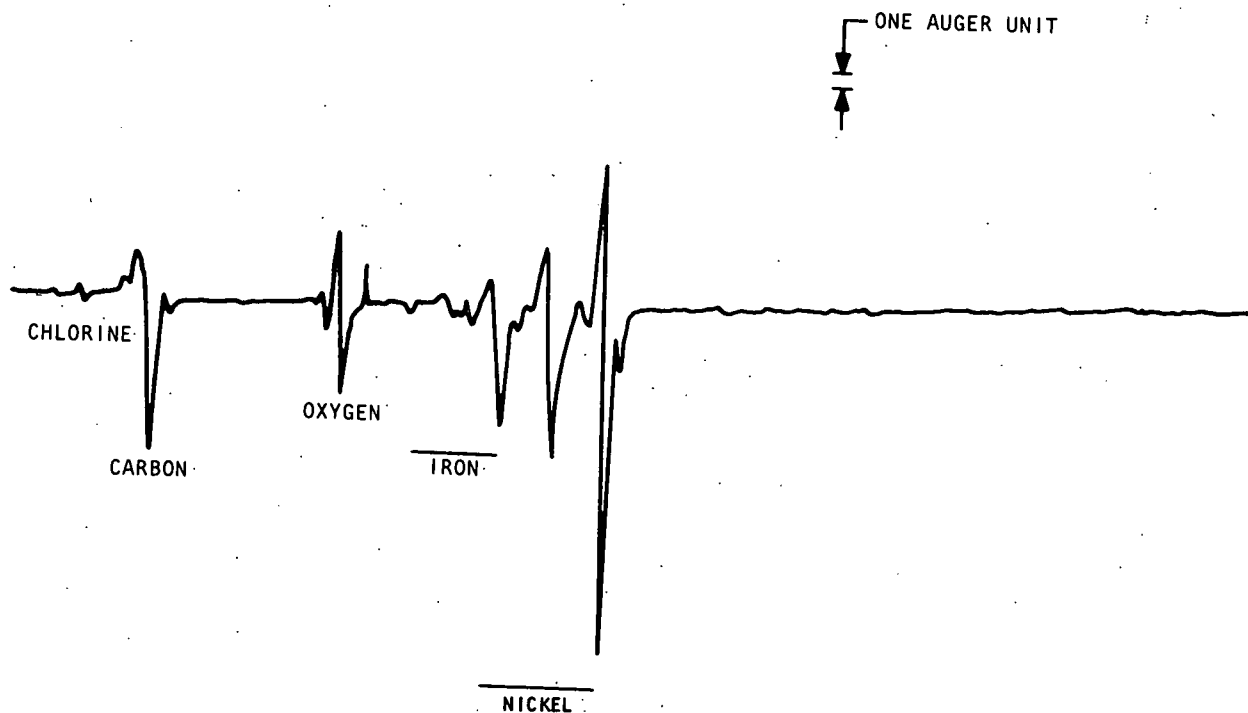
Figure 5. Auger Chart of Kovar Pin Centrifugal Barrel Finished in N14 Dolomite and PC8A

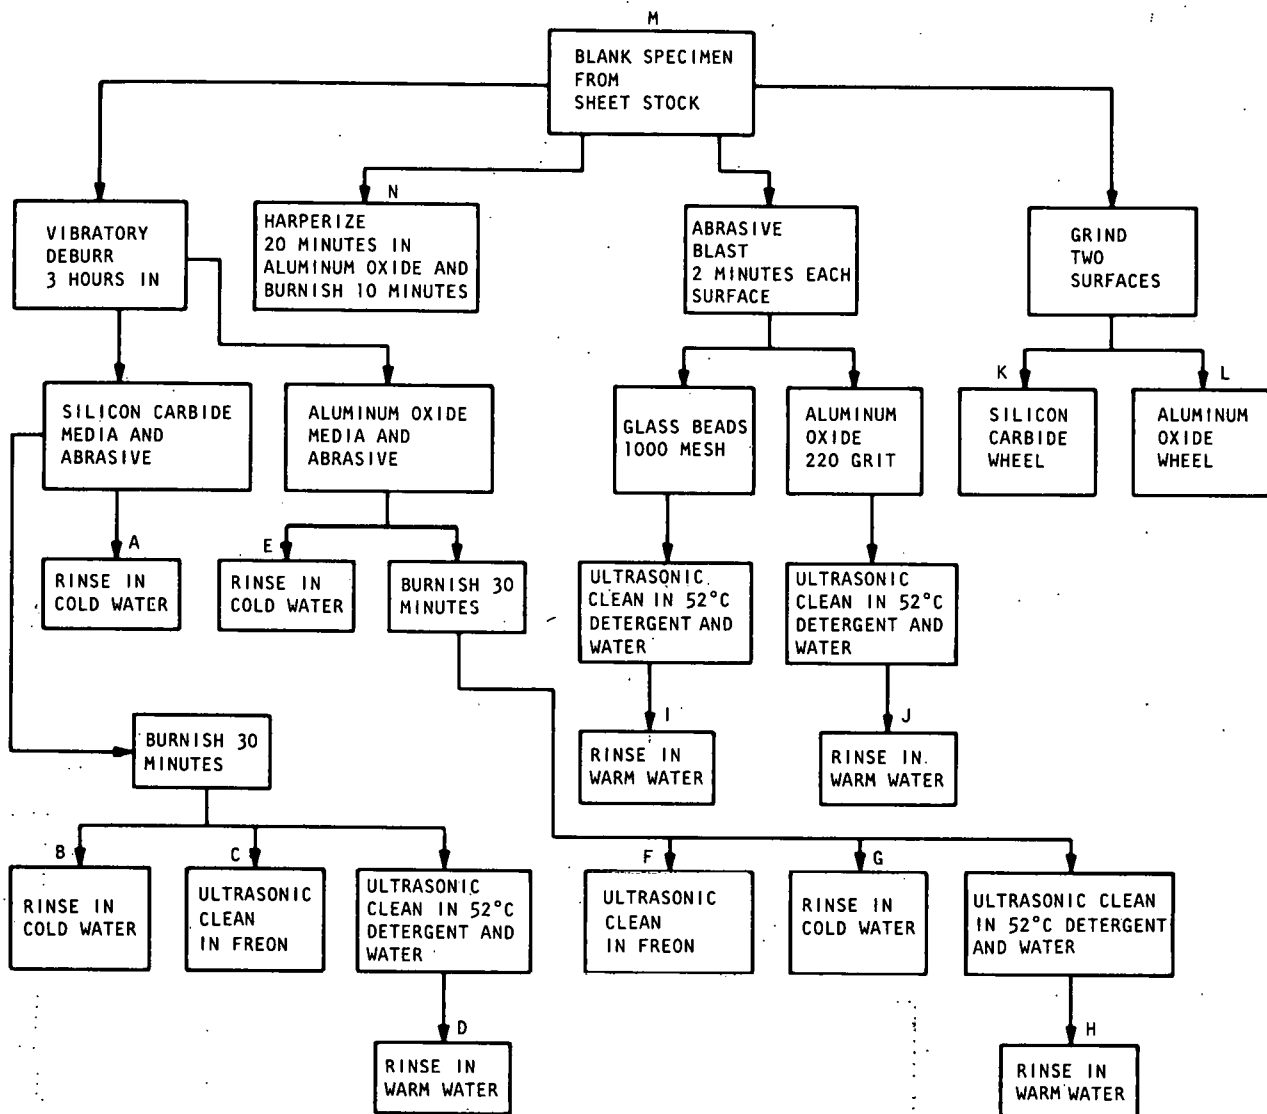
All vibratory deburred specimens contained impregnated silicon carbide or aluminum oxide regardless of the cleaning method used (Figure 6, conditions A through H). Large quantities of aluminum oxide were evident on the centrifugal barrel finished specimens. The concentration of abrasive was not affected by the cleaning method. Abrasive blasted stainless steel specimens contained either aluminum or silicon depending upon the media used. The aluminum specimens which were blasted with glass beads contained small but measurable amounts of silicon. Specimens which were surface ground but not otherwise subjected to abrasive media contained no impregnated material. Blanked specimens (condition M in Figure 6) of stainless steel which were not subjected to media demonstrated a trace reading of aluminum. This may have been the result of a polishing treatment at the steel mill.

Figure 6. Flowchart of Conditions Studied
