Asphalt Emulsion Sealing of Uranium Mill Tailings 1979 Annual Report

June 1980

1979 ANNUAL REPORT

Pacific Northwest Laboratory
Richland, Washington 99352

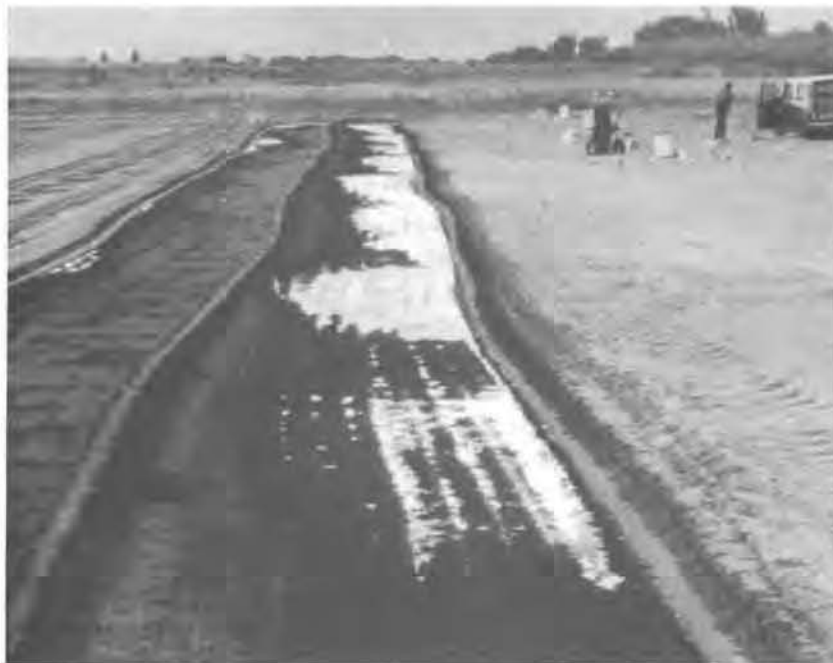
The only operational problem encountered during the first emulsion application was when the distributor truck bogged down in the fluffed tailings at the east end of the plot. When this happened, the truck was towed with a tractor. Bogging down of the distributor truck did not occur during the second asphalt emulsion application because the compacted admix seal provided a firm base for the truck to drive on.

FIGURE 21. Results of Single-Pass, $\sim 9 \text{ wt\%}$ Asphalt Emulsion Application - Poor Mixing

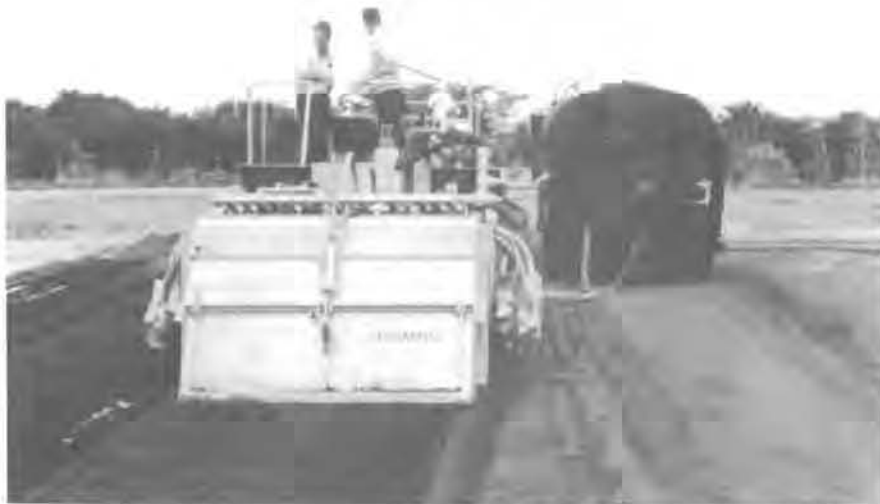
The next day, the second application of emulsion was applied (see Figure 22). The MPH 100 mixing depth was set at ~ 7.6 cm (3 in.) in depth. Once again poor mixing was observed during the application. Therefore the admix was remixed. The tailings looked much more uniform in composition after the second mixing. However, uncoated agglomerates of tailings were observed in the admix. These agglomerates are thought to be a result of the design of the mixing blades on the MPH 100 since they were designed to cut pavement instead of mixing tailings.

The admix was then compacted several times with the BOMAG vibratory compactor. An attempt to compact the admix transversely resulted in formation of cracks. The remainder of the compacting was done in the direction the mixture was laid down. Also, compaction resulted in a slight wave in the surface of the seal. This wave is thought to be due to the admix being pushed in front of the compactor because of poor tailings base stability.

FIGURE 22. Second Application of ~ 9 wt% Asphalt Emulsion

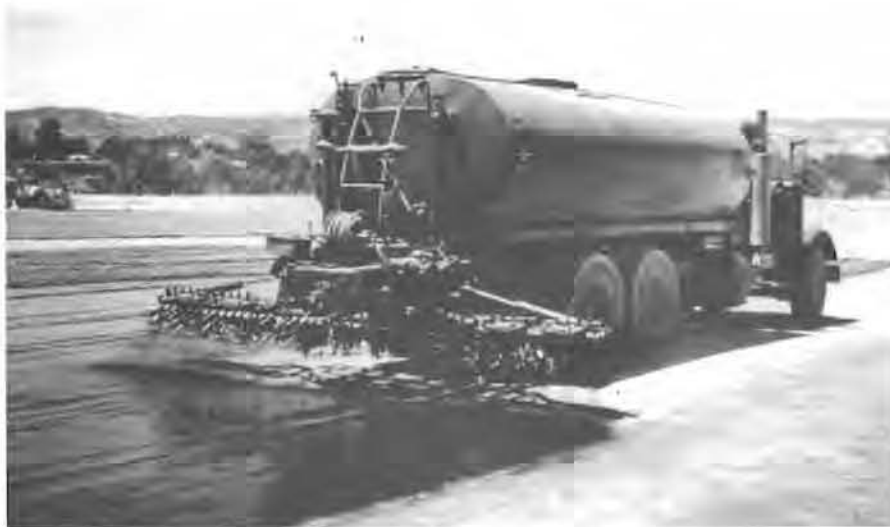
The next step in the tailings sealing procedure was the application of the spray-coat asphalt emulsion seal (see Figure 23). For the emulsion to penetrate the admix and bond well, the admix must be watered beforehand. However, when we were ready to apply the spray-coat seal, the water truck pump failed and we were not able to obtain a suitable substitute since it was on a weekend. The spray-coat seal was applied anyway, and a poor bond to the admix resulted. We could not wait until Monday because the admix seal would have been too cured for the spray-coat seal to bond. The sprayed-on asphalt emulsion was mechanically bonded to the compacted admix rather than electrostatically bonded. Therefore, the mechanical strength of the spray-coat seal was quite poor.

FIGURE 23. Applying the Spray-Coat Seal on the Admix Seal

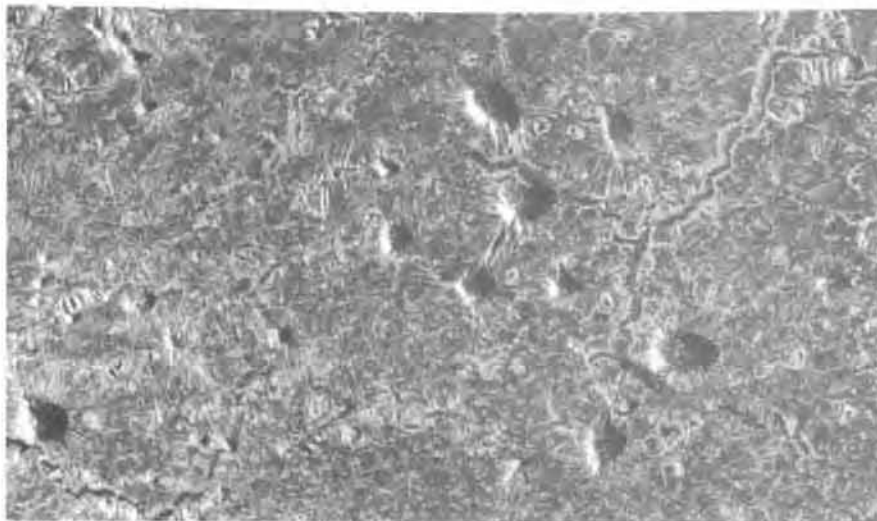
After several days, bubbles in the spray coat formed because of water vapor passing through the admix and expanding as a result of the high ambient temperatures up to 32°C (90°F) (Figure 24). This illustrates the poor bonding of the sprayed-on coating to the admix. These bubbles, if ruptured, are potential points for radon gas leaks.

FIGURE 24. Bubbles in the Spray-Coat Seal Caused by Water Vapor from the Curing Admix Seal

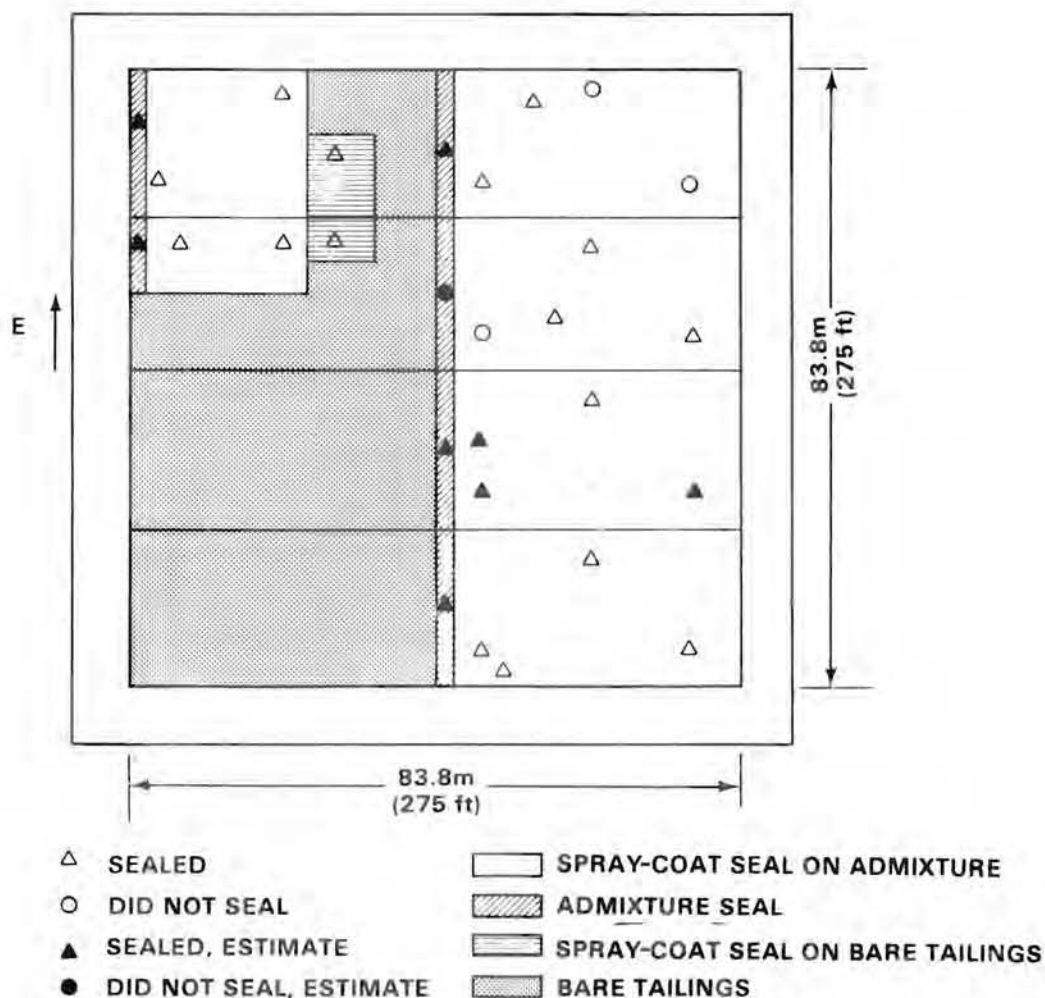
FIGURE 37. Test Plots on Seal Which Did and Did Not Reduce the Radon Flux

The admixture seal was a moderate success. Only one test spot reduced the radon exhalation by greater than 90%. This was in an area that had a high asphalt content. However, five out of the six test areas measured on admixture

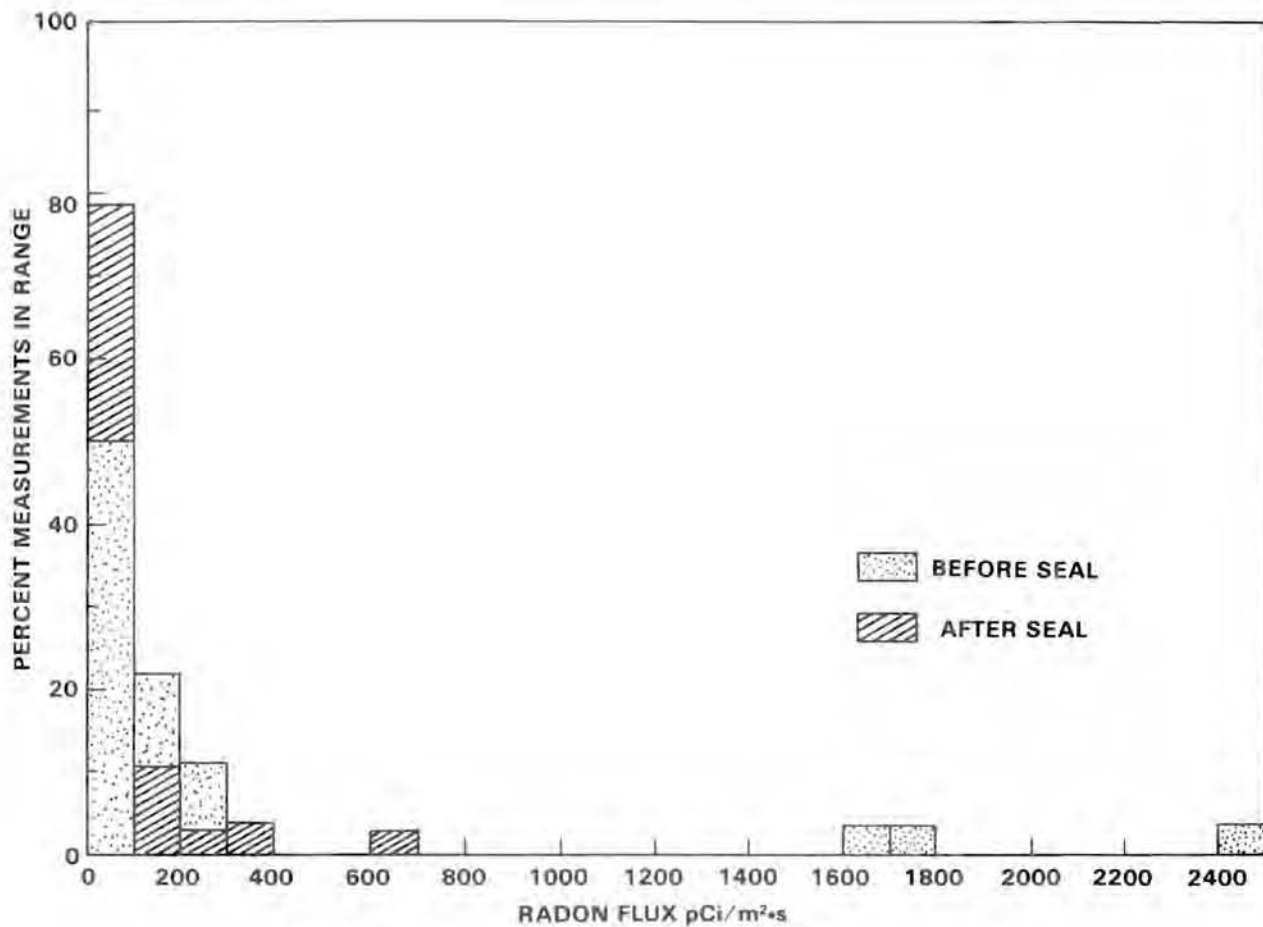
It can be seen in Figure 38 that the seal had a definite effect on the radon exhalation. Before the seal was applied, approximately 50% of the radon fluxes measured were in the 0 to 99 pCi/(m²·s) range. After the seal was applied, nearly 80% of the fluxes fell in this range. Also, before the seal was applied, fluxes as high as 2400 pCi/(m²·s) were encountered. After the

FIGURE 38. Distribution of Radon Fluxes Before and After the Seal was Applied

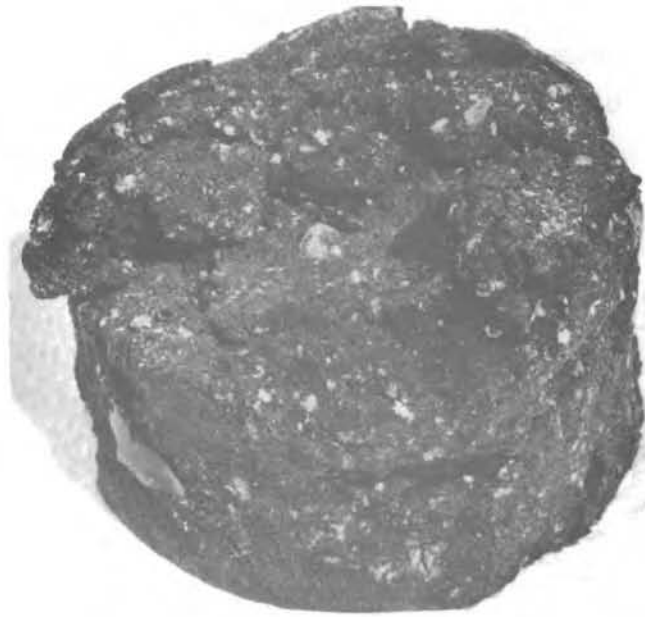
FIGURE 40. Core Sample Taken from the Admix Seal
Showing Poor Particle Coating

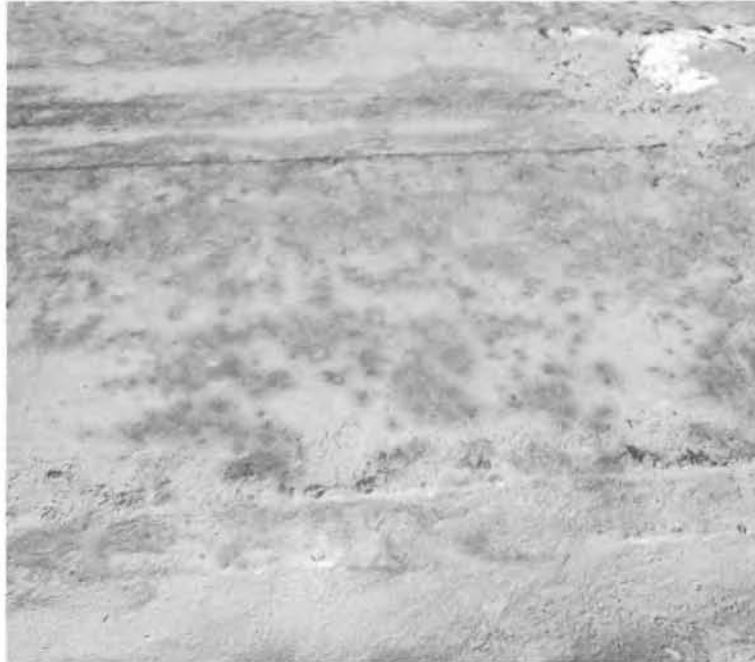
Another problem was an increase in the rate of water vapor transmission through the admix seal because the seal was not a total gas/water vapor seal. Accompanying this water vapor were many salts, which precipitated throughout the admix seal as well as on top of the seal (Figures 41 and 42). This salting problem was caused by 1) a non water-vapor seal and 2) the admix being a black

FIGURE 41. Salts Transporting Through Admix Seal at Slimes
Area - December 1979 Grand Junction

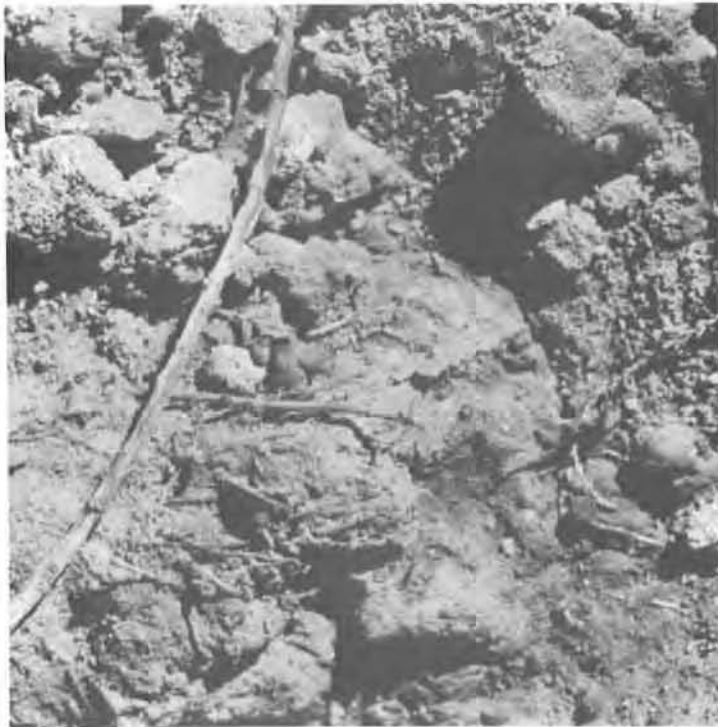
FIGURE 42. Salts Transporting to the Surface of Grand Junction Tailings on Bank Near Colorado River - December 1979

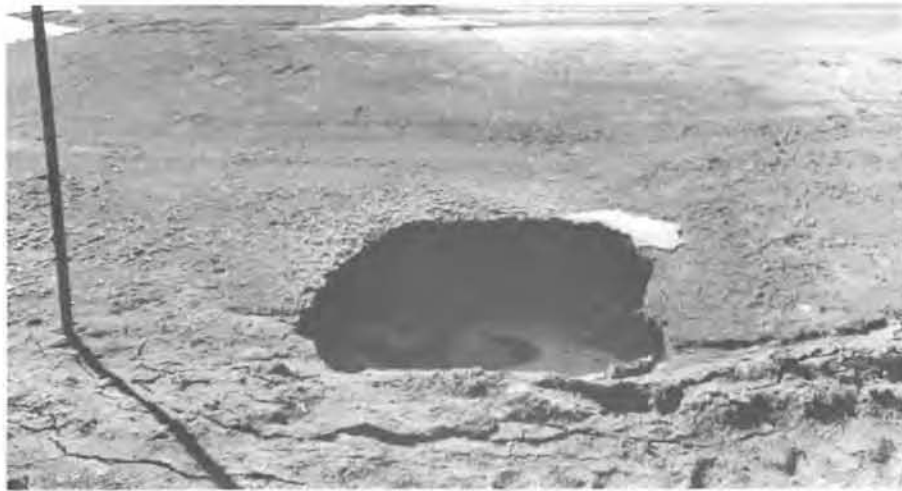
Another problem occurred several months after the field test when an area about 6 m (19.5 ft) subsided (Figure 43). It is speculated that one or more of three possible mechanisms caused this subsidence. There could have been enough water movement through the tailings to physically remove some of the underlying tailings. A second possible mechanism is a phenomena called "piping". Piping is the dispersion of the clay in the soil due to a high

FIGURE 43. Sink Hole at North Edge of Area 7
