## MICROSTRUCTURAL EXPLANATION FOR IRRADIATION EMBRITTLEMENT OF V-15Cr-5Ti

PNL-SA--17021

International Conference for  
Fusion Reactor Materials  
Kyoto, Japan  
December 4-8, 1989

# A MICROSTRUCTURAL EXPLANATION FOR IRRADIATION EMBRITTLEMENT OF V-15Cr-5Ti

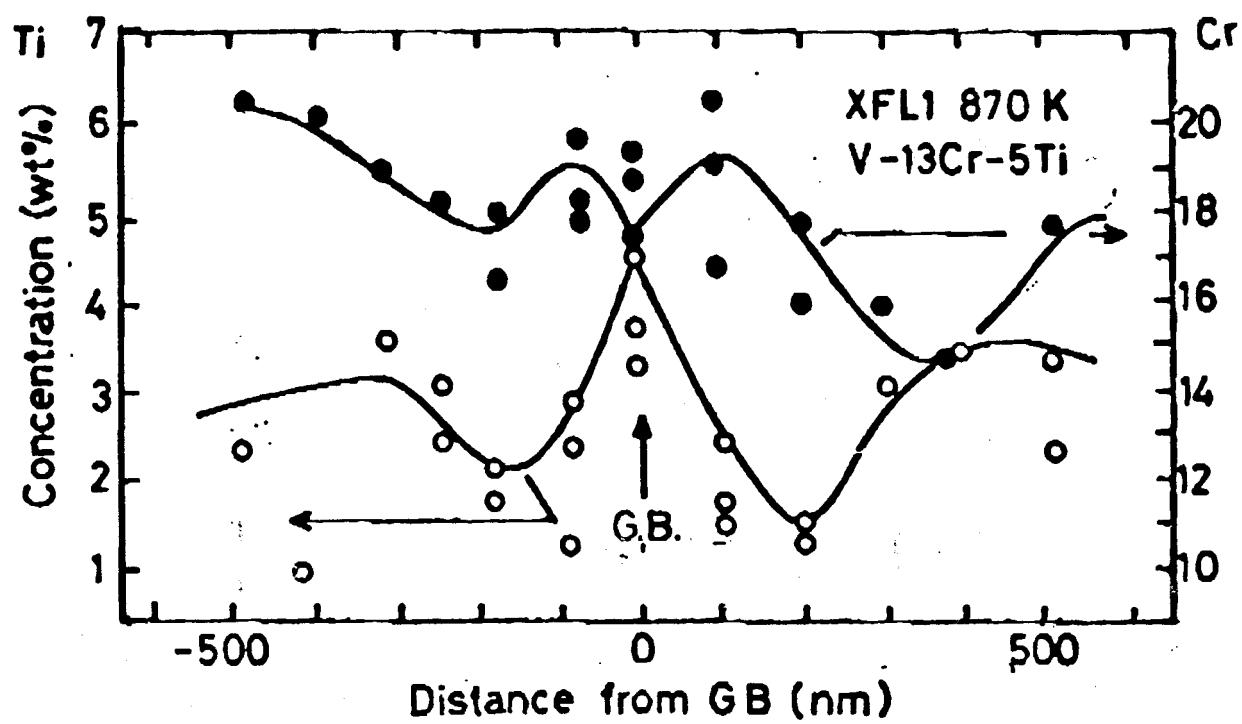
Fig. 8

Specimen XFL1 was analyzed to provide results on microchemical segregation in the vicinity of a grain boundary. The results are shown in Figure 8, giving titanium and chromium concentrations as a function of distance from the grain boundary (G.B.) for an area containing a grain boundary. Figure 8 demonstrates that titanium levels are higher at the grain boundary and lower adjacent to the boundary, whereas chromium concentrations are relatively unaffected, with perhaps slight enhancement adjacent to the boundary. Therefore, titanium tends to segregate towards all point defect sinks, and chromium tends not to segregate. The effective diffusion distance for segregation at 600°C to 14 dpa is on the order of 200 nm based one the extent of the denuded zone.

Figure 8. Microchemical segregation in the vicinity of a grain boundary in V-15Cr-5Ti specimen XFL1 following irradiation at 600°C to 14.1 dpa.2
