OAK RIDGE
NATIONAL
LABORATORY

LOCKHEED MARTIN

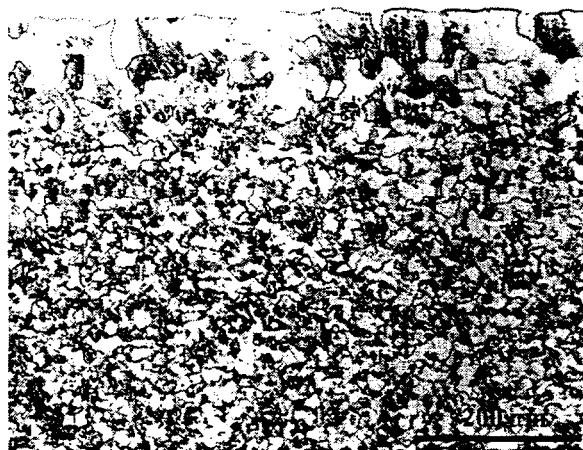
(a) Sandvik 3R12/4L7 (304L/SA-210)

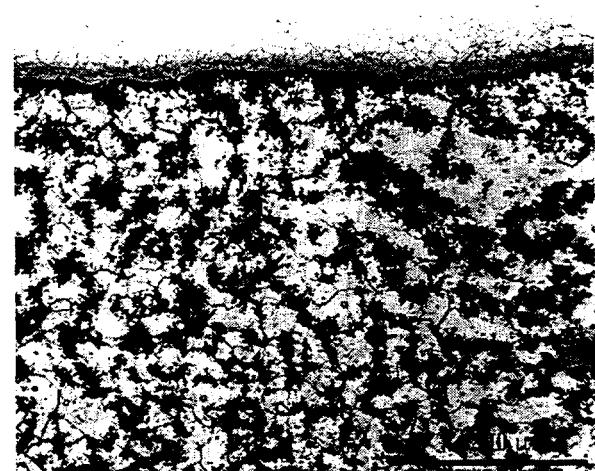
(d) Sumitomo Alloy 825/SA-210

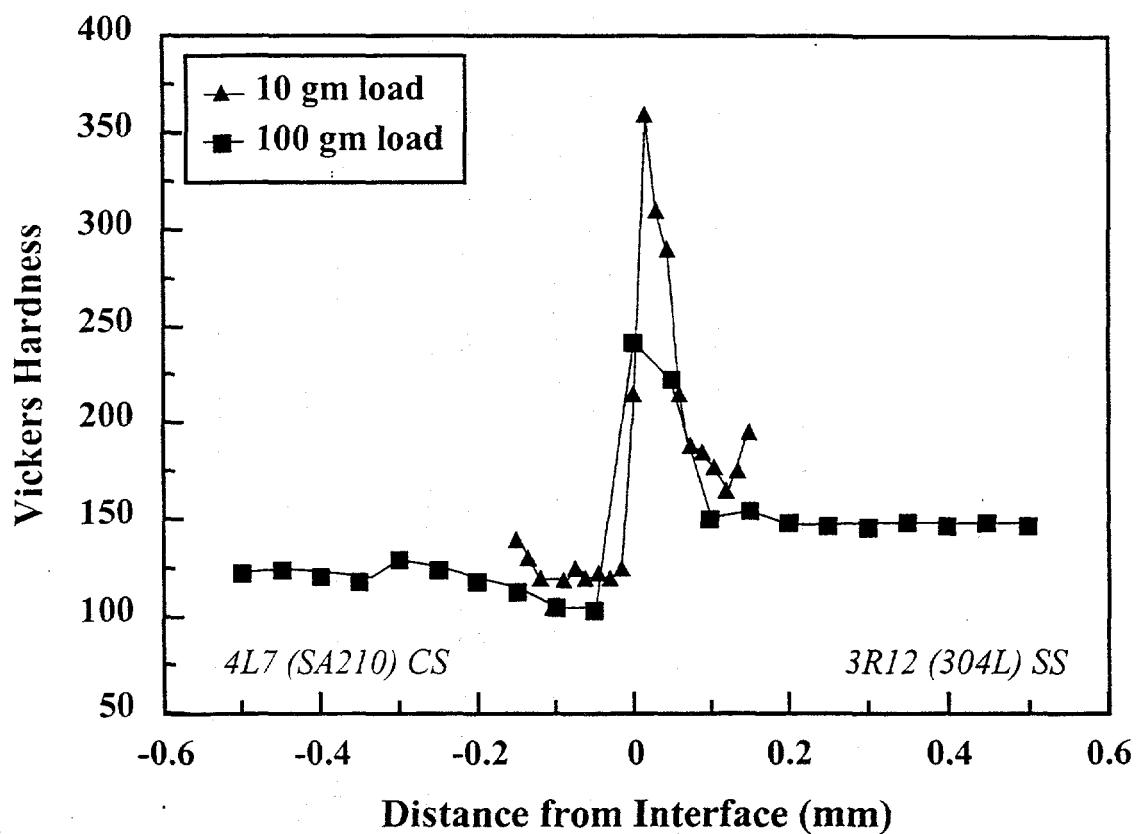
Fig. 2. Vickers hardness profile across the cross section of a Sandvik 304L/SA-210 coextruded tubes. Similar data were obtained from a Sumitomo tube.

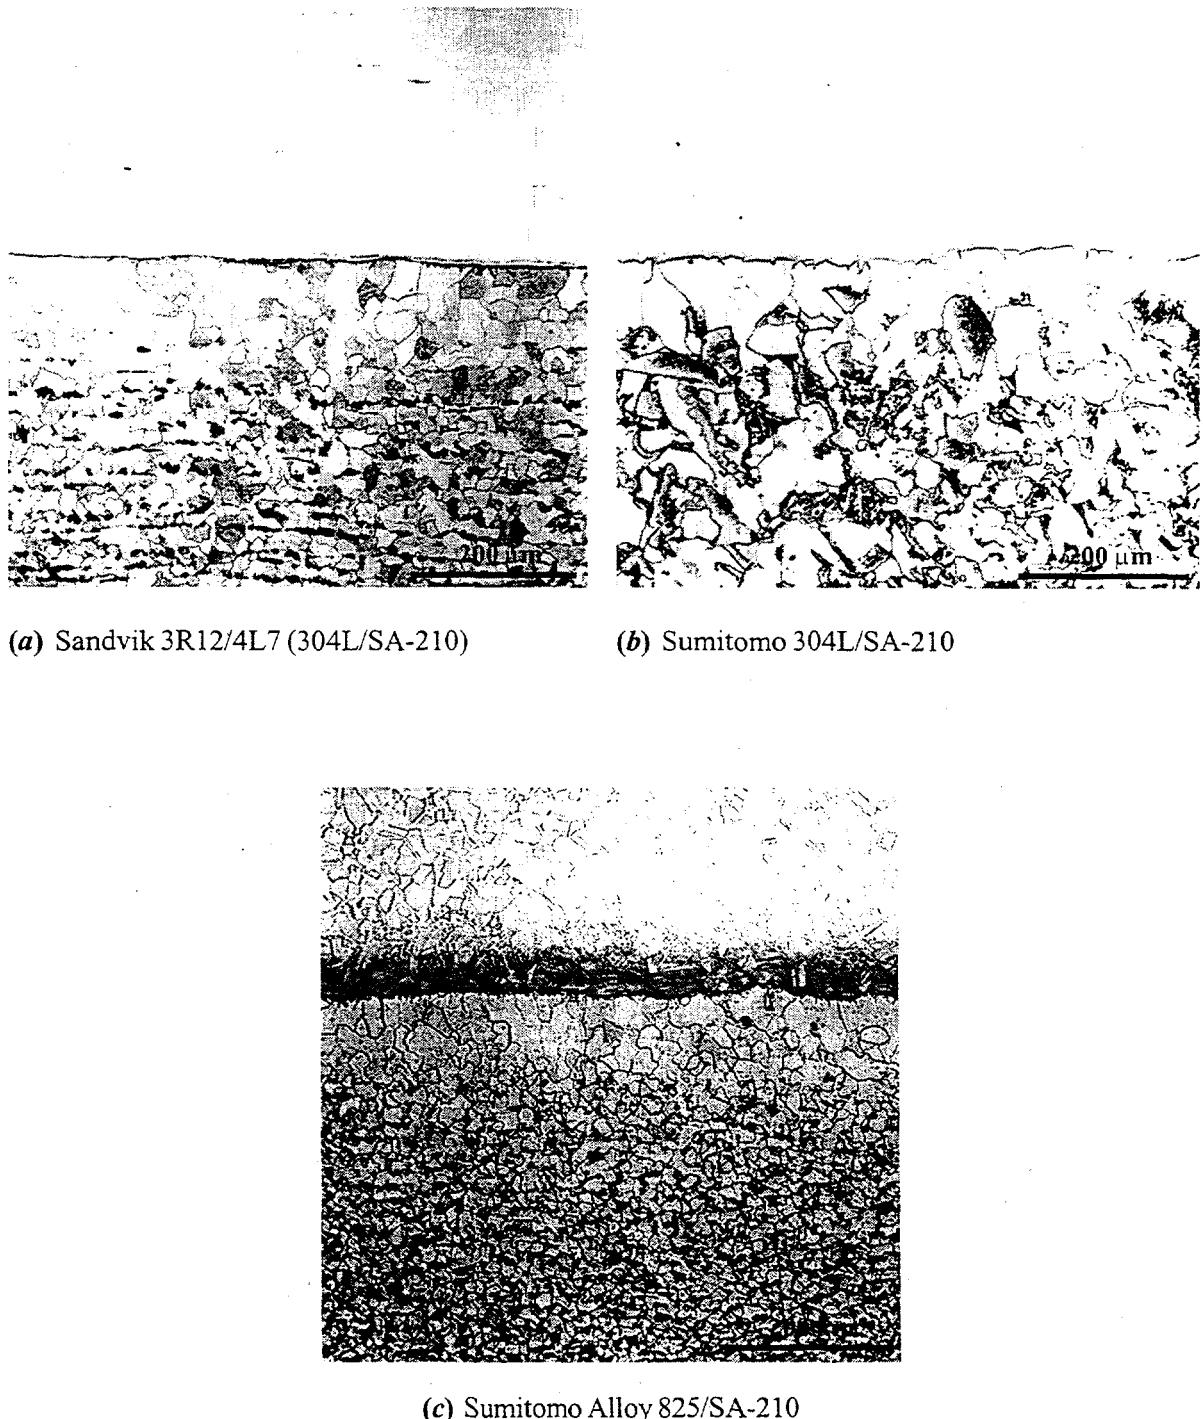
Fig. 3. Comparative photomicrographs of the cross section of different coextruded tubes. Note the variation in grain size and phase distribution across these samples as well as those included in Fig. 1. Stainless steel was etched with aqua regia; carbon steel was etched with 2% nital. The outer stainless steel layer in each tube appears at the top of each micrograph; the carbon steel is at the bottom.

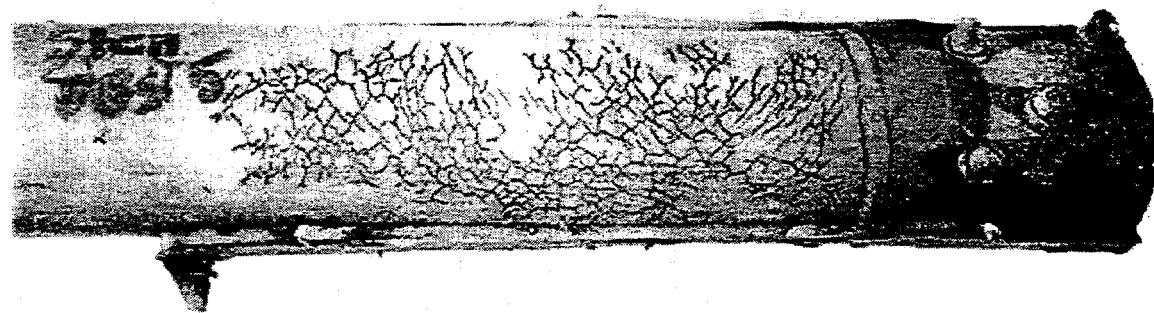
Fig. 6. Boilers with carbon steel floors and coextruded wall tubes are susceptible to cracking. This portion of coextruded tube from a European boiler formed the lower bend of a coextruded wall tube at the point where the tube is butt-welded to a studded carbon steel floor tube.

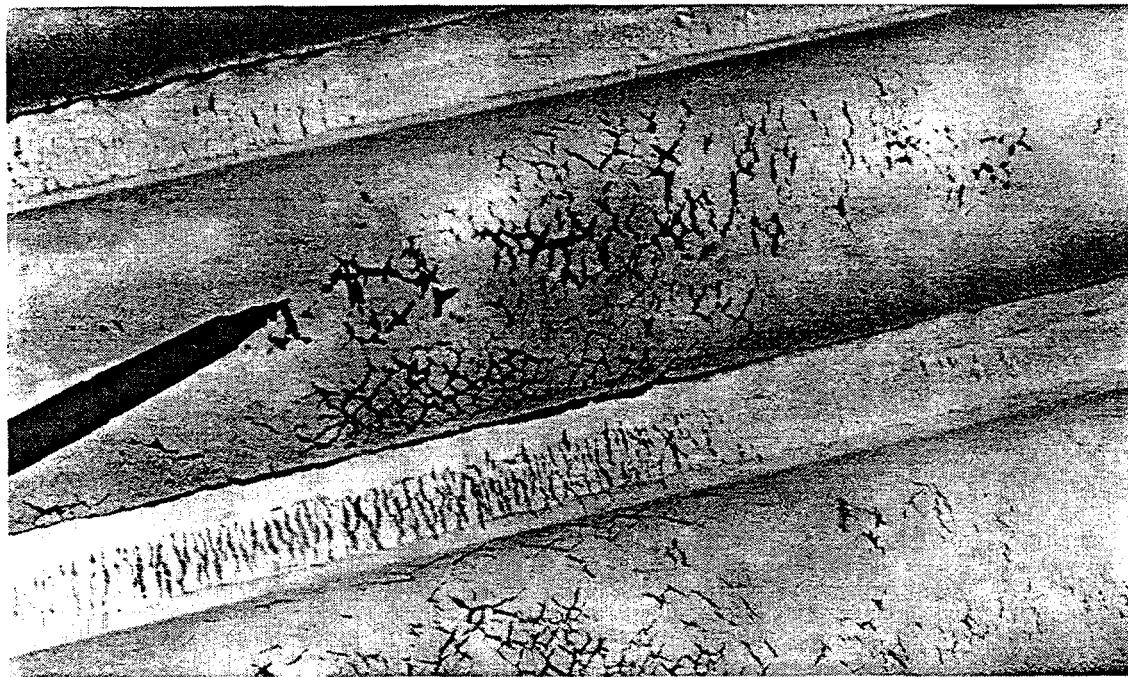
Fig. 7. Floor-tube panel from a North American boiler showing cracking in coextruded tubes. Cracks have been highlighted by dye-penetrant inspection. Cracks can be observed on the tube crown, at the tube-membrane interface, and in the membrane.

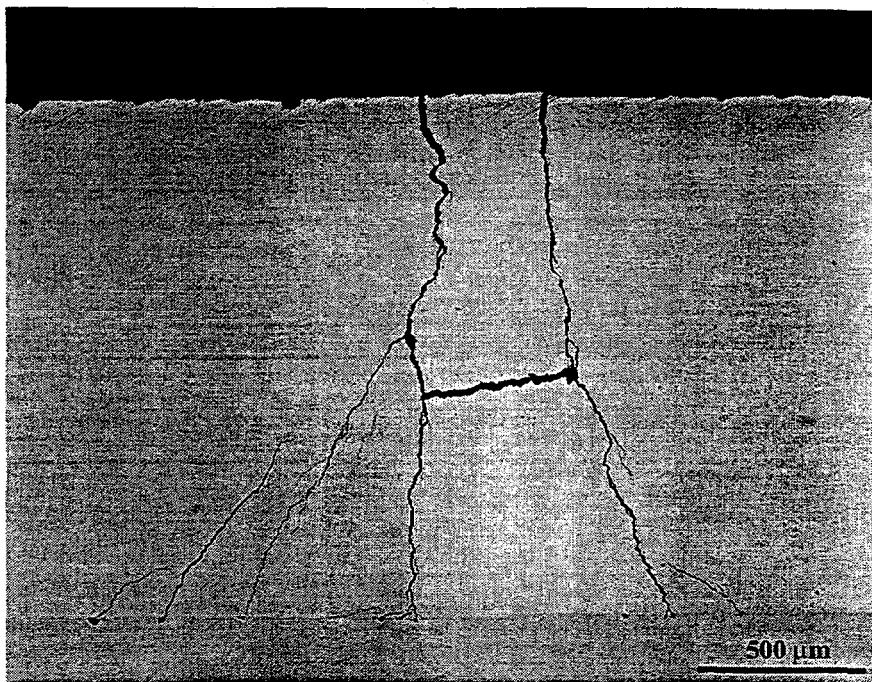
Fig. 8. Severe cracking can lead to spalling of the outer stainless steel layer and can leave exposed carbon steel underneath.

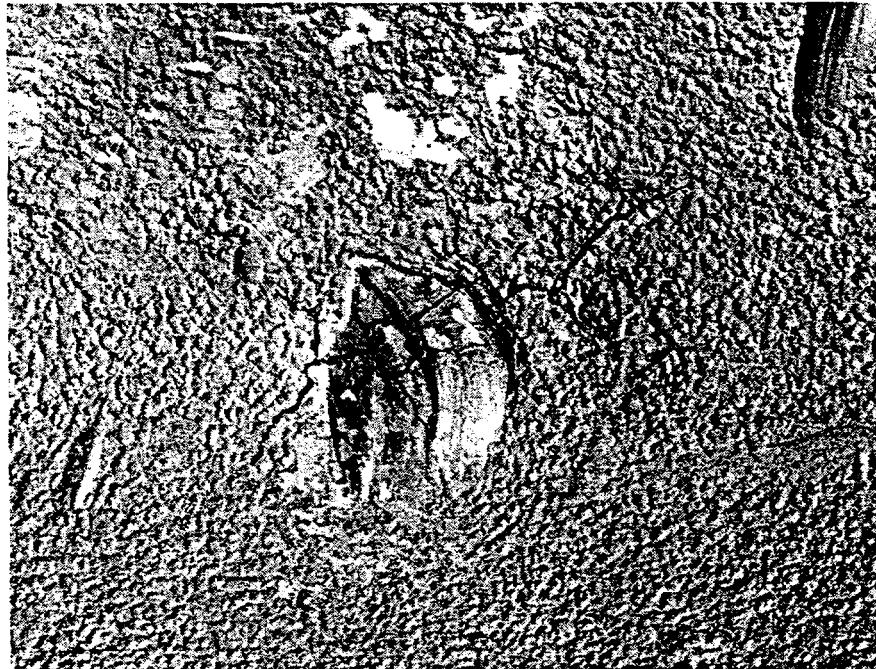
Fig. 9. "Star-burst" crack on surface of spout opening tube damaged by rodding.

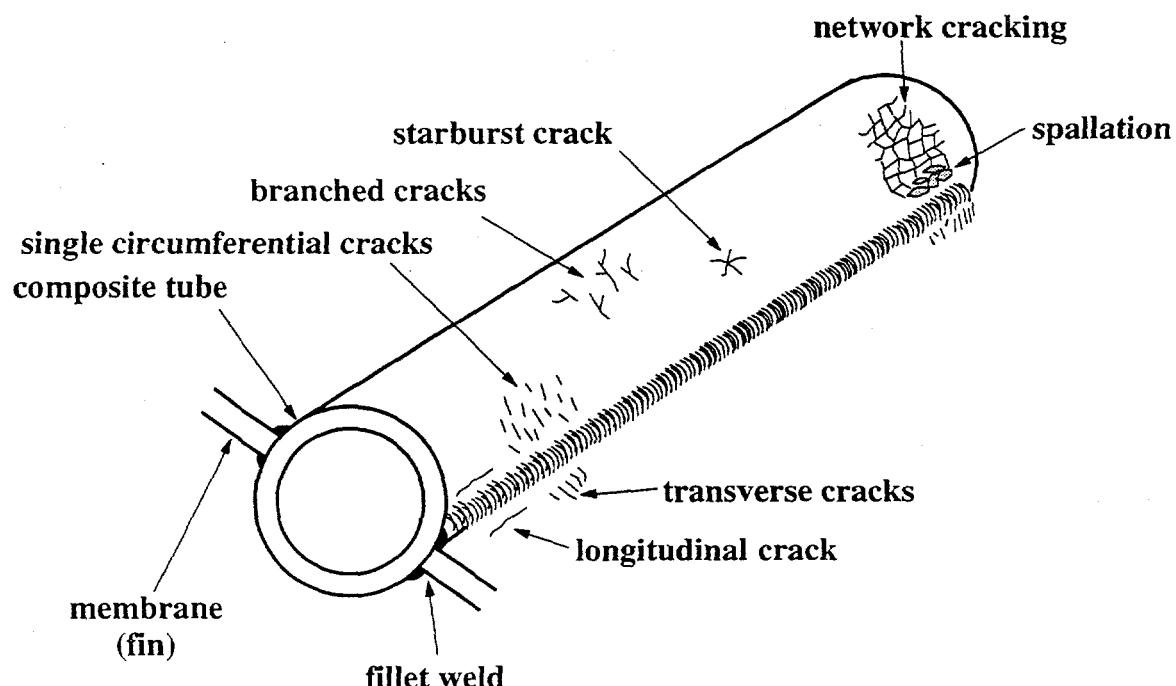
Fig. 10. A "composite" drawing showing the manifestations of the various forms of cracking found on the surface of coextruded tubes.

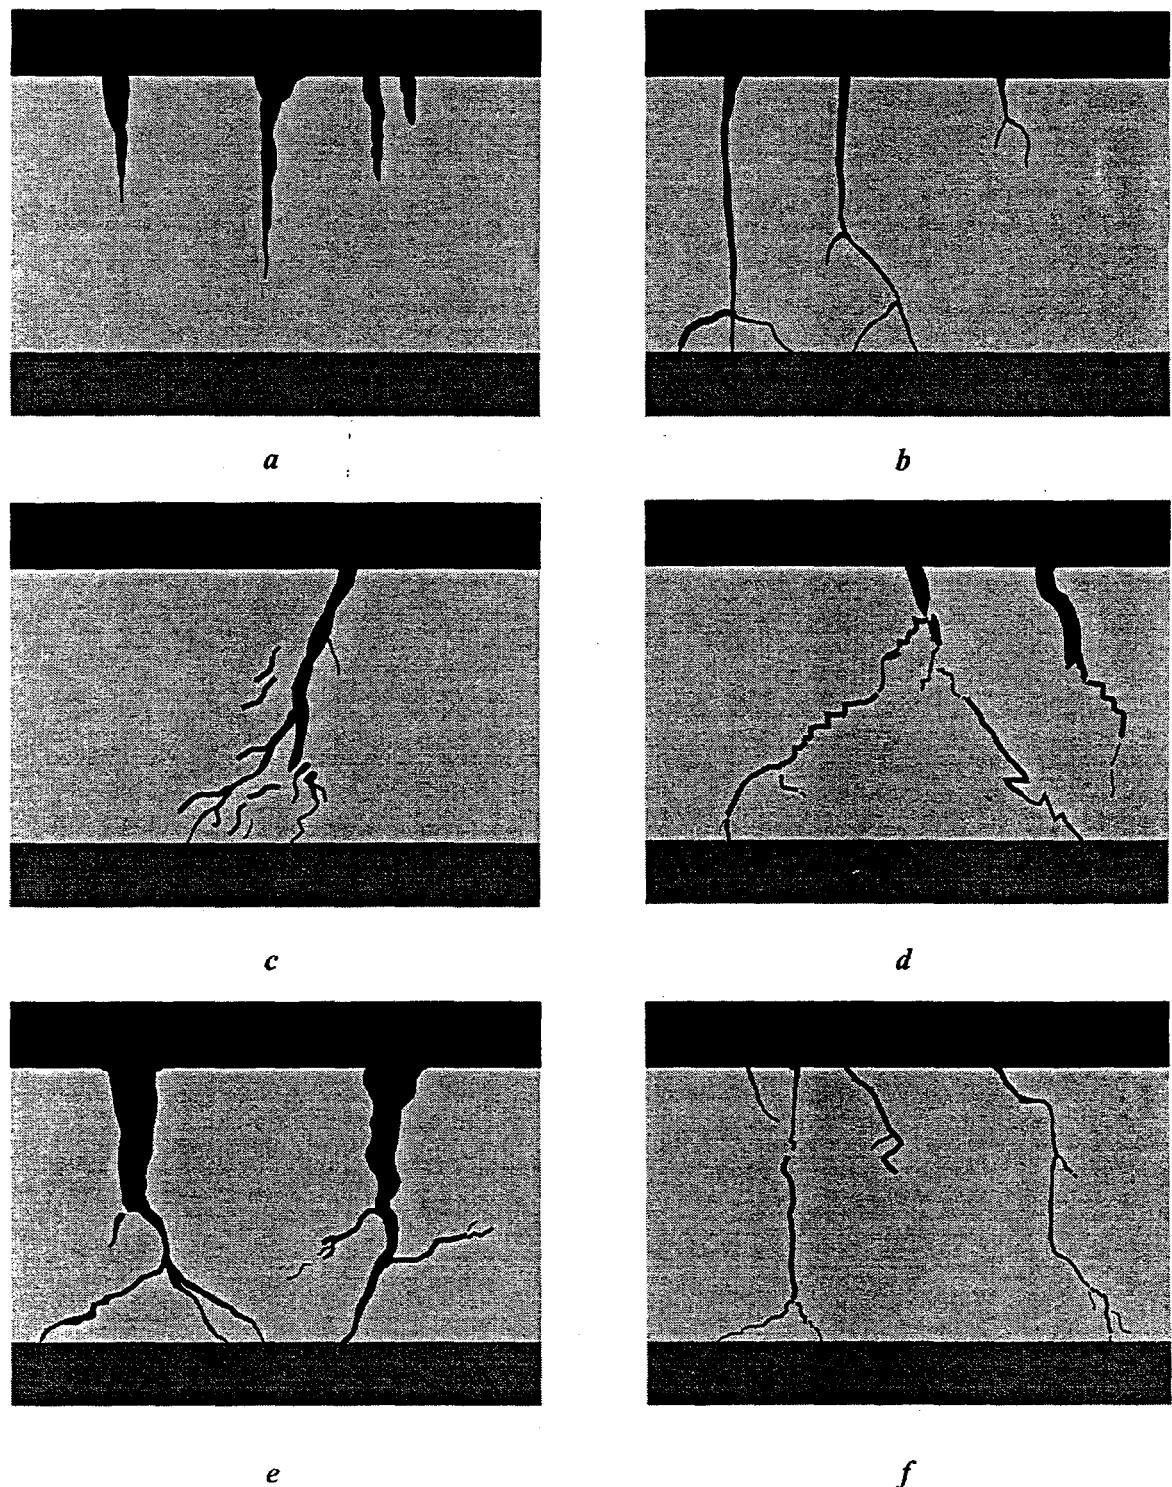
Fig. 11. Schematic drawing showing the various types of crack morphology found in coextruded tubes as cracks propagate to the interface between the carbon steel and the stainless steel.

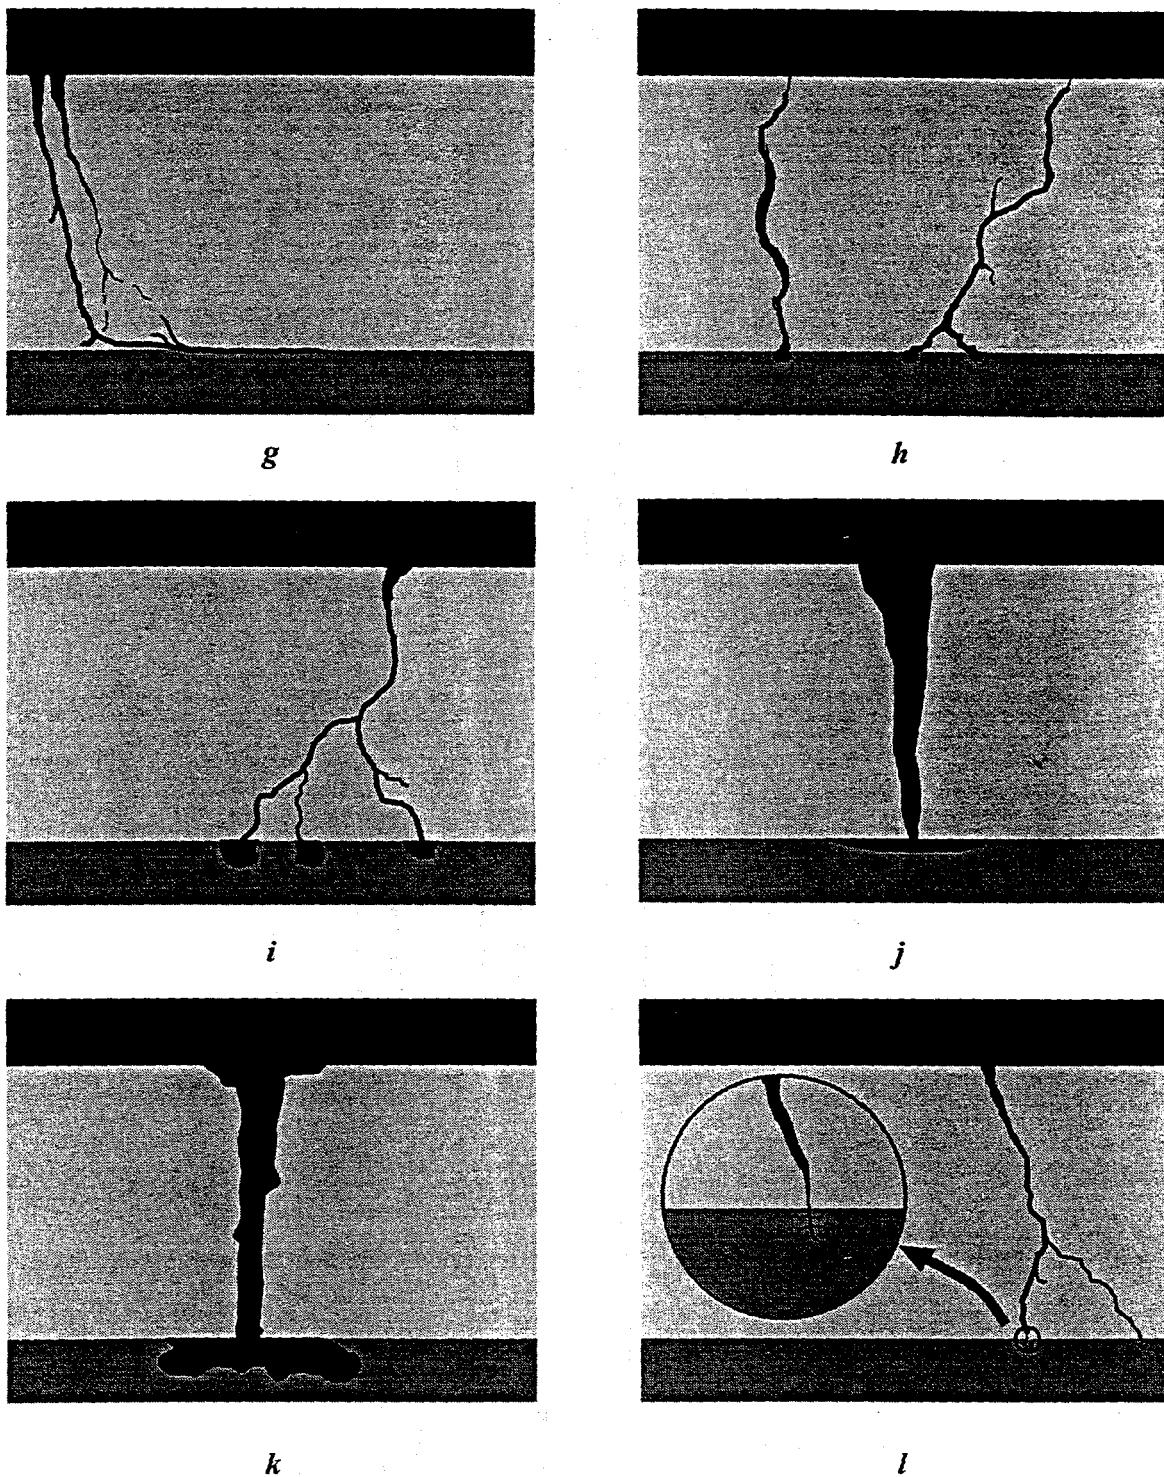
Fig. 11. (continued)

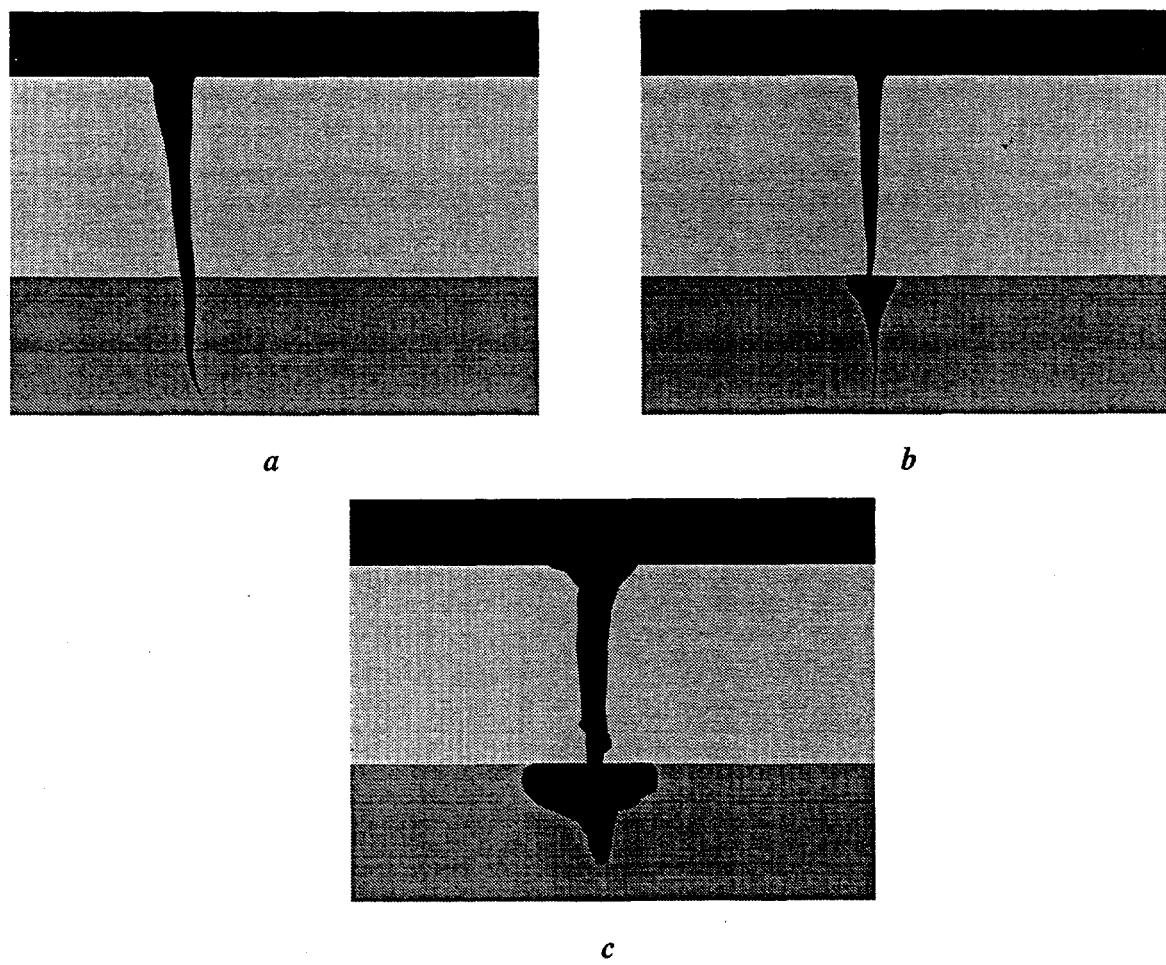
Fig. 12. Schematic drawing showing the morphologies of cracks progressing through the interface into the carbon steel core.

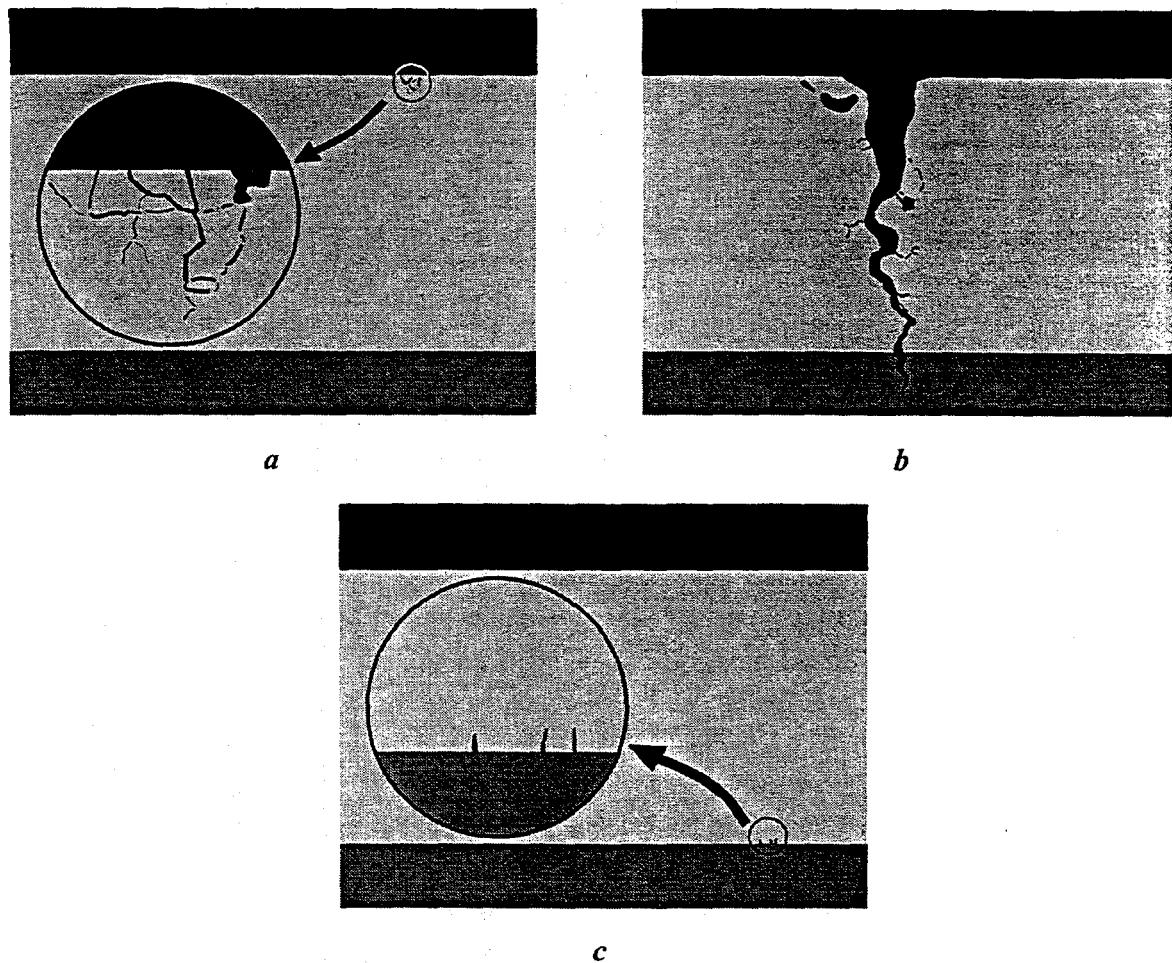
Fig. 13. Intergranular cracking and interface cracking in coextruded tubes.
