ORNL/TM-7698

## Performance of 9—12% Cr-1 Mo Steels During Flattening Test

V. K. Sikka  
R. E. McDonald

Date Published: April 1981

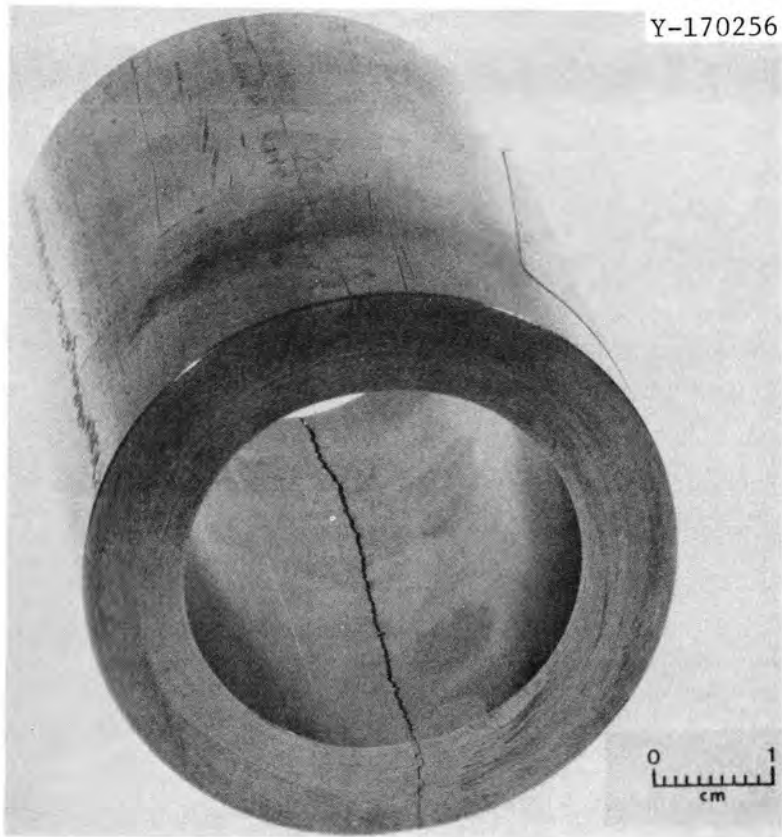
Figure 1 shows that when tested in the normalized condition, modified 9 Cr-1 Mo cracked even after a slight flattening. This is an important result because it shows the need for tempering the hard martensite for use in the unwelded or welded condition. Figure 2 shows the results of the flattening test on both heats of modified 9 Cr-1 Mo. Both tubes were tested in the normalized and tempered and normalized and softened conditions. After each heat treatment the specimen was cooled to room temperature. The softening treatment consisted of holding the specimen for 1 h at 900°C, furnace cooling, holding at 700°C over 16 h, and air cooling to room temperature. This treatment produced a condition softer than produced by tempering (Rockwell B 60–65 vs 85–95). For both heats (fabricated by two significantly different processes) and heat treatments, modified 9 Cr-1 Mo tube could be flattened until the sides met without any cracking. Heat XA3602, when tested in the normalized and tempered condition, showed a small surface defect as circled on Fig. 2. This surface defect is not too different from that observed for type 316 stainless steel, which will be shown later.

Fig. 1. Response to flattening test of normalized tube of modified 9 Cr-1 Mo steel, heat XA3602.

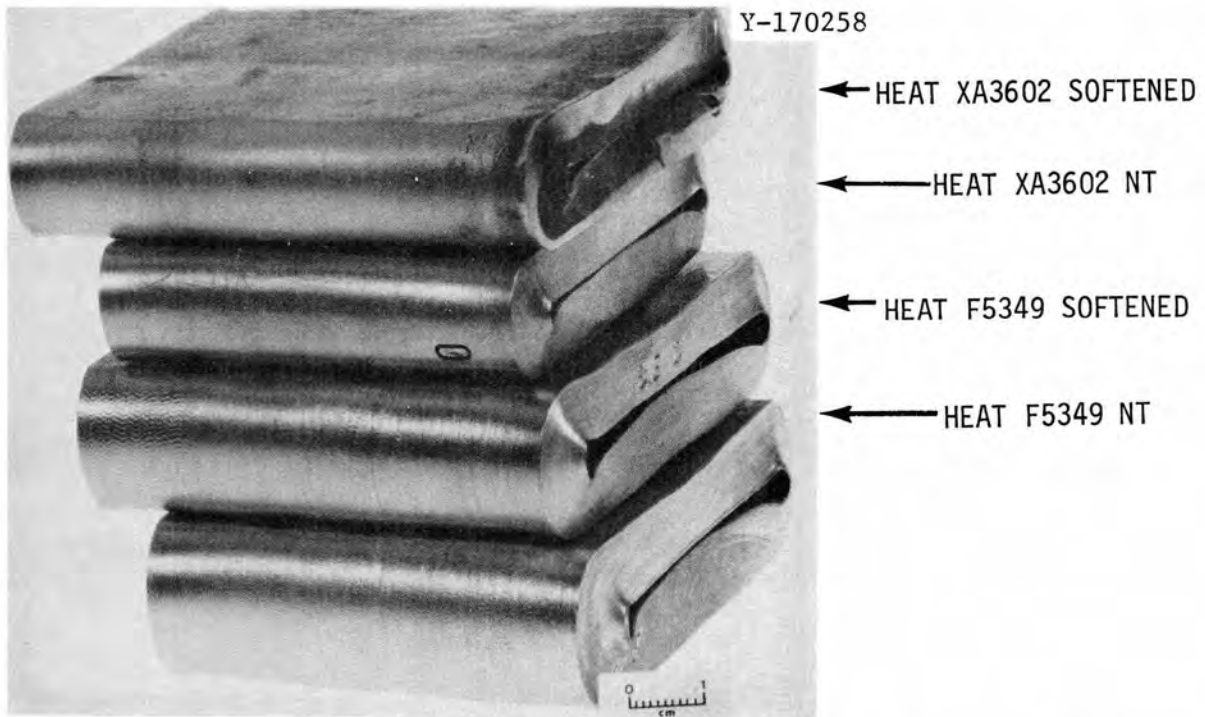
Fig. 2. Response to flattening test of two heats of modified 9 Cr-1 Mo steel, one each tested in normalized and tempered condition and softened condition.

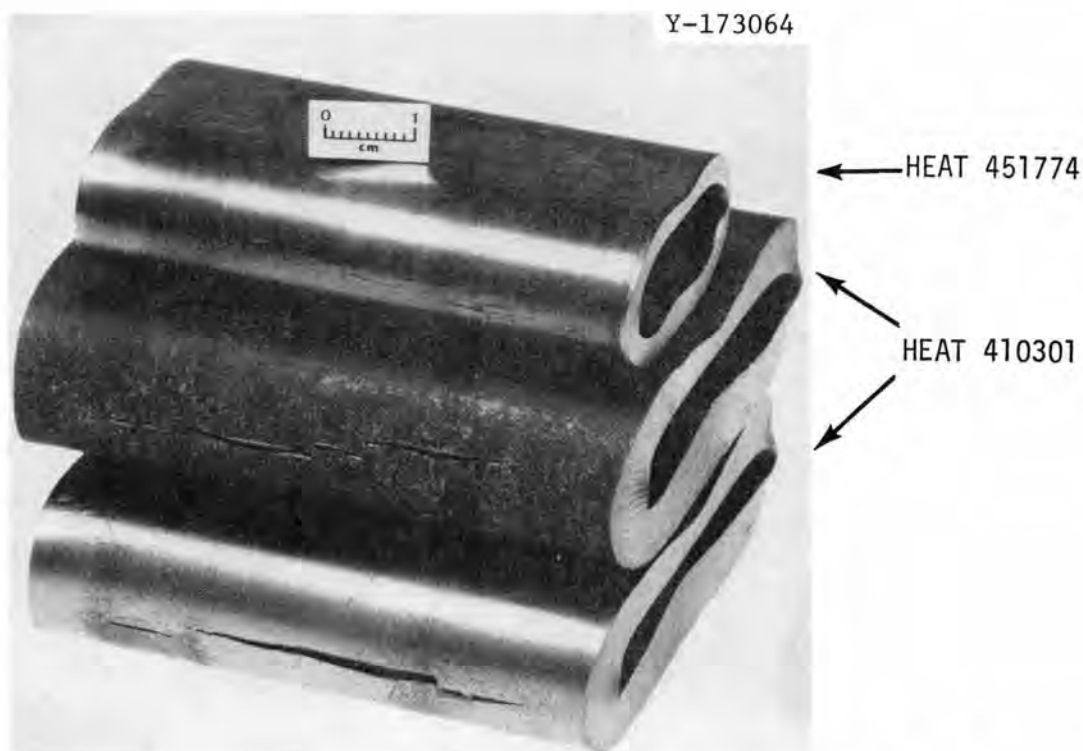
Figure 3 shows the flattening test response on two heats (410301 and 451774) of HT9 tested in the normalized and tempered condition. Tubes from heat 410301 were tested in both the oxidized and machined surface conditions. The tubes from both heats cracked much before complete flattening. It should be mentioned that these tubes cracked only during the second step of the flattening test, indicating that the cracking was not a result of insufficient ductility but probably a result of inadequate soundness.

Fig. 3. Response to flattening test of two normalized and tempered heats of HT9. Heat 410301 was tested in two different surface conditions: oxidized and machined.

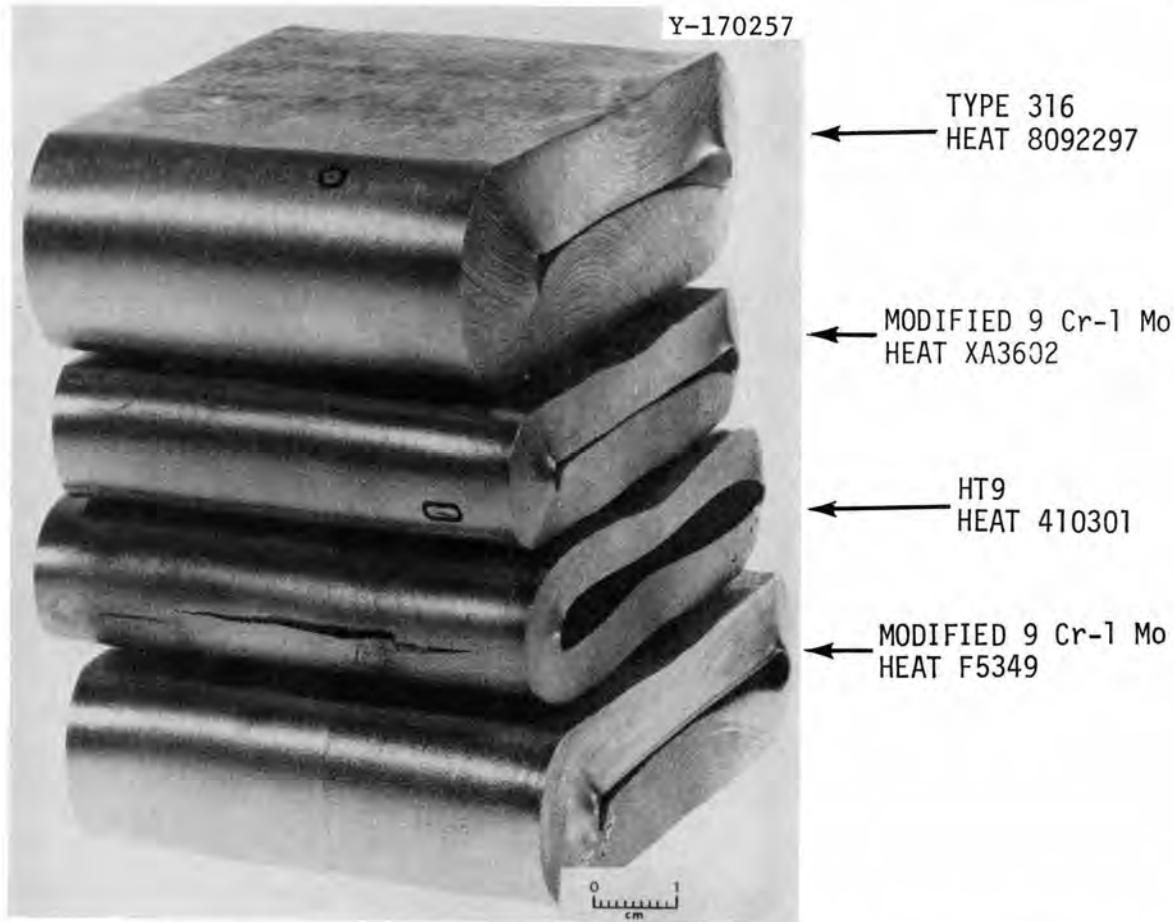
Figure 4 compares the flattening test response on modified 9 Cr-1 Mo (from Fig. 2) with HT9 (from Fig. 3) and type 316 stainless steel. The response of modified 9 Cr-1 Mo is much superior to that of HT9 and as good as that of type 316 stainless steel. Note that the stainless steel specimen shows a surface flaw similar to that seen on heat XA3602 of modified 9 Cr-1 Mo steel. The type 316 stainless steel had come from a lot given this test by the manufacturer.

Fig. 4. Response to flattening test of two normalized and tempered heats of modified 9 Cr-1 Mo, one normalized and tempered heat of HT9, and one solution annealed heat of type 316 stainless steel.

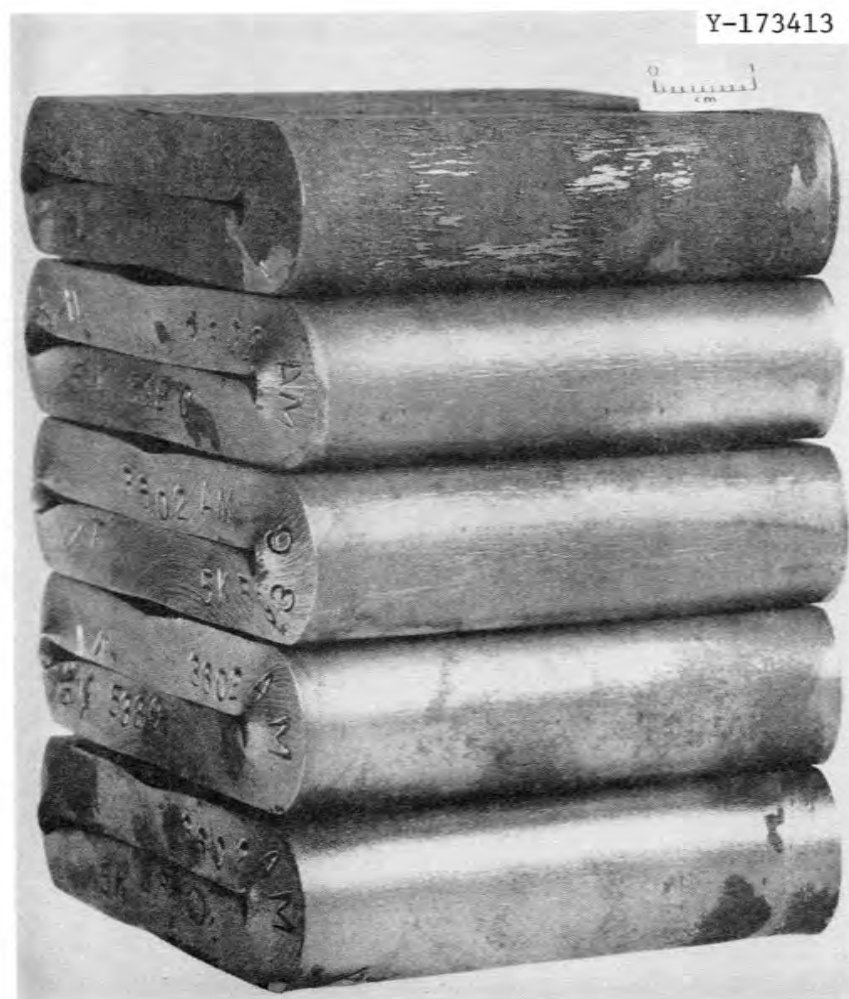
Figures 5 and 6 show the flattened tubes of modified 9 Cr-1 Mo and HT9 after 3000-h exposures at 482, 538, 593, 649, and 704°C. Since the tubes were aged in air (wrapped in stainless steel foil), they had oxidized. The oxidized layer (one of possibly three) was removed by buffing the tube surfaces of both alloys. Modified 9 Cr-1 Mo tubes remained uncracked after aging at all five temperatures. The HT9 cracked after aging at four of the temperatures. The only aging temperature for which HT9 did not crack was 704°C.

Fig. 5. Response to flattening test of the aged tubes of modified 9 Cr-1 Mo. Normalized and tempered tubes were aged 3000 h at 482, 538, 593, 649, and 704°C (from bottom to top, respectively).

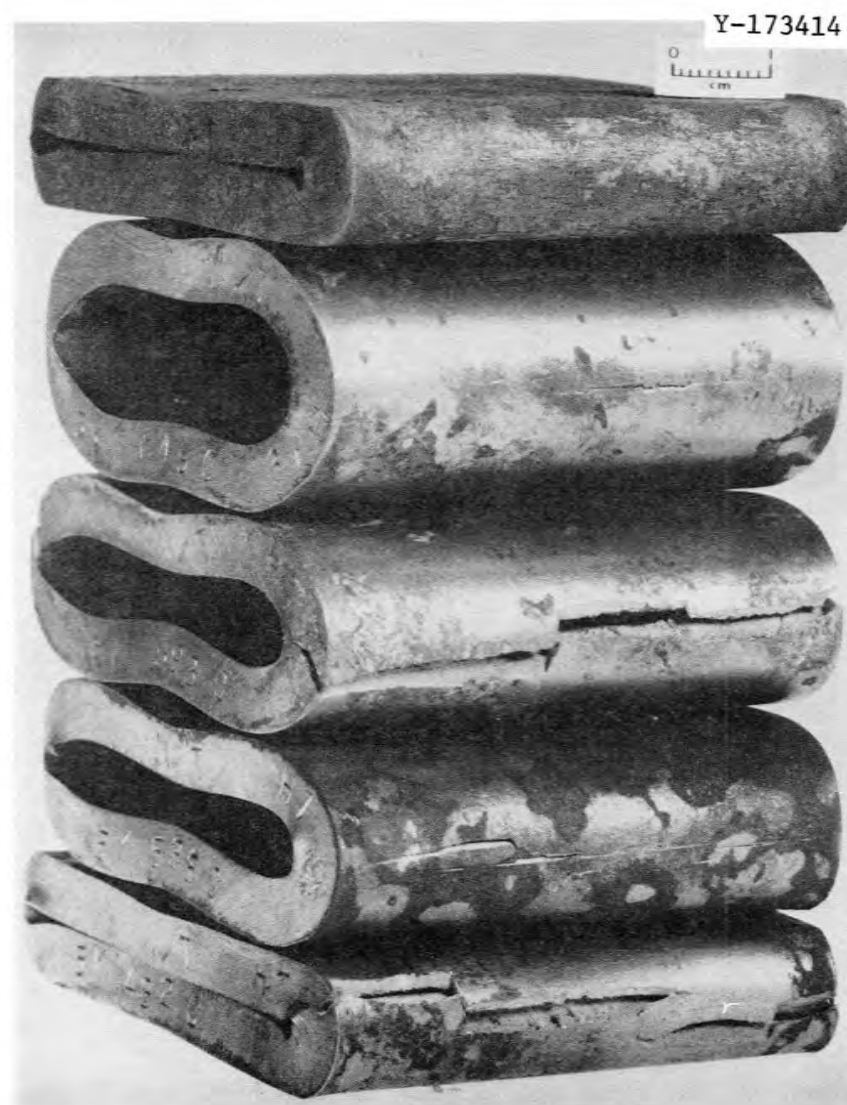
Fig. 6. Response to flattening test of the aged tubes of HT9. Normalized and tempered tubes were aged 3000 h at 482, 538, 593, 649, and 704°C (from bottom to top, respectively).

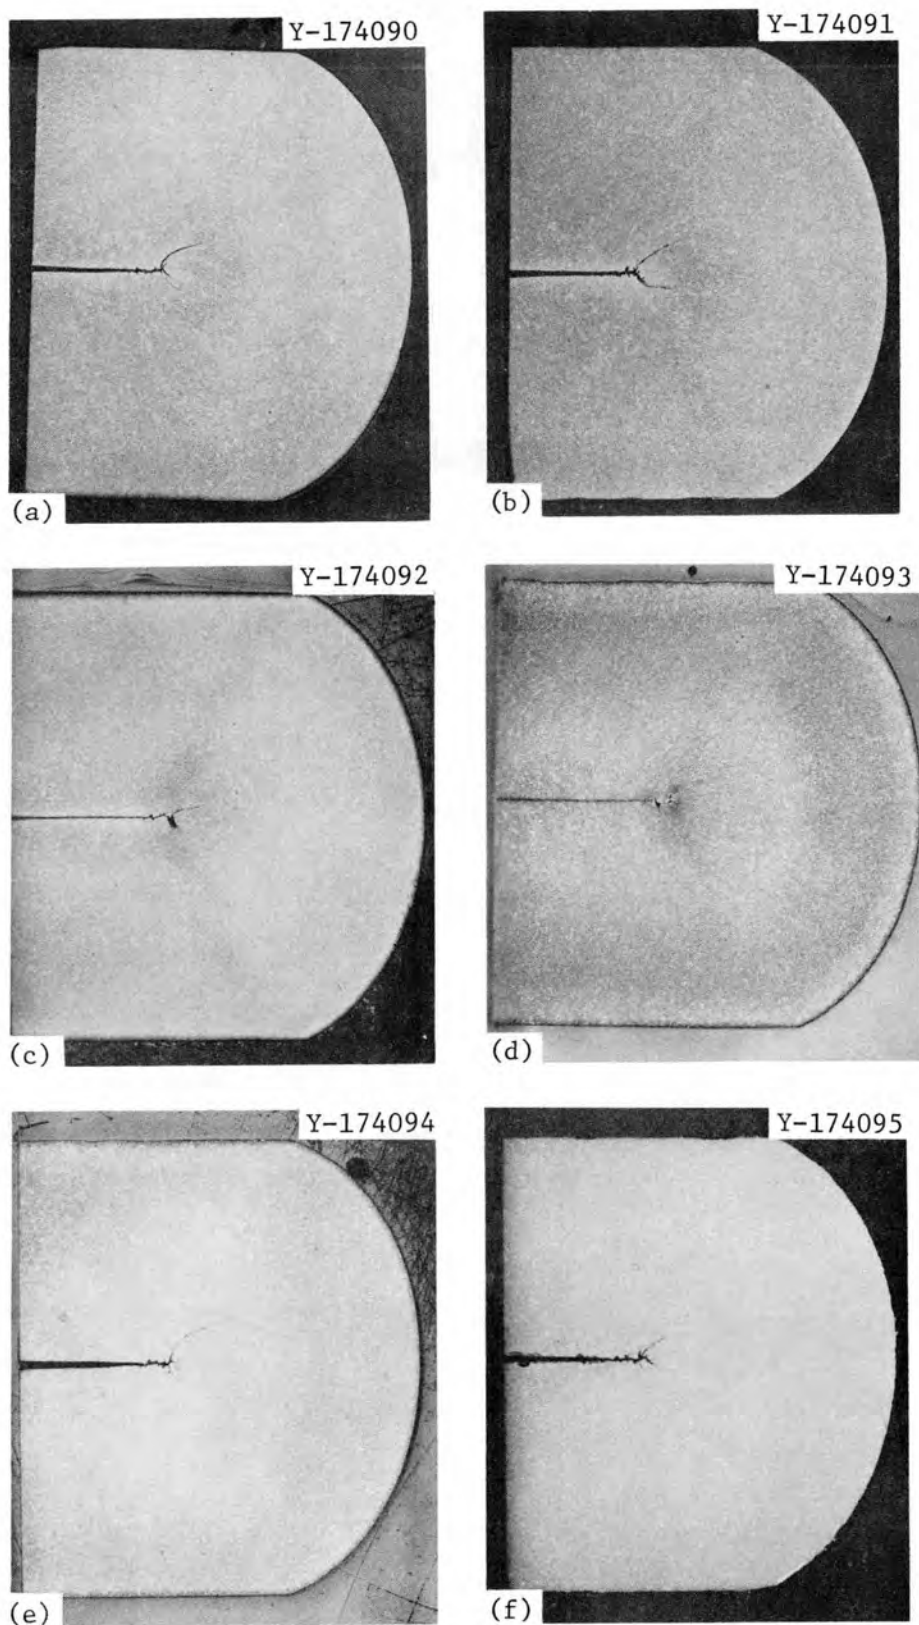
Fig. 7. Transverse sections of the flattened tubes of modified 9 Cr-1 Mo. (a) Unaged; (b) through (f) aged 3000 h at 482, 538, 593, 649, and 704°C, respectively.

In agreement with Fig. 5 the transverse sections in Fig. 7 showed no evidence of cracking on the outer surface of either the unaged or aged tubes of modified 9 Cr-1 Mo alloy. The complete flattening of modified alloy tubes produced sufficient compressive deformation to initiate cracks on the inner surface. For HT9, cracks are seen on both surfaces of the tubes after flattening both in the normalized and tempered condition and after aging at 482 through 649°C. Aging at 704°C resulted in only cracks on the inner surface similar to those observed for modified 9 Cr-1 Mo alloy. The lack of outer surface cracks in Fig. 8(e) compared with Fig. 6 is just a result of metallographic specimen location along the tube. If the specimen had been cut from near the tube center, we would have observed the outer surface cracks. Comparison of Figs. 7 and 8 shows that HT9 is much more susceptible to cracking at both surfaces than modified 9 Cr-1 Mo alloy. This is true for the alloy in both the unaged and aged conditions.

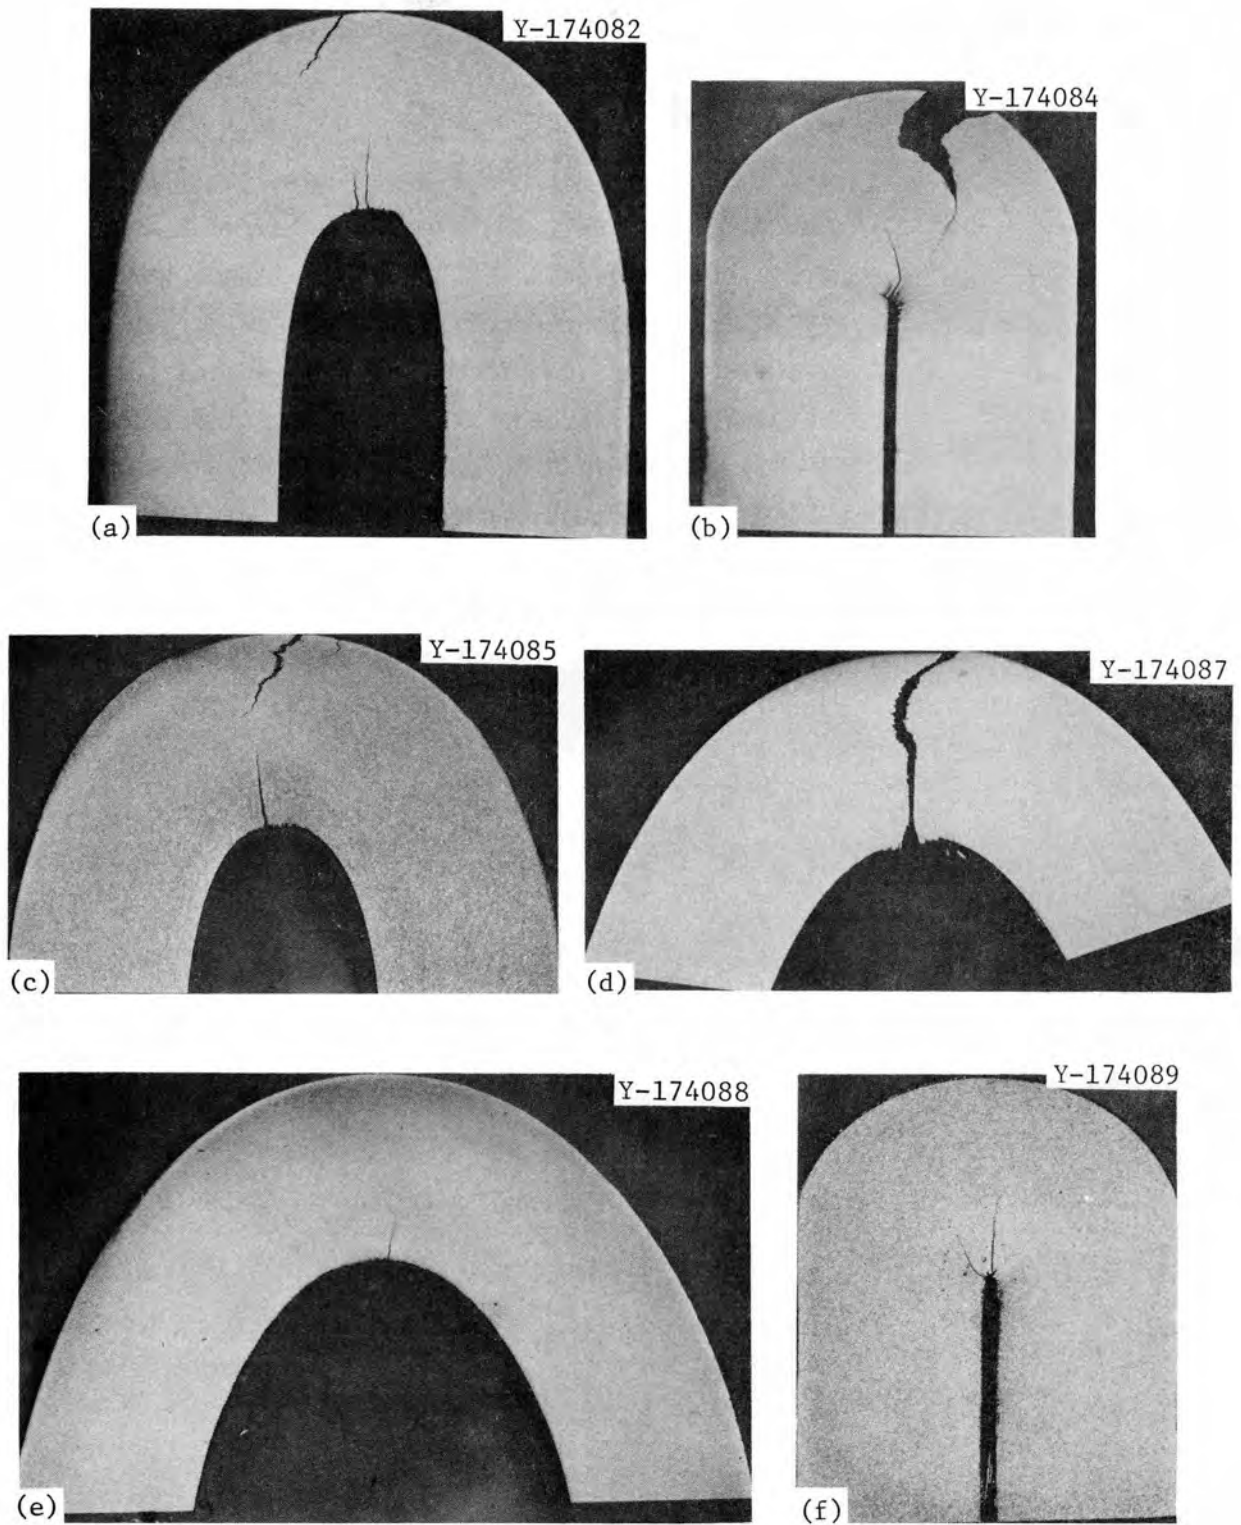
Transverse and longitudinal sections from each of the flattened tubes were cut and mounted for metallographic observations. The transverse sections for the unaged and aged modified 9 Cr-1 Mo and HT9 are shown in Figs. 7 and 8.

Fig. 8. Transverse sections of the flattened HT9 tubes. (a) Unaged; (b) through (f) aged 3000 h at 482, 538, 593, 649, and 704°C, respectively.

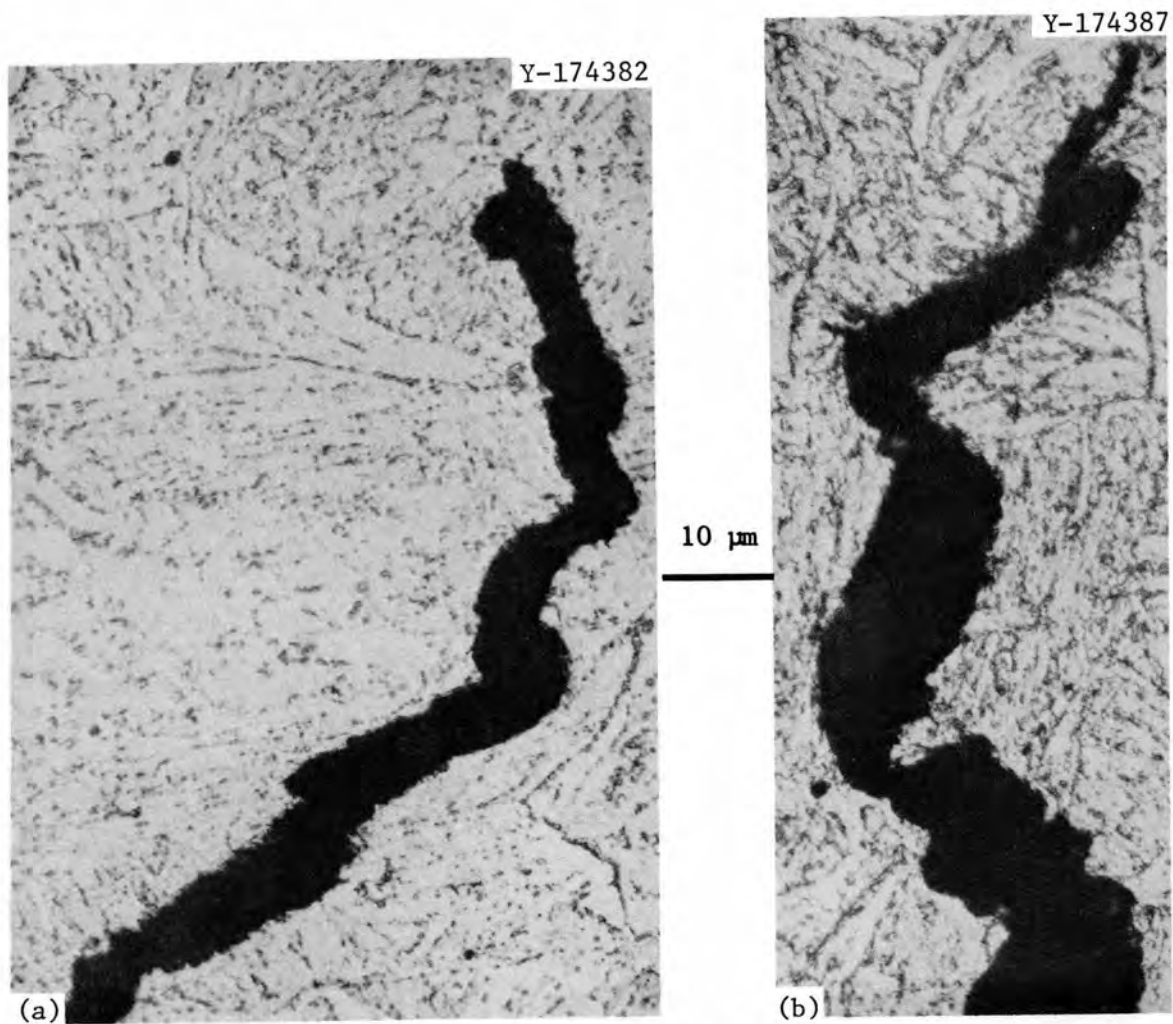
Photomicrographs of the cracked tubes of HT9 unaged and after aging for 3000 h at 538°C are shown in Fig. 9. This figure shows that the cracks in both cases are transgranular.

Fig. 9. Crack path in flattened tubes of HT9. (a) Unaged. (b) Aged 3000 h at 538°C.

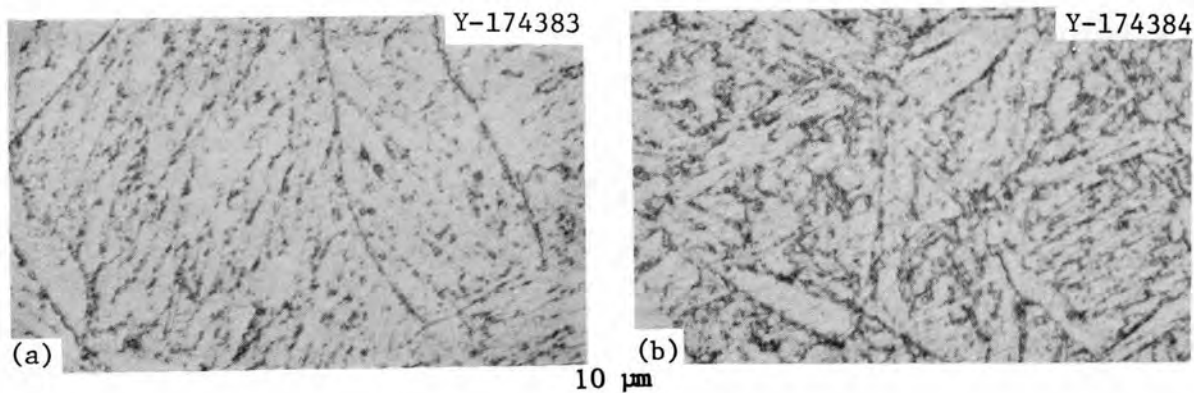
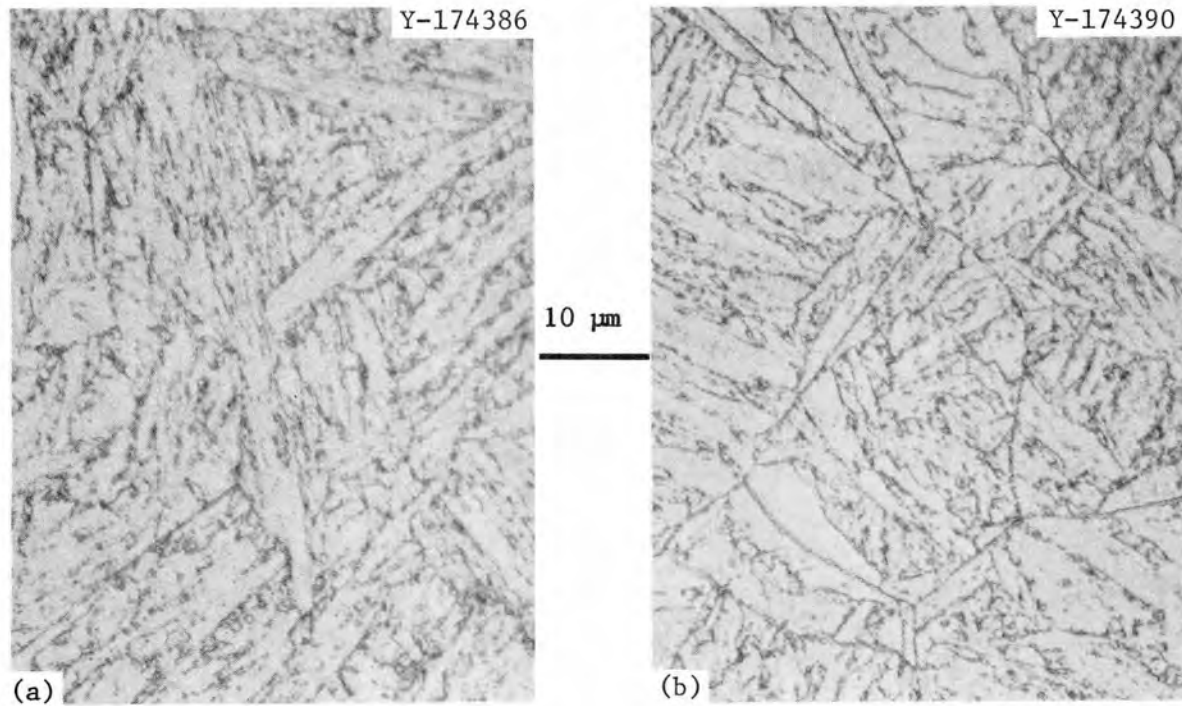
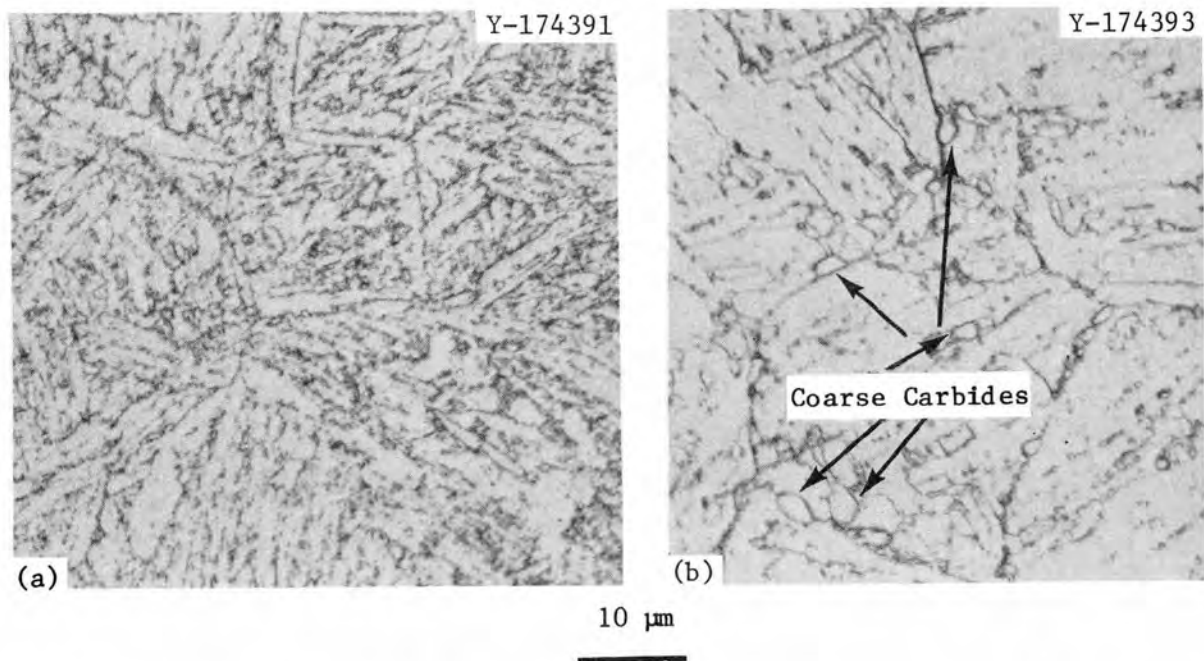
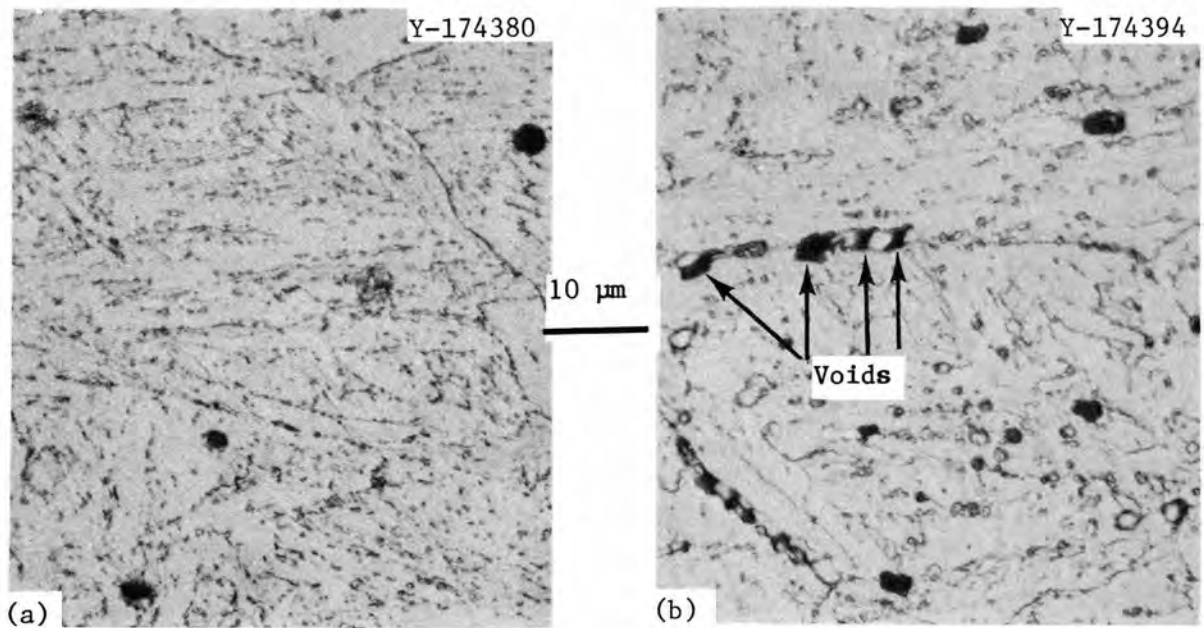
Figures 10 through 12 show that only small changes occur in HT9 as a result of thermal aging for 3000 h at 482, 538, 593, and 649°C. However, aging at 704°C produces a significant amount of coarsening of precipitate particles in the matrix and at the grain boundaries. Figure 13 shows that coarse precipitate particles help relieve the strains during flattening by void formation at their interfaces. Also significant strains can be taken up by the relatively precipitate-free matrix. Both these conditions are responsible for preventing cracking during flattening HT9 tubing aged for 3000 h at 704°C.

Fig. 10. Longitudinal sections of flattened HT9 tubes. (a) Unaged. (b) Aged 3000 h at 482°C.

Fig. 11. Longitudinal sections of HT9 tubes flattened after aging 3000 h at (a) 538 and (b) 593°C.

Fig. 12. Longitudinal sections of HT9 tubes flattened after aging 3000 h at (a) 649 and (b) 704°C.

Fig. 13. Transverse sections near outer surface of flattened HT9 tubes. (a) Unaged. (b) Aged 3000 h at 704°C.

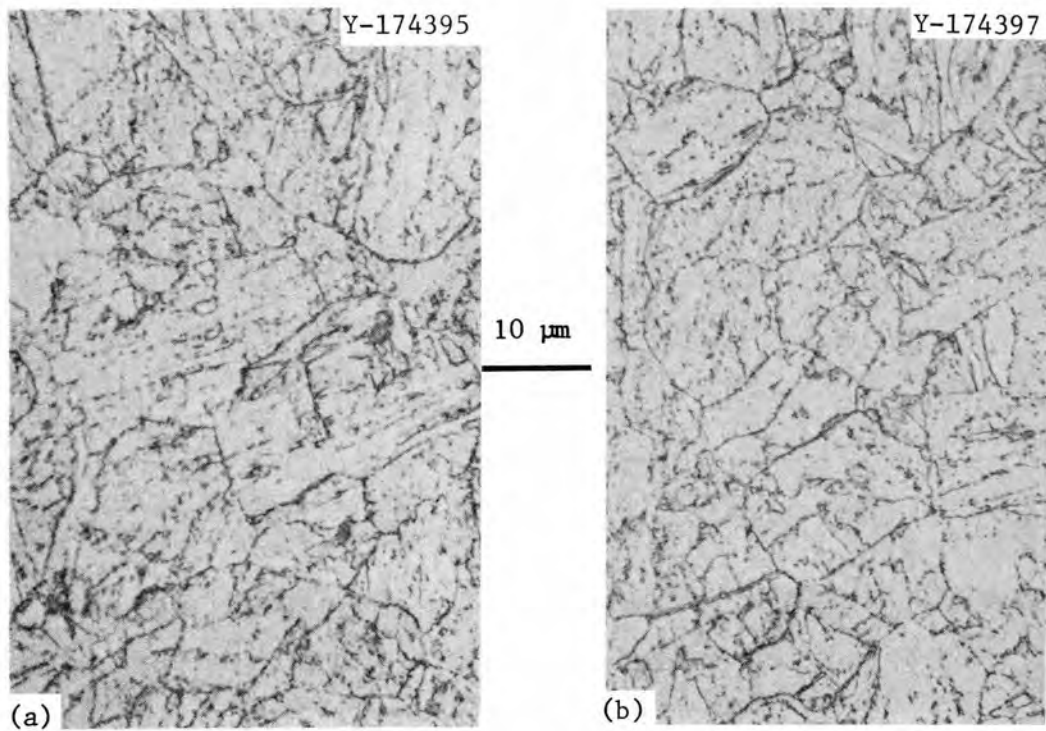
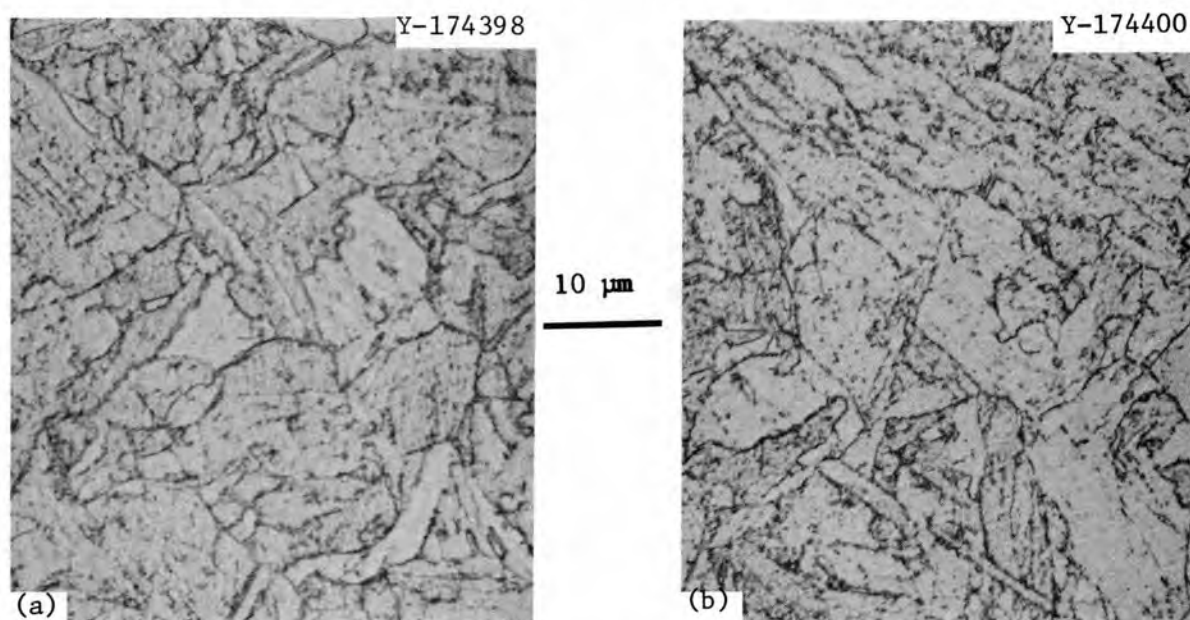
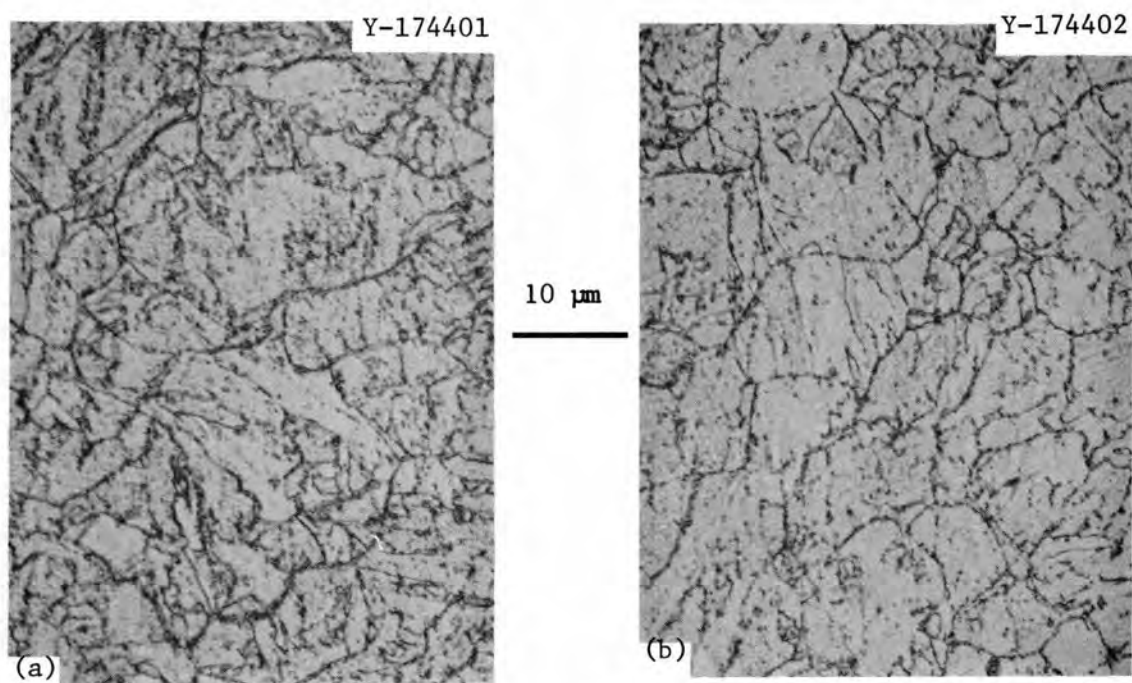
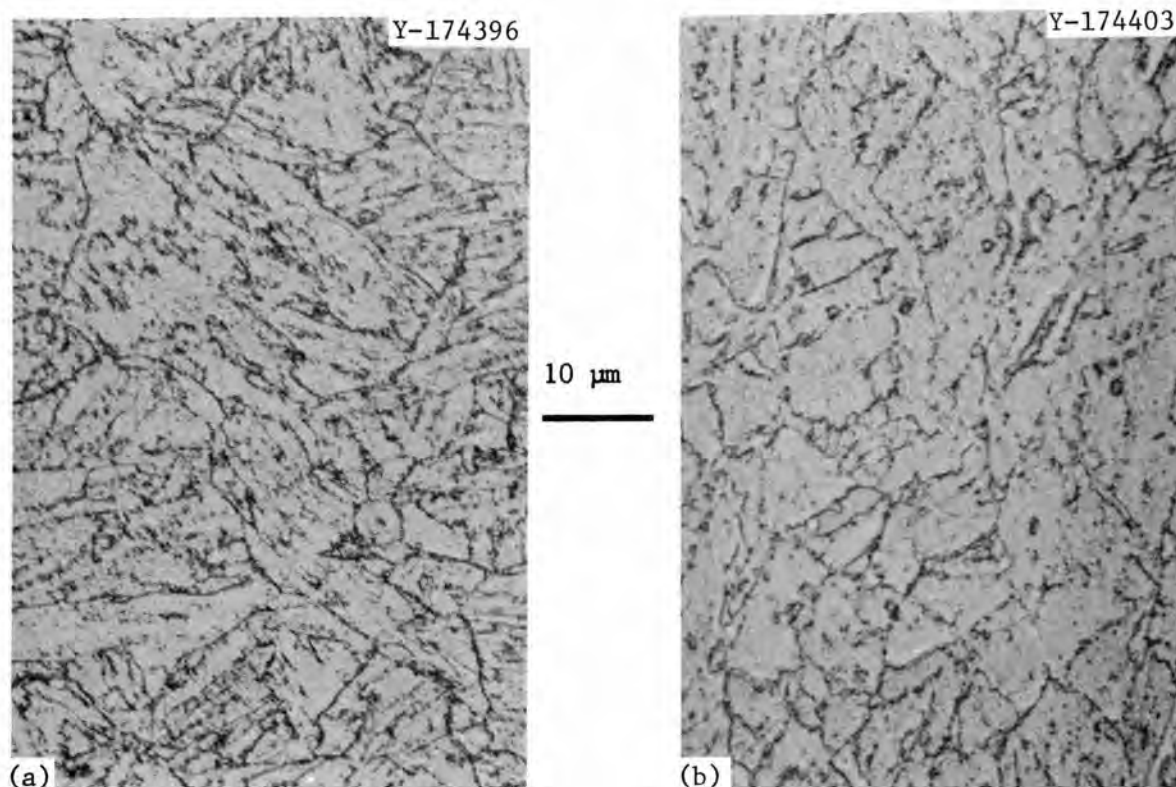
Fig. 14. Longitudinal sections of flattened modified 9 Cr-1 Mo tubes. (a) Unaged. (b) Aged 3000 h at 482°C.

Fig. 15. Longitudinal sections of modified 9 Cr-1 Mo tubes flattened after aging 3000 h at (a) 538 and (b) 593°C.

Fig. 16. Longitudinal sections of modified 9 Cr-1 Mo tubes flattened after aging 3000 h at (a) 649 and (b) 704°C.

Fig. 17. Transverse sections of flattened modified 9 Cr-1 Mo tubes. (a) Unaged. (b) Aged 3000 h at 704°C.

Figures 14 through 17 show only small changes in the microstructure of modified 9 Cr-1 Mo after aging for 3000 h at 482, 538, 593, and 649°C. The aging treatment of 704°C produced a relatively cleaner matrix. However, the grain boundary carbide was still fine. This is in contrast to HT9, where significant carbide coarsening occurred as a result of this aging treatment. Of course, the microstructure of modified 9 Cr-1 Mo alloy is such that it remains crackfree in the unaged and aged conditions.

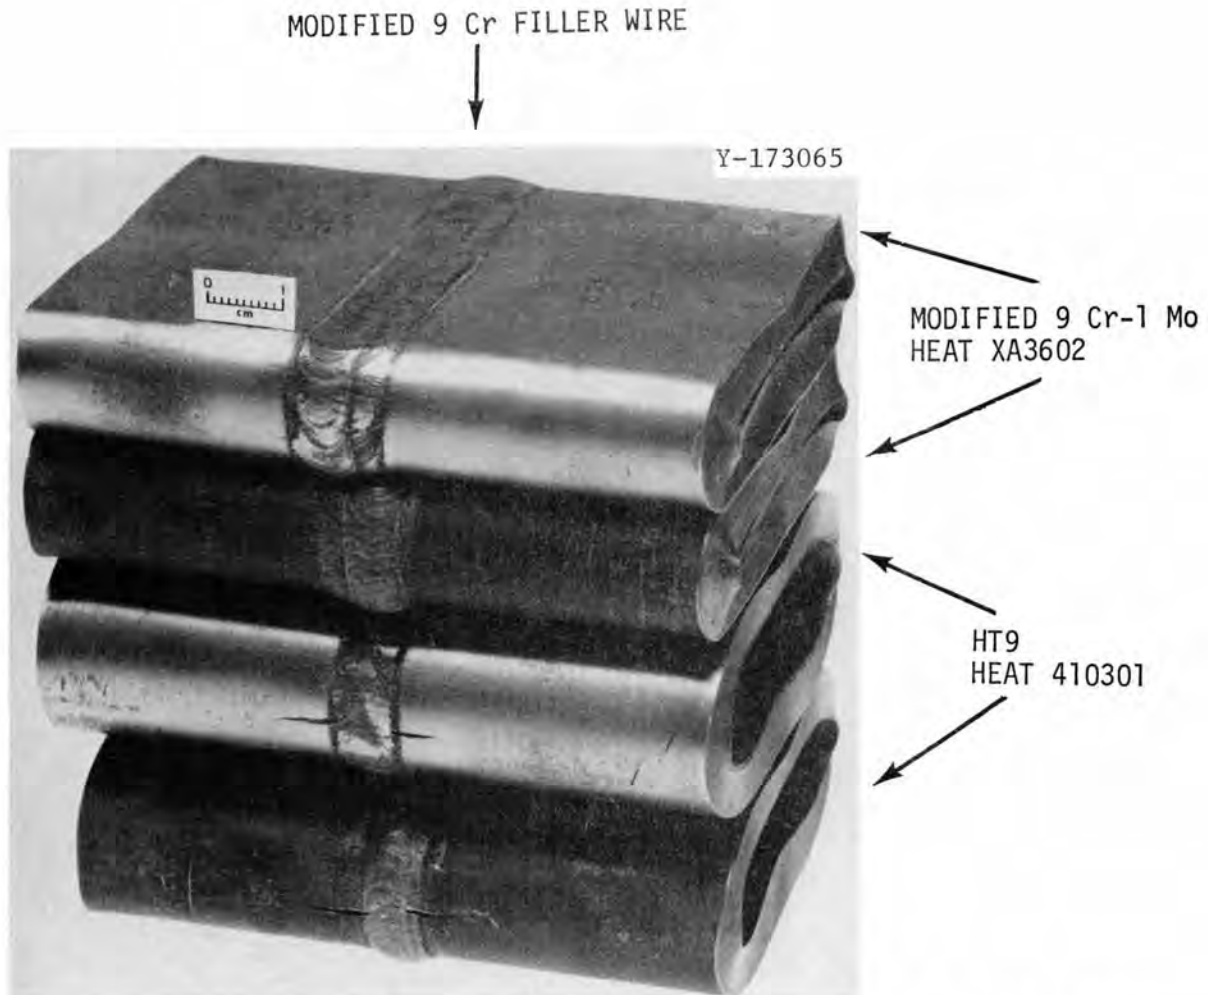
Results of the flattening test on welded tubes of modified 9 Cr-1 Mo and HT9 are presented in Fig. 18. Both alloys were welded by identical procedures using modified 9 Cr-1 Mo filler wire. Both tubes were postweld heat-treated at 732°C for 1 h. Figure 18 shows that the welded tube of modified 9 Cr-1 Mo can be flattened until the sides meet, without evidence of any cracking. However, HT9 tubes cracked in the base metal much before total flattening. The cracks initiated in the base metal appeared to be propagating through the weld metal. However, the weld metal is expected

Fig. 18. Response to the flattening test conducted on welded tubes of modified 9 Cr-1 Mo and HT9. Both materials were welded with modified 9 Cr-1 Mo filler wire and postweld heat-treated at 732°C for 1 h.

to resist crack propagation because of its good toughness, as evidenced by the total flattening of modified 9 Cr-1 Mo tubes containing the weld made out of the same filler wire.

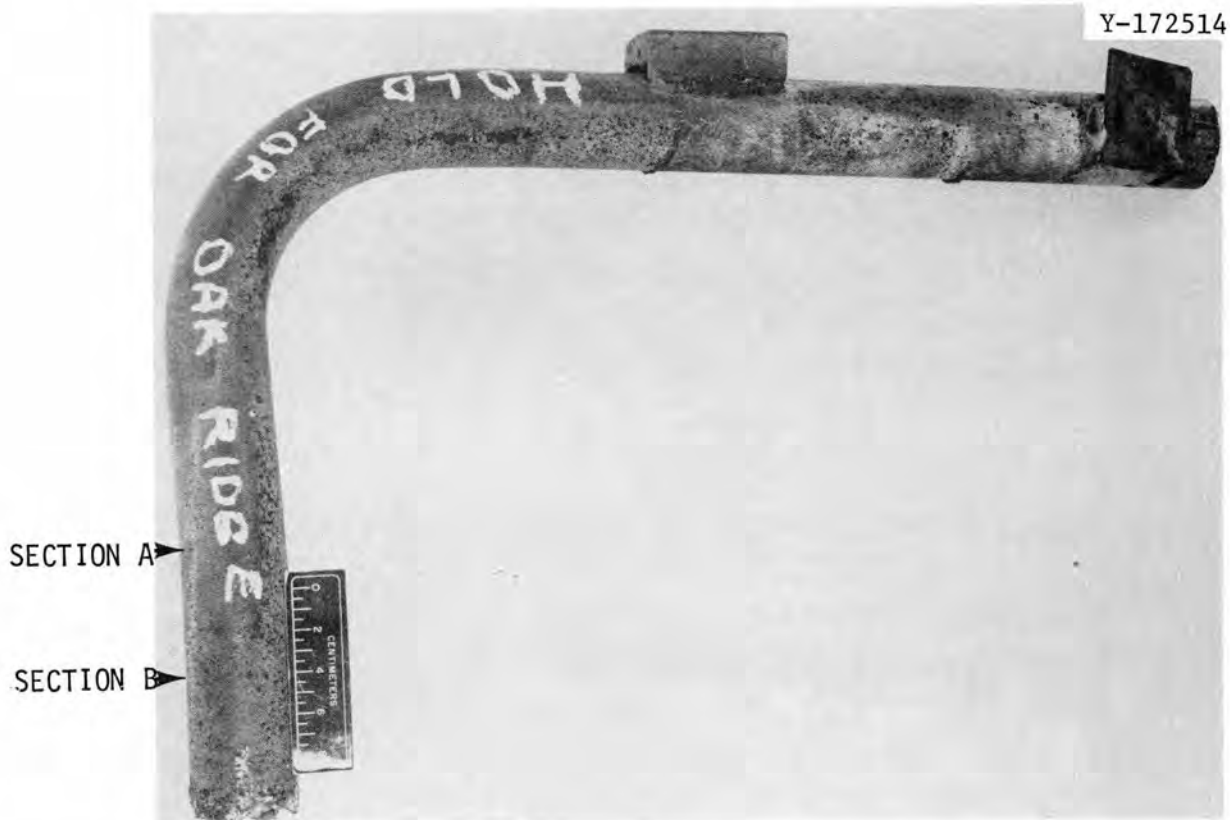
tubes are repaired and tubes put back in service, leaks develop in type 321 tubes about 300 mm from the joint. To determine the reason for these leaks, we conducted a flattening test on a tube (Fig. 19) removed from the TVA Kingston power plant. Some pieces of this tubing were also flattened after solution annealing for 0.5 h at 1065°C. Results of the flattening tests are presented in Fig. 20 and in Table 3., p. 7.

Fig. 19. Type 321 stainless steel tubing removed from the TVA Kingston plant.

The leak during service after transition joint repair is possibly a result of the same mechanism as suggested above except that cracks propagated as a result of thermal stresses from welding repair.

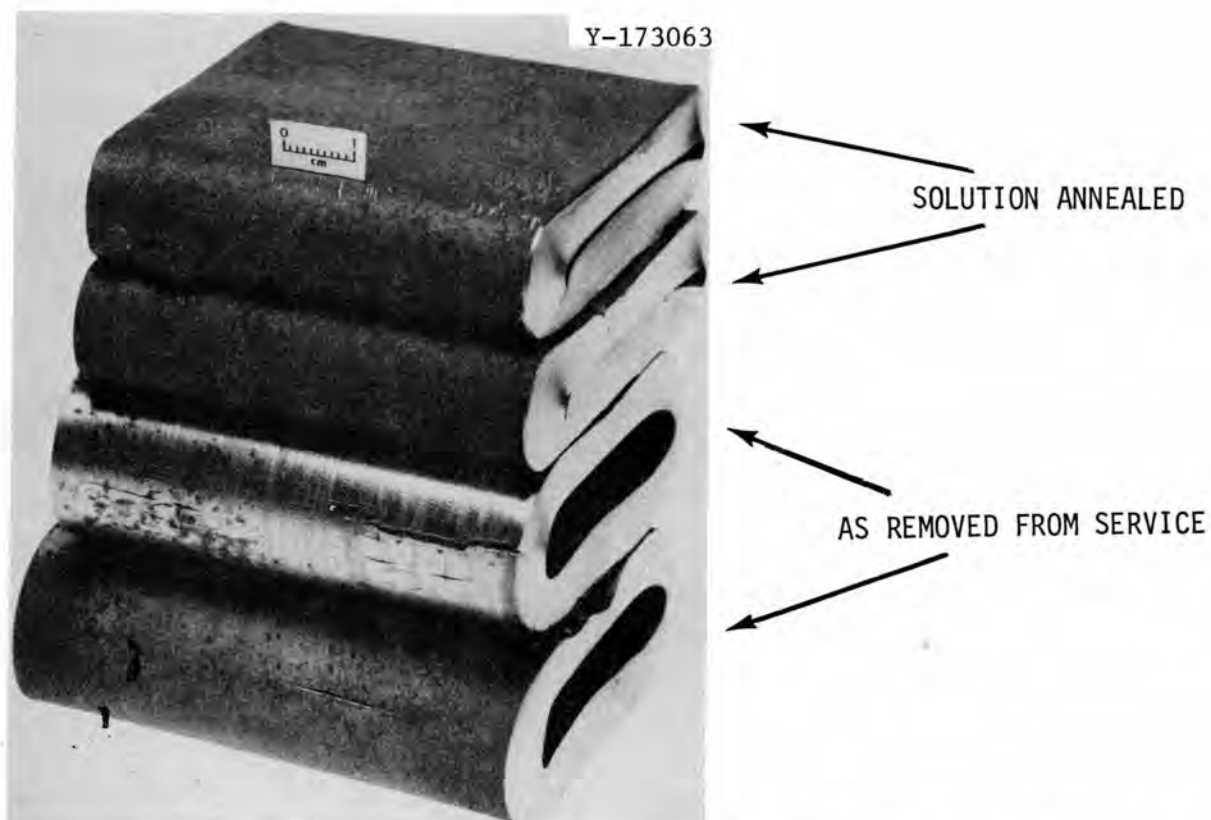
Figure 20 shows that as-removed tubes of type 321 stainless steel cracked during flattening at approximately the "H" value, indicating that the tube possessed only limited ductility. Once solution annealed, the tubes flattened until the sides met without cracking, a characteristic expected of this alloy.

Fig. 20. Response to flattening test of type 321 stainless steel removed from the TVA Kingston power plant. Two pieces each were tested as removed from service and after solution annealing for 0.5 h at 1065°C.
