ORNL/TM-7698

## Performance of 9—12% Cr-1 Mo Steels During Flattening Test

V. K. Sikka  
R. E. McDonald

Date Published: April 1981

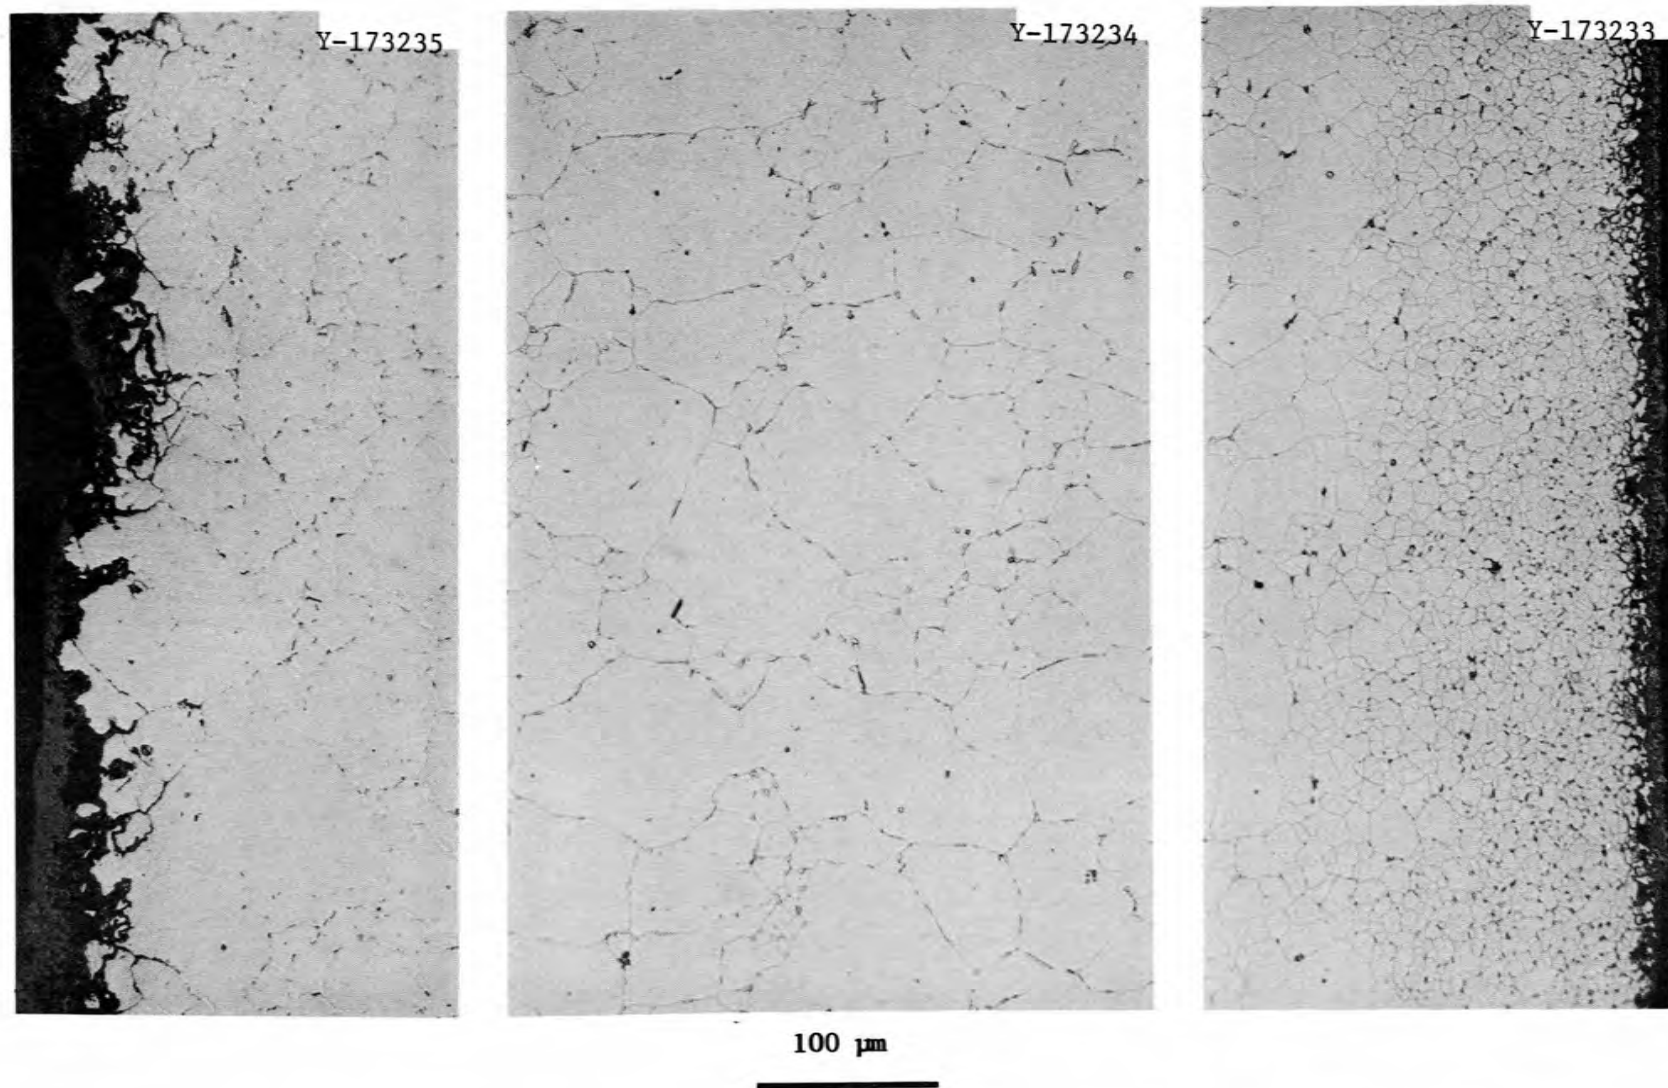
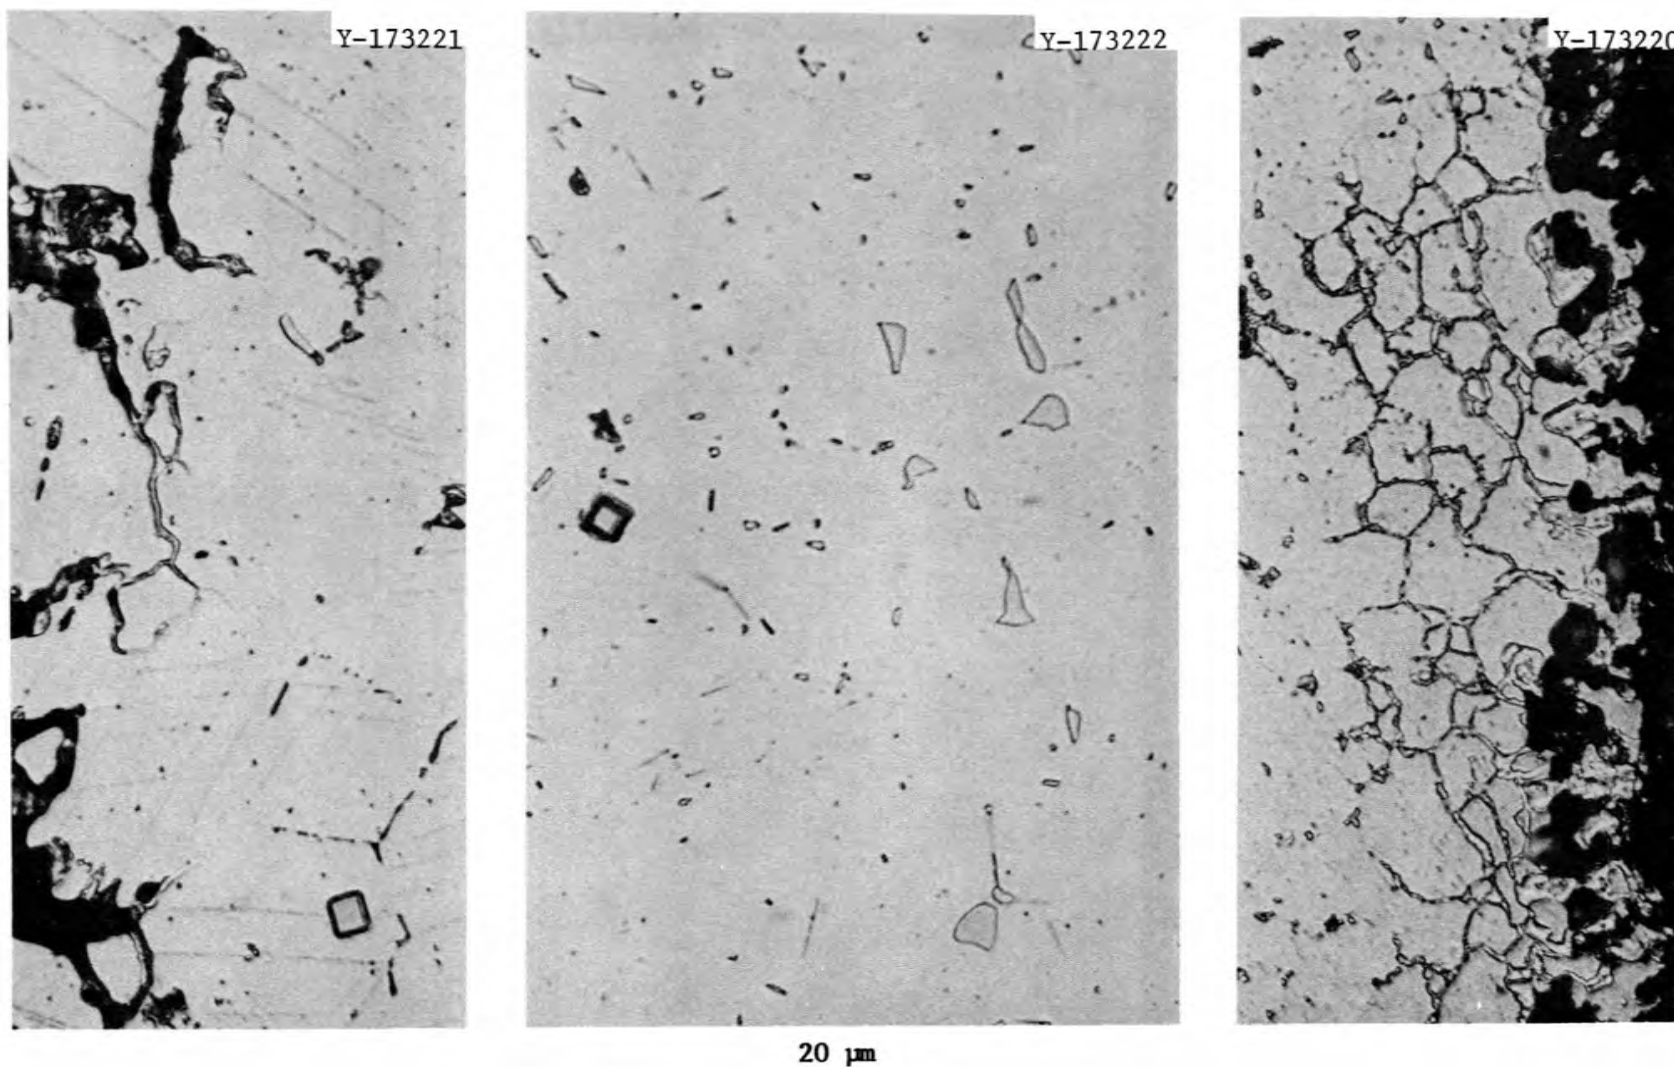
Low- and high-magnification photomicrographs of the outside, center, and inside of the as-removed tube of type 321 from two different locations (A and B in Fig. 19) are shown in Figs. 21 through 24. These micrographs show the following features:

1. very fine grain size on the inside and coarse grain size on the outside and midthickness of the tube,
2. oxide scale on both surfaces of the tube,
3. continuous film of sigma phase on the grain boundaries of tube inner surface,
4. cracking at grain boundaries near the outer surface, and
5. sigma-phase particles at grain boundaries across the entire tube thickness.

Fig. 21. Low magnification of outside, midthickness, and inside of section A (Fig. 19) of type 321 stainless steel tube removed from the superheater section of the TVA Kingston power plant.

Fig. 22. High magification of outside, midthickness, and inside of section A (Fig. 19) of type 321 stainless steel tube removed from the superheater section of the TVA Kingston power plant.

The cracking of the as-removed tubes of type 321 stainless steel during flattening is probably the result of propagation of the cracks present at grain boundaries near the tube outer surface along the sigma-phase-embrittled grain boundaries across the wall thickness. The absence of any cracking during flattening of the reannealed tubes is a result of dissolution of sigma phase and consequent elimination of embrittled boundaries.

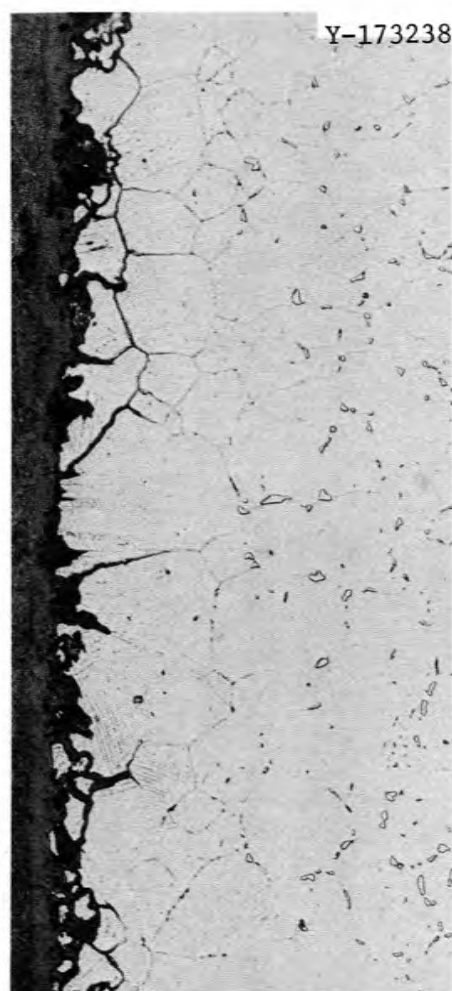
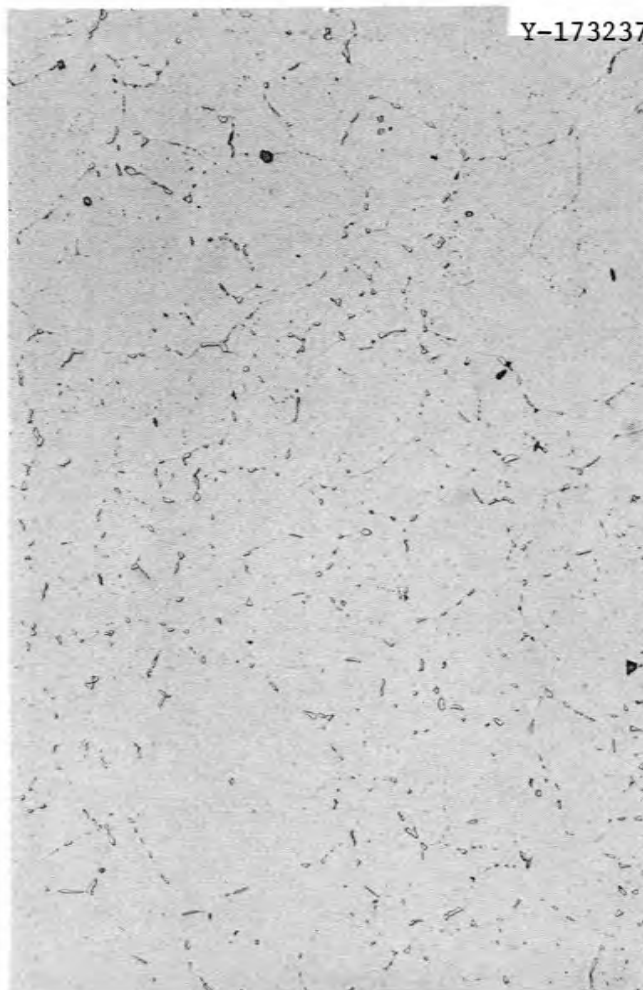
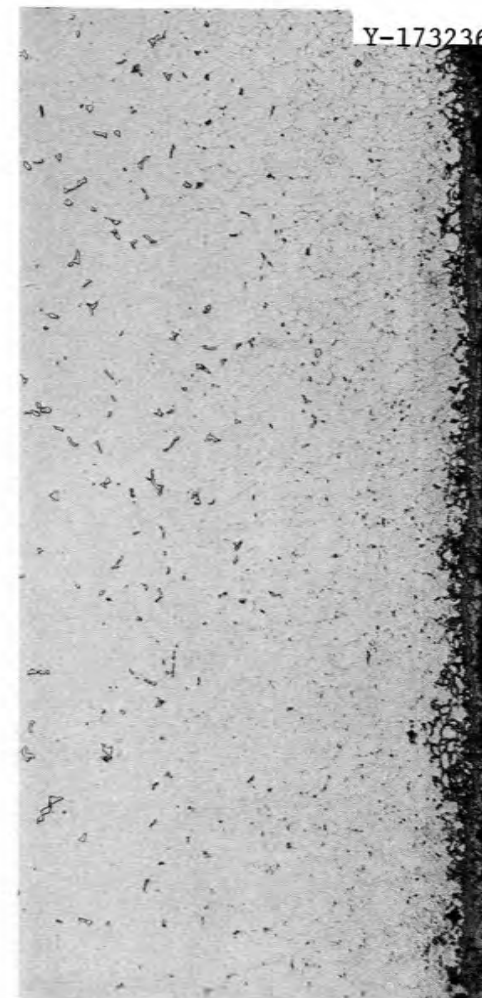
Fig. 23. Low magnification of outside, midthickness, and inside of section B (Fig. 19) of type 321 stainless steel tube removed from the superheater section of the TVA Kingston power plant.

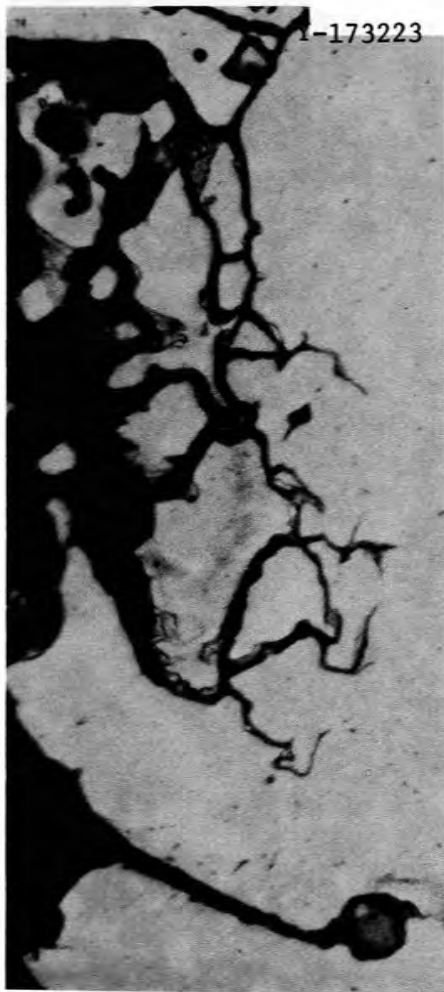
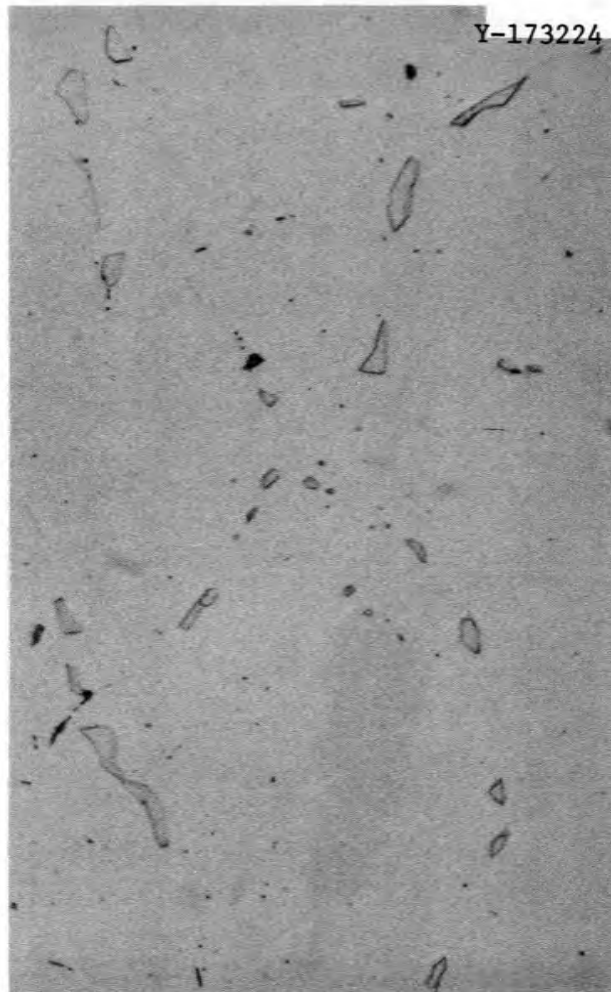
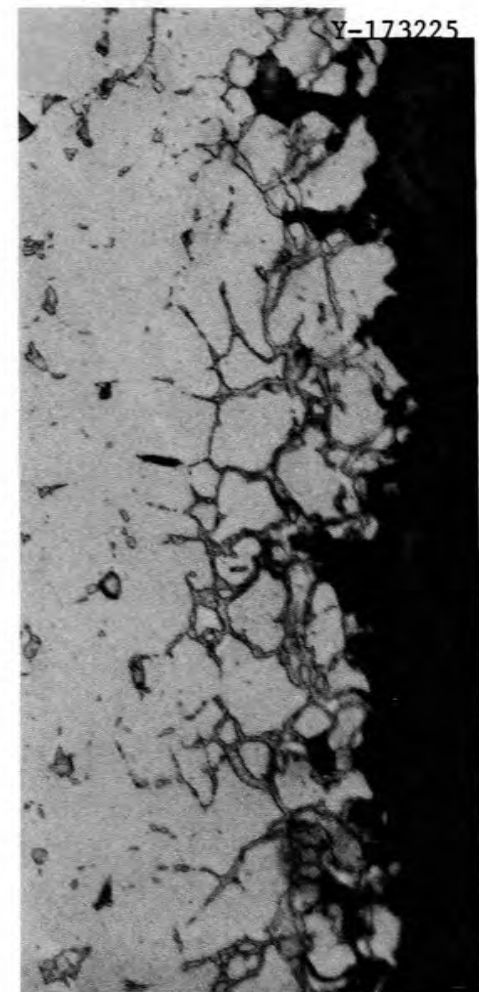
Fig. 24. High magification of outside, midthickness, and inside of section B (Fig. 19) of type 321 stainless steel tube removed from the superheater section of the TVA Kingston power plant.
