SAND2000-1702

Characterization of Sidewall and Planar Surfaces of Electroformed LIGA Parts

Somuri V. Prasad, Aaron C. Hall, and Michael T. Dugger

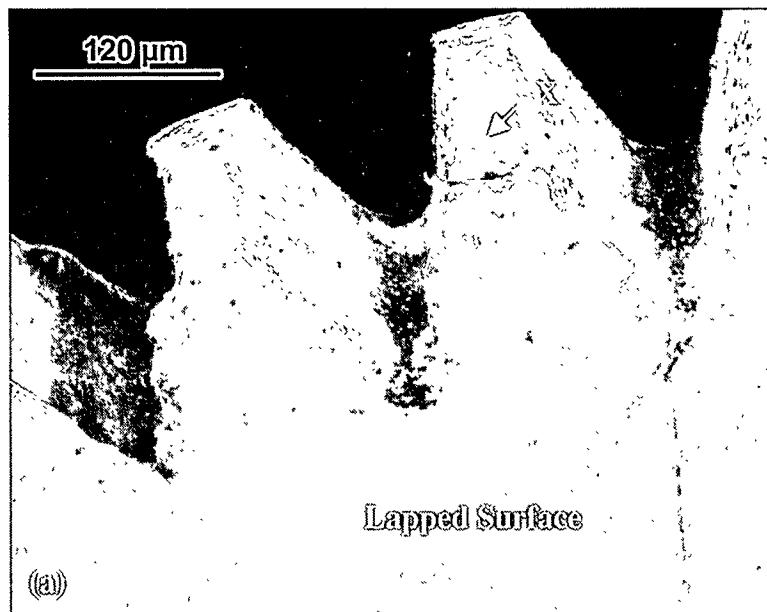
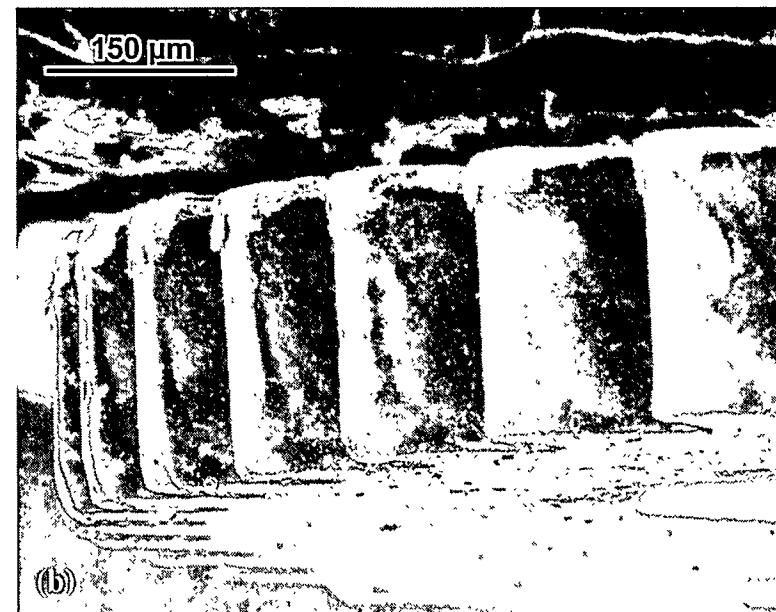
Metallographic polishing of softer metals is known to be a challenging task as there will be some stress concentration at the unsupported edges of a lapped component, e.g. gear teeth. This is clearly illustrated in the SEM micrographs of a LIGA Cu gear shown in Fig. 2. Damage to gear teeth edges is evident in Fig. 2a. Scratches are present on the lapped surface (Fig. 2a). Smearing of material on teeth edges, presumably from lapping, can be seen in Fig. 2b. Figure 2c is a higher magnification micrograph showing extensive plastic deformation of copper during lapping that actually flowed beyond the sidewall, and was probably bent down after release. Scratches seen on gear teeth at the location marked "X" in Fig. 2a were probably due to uncontrolled handling of parts prior to analysis. Edge damage to gear teeth does not appear to be a major problem in the case of LIGA Ni gears. At moderate magnifications, the lapped surface appeared to be smooth and free of scratches, as can be seen from Fig. 3b. Lapping on this particular Ni gear introduced only submicron scratches (Fig. 3b and 3c).

Fig. 2 SEM images of a LIGA Cu (CA) gear showing edge rounding (or lack of edge retention).

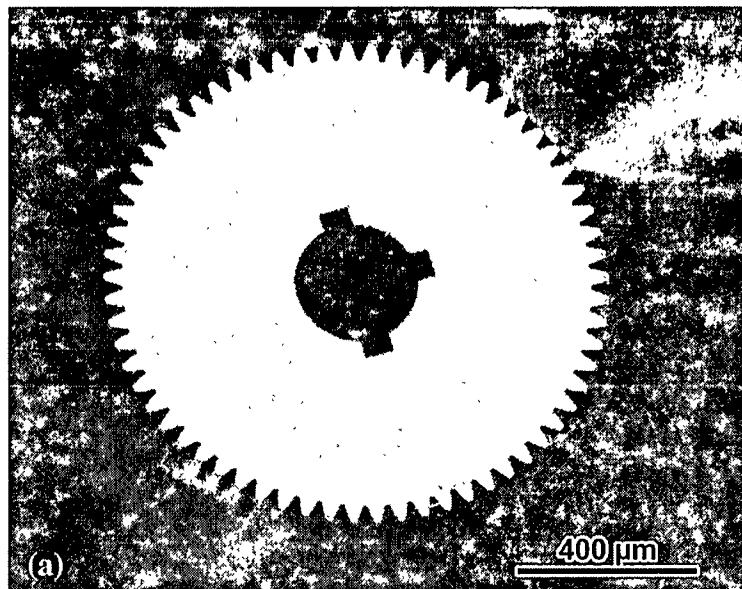
Fig. 3 Typical surface morphology of a LIGA Ni gear (NM): Lapped surface.

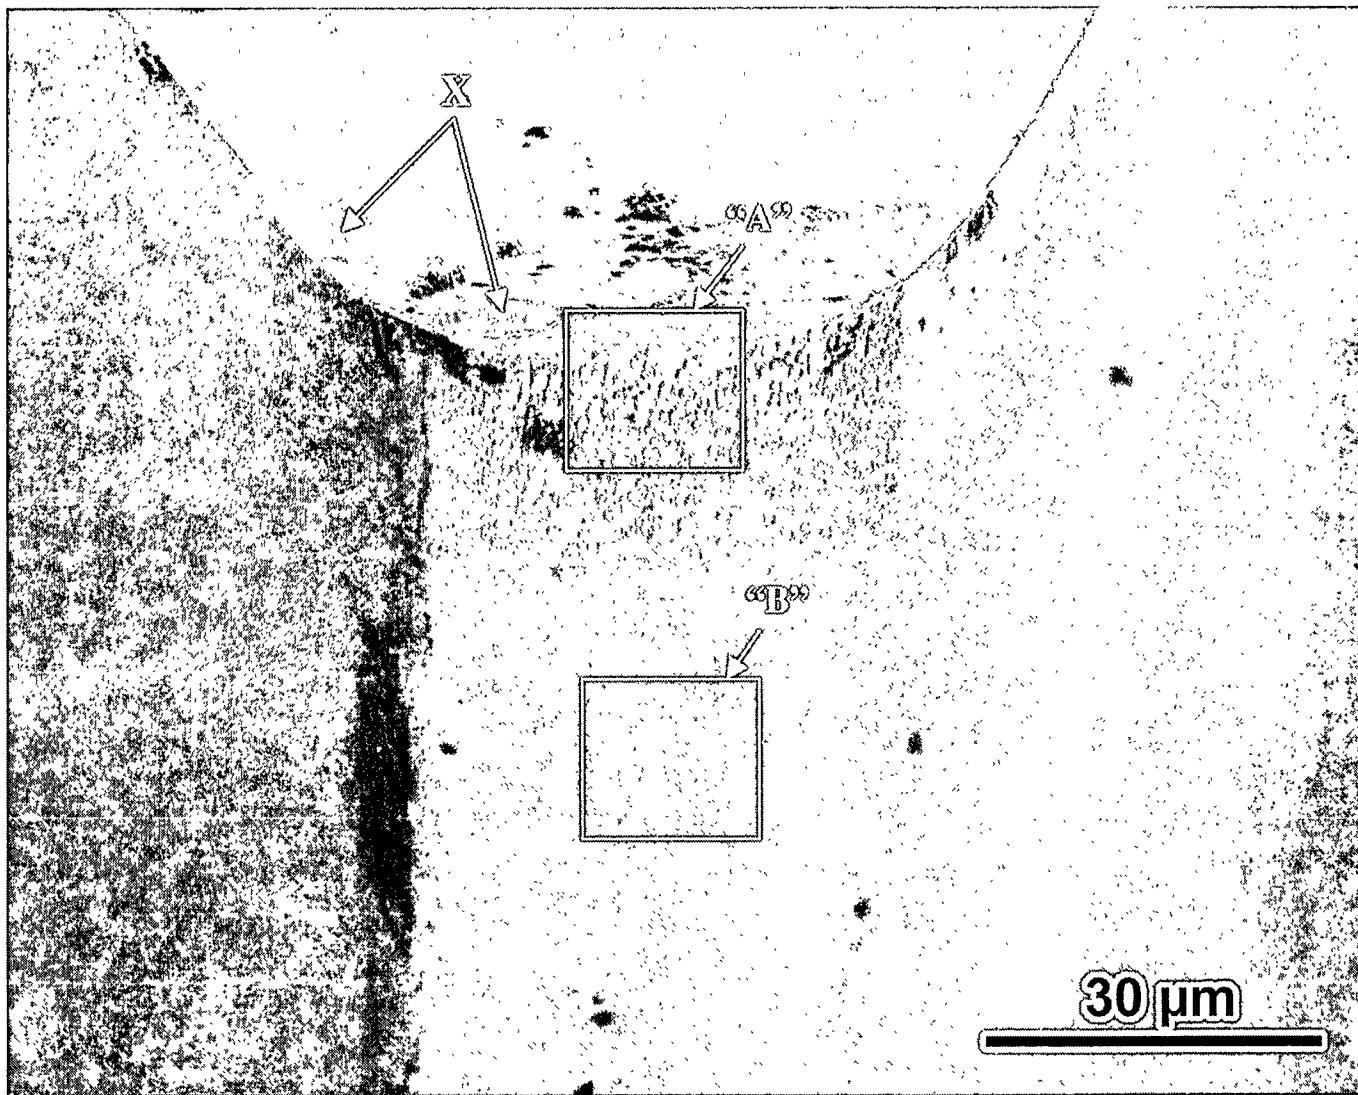
An SEM micrograph of a LIGA Ni gear sidewall is shown in Fig. 7. The damage seen at locations marked "X" in Fig. 7 was probably caused by handling of parts prior to analysis. The top is the lapped side showing minor damage to the tooth edge. Higher magnification images of the regions marked "A" and "B" are shown in Fig. 8. There is a blister-like morphology at the top of the gear tooth. The middle is more like a columnar structure (Fig. 8b). The microstructure of electroformed Ni is typically columnar in nature. For instance, earlier work by Buchheit and coworkers [2,3] in this laboratory showed that LIGA Ni has a (100) texture, i.e., (100) crystal orientations are nearly parallel to the growth direction. However, the columnar grain size determined by backscattered electron Kikuchi patterns (BEKP) in those studies [2,3] is much larger than the nanometer-size columns seen in Fig. 8b. It is very likely that the morphology seen in Fig. 8b is a surface feature resulting from the x-ray mask. Examination of mold surfaces

Fig. 7 Sidewall morphology of a Ni Gear (NM). Higher magnification images of regions marked "A" and "B" are given in Fig.7.

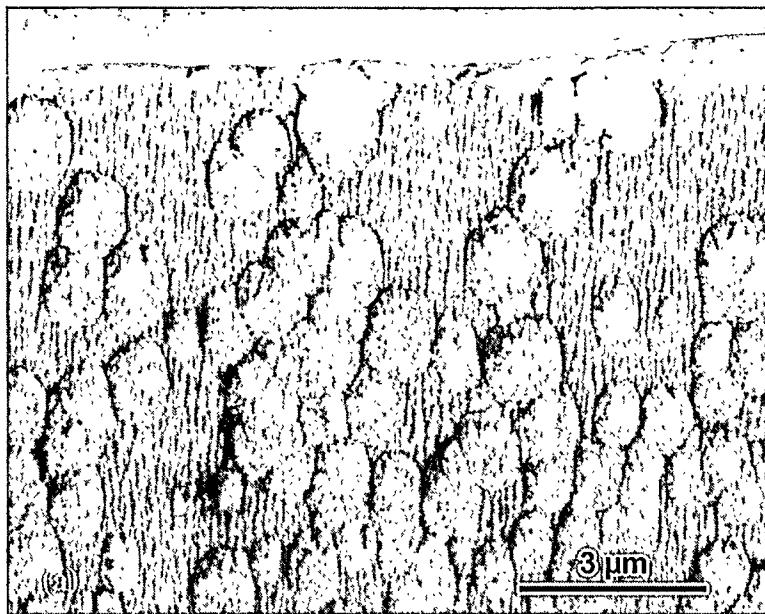
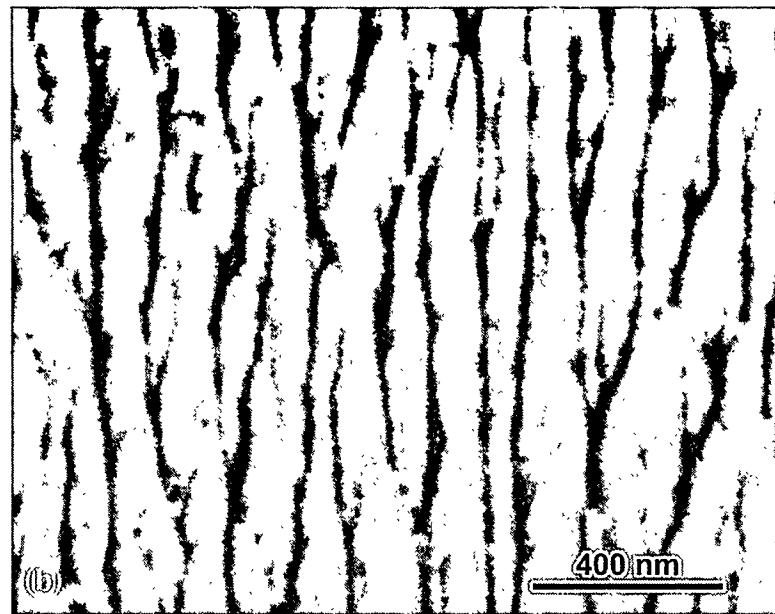
Fig. 8 Higher magnification images of sidewall morphology of a LIGA Ni gear (NM). Figure (a) corresponds to the region marked "A" in the previous figure, while Fig. (b) corresponds to the higher magnification image of the region marked "B" in Fig. 7.

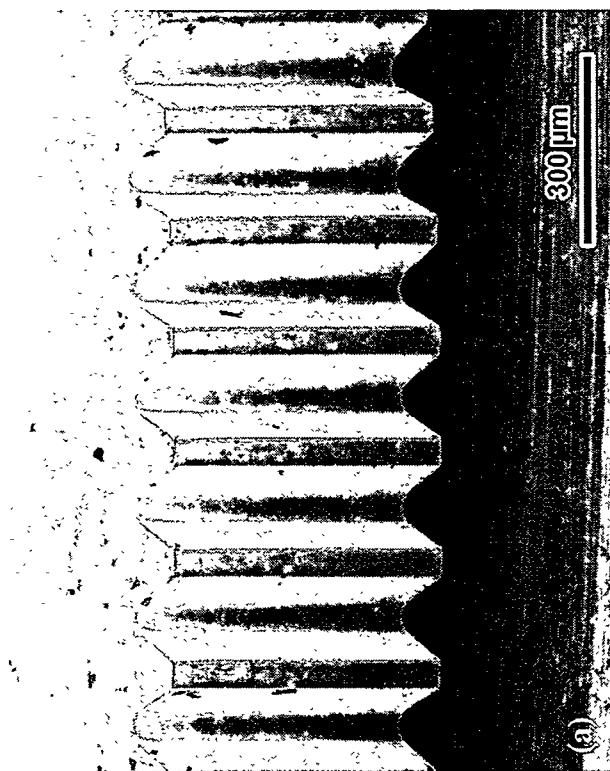
prior to plating could resolve whether the sidewall roughness is due to mold structure. SEM micrographs of another LIGA Ni gear sidewall showing essentially the same features are given in Fig. 9. The LIGA Cu gear sidewalls also showed similar morphology (Fig. 10). The root of the LIGA Ni gear showed steps at regular intervals (Fig. 11a). Similar images from another Ni part (Fig. 11 b and c) show "scales" that appear to be partially detached from the remainder of the gear tooth at one edge. Additional metallographic sectioning and analysis will be required on future samples to determine if this is the case.

Fig. 9 Sidewall morphology of another Ni Gear (NM).

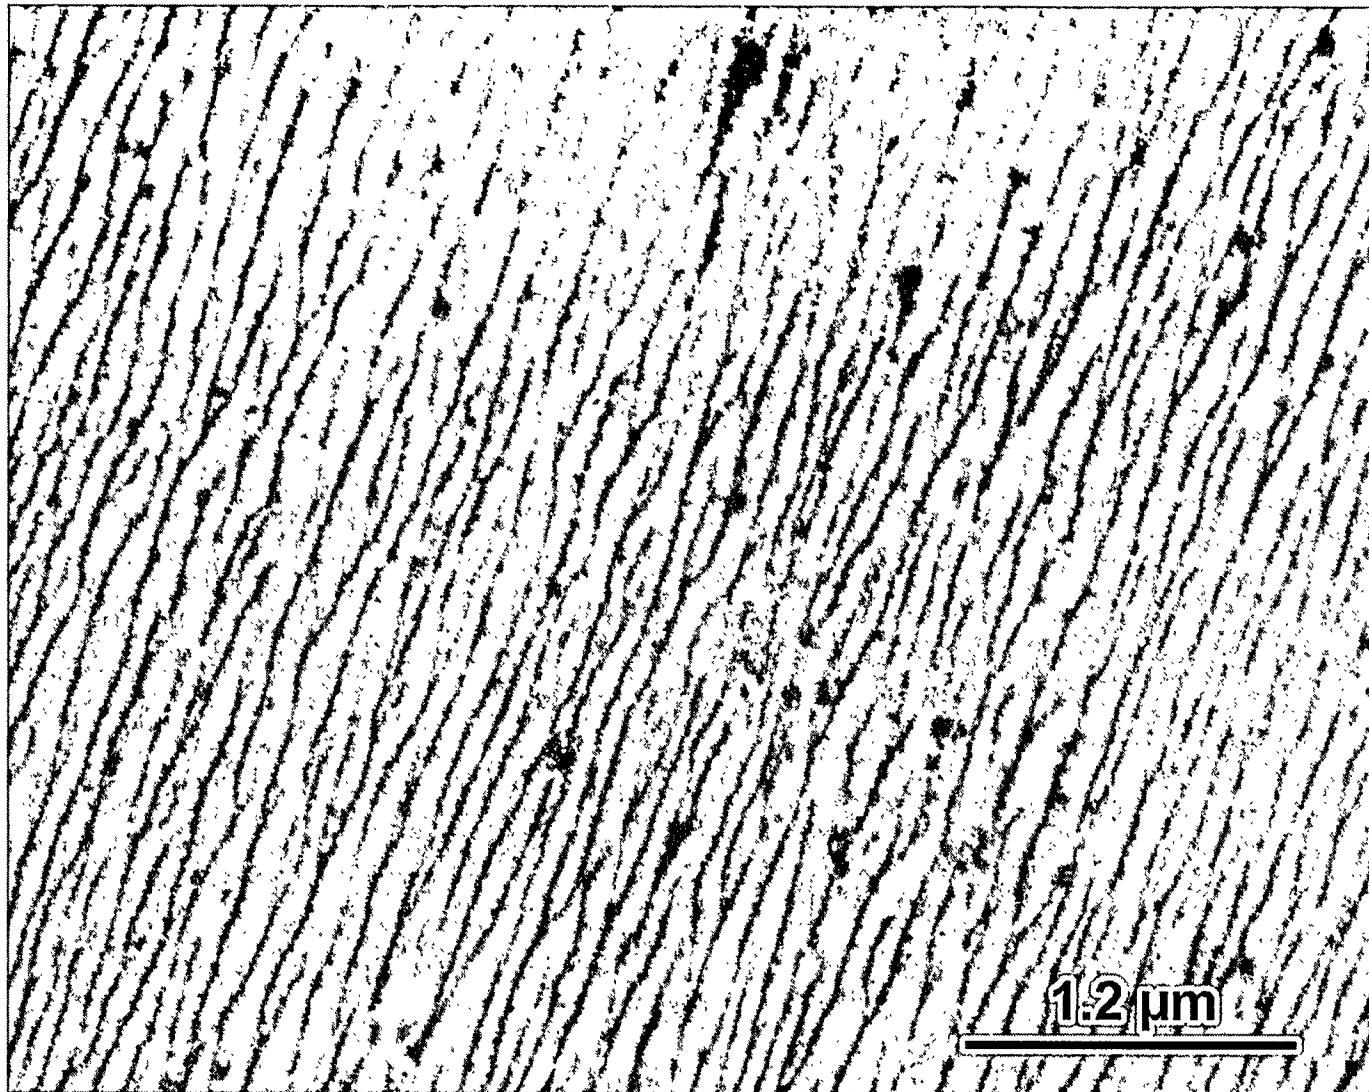
Fig. 10 Side wall morphology a LIGA Cu gear (CA).

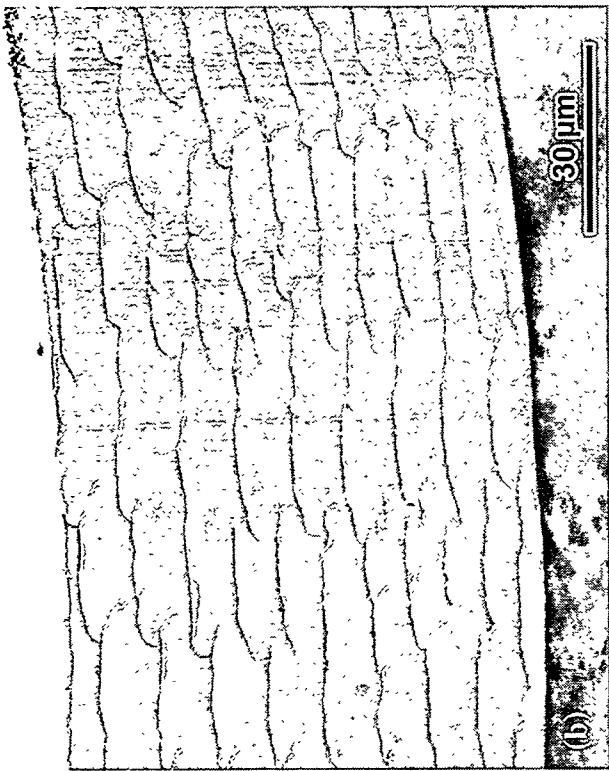
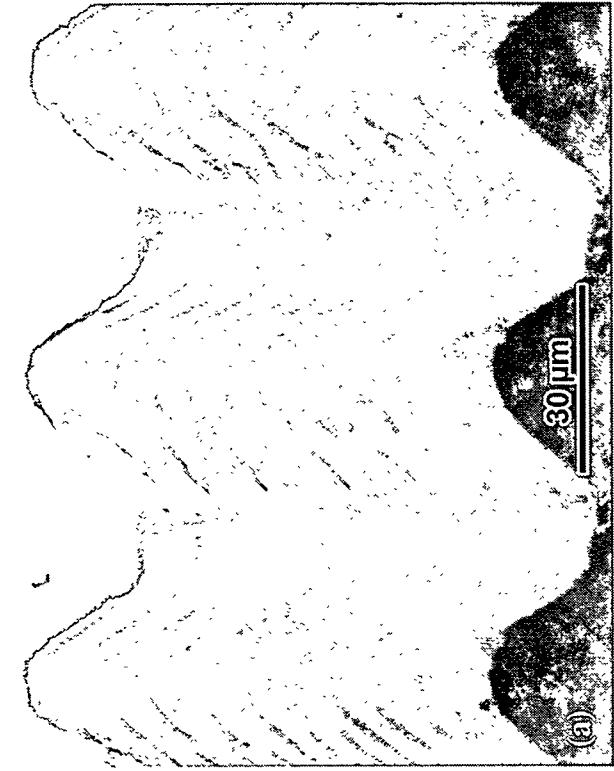
Fig. 11 (a) and (b) Sidewall morphologies of two different LIGA Ni (NM) gears; (c) higher magnification micrograph of Fig. (b).

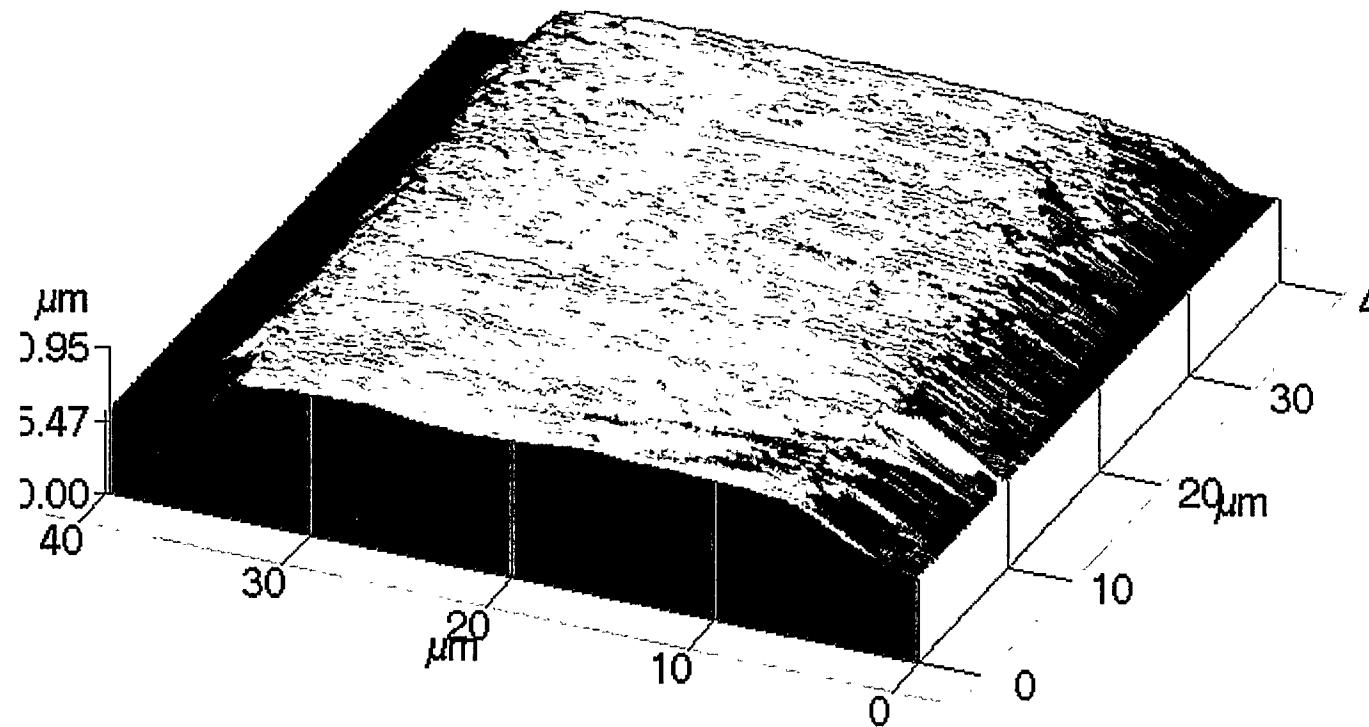
Figure 14 shows the tip of a copper gear tooth. For the three parts listed, this sidewall surface was the smoothest. SEM analysis showed that the copper gear is covered with what appears to be a polymer film. The roughness measured on this part is likely characteristic of this film and not the LIGA copper surface. The sidewall surfaces of both Ni parts were similar and exhibited comparable roughness numbers. Figure 15 shows the sidewall of a Ni Sandia Logo (NM). Roughness is present on this surface at two scales. Undulations with a period of $\sim 5\mu\text{m}$ perpendicular to the thickness direction can be seen in the $20\mu\text{m}$ scan. This type of feature was noticed on all the Ni LIGA parts, and may be due to a roughness in the patterned PMMA resist. A much smaller (nm scale) roughness

Fig. 14 Tip of a Cu gear (CA) tooth: AFM image.
A location such as this can be seen in Fig. 2b.

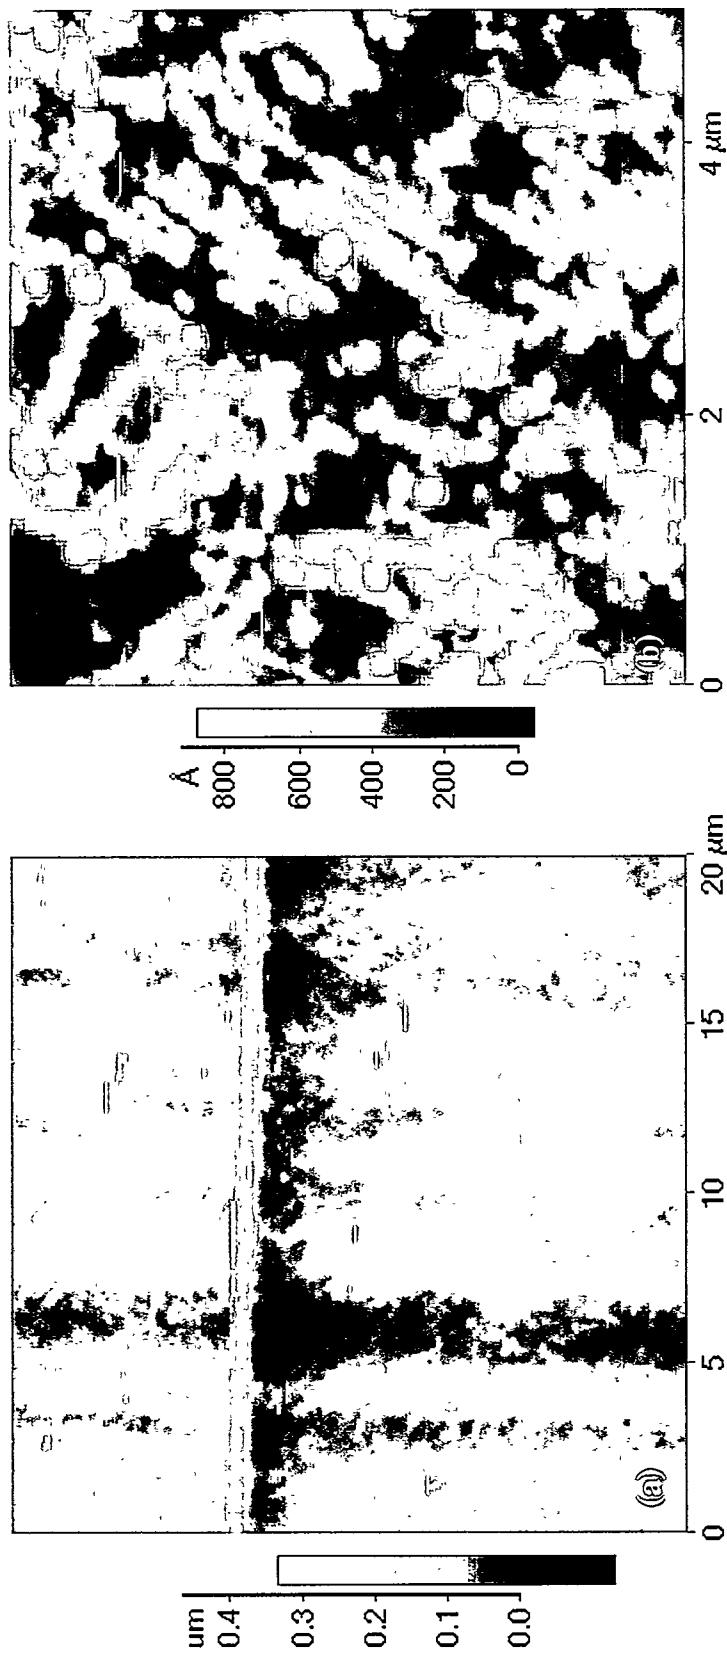
can be seen in the 5 μ m scan. This roughness is the columnar structure seen in the SEM (Figure 10). Because these features are on the order of the tip radius they are convoluted with the tip shape in the image.

Fig. 15 Sidewall morphology of a LIGA Ni (NM) SANDIA LOGO: AFM images. (a) showing surface undulations, (b) showing the columnar structure seen in Fig. 10. Distortion in the image is an effect of tip convolution.
