## **Diffusion Coatings for Corrosion-Resistant Components in Coal Gasification Systems**

Quarterly Technical Progress Report 14

Covering the period October 1, 2006 through December 31, 2006

SRI Project P13063

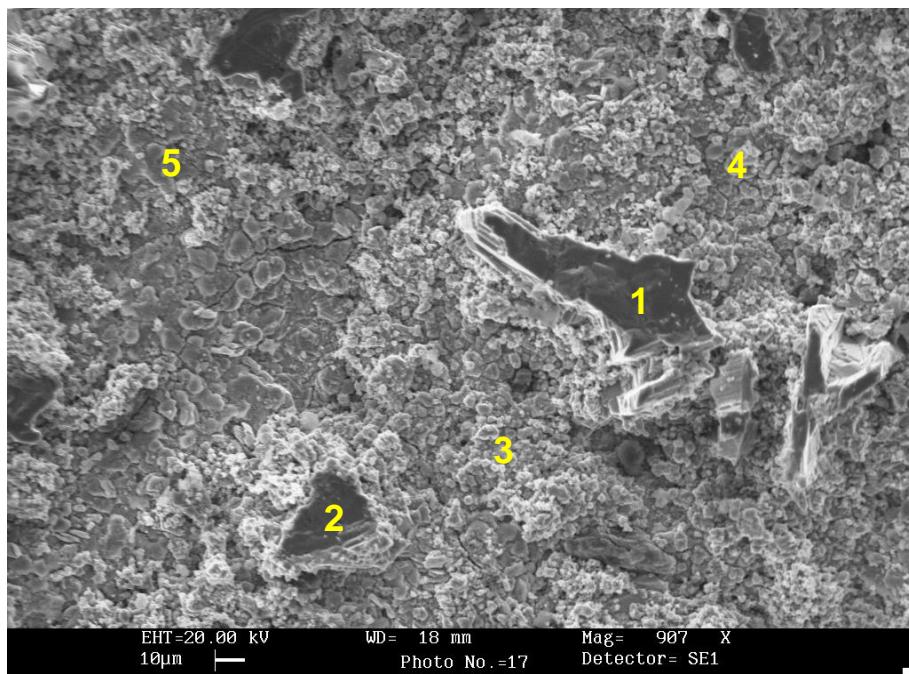
Porous coupons from runs 62 and 88 were exposed at 370°C for 2140 h at the Wabash River Gasifier plant. After exposure, we could not observe internal porous structure of the sample from run 62, due to the growth of sulphide scales in the interior of the sample (Figure 1). Table 2 shows results of EDX measurements carried out at the marked points in the micrograph, which show high S contents in many areas, and we observed the presence of sulfide islands. The presence of neither Ti nor Ta was detected.

Figure 1. SEM of the top of sample from Run 62.

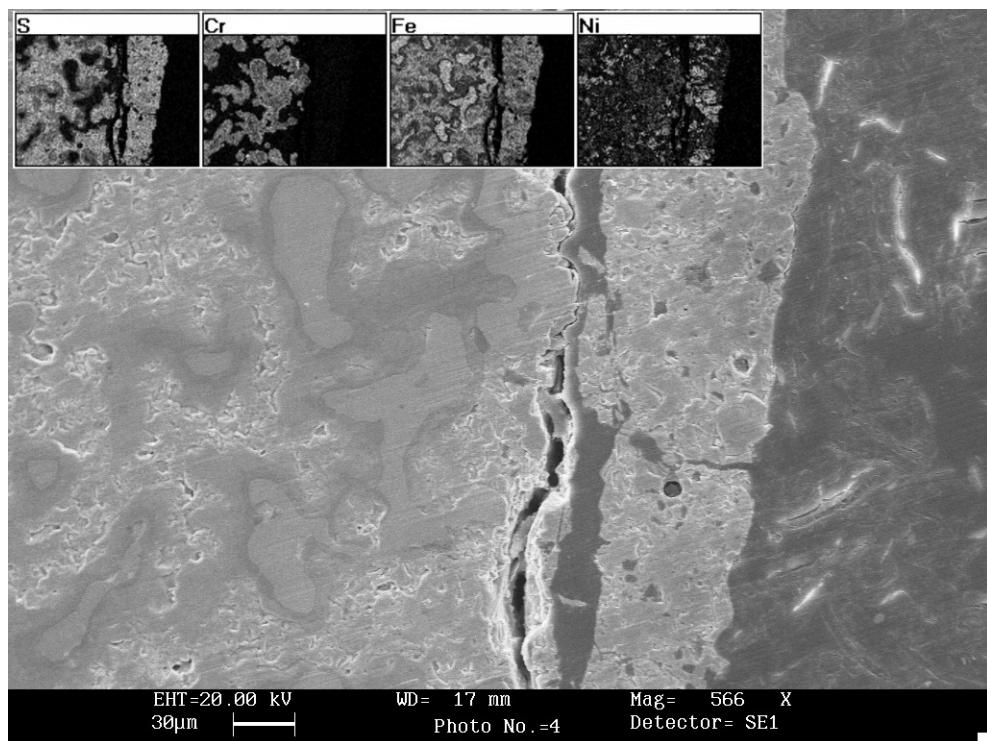
A cross section of the sample, after cutting, mounting and polishing, is shown in Figure 2. The insets in the micrograph are EDX mapping for S, Cr, Fe, Ni. As can be seen, Cr and S maps are complementary, Fe is detected in all zones, and Ni is especially concentrated at the surface. This elemental distribution confirms that the scales formed after exposure are mainly Ni and Fe sulphides. This observation indicates that TiTaN-coated 316 alloy steel did not survive the corrosion test. Because Ni is attacked in sulphidizing atmospheres, 316 steel is not used for further tests.

Figure 2. SEM cross-section view and map of EDX analyses for S, Cr, Fe and Ni.

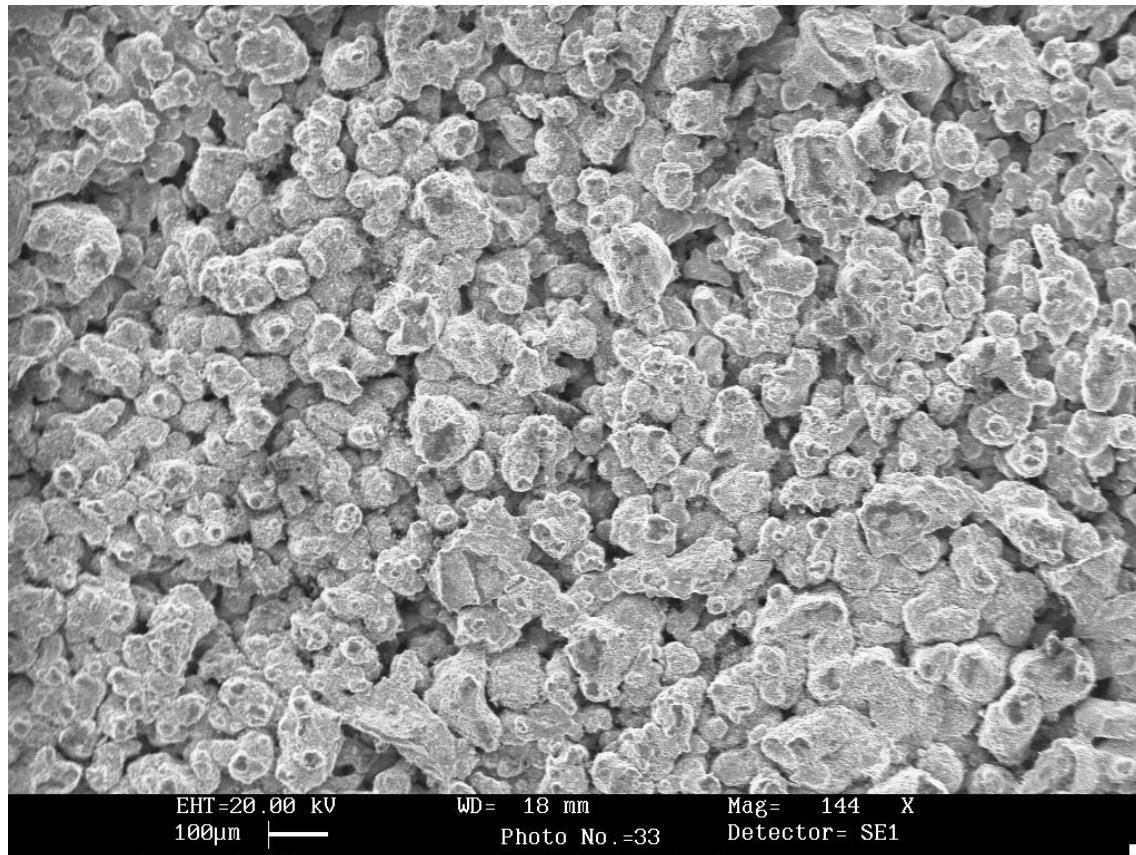
The SEM photograph of the surface of a coupon from run 88 after being exposed to the gasifier plant environment can be seen in Figure 3. The morphology of the sample did not change after exposure; the porous structure generated by sintering alloy steel powder remains unchanged. Results regarding EDX surface analyses done in 3 different zones of the coupon are presented in Table 3. They show a high surface concentration of Al and a low concentration of S. According to these results, an alumina layer was formed that covered the steel and it prevented the formation of iron sulfide.

Figure 3. SEM of the surface of the porous coupon from run 88 after exposure in the gasifier.

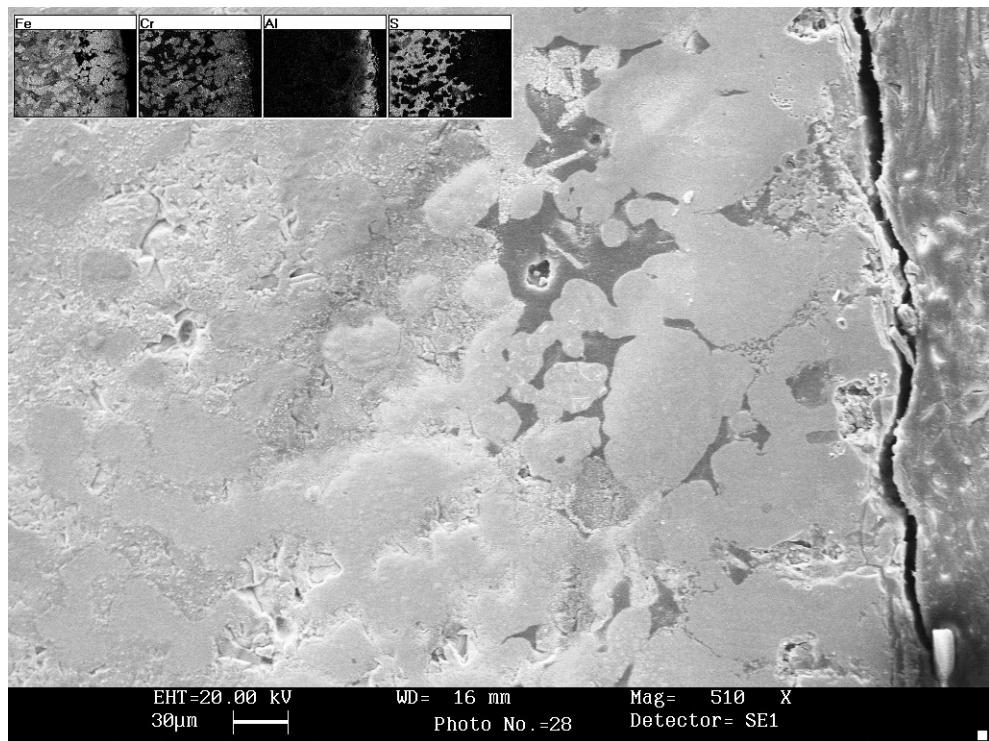
Figure 4 shows a cross-section view of the porous sample as observed in the SEM. We observed clearly that the external part of the coupon (approximately the first 100  $\mu\text{m}$ ) is different than in the bulk. To investigate the differences, insets in the same figure show EDX maps for Fe, Cr, Al, S and Ti, in this order. As observed, the external part is rich in Al. But beneath the external area, a solid was found inside the voids of the filter, composed of S and Fe. This observation suggests that an alumina layer was formed in the external portion that was protective against sulfidation, but such protection did not occur in the bulk of the sample. We believe that Al was not deposited in the interior portion of the sample. During coating deposition,  $\text{AlCl}_3(\text{g})$  reacts in contact with the coupon and it is depleted as the gas infiltrates into the bulk of the

sample. As a consequence, Al deposition is more efficient in the external parts of the coupon. In the outer zone, a protective alumina layer can be formed.

Figure 4. SEM cross section, porous coupon from run 88, and EDX map for Fe, Cr, Al and S.

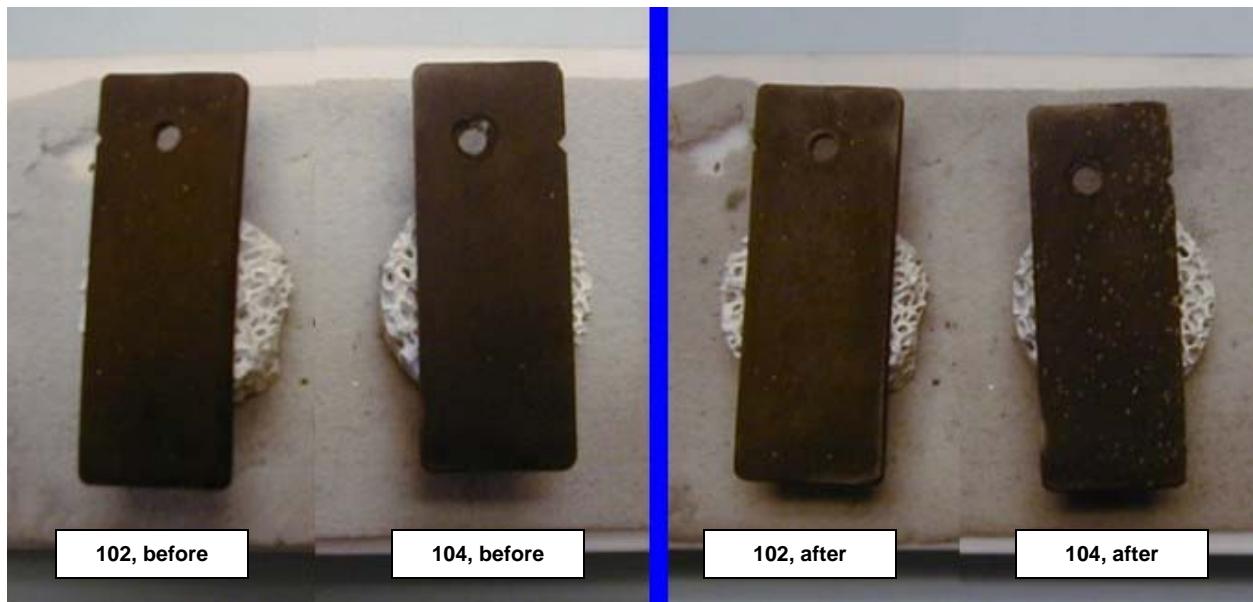
In previous reports, we described the setup for exposure of coupons to simulated coal gas. Some porous coupons were exposed at 370°C for 300 h. As discussed in a previous report, the sample from run 93 was attacked in the corrosion test. We observed that iron sulfide scales that plugged the pores were formed in its bulk, but in the most external part of the coupon (close to the surface) the coating was protective and the porous structure was intact. As mentioned above, runs 102 and 104 aimed for better corrosion resistance through improvement of the coatings at the bulk of the coupons. Figure 9 shows a picture of samples from runs 102 and 104 before (left) and after (right) the corrosion test. The appearance of the samples suffered only minor changes during the test, but both suffered a weight gain: 5.1 % (run 102) and 7.9 % (run 104), slightly lower than what we found in run 93 (10.3 %). However, a better estimation of the corrosion resistance requires observation of the bulk of the coupons, as will be next discussed.

Figure 9. Samples before and after exposure for 300 h at 937°C in simulated gasifier test.

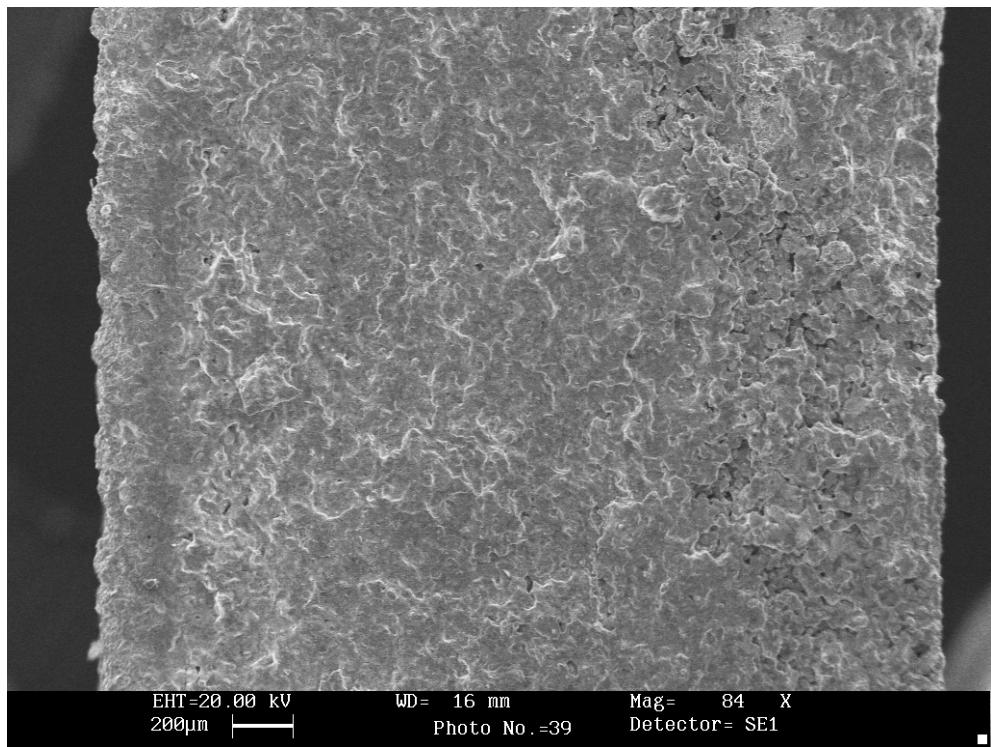
Figures 10, 11 and 12 show cross-section views of fractured coupons from runs 93, 102 and 104 after exposure for 300 h to our low-temperature corrosion test. As can be seen in run 102, we could extend the zone where the coatings provide enough protection versus sulfidation. It seems therefore that protection of the full sample bulk could be achieved with even longer deposition times. We observed that the sample containing a Nb-based interlayer has even higher corrosion resistance in the tested atmosphere. As shown in Figure 12, most of the sample survived the test and sulfide scales were only found in the most internal part of the coupon.

Figure 10. Cross-section of a fractured coupon from run 93 after exposure for 300 h to the low-temperature corrosion test.

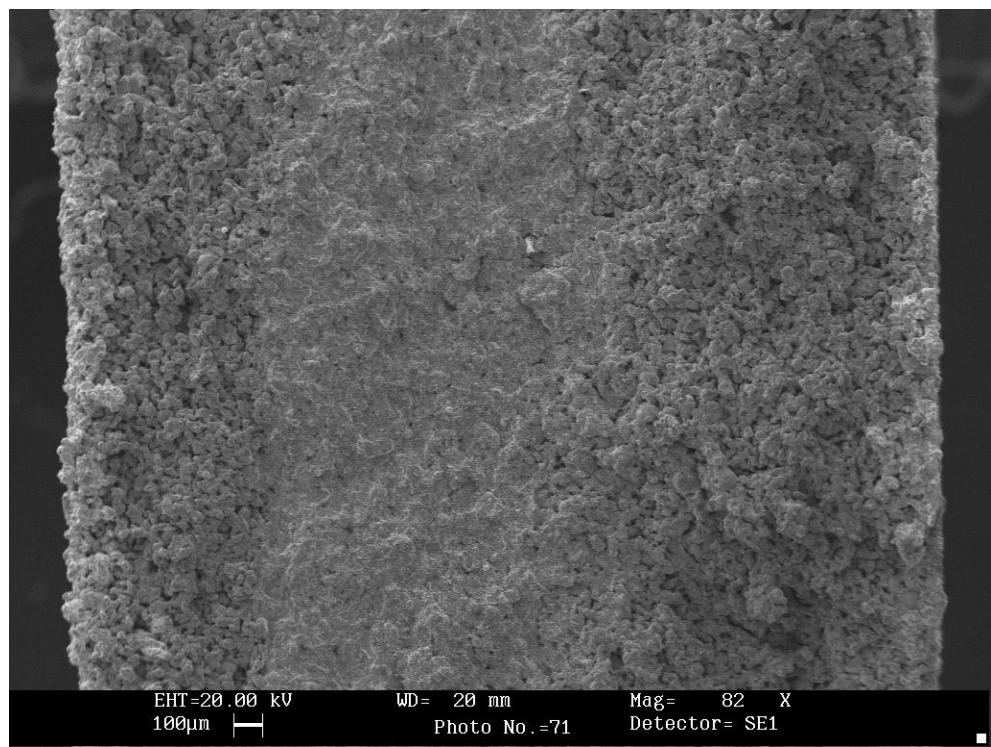
Figure 11. Cross-section of a fractured coupon from run 102 after exposure for 300 h to the low-temperature corrosion test.

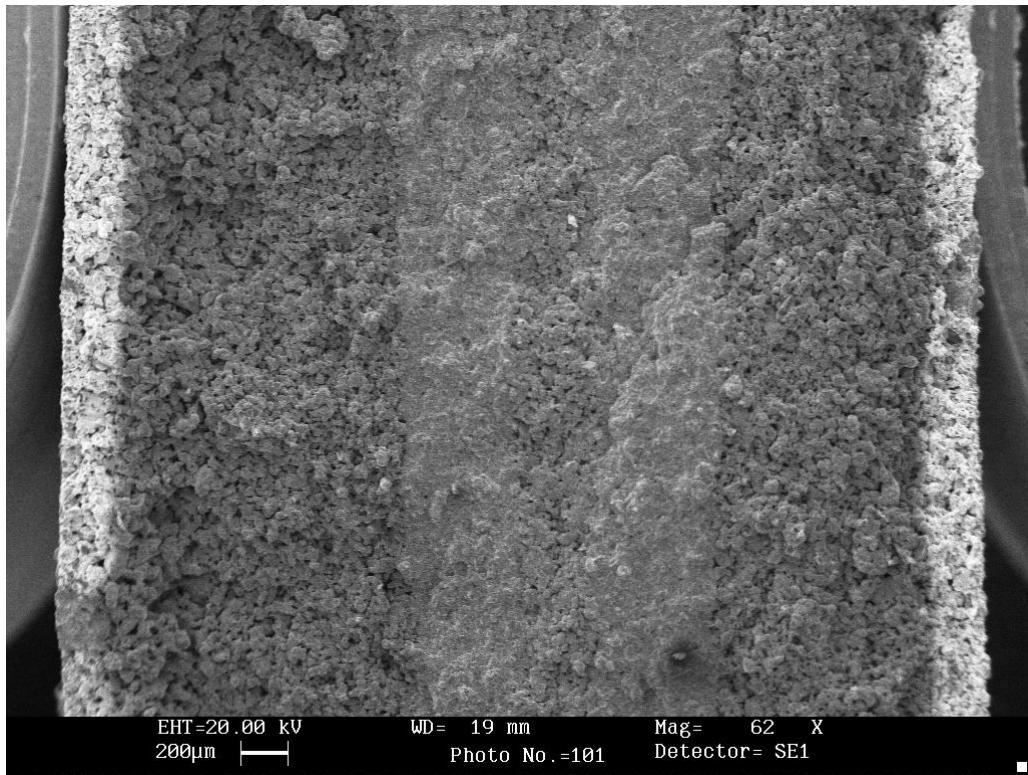
Figure 12. Cross-section of a fractured coupon from run 104 after exposure for 300 h to the low-temperature corrosion test.

After these promising results, in the next quarter, future runs are planned in which further improvement will be made in our deposition process in order to extend protection to the whole bulk of the coupons.
