**Surface Radiological Investigations  
of Trench 6 and  
Low-Level Waste Line Leak Site 7.4b  
at the  
Oak Ridge National Laboratory,  
Oak Ridge, Tennessee**

Date Issued—August 1991

Prepared by  
Health and Safety Research Division

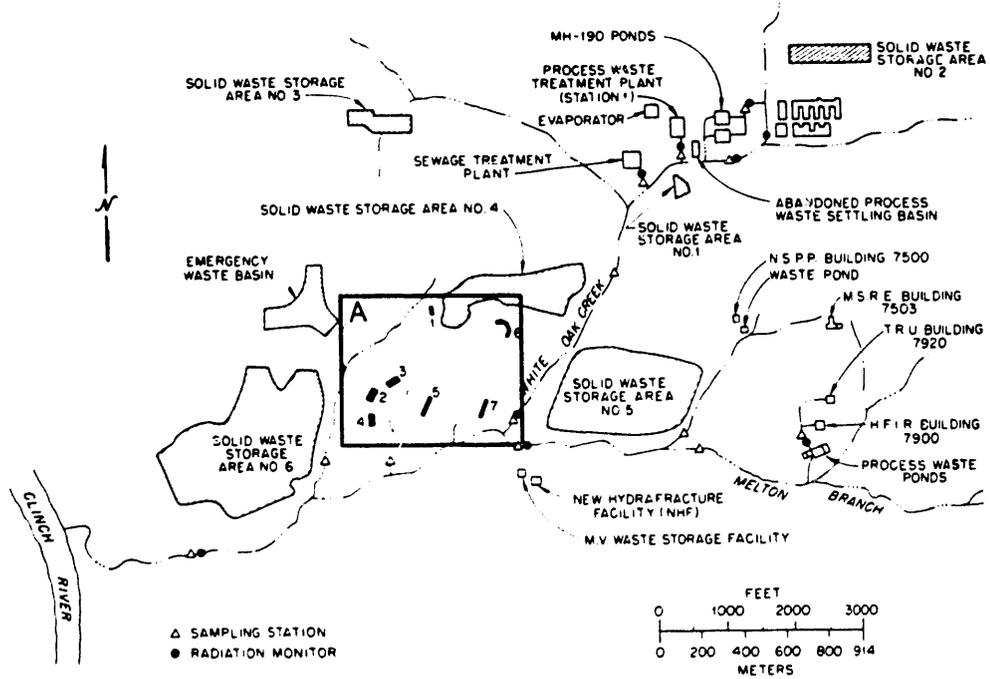
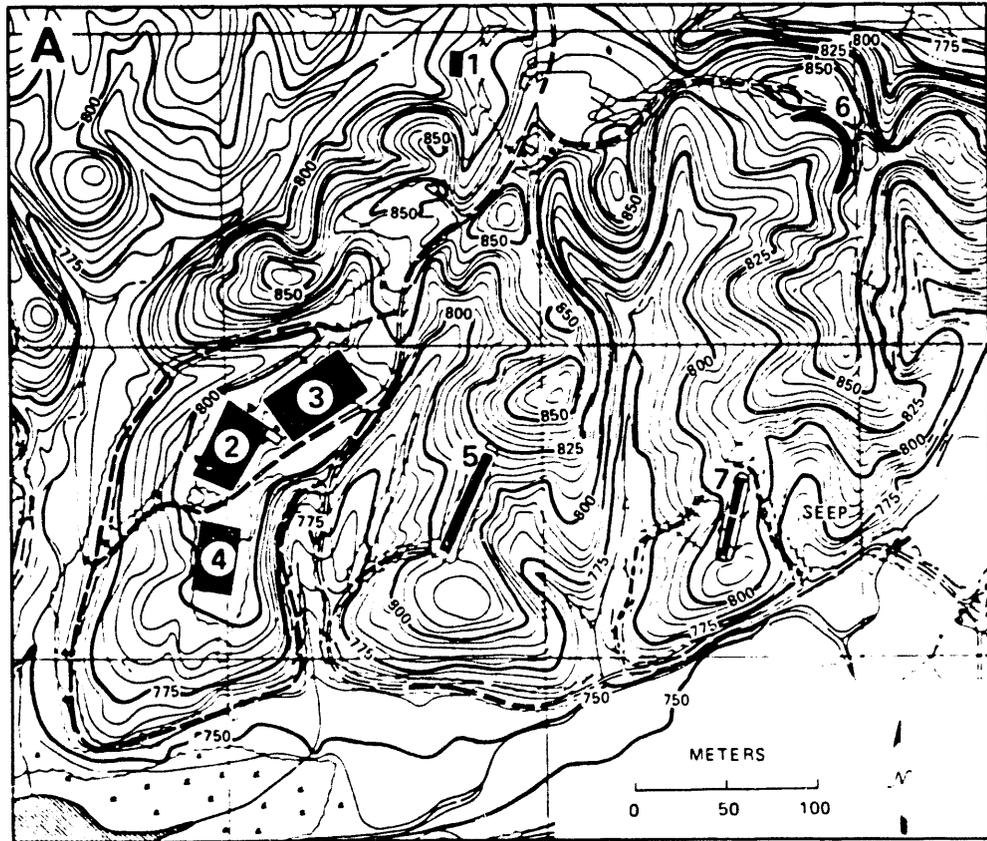
Fig. 1. Diagram showing location of Trench 6 in relation to other waste storage areas, the main ORNL complex, and the Clinch River.

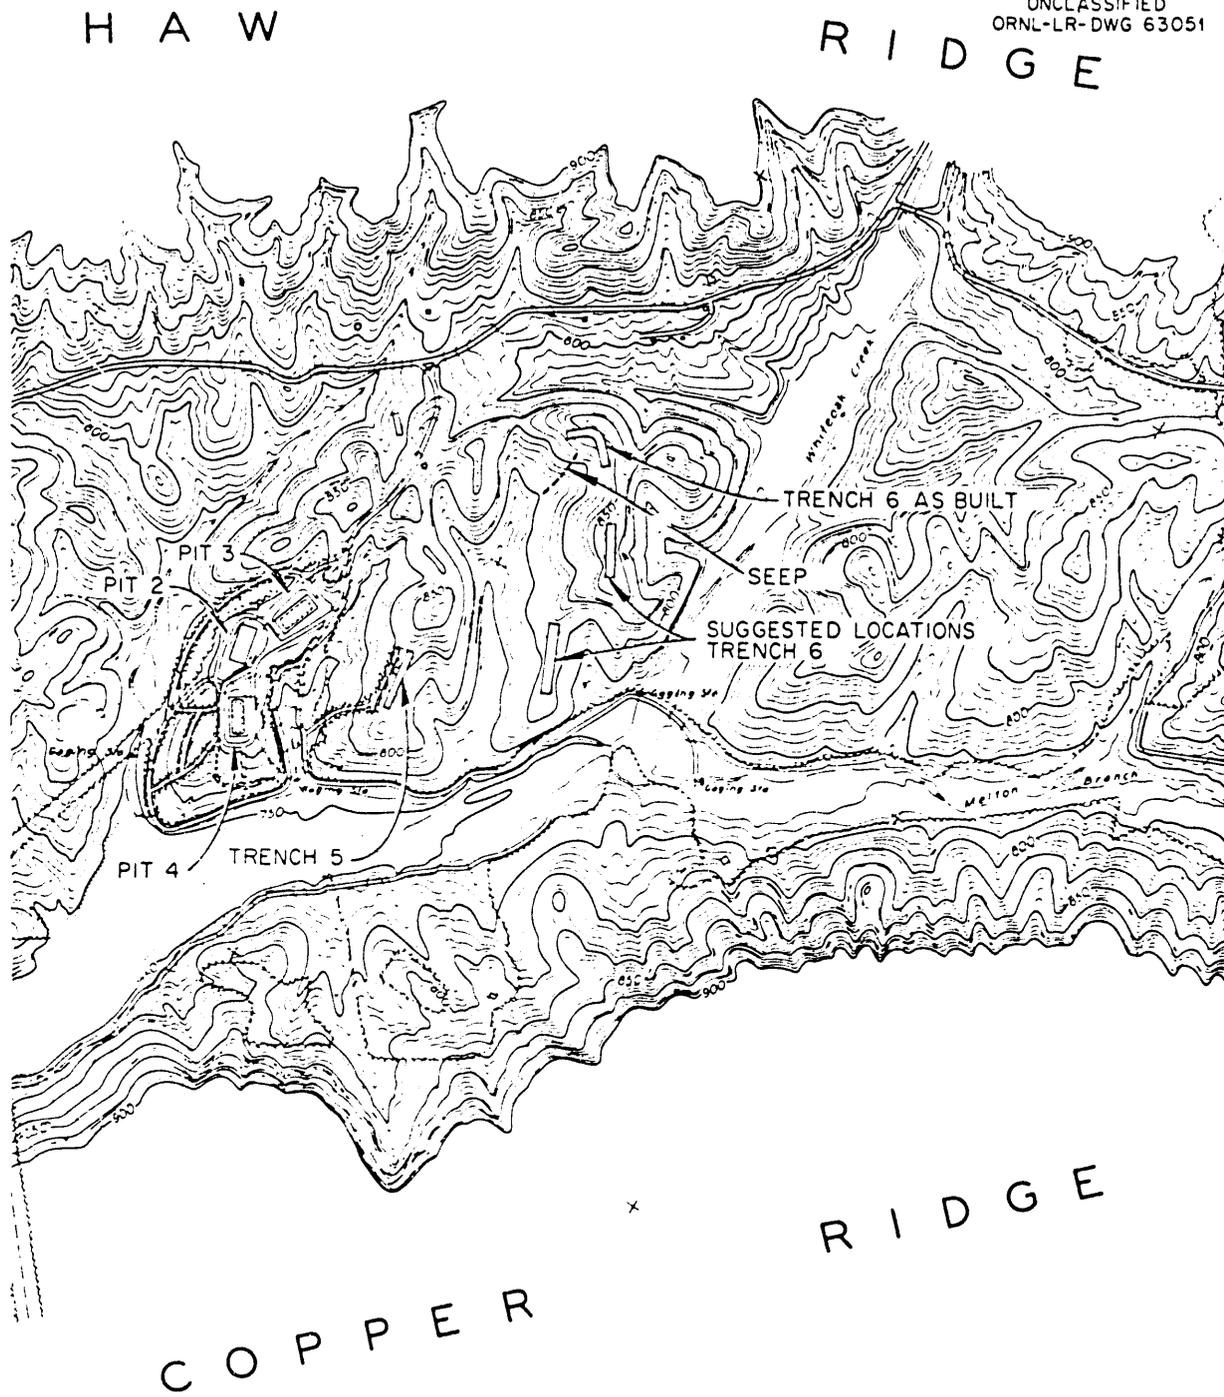
Fig. 2. Contour map showing proposed and final location of Trench 6.

Trench 6 is one of seven ORNL seepage pits and trenches that were used to dispose of approximately 160 million liters (42 million gallons) of radioactive liquid wastes between 1951 and 1966. Trench 6 was constructed in 1961 on a ridge top just south of SWSA 4 at ORNL grid coordinates (measured in feet) N18,680 and E27,980 (Fig. 1). The actual choice of the site of Trench 6 was based on construction cost estimates rather than geologic advice or preconstruction coring and water table monitoring (Fig. 2).<sup>1</sup>

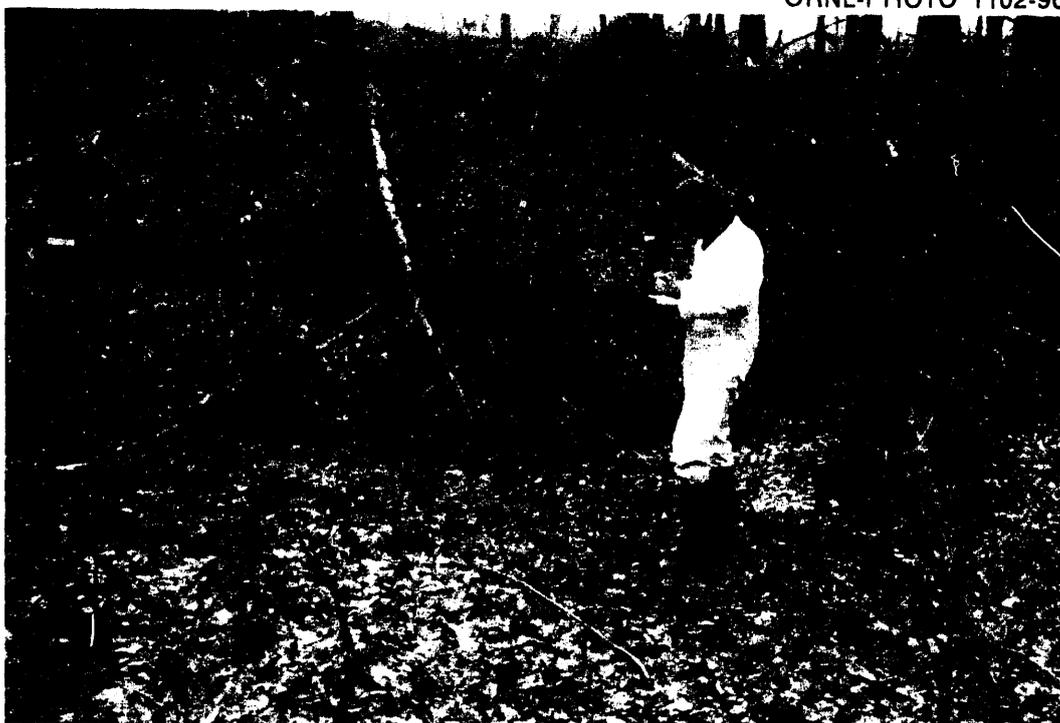
ORNL-PHOTO 1102-90

Fig. 6. View of contamination zone sign in the area of former seep (January 1990).

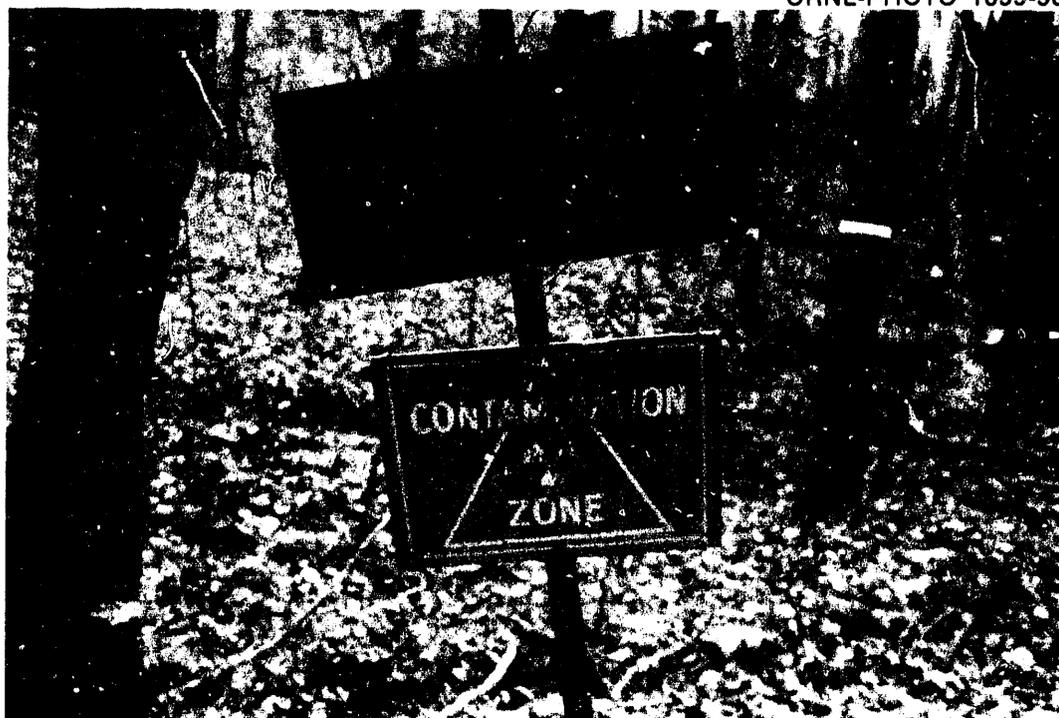
Fig. 7. Weathered contamination zone sign in area of former seep (January 1990).

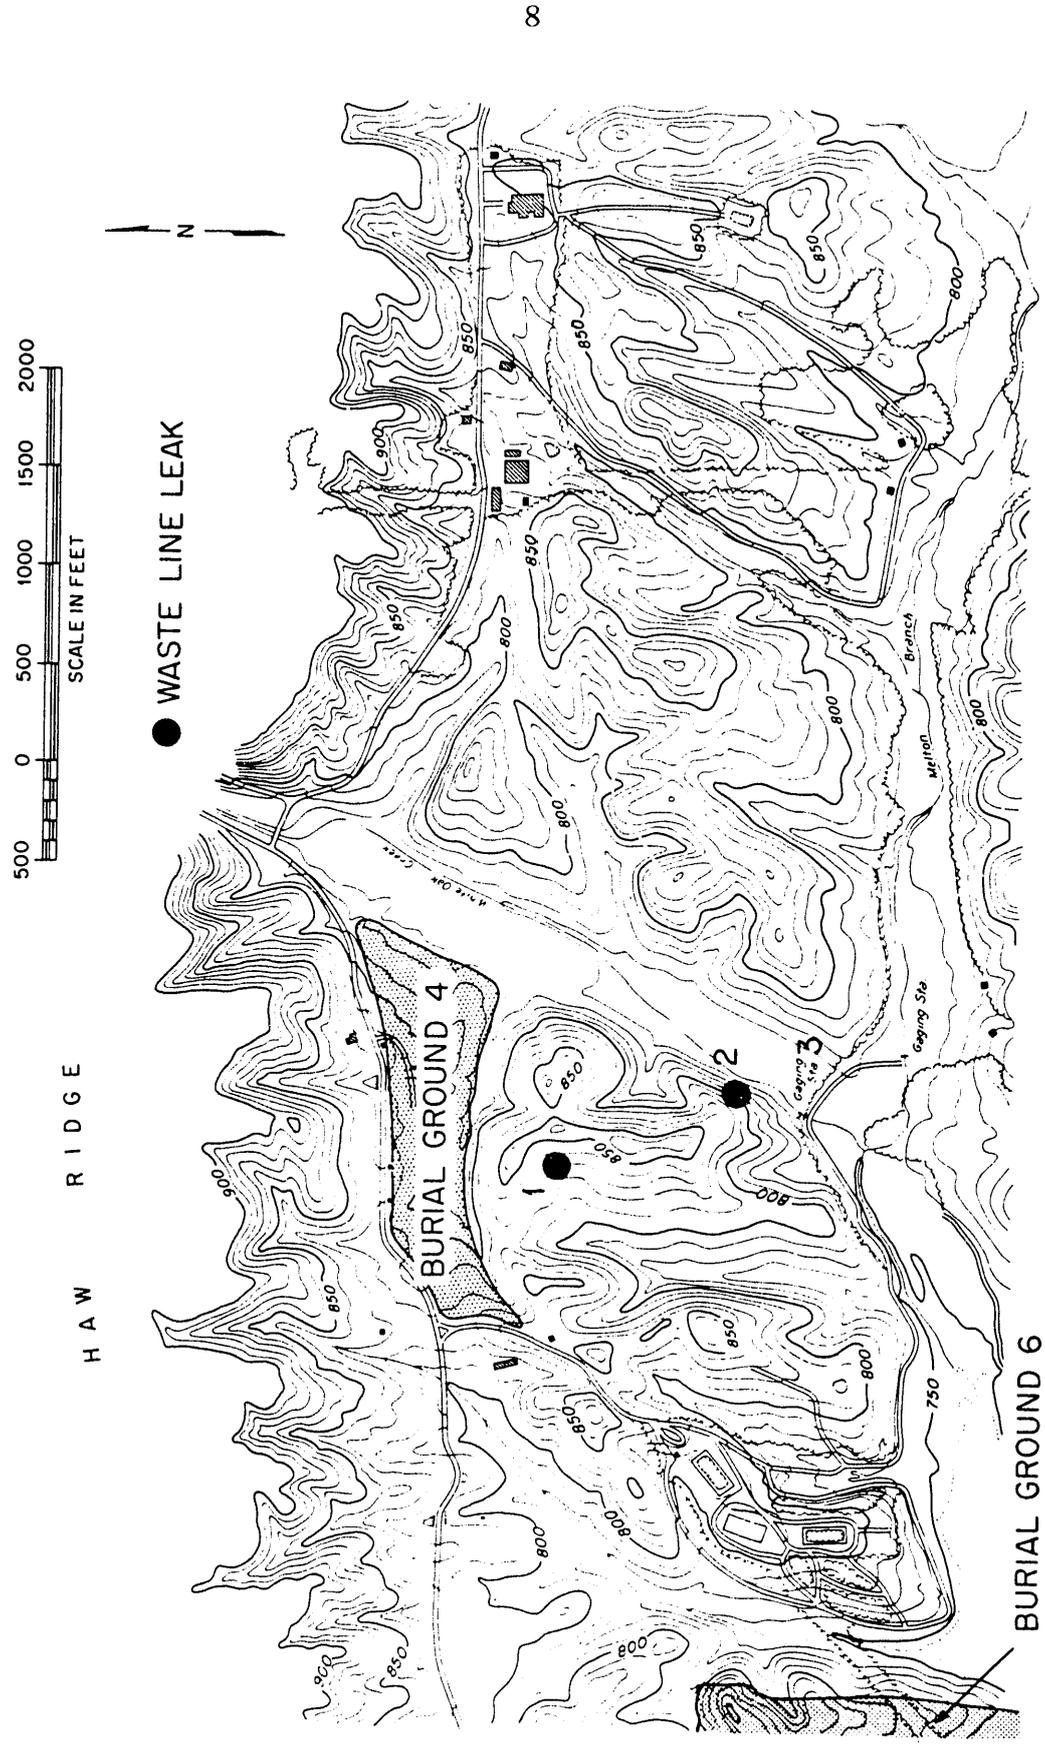
Fig. 8. Contour map showing location of LLW Line Leak Site 7.4b (Leak Site No. 1).

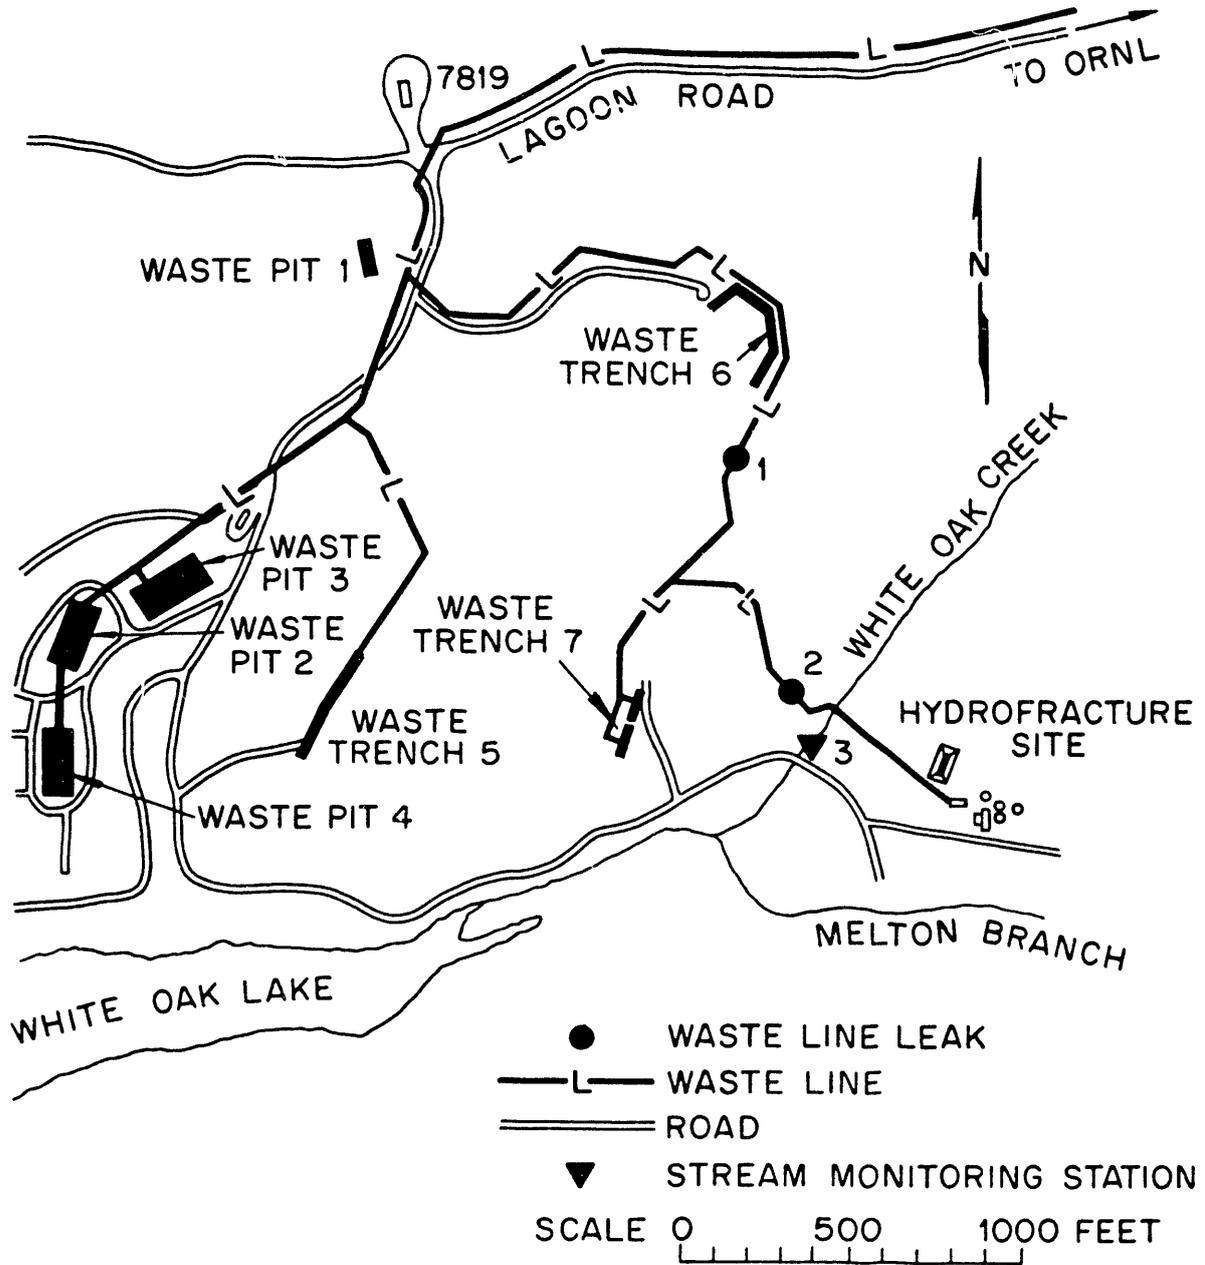
Fig. 9. Diagram showing low-level radioactive waste (LLW) line, Trench 6, and LLW Line Leak Site 7.4b (Leak Site No. 1).

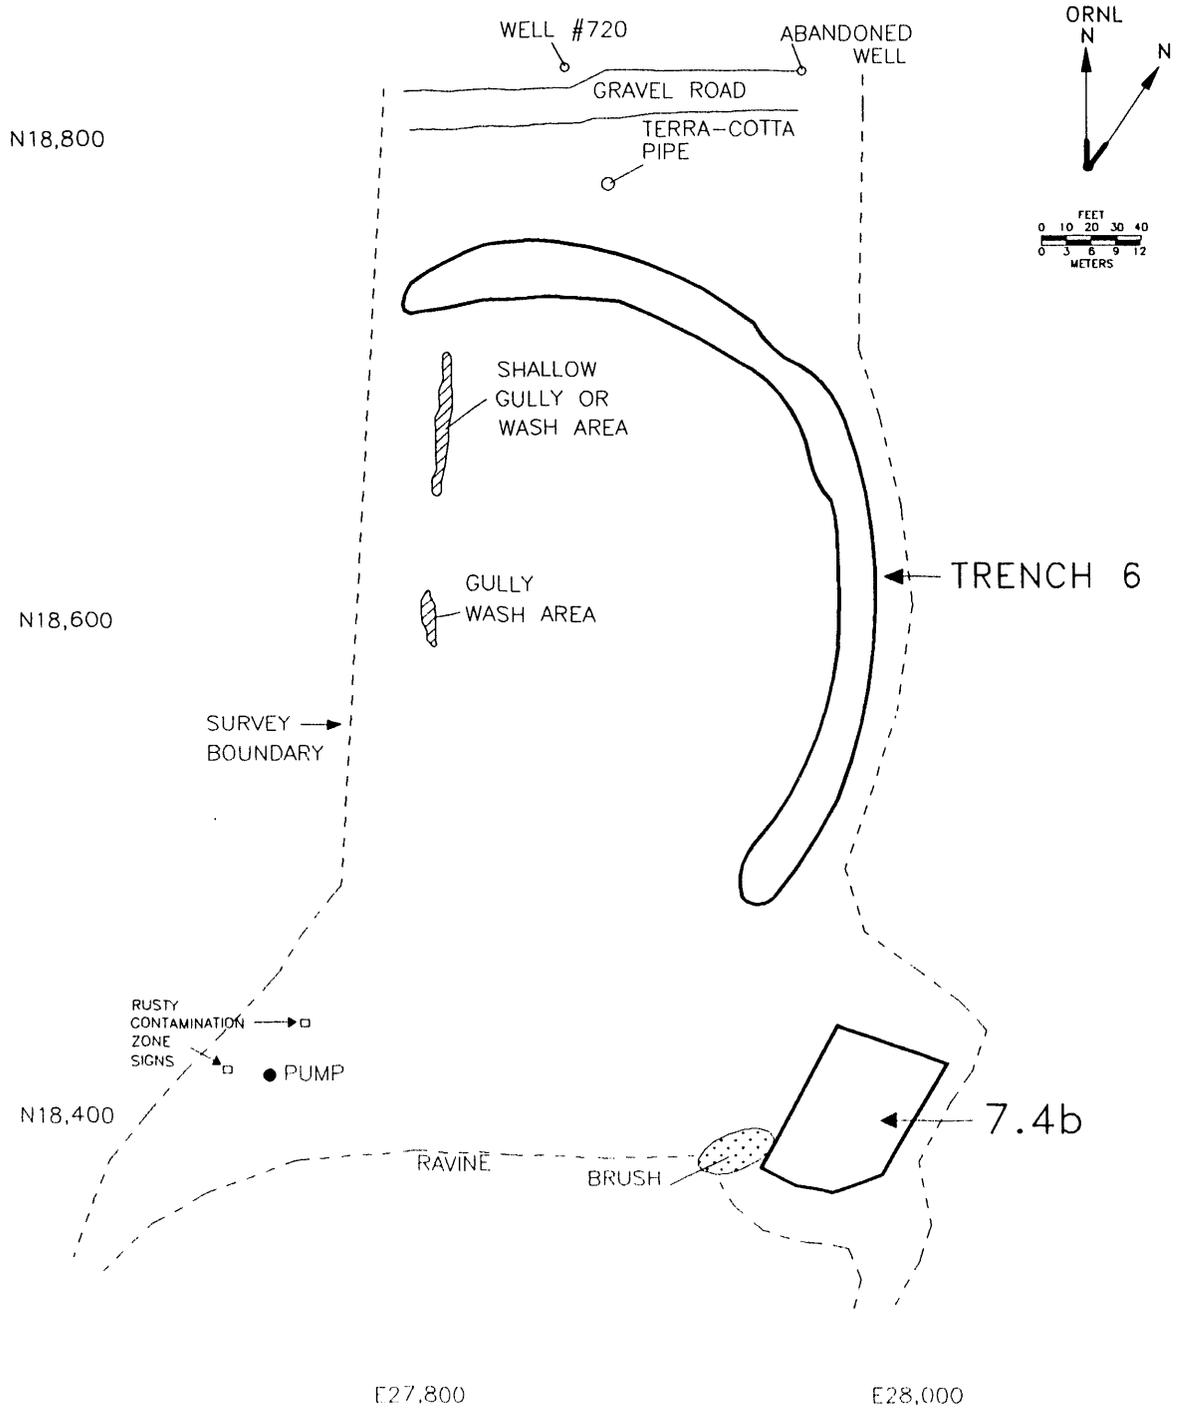
- A surface gamma scan of the area including the asphalt layers on the trench and leak site, the gravel road north of the trench, and wooded regions in the area including the site of a former seep. Area covered in this survey is delineated with a dotted line in Fig. 11. A NaI scintillation probe held approximately 5 cm (2 in.) above the ground surface was used to detect gamma radiation. When radiation levels exceeded the detection limits of the scintillator, the GSM or cutie pie ionization chamber was used.
- Measurement of beta-gamma activity on contact with the trunks of numerous contaminated trees.
- Radionuclide analysis of eight soil samples collected from four locations.
- Radionuclide analysis of three vegetation samples collected from three locations.
- Radionuclide analysis of one water sample.

Fig. 11. Diagram showing area covered by the surface radiological survey at Trench 6 and LLW Line Leak Site 7.4b.

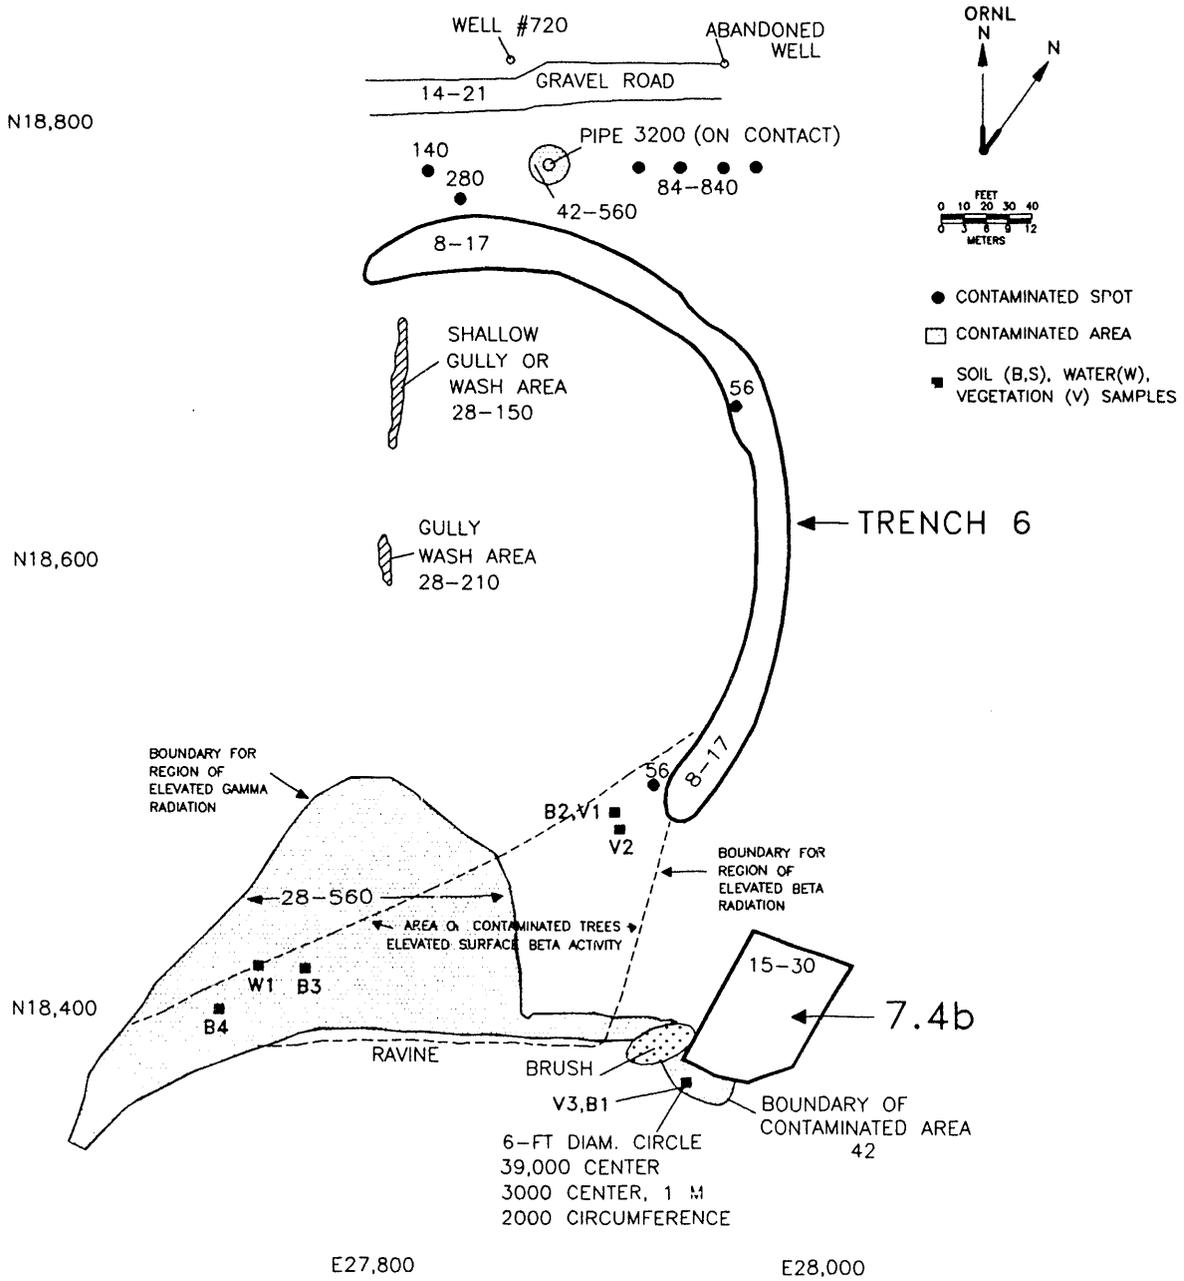
Results of the surface gamma scan are shown in Fig. 12. The asphalt covering on Trench 6 showed surface gamma radiation levels ranging from 8 to 17  $\mu\text{R/h}$ , with one spot reaching 56  $\mu\text{R/h}$ . Gamma levels up to 140  $\mu\text{R/h}$  were recorded on contact with the sides of several pipes (vents) protruding vertically from the asphalt surface.

**Fig. 12. Diagram showing results of surface radiological survey and locations of environmental samples at Trench 6 and LLW Line Leak Site 7.4b. Surface gamma exposure rates, measured with a NaI scintillator or closed-window GSM, are given in microrentgens per hour.**

Results of soil sample analysis are given in Table 2, and collection locations are indicated on Fig. 12. Samples B1A, B1B, and B1C were composed of wood chips mixed with soil collected ~0.6 m (2 ft) east of the spot measuring 39 mR/h located near the southwest corner of Leak Site 7.4b. Sample B1A contained 8500 pCi/g  $^{137}\text{Cs}$  and 77,000 pCi/g gross beta activity. Sample B1B contained less  $^{137}\text{Cs}$  (7900 pCi/g) but more gross beta activity (81,000 pCi/g), suggesting that the beta activity is from another radionuclide, probably  $^{90}\text{Sr}$ . Surface gamma levels\* reached 39 mR/h in the area, but at the soil sample hole, gamma levels ranged from 19 mR/h at a depth of 30 cm (12 in.) to 32 mR/h at the surface. Beta-gamma dose rates measured 40 mrad/h at the sample location. Surface alpha was below the minimum detectable activity of the instrument.

Highest surface radiation levels encountered during the survey were found outside fenced, placarded contamination zones just south of LLW Line Leak Site 7.4b. At this location, surface gamma levels reached 39,000  $\mu\text{R/h}$  and 1-m levels measured 3000  $\mu\text{R/h}$ . The 1-m measurement is 300 times the average gamma level (10  $\mu\text{R/h}$ ) found in uncontaminated areas on the Oak Ridge Reservation. Elevated gamma levels were previously detected in this area during a scoping investigation in August 1987. At that time, the current area of concern was covered with cut trees, vegetative debris, and fill dirt (Fig. 20). This debris has since been moved and relocated to the west, making the area more accessible for surface radiation measurement. Figures 10 and 20 depict site conditions during the 1987 and 1990 surveys, respectively. Figure 12 shows the current location of the brush pile.

- Gamma exposure rate measurements outside the fenced, placarded contamination zone immediately south of the Leak Site 7.4b (Fig. 12) revealed 3 mR/h at 1 m from the ground surface (the highest surface reading was 39 mR/h). Based on guidelines for establishing contamination control zones developed by ORNL Health Physics, it is recommended that Contamination Area control measures be implemented at this region. The rationale for recommending a "Contamination Area" rather than a "Radiation Area" is that surface radioactivity present at the seep/line leak areas is more highly transferable during wet conditions (e.g., storm events). Contamination control measures including warning signs, definition of zone boundaries, and access control procedures are needed. We recommend that the number of zone portals (point of entrance and exit) be limited to one. In addition, a weatherproof diagram of this area showing radiation levels and localized area of surface contamination should be posted at the zone portal.

- Radiation control measures should be considered for the large contaminated land area exhibiting high surface gamma radiation levels and beta activity levels, including the large area of contaminated trees (see Fig. 12). Warning signs should be posted with instructions to contact the Radiation Protection Section of the Office of Environmental and Health Protection before entering the area. Based on recommendations outlined by ORNL Health Physics, "Radiation Hazard—Keep Out" signs would be applicable to this area. This type of warning sign is used primarily to warn the general Laboratory population and the public where access to an area is limited to authorized personnel who have the training necessary to safely perform their job functions within the area.

- A diagram of the radiological surface conditions at the Trench 6/Leak Site 7.4b area, depicting current radiation levels, surface hot spots, and contaminated tree area (such as Fig. 12 in this report), should be maintained, updated, and made readily available to authorized personnel requiring access into these areas. Consideration should be given to posting such information at a highly visible location on site. Instructions to contact responsible area personnel (e.g., ORNL Health Physics personnel, ORNL ERP) with current telephone numbers should be included.

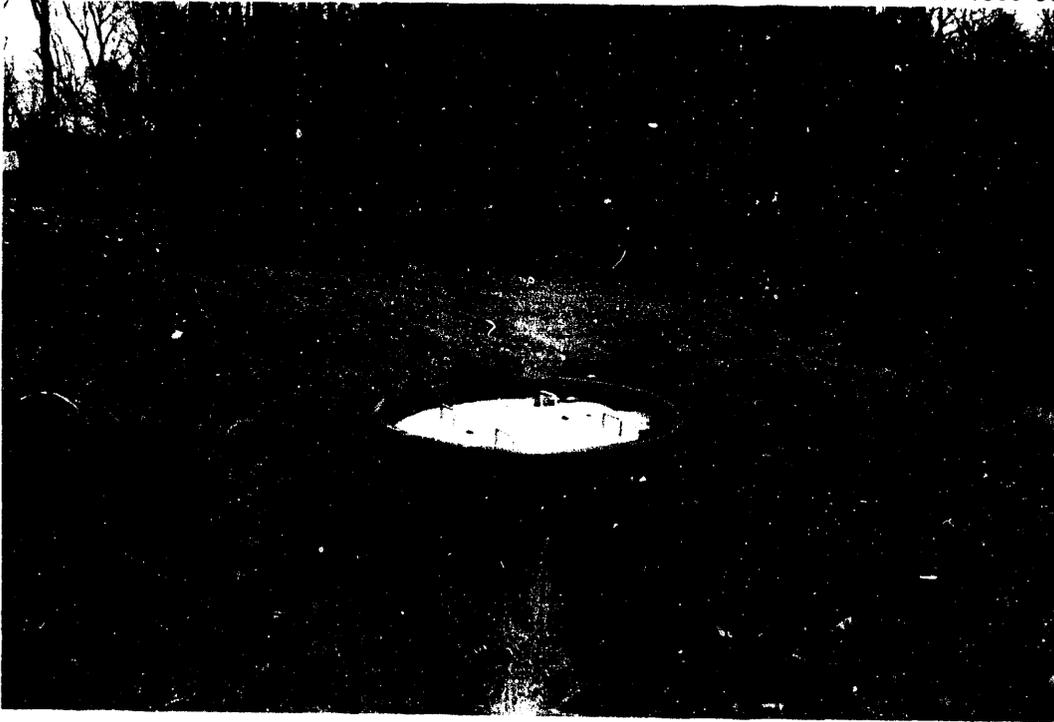
ORNL-PHOTO 1089-90

Surface gamma levels on the gravel road north of Trench 6 ranged from 14 to 21  $\mu\text{R/h}$ . Six spots of surface contamination between the gravel road and the north end of Trench 6 ranged from 84 to 840  $\mu\text{R/h}$ . In this same area, a terra-cotta pipe about 4 ft in diameter (Figs. 12 and 13) showed gamma radiation levels of 3200  $\mu\text{R/h}$  on contact with the metal cover and 800  $\mu\text{R/h}$  at 1 m above the edge of the metal cover. Radiation emanating from the pipe ranged from 42 to 560  $\mu\text{R/h}$  over a 13-m<sup>2</sup> (140-ft<sup>2</sup>) area. A faded radiation hazard sign is affixed to the metal cover but is visible only after one enters the radiation field, walks up to the pipe, and looks down at the cover (Fig. 13).

**Fig. 13.** View of terra-cotta pipe located north of Trench 6 (January 1990). A faded radiation hazard sign is located between the two handles on the right side of the metal cover.

- Gamma radiation measurements revealed levels of 3.2 mR/h on contact with a metal cover of a terra-cotta pipe located north of Trench 6 (Fig. 12). At this location, gamma levels emanated to 800  $\mu$ R/h at 1 m from the pipe. We recommend positioning updated "Radiation Hazard—Keep Out" signs at visible locations outside the perimeter of the emanative area.

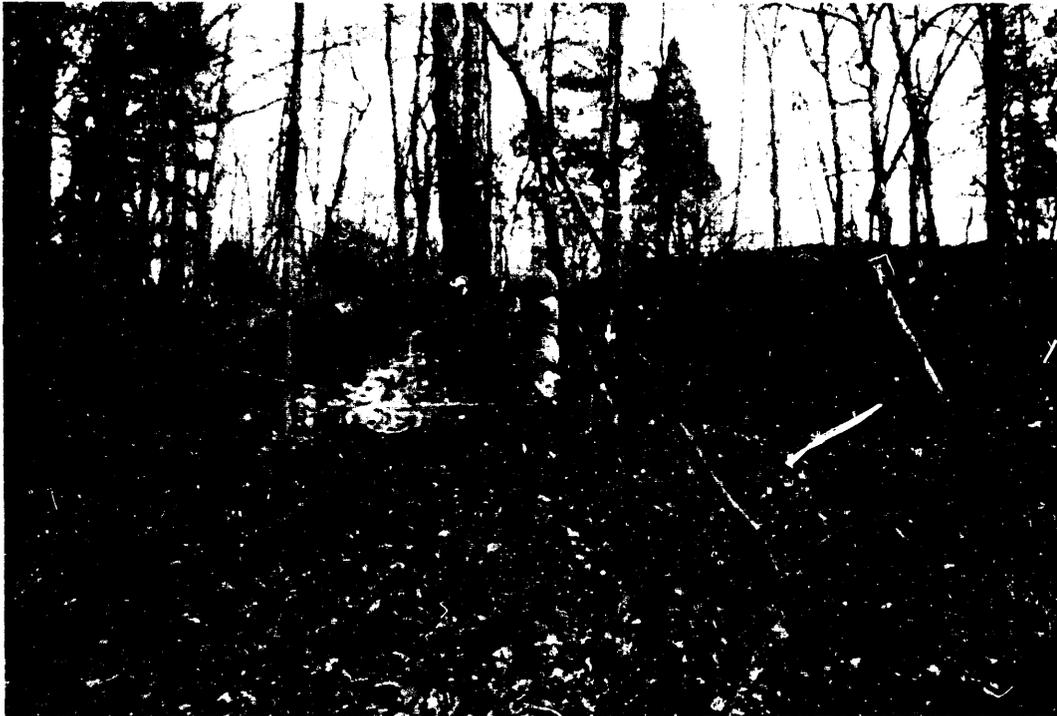
ORNL-PHOTO 1094-90

More than 50 contaminated trees (Figs. 16 and 17) were found along a line extending from the south end of Trench 6 southwest into the area with elevated surface gamma levels and beyond the western perimeter of the survey area. The area containing contaminated trees is delineated with a dotted line in Fig. 12. Beta-gamma levels measured on contact with the tree trunks ranged from 0.21 to 17 mrad/h. Dead leaves lying on the ground beneath the trees measured 1.6 mrad/h; the soil beneath the leaves measured 0.9 mrad/h after the leaves were removed. Gamma activity was not associated with the leaf litter or the

**Fig. 16. View looking north at contaminated trees near southwest end of Trench 6 (January 1990).**

The most significant finding of this survey was the large area of trees with elevated beta levels (0.21 to 17 mrad/h) suggesting that tree roots are reaching contamination deep within the ground. The contaminated trees cover the area between Trench 6 and the former seep, which contained significant levels of  $^{90}\text{Sr}$  and  $^{137}\text{Cs}$  when first discovered in 1961. No gamma radiation was detected on the trees or leaves, indicating that  $^{137}\text{Cs}$  is not involved; therefore, the elevated beta levels of the trees are probably caused by the uptake of underground  $^{90}\text{Sr}$ . Strontium-90 acts as an analog of calcium, which is readily taken up by vascular plants. Furthermore, it has been reported that trees may concentrate  $^{90}\text{Sr}$  more readily than other plant species.<sup>4</sup>

- Highly contaminated trees inside the proposed fenced area (noted above) should be identified with yellow or magenta paint, using a predetermined configuration placed at some specific height on the tree trunk. Additionally, the contaminated-trees area should be encircled by a roped or fenced boundary with "Contaminated Foliage" signs attached. This type of sign should specify the radiation hazard and date of such designation.

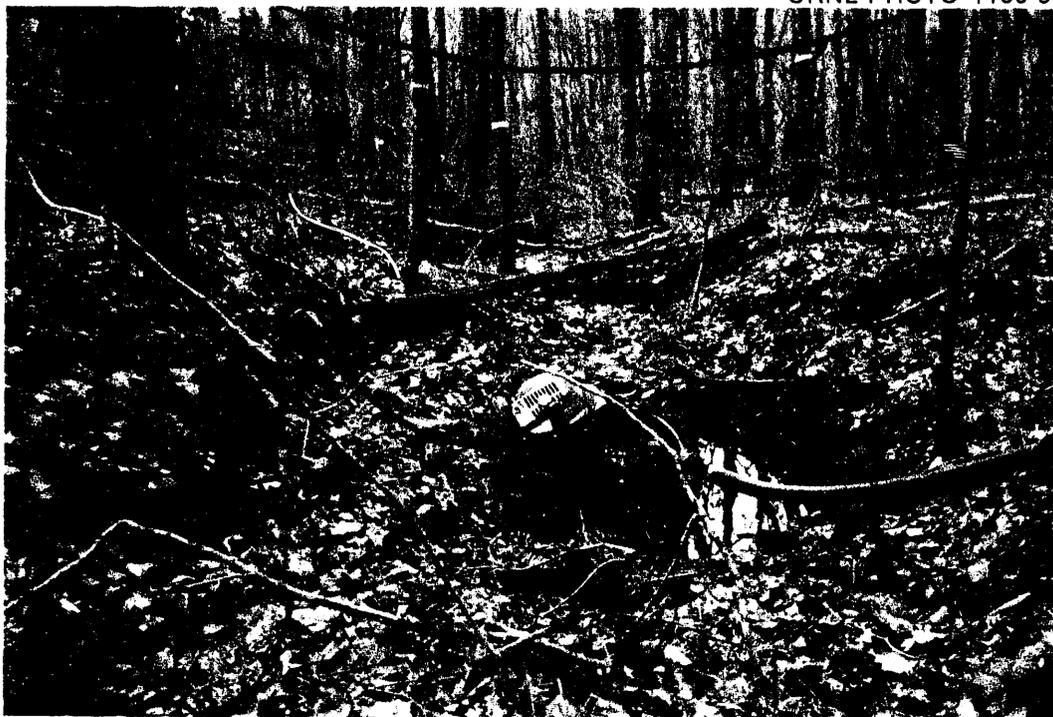
**Fig 19. View showing abandoned pump located in the area of former seep (January 1990). A water sample from pool beside pump contained beta activity.**

(1900 pCi/g), Sr (680 pCi/g),  $^{137}\text{Cs}$  (350 pCi/g), and  $^{60}\text{Co}$  (300 pCi/g). A water sample in the seep area contained beta activity (3800 pCi/L) and  $^{137}\text{Cs}$  (270 pCi/L) at 27 and 19 times levels normally found in uncontaminated groundwater in the Oak Ridge area.\*
