HELIUM INDUCED DEGRADATION IN THE WELDABILITY OF AN AUSTENITIC STAINLESS STEEL*

H. T. Lin¹, S. H. Goods², M. L. Grossbeck³, and B. A. Chin¹

1. Auburn University. 2. Sandia National Laboratories, Livermore, 3. Oak Ridge National Laboratory

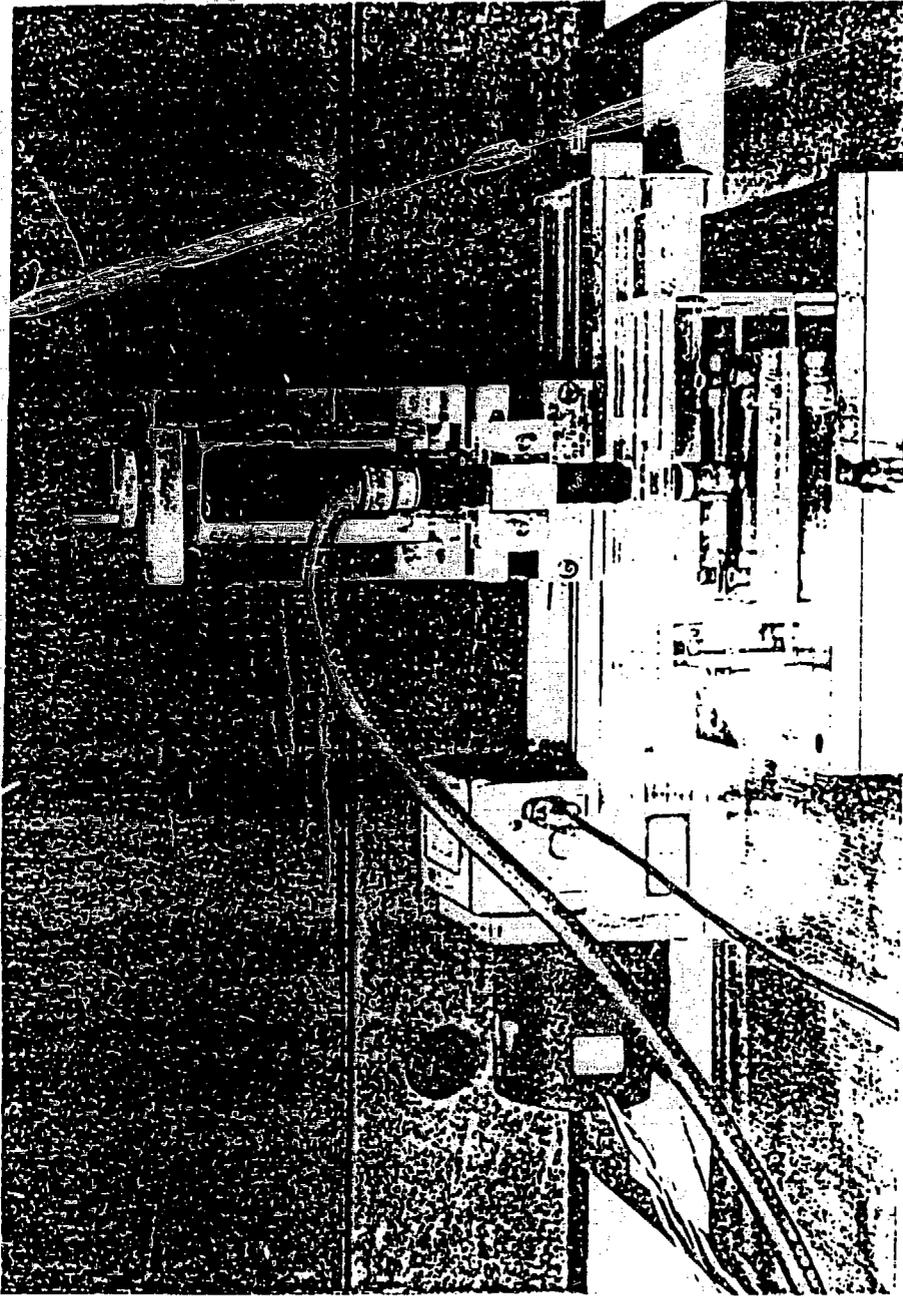
- Figure 1. Experimental welding station.
- Figure 2. Morphological Features of As-Welded Material: Helium Level 27 appm. (a). Macrograph of Heat-Affected Zone Showing Intergranular Fracture. (b). Scanning Electron Micrograph Showing Details of Intergranular Fracture. (c). Scanning Electron Micrograph of Grain Boundary Facets Decorated with a Uniform Distribution of Dimples.

Autogenous bead-on-plate welds were made using gas tungsten arc welding. Figure 1 shows the welding station that was located in a high velocity airhood with an air flow rate of 1.5 m/s. The semiautomatic motion of the welding torch was driven and controlled by a Unislide 8201M stepping motor controller. Welding was performed at 10 VDC, 24 A at a travel speed of 3.6 mm/sec under a protective argon atmosphere. Full penetration welds were produced in the 0.76 mm thick plate. The plates were laterally constrained during welding.

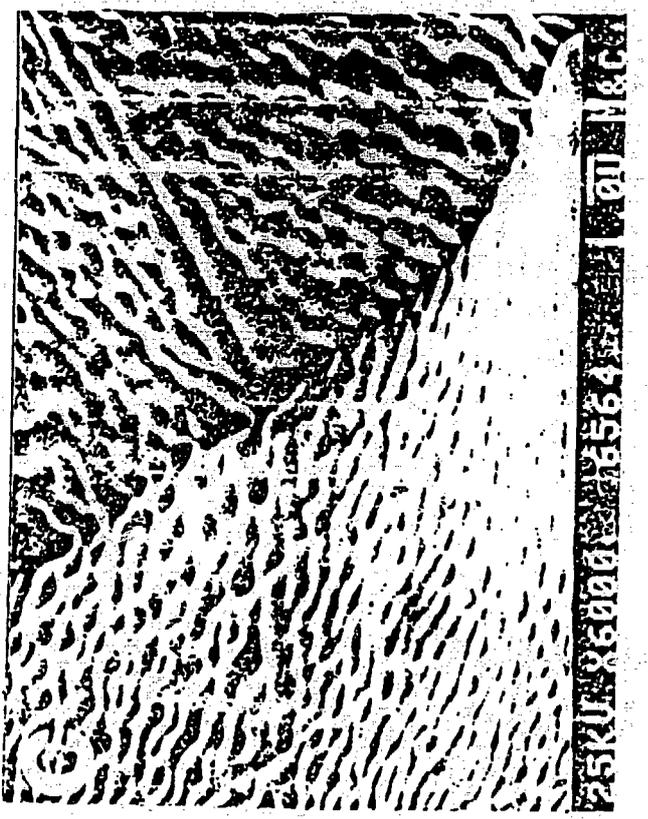
Figure 3

- Figure 3. Morphological Features of As-Welded Material: Helium Level 105 appm. (a). Macrograph of Brittle Fracture in Heat-Affected and Fusion Zones. (b). Scanning Electron Micrograph Showing Details of Intergranular Fracture. (c). Scanning Electron Micrograph of Grain Boundary Facets Decorated with a Uniform Distribution of Dimples. (d). Scanning Electron Micrograph Showing that Brittle Failure Proceeded along an Interdendritic Path.

Figures 2 and 3 show the morphological features of the as-welded materials with helium levels of 27 and 105 appm respectively. In the low helium content material, continuous through-thickness cracking in the HAZ was observed in 75% of the welded plates (6 out of 8). In the remaining plates, the cracking was discontinuous. Typically, this cracking occurred in the HAZ immediately adjacent to the fusion zone and was intergranular in nature (Figure 2b). In the higher helium content material, all of the welded plates (9 out of 9) showed HAZ cracking; in addition, more than half of the welded plates (6 out of 9) exhibited evidence of centerline cracking in the fusion zone as well. As in the previous instance, the HAZ cracking was fully intergranular in nature (Figure 3b) and occurred very near to the weld interface. Since no external loads were applied, in all cases, the cracking resulted from shrinkage stresses as the laterally constrained plates cooled after welding.

Features of weld crack surfaces in the HAZ and fusion zone were studied in detail using scanning electron microscopy. Figures 2 and 3 show these typical surface features. As stated above, the weld cracking was entirely intergranular in nature, and at higher magnification the grain boundary facets were observed to be decorated with a uniform distribution of dimples (Figures 2c and 3c). The average dimple size was approximately 1 μm and was the same for both the high and low helium content specimens. However, the dimple morphology (symmetry and spacing) observed on grain facets varied with the orientation of the grain boundaries with respect to thermal stresses in the HAZ. The

dimples on the exposed facets exhibited symmetrical features which indicated that they were formed from cavities that grew under the action of stresses normal to the boundary. Incipient cracking, arising from coalescence of cavities, was also observed along the grain boundary intersections (Figures 2c and 3c). The shear ligaments separating the dimples have been rounded by surface diffusion, indicating that the cracking occurred at high temperatures. Examination of the fusion zone centerline cracking indicated that the brittle failure proceeded along an interdendritic path during material resolidification (Figure 3d). Isolated spherical pores resulting from the precipitation of the entrapped helium were also observed on the interdendritic fracture surface.

Weld crack features of the fusion zone of the 105 appm welded material (Figure 3d) reveal that brittle fracture occurred along interdendritic paths. Metallography of the fusion zone (Figure 5) suggests that brittle failure had its origins in the precipitation of helium bubbles in the dendritic boundaries. As solidification proceeds, helium is rejected by the growing dendrites because of the low solubility of helium in the metal and is trapped in the interdendritic region which is the last to solidify. These bubbles coalesce into microcracks. Tensile stresses developed in the weld during cooling then cause these cracks to propagate.

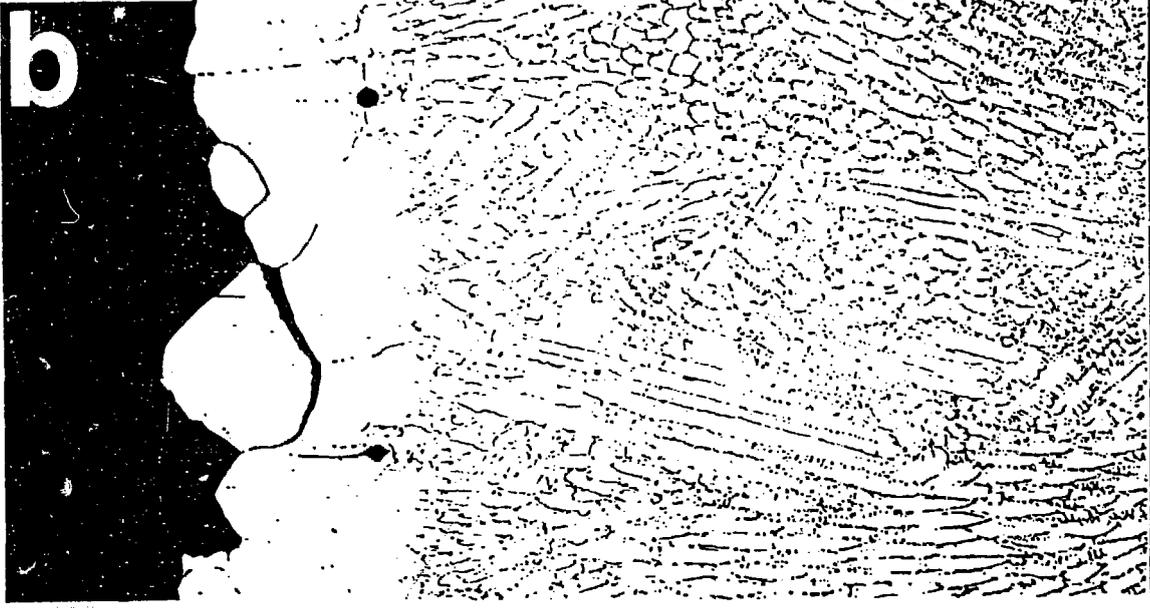
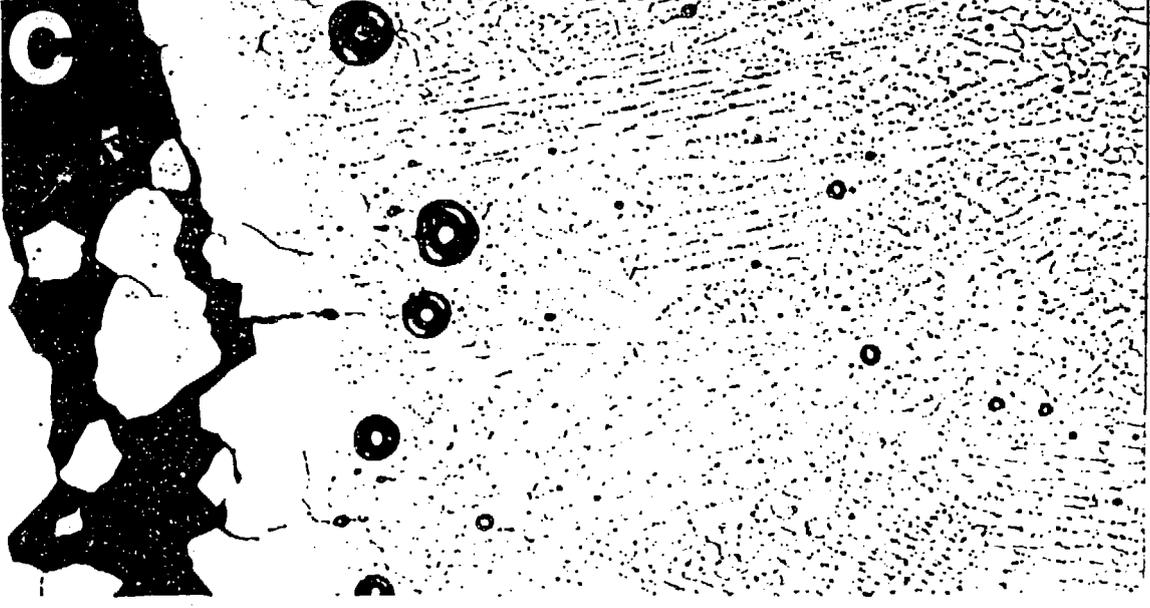
- Figure 4. Optical Micrographs of Welds Taken Transverse to the Welding Direction. (a). Control Material. (b). 27 appm. (c). 105 appm. Failure Occurred in the Heat-Affected Zone. Larger Pore Size and Greater Density of Helium Bubbles Occurred in the Fusion Zone near the Fusion Line.

Figure 4 shows the optical metallography of the welds from a section taken transverse to the welding direction for the 27 and 105 appm helium materials. A small amount of ferrite precipitation was observed near the fusion boundary. Generally, the microstructure of the fusion zone was primary austenite with visible spherical pores decorating the solidification dendrite boundaries. It is clear by comparing Figure 4b and c that the degree and size of the porosity was greater in the material containing 105 appm helium than in the lower helium concentration plates. The size of visible pores ranged from 0.5 to 70 μm . The larger pores were preferentially located in the fusion zone close to fusion boundary. The tendency to form bigger bubbles adjacent to the weld interface suggests that convective flow patterns in the weld pool act to sweep the helium toward that region, and the

As shown in Figure 4, the metallographic analysis revealed that the intergranular cracking occurred in the HAZ close to the weld interface. Within this narrow zone, secondary cracking away from the main fracture was observed along with porosity on the grain boundaries. Fracture appeared therefore to occur due to the growth and coalescence of helium bubbles along grain boundaries. This is obviously the region of solid material which experiences the combination of the highest temperatures and the highest shrinkage stresses required to induce the cracking phenomenon.

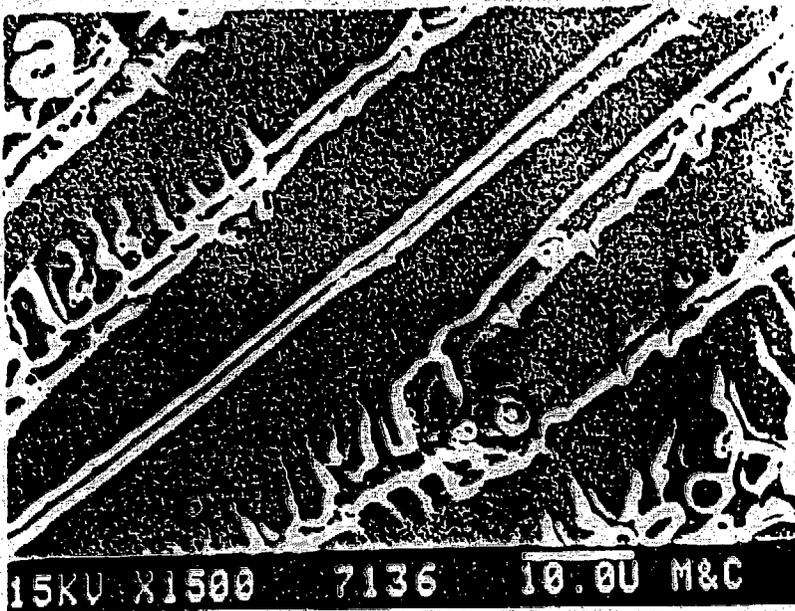
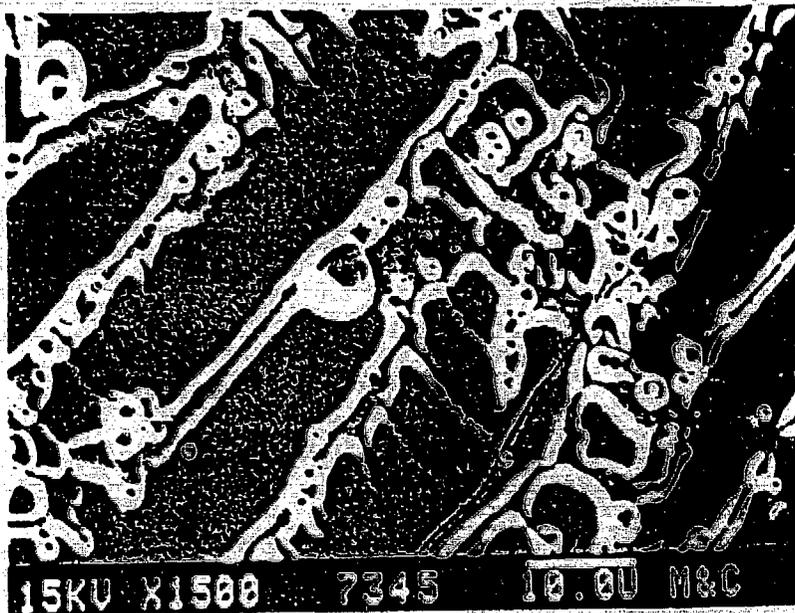
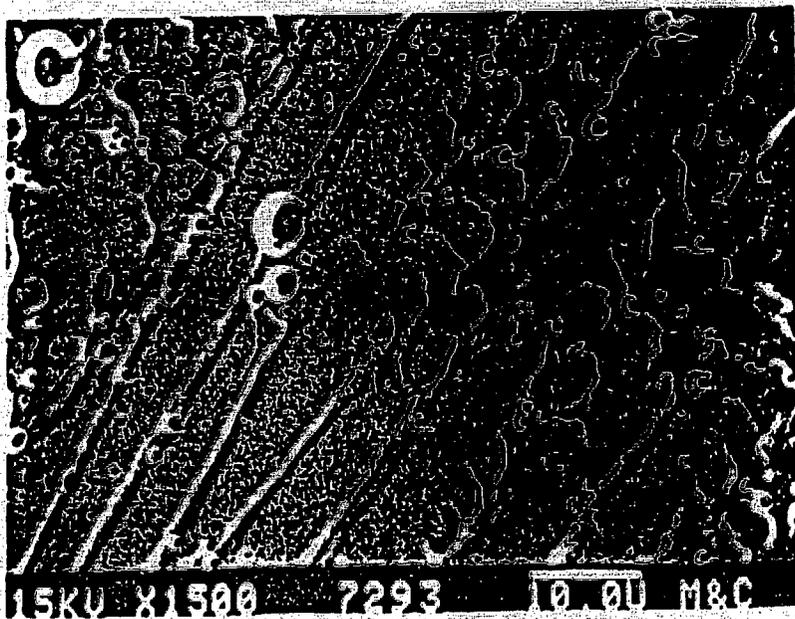
- Figure 5. SEM Micrographs of the Fusion Zone. (a). Control Material. (b). 27 appm. (c). 105 appm.
- Figure 6. Temperature and Helium Concentration Dependence of Yield Strength.

The degree to which the pores decorated the dendritic interfaces is more clearly shown in Figure 5 where once again it is seen that the size and extent of porosity increased with increasing helium content. As no such porosity occurred in helium free stainless steel welded under identical conditions, it is reasonable to conclude that the spherical pores observed in the fusion zone are helium bubbles.

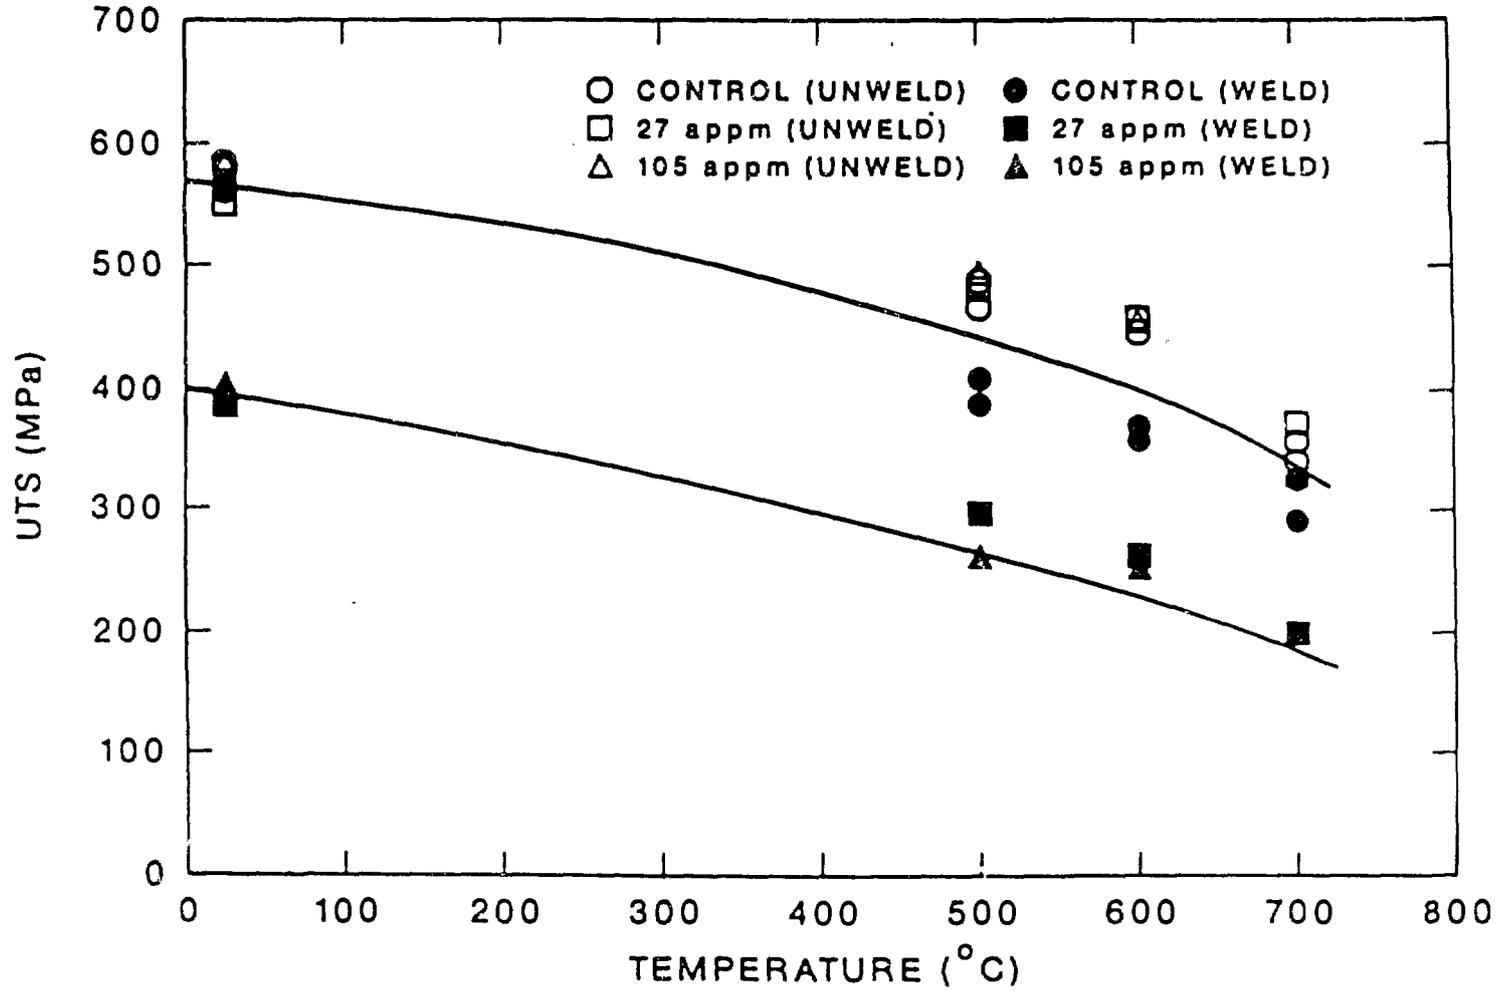
Figure 7

- Figure 7. Temperature and Helium Concentration Dependence of Ultimate Tensile Strength.
- Figure 8. Temperature and Helium Concentration Dependence of Total Elongation.

In all cases, the ultimate tensile strength (UTS) decreased with increasing test temperatures (Figure 7). For unwelded materials, the results reveal that the UTS was insensitive to the presence of helium at these concentrations. The strength of the welded control (no helium) was the same as that of the unwelded control at room temperature. However, it was somewhat less at the elevated test temperatures. The UTS of the He-bearing specimens subsequent to welding was severely degraded relative to welded control, unwelded control and unwelded He-doped materials. In fact, the UTS of the welded He-doped specimens was virtually identical to their yield strengths (Table II), indicating that the specimens failed immediately upon yielding.

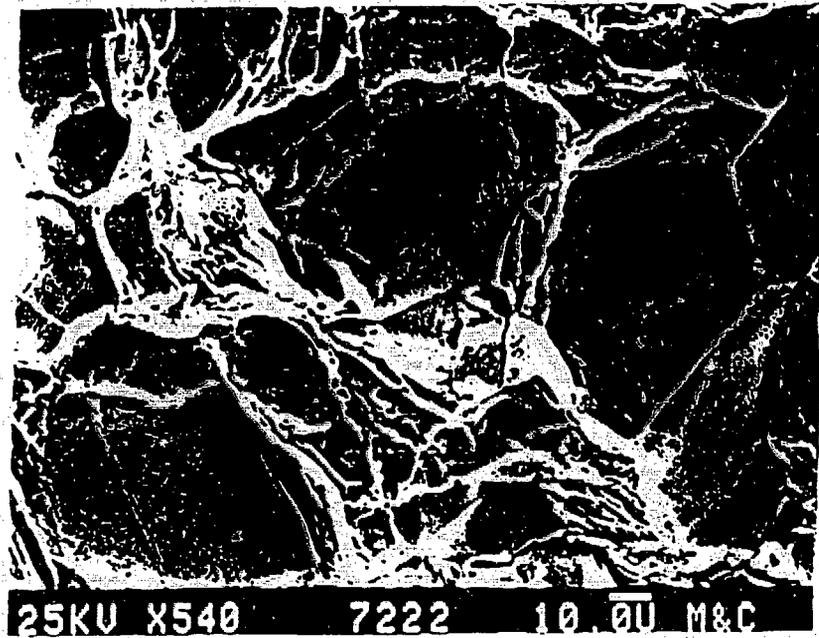
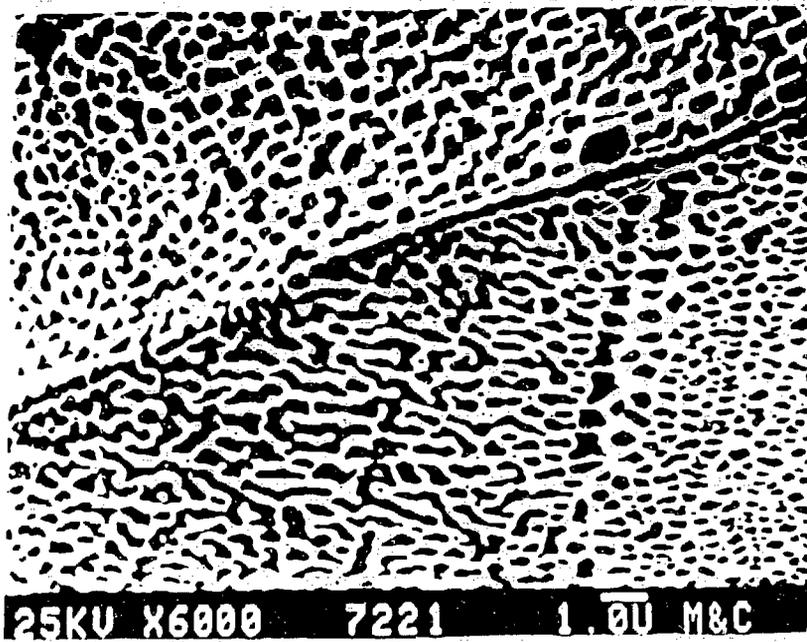
Figure 9

- Figure 9. Scanning Electron Micrographs of welded 27 appm material Tested at 25°C. (a). Intergranular Fracture. (b). Feature Showing Uniform Distribution of Dimples.

that the deformation and fracture is restricted to the fusion zone. The welded, He-doped specimens showed the lowest ductilities, generally less than 2% and as low as 0.2%. All welded, He-doped specimens failed at the fusion boundary. A typical fracture surface of a welded specimen containing 27 appm He tested at room temperature is shown in Figure 9. The fracture surface was nearly 100 percent intergranular, and at high magnification the grain boundary facets exhibited a dimple structure that was quite similar to the weld crack surface in the HAZ. The main difference was that the dimple shear walls were much more sharply defined as the result of room temperature fracture.
