Underground Corrosion after 32 Years: A Study of Fate and Transport

1. Research Objective

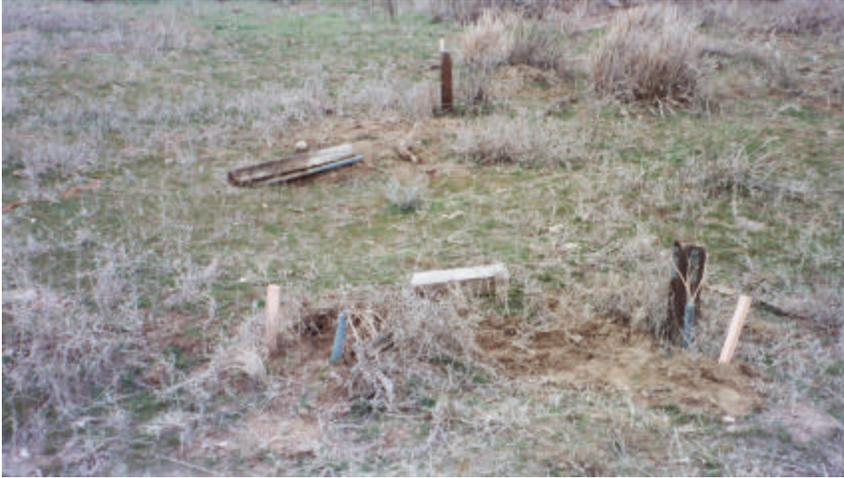
Site A. Trench location markers with galvanic measurement connections. (2-13-03)

Site Details Soil	Location	Landowner	Status of Specimens	Site Access
Site A, Sagemoor Sandy Loam, salt grass and short brush	About 18- miles southwest of Toppenish, WA	Yakama Indian Nation	Site visited and photographed. Many trench markers (4X4) posts are still standing in the ground.	Site access for specimen removal is in process and pending. A Memorandum of Agreement between the INEEL and the Yakama Indian Nation is being generated by the tribal legal council and is pending.

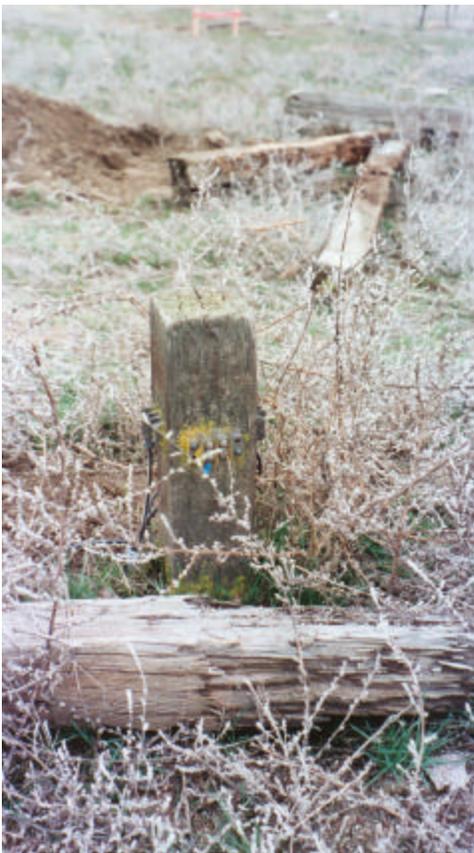
Site A. Location marker. (2-13-03).

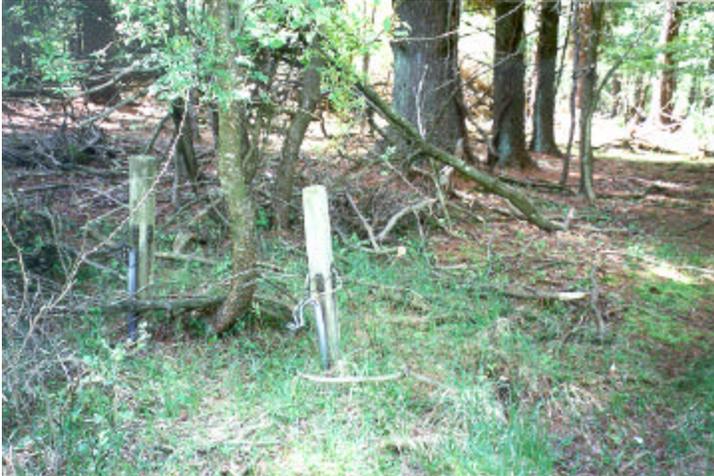
Site B. Location Markers. (5-27-03).

Site Details Soil	Location	Landowner	Status of Specimens	Site Access
Site B, Hagerstown Loam, grassy field next to a forest	At the Lock Raven Reservoir north of Baltimore, MD	Loch Raven Water Works and the City of Baltimore, MD	Site visit planned for 6/26/03. The landowner has identified the site. Three trench markers were found at the site.	A right of entry permit to remove specimens has been submitted to the Baltimore Water Works for review and approval.
Site C, Clay, is located in a wetland heavily overgrown with Phragmite an invasive reed.	On the U.S. Coast Guard Receiving Station at Cape May, NJ	U.S. Coast Guard	Site visit planned for 6/26/03. Maps made by NIST personnel guided the landowner to the site. The site has been identified as a Phragmite (invasive reed) overgrown wetland. No photographs of the site are currently available.	Not yet defined. The 6/26/03 meeting will cover these details.

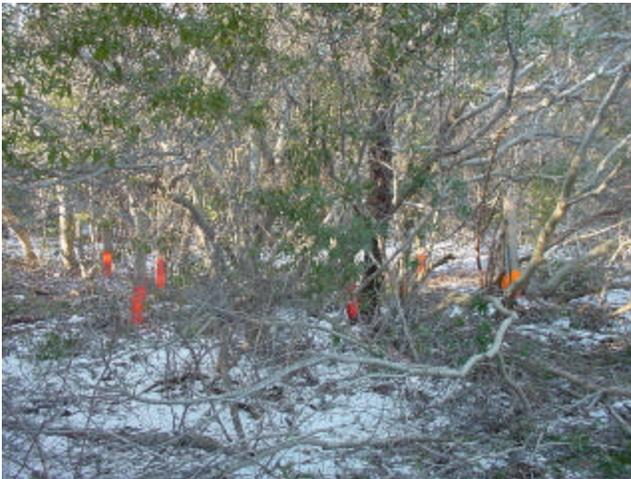
Site D. Location Markers. (3-25-03).

Site D, Lakewood Sand, heavily overgrown with tall brush and weeds.	On the U.S. Coast Guard Loran Support Unit near Wildwood, NJ	U.S. Coast Guard	Site visit planned for 6/26/03. Maps made by NIST personnel showing the location of the site guided the landowner to the site. The location was identified, and trench markers were found.	Not yet defined. The 6/26/03 meeting will cover these details.
