PNL-SA-23412

THE DEVELOPMENT OF PERMANENT ISOLATION  
BARRIERS FOR BURIED WASTES IN COOL  
DESERTS: HANFORD, WASHINGTON.

December 1993

Presented at the  
Desert Technology II Conference  
December 5-10, 1993  
Kona, Hawaii

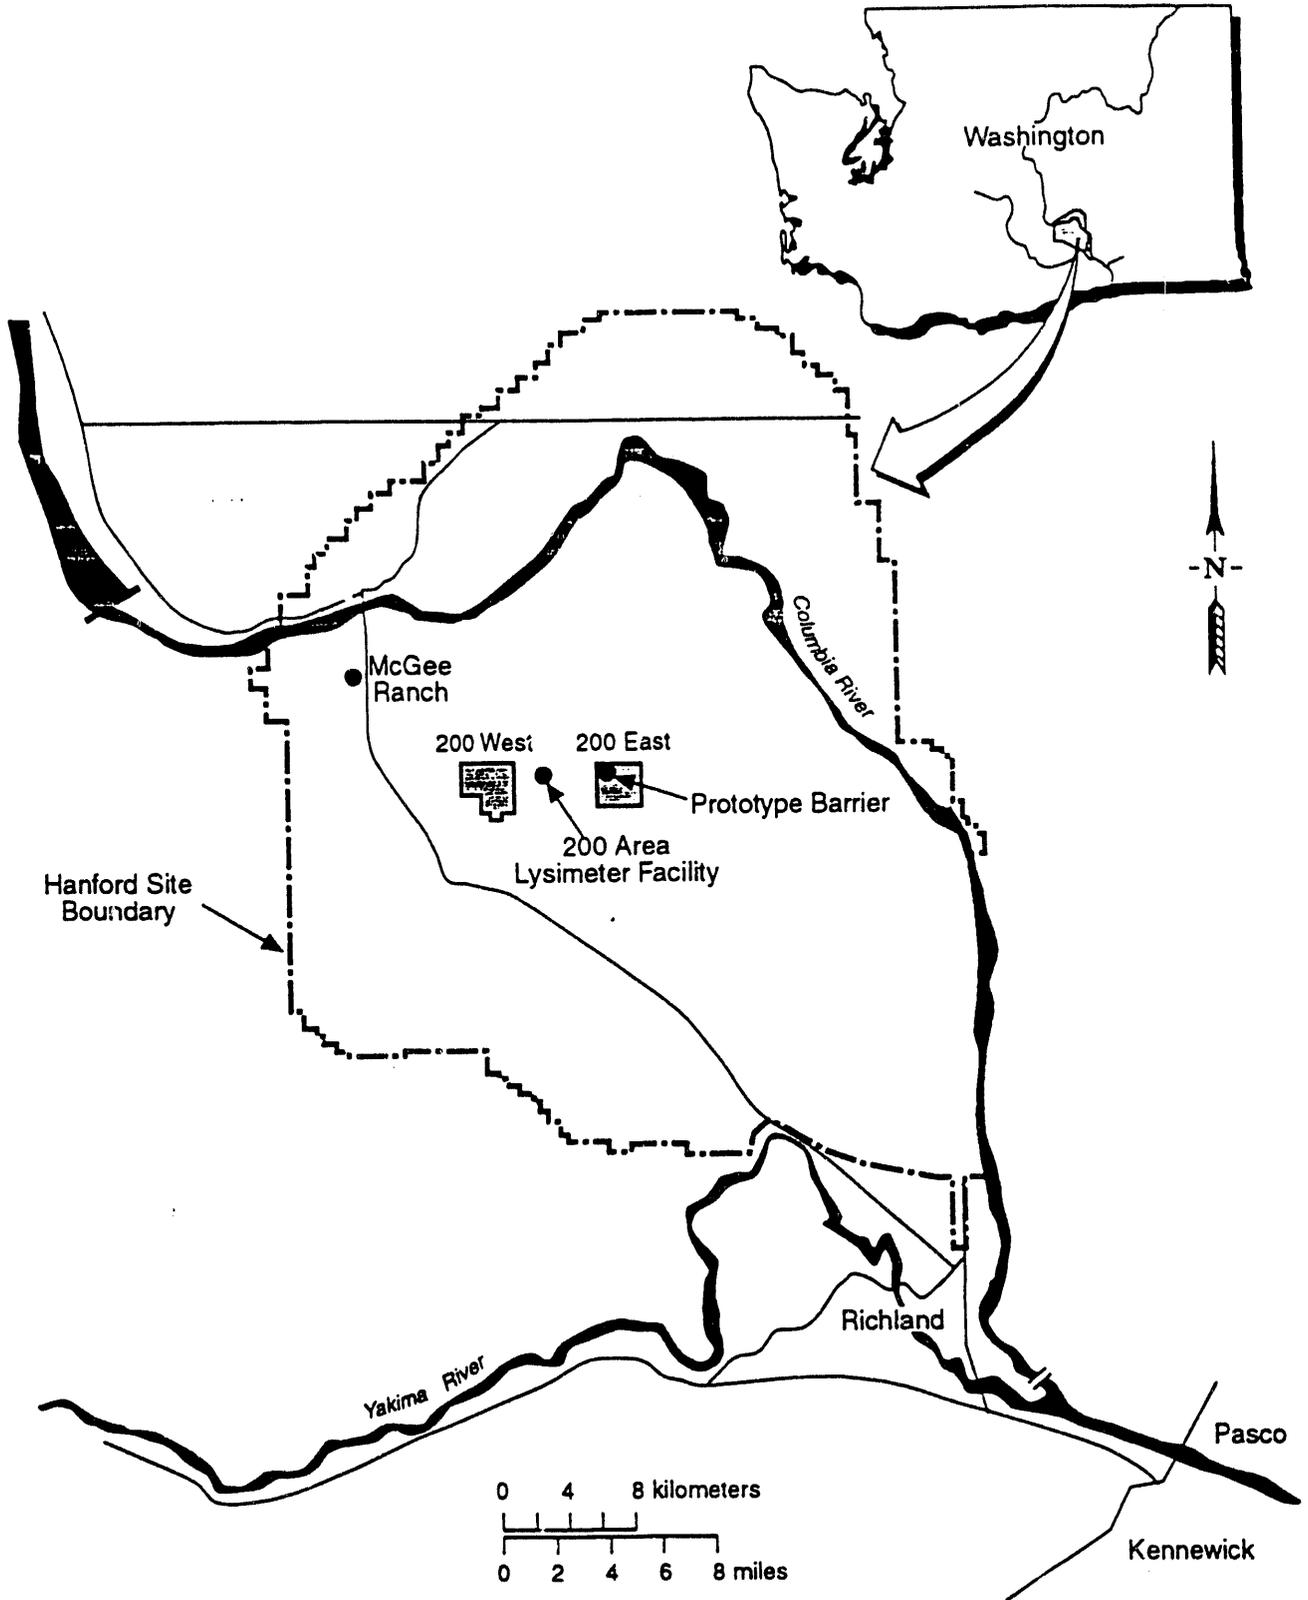
Fig 1

- Figure 1. Hanford Site map showing the location of McGee Ranch and the permanent isolation barrier in the 200 Area Plateau.
- Figure 2. Typical isolation barrier.
- Figure 3. Functional performance of barriers.
- Figure 4. Weighing lysimeters at the 200 Area Lysimeter Facility.
- Figure 5. Water storage for weighing lysimeters.
- Figure 6. Small tube weighing lysimeters at the 200 Area Lysimeter Facility.

The study area is on the United States Department of Energy's Hanford Site in south-central Washington (Fig. 1). The Hanford Site is 1480 km<sup>2</sup> in area and varies in elevation from 120 to 1200 meters above sea level (m.a.s.l.). The area has an arid climate with hot dry summers and cool wet winters. Average yearly precipitation is about 162 mm, falling mostly in the fall and winter.<sup>17</sup>

The McGee Ranch site (244 m.a.s.l.), from which barrier surface soils are obtained (Fig. 1), is dominated by shrubs (*Grayia spinosa* and *Artemisia tridentata*) with several species of forbs, perennial grasses, and the annual grass *Bromus tectorum*. The soils have been classified as Xerollic Camborthids such as Warden silt loams.<sup>4</sup> A description of soil characteristics is given in Table 1. A complete site description has been documented.<sup>18</sup>

The site where the permanent isolation barrier is to be built is located on the 200 Area Plateau at an elevation of 223 m.a.s.l. (Fig. 1). It has the same floral makeup as the McGee Ranch site with the addition of the shrub *Purshia tridentata*. The soils are coarse-textured alluvial sands covered by a mantle of wind-deposited fine sands of the Quincy soil series (mixed, mesic Xeric Torripsamments).<sup>4</sup>

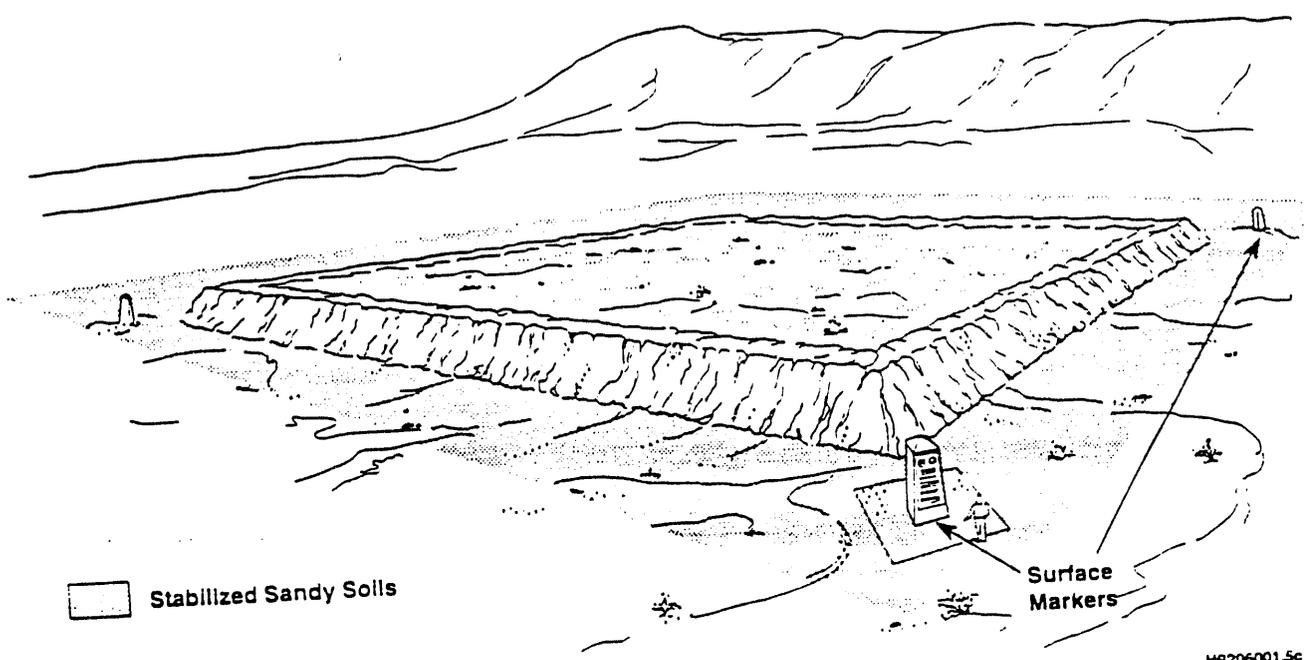
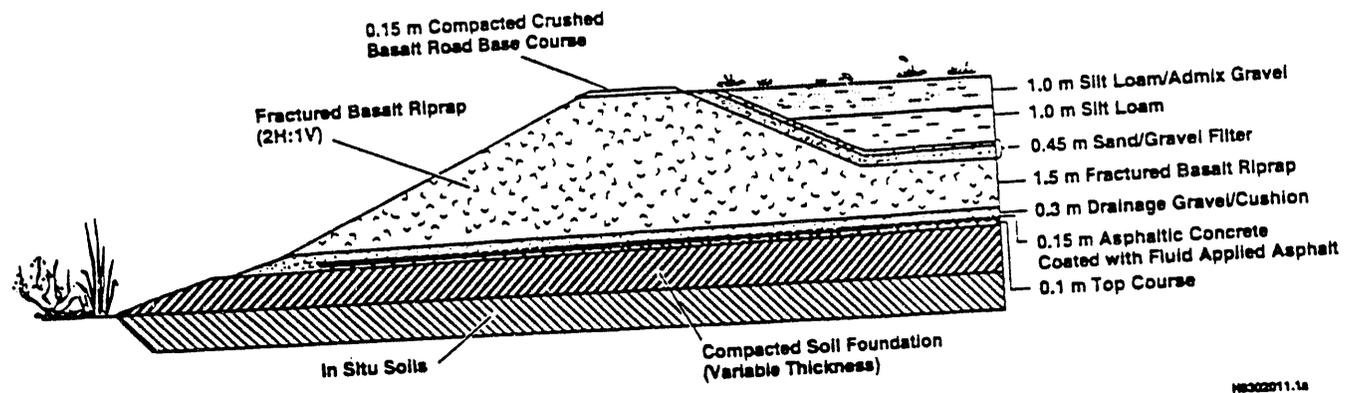
Fig 2

Figure 1.1. Typical Isolation Barrier

The permanent isolation barrier (Fig. 2) consists of various materials placed in layers forming an above-grade mound over the waste zone. The design consists of a vegetated fine-soil layer overlying layers of sand, gravel, riprap, and asphalt. Each layer serves a distinct purpose. The vegetated fine-soil layer acts as a medium in which moisture is stored until the processes of evaporation and transpiration return the water to the atmosphere (Fig. 3). The coarser materials (sand, gravel, riprap) below the fine-soil layer create the capillary break that inhibits the downward infiltration of water through the barrier. The coarse materials also inhibit biointrusion below the fine-soil layer. The asphalt layer will be placed below the coarse layers just above the ground surface. This layer will divert any water that gets through the capillary break away from the waste zone.

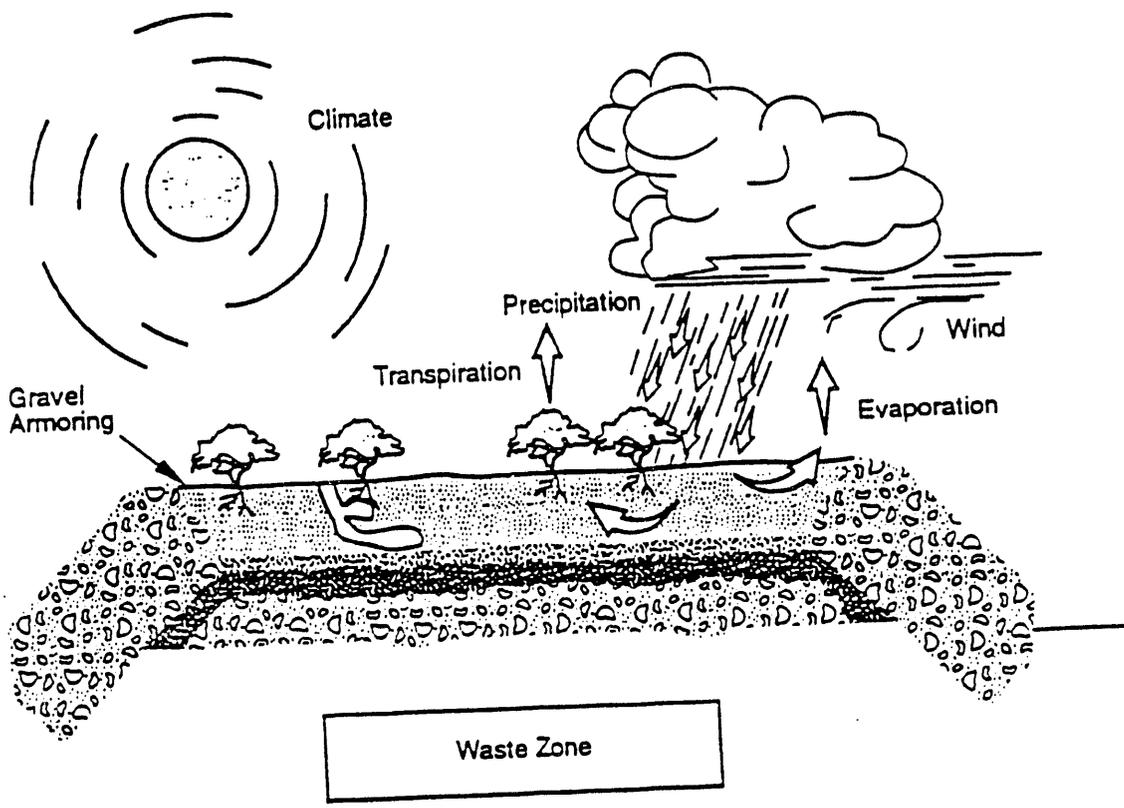
Fig 3

Figure 1.2. Functional Performance of Barriers

The study of the effectiveness of capillary break configurations on soil water storage was conducted at the 200 Area Lysimeter Facility (Fig. 1). We tested the hypothesis that a thick fine-soil layer over coarse sands would prevent drainage under four treatment conditions: ambient precipitation non-vegetated, ambient precipitation vegetated, additional precipitation non-vegetated, and additional precipitation vegetated.

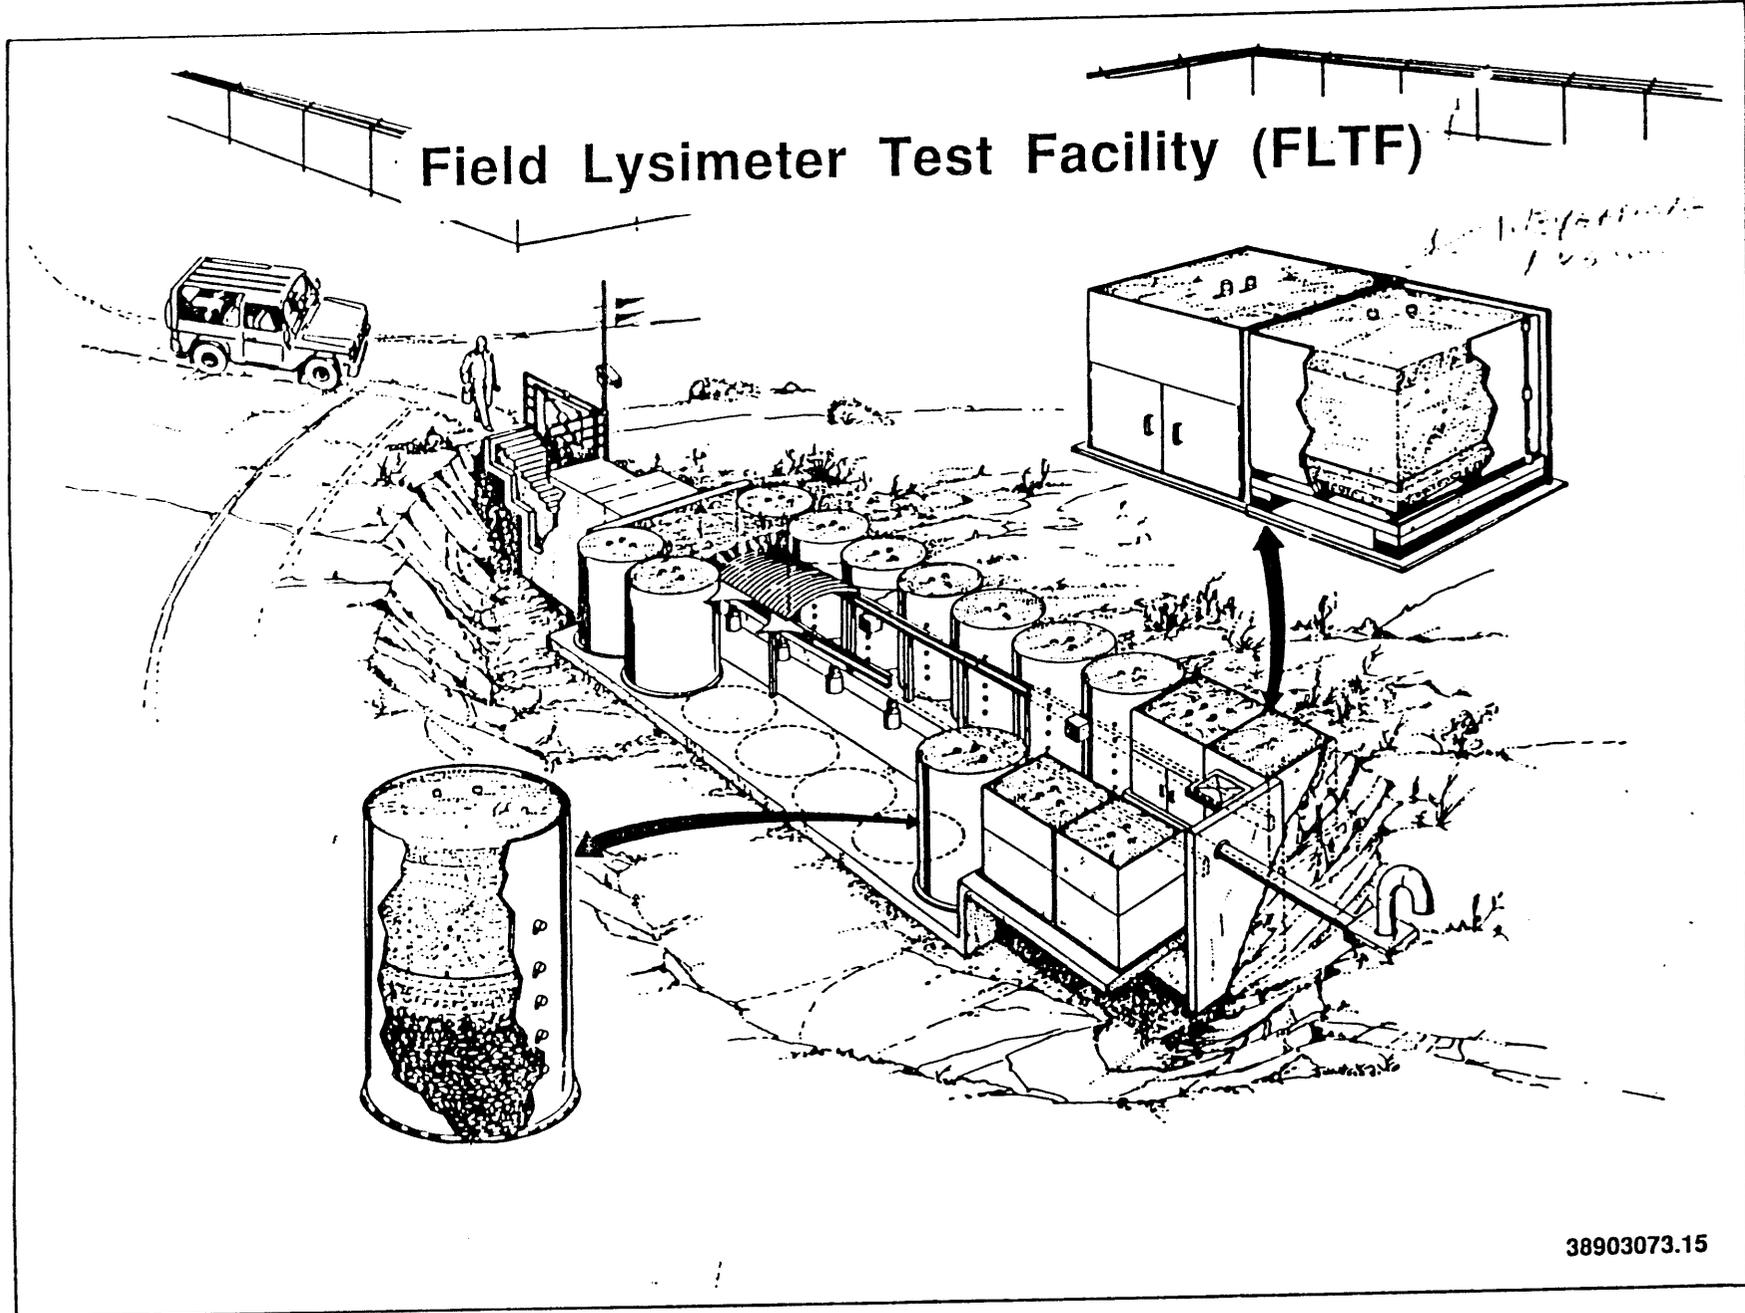
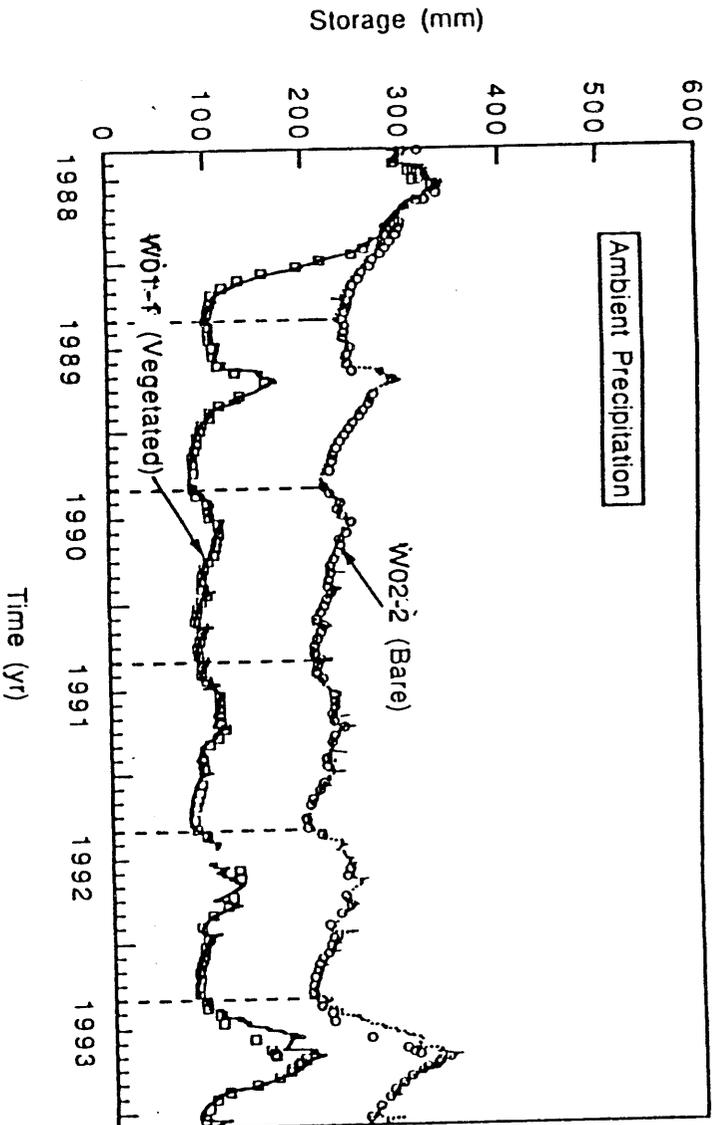
Fig 4

# Field Lysimeter Test Facility (FLTF)

The weighing lysimeters are 1.5 x 1.5 x 1.7 m and contain about 5,900 kg of soil (1.5 m deep) placed on top of about 0.2 m of sand (Fig. 4). Vegetation consists of the deep-rooted evergreen shrub *Artemisia tridentata*, the deep-rooted perennial bunchgrass *Oryzopsis hymenoides*, the shallow-rooted perennial bunchgrass *Poa sandbergii*, and the shallow-rooted winter annual grass, *Bromus tectorum*. Precipitation treatments consisted of ambient precipitation and twice ambient precipitation (~320 mm yr<sup>-1</sup>). In the last 3 years of observation, precipitation was increased to 480 mm yr<sup>-1</sup>. Scale weights are recorded every 20 s and have been recorded since November 1987. To measure drainage, these lysimeters have sloping bottoms and a drain port at the low point.

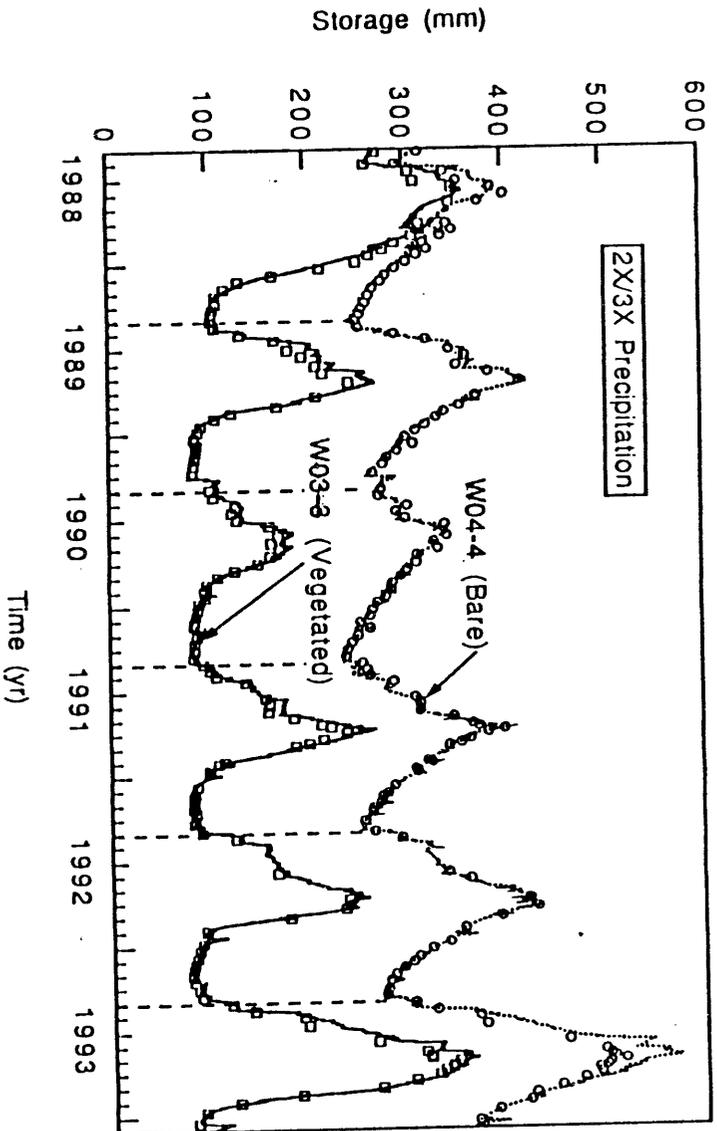
Fig 5

FIGURE 3.4. Water Storage for Weighing Lysimeters

The soil water storage dynamics of the four lysimeters from 1987 through 1993 are presented in Figure 5. All four treatments exhibit a seasonal cycle of storage with maximum storage occurring in March after

the winter rains and minimum storage occurring in October just before winter rains begin. The ambient precipitation lysimeters had the smaller seasonal amplitude compared with the irrigated lysimeters. The vegetated lysimeters had the smaller storage having minimum values near 90 mm in ambient or irrigated lysimeters. The non-vegetated lysimeters had the larger storage, which was over 200 mm over the entire period. The only period where drainage occurred was in the non-vegetated irrigated lysimeter in 1993 when storage exceeded the 500-mm level needed to cause drainage.

Vegetation plus soil evaporation is able to return at least 480 mm yr<sup>-1</sup> to the atmosphere. Water storage in the vegetated lysimeters is reduced to a unique lower limit every year, which indicates that the plants use all the water available to them. Plant biomass in the irrigated lysimeters was more than twice as great as biomass in the ambient precipitation lysimeters, which indicates that water is limiting for biomass production even with twice ambient precipitation.<sup>14</sup> A capillary break system with vegetation verifies the performance of capillary barriers for the Hanford Site even under extreme conditions.

The non-vegetated lysimeters always had more water stored in them than the vegetated lysimeters. In only one instance did drainage occur in the non-vegetated lysimeters. This occurred in the 3 times ambient precipitation treatment when the drainage limit was exceeded in February 1993. This indicates that a capillary barrier will prevent drainage under almost all worst-case scenarios for the barrier. The worst case scenario is a fire that destroys all vegetation with virtually no recovery followed by an extremely wet winter (e.g., more than 3 times ambient precipitation). This scenario is not very likely because vegetation usually

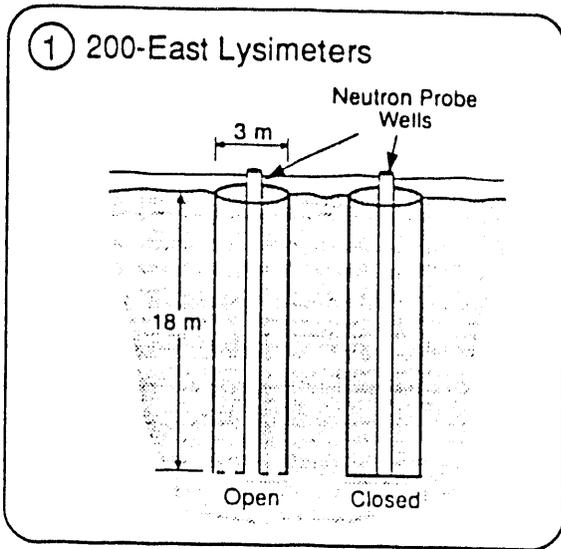
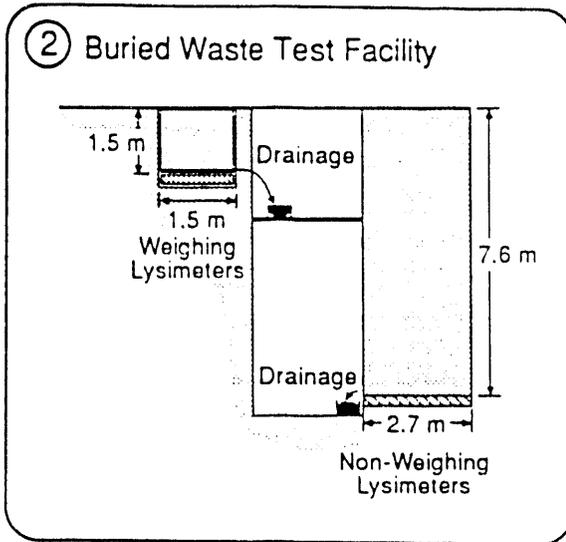
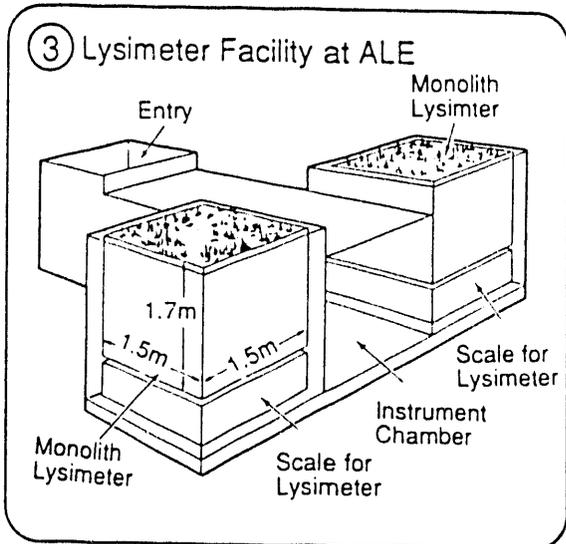
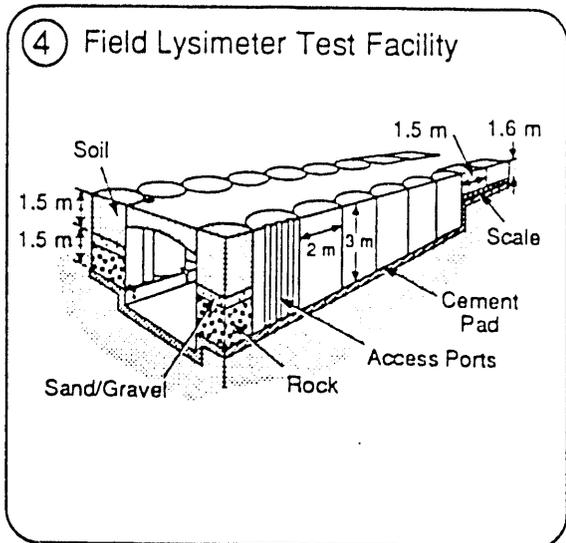
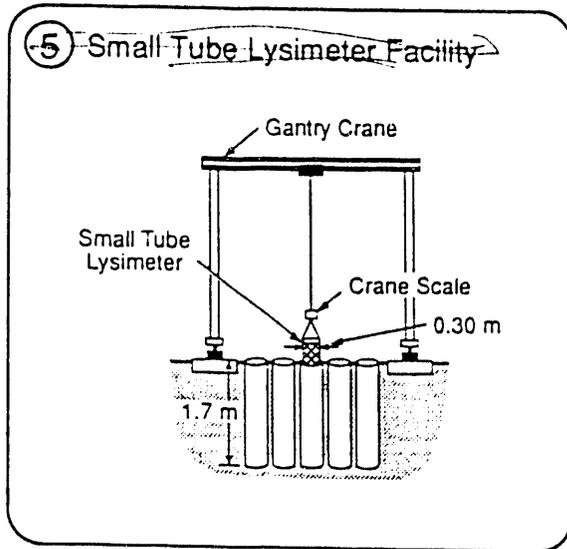
Fig  
6

Figure 2. Schematics of lysimeter facilities.  
Numbered circles are locations show on Figure 1.

The study of the effect of surface conditions on soil water storage was also done at the 200 Area Lysimeter Facility (Fig. 1) in small tube weighing lysimeters (Fig. 6). Soil water storage will be minimized if a surface gravel layer is not used and if plants are used to transpire water back into the atmosphere. We hypothesized that a gravel layer on the surface would eventually result in drainage through the capillary break, and that plants would minimize soil water storage. Because the environment where the barrier is to be built has high winds that could cause loss of fine surface soils, we observed the effect that an admixed surface (gravel mixed into the fine soil) would have on water budgets. Admixes lead to a surface armor development that reduces wind erosion.<sup>21</sup> Finally, because of high winds, it was hypothesized that dune formation or a sand on top of the barrier would increase soil water storage.

The small-tube lysimeter facility consists of an array of 21 rows of 5 lysimeters (Fig.6). The lysimeters are 170 cm long by 30 cm wide sections of plastic pipe. The bottom ends are fitted with a cap and a drain port. The lysimeters are placed in larger plastic pipe sleeves. Weighing

is done with a calibrated load cell attached to the gantry. Weighing and drainage measurements were taken monthly from December 1988 through August 1992. The lysimeters were filled with Warden silt loam overlying a capillary break consisting of sand on top of gravel. The surface treatments consisted of soil, an admix of gravel (30% by weight) in the top 20 cm of soil, gravel, and sand. These treatments were tested with and without vegetation and with and without additional water.
