# 100-D Area Technical Baseline Report

Prepared for the U.S. Department of Energy  
Office of Environmental Restoration and  
Waste Management

**Westinghouse**  
**Hanford Company** Richland, Washington

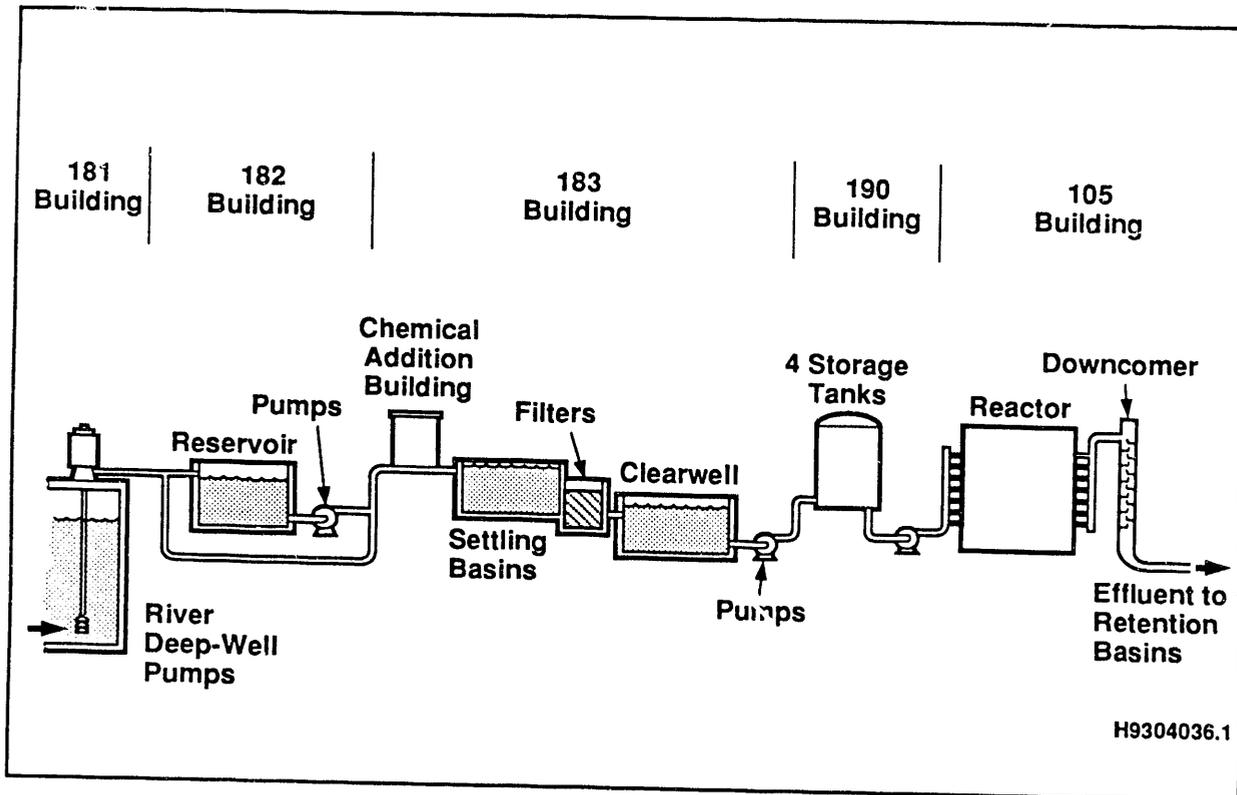
Figure 2-4. Typical Water Treatment System.

A continuous supply of high-quality cooling water was essential to reactor operations. It prevented reactor core damage from heat generated by the fission reactions. Many of the 100-D Area facilities were part of this cooling water system. At a daily use rate of 148-204 million gallons, this system generated the largest liquid waste volume in the 100-D area (Figure 2-4).

Water obtained from the Columbia River was extensively treated before passing through the reactors. Settling, chemical treatment, filtering, pH management, and refrigeration were utilized to purify and prepare the water. It then circulated in a single pass through the reactor process tubes, cooling tubes imbedded in the thermal shield, and reactor horizontal control rods. The cooling water exiting the reactors contained radioactive species from the fission process reactors, activated products from impurities in the water, and chemical contaminants added to treat the raw water before use. After exiting the reactors, the cooling water passed through retention basins and was discharged through outfall structures to the center of the river via large steel pipes embedded in the river bottom.

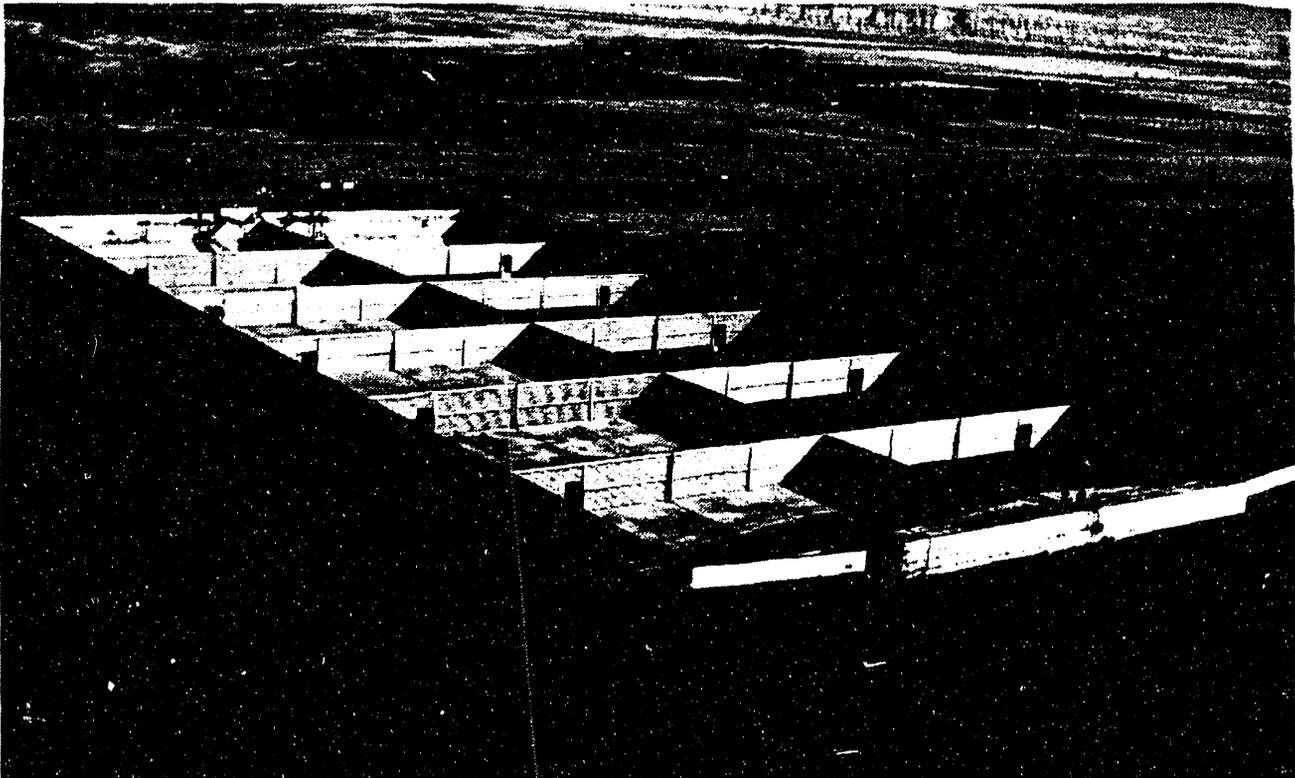
Figure 2-6. 107-DR Retention Basin, 1948.

- Open emergency dump trenches were used beginning in 1950. The highly contaminated water was segregated and drained to the 116-DR-1 basin trench via a 24-in.-diameter steel pipe that connected the basin outlet with the west end of the trench (PNL 1991). The retention basins were, by construction, divided into two compartments. When a fuel cladding failure occurred, the highly contaminated water was diverted into one of the two compartments. It was then drained to the emergency dump trench. This practice continued on a regular basis until 1954 when increased flows and structural stresses on the basins due to the temperature differences between the full and empty sides necessitated that both sides of the basin be used at the same time. The change to parallel operation in virtually marked the end of "cribbing" rupture effluent (Dorian and Richards 1978) (Figure 2-6).

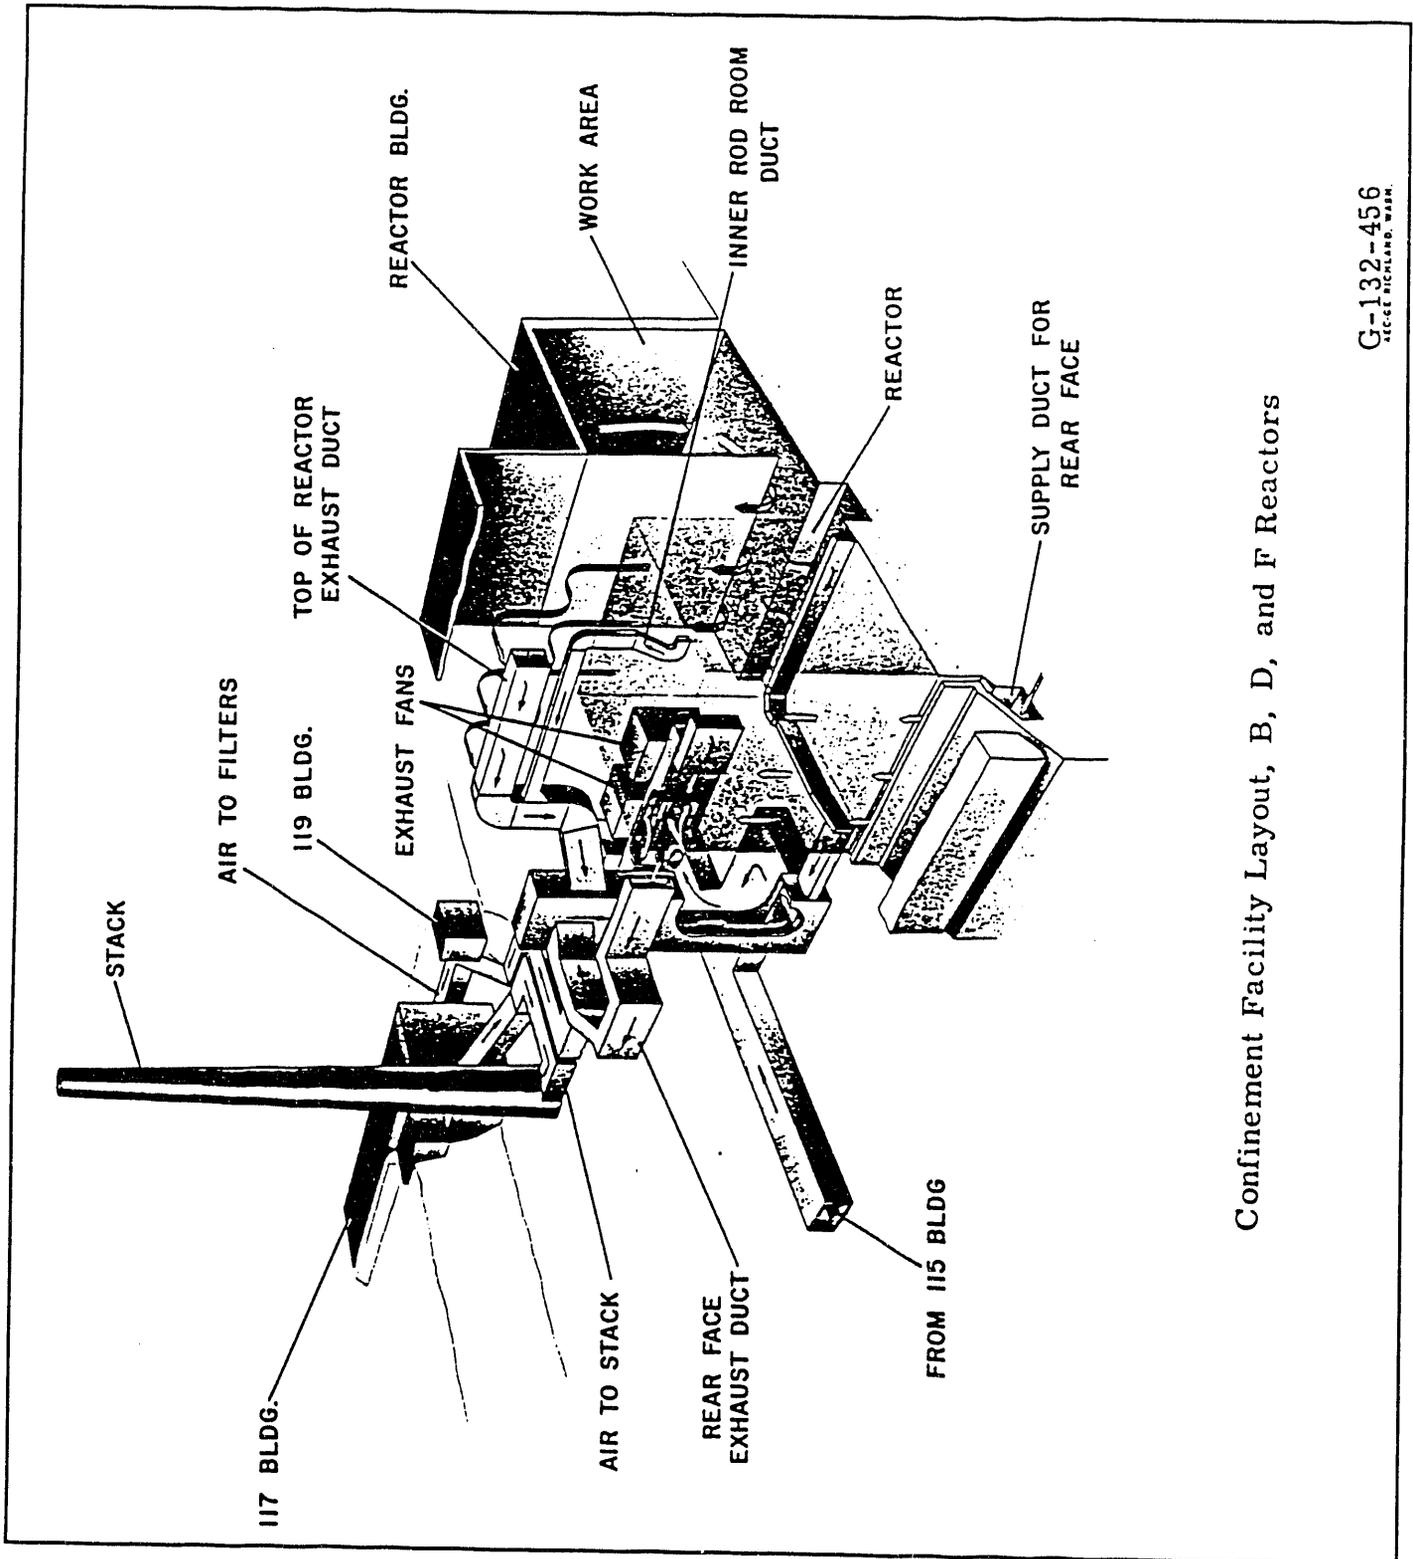
Figure 2-9. Typical Confinement Facility Layout.

Confinement Facility Layout, B, D, and F Reactors

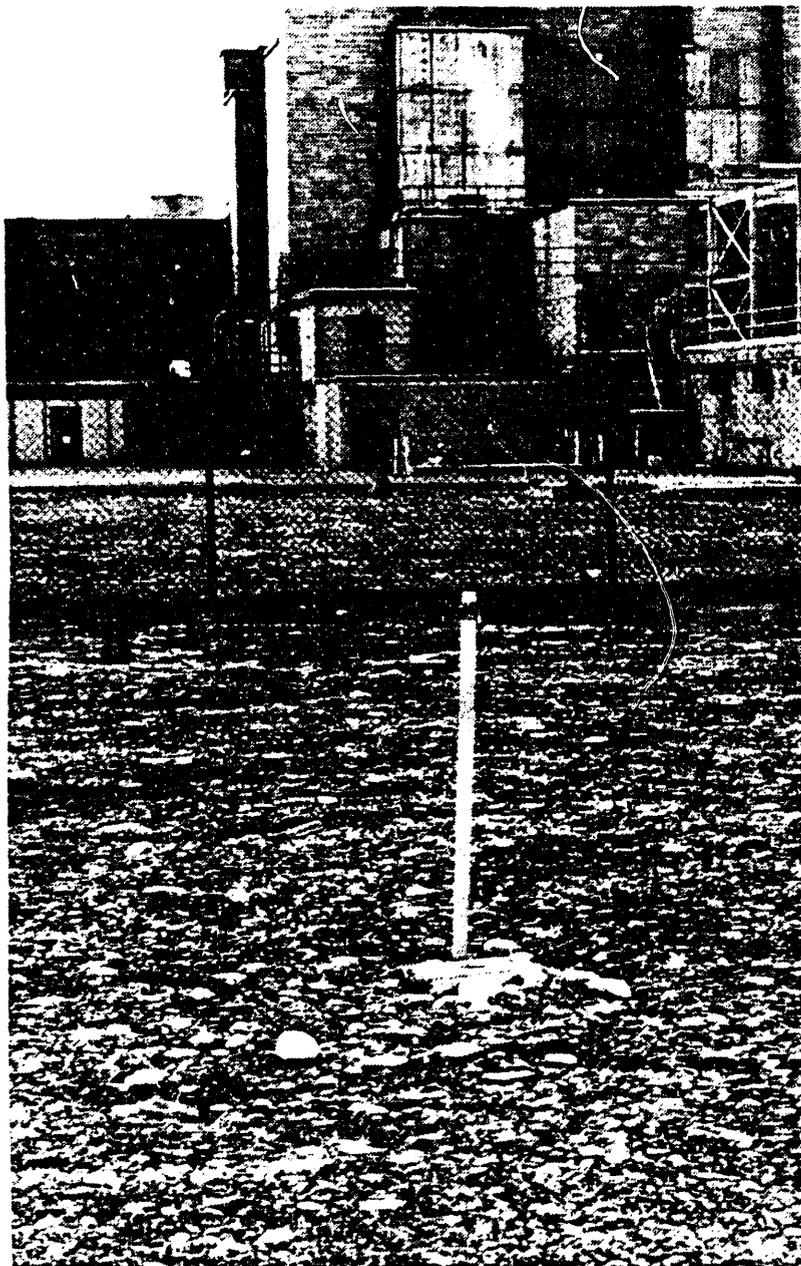
Figure 4-8. 108-D French Drain #2.

There is some conflicting data concerning this french drain. Heid (1956) reports that the crib was dug in 1951 and was covered by 8 ft of soil. Stenner et al (1988) reports its location as Hanford coordinates N92300 W52620.

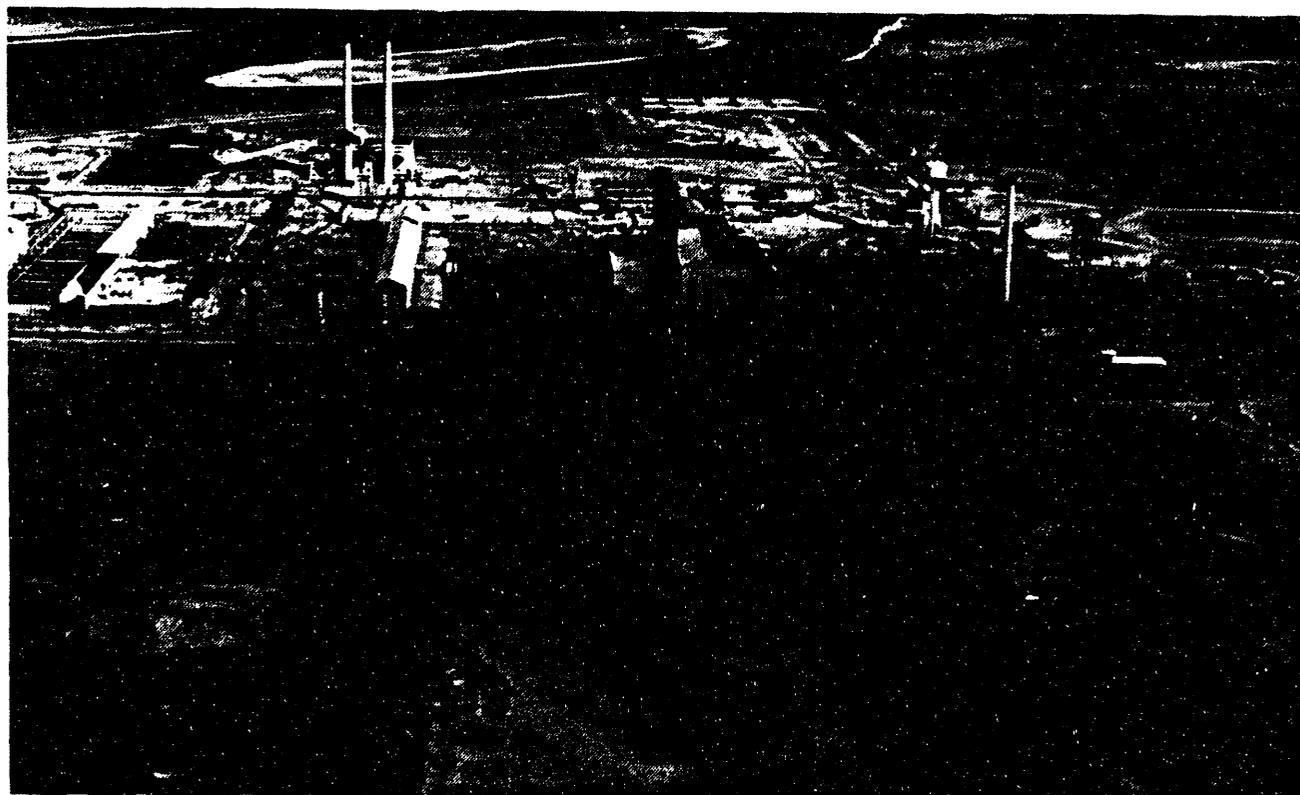
Figure 4-13. 100-D Area, 1944,  
Retention Basins.

Radionuclide inventories of samples taken in the vicinity of the basin ranged from 5 to over 400 Ci. Seventy percent of the total received inventory is contained within the soil adjacent to the basin (WHC 1991). Underground contamination is greatest at the north and east sides from past leakage; measurable contamination is confined to within 100 ft of the north wall and 25 ft of the other walls. Sample holes indicate that contamination beneath the floor of the basin is confined to within 6 ft of the basin floor. Approximately 10 Ci have leached into the concrete floor and walls (Dorian and Richards 1978).

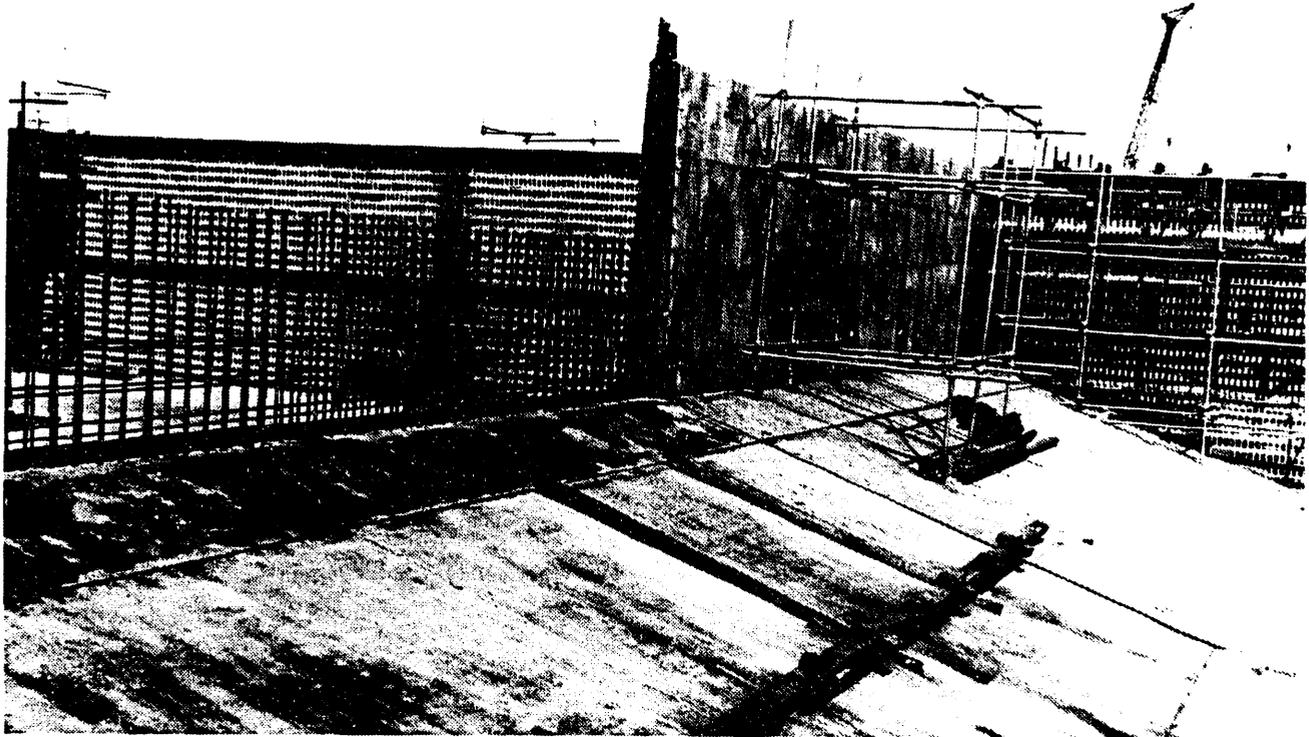
Figure 4-21. 107-DR Retention Basin Construction.

The walls sloped from the floor to a point 10 ft above the floor level with the remaining wall (about 10 ft) being vertical. The sloping wall sections were 4 in. thick, and the vertical walls were reinforced concrete with a minimum thickness of 1 ft at the top and 5.75 ft at the bottom. Each side of the basin was divided into six sections, separated by baffle walls constructed of concrete and concrete blocks set on their sides. The purpose of these baffles was to slow and control channeling of the reactor cooling effluent water to maximize cooling and decay of short lived radioisotopes prior to release to the Columbia River (Figures 4-21 and 4-22).

Total radionuclide inventories of samples taken in the vicinity of the basin ranged from 5 to over 400 Ci. Seventy percent of the total radionuclide inventory is contained in the soil adjacent to the basin. The remaining inventory (approximately 10 Ci) is contained in the demolished concrete walls and floor.

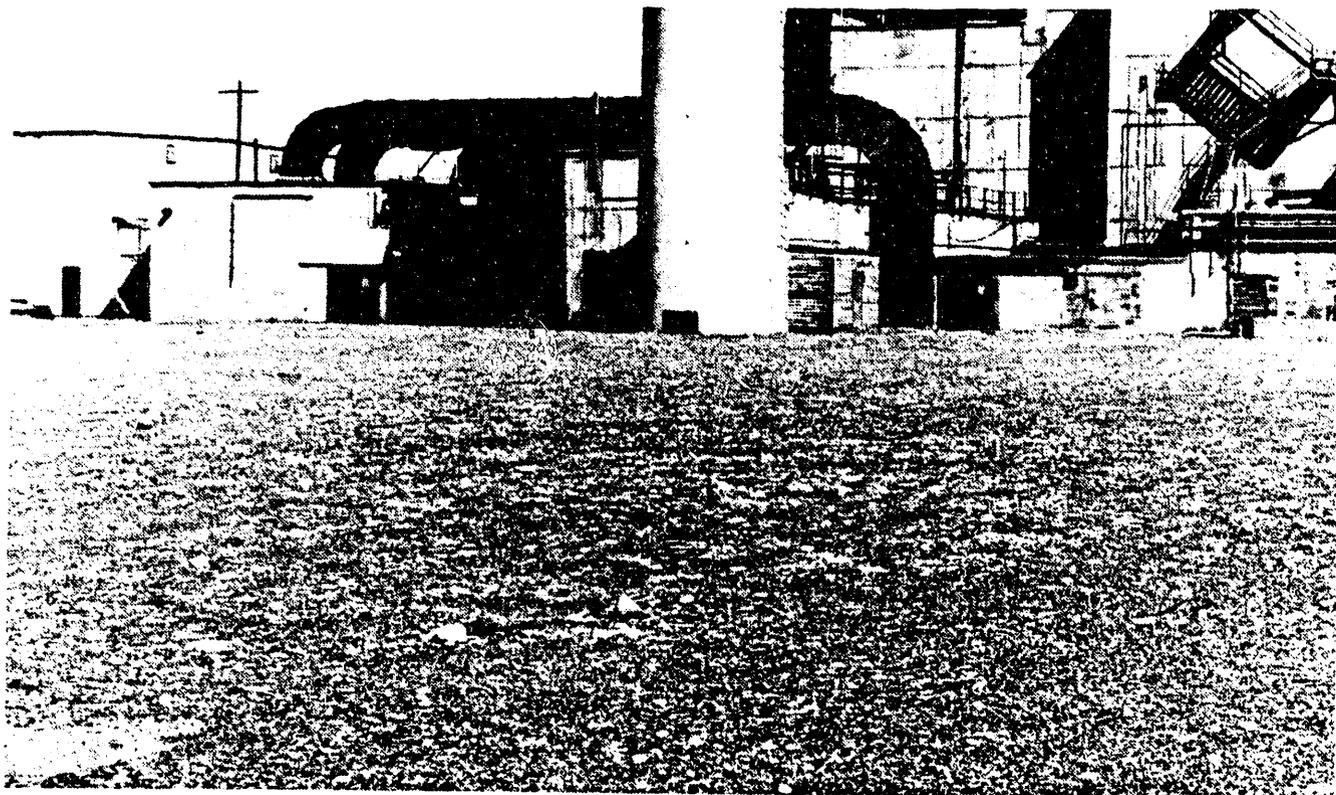
Figure 4-36. 115-D/DR Gas Recirculation Facility.

1964 post deactivation surveys indicated maximum smearable contamination on the internal surfaces of the DR gas tunnel to be 5,000 c/m. The maximum dose rate observed was 30 mrad/hr including 5 mR/hr at 4 in. from the drain trough. No decontamination other than general housekeeping and flushing down with water was attempted (Winship 1965).

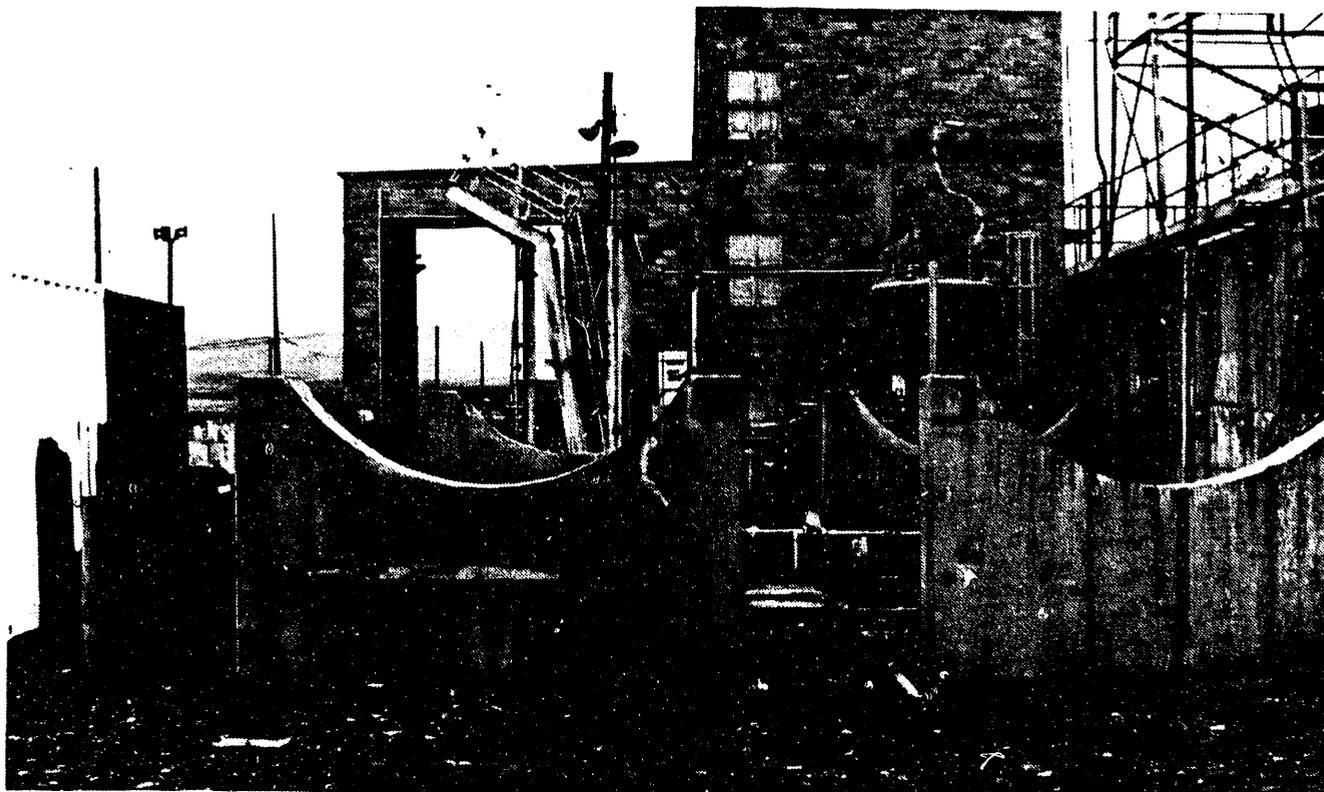
Figure 4-62. Acid Tank Cradles and Drain Trench Near 192-D.

After making the sodium dichromate, the mixing tank facilities and, when otherwise needed, the sodium dichromate system, were cleaned and drained through the building drain to the process sewer and to the river via the 1904-D outfall.

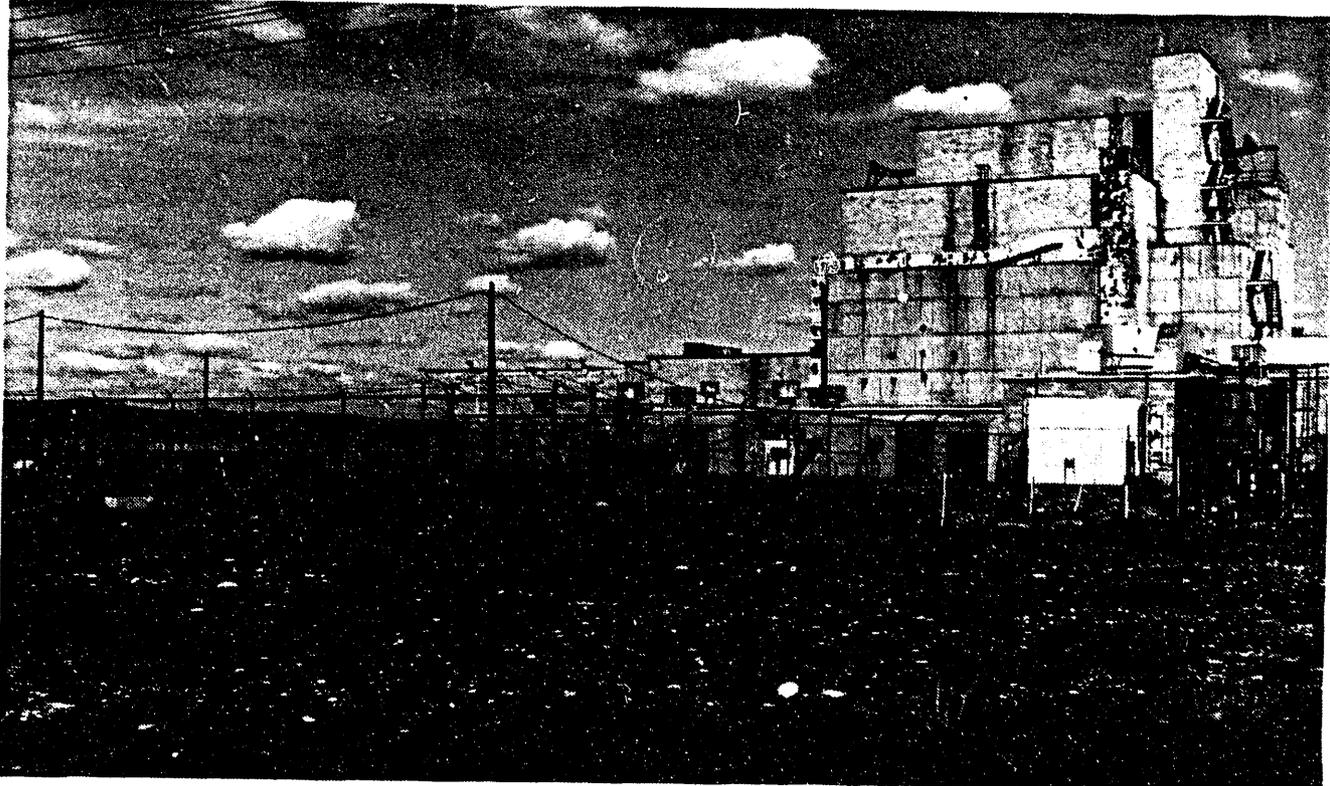
Figure 5-2. 100-D Cask Pad, Early 1993.

Located to the rear of the pad (west side) are two concrete support structures. They once supported a small hoist attached to the construction facility that was located at the site during construction of the DR Reactor.

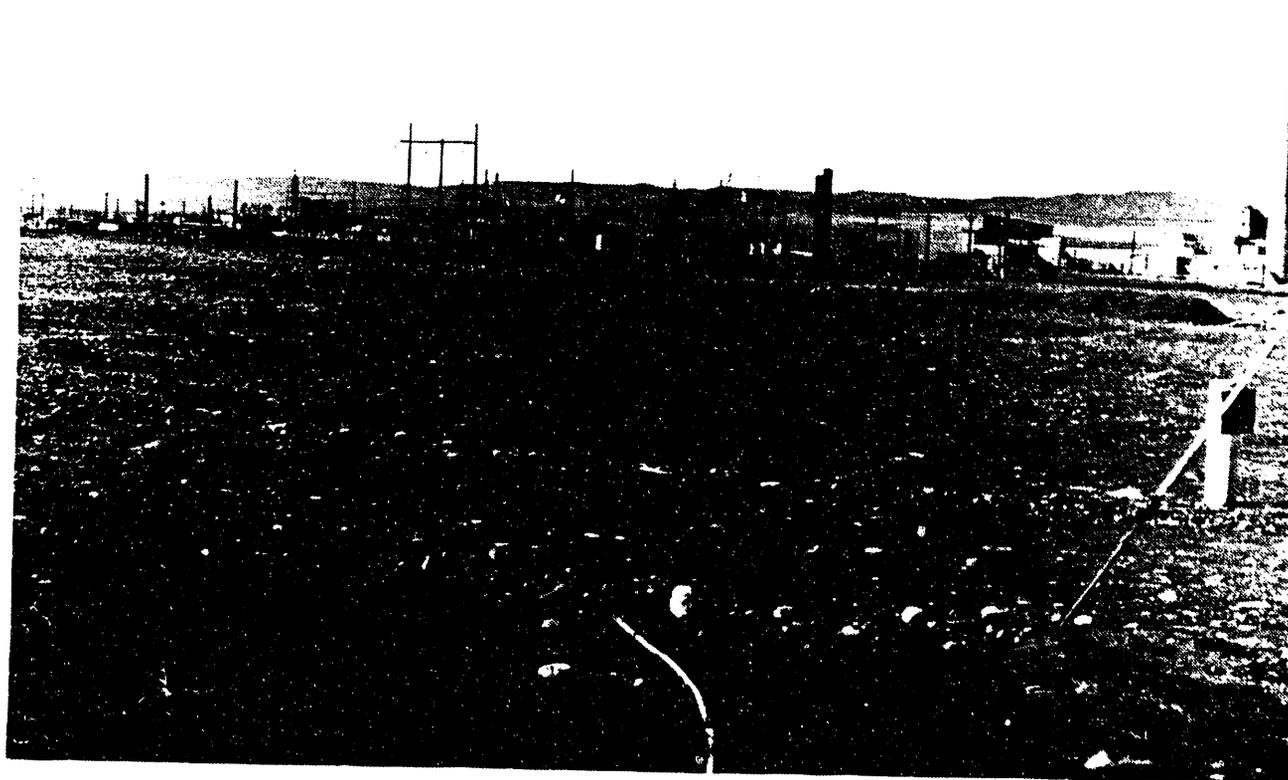
Figure 6-2. 100-D Area Burial Ground Number One.

The area appears today as a vegetation-free, cobble-covered field. It is bordered by permanent concrete markers and is posted with Underground Radioactive Material warning signs. The western section of the site is elevated about 2 ft above the rest of the area. A terraced dirt mound, located in the southeast corner of the site, was constructed prior to 1987 as part of a feasibility study for the revegetation of burial grounds. It was terraced to determine the minimum soil depth required to sustain plant growth. Currently the 118-D-1 and mound are treated annually with defoliants (Figure 6-2).

The site contained many trenches running east-west and five disposal pits. The trenches are 66 ft wide at the surface, 20 ft wide at the bottom, and 20 ft deep. Each site is composed of two small pits, constructed with railroad ties, with interior dimensions of about 6 by 6 ft, placed within an excavation 24 by 24 ft deep. All were covered with 6 ft of soil.

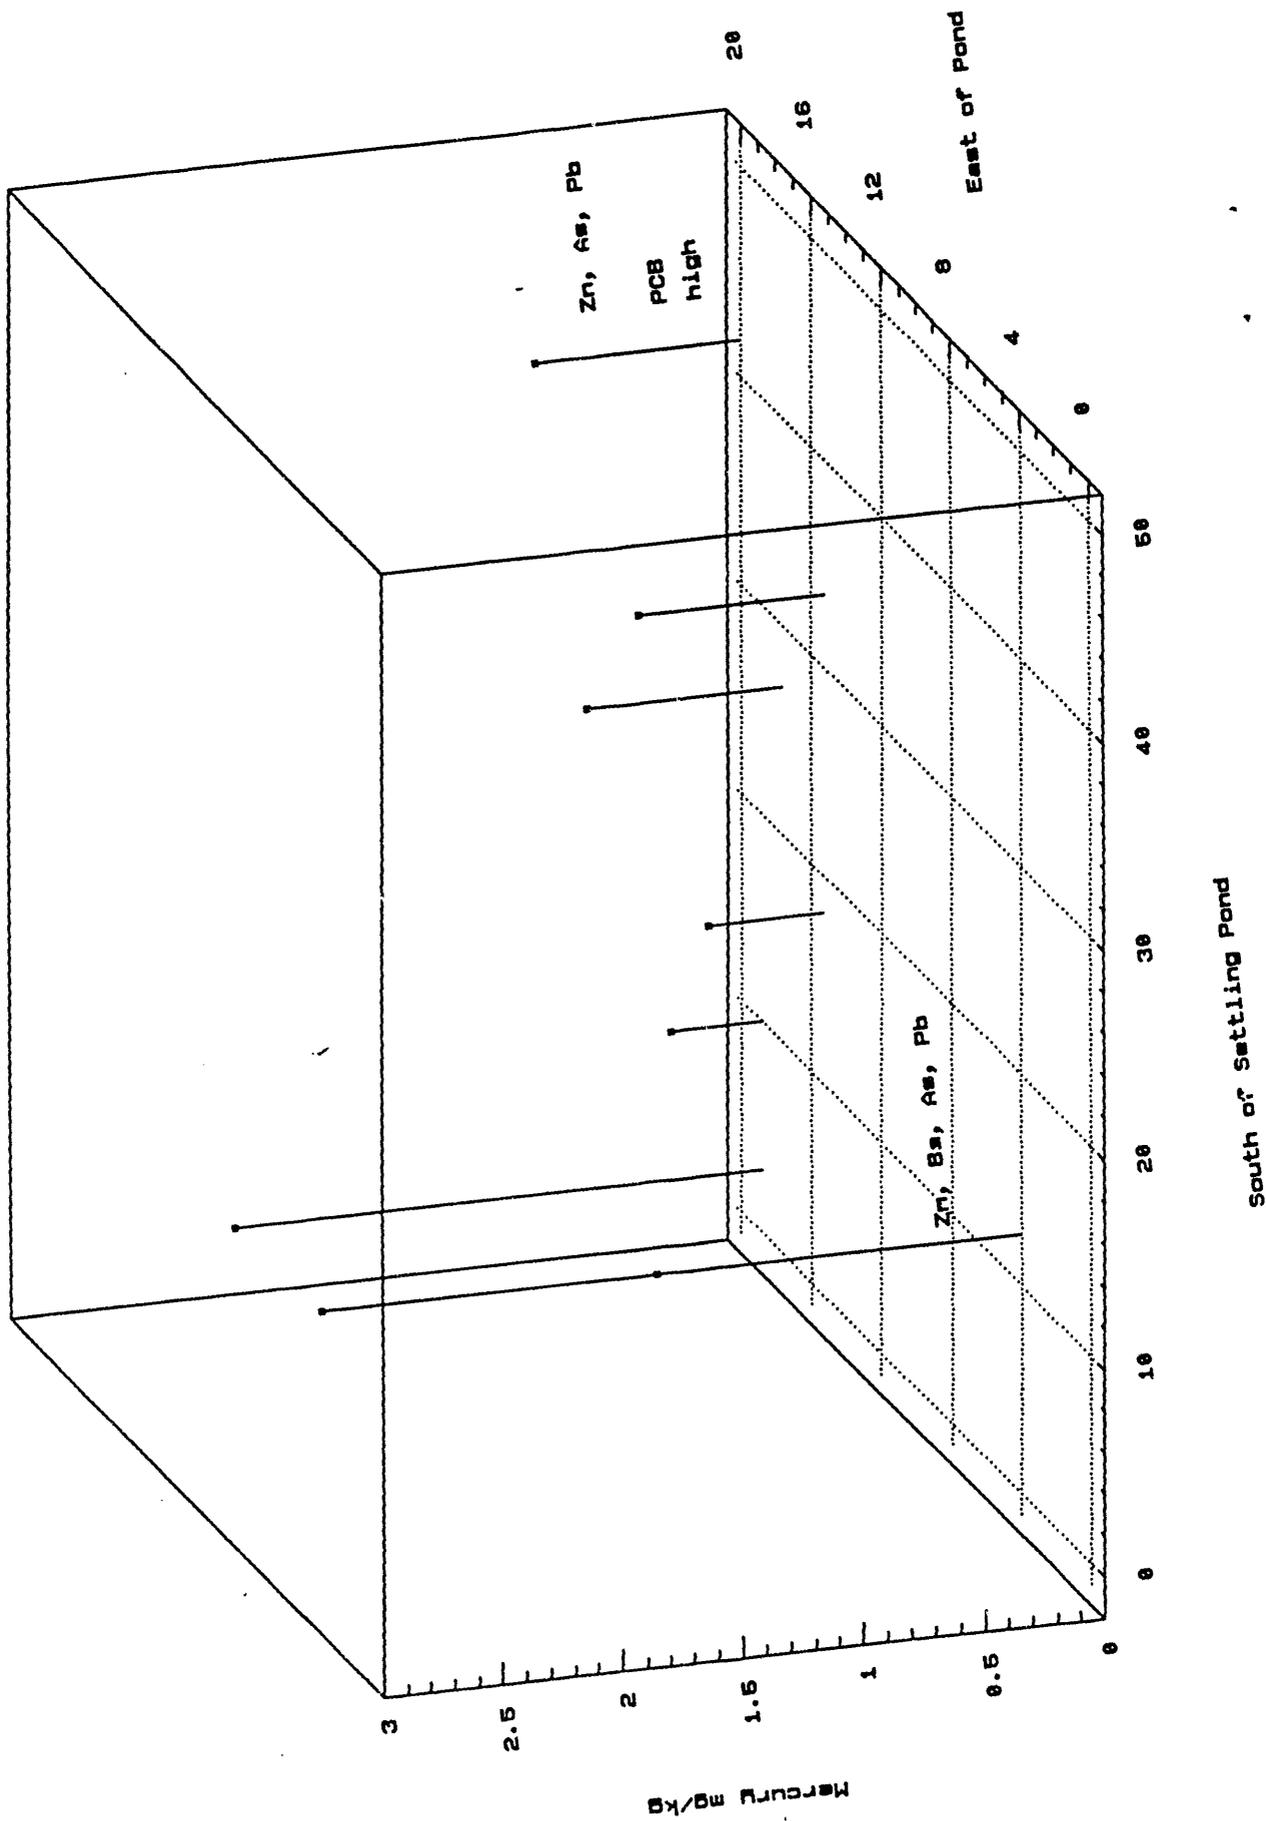
Plot of Mercury Above Background in  
100-D Settling Pond

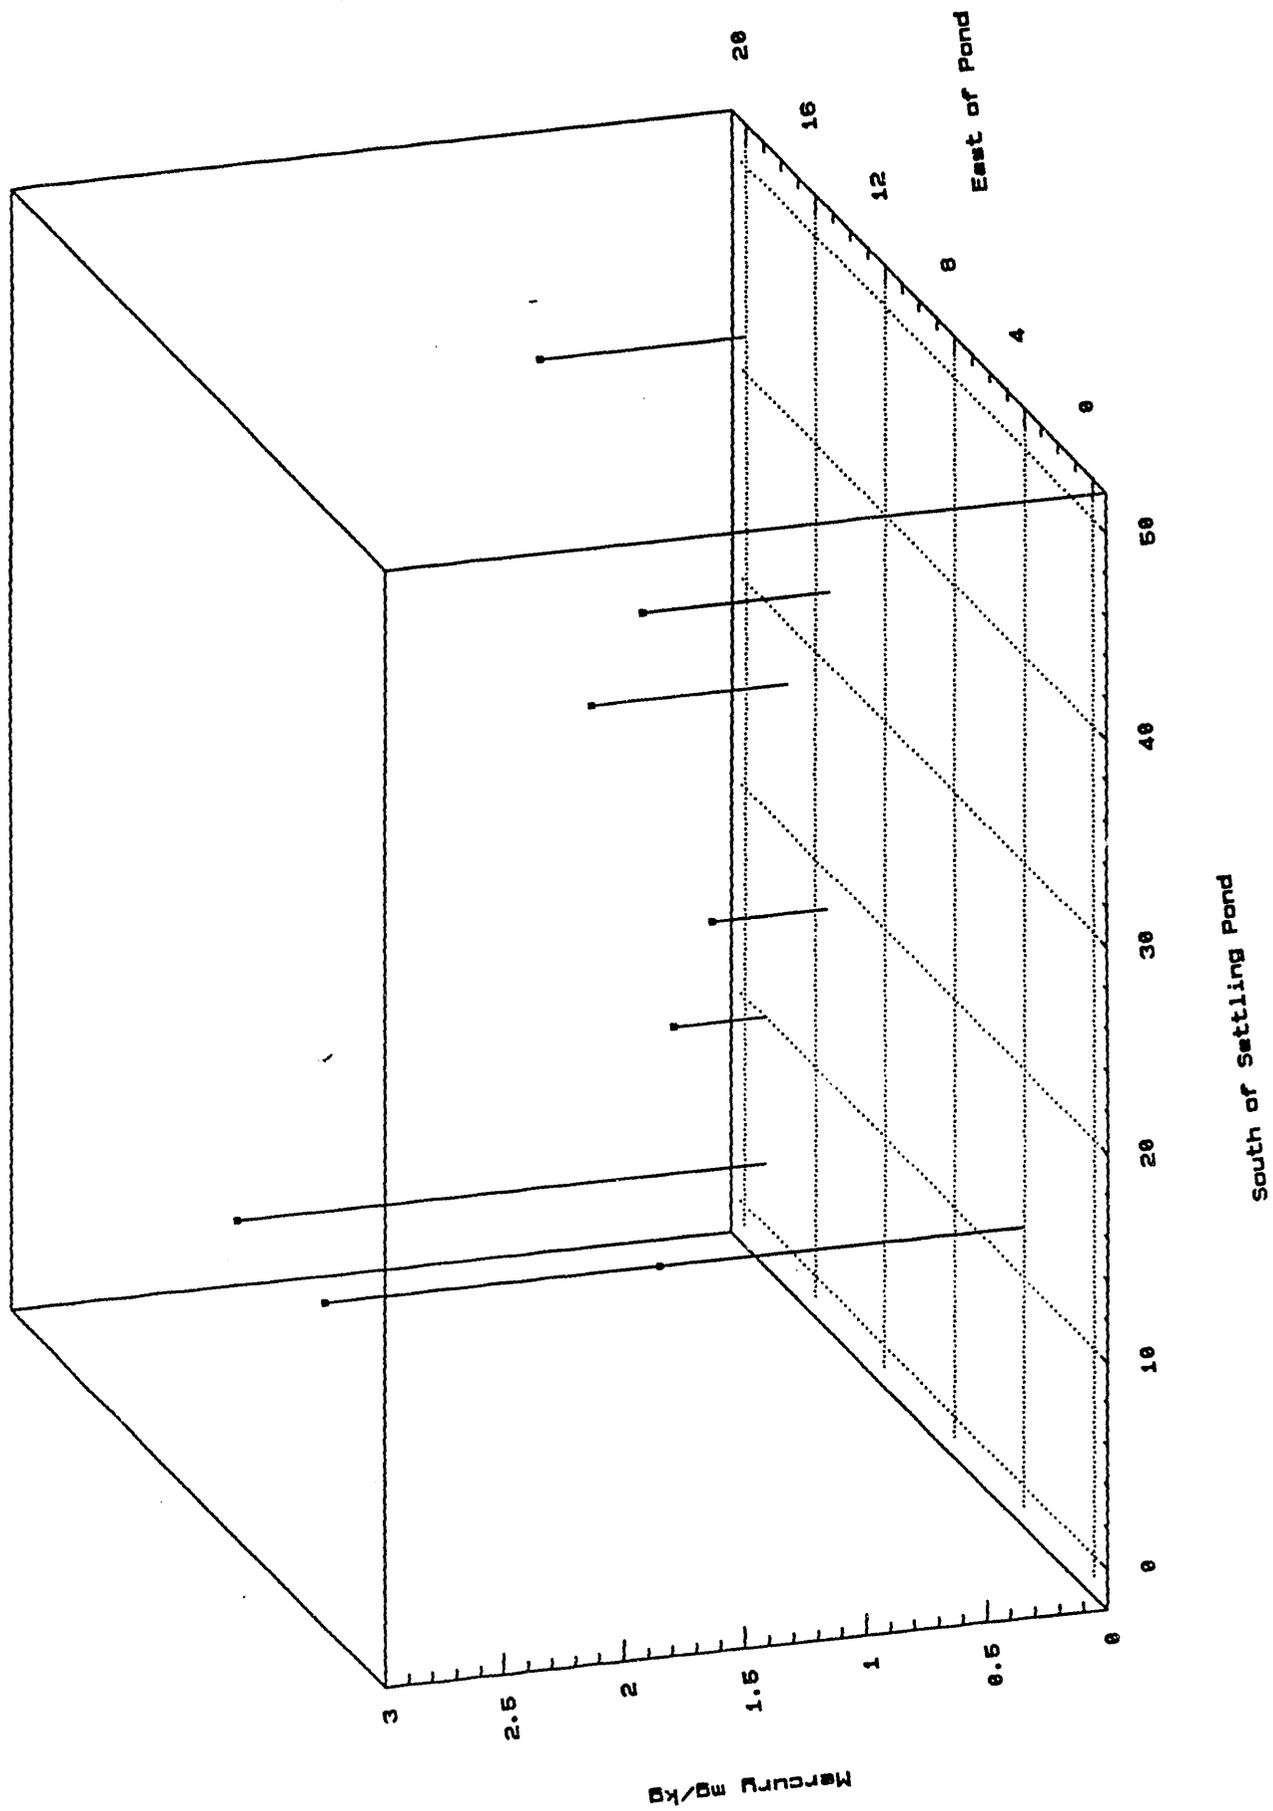
Plot of Mercury Above Background in  
100-D Settling Pond
