PNL-8829
UC-520

**LARGE-BREAK LOCA, IN-REACTOR
FUEL BUNDLE MATERIALS TEST MT-6A**

October 1989 - Completion Date
September 1993 - Publication Date

Pacific Northwest Laboratory
Richland, Washington 99352

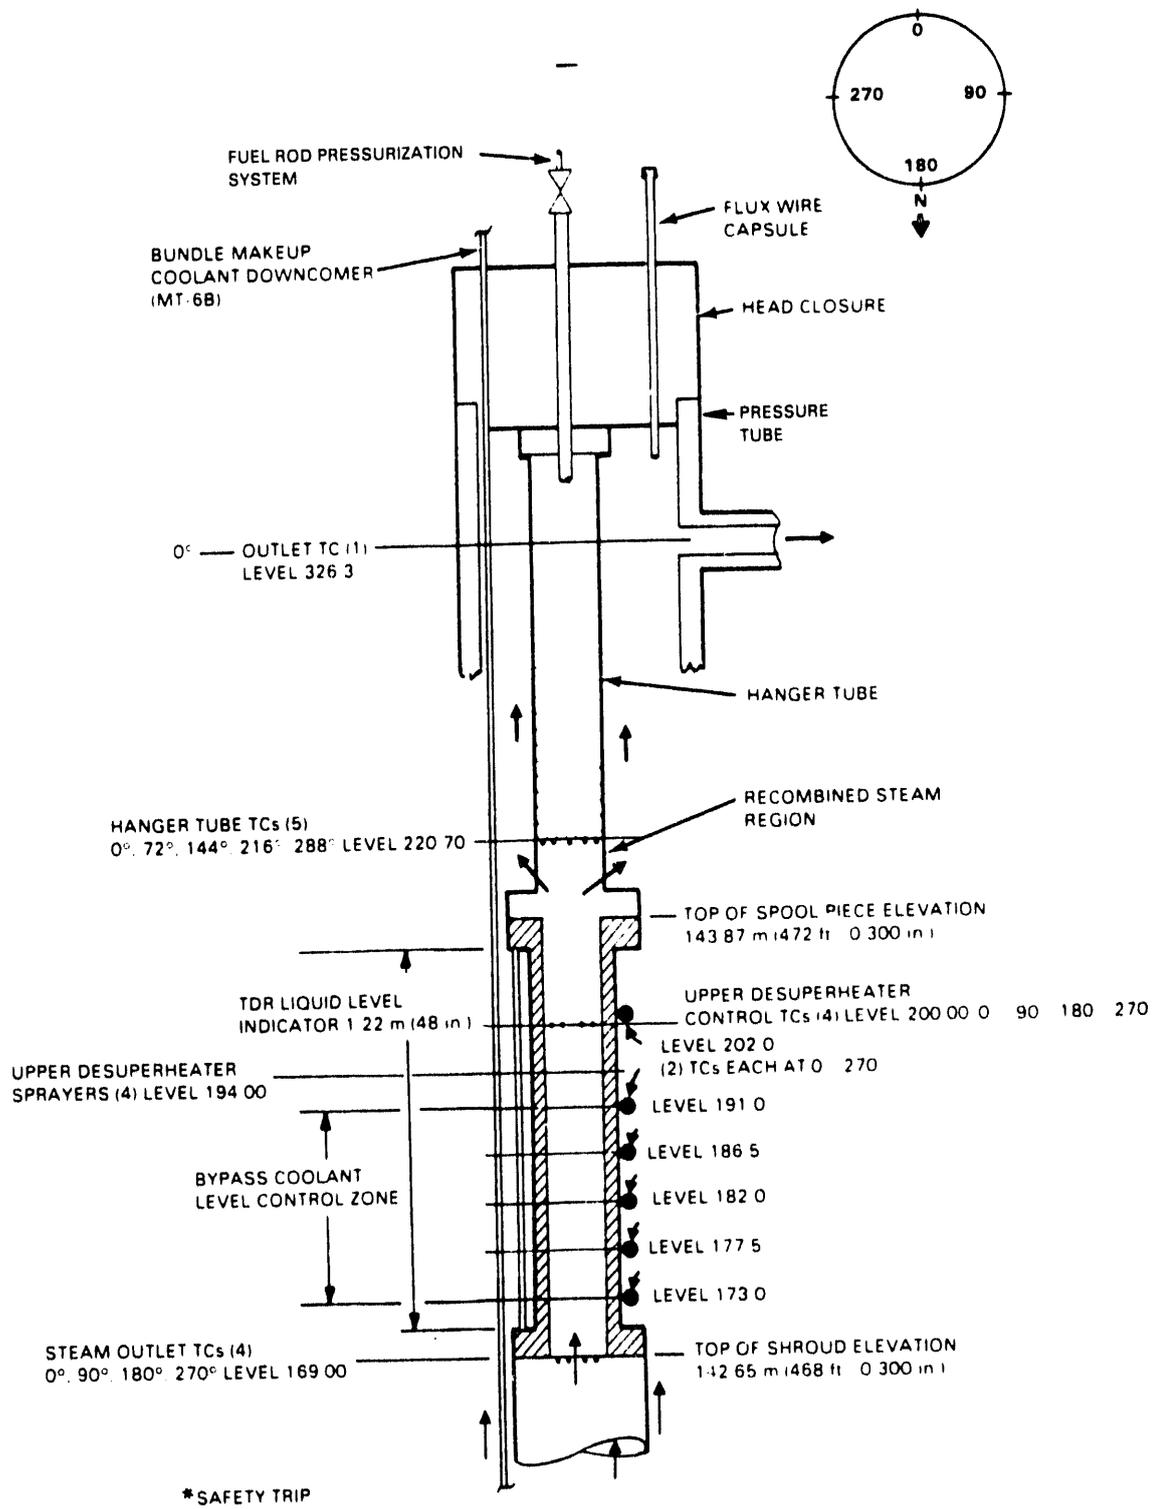
FIGURE 1. Closure, Pressure Tube, and Hanger Tube Assembly for MT-6A and MT-6B, Upper Longitudinal Section. (Levels are inches above the fuel bundle bottom tie plate.)

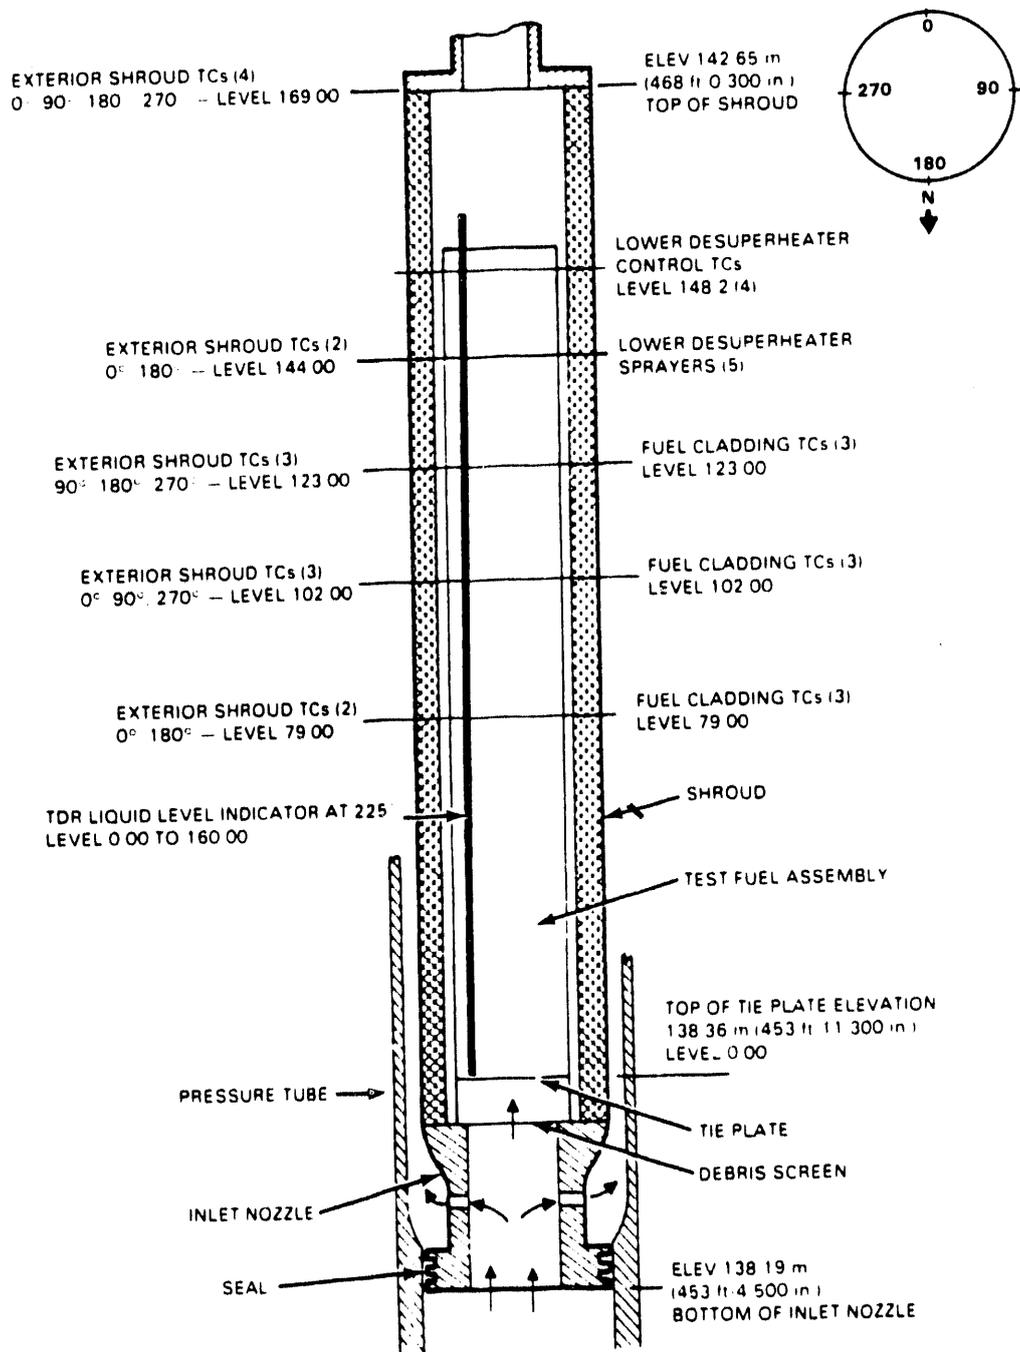
FIGURE 2. MT-6A Pressure Tube with Insulating Shroud and Test Fuel Assembly, Lower Longitudinal Section. (Levels are inches above the fuel bundle bottom tie plate.)

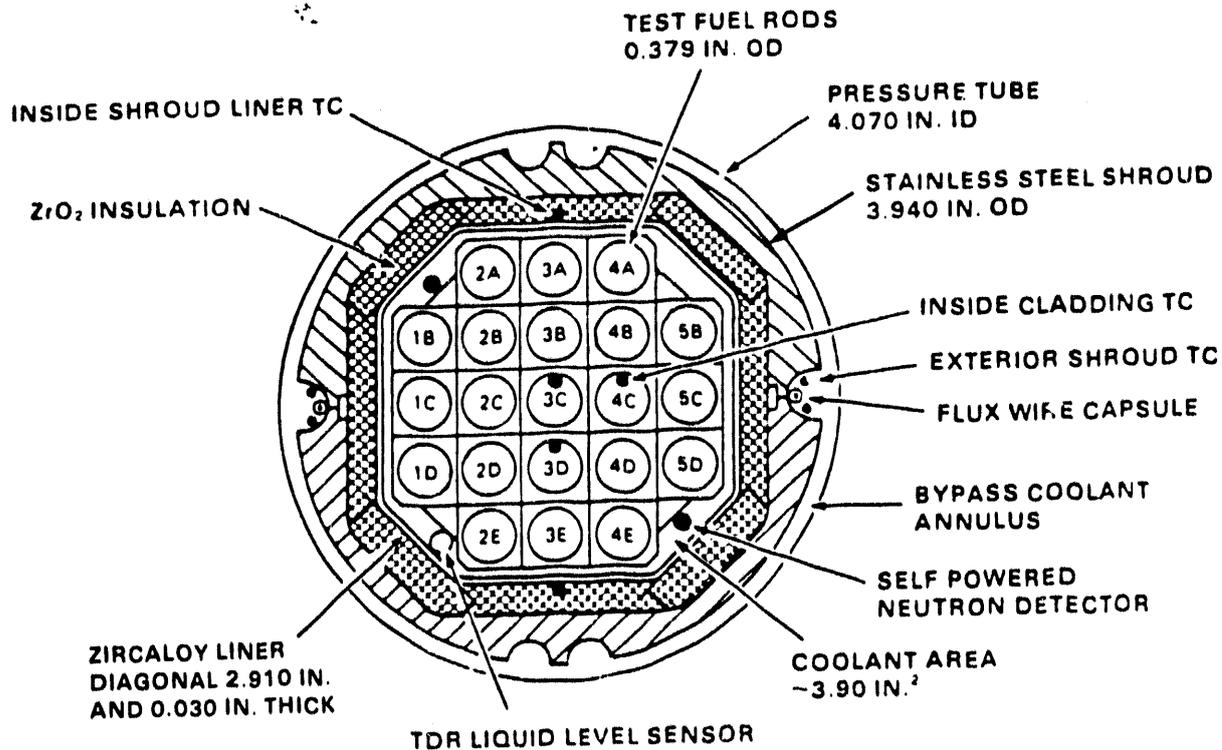
FIGURE 4. MT-6A Test Assembly Cross Section

The fuel assembly consisted of a 5 x 5 segment of a 17 x 17 PWR fuel assembly with the four corner rods removed (Figure 4) and provided a basic fuel bundle array of 21 rods (see Table 1). All rods were pressurized just before the transient test. A helium fill pressure of 6.03 MPa (875 psia) at 295K (70°F) was used. The prepressurization provided the necessary internal cladding stresses to cause test rod rupture in the desired temperature range.

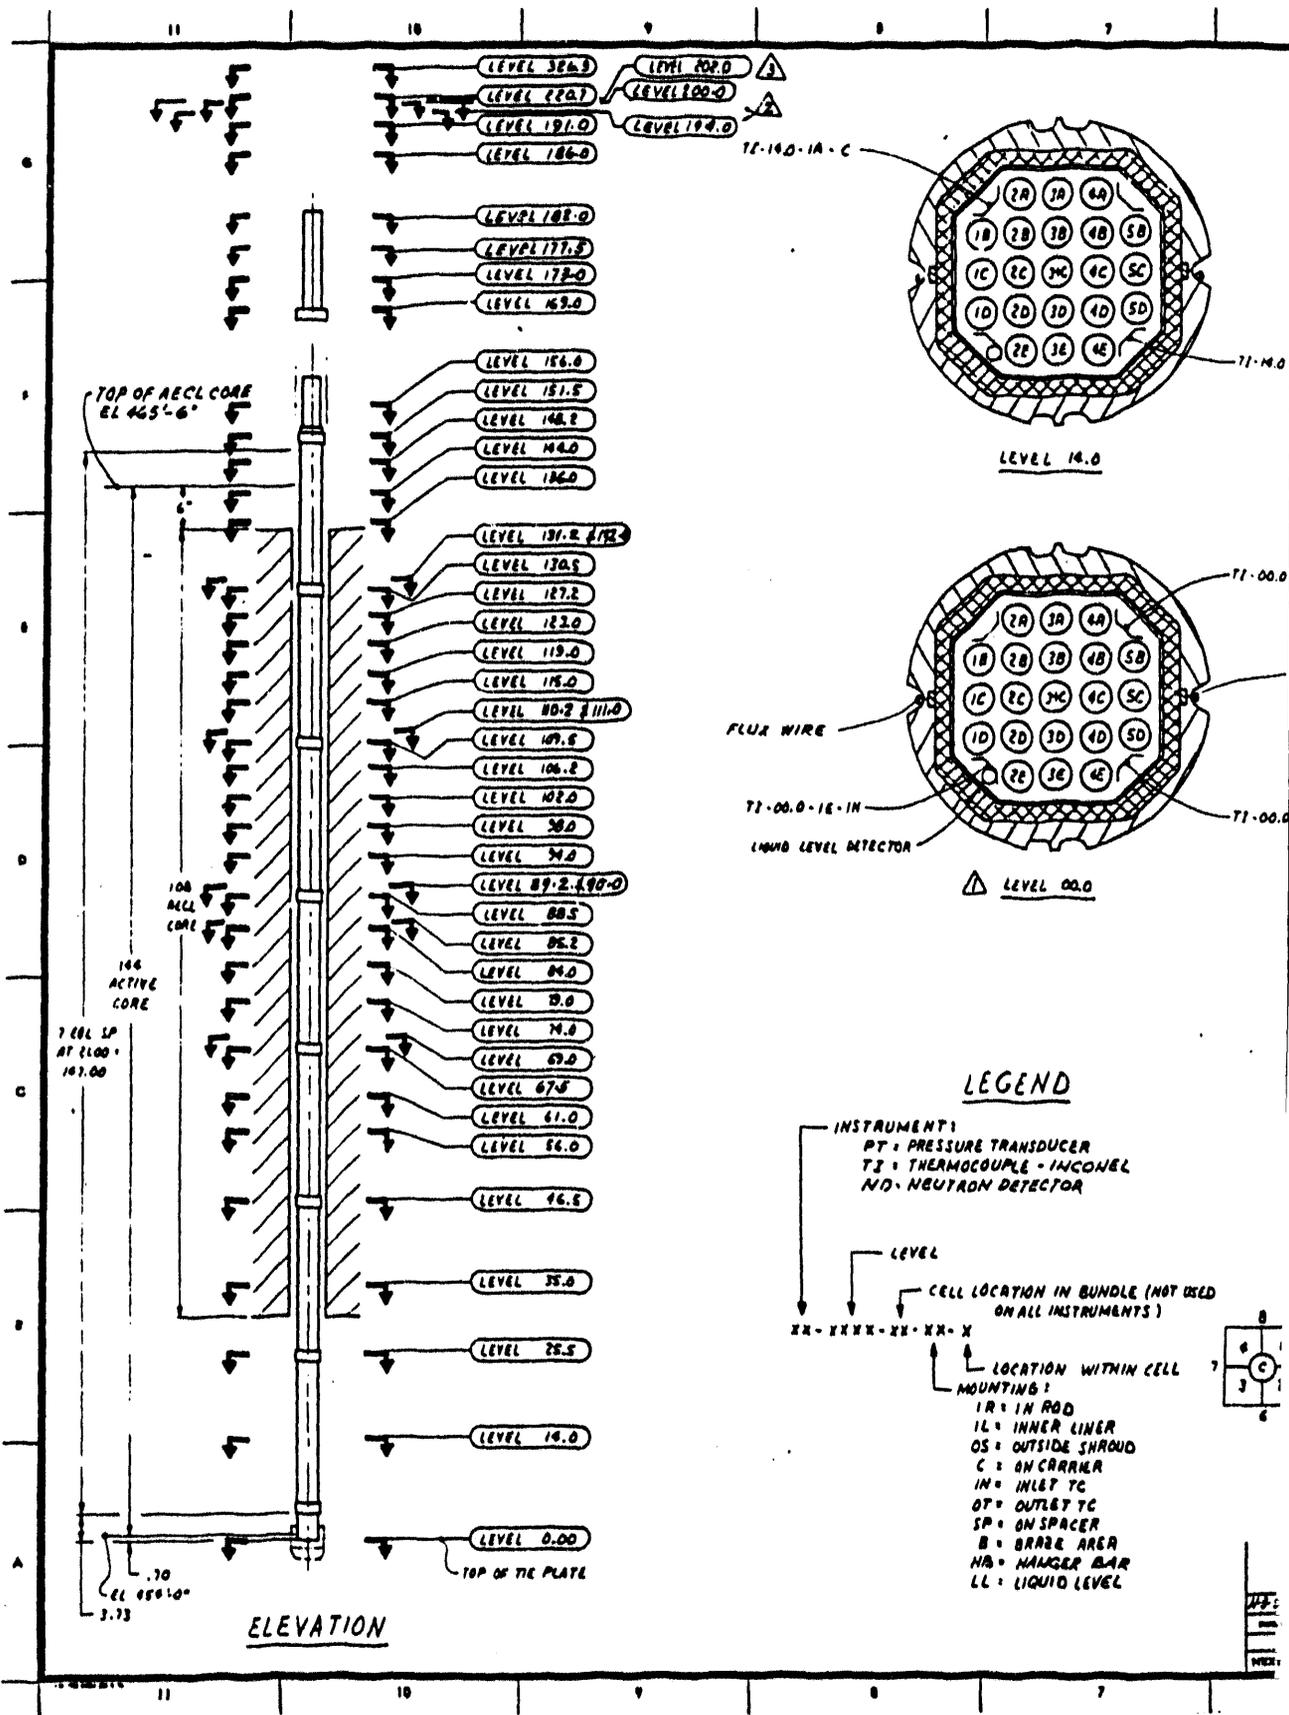
FIGURE 5. MT-6A Instrumentation

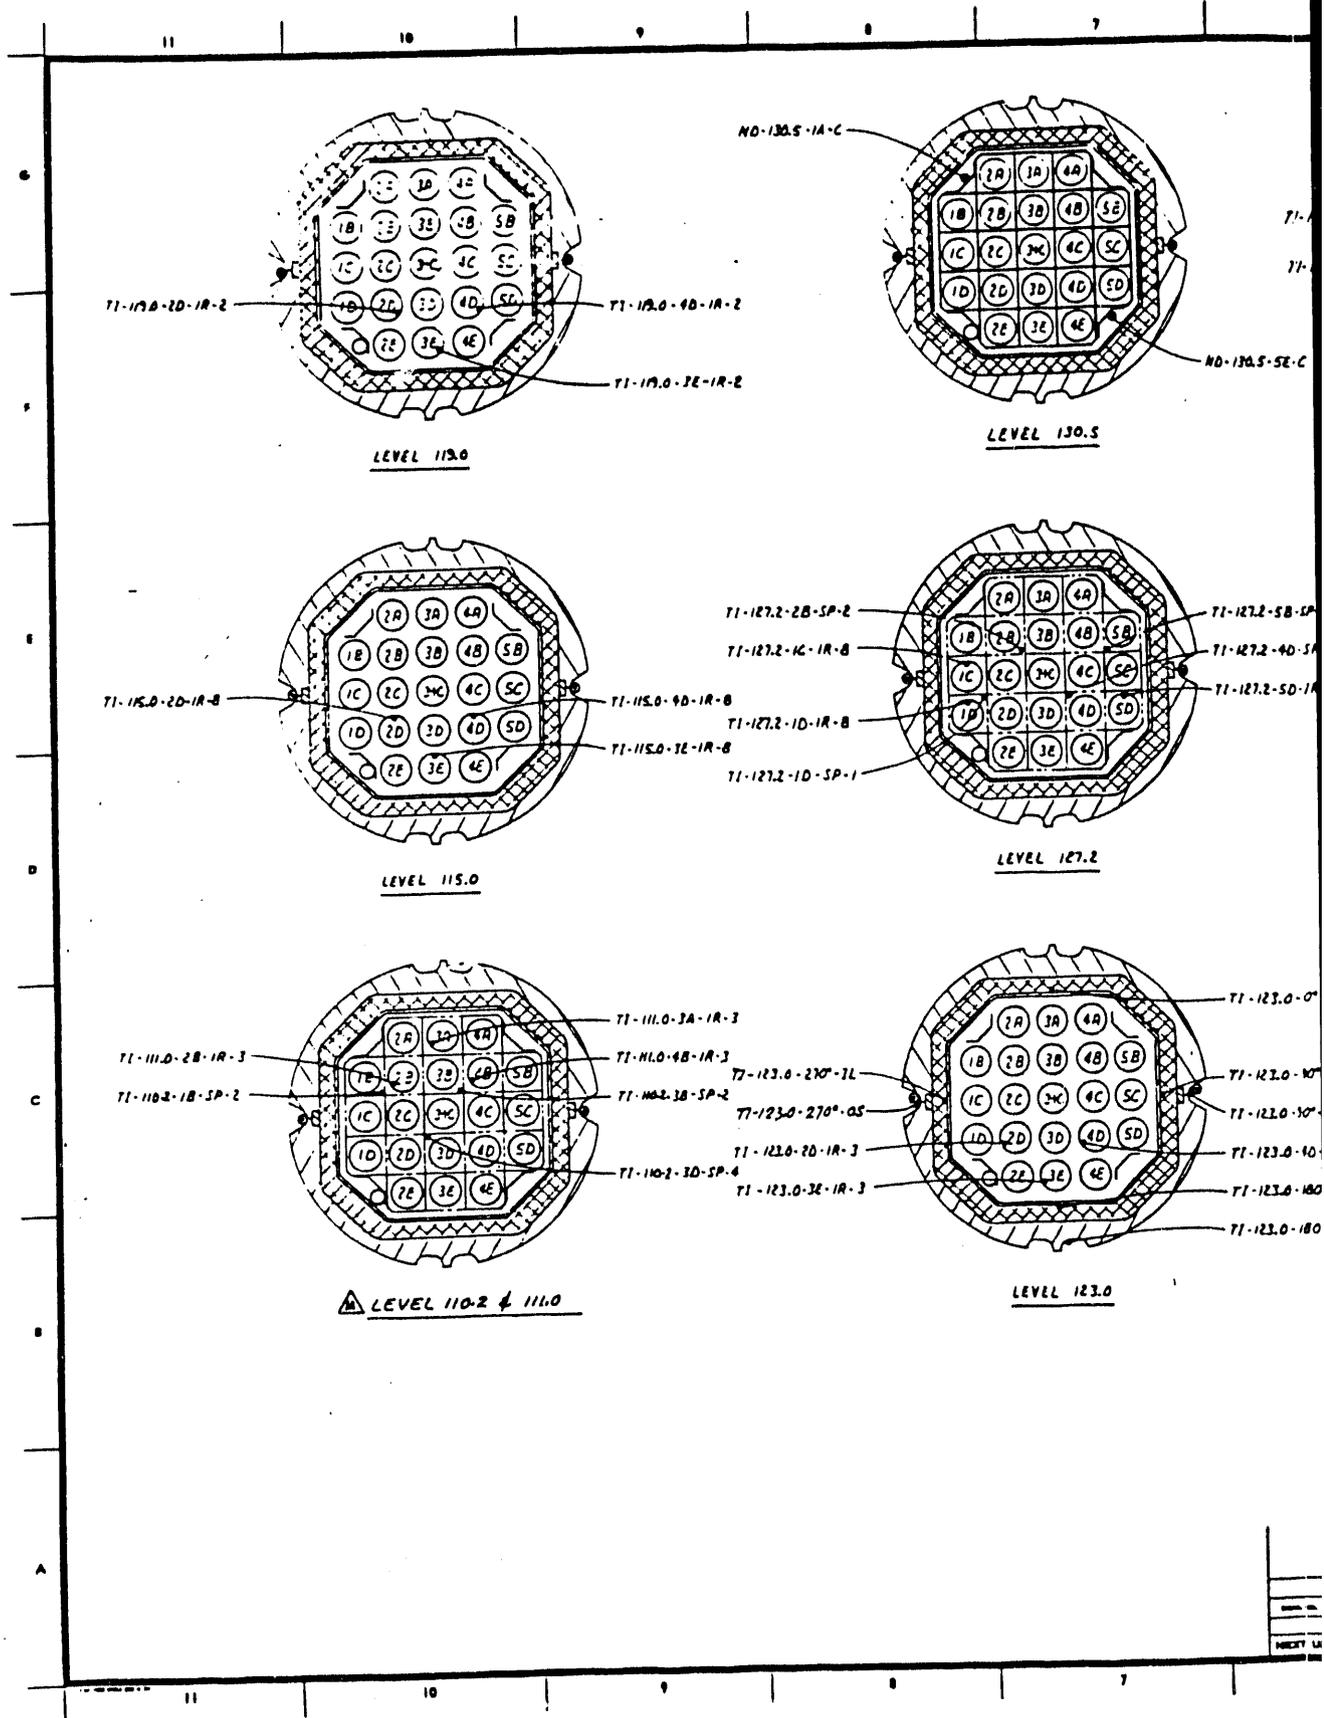
FIGURE 7. MT-6A Instrumentation Arrangement

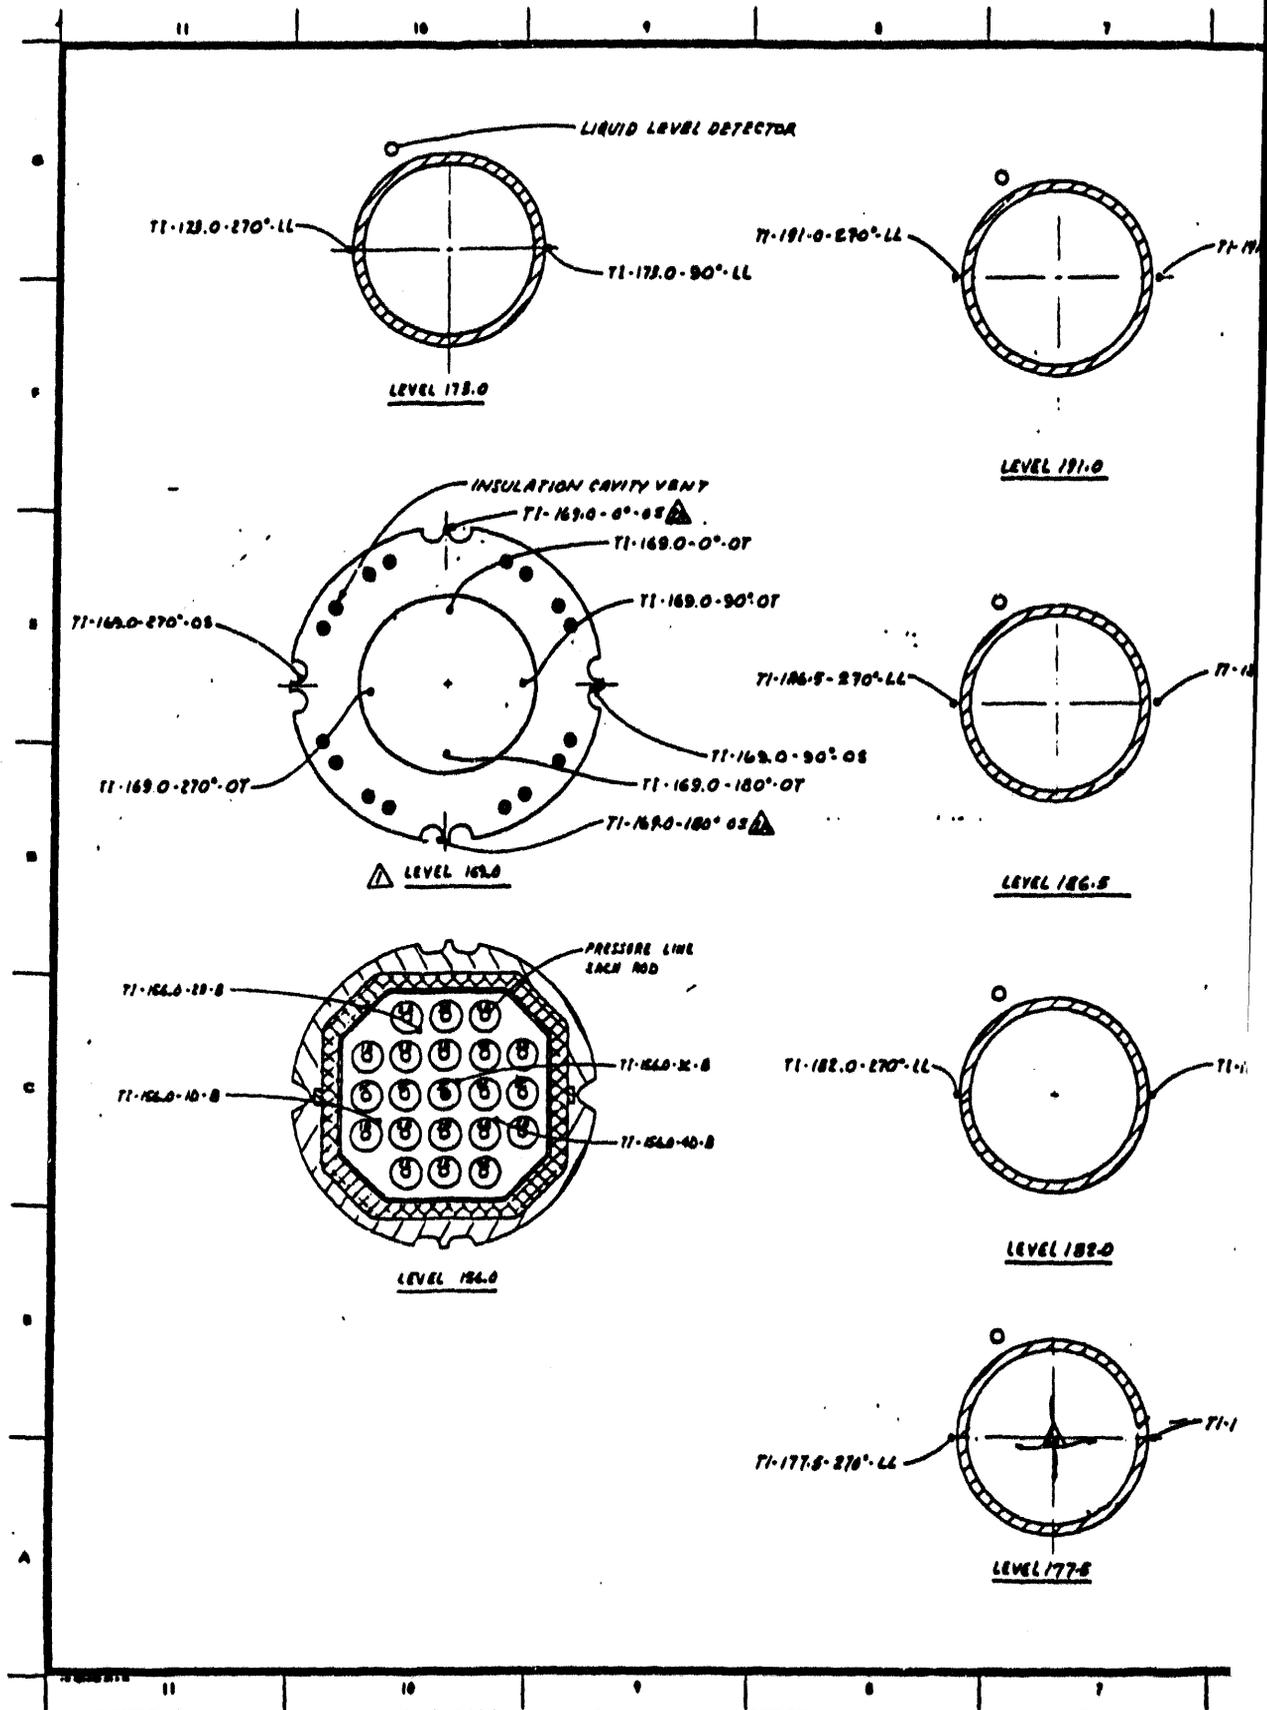
FIGURE 8. MT-6A Instrumentation Arrangement

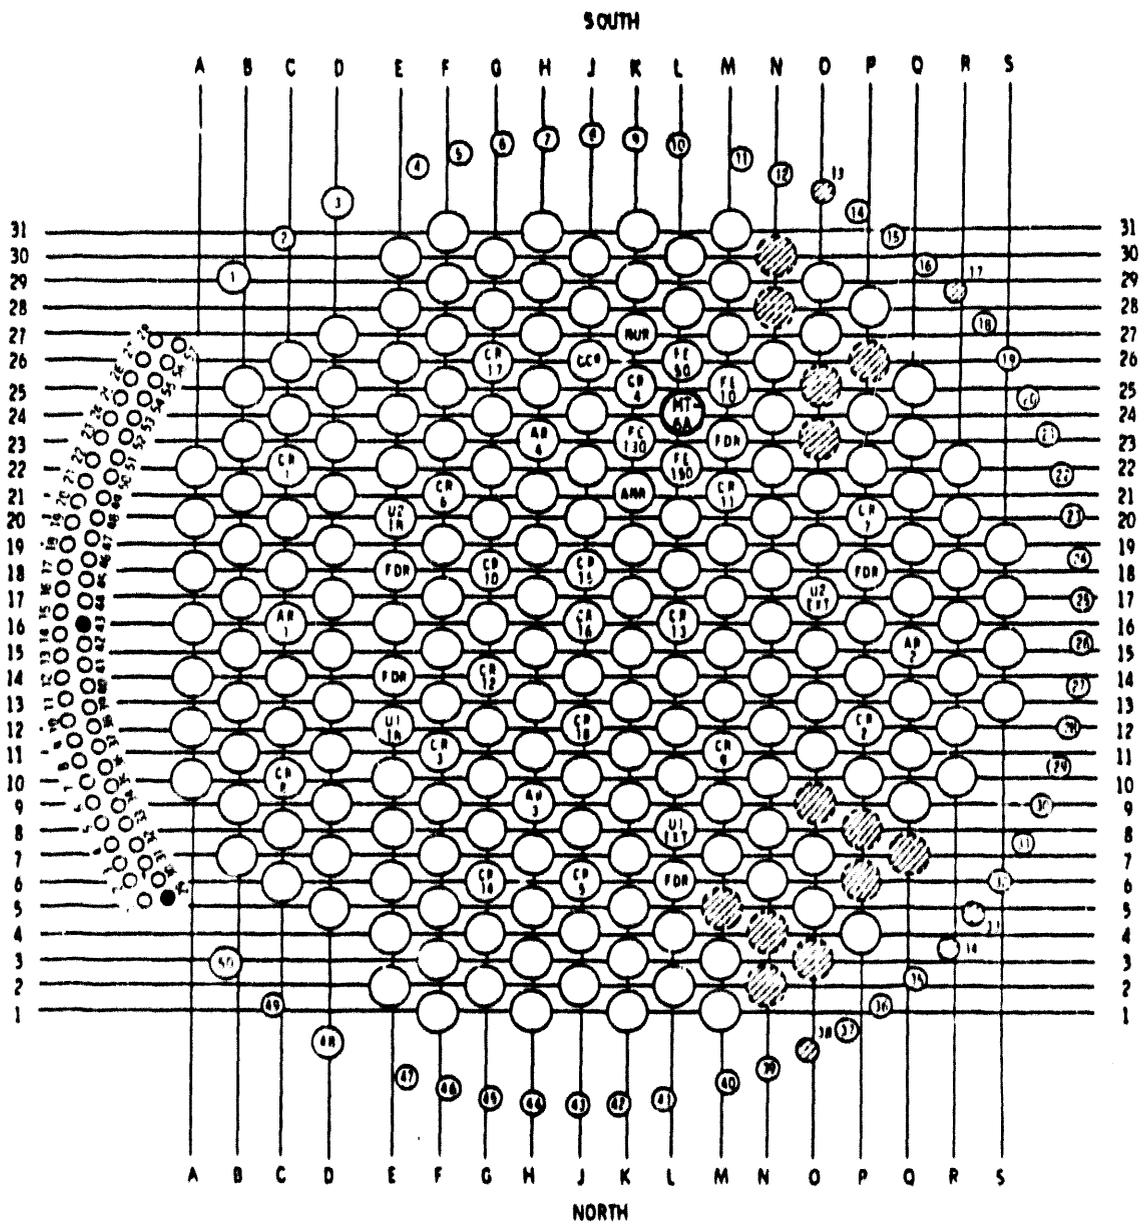
FIGURE 9. NRU Reactor Core Configuration

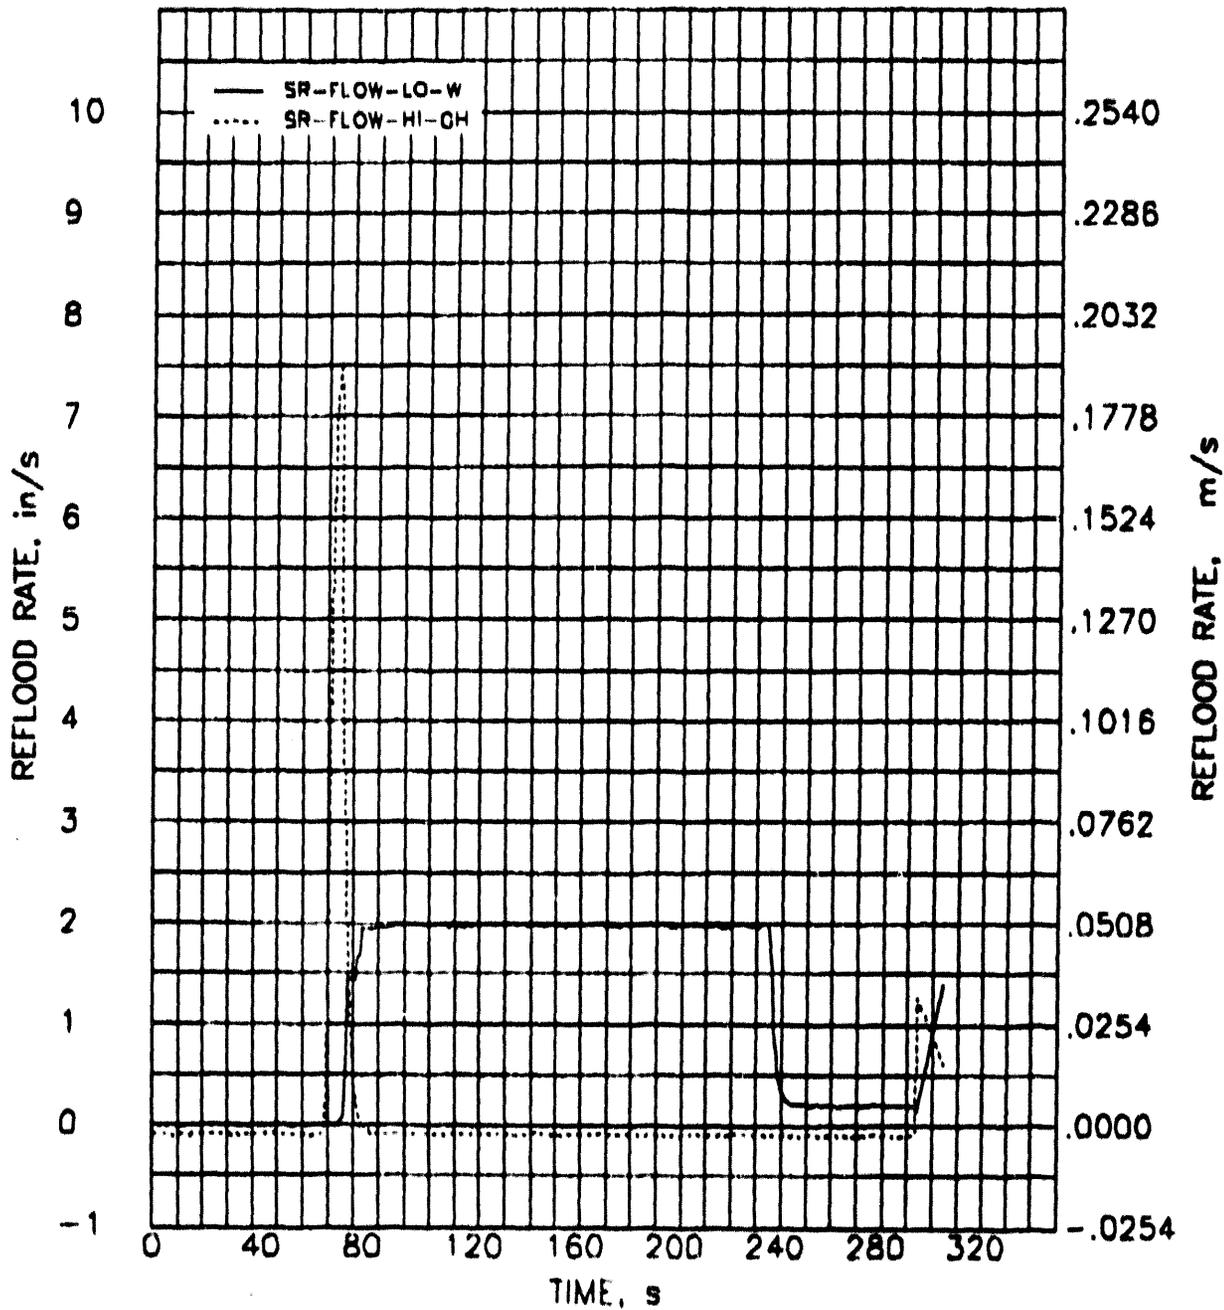
FIGURE 10. Reflood Rates During the MT-6A Transient

The MT-6A transient test used the LCS preprogrammed reflood rate control. After a preset reflood delay (controlled by the DACS), the LCS was programmed to control the reflood rate at 0.20 m/s (8 in./s) for 3 s, 0.18 m/s (7 in./s) for 3s, 0.051 m/s (2 in./s) for 3 s. At that time, the DACS was supposed to take over reflood control to maintain fuel temperatures approximately constant. An anomaly in the reflood control prevented the DACS from taking control once the reflood rate reached 0.051 m/s (2 in./s). The continued reflood at this rate caused the fuel to cool and quench, ending the test. The reflood rates are shown in Figure 10.

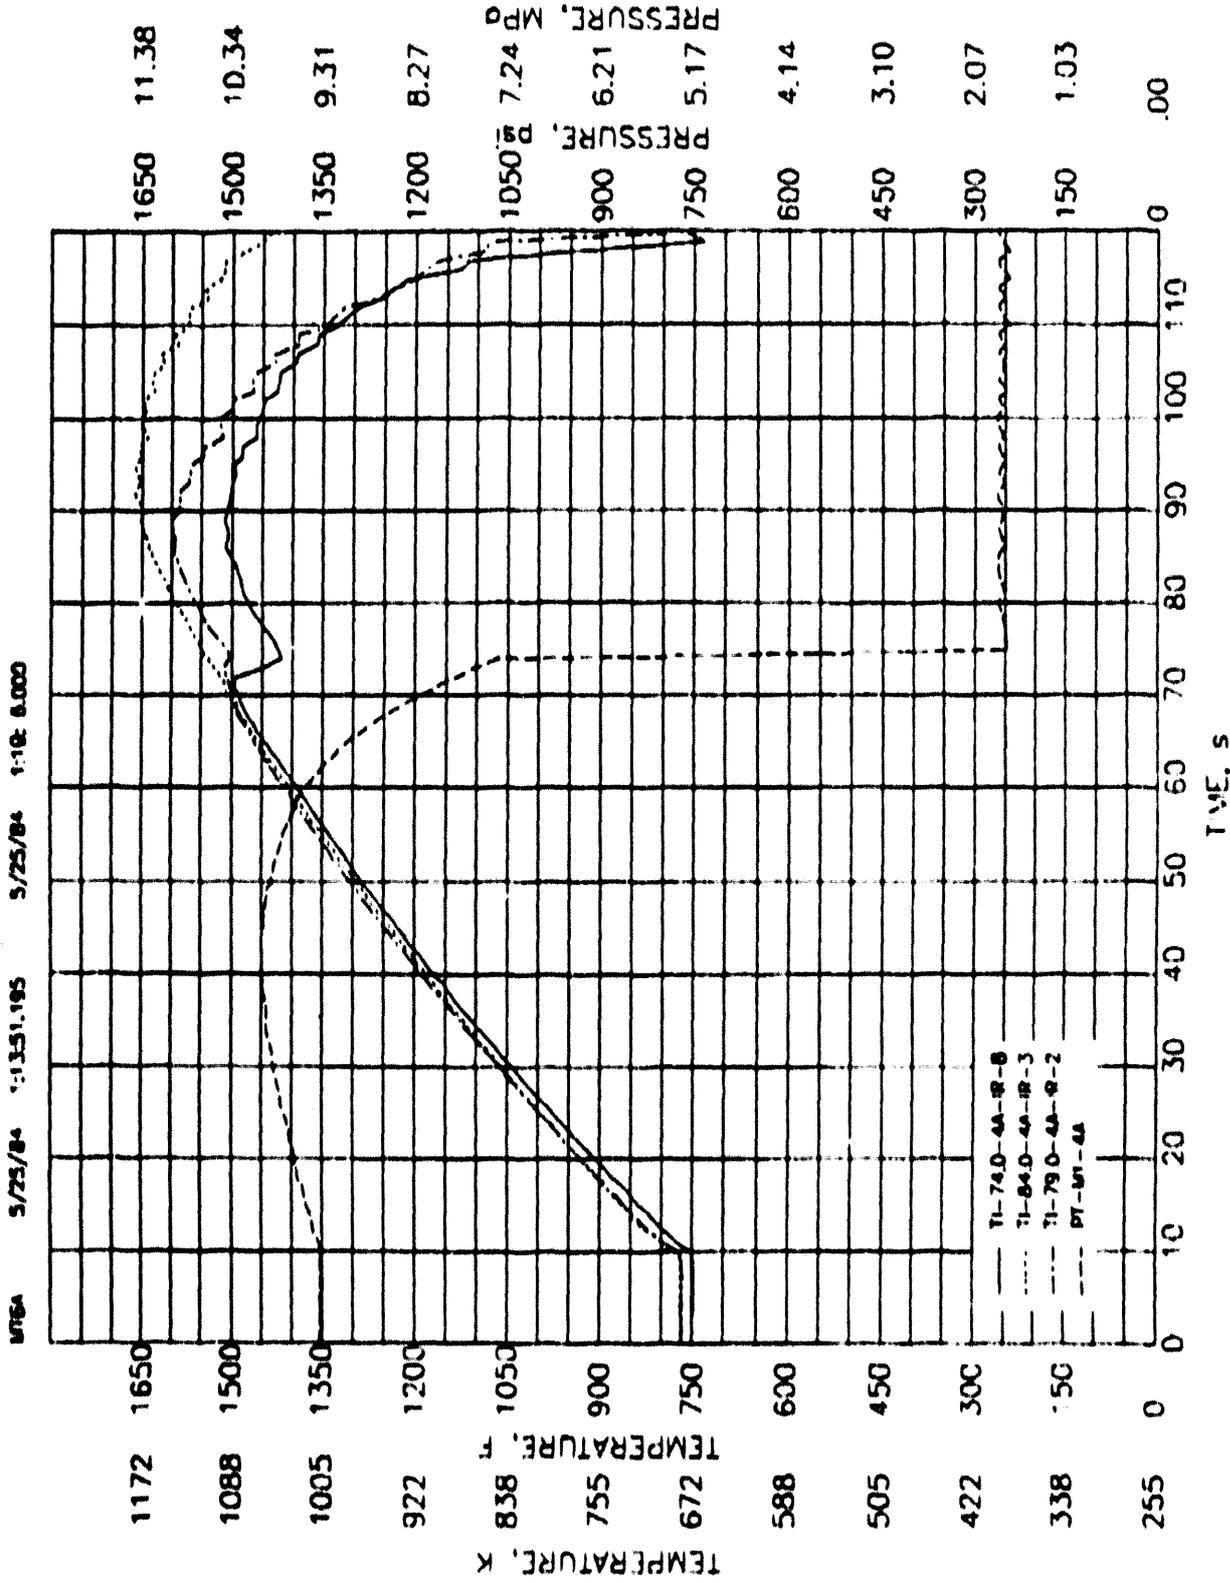
FIGURE 11. Pressures and Temperatures for Rod 4A During the MT-6A Transient

The pressure transducers indicated rod failure, as summarized in Table 3. The test rods were fitted with strain gauge-type pressure transducers. The pressure transducers were located outside the reactor above the test assembly and were connected to the fuel rod plenums by capillary tubes. Pressure transducer data for two rods are (4A and 5D) shown in Figures 11 and 12.

constant, the fuel heatup caused the pressure to increase. Because the fuel ballooned at higher temperatures, the pressure eventually decreased until rupture, which was followed by a rapid decrease in pressure. As shown in Figure 11, the fuel temperature was constant prior to the transient. After the steam cooling was shut off, the fuel temperature increased until just prior to rupture. Just before rupture, cladding temperatures dropped near the rupture location, perhaps because of cladding liftoff near the rupture zone. The temperature and corresponding pressure for a rod that has one TC hot junction located close to the rupture region are shown in Figure 11. A similar trace where the TCs are not close to the rupture region is shown in Figure 12. Peak fuel temperatures near a rupture region tend to be lower than those away from the rupture region, which tends to confirm that ballooning has no deleterious effect on heat transfer and may even enhance it.

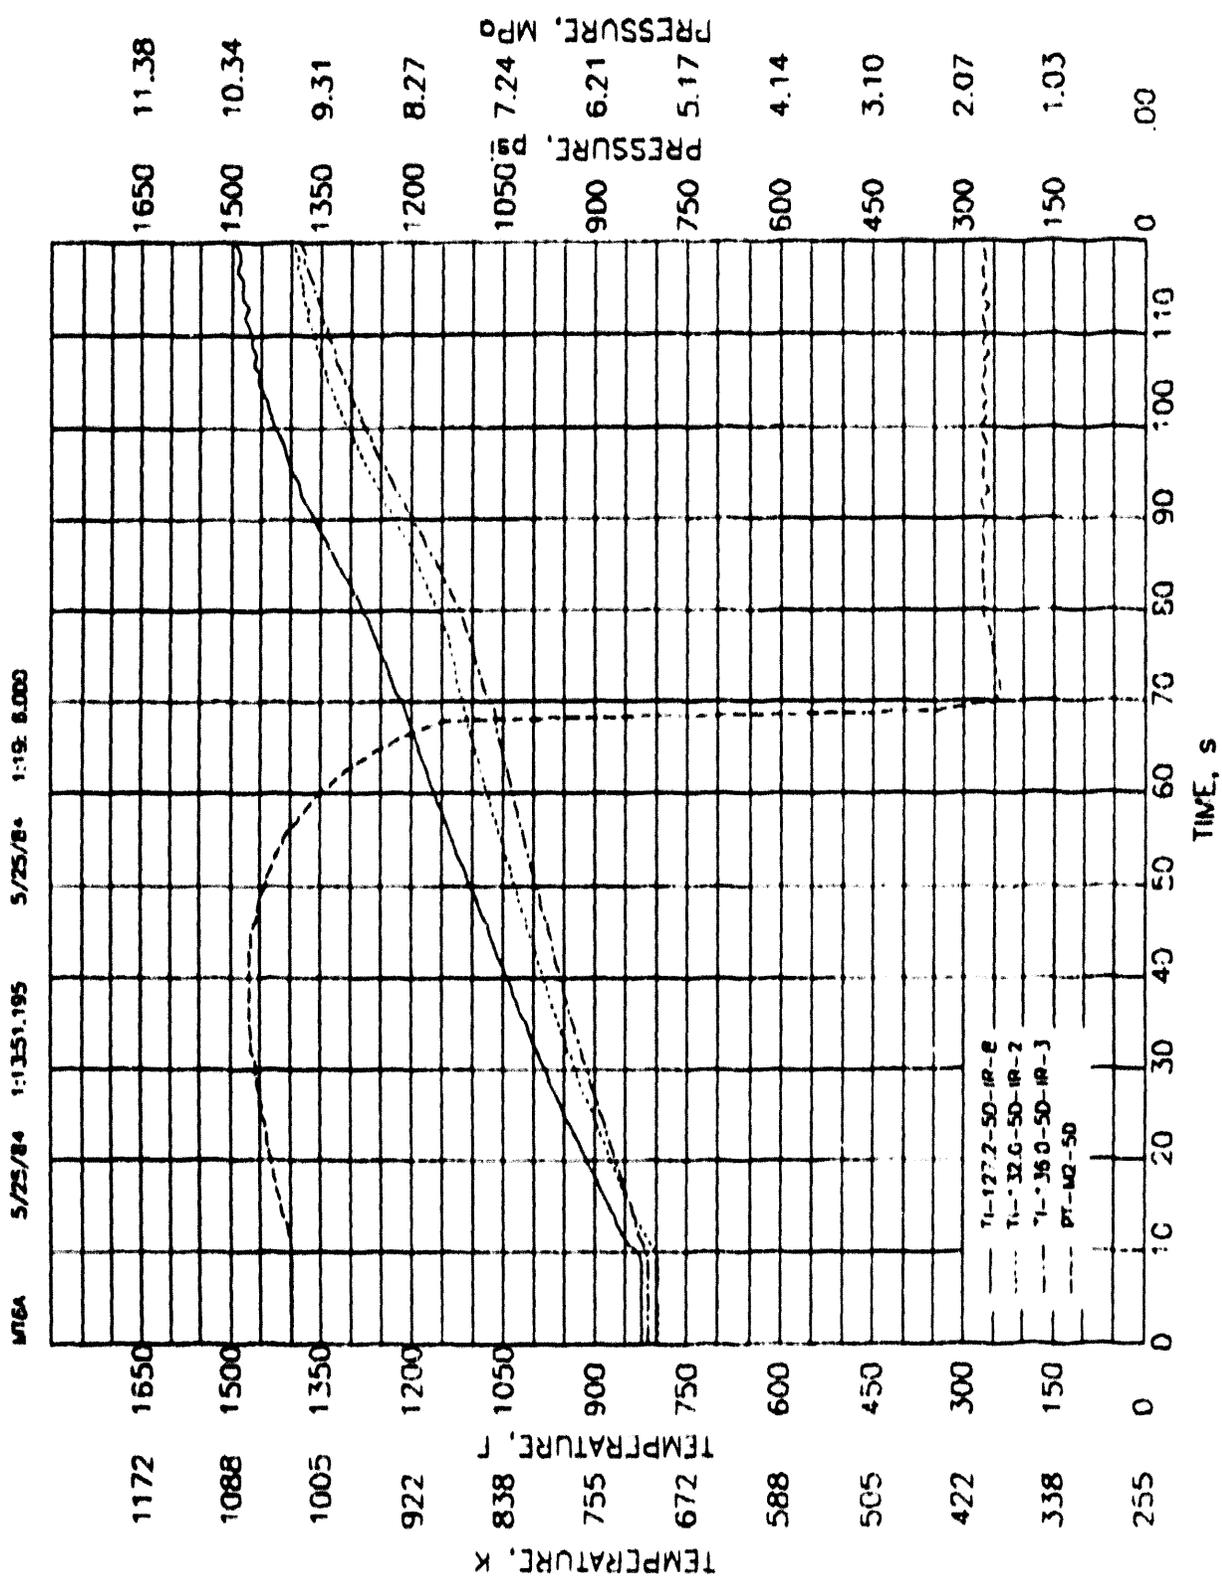
FIGURE 12. Pressures and Temperatures for Rod 5D During the MT-6A Transient

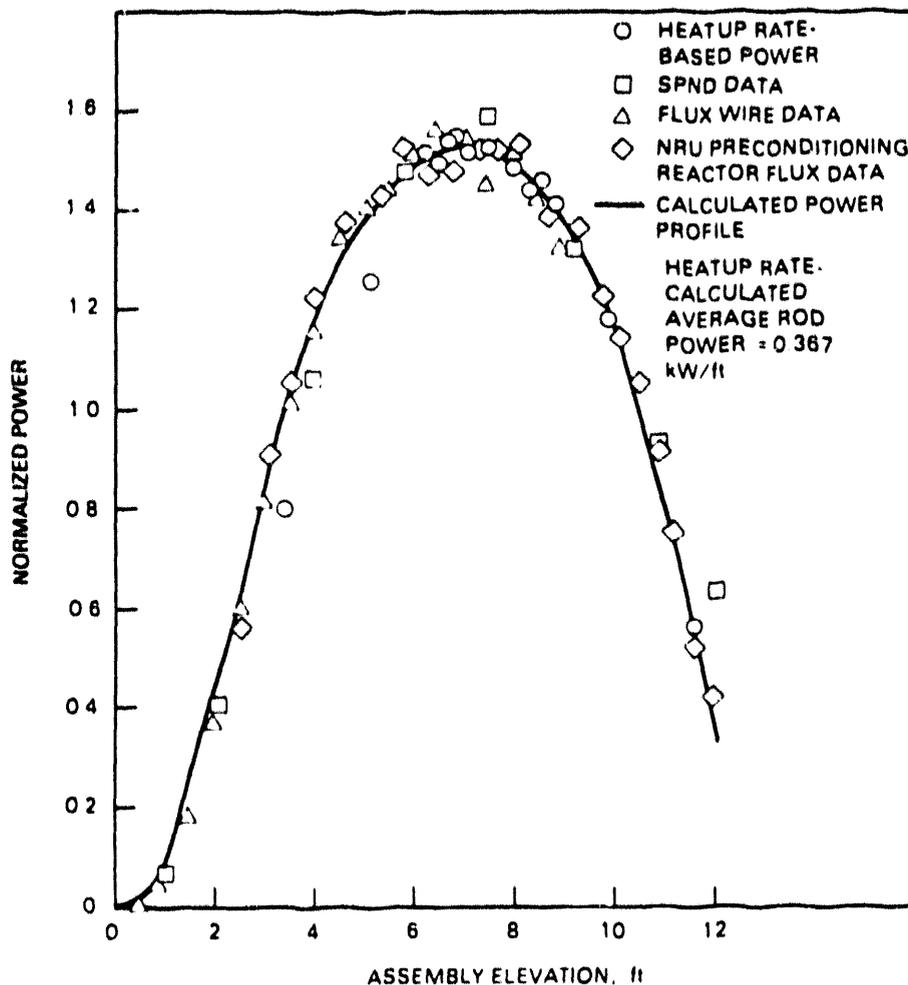
FIGURE 13. Comparison of MT-4 Heatup Rate-Based, SPND, Flux Wire, NRU Reactor Preconditioning, and Calculated Axial Power Profiles

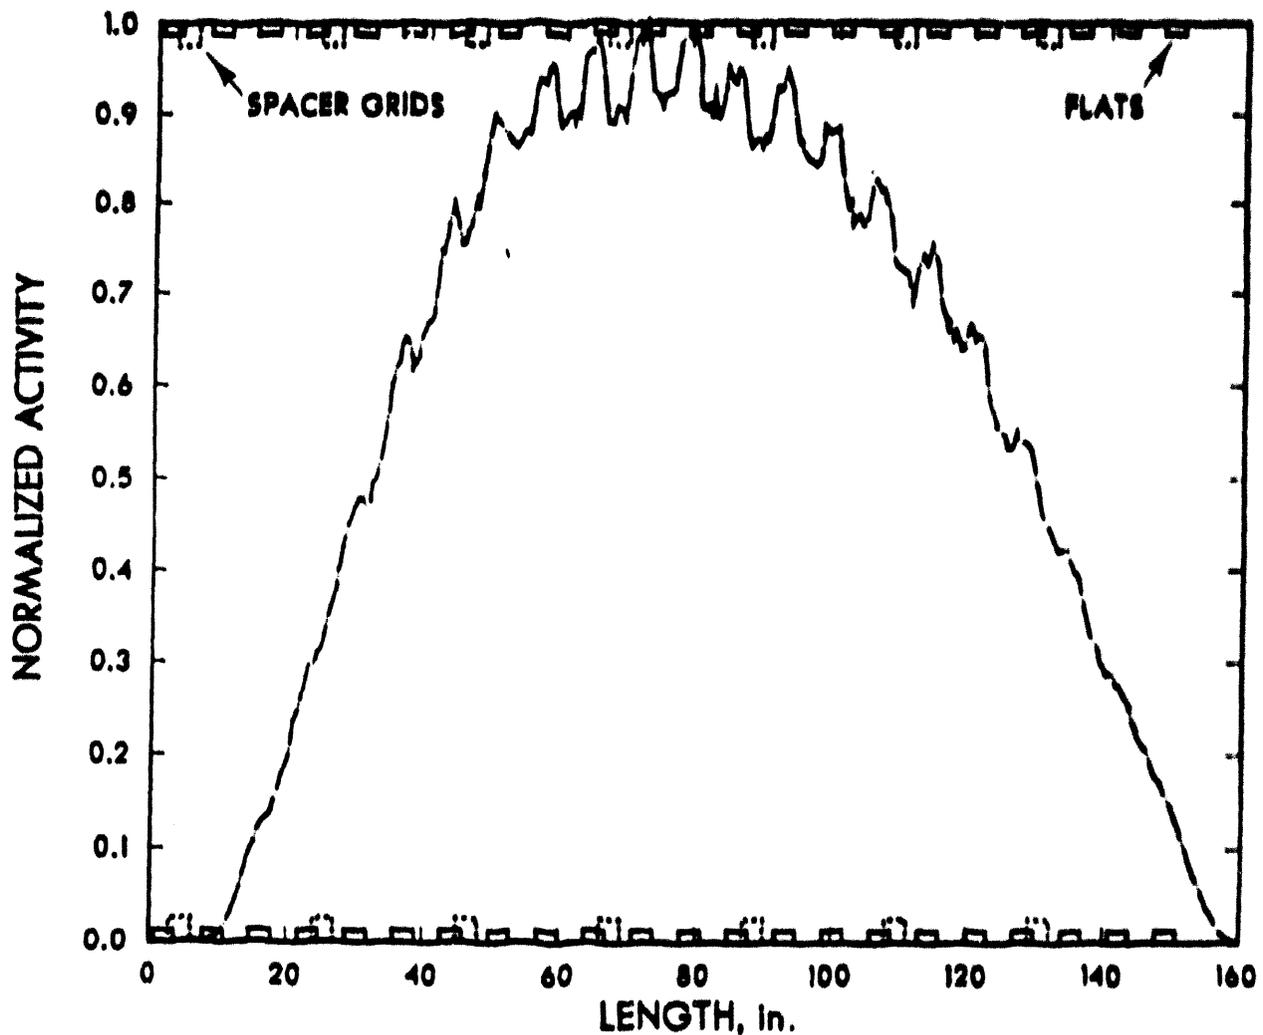
FIGURE 14. Axial Neutron Flux Distribution During the MT-6A Transient

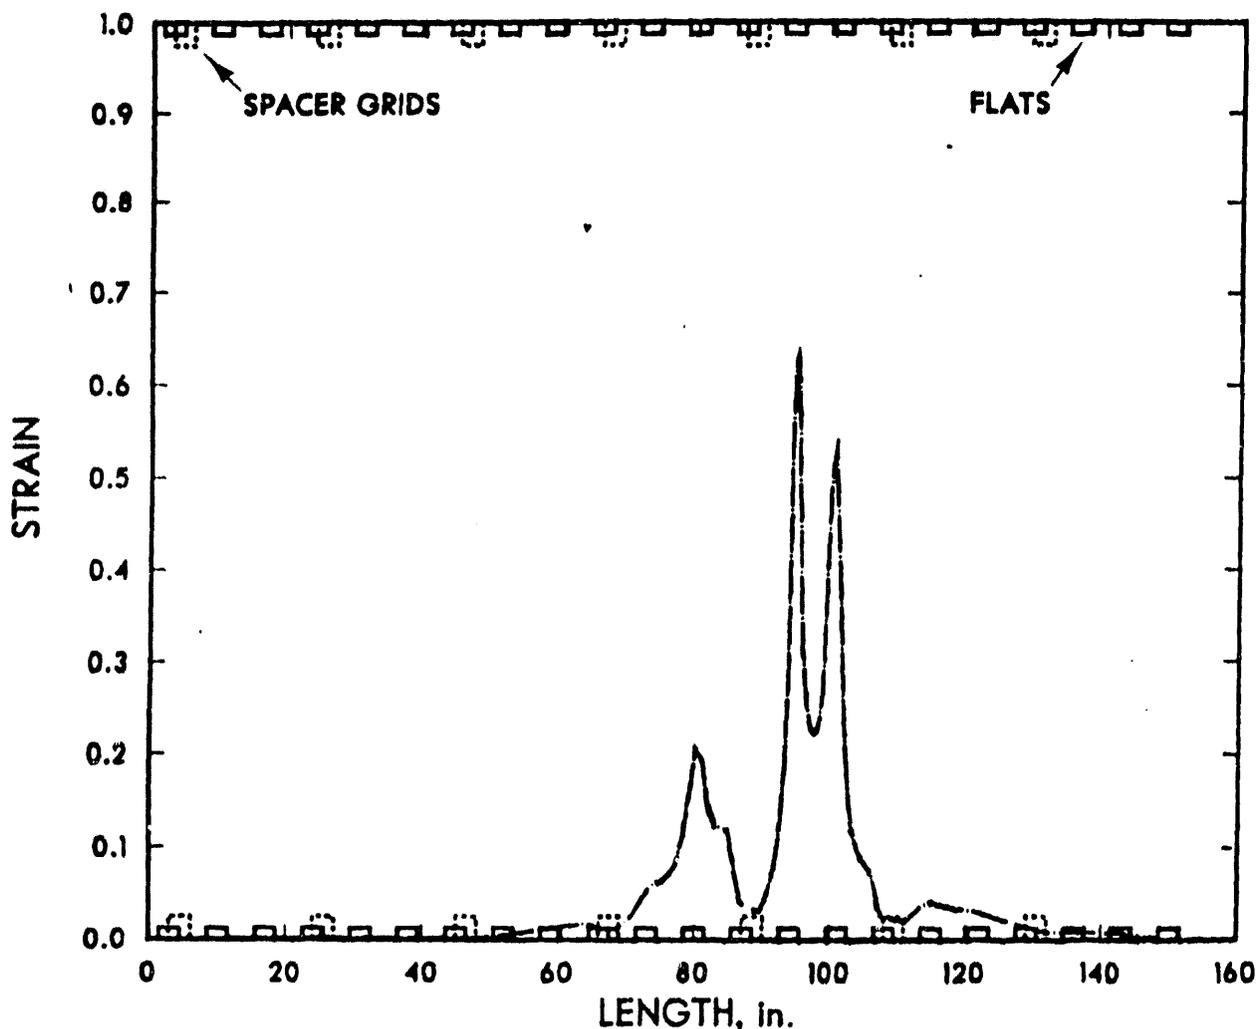
FIGURE 15. Axial Strain Profile for MT-4

The effects of the localized neutron flux and the resulting power and cladding temperature variations on the measured cladding strain for the MT-4 rods are shown in Figures 15 and 16. There is a correspondence between the locations of the flats on the shroud and the localized strain effects in the cladding. The large decrease in strain in the middle of the middle span is coincident with a nonflat region in the shroud. The effect of the mechanical restraint provided by the spacer grids on cladding strain is also clearly shown. There are no indications of significant cladding strain reductions between the other spacer grid spans, as was noted in MT-1 and MT-2. However,
