PNL-8829
UC-520

**LARGE-BREAK LOCA, IN-REACTOR
FUEL BUNDLE MATERIALS TEST MT-6A**

October 1989 - Completion Date
September 1993 - Publication Date

Pacific Northwest Laboratory
Richland, Washington 99352

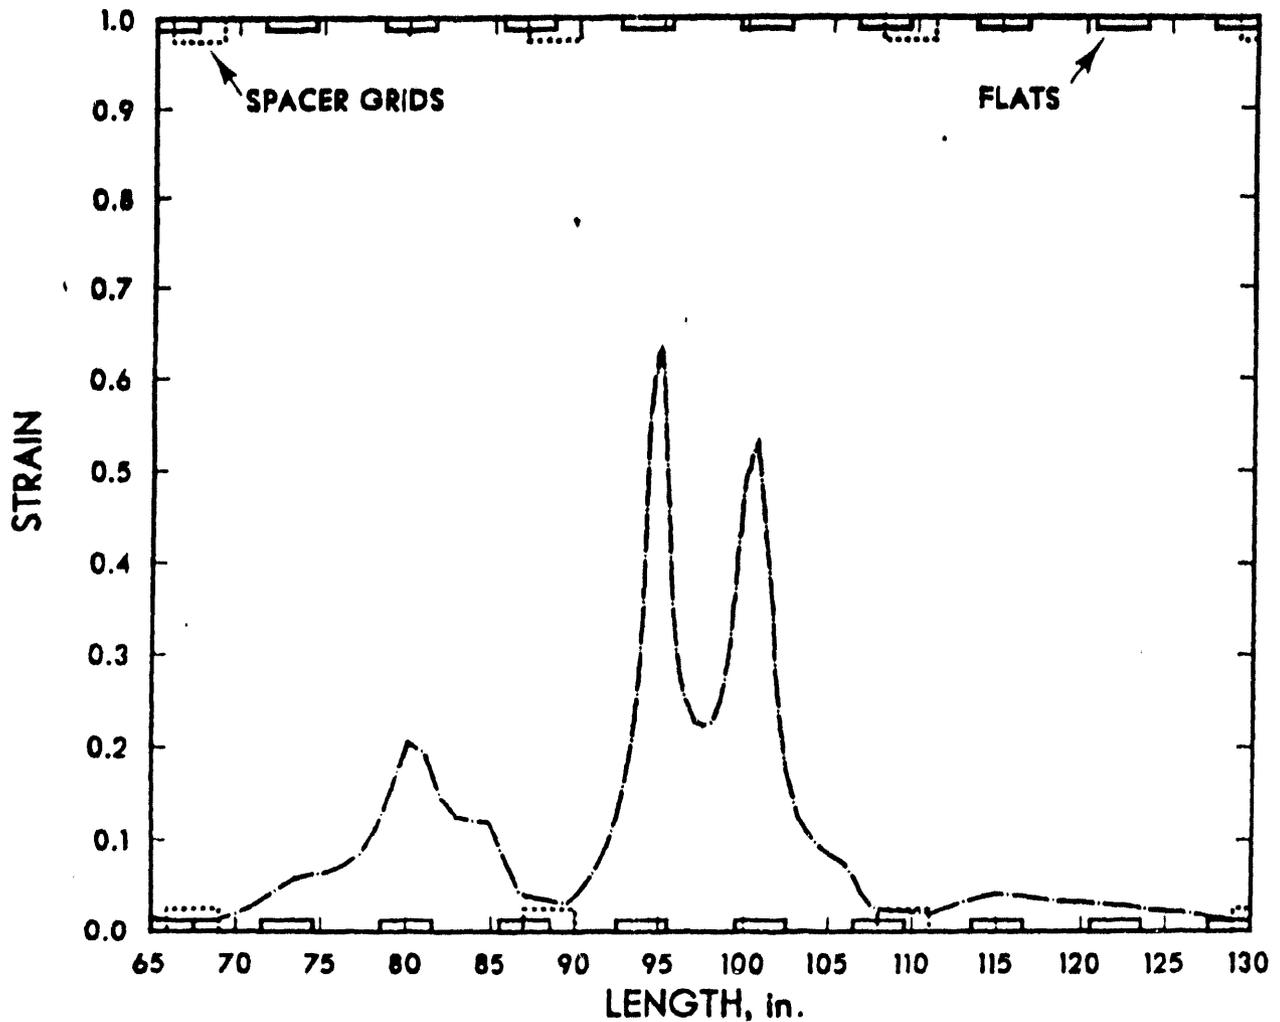
FIGURE 16. Partial Axial Strain Profile for MT-4

The effects of the localized neutron flux and the resulting power and cladding temperature variations on the measured cladding strain for the MT-4 rods are shown in Figures 15 and 16. There is a correspondence between the locations of the flats on the shroud and the localized strain effects in the cladding. The large decrease in strain in the middle of the middle span is coincident with a nonflat region in the shroud. The effect of the mechanical restraint provided by the spacer grids on cladding strain is also clearly shown. There are no indications of significant cladding strain reductions between the other spacer grid spans, as was noted in MT-1 and MT-2. However,

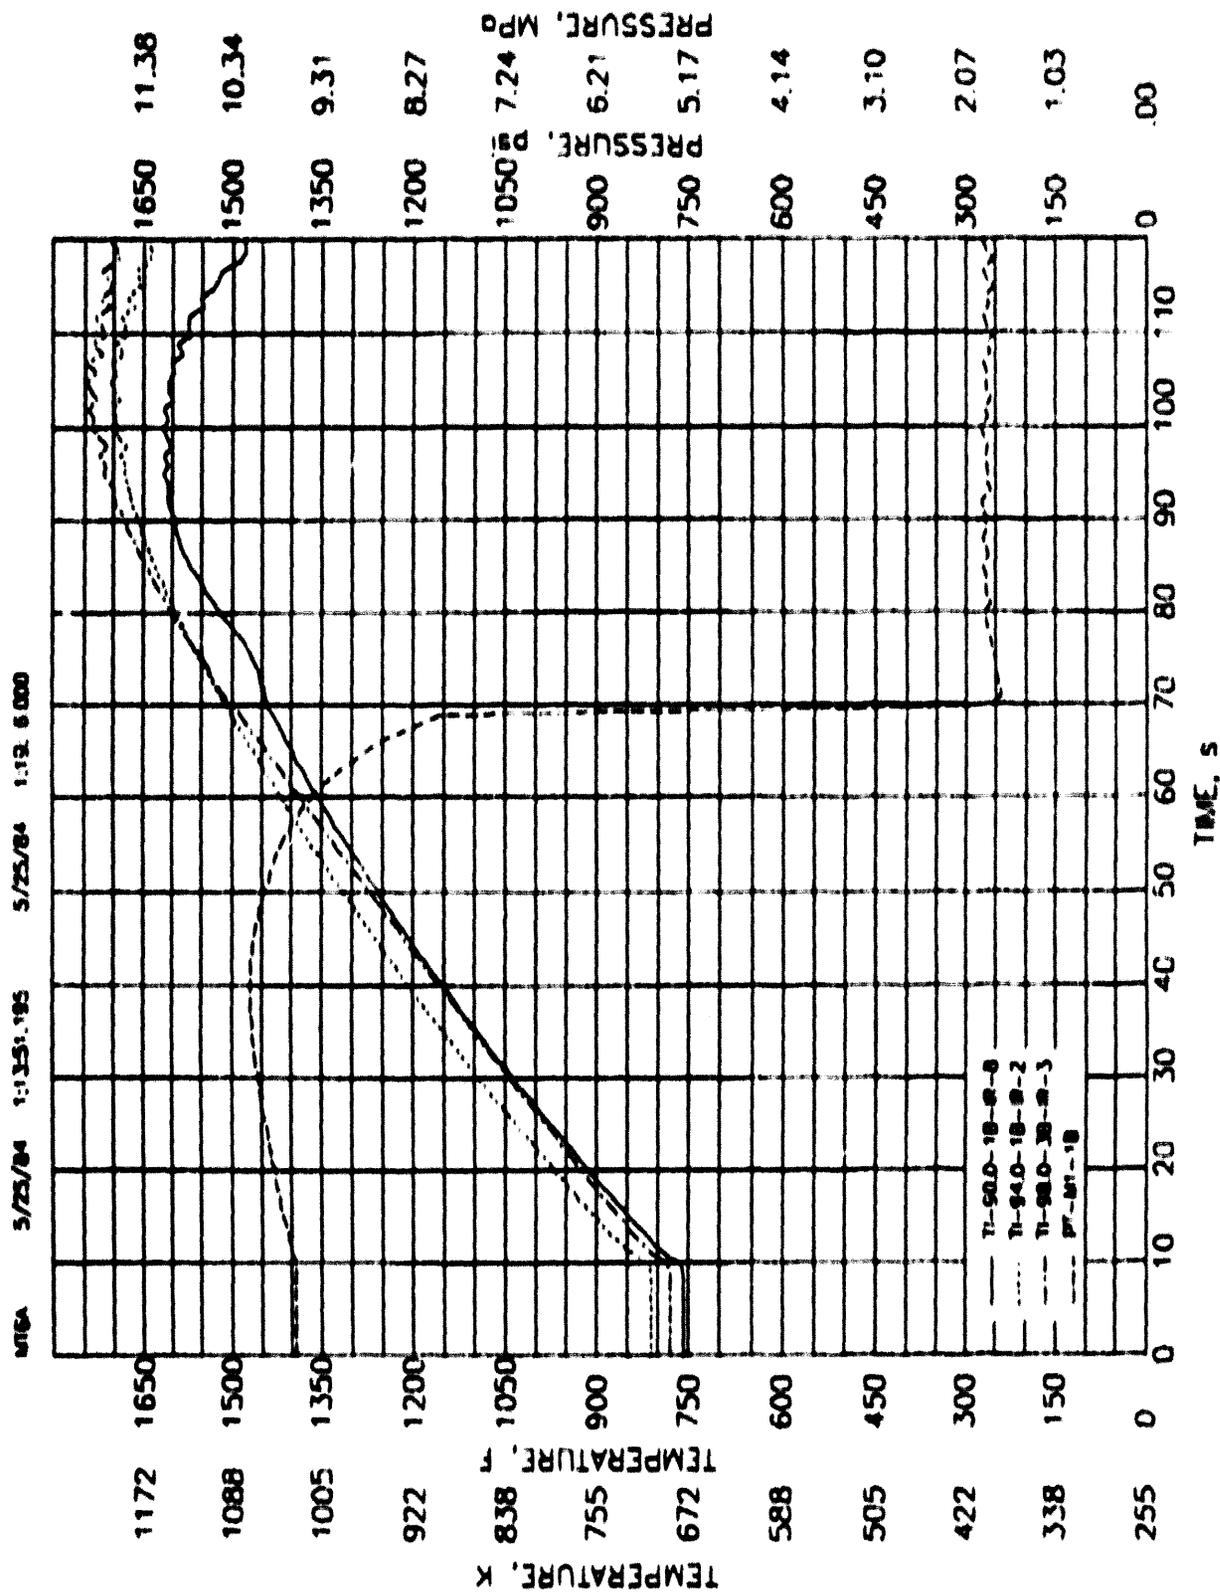
FIGURE A.1. Fuel Rod Interior Cladding Temperatures for Rod 1B at Levels 90.0 and 94.0, Rod 3B at Level 98.0, and Plenum Pressures for Rod 1B

Fuel cladding thermocouples were welded to the inside of the fuel cladding. Temperature curves for these thermocouples for the MT-6A transient are presented in this appendix. These curves demonstrate how the fuel heats up almost adiabatically until the reflood water starts to cool the fuel at the thermocouple elevation. These curves demonstrate that the rods can be cooled, even though all 21 rods ballooned and ruptured and were constrained by the shroud.

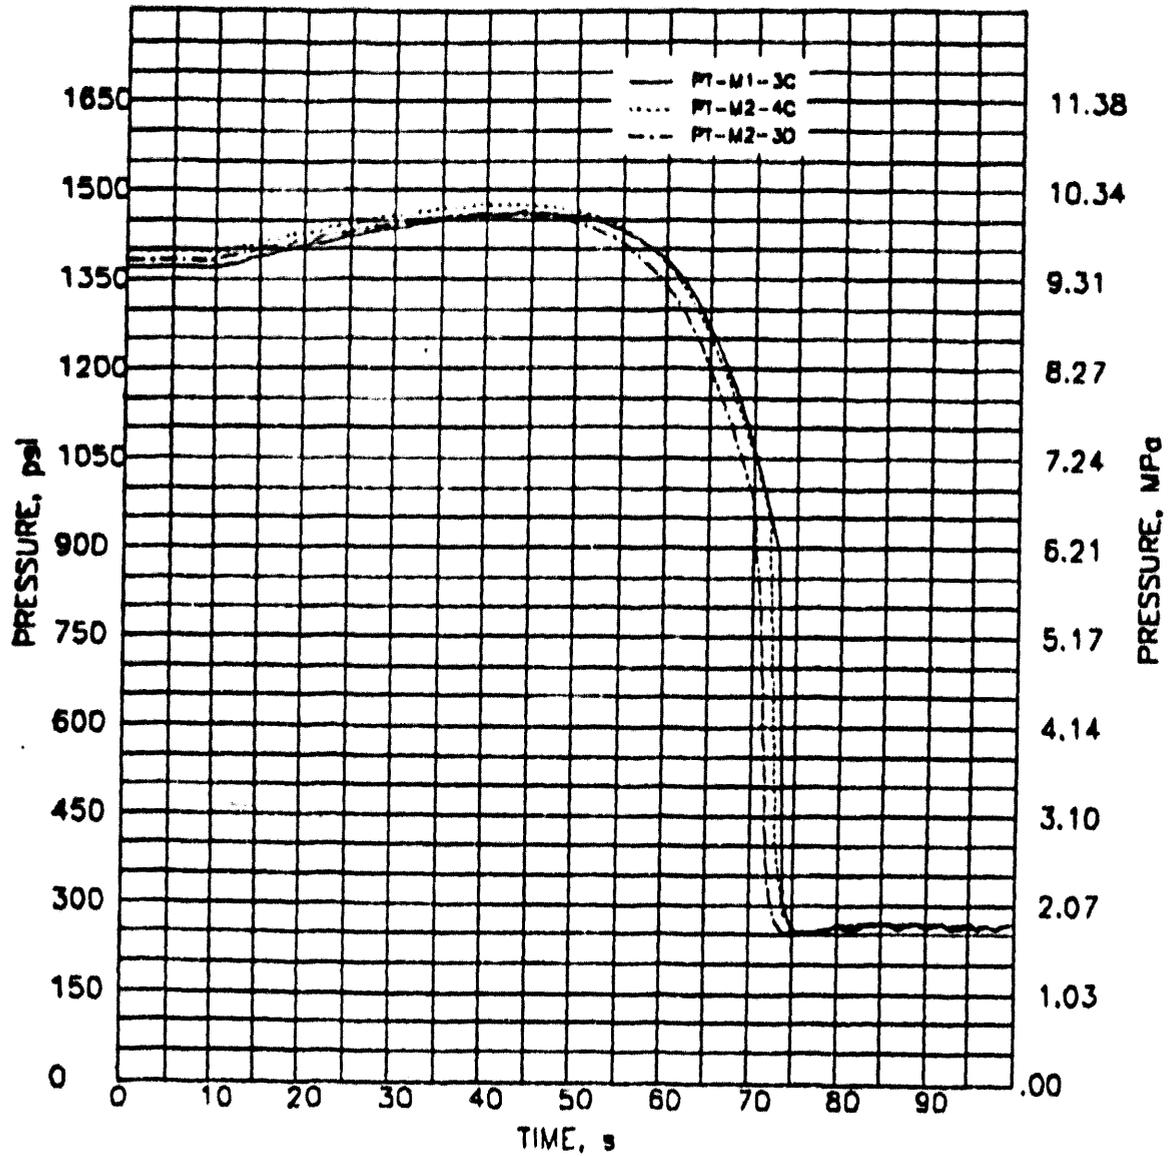
FIGURE A.19. Fuel Rod Plenum Pressure for Rods 3C, 4C, and 3D

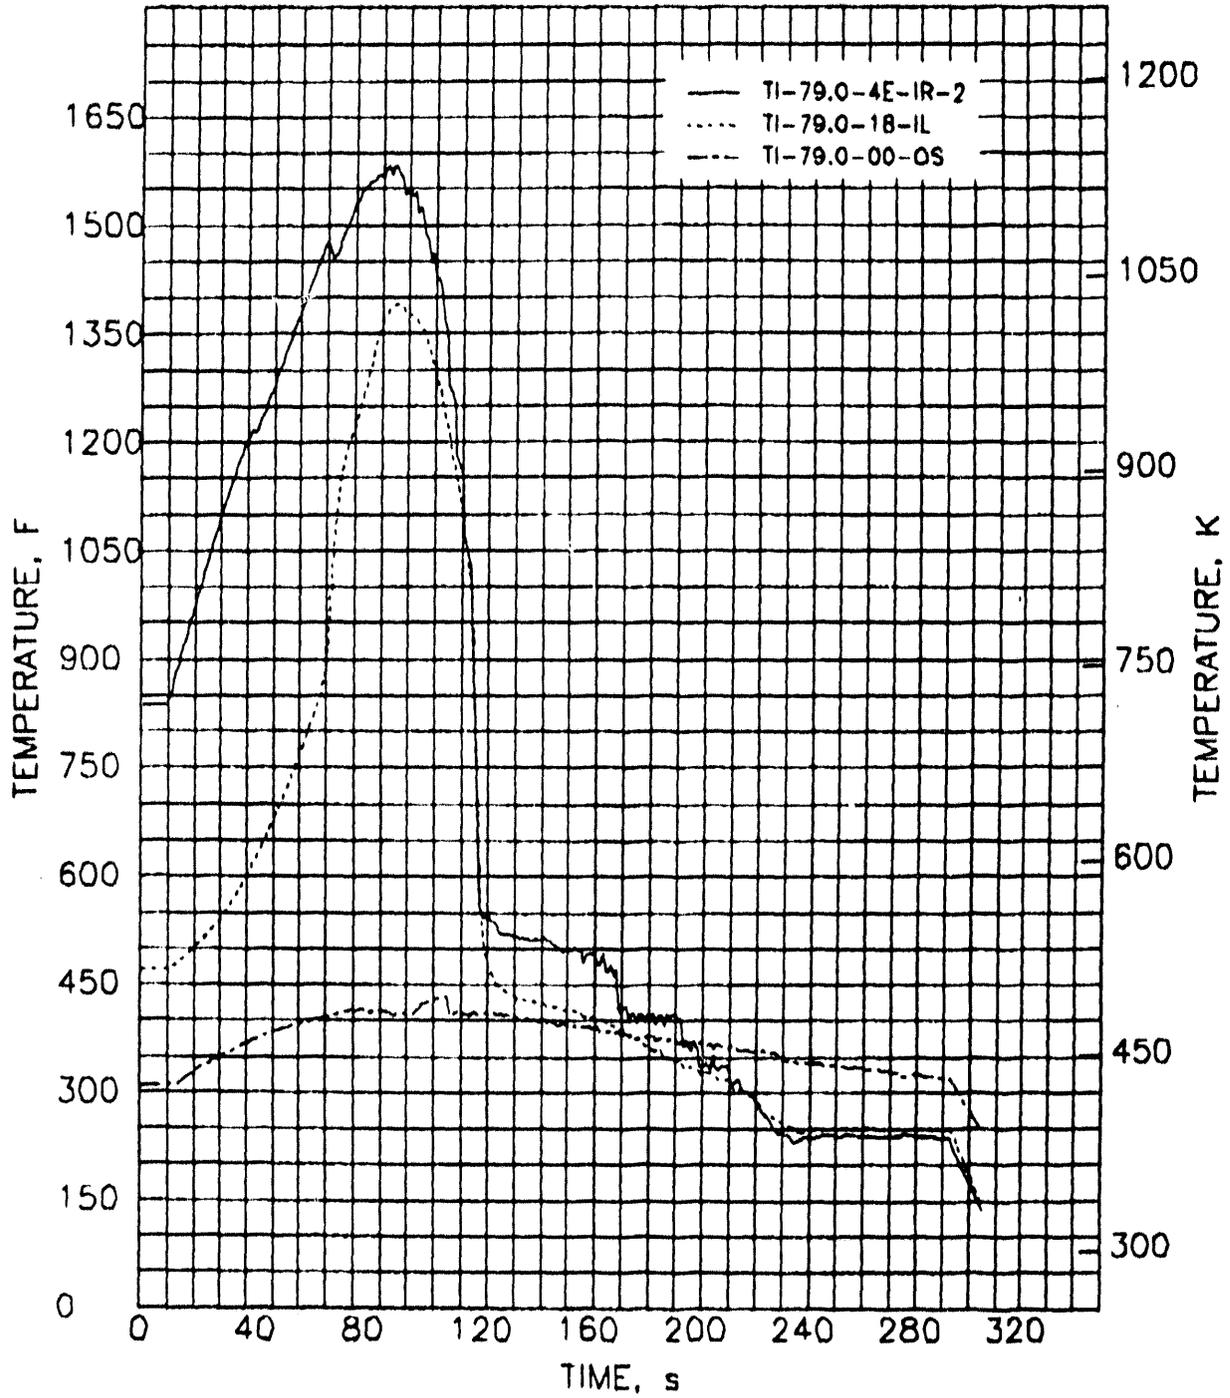
FIGURE C.1. Comparison of Fuel Rod Interior Cladding, Shroud Inner Liner, and Shroud Outside Temperatures at Level 79

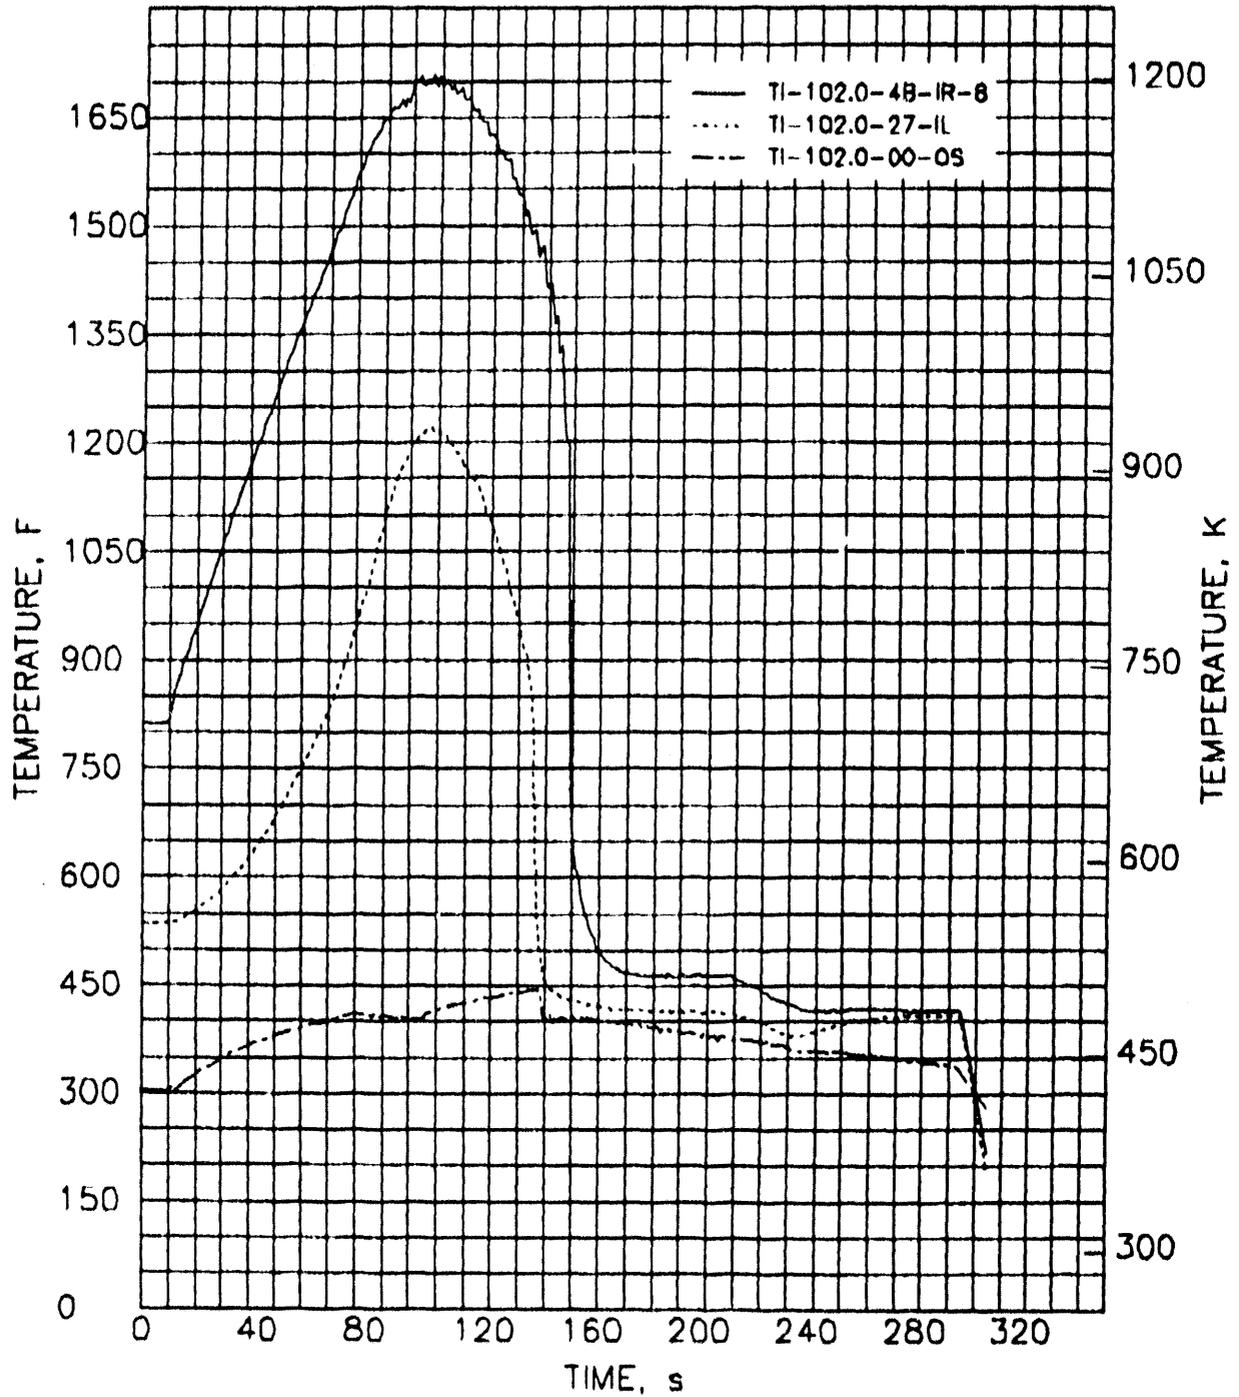
FIGURE C.2. Comparison of Fuel Rod Interior Cladding Shroud Inner Liner, and Shroud Outside Temperatures at Level 102

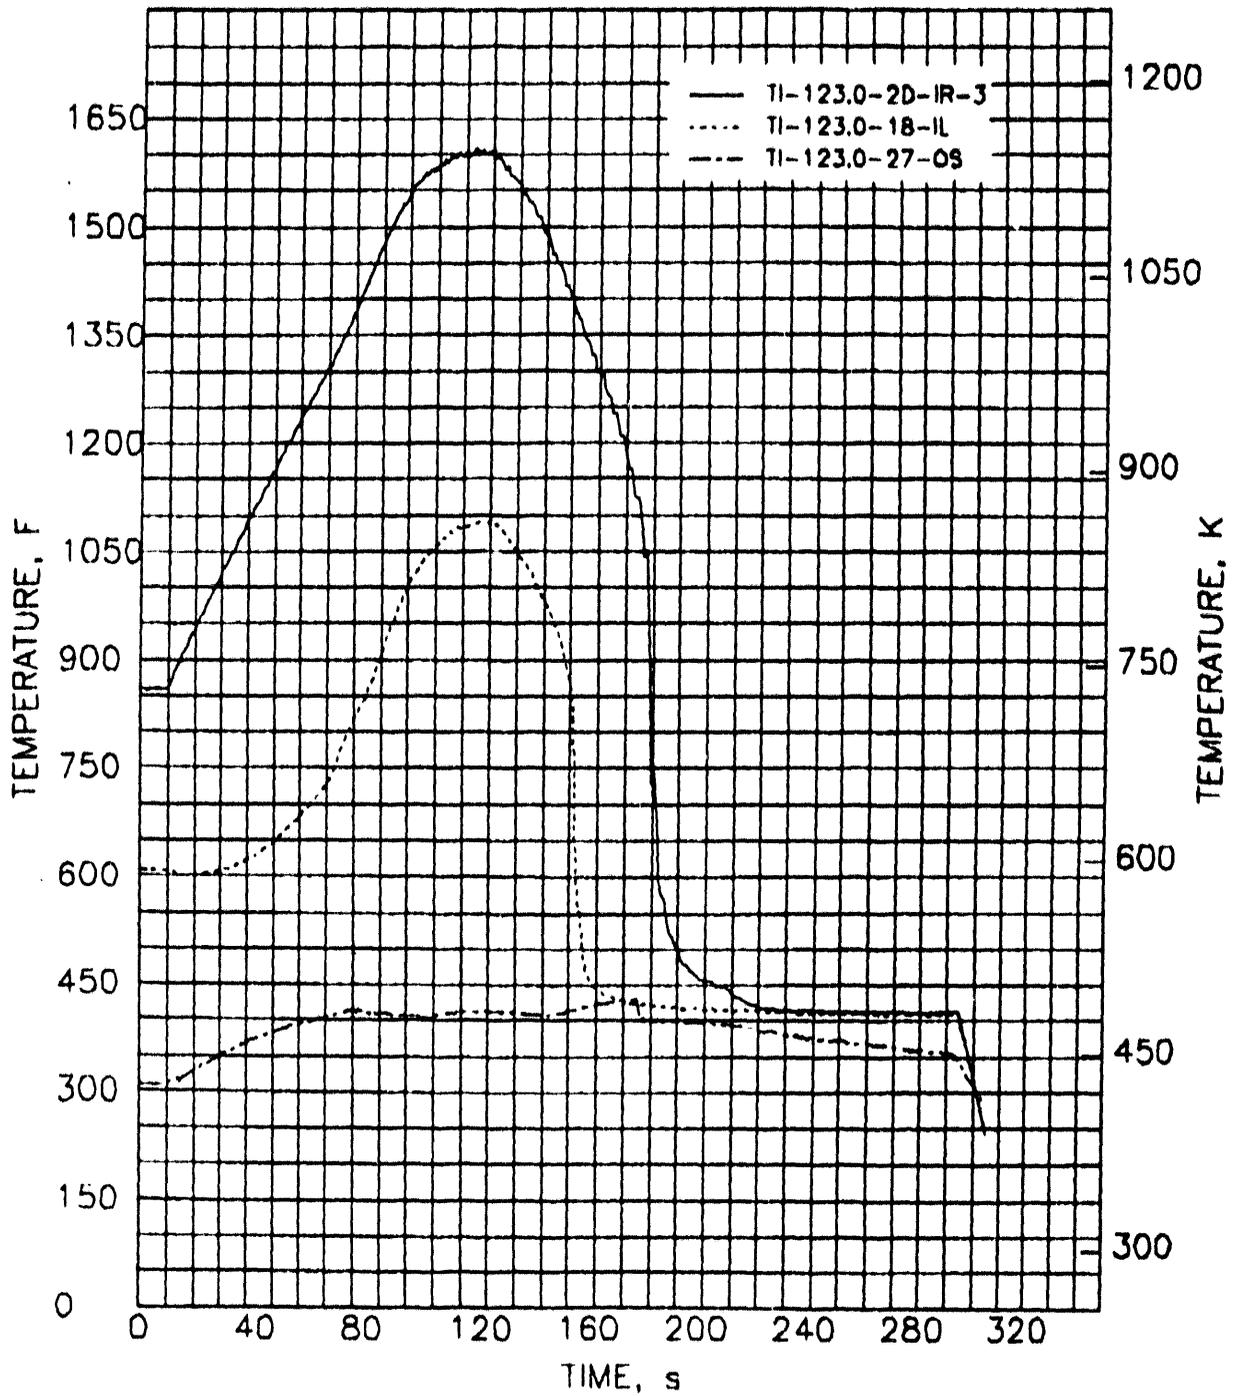
FIGURE C.3. Comparison of Fuel Rod Interior Cladding, Shroud Inner Liner, and Shroud Outside Temperatures at Level 123
