West Valley Support Program

Final Report

External Corrosion of Tanks 8D-1 and 8D-2

May 1995

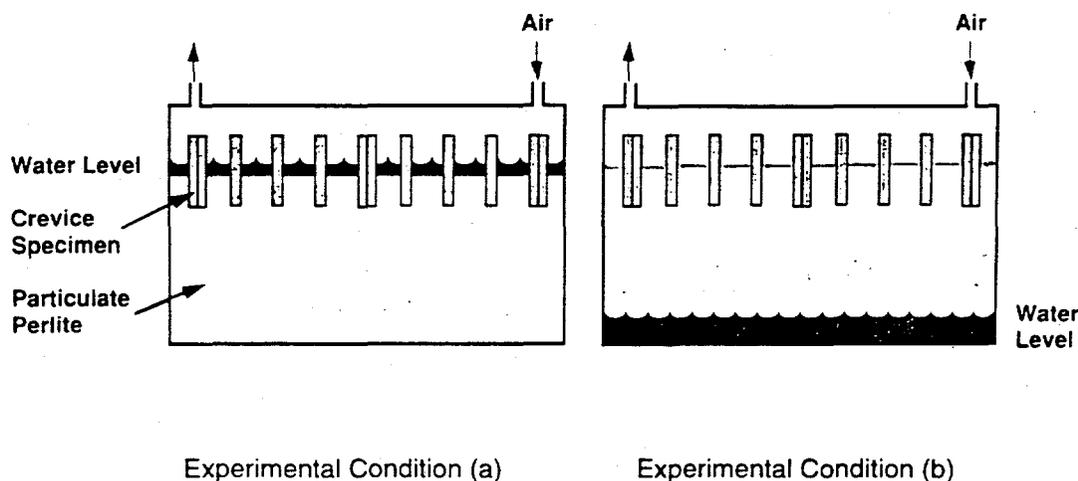
FIGURE 1. Method of Exposing Steel Specimens to Conditions Simulating Those at the External Tank Surfaces

The basic test approach involved simultaneously exposing mild steel specimens to (a) an environment of air, water, and water-immersed unexpanded perlite, and (b) an environment of air and moist unexpanded perlite. These two environments differ only in the position of the water table relative to the surface of the perlite. Each of the two environments described was being held at a temperature of $30 \pm 5^\circ\text{C}$ and $90 \pm 5^\circ\text{C}$, to span (conservatively) the temperature range of the two tank's operating histories. The two experimental conditions are shown schematically in Figure 1.

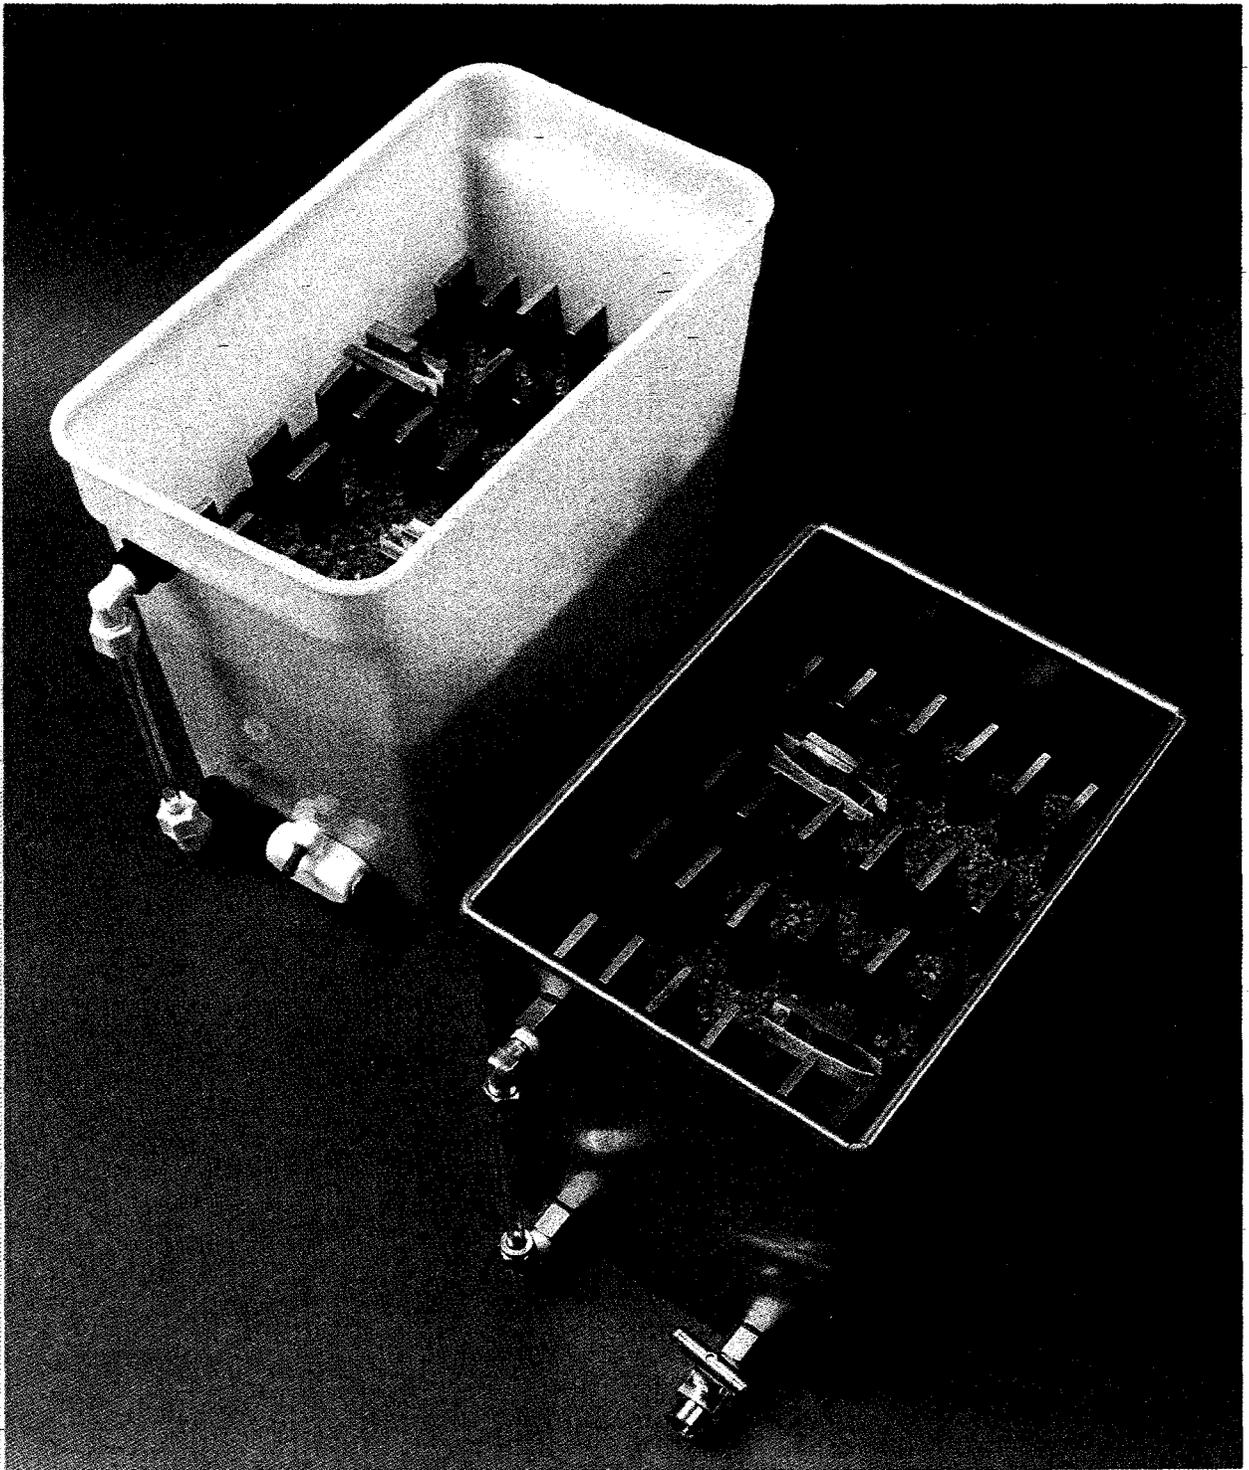
FIGURE 2. Two of Four Reaction Vessels Used in Corrosion Tests

Four reaction vessels, of the type shown in Figure 2, were used in the tests. The $30 \pm 5^\circ\text{C}$ tests used polyethylene containers, the $90 \pm 5^\circ\text{C}$ tests used stainless steel containers. (The water had not yet been added to the containers shown in Figure 2.) The crevice specimens, held together by clamps insulated with PTFE, can be seen in the specimen arrays. The specimens were inserted into the perlite to a depth of 64 mm (2.5 in.), which left 50 mm (2 in.) of specimen protruding above the perlite level. Pan water was added to the high-water-level tests until the level of water was 10 ± 5 mm (0.4 ± 0.2 in.) above the level of the perlite. Oxygen concentration cells were produced on specimens in this test; oxygen was reduced in the cathodic region of the cell at the air-water interface,

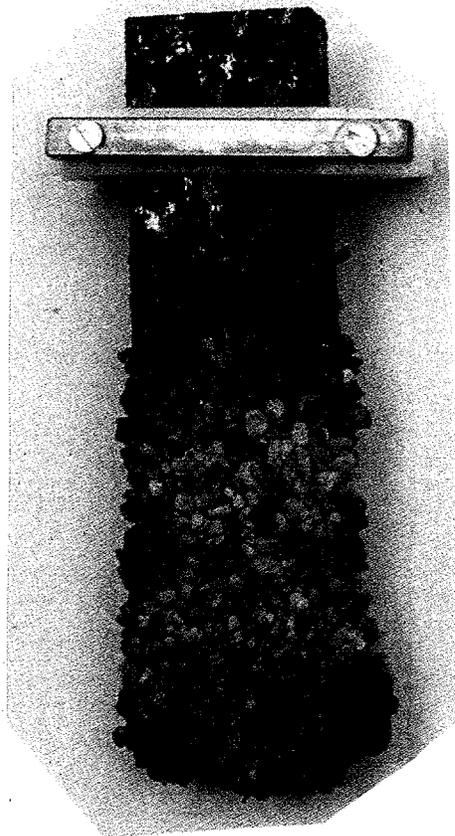
FIGURE 3. Typical Appearance of Specimens Upon Removal from the 30°C Low-Water-Level Test (left) and the 30°C High-Water-Level Test (right), 30-Month Exposure. Specimens shown are crevice-type specimens before disassembly. They are encrusted with corrosion product and embedded perlite particles. Specimens are shown approximately 90% actual size.

When the specimens were removed from the perlite, they were typically covered with a mass of corrosion product (typical hydrated iron oxides, or "rust") with embedded perlite particles. The appearance of the specimens after the 30-month test period is shown in Figures 3 and 4. The crevice specimens were arbitrarily selected for these figures--the "single" coupons displayed a similar appearance.

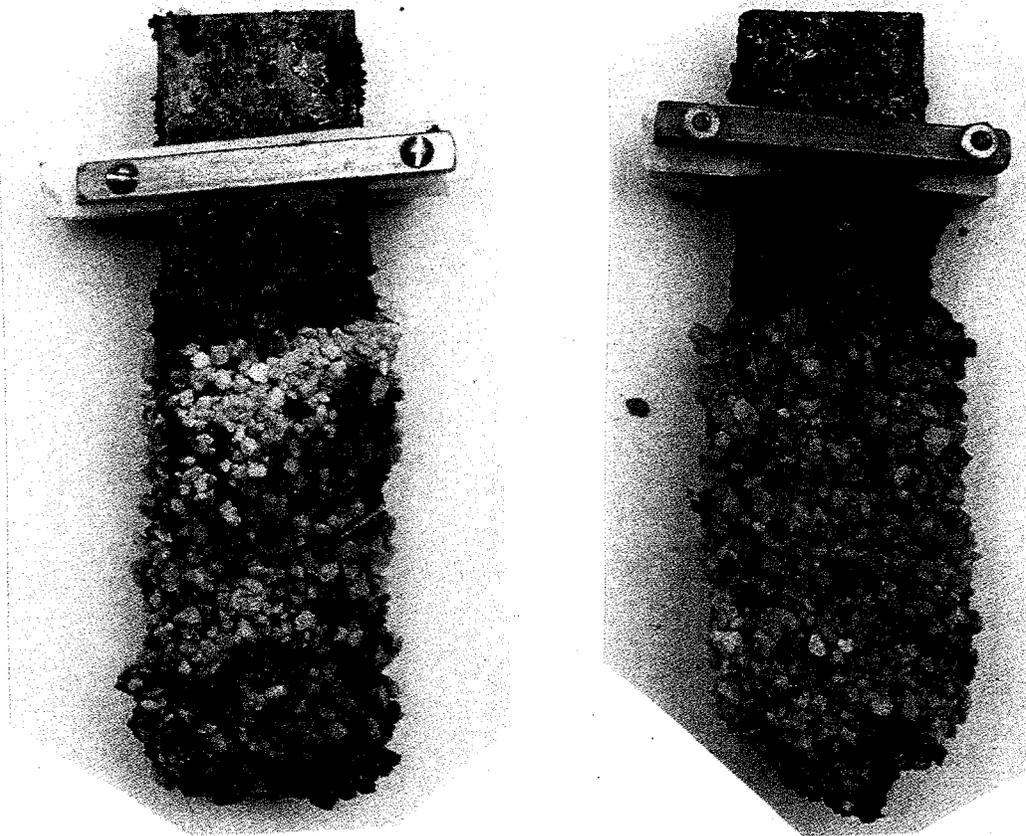
FIGURE 4. Typical Appearance of Specimens Upon Removal from the 90°C Low-Water-Level Test (left) and the 90°C High-Water-Level Test (right), 30-Month Exposure. Specimens shown are crevice-type specimens before disassembly. They are encrusted with corrosion product and embedded perlite particles. Specimens are shown approximately 90% actual size.

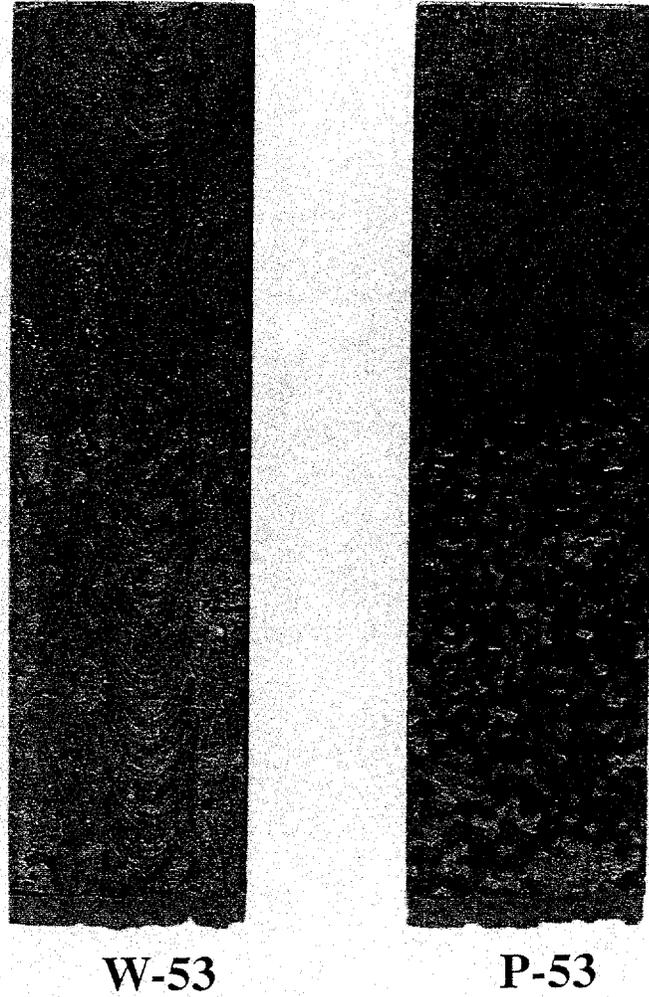
FIGURE 5. Typical Appearance of Cleaned Specimens After 30-Month Exposure, 30°C, Low-Water-Level Test. Specimens shown approximately actual size.

The appearance of the specimens after corrosion product removal in inhibited HCl solution is shown in Figures 5 through 9. The relatively aggressive nonuniform attack is evident from the figures. It is also evident that the higher temperature produced a significantly greater degree of attack. It was noted earlier (progress report, PNL to WVNS, November 22, 1993) that significant attack occurred in what would ordinarily be considered the "vapor phase" region of the test specimen. This phenomenon was again observed, e.g., Figure 7 in this report. Water apparently migrated up the coupon via the corrosion product layer, and would be expected to become enriched in electrolytes through evaporation. The phenomenon produced pits of significant depths, possibly because of the ready availability of oxygen and a relatively high ionic strength electrolyte.

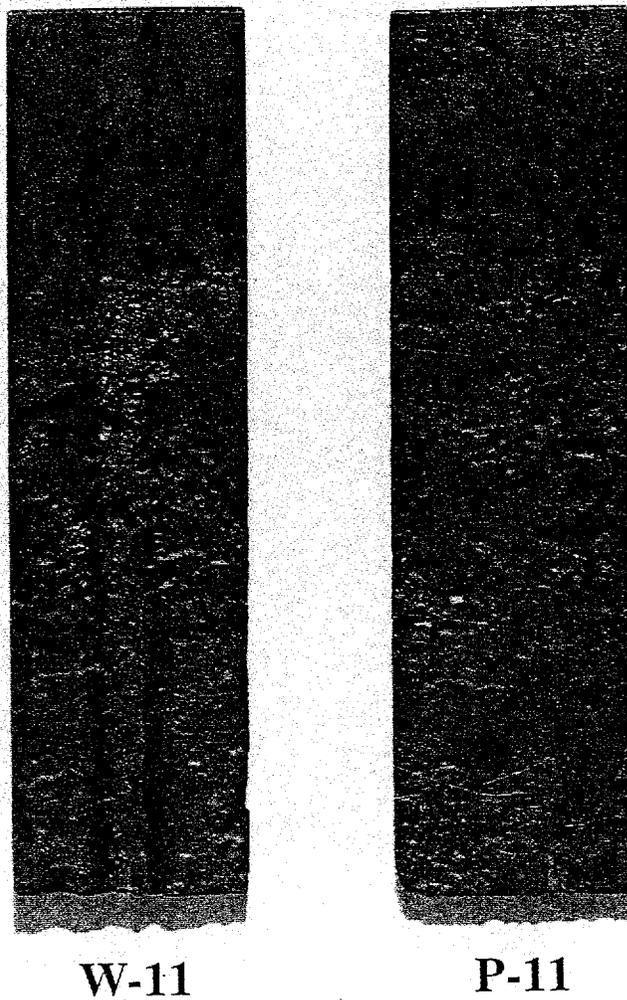
FIGURE 8. Typical Appearance of Cleaned Specimens After 30-Month Exposure, 90°C, High-Water-Level Test. The root side of the weldment of Specimen W-11 is shown in the figure. Specimens shown approximately actual size.

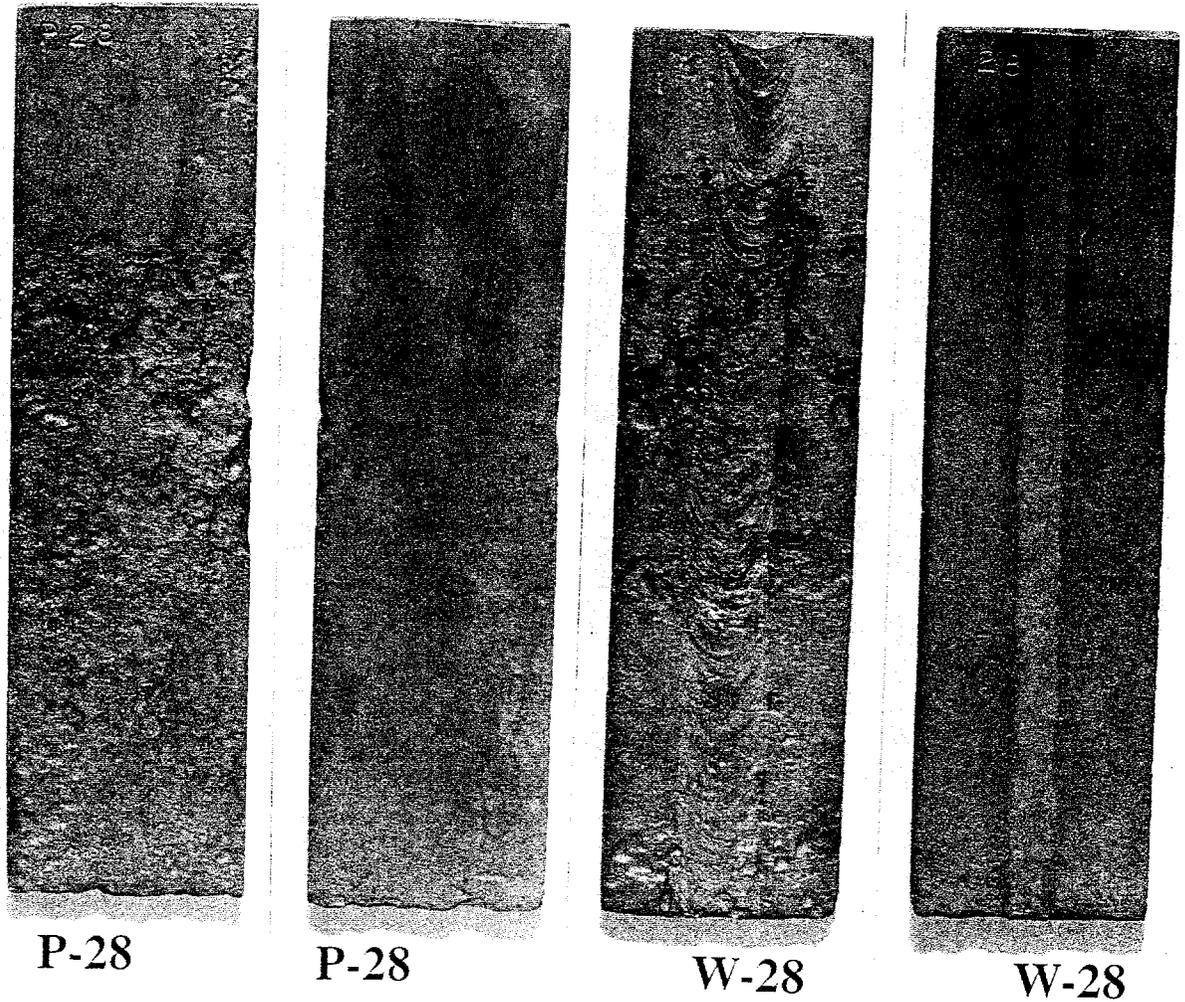
FIGURE 9. Appearance of Cleaned Components of Crevice Specimen W-28/P-28, 90°C, Low-Water-Level Test, 30-Month Exposure. The severely corroded surfaces (P-28, left; W-28, left) were the external surfaces of the crevice specimens. The internal surfaces exhibited much less corrosion attack than the external surfaces, and there was no evidence of true crevice corrosion. Specimens shown approximately actual size.

The internal surfaces of the crevice coupons showed very little attack, in all cases, compared to the external surfaces. The appearance of a typical crevice specimen is shown in Figure 9. In the case of the welded specimens, no unusual corrosion attack appeared to be associated with any of the features of the weldment (e.g., bead or heat-affected zone).

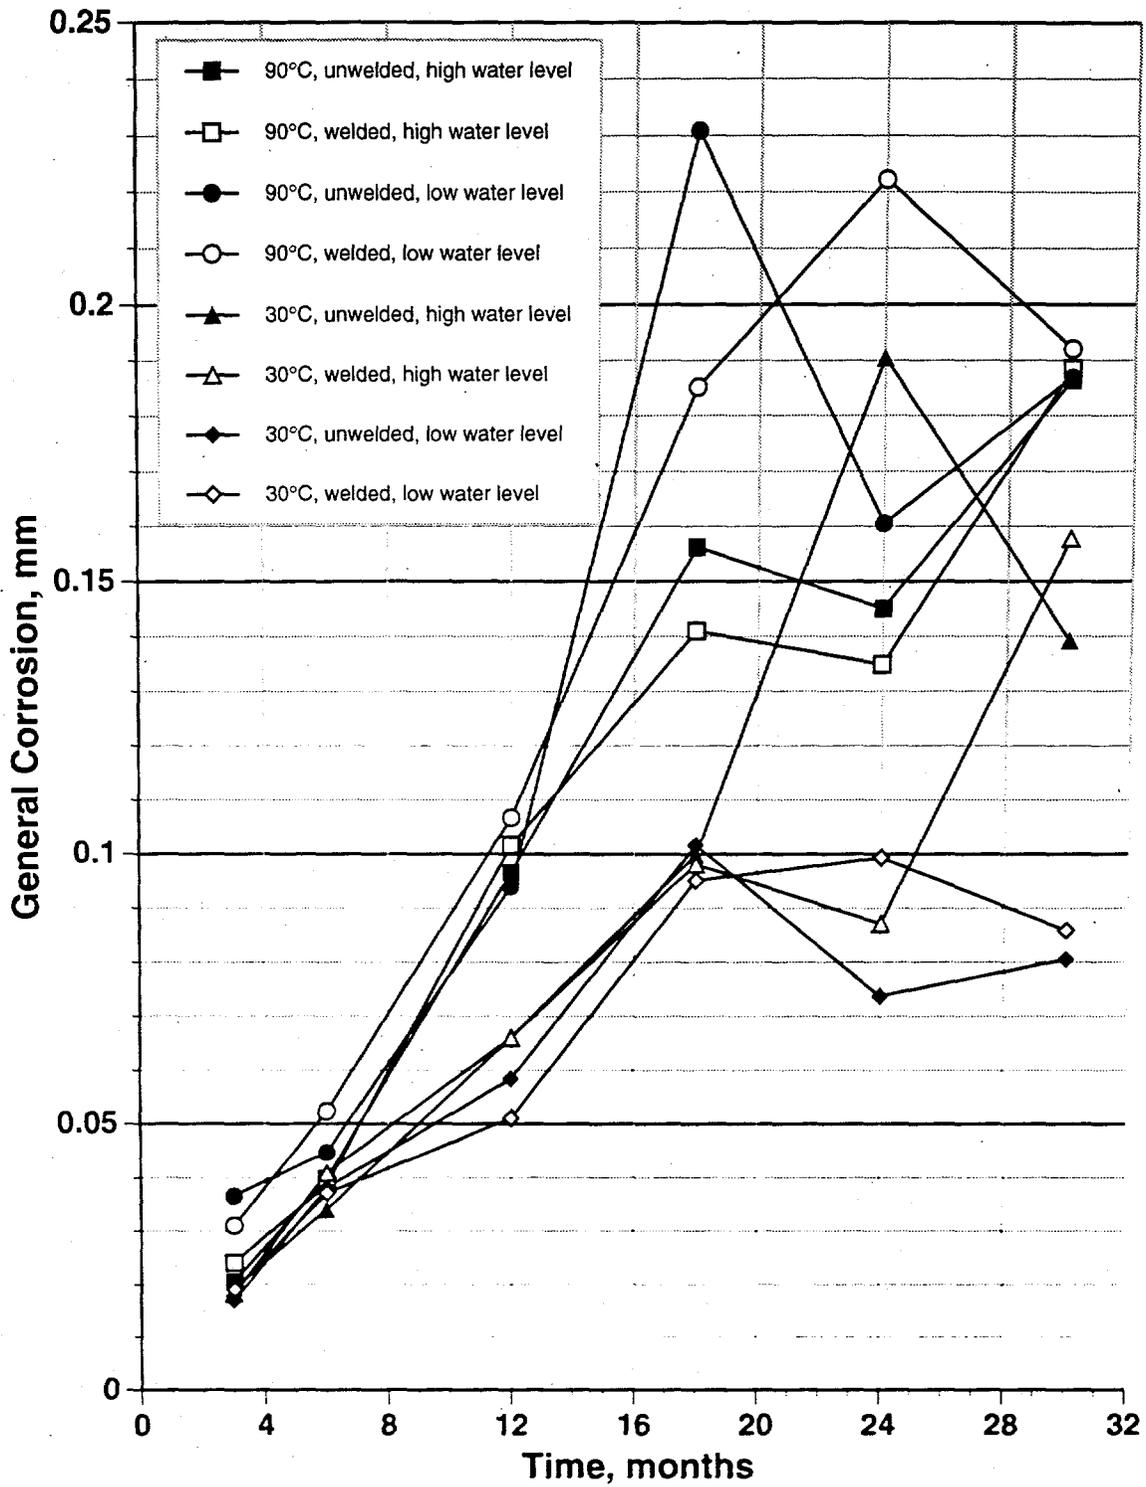
FIGURE 10. General ("Uniform") Corrosion as a Function of Exposure Time

The quantification of the general ("uniform") corrosion attack by gravimetric methods is shown in Figure 10. Data for all the test exposures are included in the figure. In using gravimetric data to compute the average, or "uniform," penetration results from the test coupons, it was assumed throughout the study that only the immersed or embedded area of the single coupons would be considered the affected area in the metal penetration computation, and that only the outside regions of the crevice coupons, immersed or embedded, would be considered the affected area in the penetration computation. Such assumptions cause computational errors in the "conservative" direction. That is, the calculated corrosion rates will be somewhat higher than the actual rates for coupons undergoing significant corrosion outside of the areas defined, including coupons undergoing corrosion in the "vapor phase" region.

There is a great deal of scatter in the data presented in Figure 10, at least partially because each data point after 12 months is the result of the analysis of only one specimen. The curves appear to exhibit a definite "leveling off" tendency with increasing time, but the data are not of long enough duration and the data scatter is too great to attempt a quantification of the rate diminution versus test time.

The effect of temperature is obvious on the general corrosion observed; no other variable, i.e., welded versus unwelded or water level had a significant effect on the overall test results. The range of general corrosion rates shown in the figure is not significant from the standpoint of tank integrity, as an extrapolation of the slopes of the curves would result in a long-term maximum corrosion rate of only <0.10 mm/yr (<4 mpy).

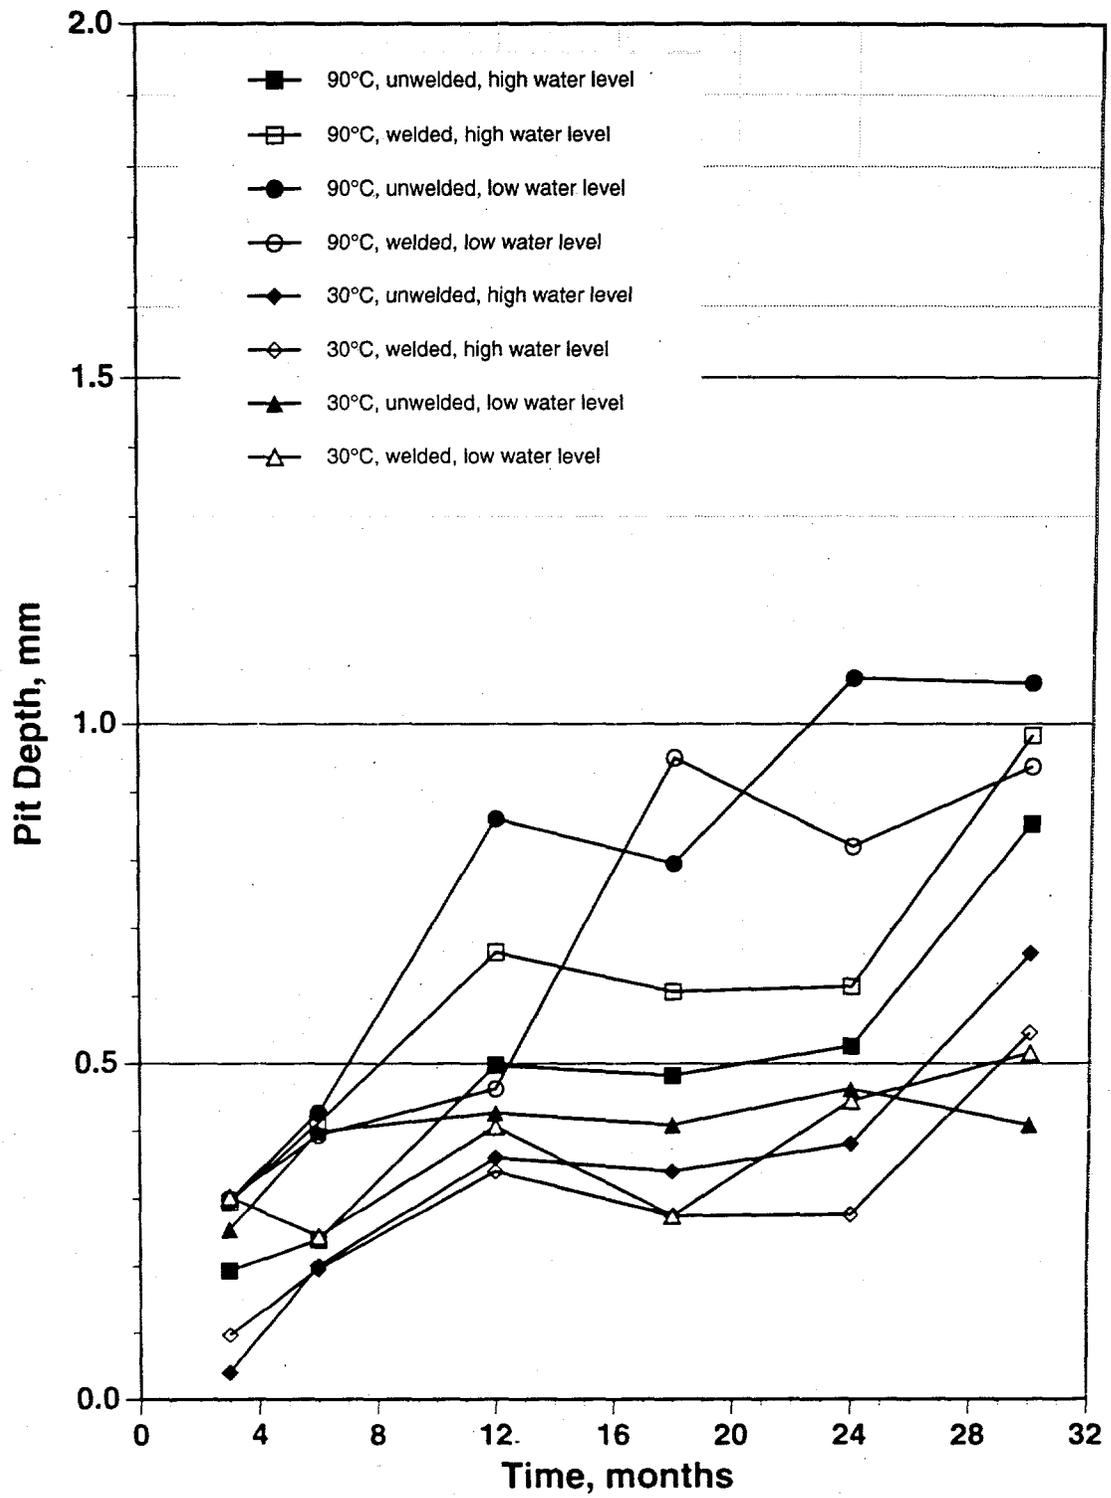
FIGURE 11. Average Pit Depth as a Function of Exposure Time

Though in any given structure the deepest pit is potentially the most important, the data of Figure 11 are intended to show whether a general diminution in rate is observed with time. The data of Figure 12 are intended to show the severity of the observed pitting, and whether the rate of deepening of the most advanced pits tends to slow with time. The data plots of Figures 13 through 15 are intended to display the range of pit depths observed in the longest duration tests, the changes in the pit-depth distribution with time, the potential effects of welded versus nonwelded regions of the tank walls, and to call out the appearance of pits in "unexpected" regions of the test specimens (such as the region in the vapor phase).

The rate of increase of pit depth (Figure 11) shows a definite decrease with time of exposure. The curves are essentially "flat" between 12 months and 30 months. A different picture emerges, however, when the maximum pit depth is plotted as a function of test time (Figure 12). This plot shows a pit-deepening rate (of the deepest pits) of ~0.25 mm/yr (~10 mpy), both for the 30°C tests and the 90°C tests, with unusually deep "vapor phase" pits observed in the 90°C tests (Figures 13, 14, 15). These very deep pits are associated with pit-deepening rates >0.5 mm/yr (>20 mpy), at the longest term (30-month) test duration.

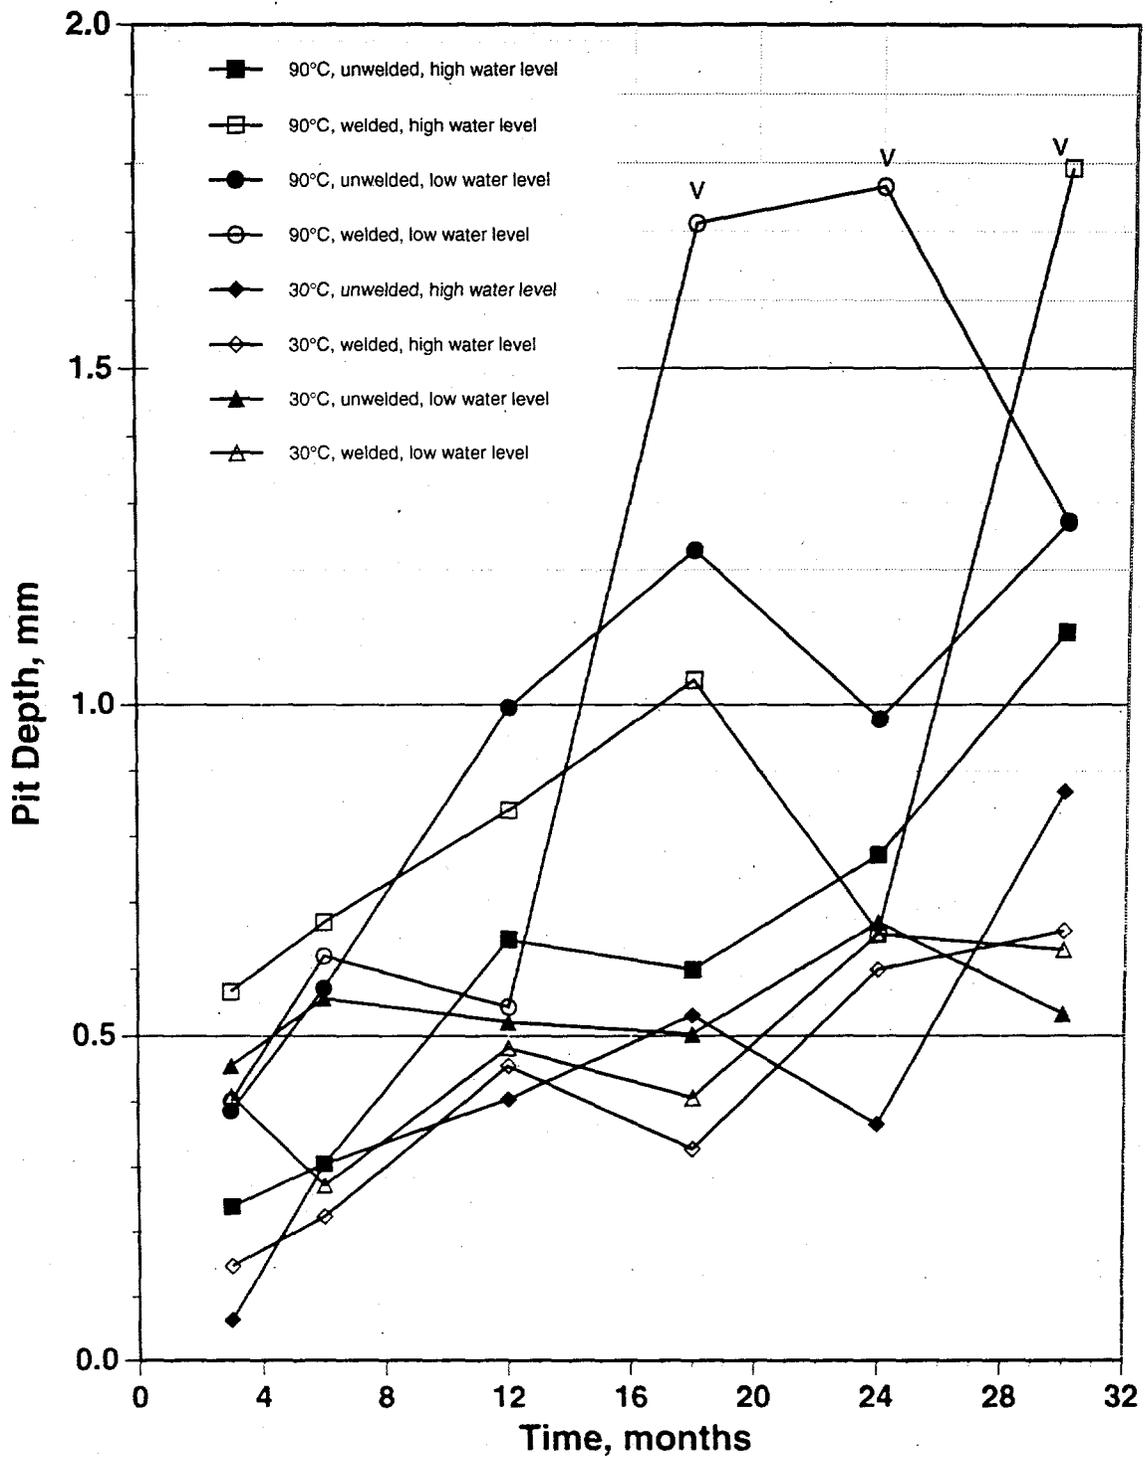
FIGURE 12. Maximum Pit Depth as a Function of Exposure Time. The three deepest pits (~1.8 mm deep) formed in the "vapor-phase" region of the test specimens; they are labeled with a "V" in the figure.

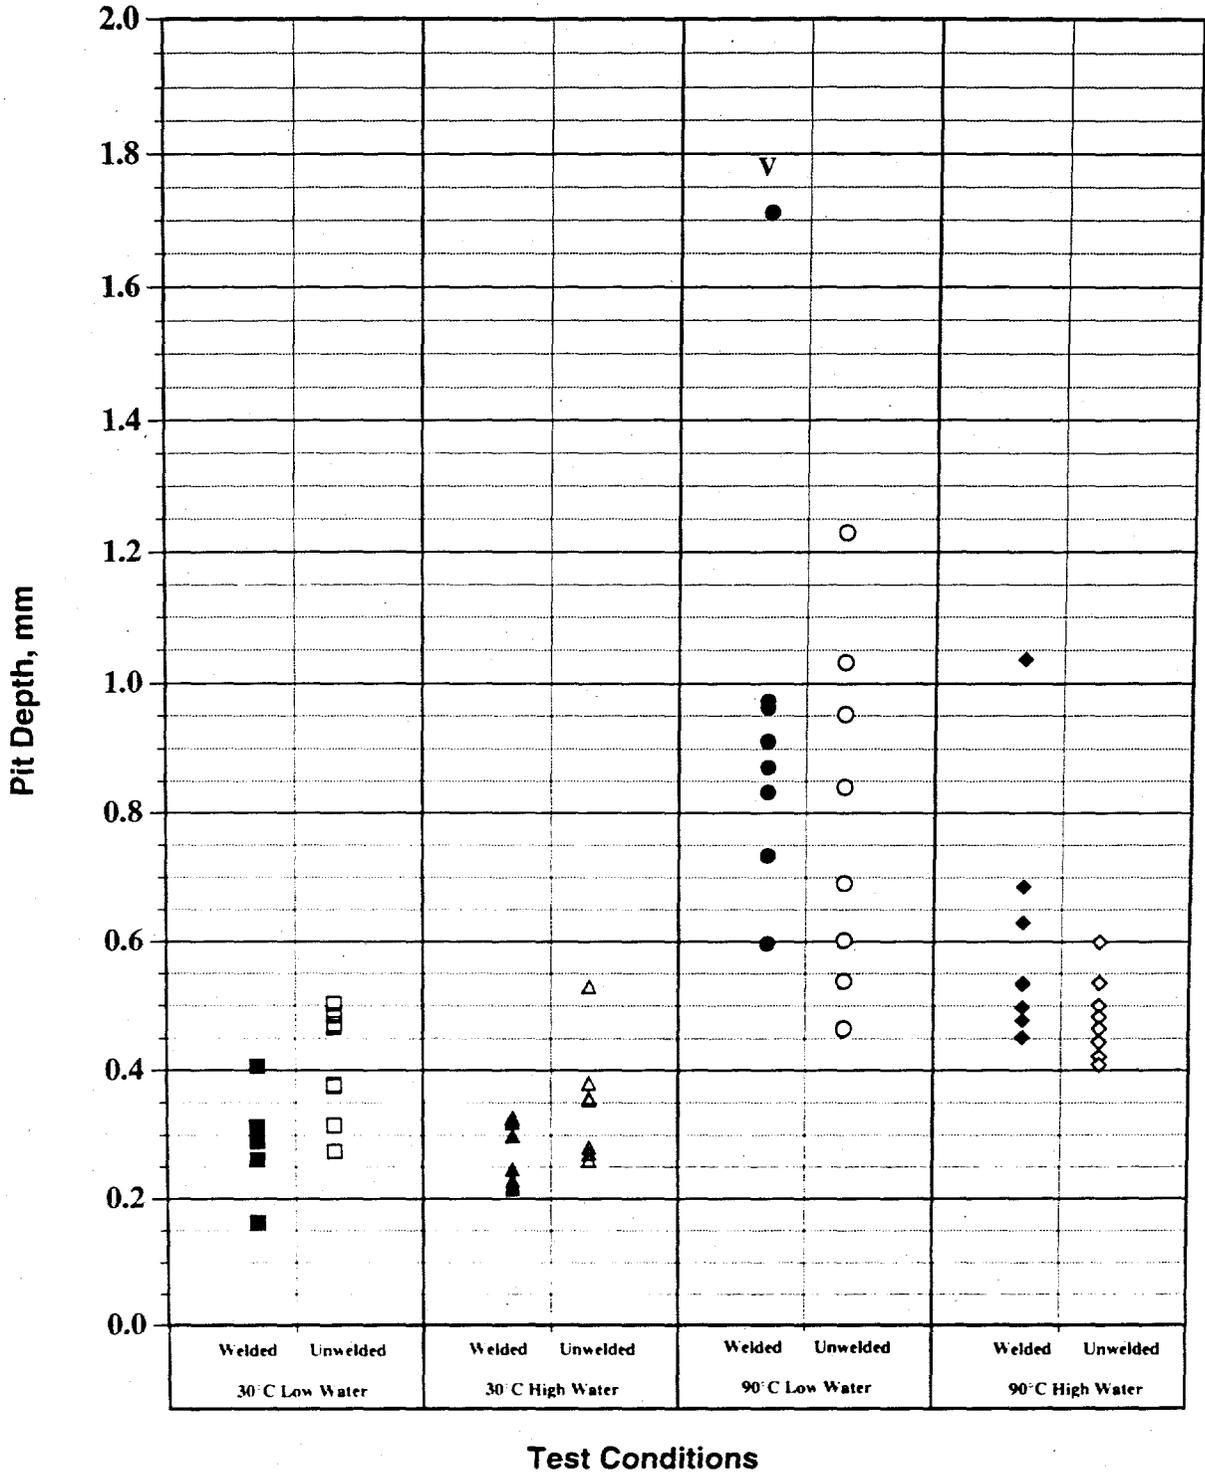
FIGURE 13. Pit Depth Measurements After 18-Month Exposure.
 V = "vapor phase" region of specimen.

The uniform corrosion, however, is not the principal concern to the integrity of tanks 8D-1 and 8D-2; nonuniform corrosion, such as that associated with pitting (on a small scale) or an oxygen concentration cell acting at a water-air interface (on a large scale) is of more concern. The average and maximum pit-depth results for all of the test exposures are shown in Figures 11 and 12, respectively. The individual data points for the 18-, 24-, and 30-month tests are shown in Figures 13 through 15. The data used to generate the figures are tabulated in Tables 4, 5, and 6.

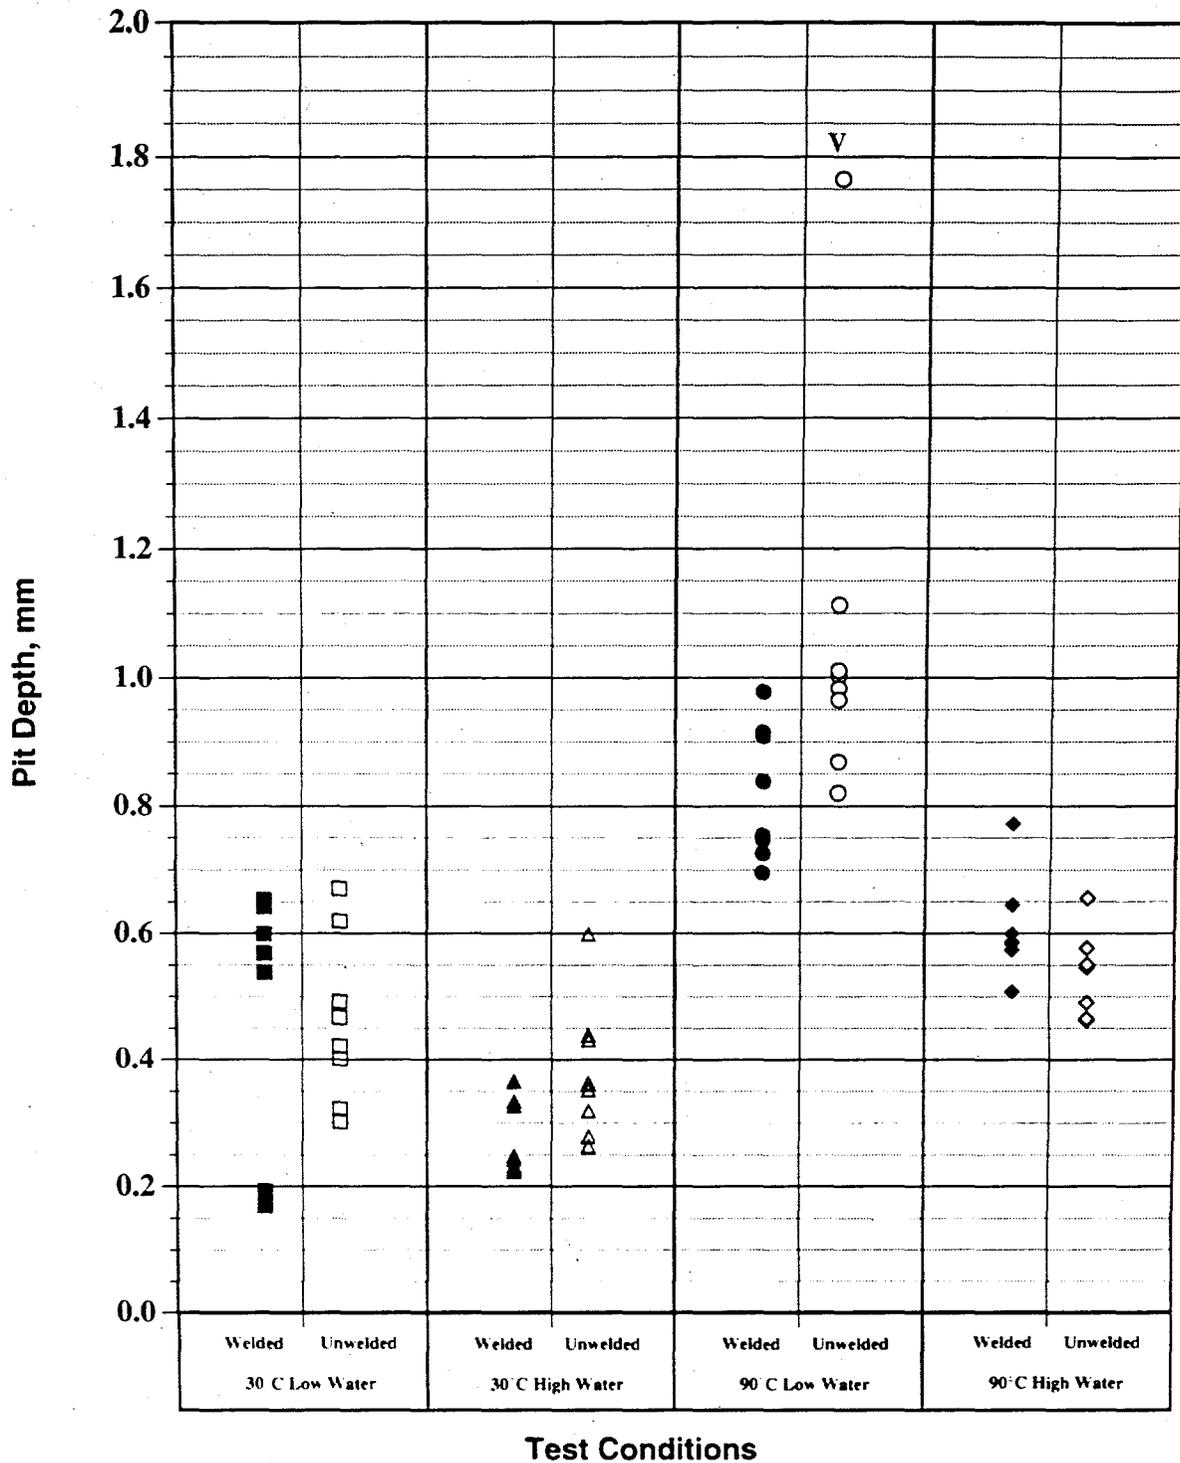
FIGURE 14. Pit Depth Measurements After 24-Month Exposure.
 V = "vapor phase" region of specimen.

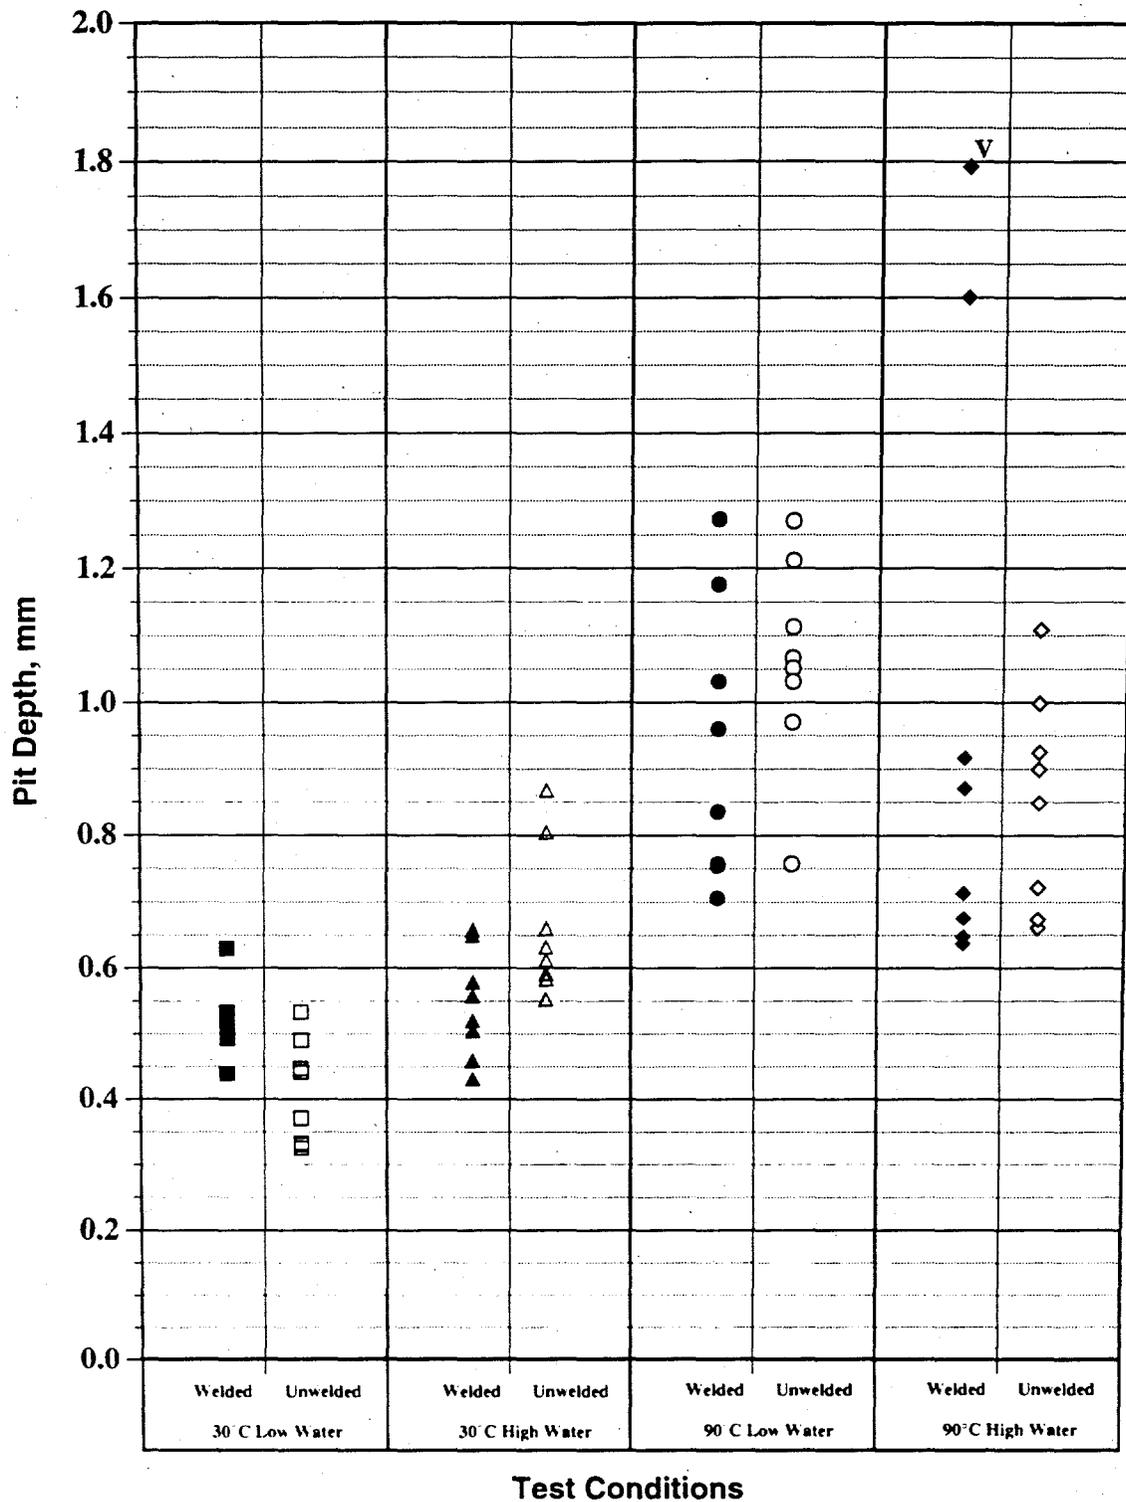
FIGURE 15. Pit Depth Measurements After 30-Month Exposure.
 V = "vapor phase" region of specimen.
