# Piping Inspection Round Robin

Prepared by  
P. G. Heasler, S. R. Doctor

Pacific Northwest National Laboratory  
Operated by  
Battelle Memorial Institute

Prepared for  
U.S. Nuclear Regulatory Commission

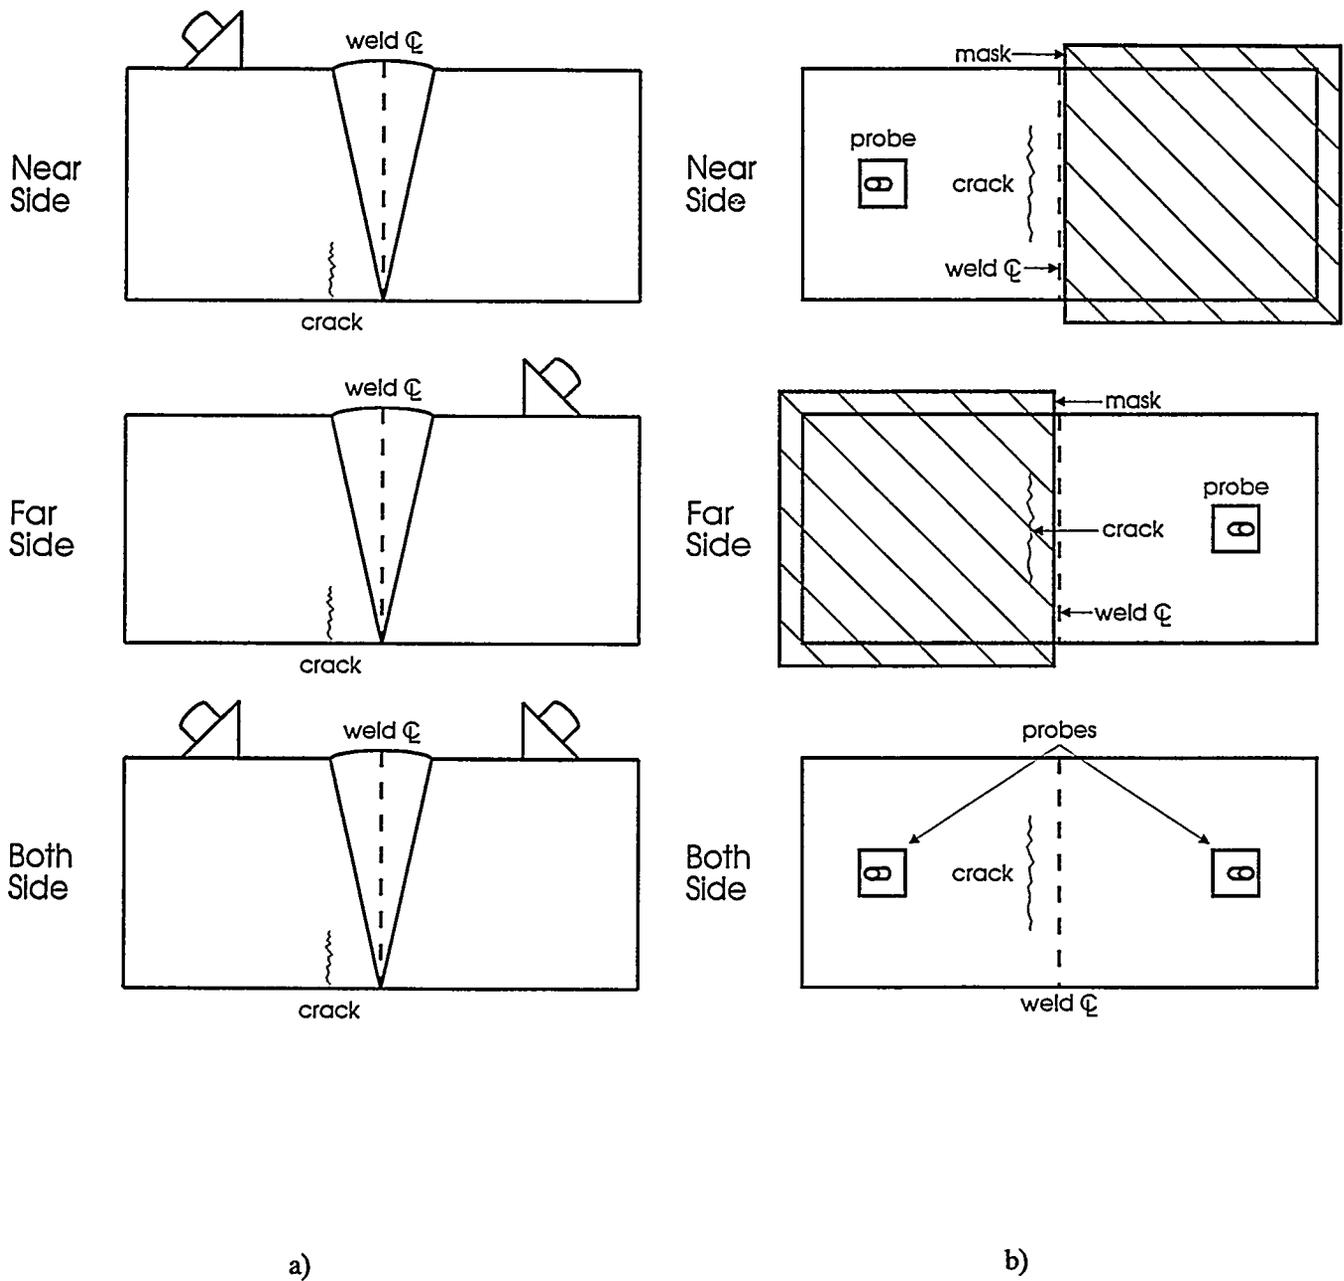
Figure 2.5 Illustrations Showing Near, Far and Both Side Access in a) Cross-sectional View, and b) Plan View.

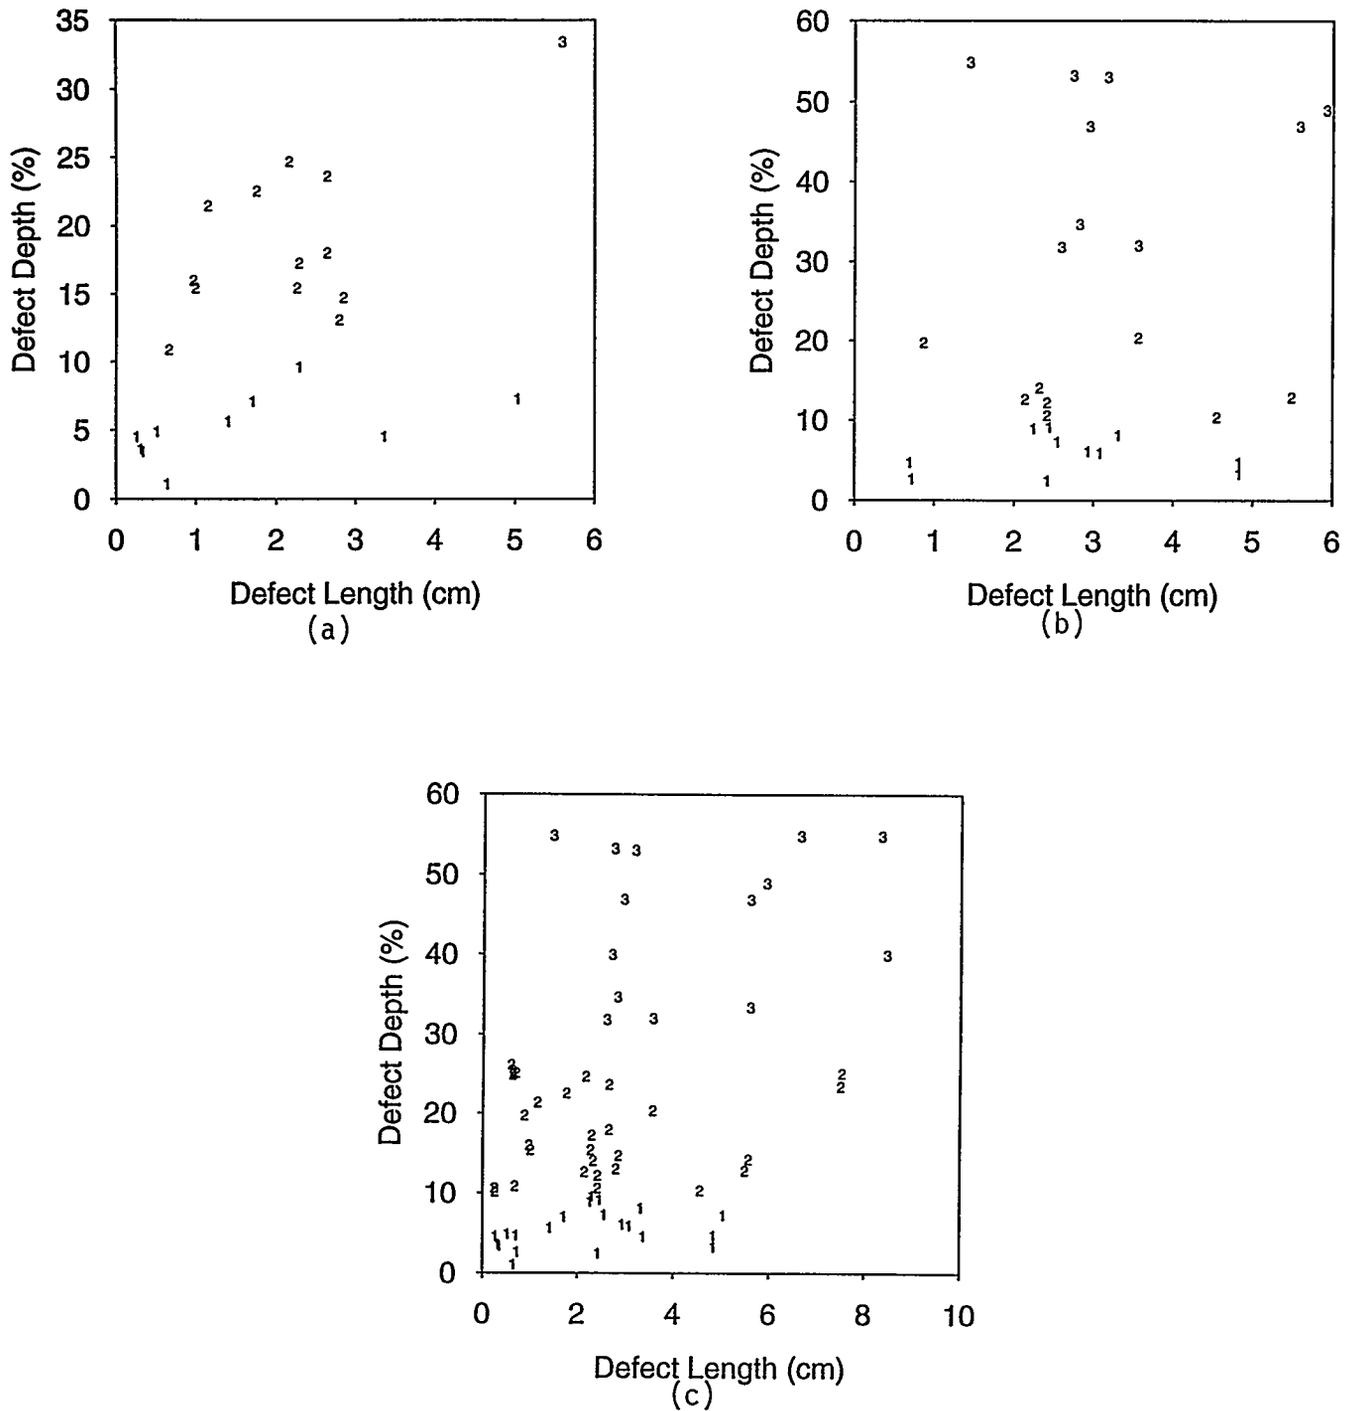
**Figure 2.8** Defect Size Categories for Wrought Stainless Steel Cracks for 10 in. (25.4 cm) diameter, either 0.594 in. (1.51 cm) or 0.5 in. (1.27 cm) wall. a) IGSCC, b) TFC, and c) IGSCC and TFC

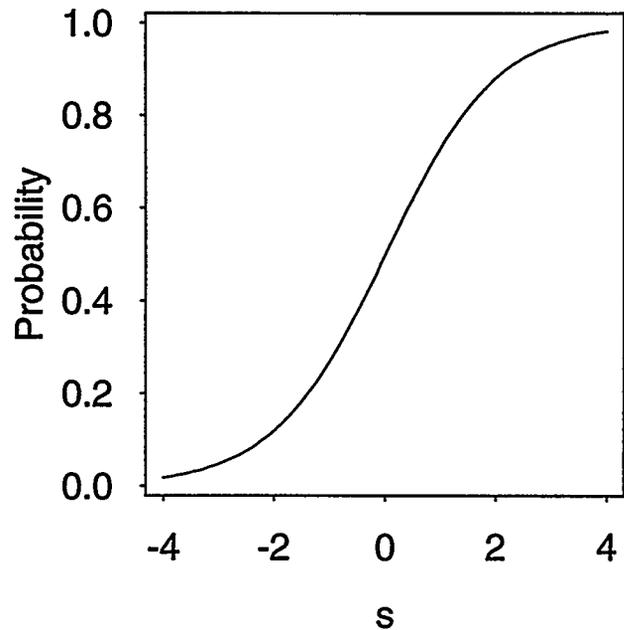
Figure 5.1 Plot of Logistic Function

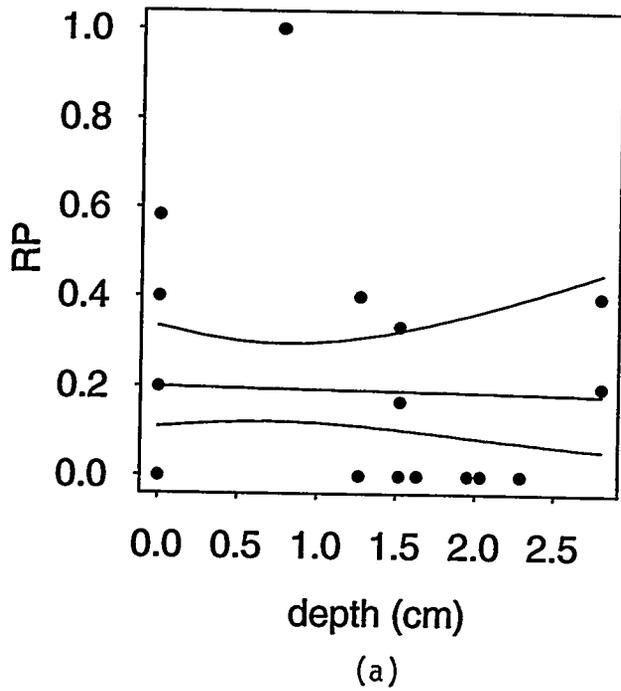
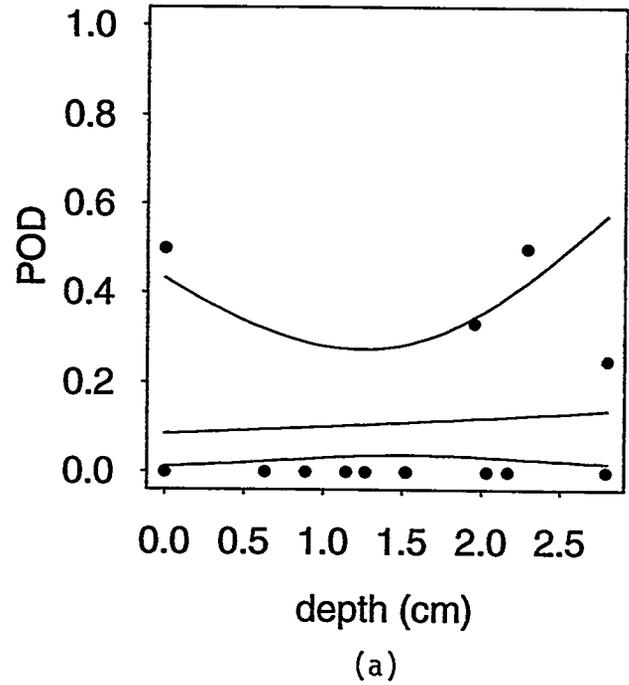
Figure 5.5 Logistic Curve Fit to RP Data with 95% Bounds (Cast Stainless Steel, Far-Side Inspections, All Teams) a) POD vs. Depth b) POD vs. Length

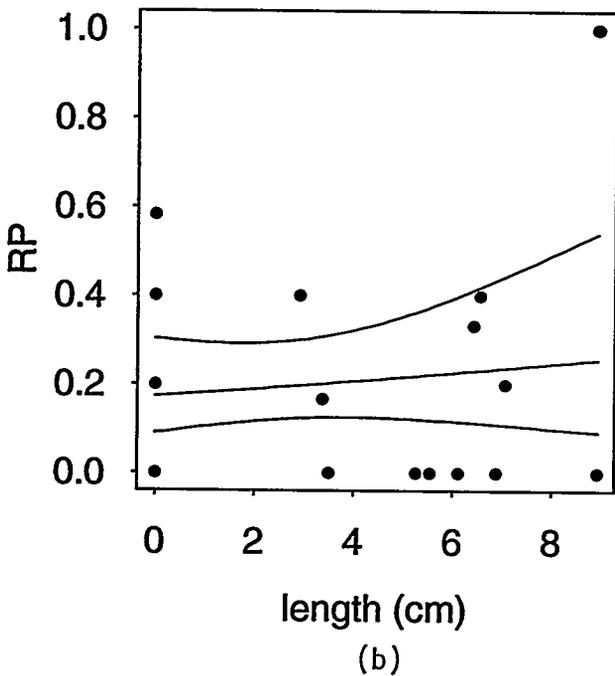
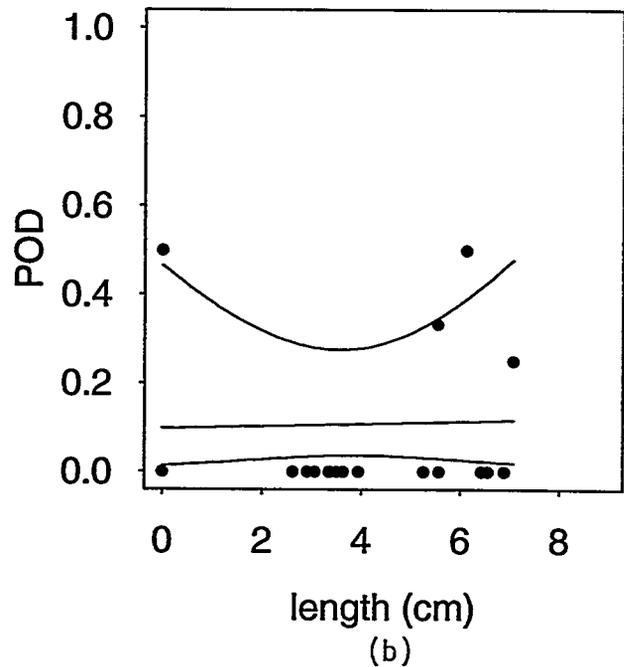
Figure 5.6 Logistic Curve Fit to POD Data with 95% Bounds (Cast Stainless Steel, Near-Side Inspections, Team #1) a) POD vs. Depth b) POD vs. Length

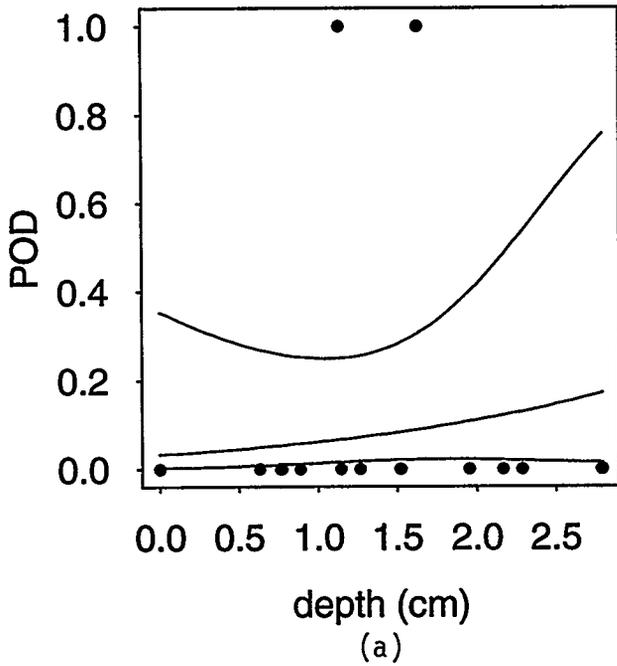
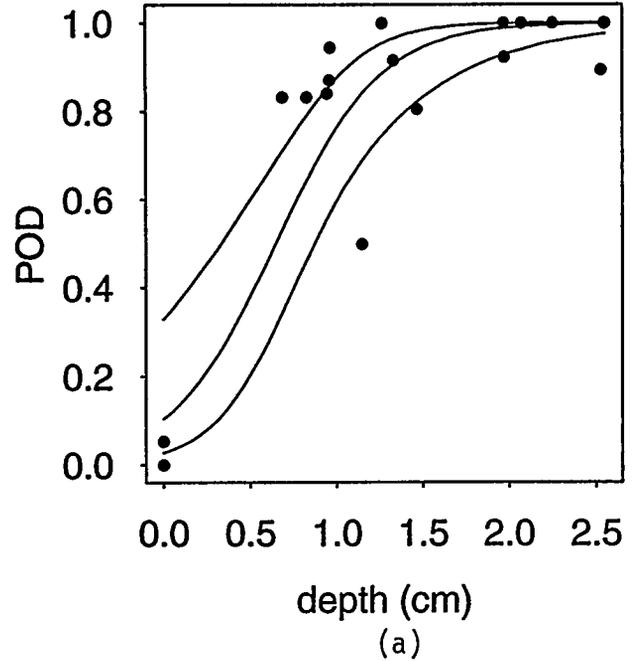
Figure 5.11 Logistic Curve Fit to POD Data with 95% Bounds (Cast SS, Near-Side Inspections, Team #7)  
 a) POD vs. Depth b) POD vs. Length

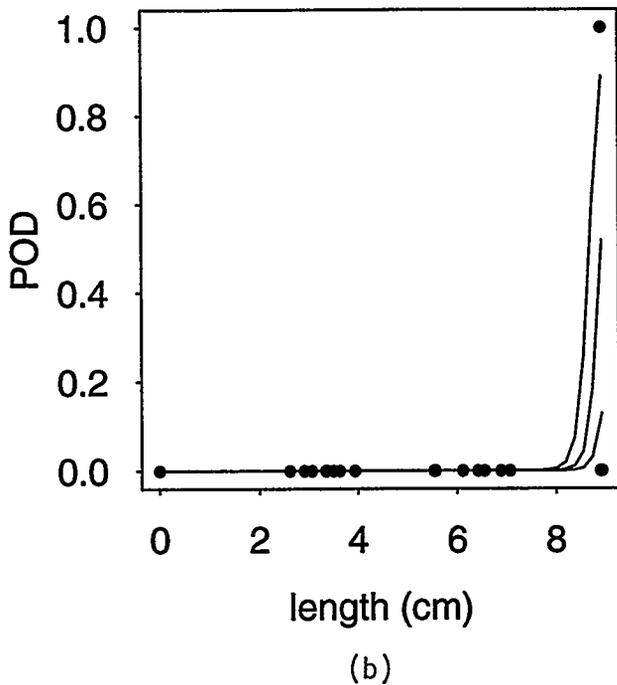
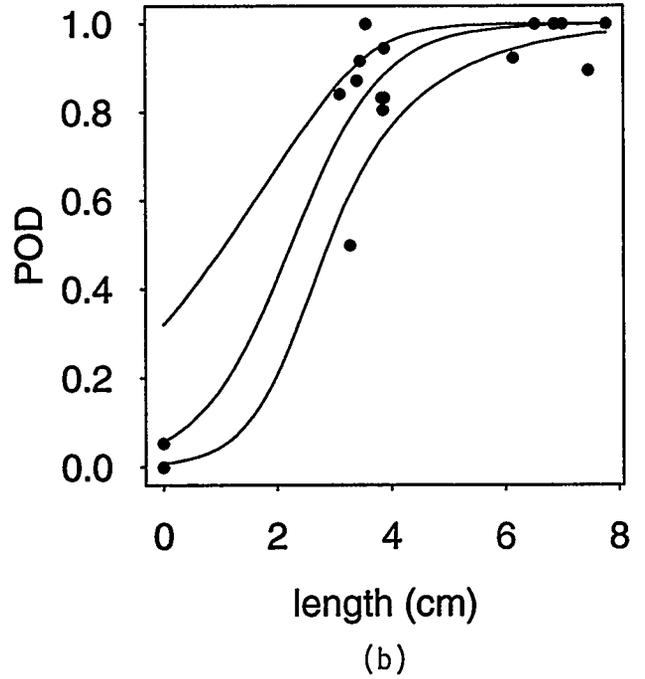
Figure 5.12 Logistic Curve Fit to POD Data with 95% Bounds (Clad Ferritic, All Teams) a) POD vs. Depth  
 b) POD vs. Length

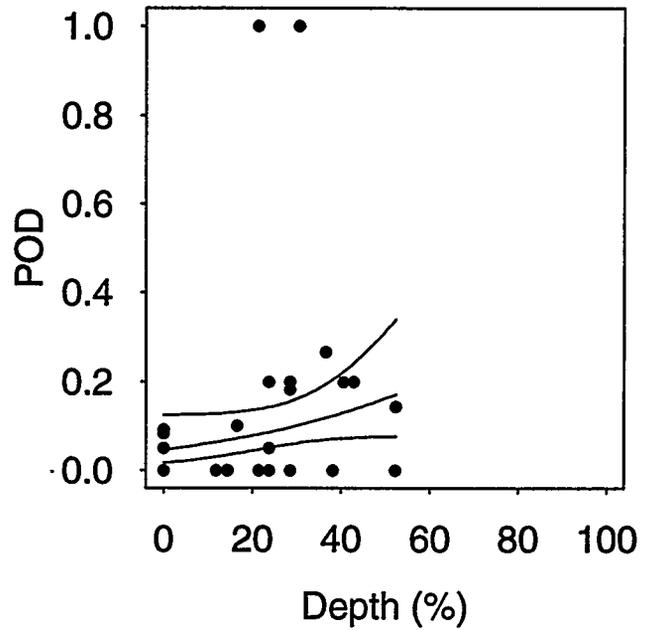
Figure 5.40 Logistic Curve Fit to POD vs. % Through-Wall Depth Data with 95% Confidence Bounds (Cast Stainless Steel, Near-Side Inspection, All Teams)

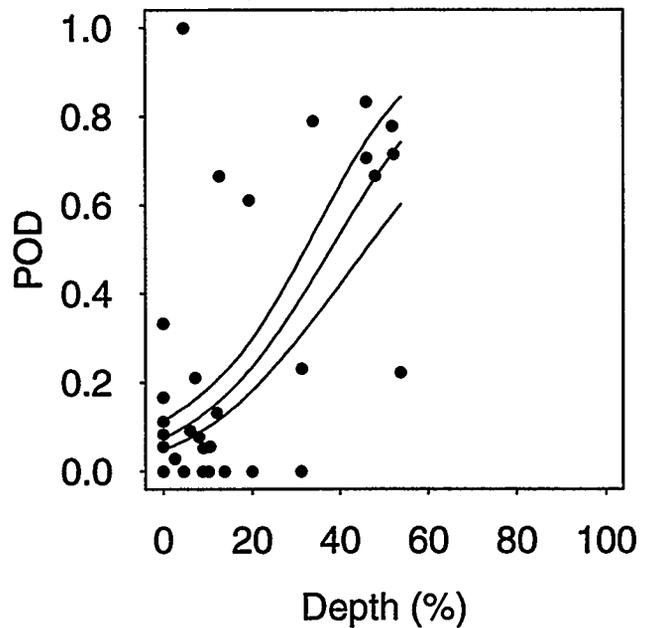
Figure 5.41 Logistic Curve Fit to POD vs. % Through-Wall Depth Data with 95% Confidence Bounds (Wrought Stainless Steel with TFC, Near-Side Inspection, All Teams)

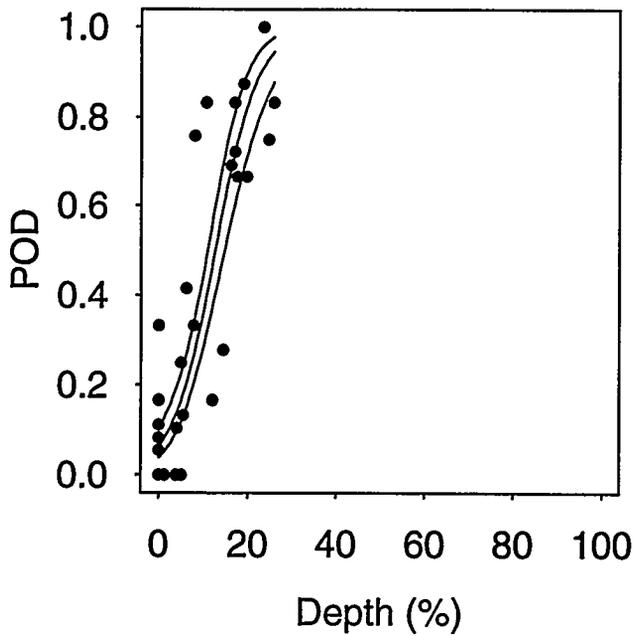
**Figure 5.42** Logistic Curve Fit to POD vs. % Through-Wall Depth Data With 95% Confidence Bounds (Wrought Stainless Steel with IGSCC, Near-Side Inspection, All Teams)

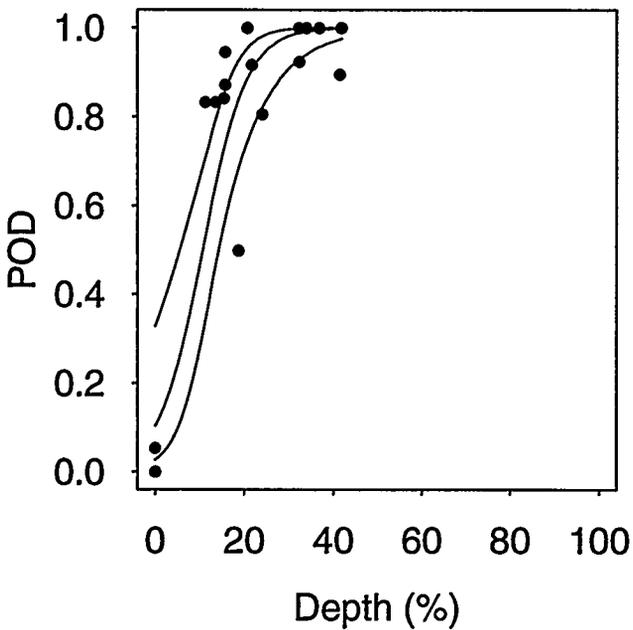
**Figure 5.43** Logistic Curve Fit to POD vs. % Through-Wall Depth Data With 95% Confidence Bounds (Clad Ferritic, Combined Near- and Far-Side Inspection, All Teams)

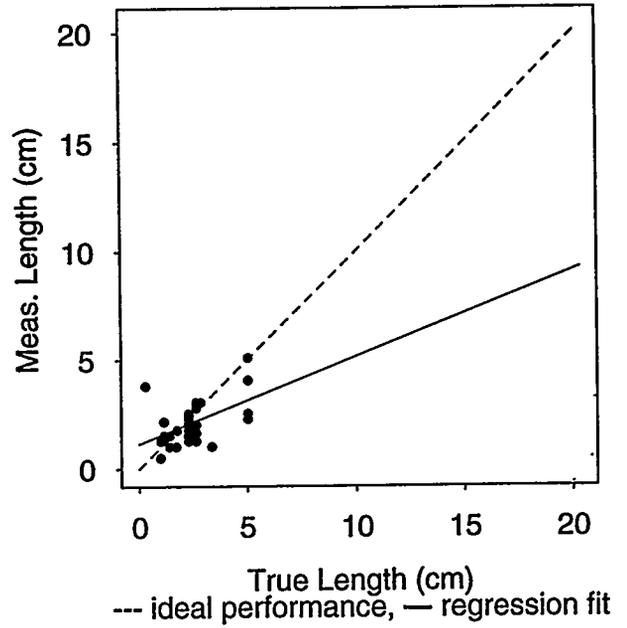
Figure 7.18 Regression Fit of Length Measurements  
(Team #5, Wrought Stainless Steel, IGSCC)
