INEEL/CON-01-01450
PREPRINT

**Underground Corrosion of Activated Metals in
an Arid Vadose Zone Environment**

NACE 2002

UNDERGROUND CORROSION OF ACTIVATED METALS IN AN ARID VADOSE ZONE ENVIRONMENT

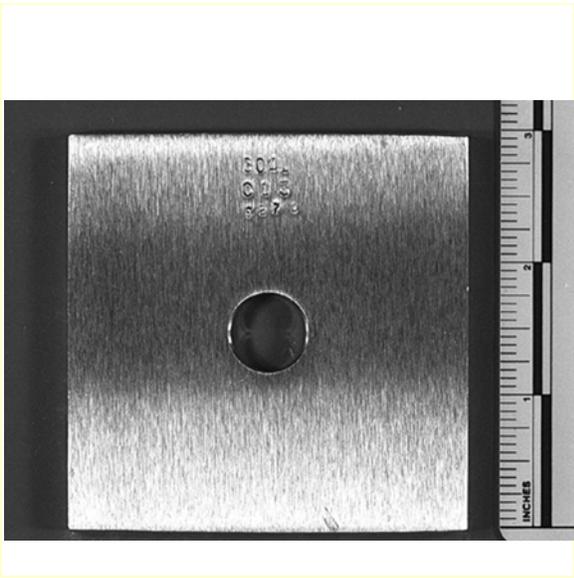
FIGURE 1. 304L stainless steel coupon.

Direct corrosion testing using buried coupons is the most widely used and simplest method of underground corrosion testing.^{1,2,3} Dimensions and mass are measured for metal coupons of known compositions before burial. The direct testing uses nonradioactive coupons of various metals and alloys selected to generally represent the irradiated metals buried at the disposal site. The materials included in the direct testing are Type 304L stainless steel, Type 316L stainless steel, welded Type 316L stainless steel, nickel-chromium alloy (UNS NO7718), beryllium, aluminum 6061, and zirconium alloy (UNS R60804). In addition, low-carbon steel (the material presently used in the disposal liners of the 55-ton scrap casks and other disposal liners and containers) and duplex stainless steel (a proposed material for construction of high-integrity disposal containers) are included as part of the test. The corrosion coupons are $3 \times 3 \times 1/8$ in. ($7.62 \times 7.62 \times 0.32$ cm) with a 0.56 in. (1.42 cm) diameter hole in the center. In general, the coupon surface finish is 120 grit (see Figure 1); however, the beryllium coupons, with a 125 RMS finish (see Figure 2), have the same surface finish as the beryllium waste disposed of at the disposal site. Twelve sets of 36 coupons were prepared and slated for testing. One complete set of coupons is stored and maintained as an archived set for comparison with the timed tests.

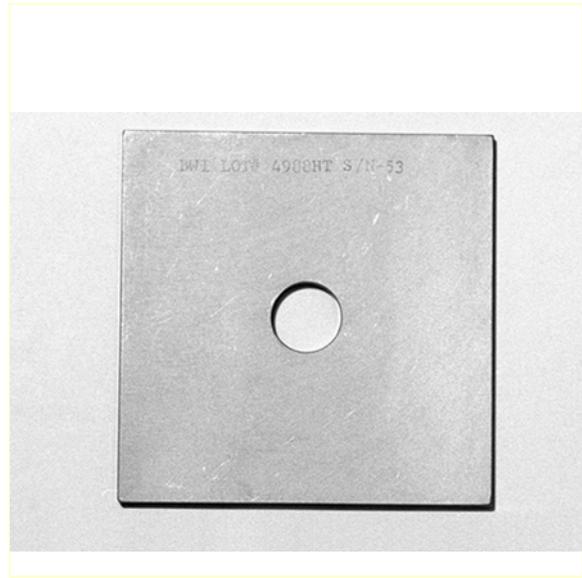
FIGURE 2. Beryllium coupon.

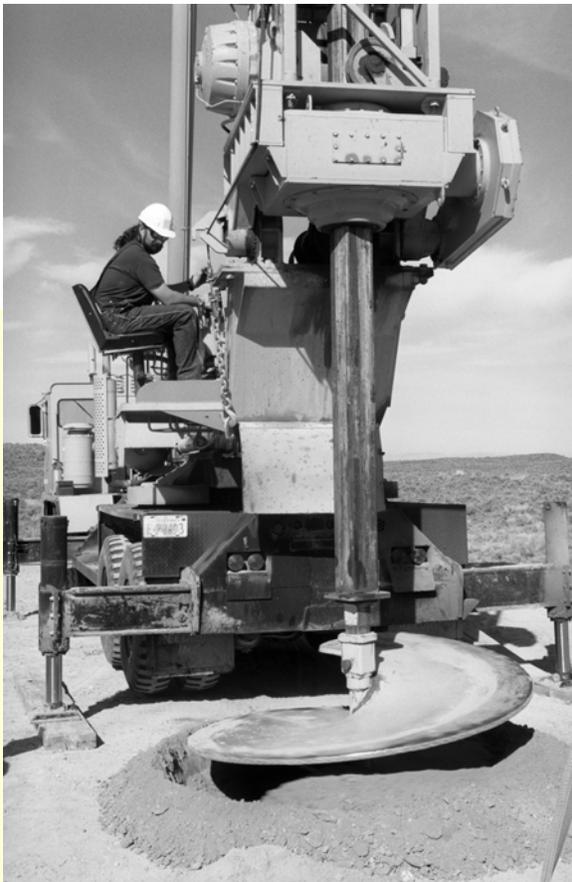
FIGURE 3. 6-ft diameter auger drill.

The long-term corrosion testing began in 1997 when a berm was constructed near the underground disposal site to test corrosion rates at two distinct depths: 4 ft (1.22 m) below surface and 10 ft (3.05 m) below surface. A 6-ft (1.83-m) diameter auger (see Figure 3) was used to drill holes in the berm for placement of the coupons. The coupons were installed as arrays, each consisting of a set of 36 coupons (four samples of each metal type) assembled on polypropylene rods with polytetrafluoroethylene (PTFE) tubing as spacers between coupons. Polypropylene and PTFE were selected because these materials are chemically inert and will electrically isolate the coupons from each other. Each end of the polypropylene rod has engraved PTFE identification markers and is secured with a threaded nylon nut. A coupon array (see Figure 4) was placed at each depth at four locations.

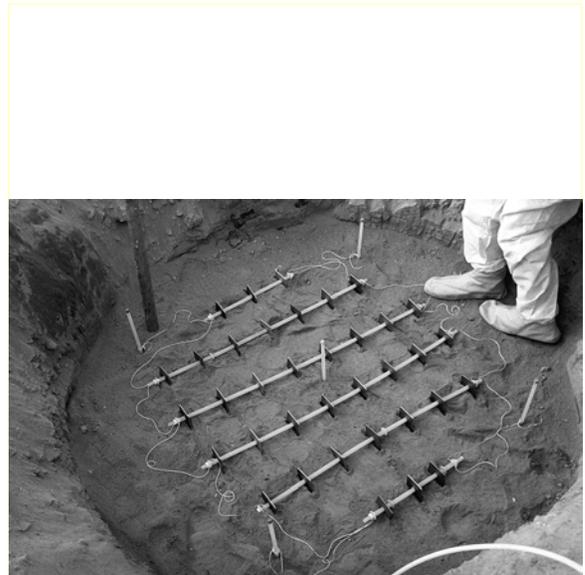
FIGURE 4. Coupon array.

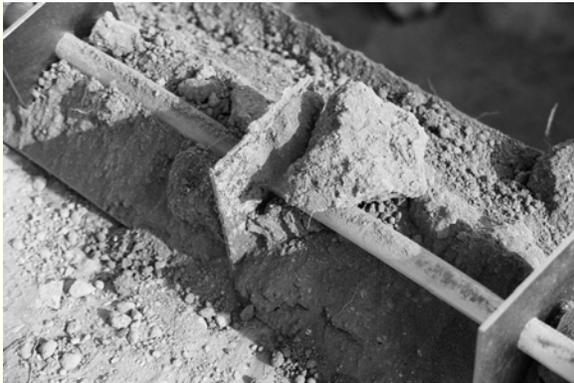
FIGURE 5. Carbon steel coupon on rod.

coupons were extracted carefully from the hole, with care not to lose the adhering soil around them (see Figure 5). The excavated coupons were double-bagged (see Figure 6) and transported to the appropriate laboratory and disassembled, and the corrosion products, including the potential presence of microorganisms, were sampled.

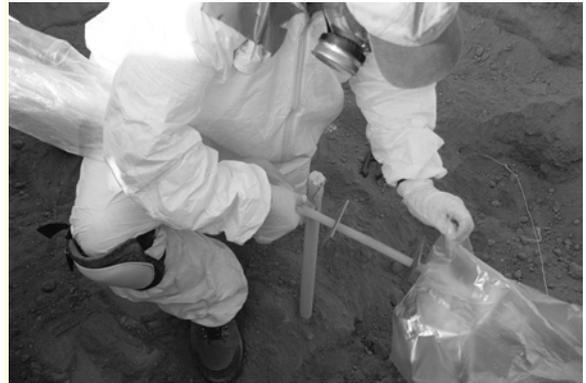
FIGURE 6. Double bagging coupons.

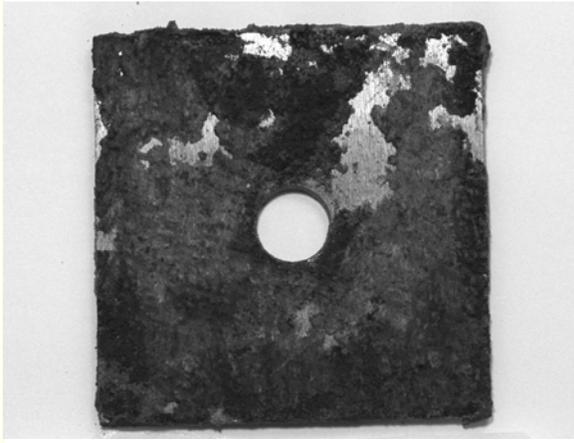
FIGURE 7. Carbon steel front - uncleaned.

The aluminum, beryllium, and carbon steel coupons all experienced pitting to some degree. Figures 7 and 8 are photographs of the front and back of a carbon steel coupon before cleaning (from the 10-ft (3.05-m) depth), and Figures 9 and 10 show the same specimen, front and back, after cleaning. Likewise, Figures 11 and 12 are photographs of the front and back of a beryllium coupon before cleaning (from the 10-ft [3.05-m] depth). Figures 13 and 14 show the same specimen, front and back, after cleaning. Pitting was evident in three metal types: aluminum, beryllium, and carbon steel. Table 3 details the pit depth measurements from six coupons with visibly deep-pitted surfaces.

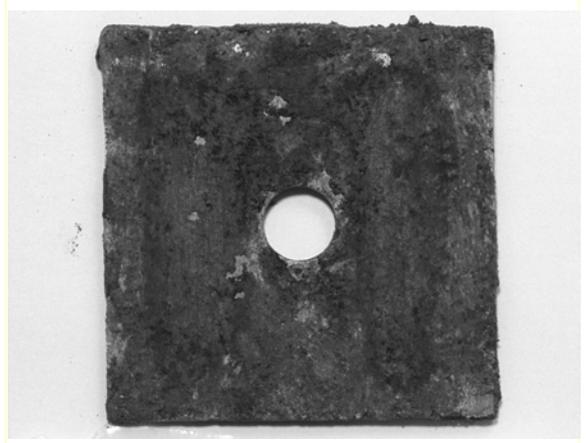
FIGURE 8. Carbon steel back - uncleaned.

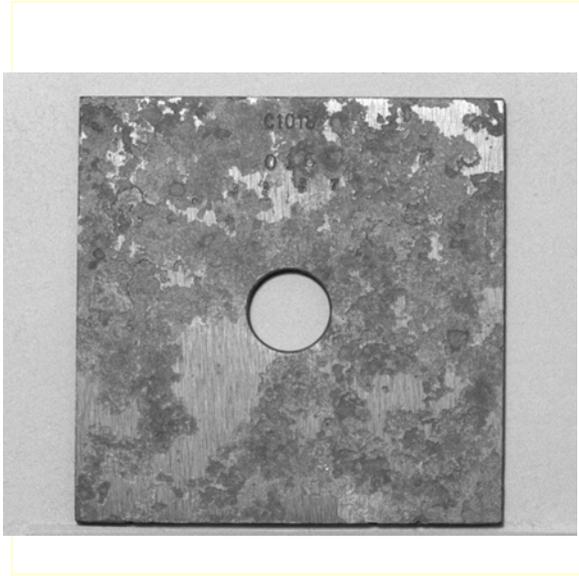
FIGURE 9. Carbon steel front - cleaned.

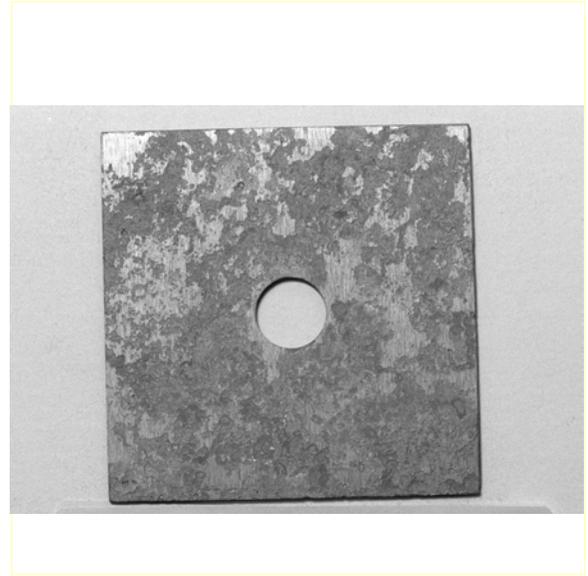
FIGURE 10. Carbon steel back - cleaned.

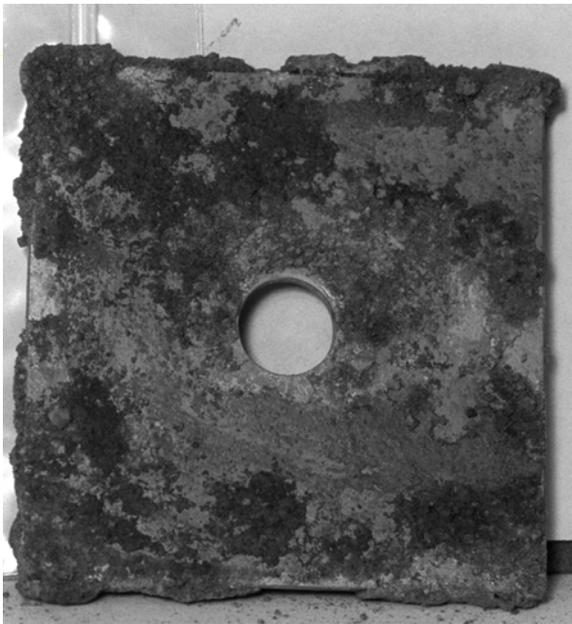
FIGURE 11. Beryllium front - uncleaned.

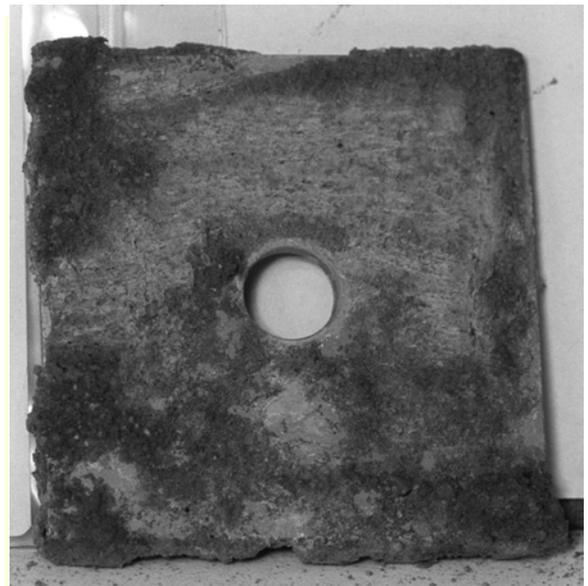
FIGURE 12. Beryllium back - uncleaned.

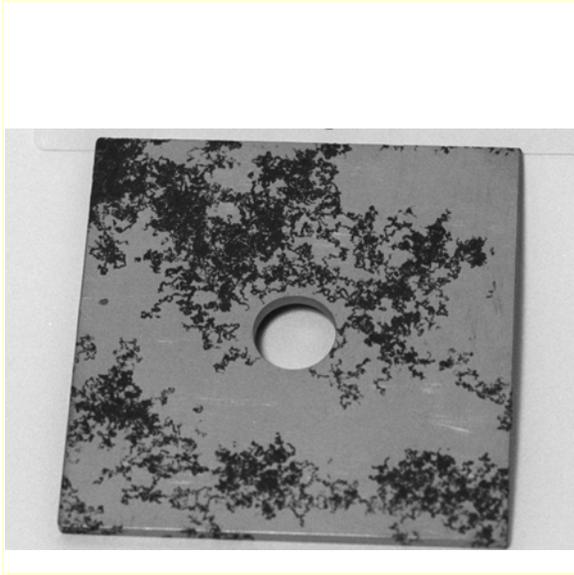
FIGURE 13. Beryllium front - cleaned.

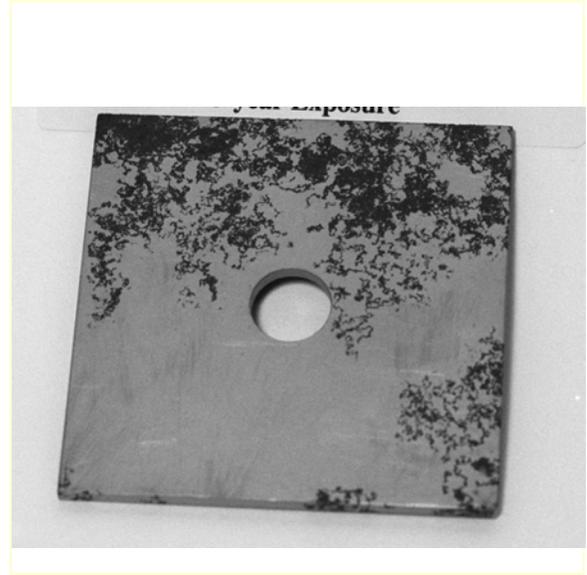
FIGURE 14. Beryllium back - cleaned.
