Research

Uniaxial and Multiaxial Creep Testing of Copper

Pertti Auerkari
Stefan Holmström
Juha Veivo
Jorma Salonen
Pertti Nenonen
Anssi Laukkanen

December 2003

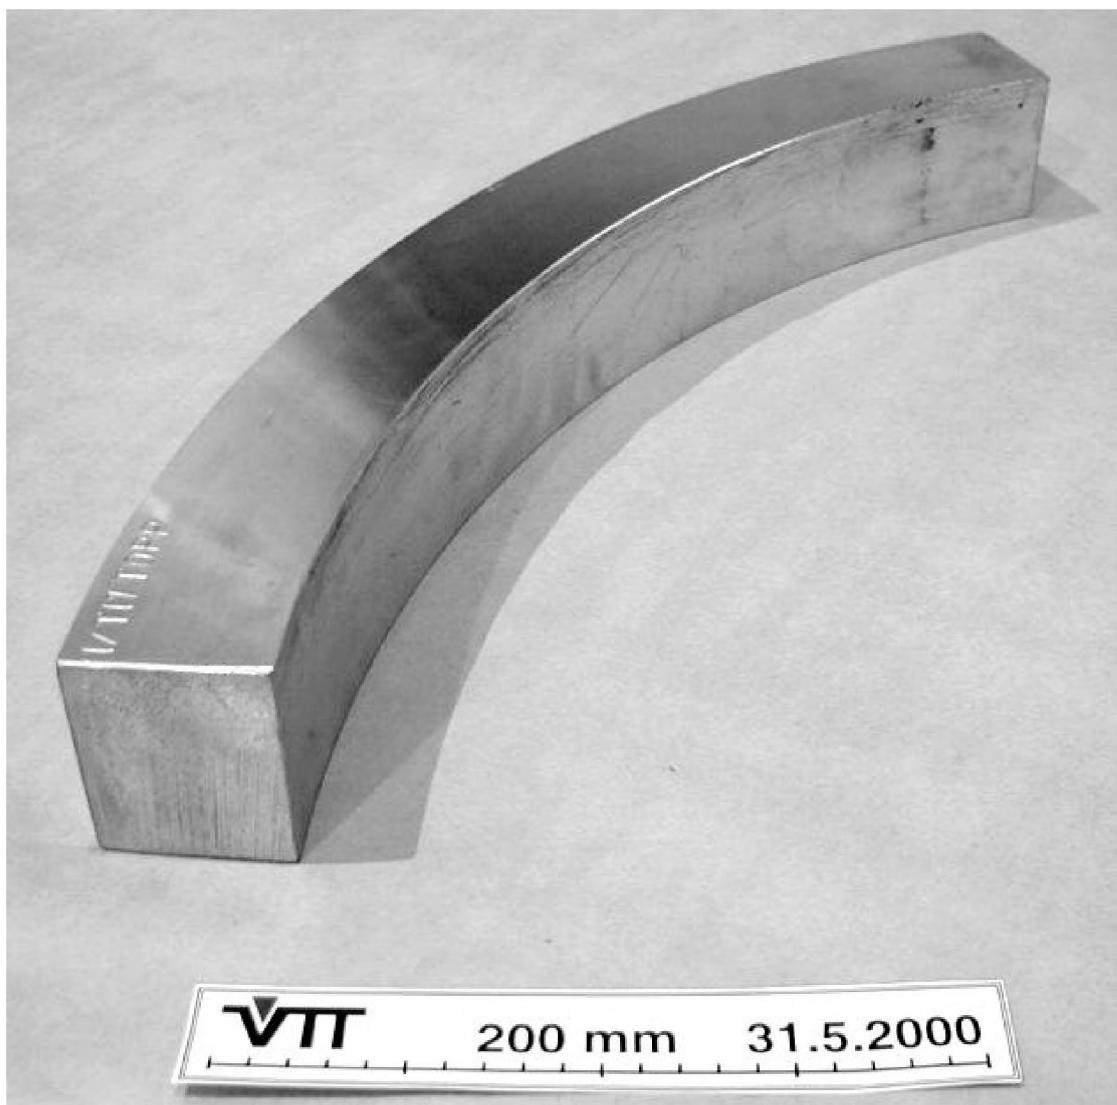
Fig. 1. The as-received test material (ring section of a hot pressed cylinder).

For the present work, SKI has provided copper material in a form of a 23 kg ring section from a hot pressed copper cylinder (Fig 1; sample marked as "1/T17 TOPP"). Some available information on the microstructure and chemical composition, as also provided by SKI, is shown in Table 1.

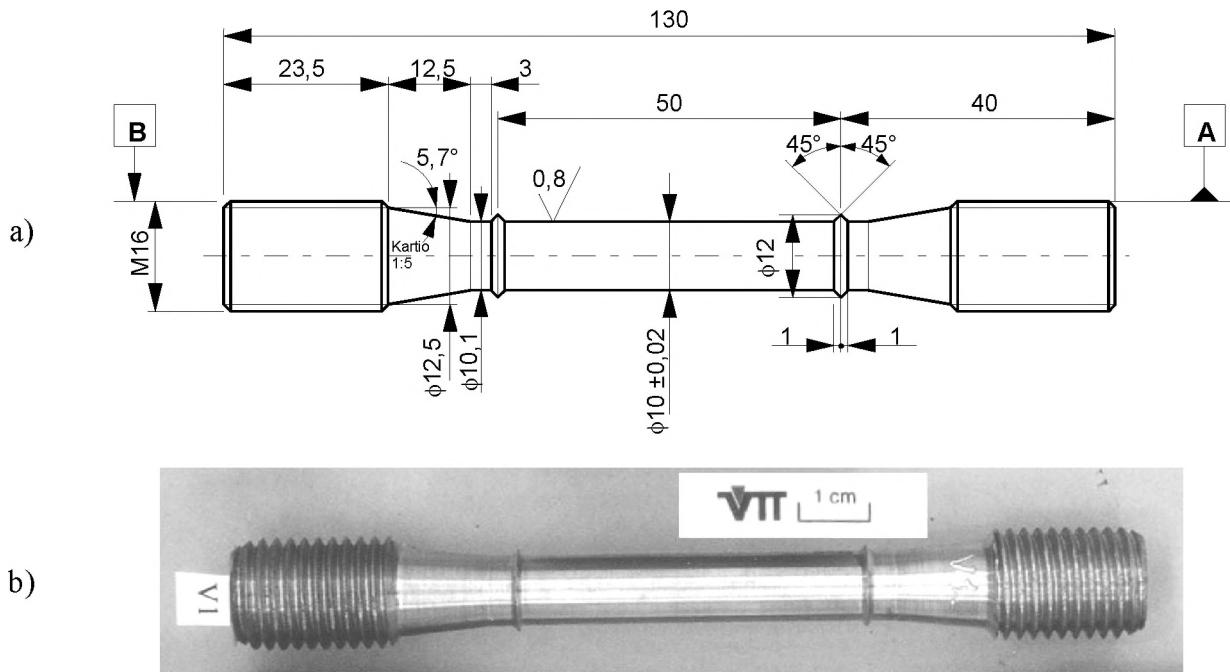
Fig. 2. a) dimensions and b) actual specimen (V1) for the uniaxial creep testing.

Three uniaxial creep testing specimens were machined with the longitudinal axis parallel to the tangential direction of the original ring section. For uniaxial tests, standard \varnothing 10 mm cylindrical specimen with 50 mm gauge length (Fig 2) were used and tested in general accordance with EN-10290. The specimens were taken as close as possible to the location of the multiaxial specimens in the ring section.

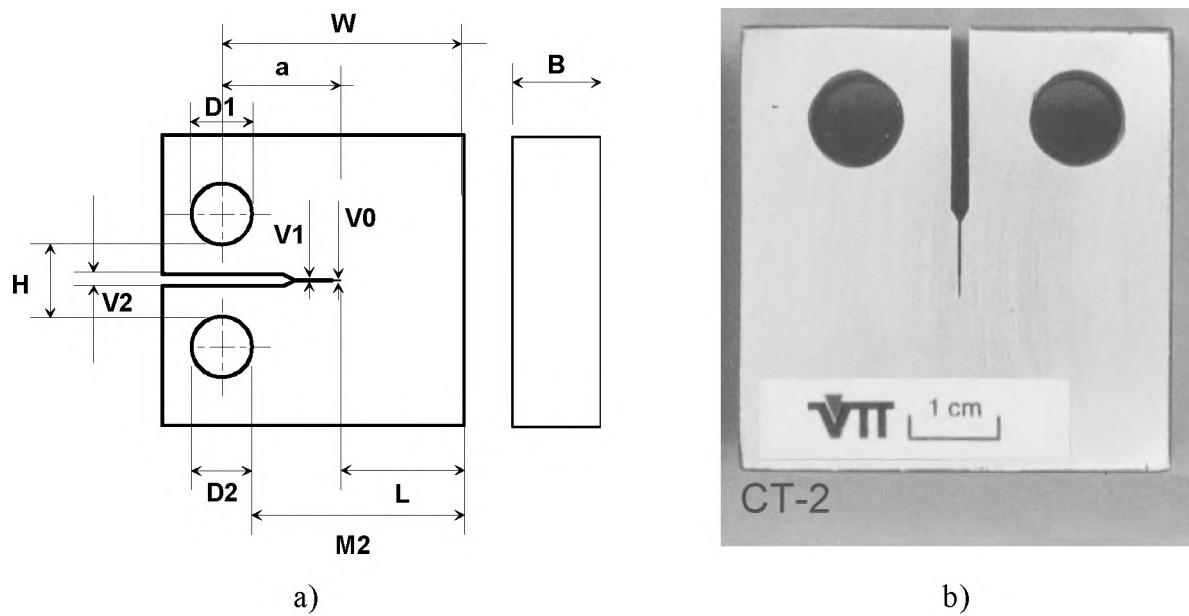
Fig. 3. a) The compact tension (CT) specimen for multiaxial creep testing; the dimensions W , B , a/W and V_0 are given in the text, b) specimen CT-2 before testing

For multiaxial testing, three compact tension (CT) specimens were machined from the copper ring section in such a way that the flat side of the specimens was parallel to the cross-section of the cylindrical capsule, with the notch cut radially from the outer surface of the capsule. The main dimensions (Fig 3) of the CT specimens are width $W = 40$ mm, thickness $B = 20$ mm, notch length/width ratio $a/W = 0.5$, and tip width $V_0 = 0.097 (\pm 0.002)$ mm.

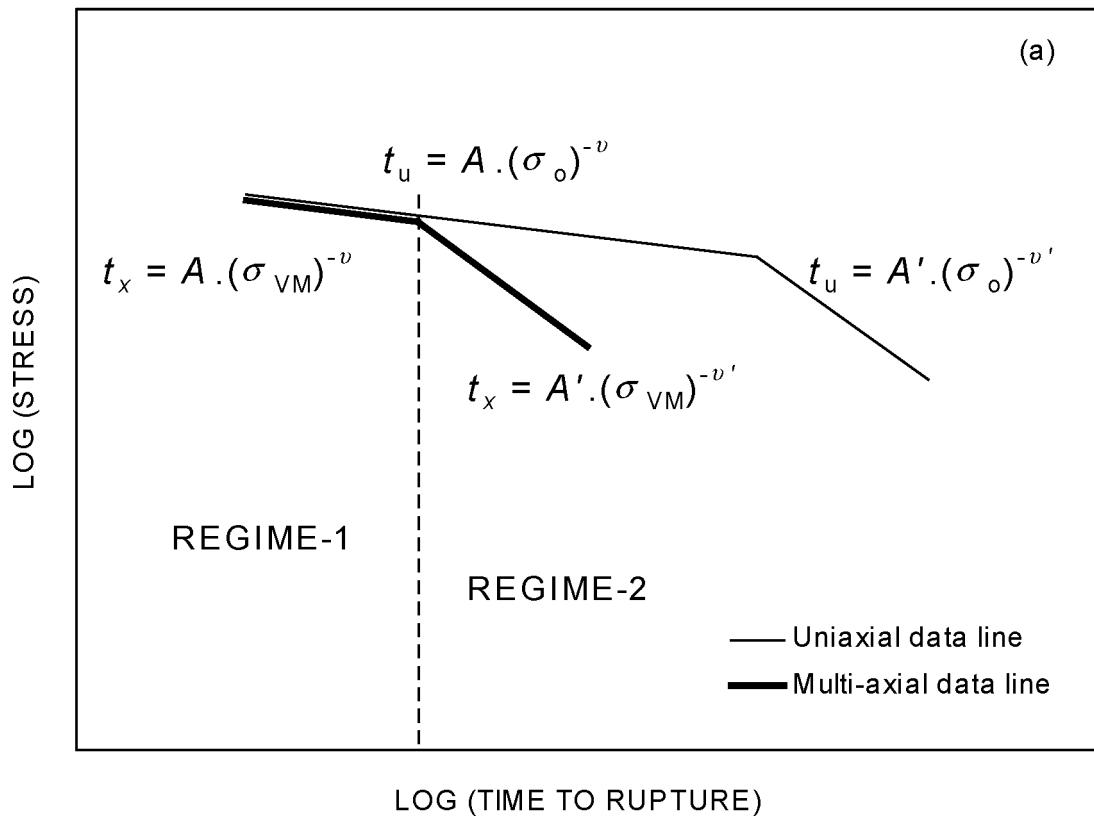
Fig. 4. The principle on shortening of creep life by damage in multiaxial loading. Creep life is described by the simple inverted Norton expression (at constant temperature). Here subscript u refers to uniaxial and subscript x to multiaxial loading; subscript VM refers to v. Mises equivalent stress and subscript o to plain uniaxial case. Regime 2 is the region where grain boundary cavitation can dominate creep damage.

where a is the notch length, B is the specimen thickness, and W specimen width (see Fig 4) and $\gamma = 2/\sqrt{3}$.

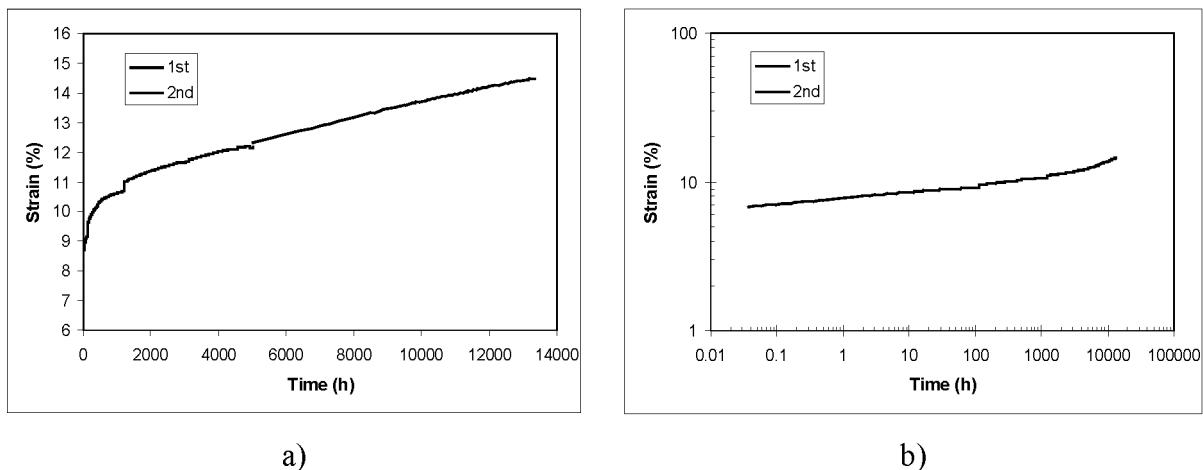
Fig. 5. Uniaxial creep curve at 150°C/120 MPa (V1) on a) linear and b) logarithmic scale. The 1st and 2nd phases refer to the curve sections before and after interruption at 5011 h.

for the longest uniaxial tests are shown in Table 5. The observed uniaxial creep curves and strain rates for the longest test are shown in Figs 5 and 6.

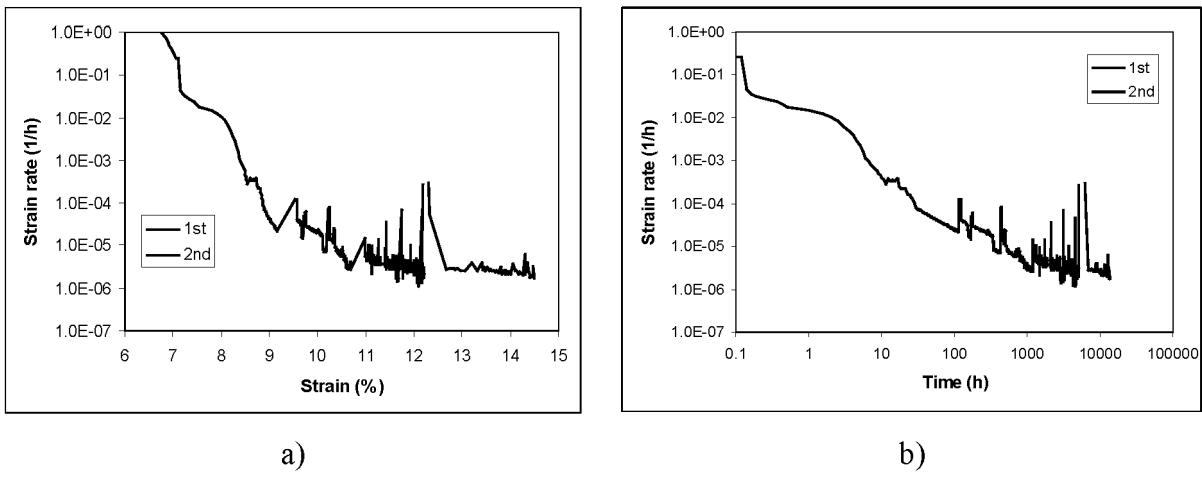
Fig. 6. Strain rate in the test (V1) of Fig 5, as a function of a) strain and b) time. The 1st and 2nd phases refer to the curve sections before and after interruption at 5011 h.

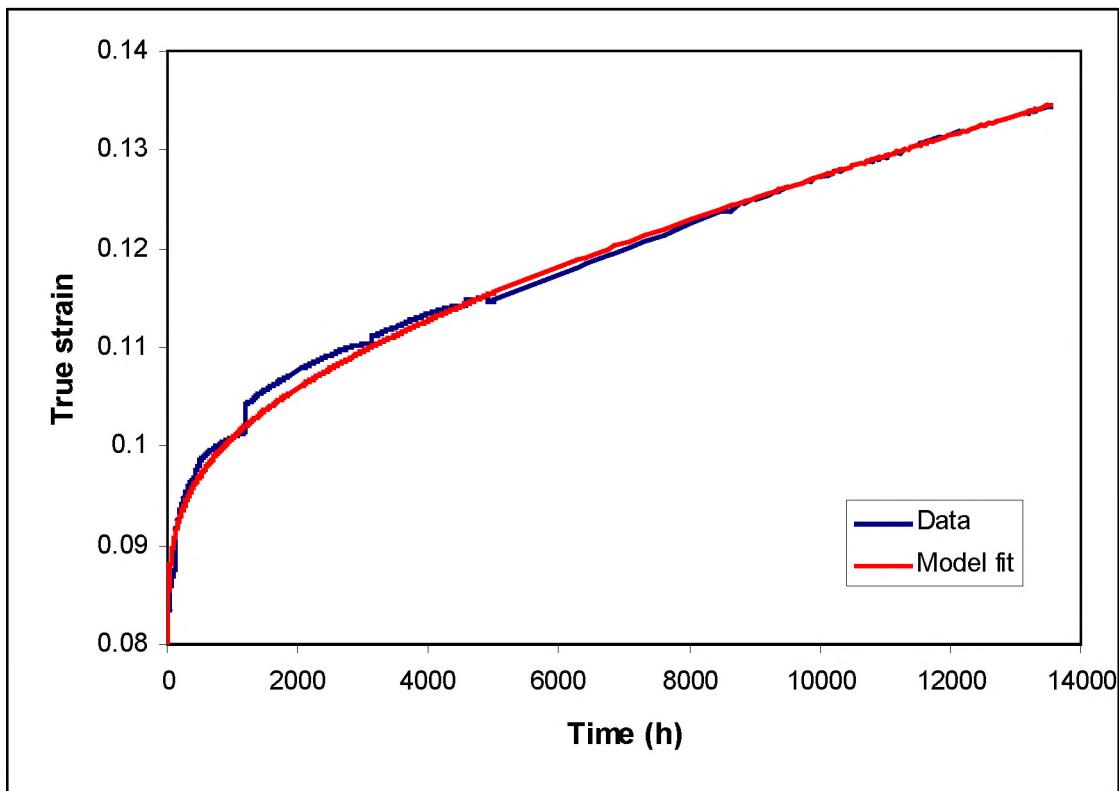
Fig 7. The uniaxial creep curve at 120 MPa/150°C (test V1), and fitted curve using model where total strain is a sum of initial "instantaneous" strain, primary creep strain and steady state strain components: $\varepsilon = \varepsilon_0 + \varepsilon_p + \varepsilon_s$.

2) At 150°C fitted to longest term test data (Fig 7), otherwise as in Nilsson (1992)

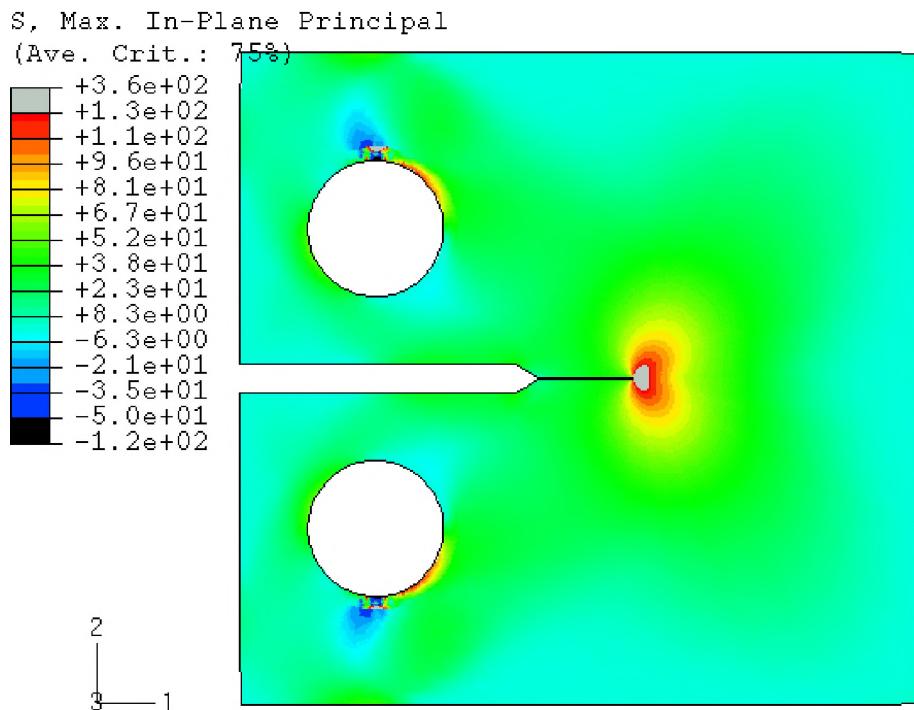
Fig. 8. Distribution of the stabilised (at 64000 h) maximum principal stress (MPa) for the specimen CT-3.

Examples of the FE analysis results in Figs 8 and 9 show the distributions of the maximum principal stress and equivalent (Mises) strain under stabilised conditions for the specimen CT-3. The equivalent strain distributions for the notch tip region of CT-3 at 6000 h (close to end of transient distribution) and 64000 h (stable distribution) are shown in Figs 10 and 11.

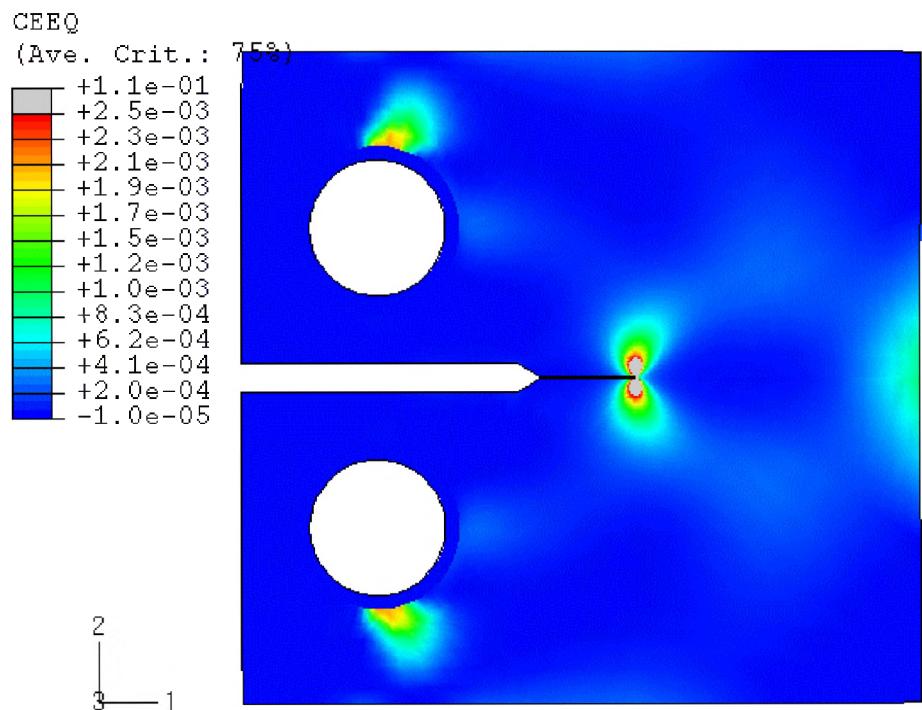
Fig. 9. Distribution of the equivalent strain for specimen CT-3 at 64000 h.

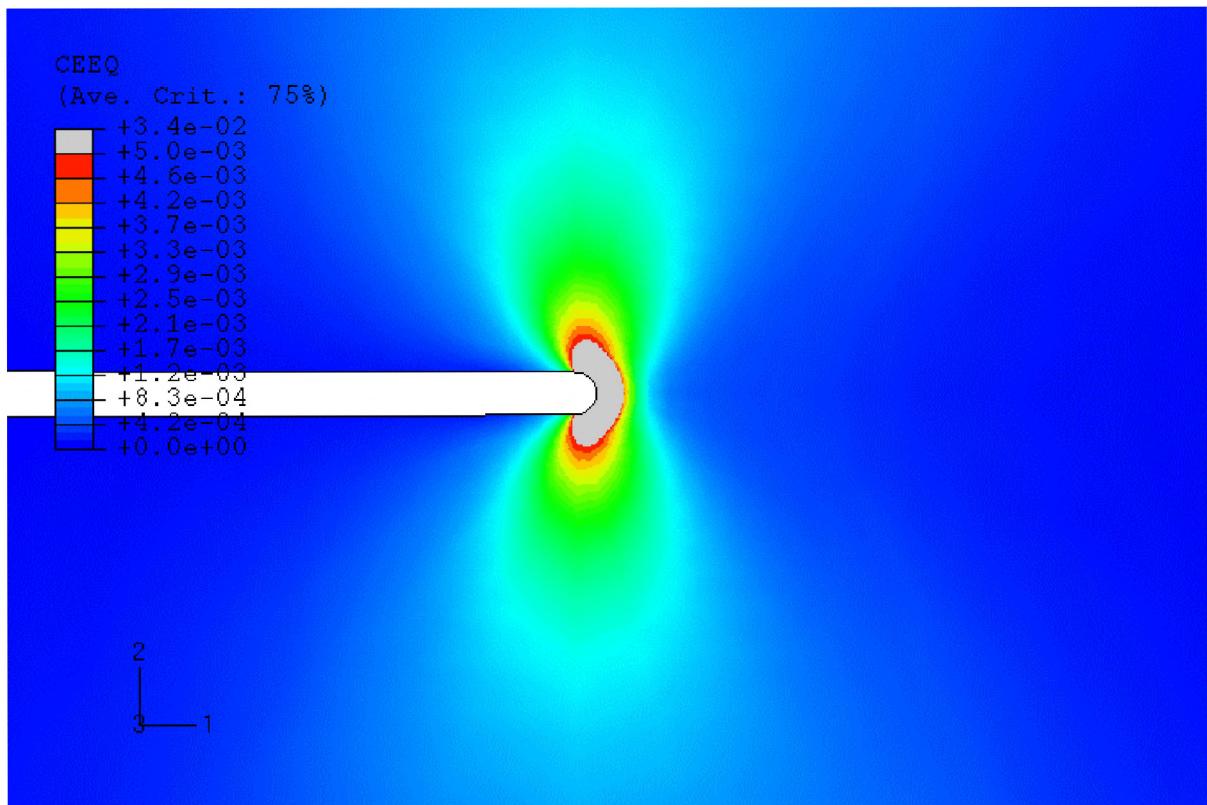
Fig. 10. Distribution of the equivalent strain for the specimen CT-3 at 6000 h.

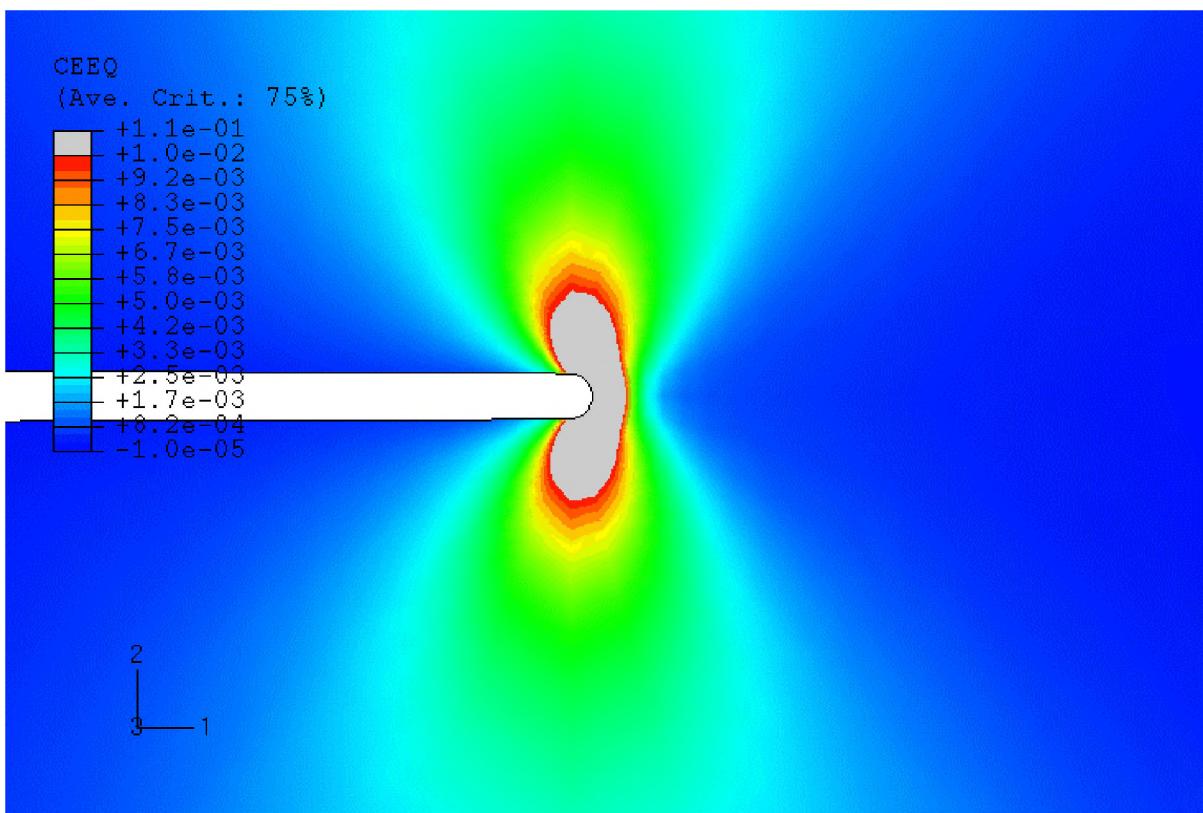
Fig. 11. Distribution of the predicted equivalent creep strain for specimen CT-3 at 64000 h.

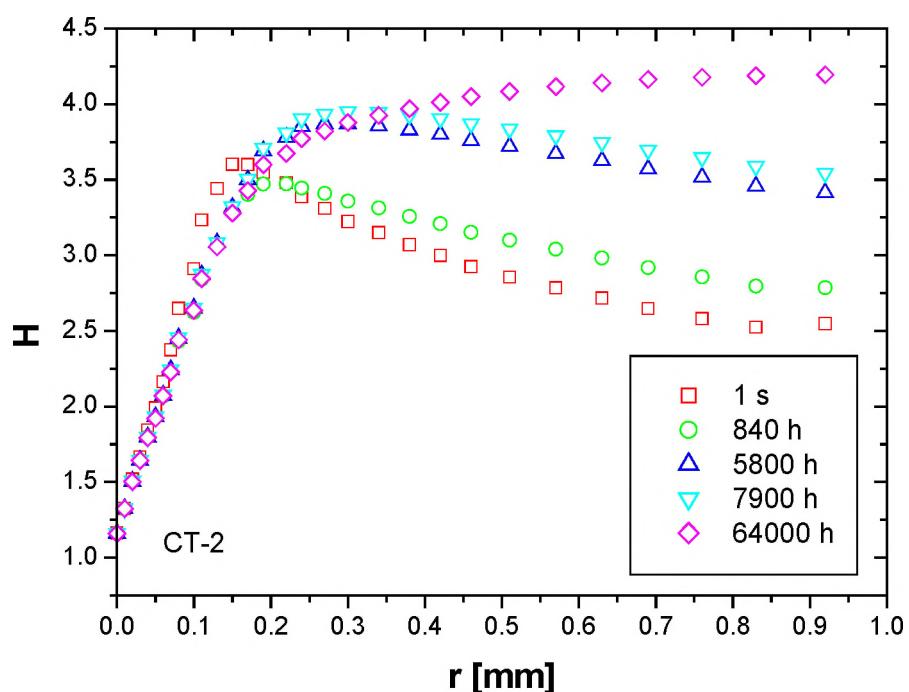
Fig. 12. Evolution of H distribution in front of the notch tip for specimen CT-2 at different times during a simulated test. The case of 64000 h corresponds to a stabilised situation.

Lower stresses and strain rates in CT-3 lead to much longer time to reach a stabilised stress state than in the specimen CT-2. Near the notch tip the first principal and equivalent Mises stresses were recorded in order to evaluate the H - parameter using the reference stress concept. The results for specimens CT-2 and CT-3 are given in Fig 12 and Fig 13, respectively.

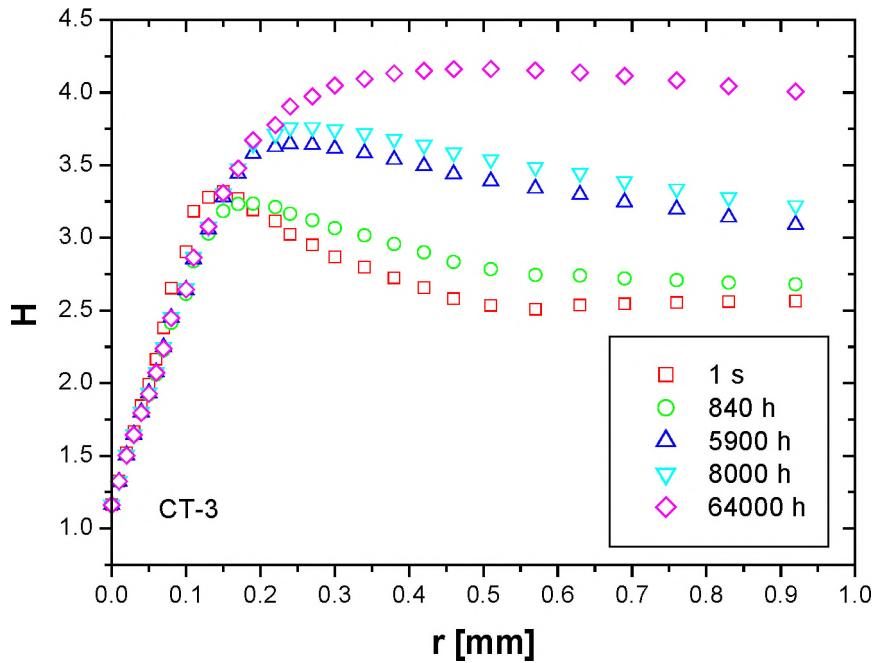
Fig. 13. Evolution of H distribution in front of the notch tip for specimen CT-3 at different times during a simulated test. The case of 64000 h corresponds to a stabilised situation.

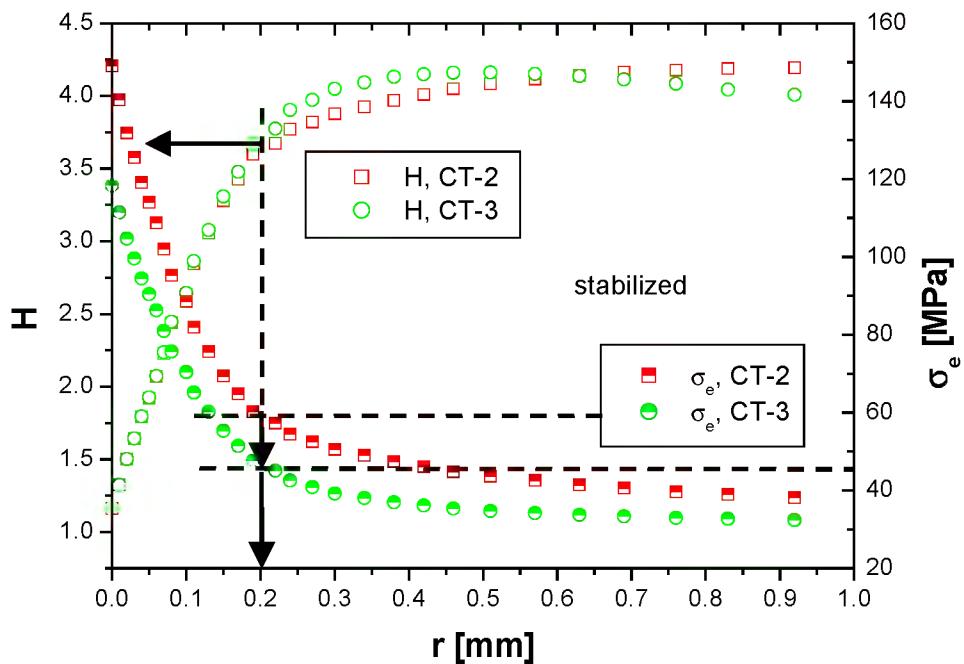
Fig. 14. Distributions of the stabilised values of H and v. Mises equivalent stress σ_e in front of the notch tip for specimens CT-2 and CT-3. At the corresponding values of reference stress of 59 MPa (CT-2) and 46 MPa (CT-3), the distance from the notch tip is 0.2 mm.

The characteristic value of H is taken from the location where the calculated Mises equivalent stress distribution equals the value of the reference stress (Fig 14). The obtained characteristic value of $H = 3.65$ for both specimens CT-2 and CT-3, and this occurs at a distance of 0.2 mm ahead of the notch tip. The results from FE analysis were originally used to set the loading levels in CT specimen testing. This was considered reasonably successful, as the loading of the specimen CT-2 resulted in accelerating creep within about 1000 h, and loading of the specimen CT-3 led to nearly constant rate or slowly attenuating creep within about 10000 h.

Furthermore, taking from the FE analysis $H = 3.65$ (Fig 14), and assuming that $\mu = 1$ (constrained conservative case) and $\nu' = 2.07$ or $\nu' = 4.64$ from two uniaxial rupture curves (see below), the resulting multiaxial acceleration factors in time are

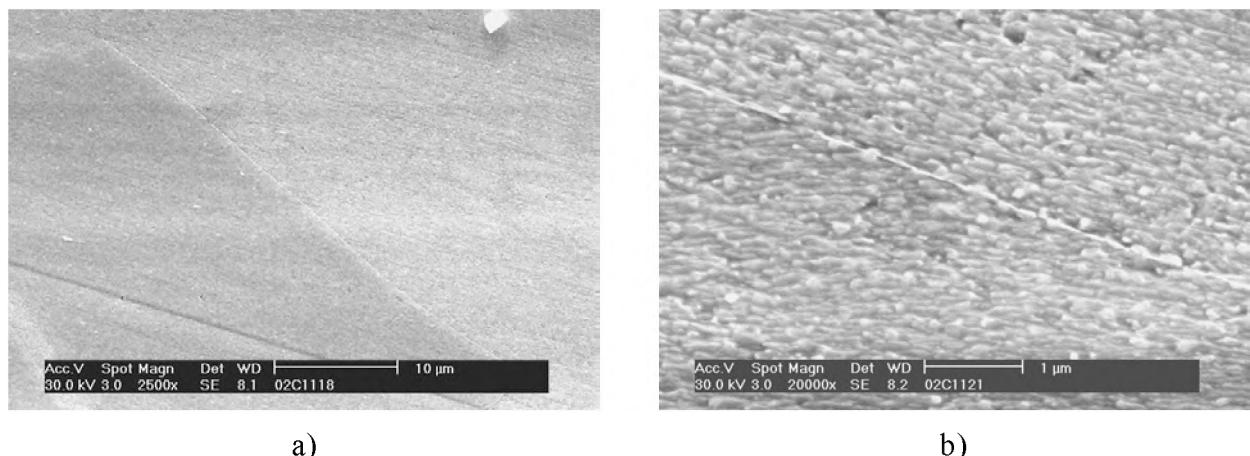
Fig 15. Microstructure of the as-received material after electropolish and slight etch; a) grain boundaries and b) detail of a grain boundary as it can be seen in SEM.

The general structure of as-received copper material was largely as expected, with no particularly special features e.g. in the grain boundaries when inspected in scanning electron microscope (SEM, Fig 15).

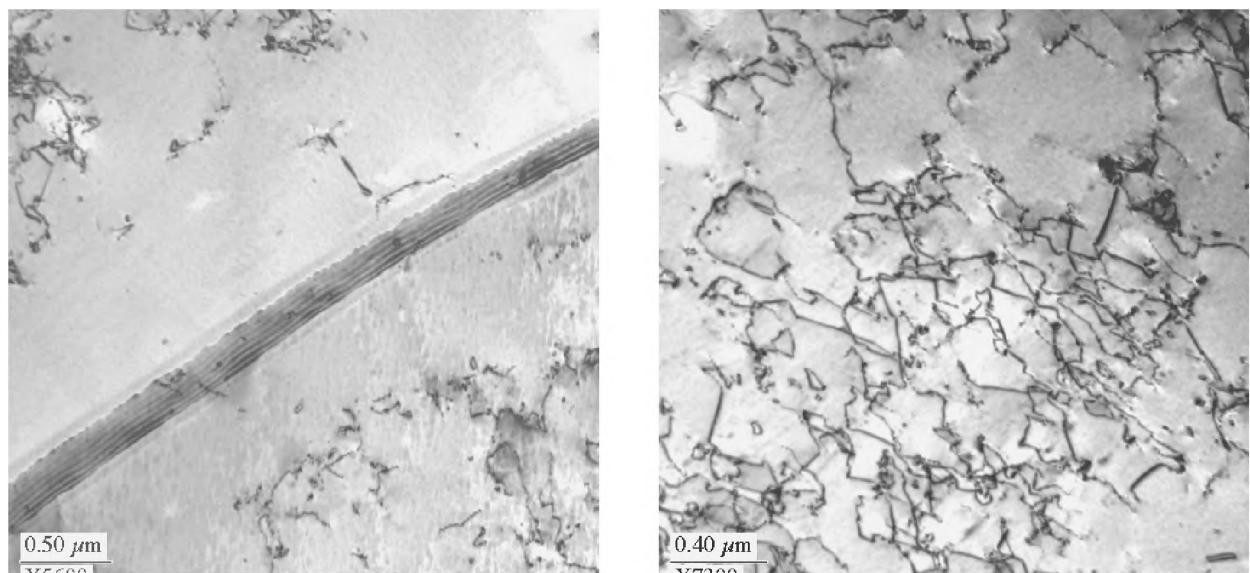
Fig 15. Microstructure of the as-received material after electropolish and slight etch; a) grain boundaries and b) detail of a grain boundary as it can be seen in SEM.

However, transmission electron microscopy (TEM) can reveal more details of the grain boundary structures. Many of these are free from precipitates (Fig 16), but also some contain grouped CuS inclusions and grain boundary films (Fig 17).

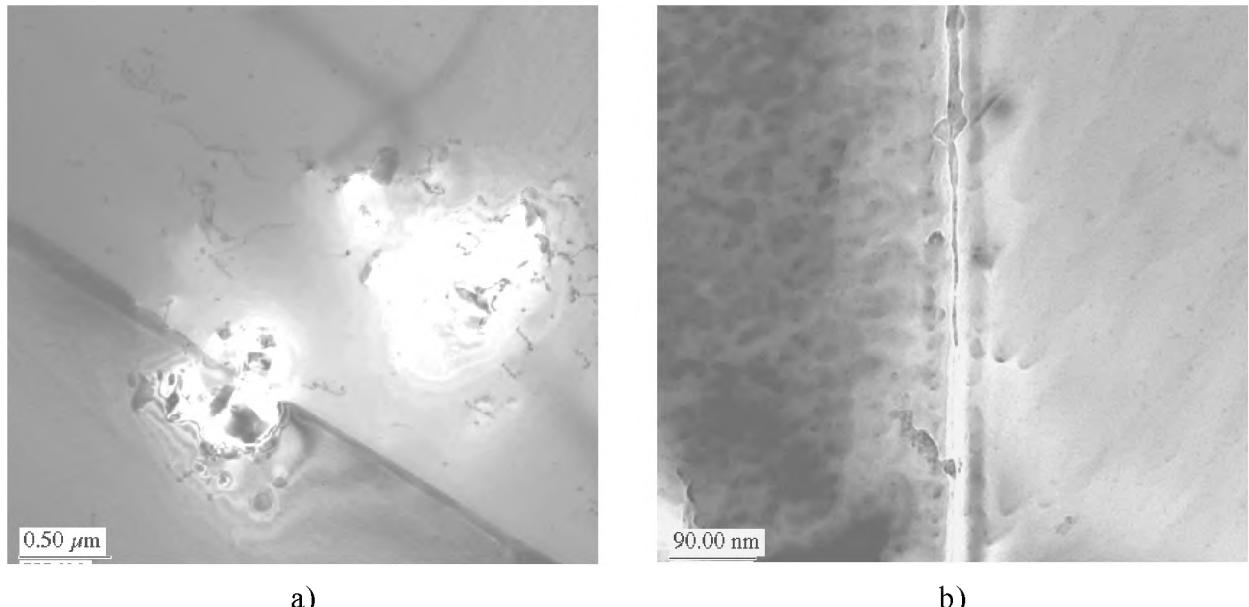
Fig 17. a) CuS inclusions appear in groups, some in grain boundaries; b) film with high oxygen and phosphorus content on a grain boundary of the as-received material (TEM).

Some cavity indications were also observed well away from the notch (Fig 26b). It is by no means certain that all false cavity indications were avoided, although care was taken to minimise the required etching (limited to electrolytic polish) at the grain boundaries. False cavity indications could be caused by the easily etching inclusions (Figs 17a & 28a), which were present, often in groups, also in the as-new material.

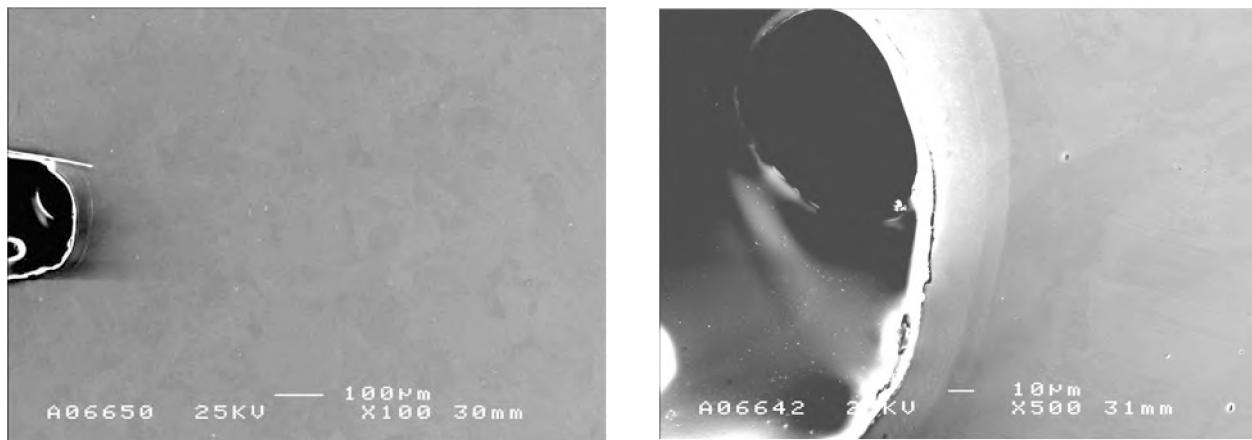
Fig 18. Specimen CT-2 (150 °C/59 MPa) side surface after 1003 h of testing, electrolytic polish, no etch; a) general view near the notch tip; b) magnification of the tip root area.

In the specimen CT-2 after 1003 h of testing at 150°C/59MPa, no obvious changes in the microstructure were observed, nor were there any clear signs of creep cavitation or cracking (Fig 18). This was confirmed from electrolytically polished specimen, as it was found that the usual etching medium for copper (ferric chloride) easily results in multiple cavity- or even cracklike features as false indications on the grain boundaries of the material.

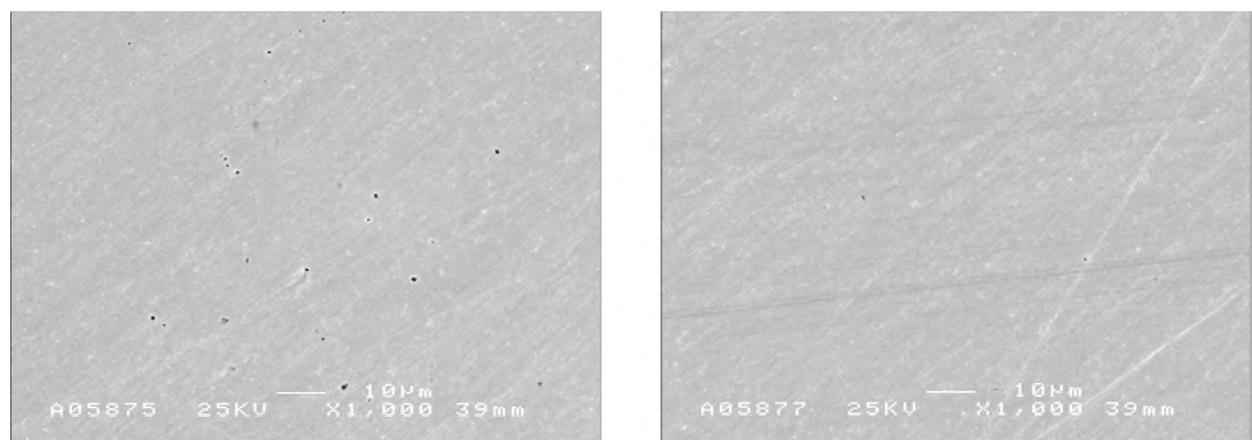
Fig 19. Specimen CT-2 (150 °C/59 MPa) side surface after 1003 h of testing; mechanical polish, no etch; a) region near the notch tip, showing cavity-like indications; b) typical area with no cavity indications.

Somewhat controversially though, one small mechanically polished unetched area appeared to show a cluster of cavity-like indications (Fig 19). This was not repeated elsewhere in the specimen, however.

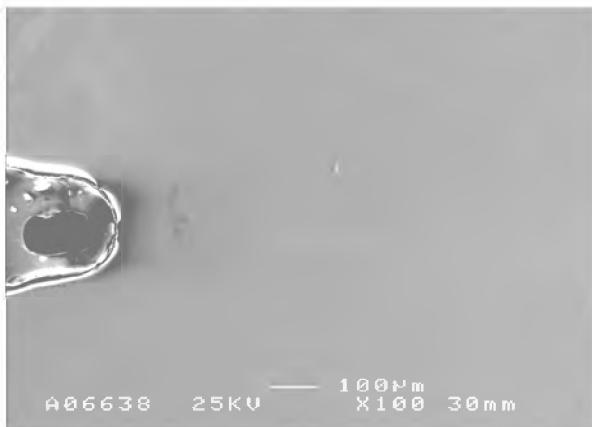
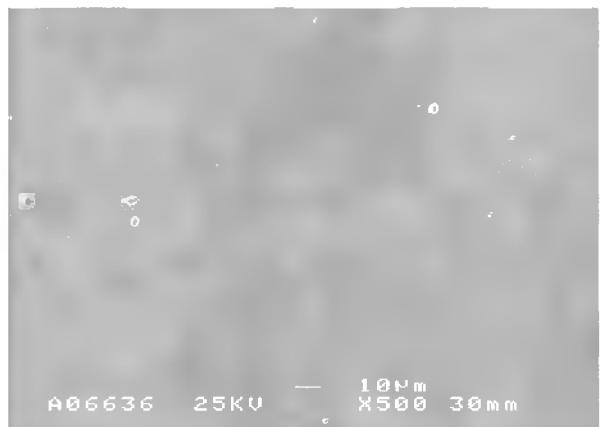
Fig 21. Specimen CT-3 (150 °C/46 MPa) side surface after 3000 h of testing, electrolytic polish; a) general view near the notch tip; b) magnification below the tip root area.

In the specimen CT-3 after 3000 h and 5018 h of testing at 150°C/59MPa, no obvious changes in the microstructure were observed, nor were there any clear signs of creep cavitation or cracking (Figs 21 and 22).

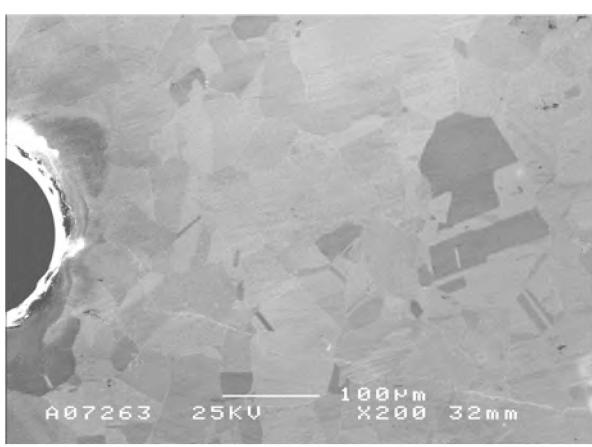
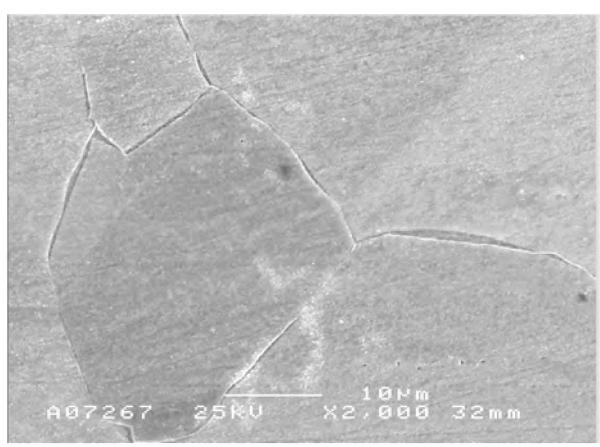
Fig 22. Specimen CT-3 side surface after 5018 h of testing, electrolytic polish and slight etch; a) notch tip region; b) magnification below the tip root area. Note the structure of some grain boundaries, suggesting an additional phase.

Indications of an additional phase were found at some grain boundaries of the specimen CT-3 after 5018 h (Figs 22 and 23). This phase appears to etch readily and give an impression of local grain boundary widening, or even boundary separation if etched too much.

A particular feature in the tested material was the observed easily etching "segregation zone", which appeared as an evenly thinned zone along some grain boundaries particularly near the notch tip after testing (Figs 22-25, 27, 28, 32). This feature was practically absent or very small in the as-received material, and showed a maximum width of about 2-3 µm near the strained notch tip region after 7900 h and 10300 h of testing at 150°C/46 MPa. Within this zone the oxygen and phosphorus contents are higher than in the surrounding matrix but lower than in the boundary films (Figs 29-31). The zone is from one side bounded by the grain matrix without any apparent phase boundary in TEM, but with a relatively sharp edge so that it does not appear to be a typical diffusion zone either. Conventional etching of copper (e.g. with ferric chloride) resulted in so strong dissolution of this zone that the appearance was that of grain boundary cracking.

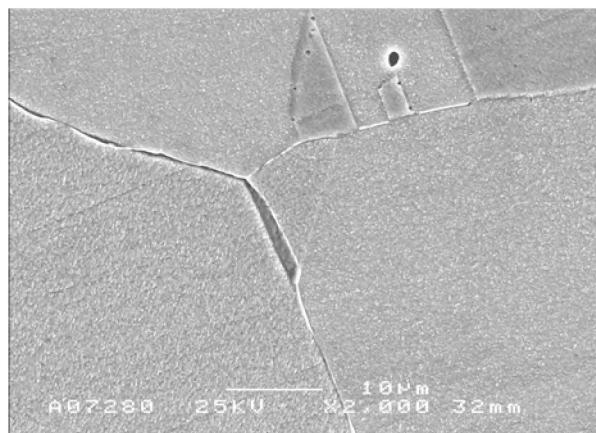
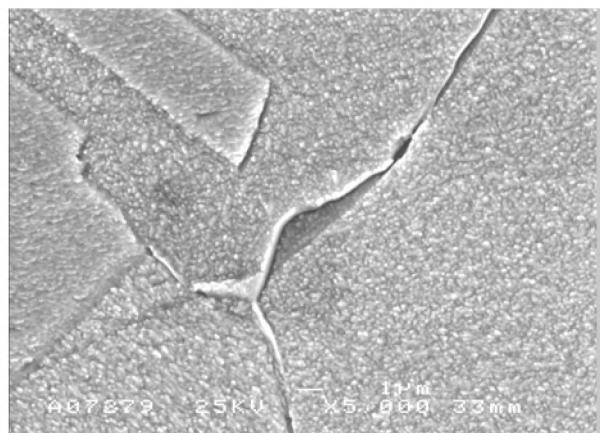
Fig 23. Specimen CT-3 side surface after 5018 h of testing, electrolytic polish and slight etch; a) grain boundary (gb) phase; b) gb phase, detail.

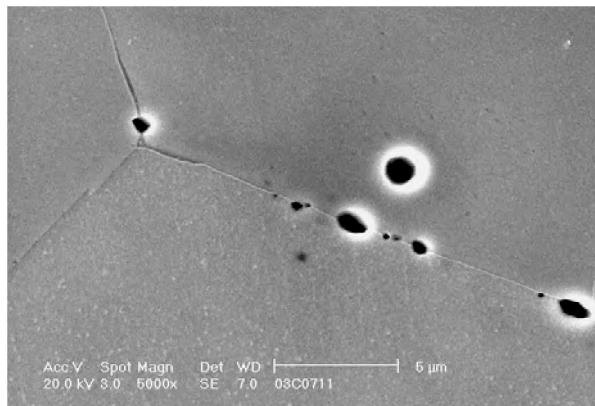
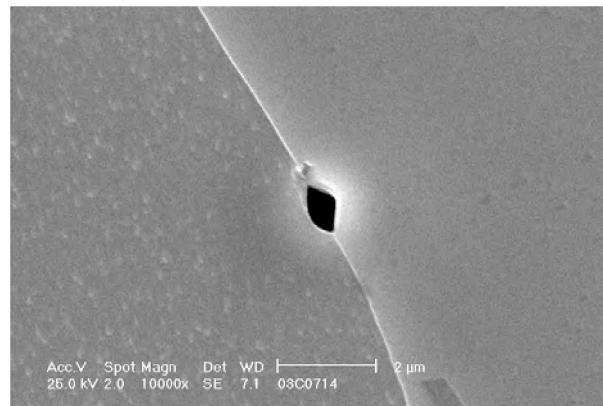
Fig 26. Specimen CT-3 mid-section after 10300 h of testing; a) gb cavity indications near the notch tip; b) a cavity indication in a low stress region (ligament side corner).

After 7900 h of testing, the grain boundary structure remained mostly similar to that after previous interruption. One small apparent grain boundary cavity indication was observed near the notch tip (Fig 24). More cavity indications were observed after 10300 h of testing, both from side surface and specimen mid-section. Even some grain boundary opening was found at the notch tip (Figs 25 - 27).

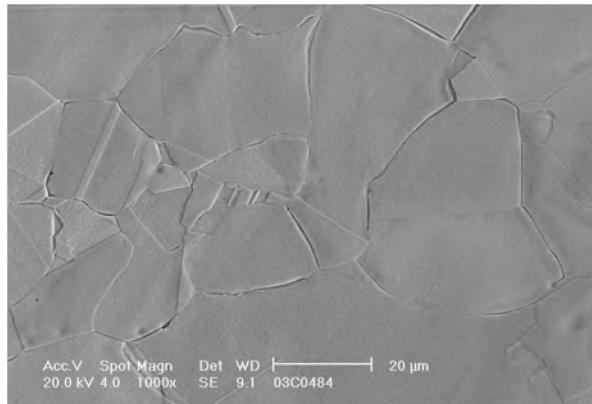
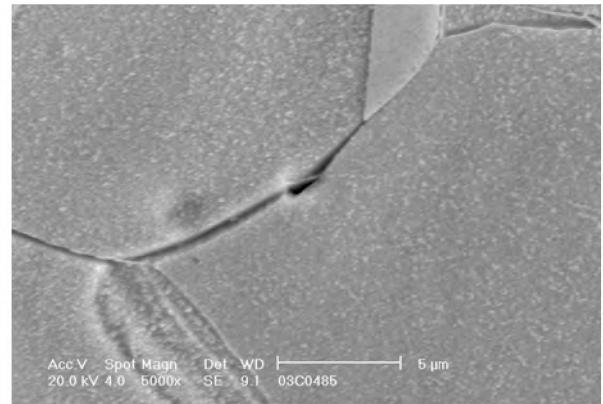
Fig 27. Specimen CT-3 side surface after 10300 h of testing, about 0.2 mm below the notch tip; electrolytic polish and slight etch; a) grain boundary with a cavity (arrow); b) magnification of the same cavity indication; note the film-like feature crossing the boundary region at the cavity indication.

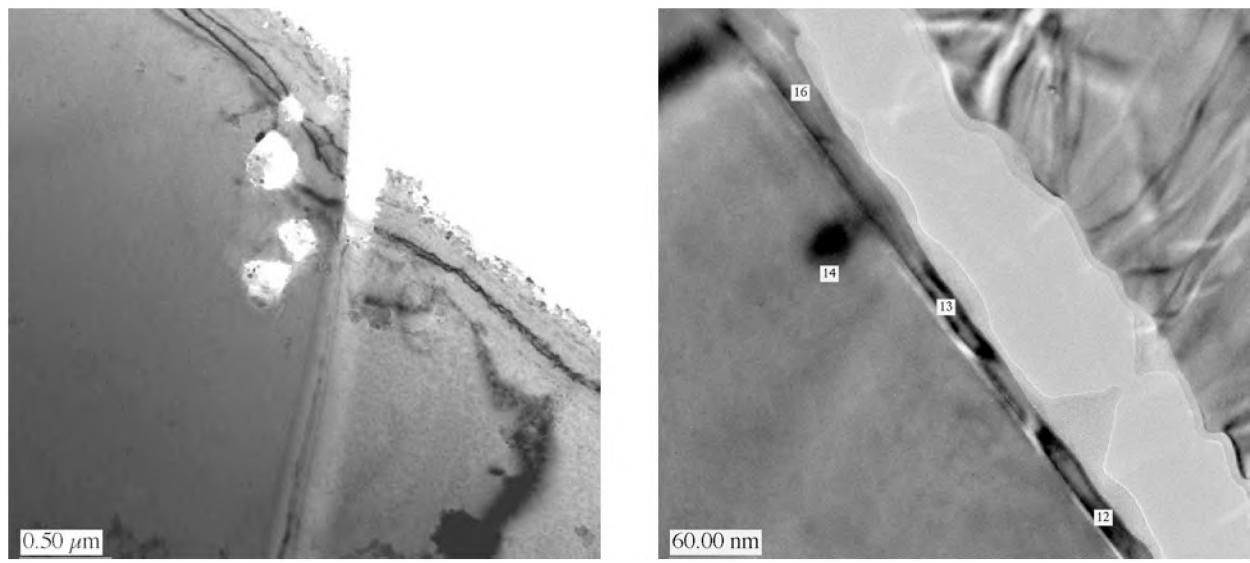
Fig 28. Specimen CT-3 after 10300 h of testing, 1.5 mm from the notch root mid-section (TEM); a) grain boundary with inclusions, boundary film and thinned zone; b) magnified image of boundary film and thinned zone.

The strongly etching phase on some grain boundaries was also most prominent near the notch tip after prolonged testing, and was not observed in the as-received material. In the TEM examination of thin foils prepared by electrolytic polishing, a thinned zone was seen at many grain boundaries (Fig 28). This zone was typically bounded from one side by the grain boundary or the boundary film with elevated P, O and C, and from the other side by the matrix with a lower content of P, O and C (Figs 29-31). No phase boundary was observed between the zone and the matrix, as is indicated by dislocations crossing the border, while the zone appears to be relatively even in thickness and with clear borderlines to the matrix (Fig 32).

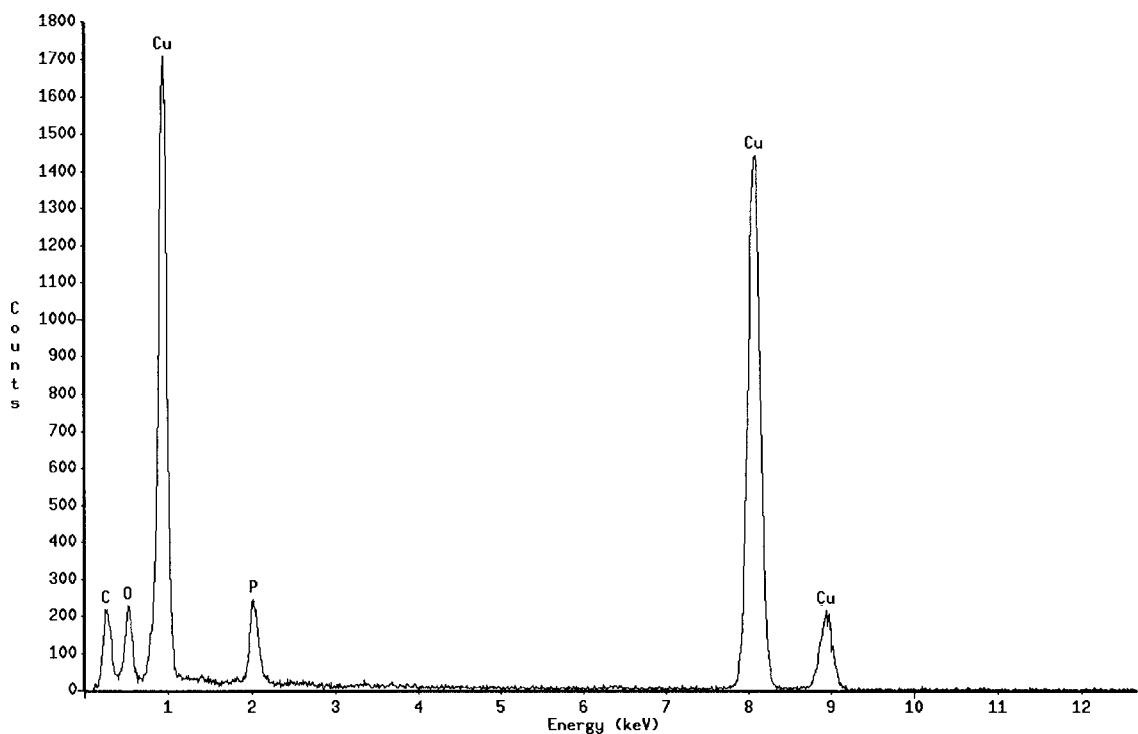
Fig 29. EDS analysis results of the thinned region adjacent to the grain boundary from Fig 28a, showing elevated concentration of P, O and possibly C (note that some indicated carbon is expected as a electron beam contaminant).

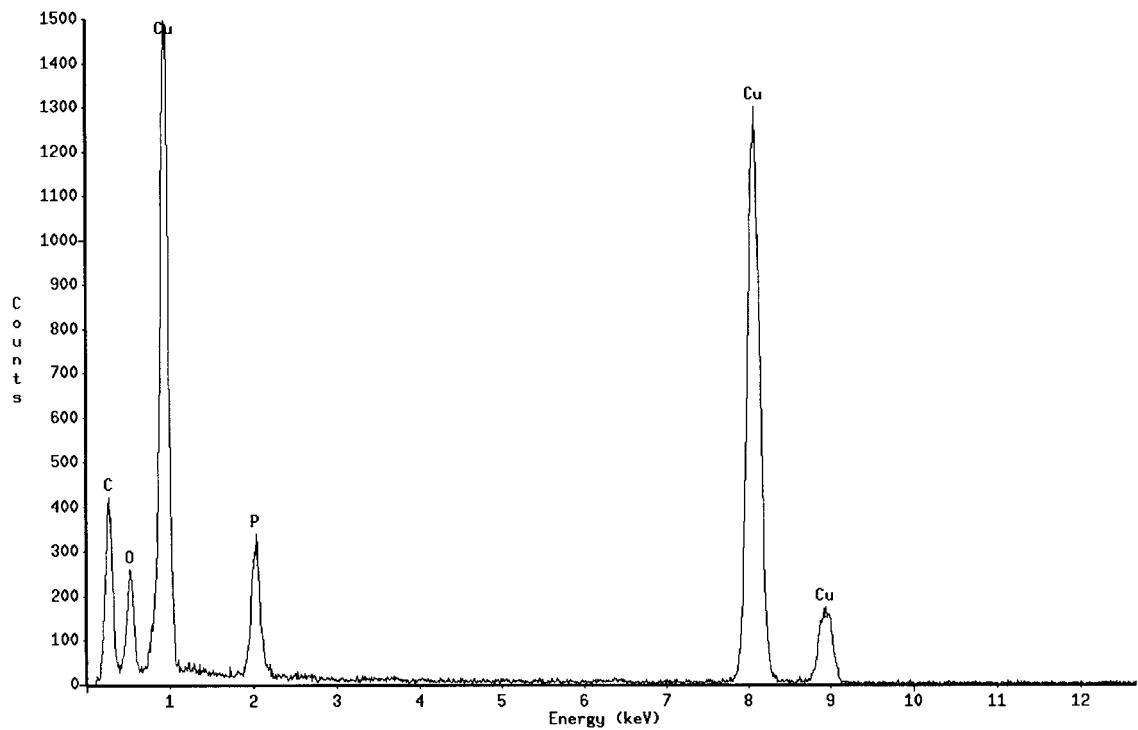
Fig 30. EDS results of the grain boundary film of Fig 28a, showing elevated concentration of P, O and possibly C at somewhat higher level than in the thinned zone (Fig 29).
