Research

Uniaxial and Multiaxial Creep Testing of Copper

Pertti Auerkari
Stefan Holmström
Juha Veivo
Jorma Salonen
Pertti Nenonen
Anssi Laukkanen

December 2003

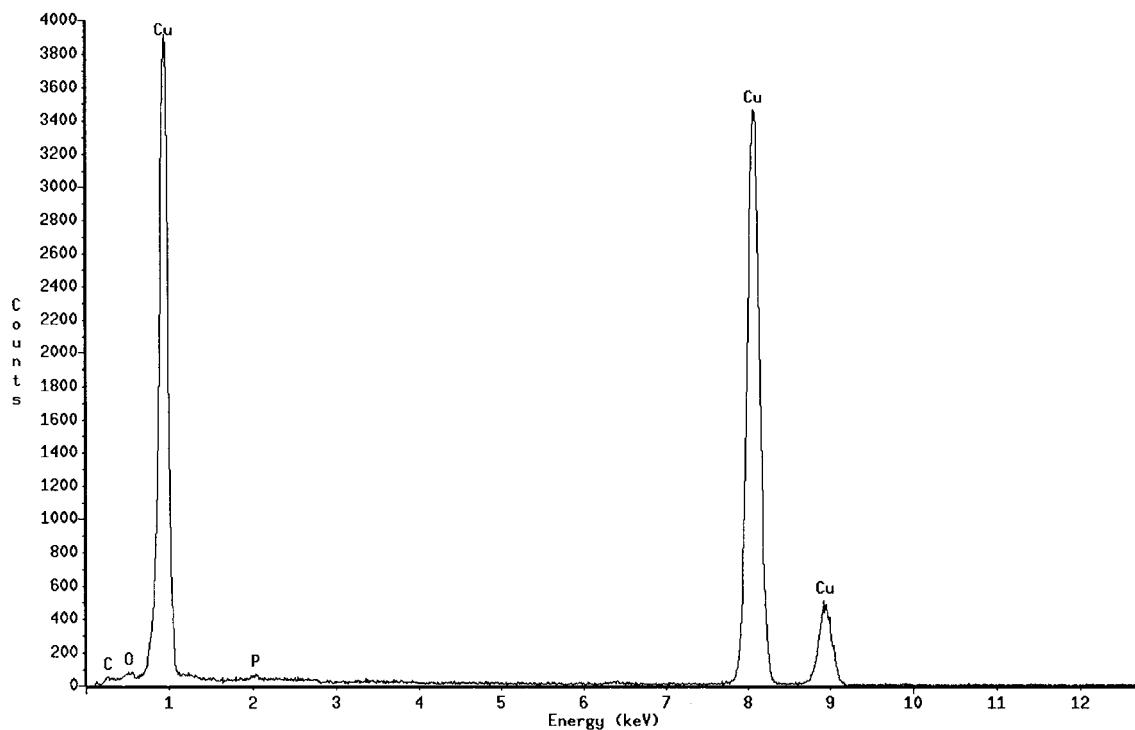
Fig 31. EDS results of the matrix outside the thinned zone in Fig 28a, showing attenuated concentration of P, O and C in comparison with the zone and the boundary film.

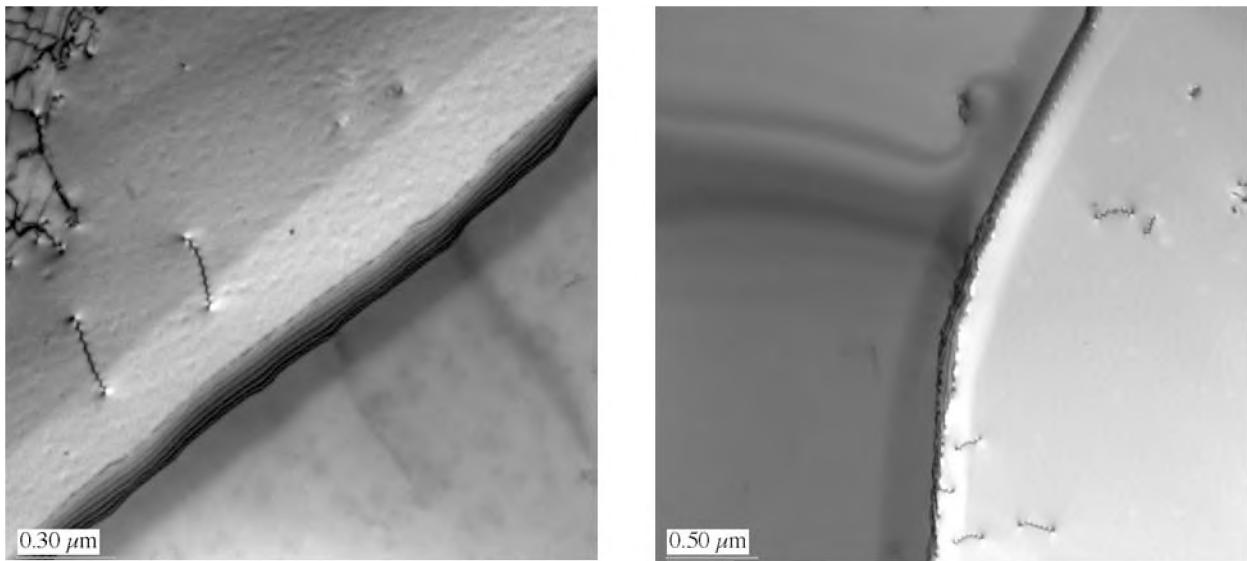
Fig 32. CT-3 after 10300 h, notch root mid-section, two TEM images showing thinned "segregation zones" along grain boundaries, with dislocations crossing the zone-matrix boundary.

The strongly etching phase on some grain boundaries was also most prominent near the notch tip after prolonged testing, and was not observed in the as-received material. In the TEM examination of thin foils prepared by electrolytic polishing, a thinned zone was seen at many grain boundaries (Fig 28). This zone was typically bounded from one side by the grain boundary or the boundary film with elevated P, O and C, and from the other side by the matrix with a lower content of P, O and C (Figs 29-31). No phase boundary was observed between the zone and the matrix, as is indicated by dislocations crossing the border, while the zone appears to be relatively even in thickness and with clear borderlines to the matrix (Fig 32).

A particular feature in the tested material was the observed easily etching "segregation zone", which appeared as an evenly thinned zone along some grain boundaries particularly near the notch tip after testing (Figs 22-25, 27, 28, 32). This feature was practically absent or very small in the as-received material, and showed a maximum width of about 2-3 µm near the strained notch tip region after 7900 h and 10300 h of testing at 150°C/46 MPa. Within this zone the oxygen and phosphorus contents are higher than in the surrounding matrix but lower than in the boundary films (Figs 29-31). The zone is from one side bounded by the grain matrix without any apparent phase boundary in TEM, but with a relatively sharp edge so that it does not appear to be a typical diffusion zone either. Conventional etching of copper (e.g. with ferric chloride) resulted in so strong dissolution of this zone that the appearance was that of grain boundary cracking.

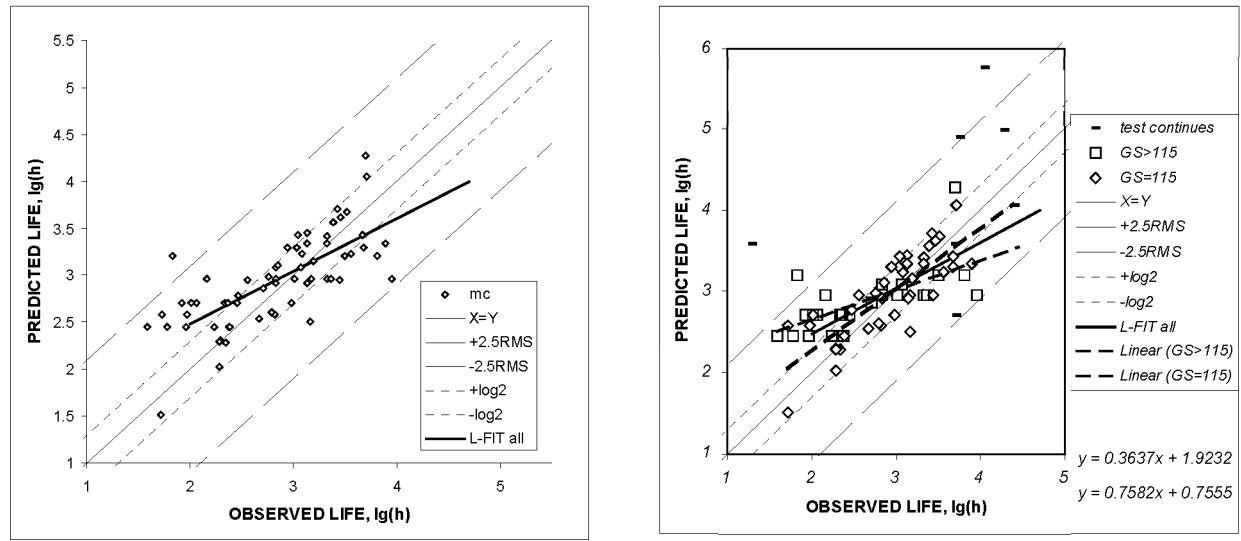
Fig. 33. Comparison of predicted and observed uniaxial creep rupture life from available data (best fit with MC parametric model). The fitted (least squares) line includes only test data > 100 h; a) all data; b) effect of grain size (GS).

One apparent reason for the observed considerable scatter in creep strength is the grain size, which varied from 40 to 2000 μm. Therefore refitting was done for various levels of grain size, resulting in a fairly clear difference between larger (> 115 μm) and smaller (max 115 μm) grain size (Fig 33b). Although the fit seems better for the smaller grain size, the longest tests are still short both for general predictive power (deviation between predicted and observed time when extending predictions in time) as well as for the intended application (200000 years = $1.75 \cdot 10^9$ h).

The limitations of the existing uniaxial creep data are apparent particularly towards the lower temperature end, which includes the longest ruptured specimen test and where the predictive fitting (Fig 33) is relatively poor though conservative (observed life > predicted life).

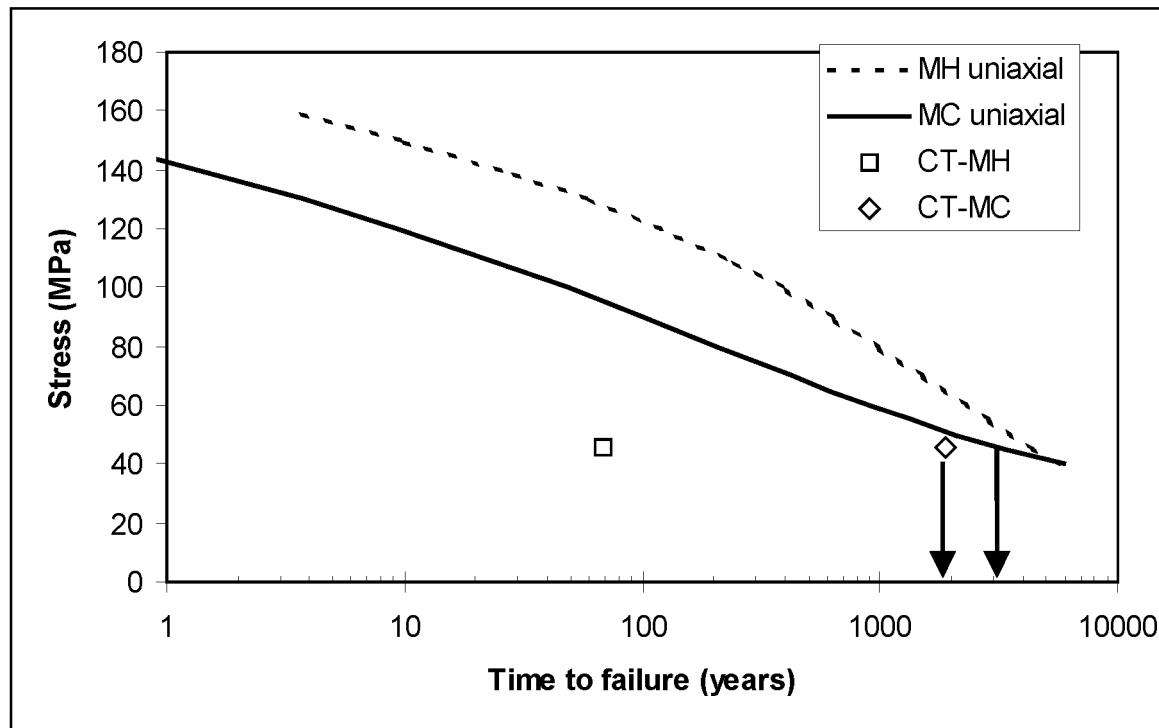
Fig 34. The estimated uniaxial creep life at 150 °C/46 MPa from the multiaxial test (CT-MH) in comparison with the predicted life from the MH expression of Lindblom et al (1995, MH uniaxial), and the corresponding comparison from the same multiaxial test (CT-MC) and from the MC expression of the present work (MC uniaxial). The latter pair gives the values of predicted life within a factor of two at 46 MPa.

This result can be compared with the corresponding uniaxial creep life for Cu-OFP (series 400) from the Manson-Haferd expression of Lindblom et al (1995), predicting for same stress and temperature a uniaxial life of about 4300 years (Fig 34). Note that this creep rupture line gives for the above estimates the lower value of ν' .

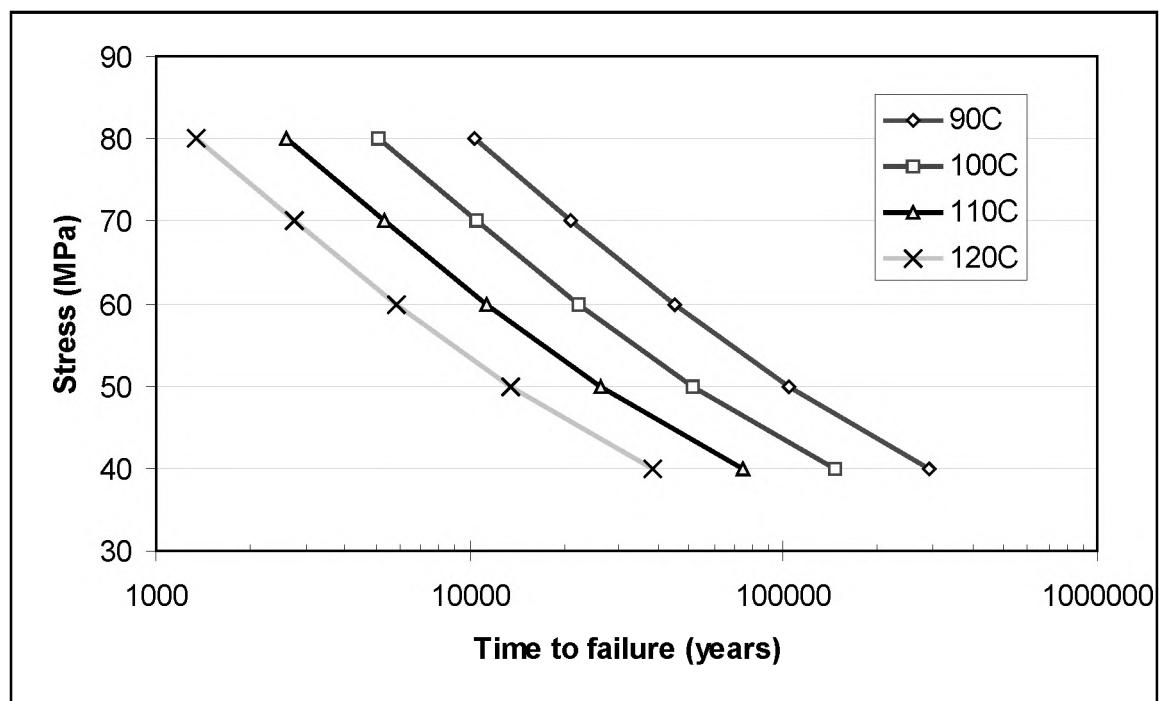
Fig 35. The predicted isothermal uniaxial creep life from the MC expression (eq. 6) for a range of 90-120 °C / 40-80 MPa.

However, for a rough indication of the resulting isothermal constant (initial) stress predictions, the life estimates at a range of relatively low temperatures are shown in Fig 35.

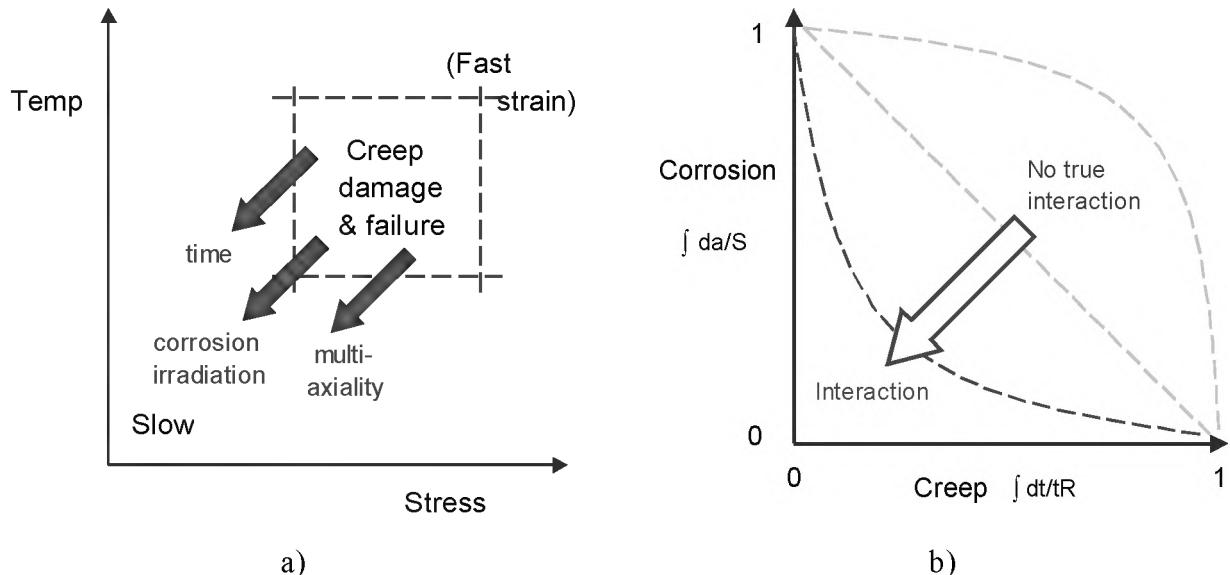
Fig 36. a) Additional potential or likely factors promoting creep and creep damage; b) types of interaction between damage mechanisms (example on corrosion and creep).
