# BALTICA IV MASTER

## Plant Maintenance for Managing Life & Performance

### Vol. 1

VTT SYMPOSIUM 184

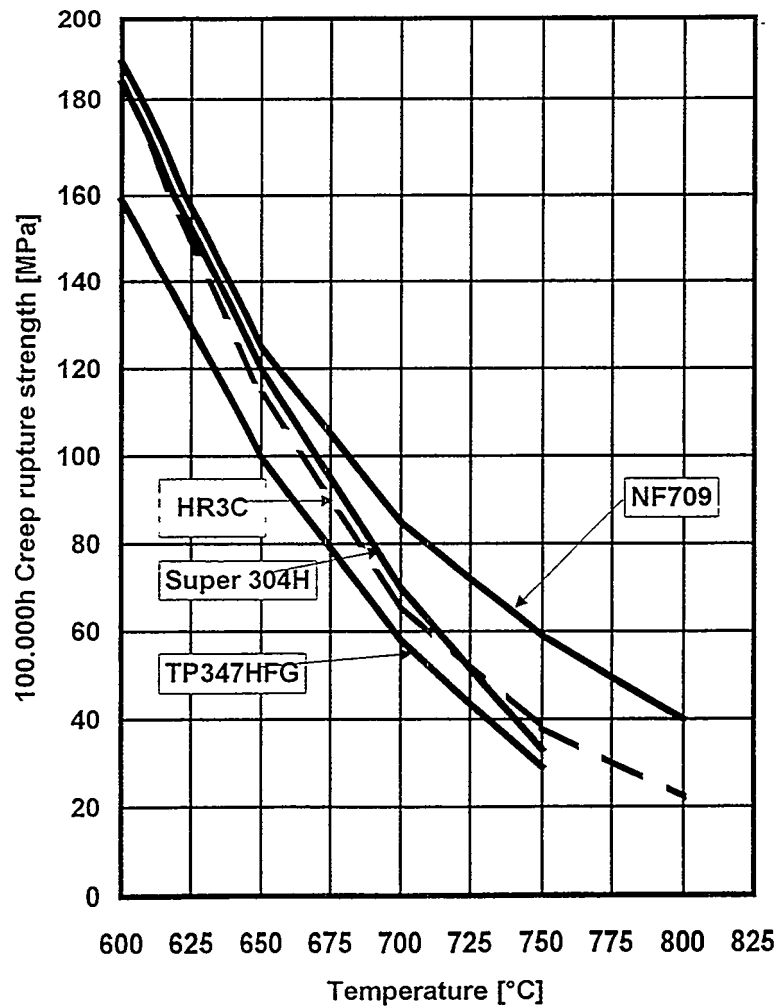
Figure 3

Chemical compositions and creep rupture strengths of new superheater steels are shown in figure 3.

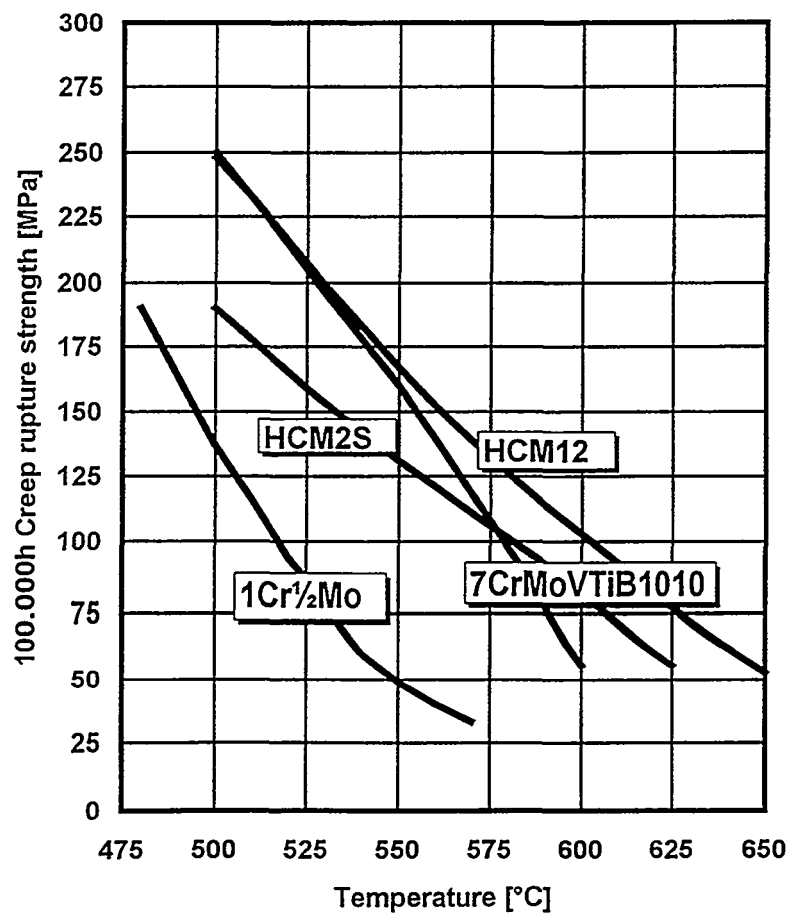
Figure 4

Compositions and creep rupture strengths of the furnace panel materials are shown in figure 4.

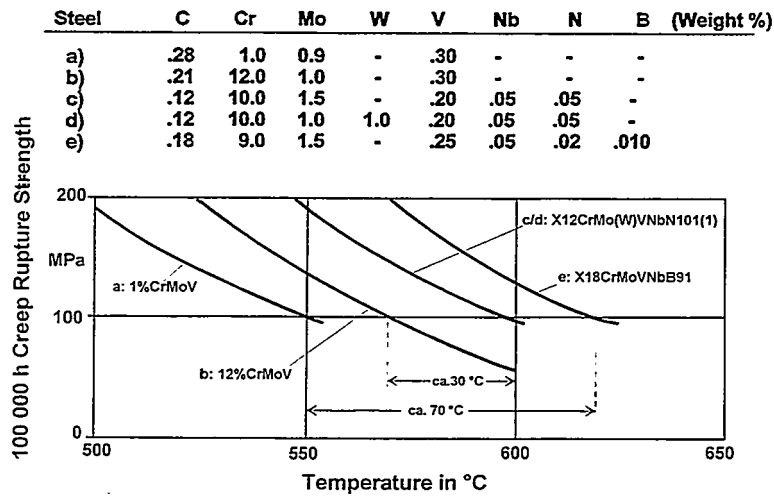
Fig. 4. 100 000 h Creep Strength of Turbine Steels.

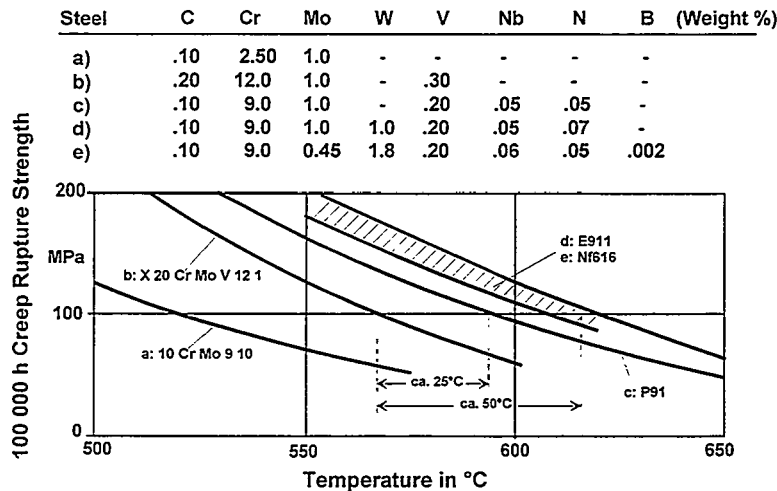
Fig. 5. 100 000 Creep Rupture Strength of Tube and Boiler Steels.

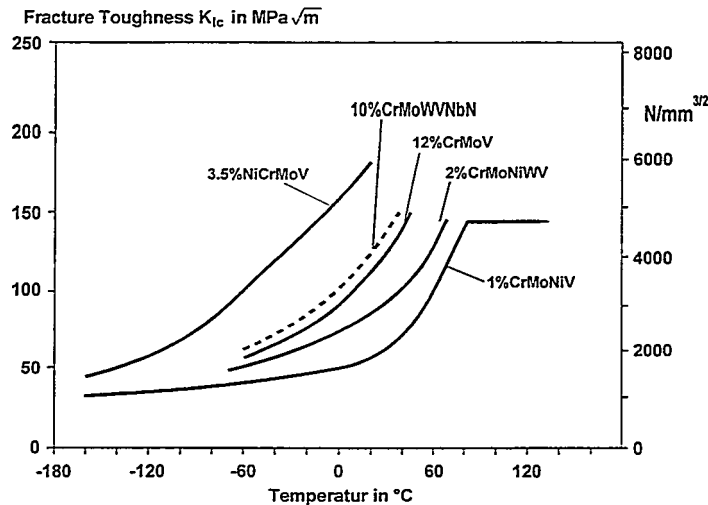
Fig. 6. Fracture Toughness of Turbine Rotor Steels.

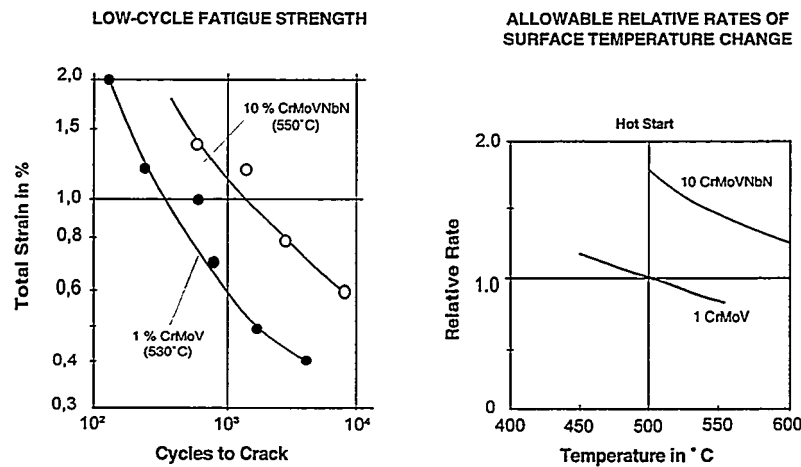
Fig. 7. Low-cycle Fatigue Strength and permissible Rate of Temperature Change of 1%CrMoV and 10% CrMo(W)VNbN HP and IP Rotor Steels.

steels compared with the low-alloys steels also has beneficial effects on the permissible start-up gradient of the turbine units. The right half of Fig.7 demonstrates the relative gain in permissible rate of temperature change at the rotor surface for a hot start for a specific shaft dimension for both these types of steel (6). The improvements achieved by employing the newly developed 10%CrMo(W)VNbN steel is over 50% in this case.

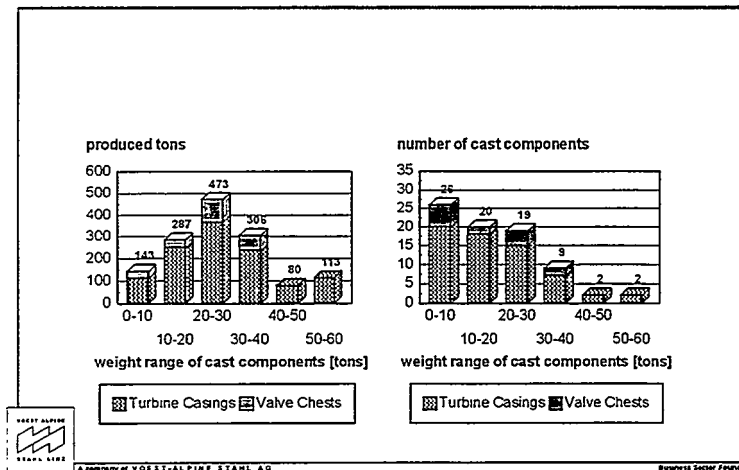
Fig. 9. Spectrum of Weight Range of Castings produced by a large Foundry.

The experience gained so far in the manufacturing of components for the above mentioned power stations is decidedly positive (8) . 3 European forgemasters were involved in the COST 501 development of the rotor materials and manufacturing of the rotors (9-11) and at least 6 European foundries manufactured the castings of which most originated from two foundries which were also actively involved in the COST 501 development work (12 and 13). One of the two foundries made over 80 castings of between 3 t and 60 t. The spectrum of weight range of the produced castings from the same foundry is given in Fig. 9.

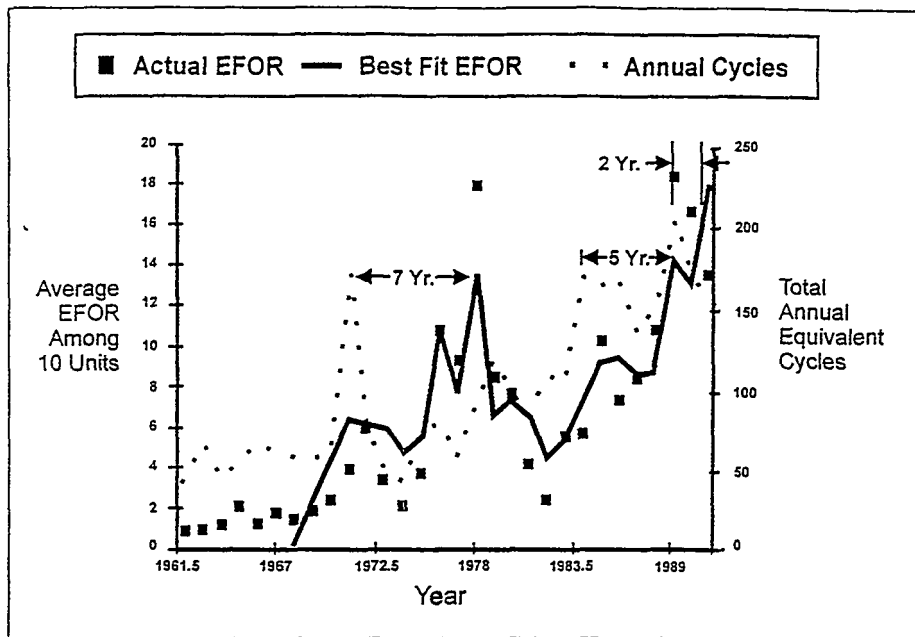
Figure 6. Effect of Cycling on Plant Reliability (EFOR).

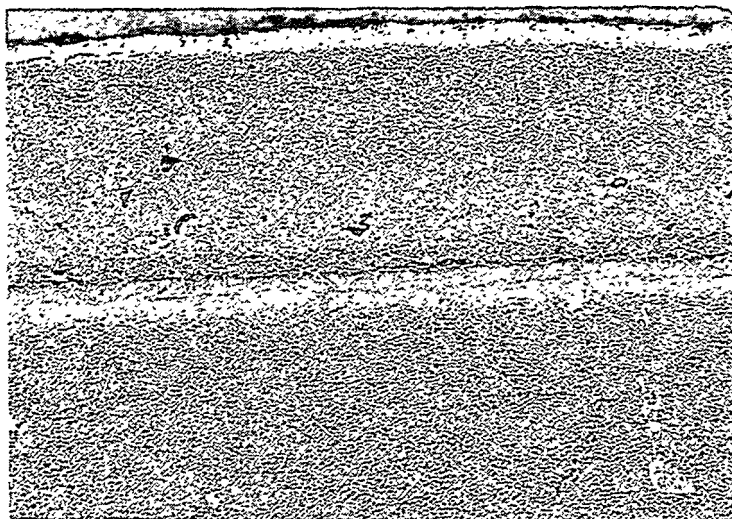
*Fig. 1. Microstructure of un-degraded CoCrAlY with a top aluminide coating layer (GT 29+).*

GE applies either CrCoAlY (GT 29) or CoCrAlY with an over aluminized layer (GT 29+) coating on row 1 and row 2 turbine blades for hot corrosion and/or oxidation resistance. The CrCoAlY coating is applied using either Vacuum Plasma Spray (VPS) or Low Pressure Plasma Spray (LPPS) processes. In the as-coated condition, the microstructure of CoCrAlY coating exhibits approximately 50% of  $\beta$ -phase (CoAl) particles, by volume in the  $\gamma$  matrix. The top aluminide is a single ( $\beta$ ) phase coating and is applied using pack cementation or the over-the-pack process. Figure 1 shows undegraded microstructure of over aluminized CoCrAlY coating on a GTD-111 blade. Nominal composition of CoCrAlY and top aluminide coatings is given elsewhere [7,8]. Nominal aluminum content in the GT 29 coating is 6%.

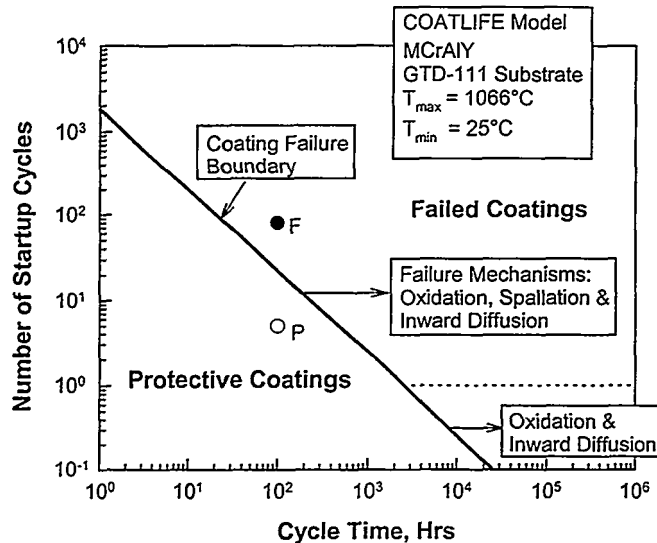
Fig. 10. Coating life diagram showing failure and no failure regions.

The model was then used to calculate the time to failure of the coating as a function of cycle time. The calculated values of the times-to-failure are then divided by the cycle time to obtain the number of startup cycles to coating failure. A coating life diagram is then obtained by plotting the number of startups as a function of cycle time in a log-log plot. As an illustration, a coating life diagram calculated for CoCrAlY coatings subjected to cycling between 25°C and 1066°C is presented in Figure 10.

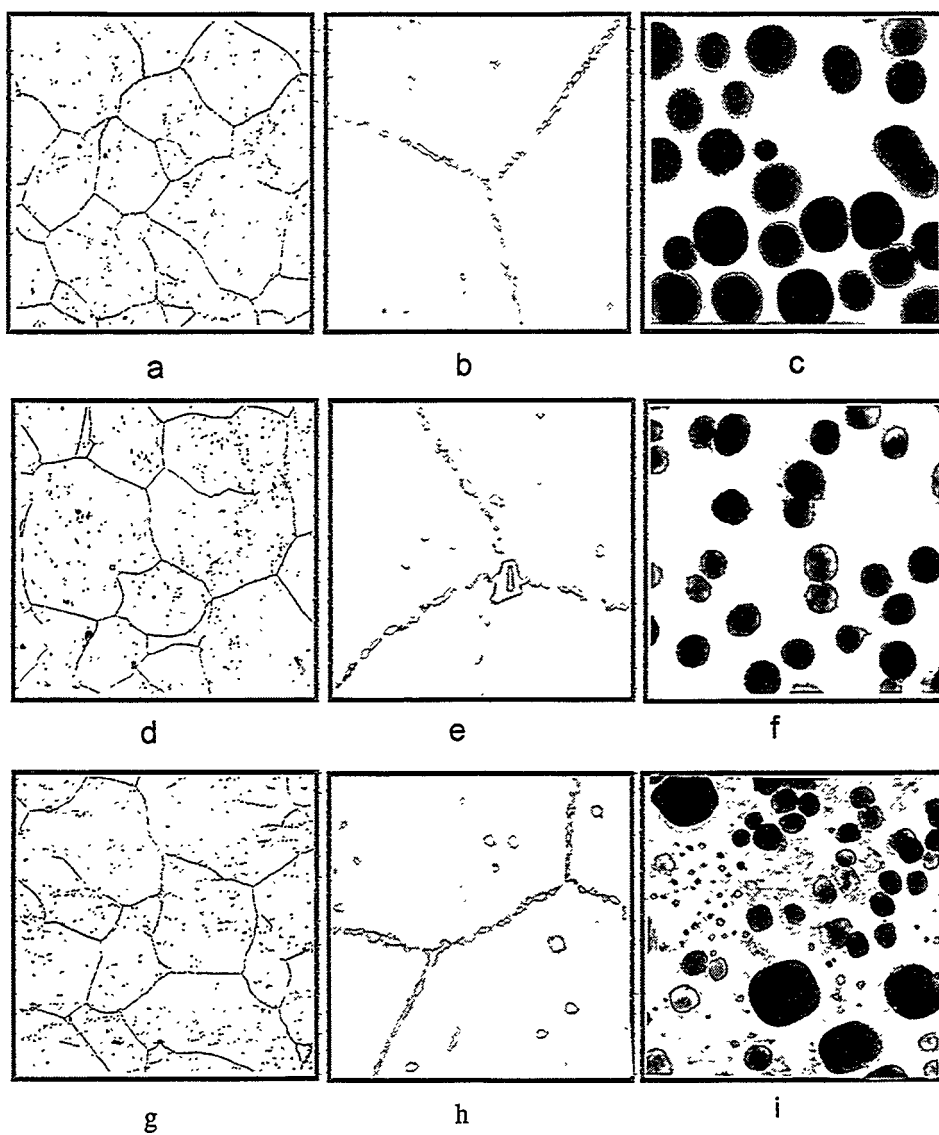
Fig. 3. Microstructure of EI 893 alloy:  
 (a-c) after coating deposition and reheat treatment  
 (d-f) after (a) + 7381 operating hours  
 (g-i) after (a) + 5903 operating hours  
 (a, d, g) optical image x 100  
 (b, e, h) optical image x 100  
 (c, f, i) electron microscope image x 50000.

Under operation the main changes of the blade metal are related to the basic alloy hardening  $\gamma'$ -phase. According to the stage number (which determines the temperature) an extra precipitation of  $\gamma'$ -phase in amount of 2 % to 6% is observed (Table 5). The structure of grain boundaries remains practically unchanged (Fig. 3). The modifications of the alloy microstructure are accompanied by changes of the blade metal properties (Table 6, 7). According to the amount of the extra precipitated  $\gamma'$ -phase the growth of the hardness and strength and the reduction of the plasticity is observed as at 20°C as at 750°C. But nevertheless, as it can be seen at Table 6, the whole complex of the blade metal properties is at high level and doesn't limit the further use of the blades.

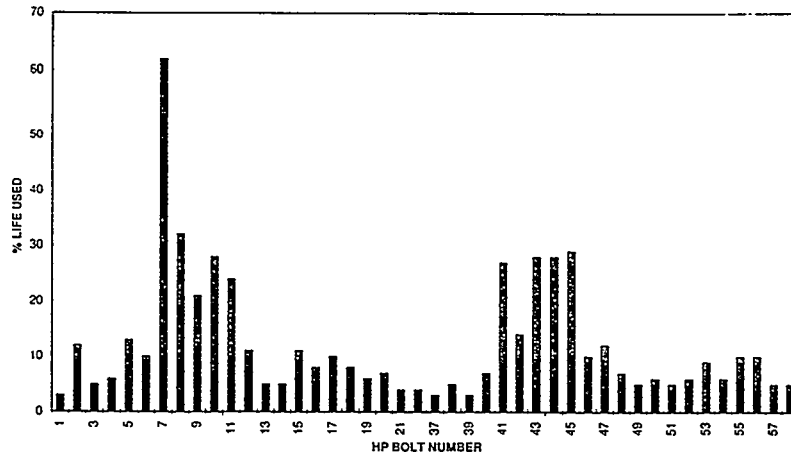
Figure 2. Life assessments of HP bolts after 122,000 hours service.

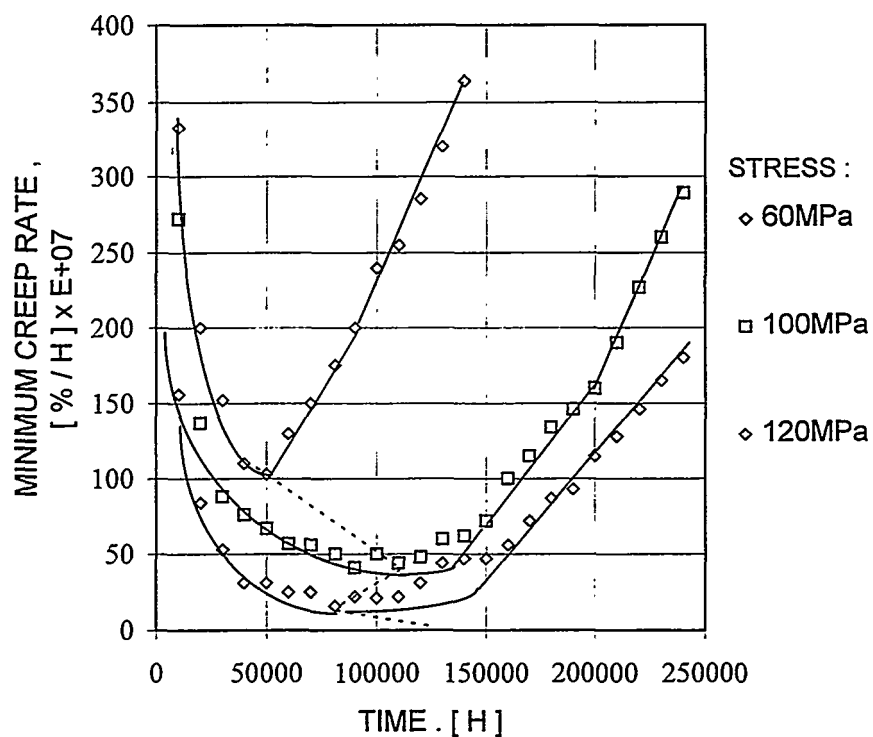
Fig. 2. Minimum creep rate curves of 1%CrMoV HP and IP rotor steel grade (R2MA) at 550 C.

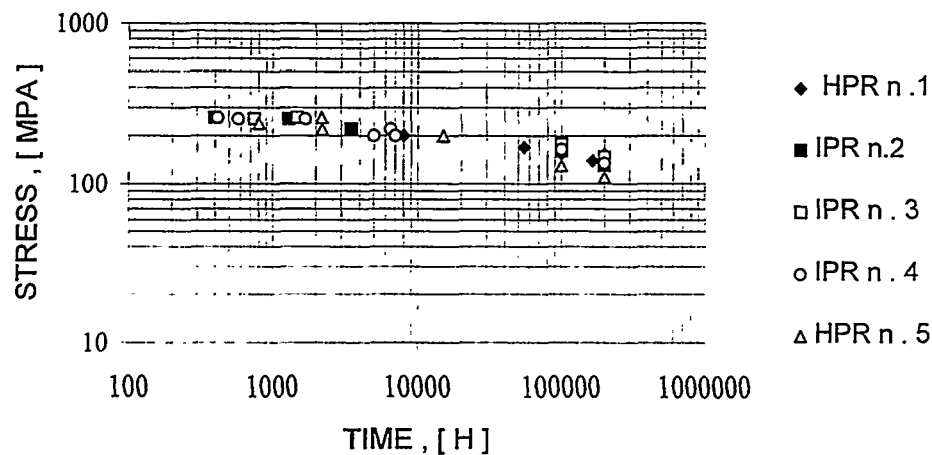
Fig. 3 . Creep rupture of 1%CrMoV rotor steel (R2MA) at 550 C from full size HP and IP rotors manufactured in 1963 - 1975 .

Note : HPR n .1-YS 500MPa (near surface body-tang) ;  
 IPR n. 2 and n . 3 -YS 500MPa (axial cores) ;  
 IPR n. 4 - YS 600 MPa (near surface body-tang) ;  
 HPR n .5 - YS 700 MPa (near surface body-tang) .

The Newly Projection Concept Micro-mechanical Modeling technique stated above was used for analysis of the data . Relations (set-3.3) and maps were used as governing state equations .Norton exponent 'm' ,creep fracture exponent 'n' and other constants were estimated based on interpolation of direct data of long-term creep tests . The  $m$  ,  $n$  and  $k$  parameters outside the point of bending were estimated by data from long-term creep tests and creep fracture tests . Figures 3 and 4 show the relationship between creep fracture strength based on direct tests with duration of loading ranging from 56,000 to up 200,000 h at temperature  $550^\circ\text{C}$ . On the basis of the presently available data, optimum creep fracture strength can be obtained as yield strength ( $R_{p0,2}$ ) of 580-620MPa .This relation of creep fracture strength with  $R_{p0,2}$  is entirely estimated using structural factors .

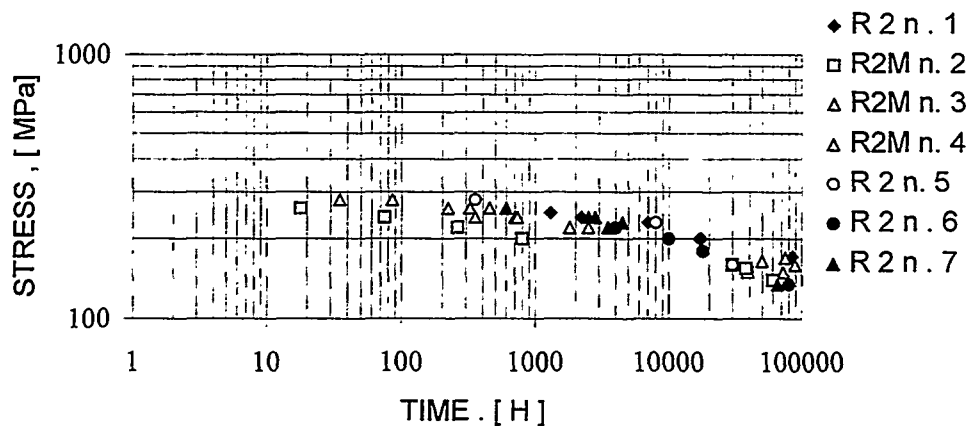
Fig. 4 . Creep rupture of 1%CrMoV rotor steels (R2 , R2MA) at 550 C from HP and IP rotors after long-term operation times (55,000 - 166,000 h) .

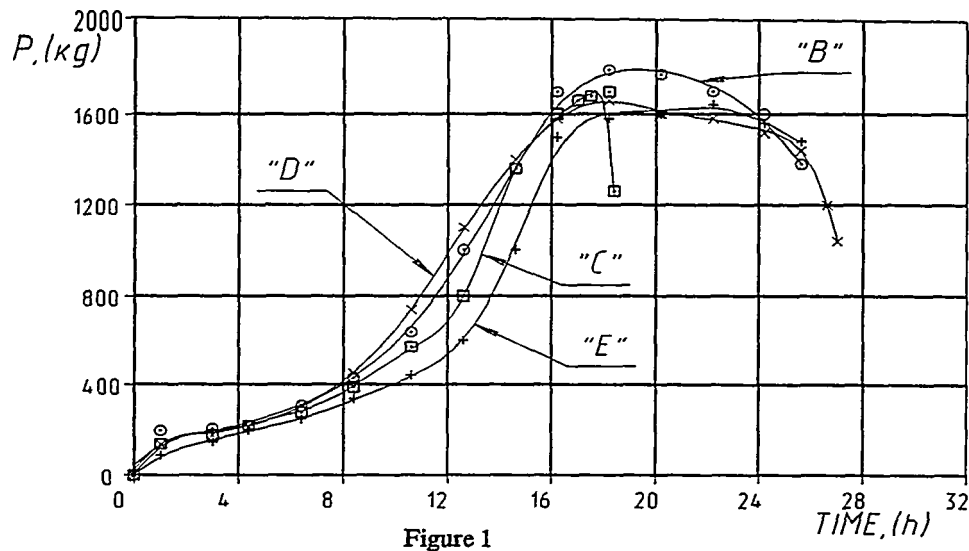
Tensile diagram of specimens  
from VT 1-0 alloy in water solution at 20 °C

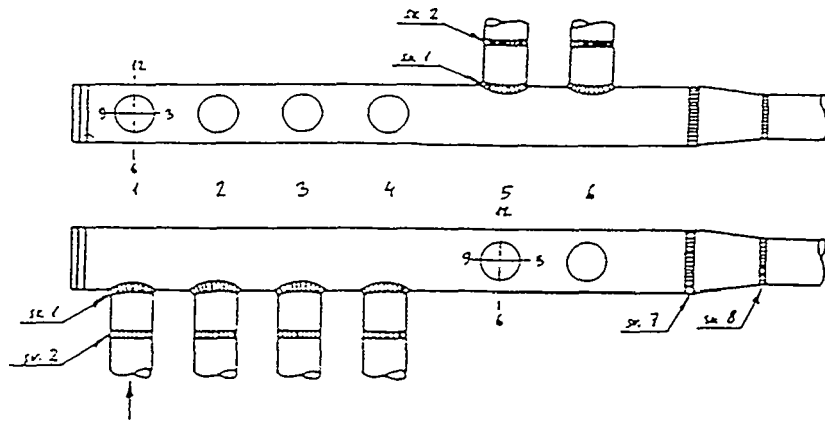
Figure 1. Header used for testing.

508) had developed. At nozzle 3 the damage was characterized as Class 3-4 and at nozzle 4 the damage was only Class 2. An inspection interval of 15.000 hours was recommended.

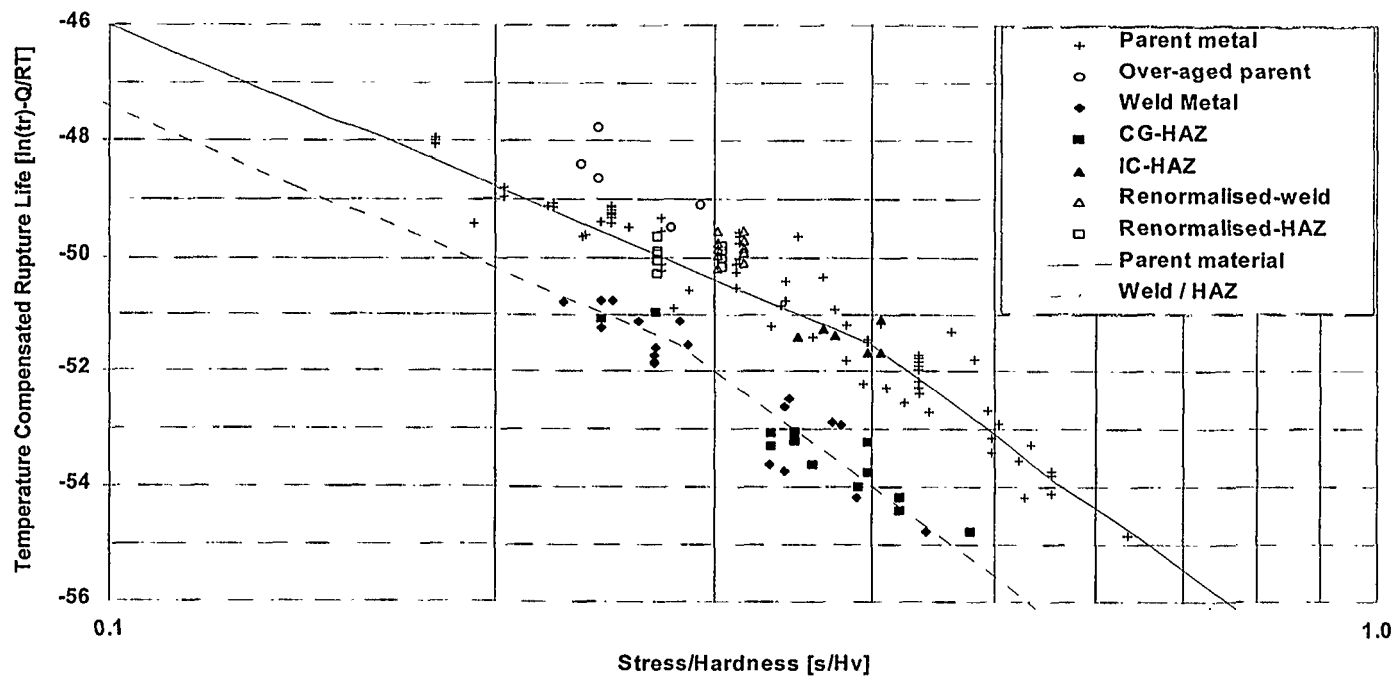
Fig. 1. Hardness compensated creep rupture data for 2.25Cr1Mo steels tested in vacuum.

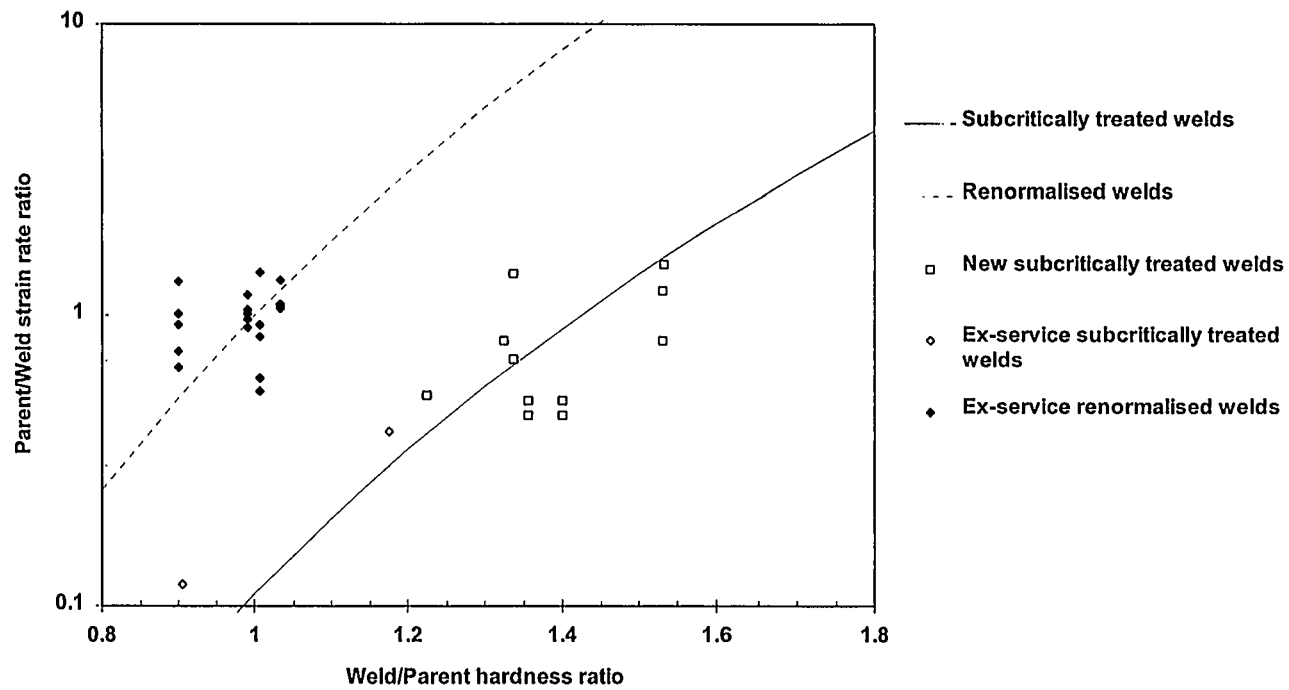
Fig. 2. Relationship between creep rate ratio and hardness ratio for large cross-weld specimens of 2.25Cr1Mo steel.

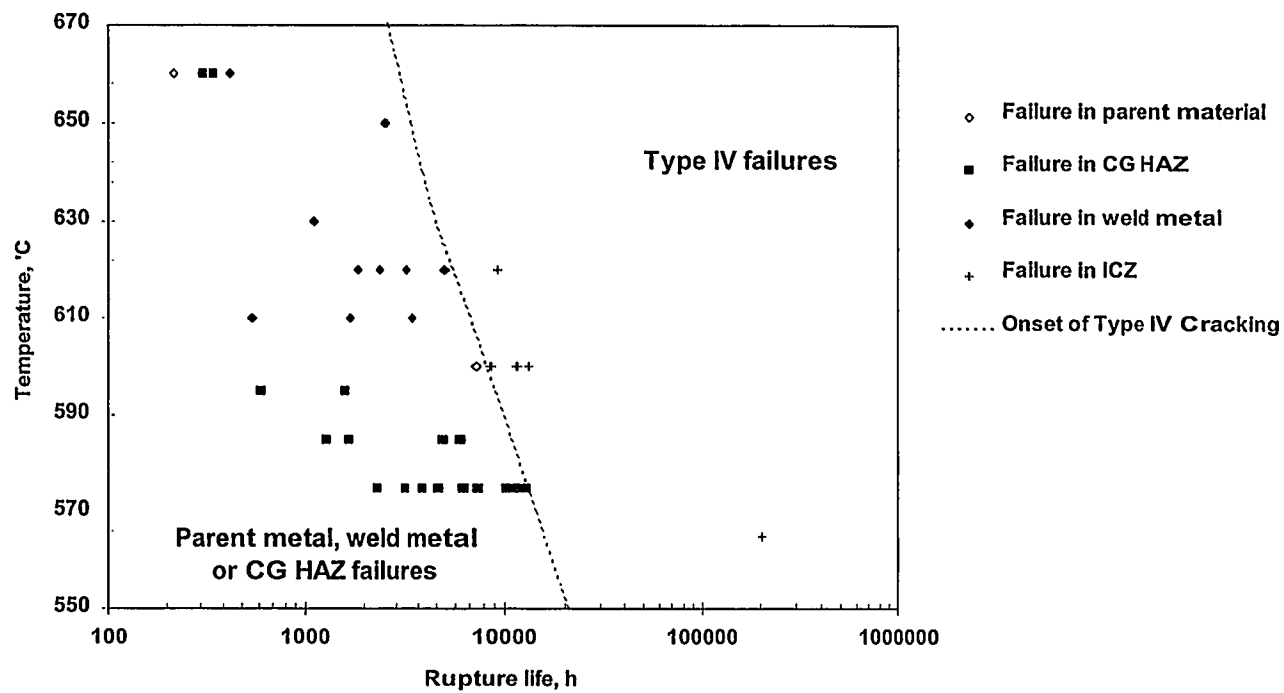
Fig. 4. The time-temperature dependence of the onset of Type IV cracking in 2.25Cr1Mo steel.

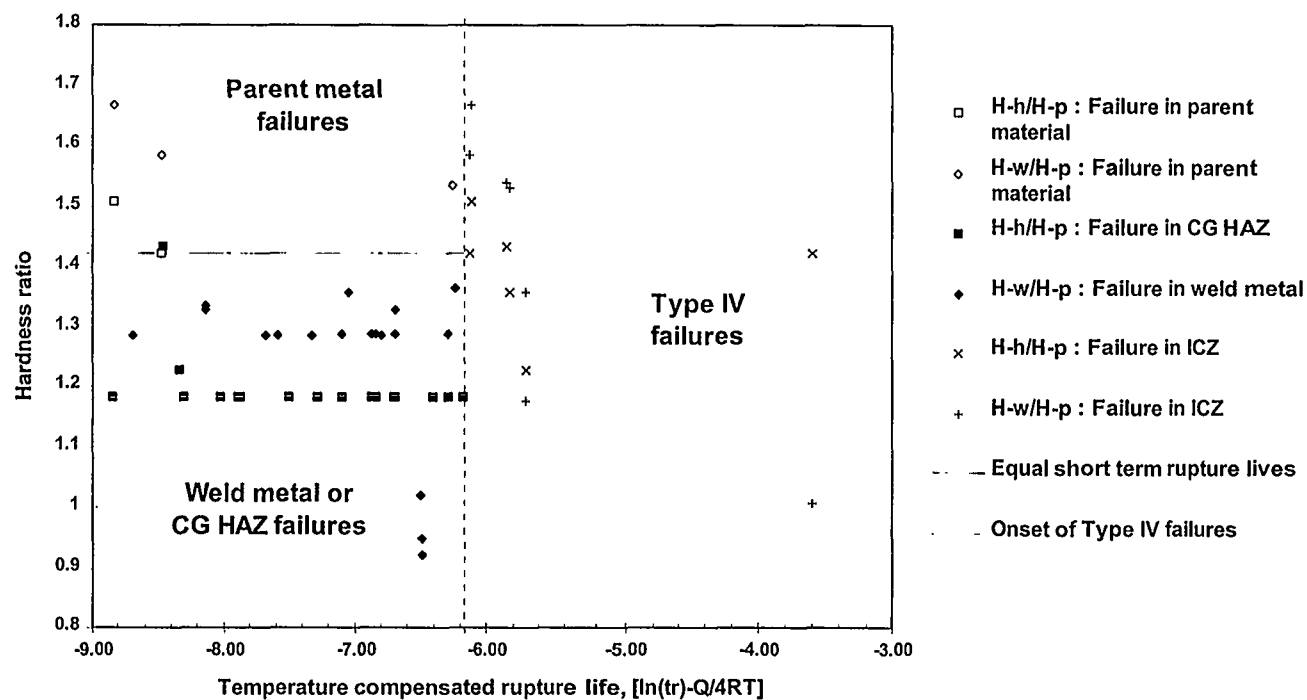
Fig. 5. Weld failure location predictor diagram, including the Type IV cracking regime, for 2.25Cr1Mo steel.

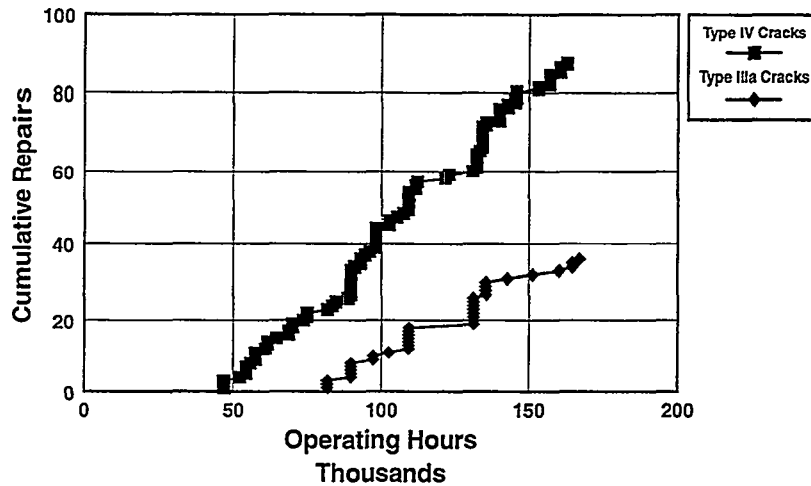
*Fig. 2. Butt weld repairs for Type IV and IIIa cracks as a function of operating hours (current coal-fired plant).*

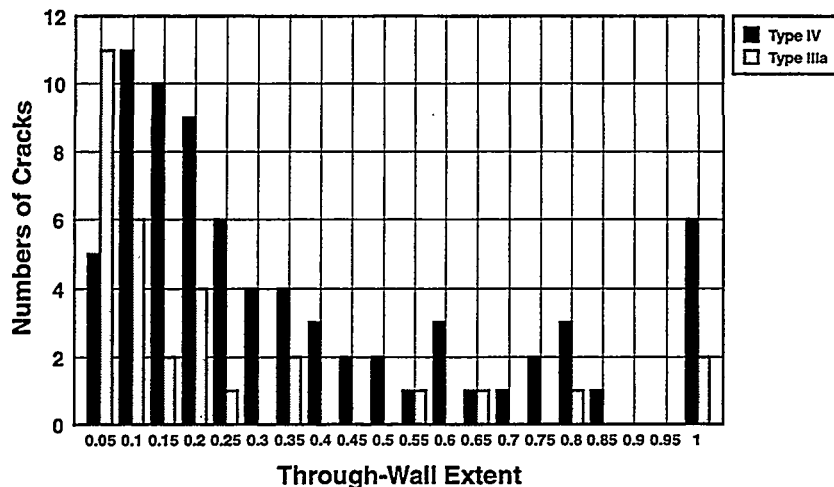
Fig. 5. The through-wall size distributions of Type IV and IIIa cracks found on current coal-fired plant

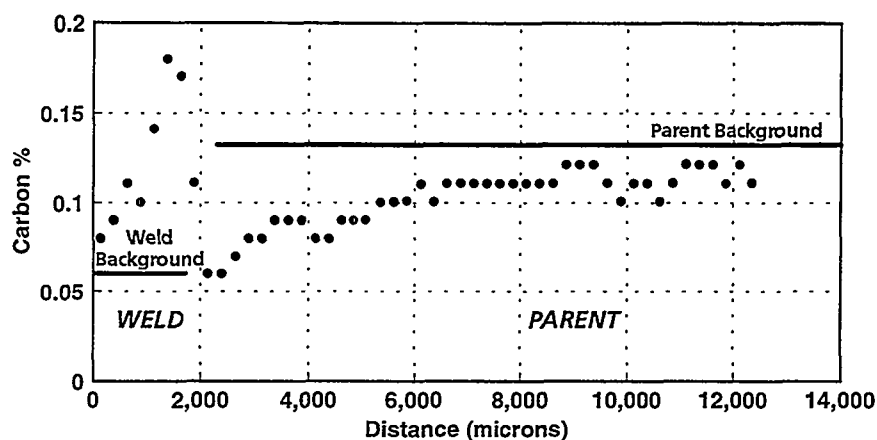
Fig. 6. Carbon profile for a 2CrMo weld in  $\frac{1}{2}$ CrMoV pipe after post weld heat treatment and ageing for 884 hours at 642°C (measurements by neutron microprobe).

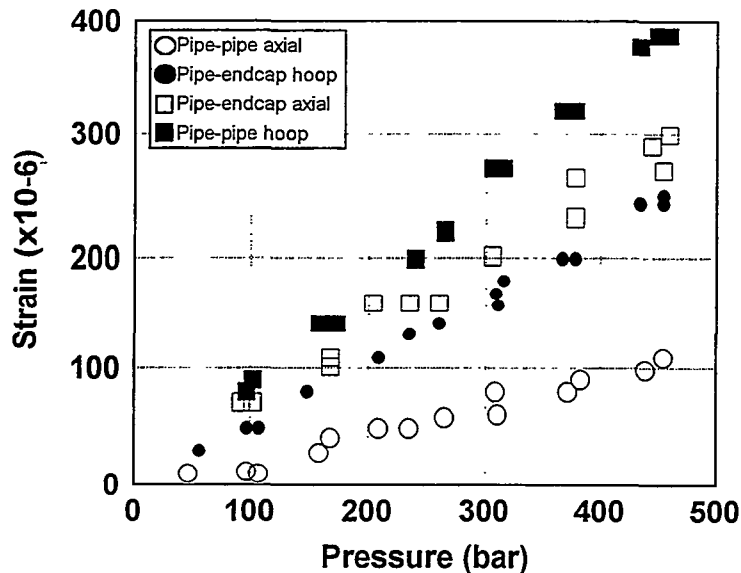
Fig. 2. The increase in hoop and axial elastic strain with pressure for pipe - pipe and pipe - end cap locations in a high temperature vessel.

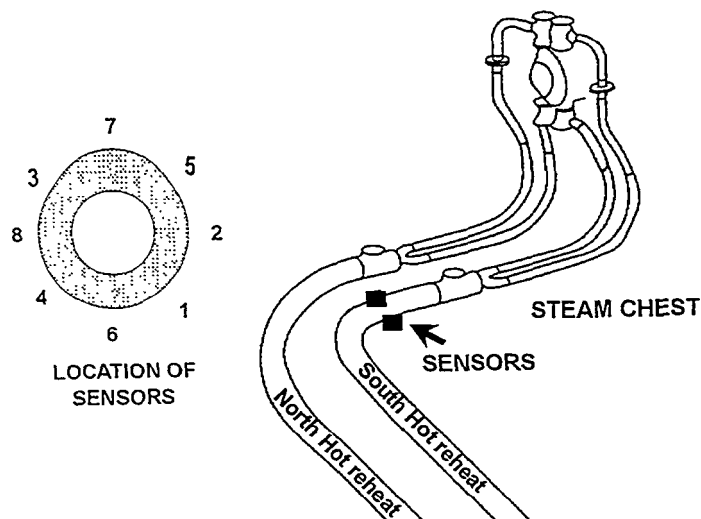
Fig. 3. Schematic diagram of plant showing the location of monitoring using SJB sensors.

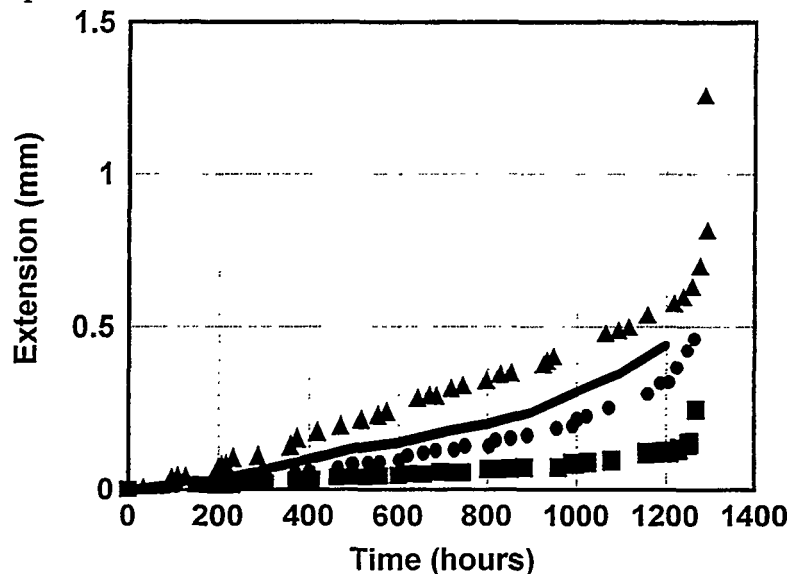
Fig. 6. Extension:time curves recorded from the extensometer ( $\blacktriangle$ ) and local sensors across the low alloy HAZ steel ( $\bullet$ ) and the adjacent 2CrMoNb buttered layer ( $\blacksquare$ ) of a transition weldment. The sum of the displacements from the local sensors is shown as the solid line (8).

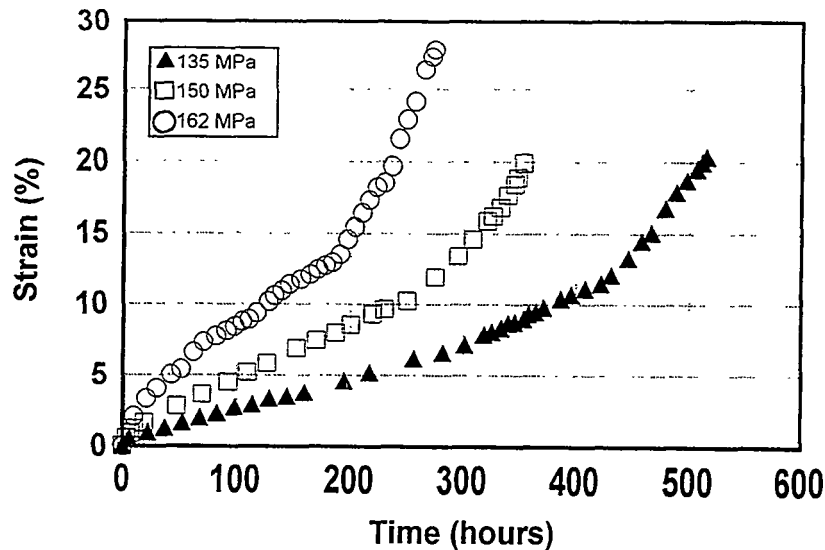
*Fig. 7. Strain:time behaviour for the intercritical region of the HAZ in low alloy steel weldments which failed by Type IV cracking.*

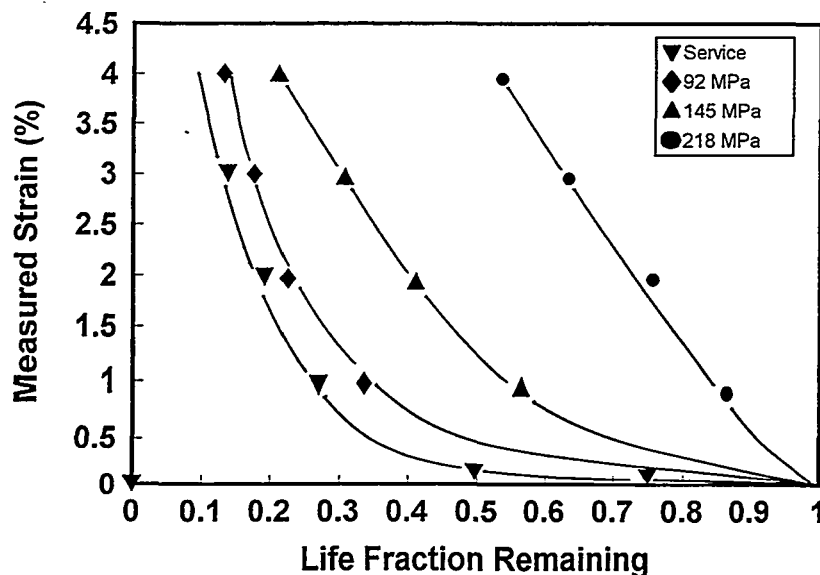
Fig. 8. Relationships between accumulated creep strain and life fraction for piping components at different hoop stresses.

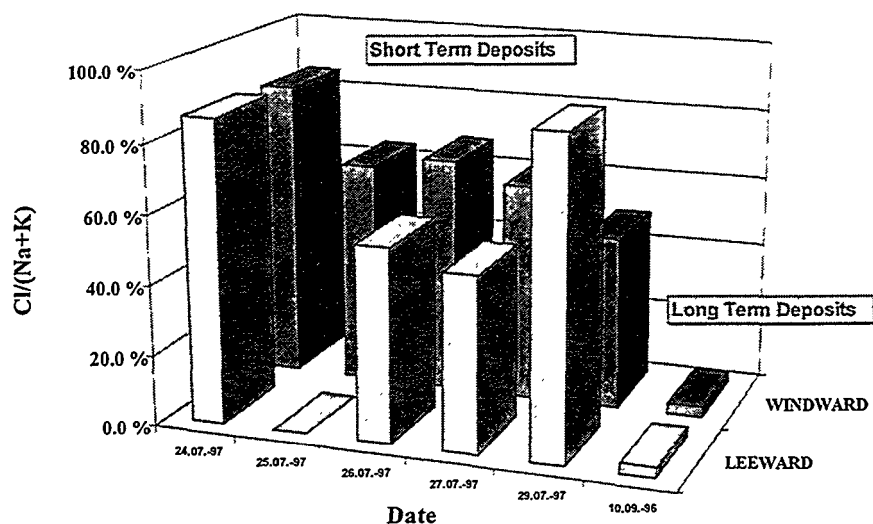
Figure 2: Measured behavior of short and long term deposits in a biomass boiler. Duration of the short and long term test is 12-24 and 1000 hours, respectively.

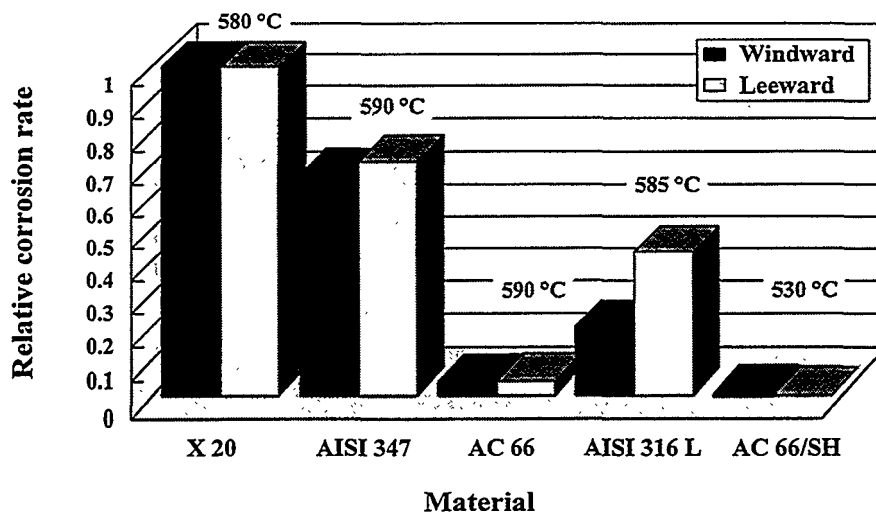
*Figure 4: Relative corrosion rate of different alloys according to probe tests. Temperatures represent probe metal temperatures, except with AC66/SH, which is the result obtained from a real superheater tube. In this case the temperature refers to the actual steam outlet temperature (530°C), not the material temperature.*

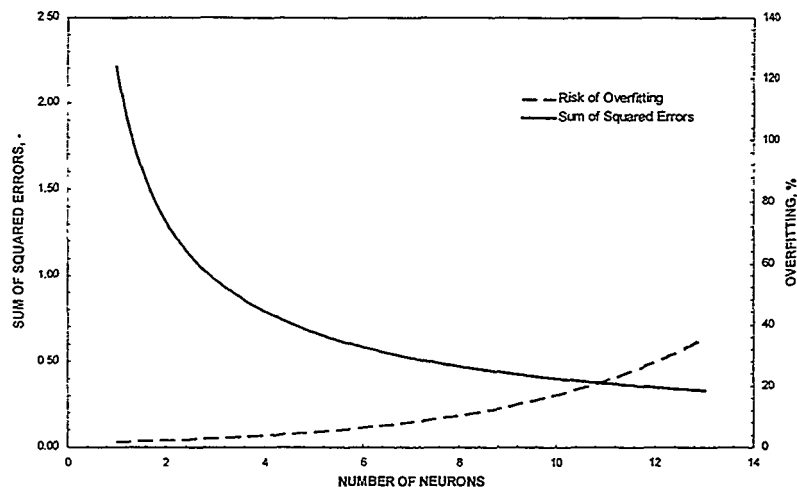
Figure 8. Dependence of SSE and overfitting on the number of neurons, Levenberg-Marquardt learning algorithm.

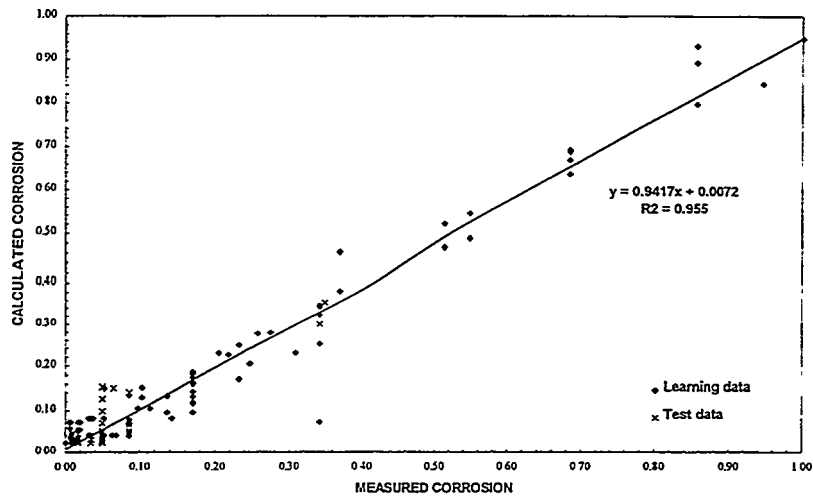
Figure 9. Calculated corrosion versus measured corrosion, normalized values.

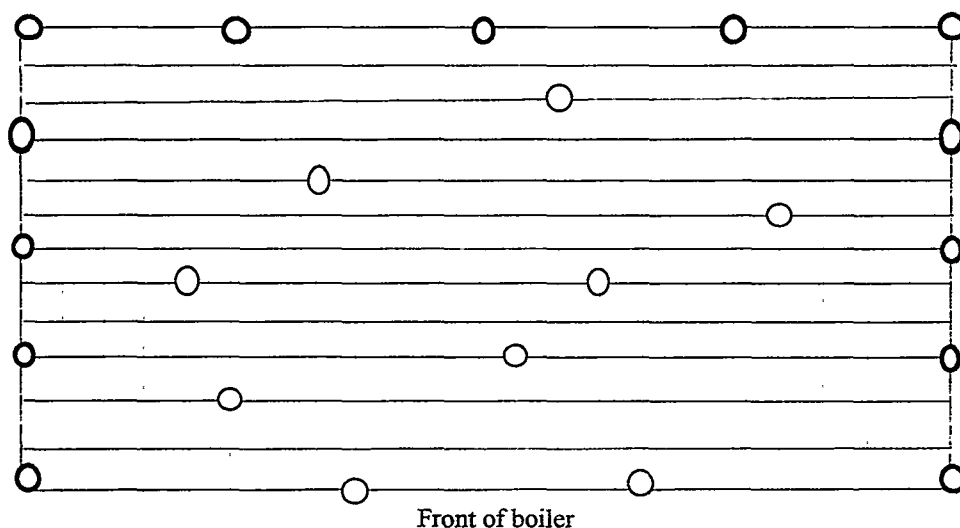
Fig. 1. Layout of bank tubes board in steam and water drums. Bold line shows welded rolled eyes.

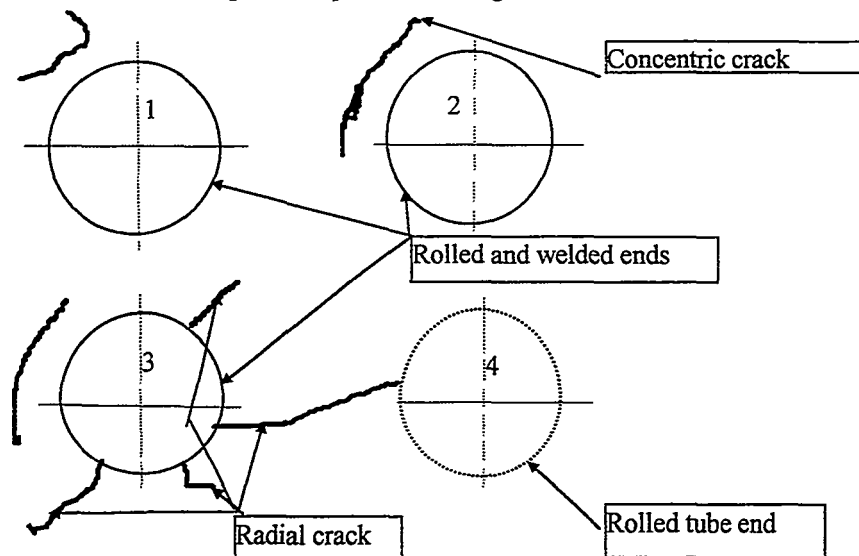
Fig. 2. Cracks with different shape.

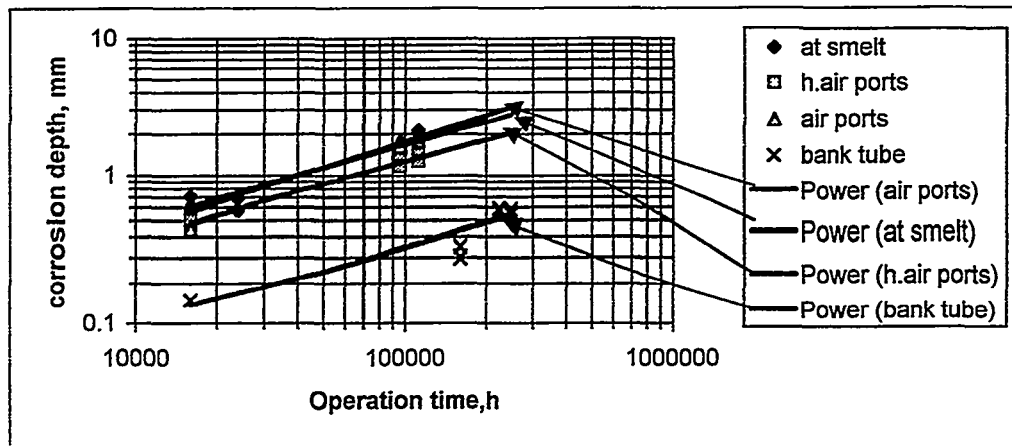
Fig.4. Corrosion depths on the tubes depend on time in the different places of boiler at metal temperature 270°C.

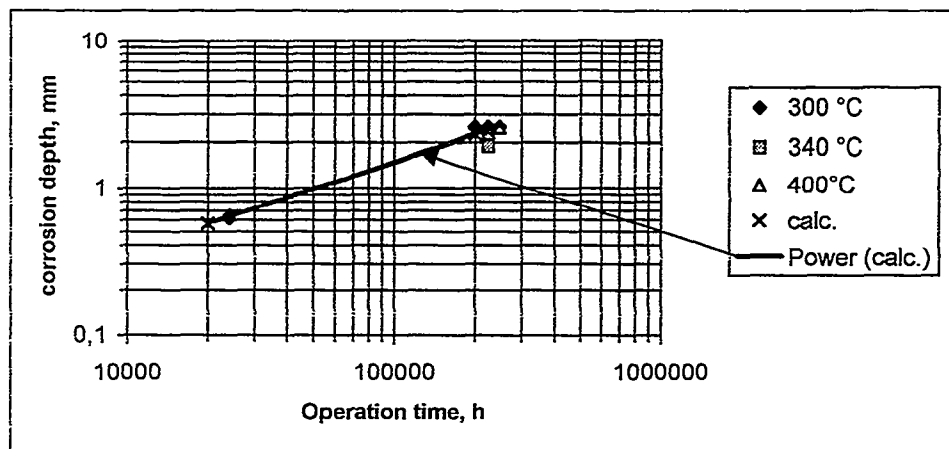
Fig.5. Corrosion depths on the superheater tubes depend on time at the different metal temperature.

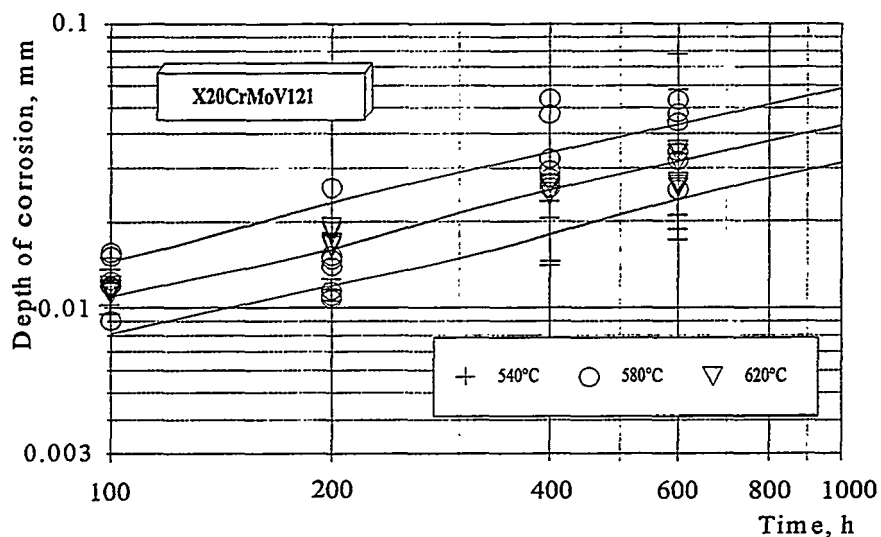
Figure 1. Experimental data and regression of corrosion depth of alloy X20CrMoV121 under impact of Estonian PF oil shale fly ash.

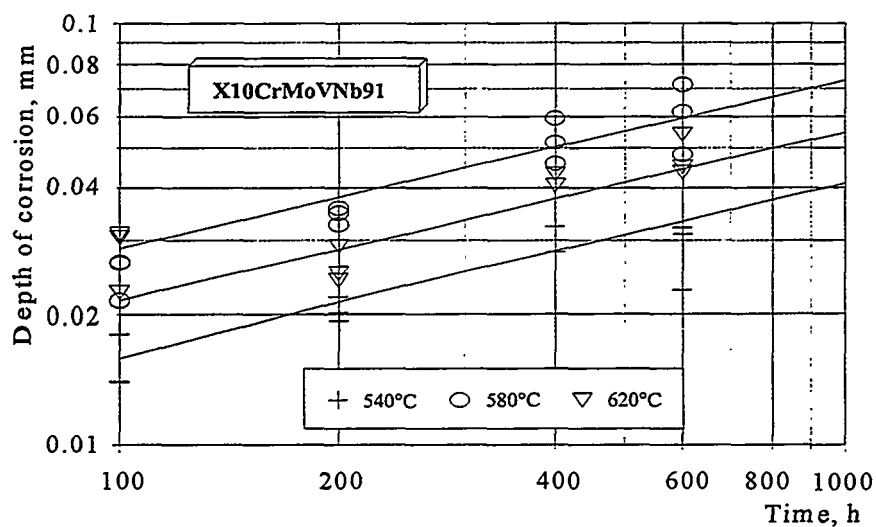
Figure 2. Experimental data and regression of corrosion depth of alloy X10CrMoVNb91 under impact of Estonian PF oil shale fly ash.

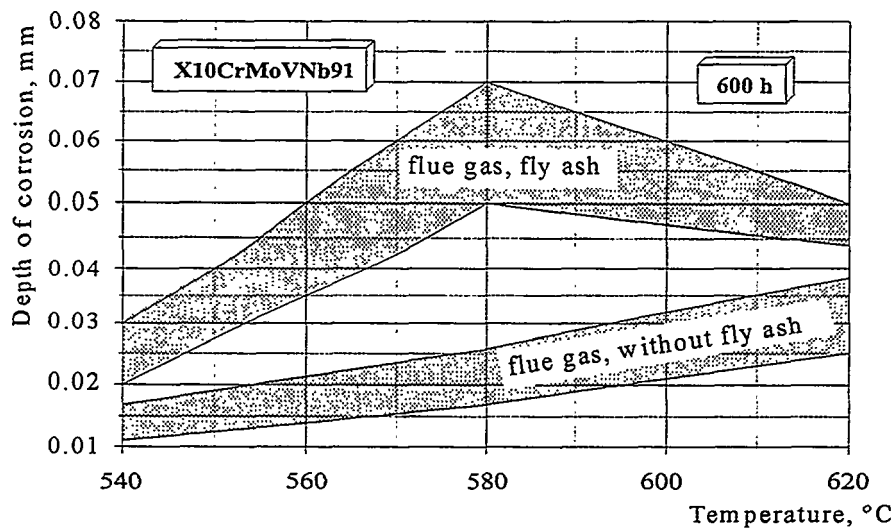
Figure 3. Corrosion depth of alloy X10CrMoVNb91 in various environment.
