# BALTICA IV MASTER

## Plant Maintenance for Managing Life & Performance

### Vol. 1

VTT SYMPOSIUM 184

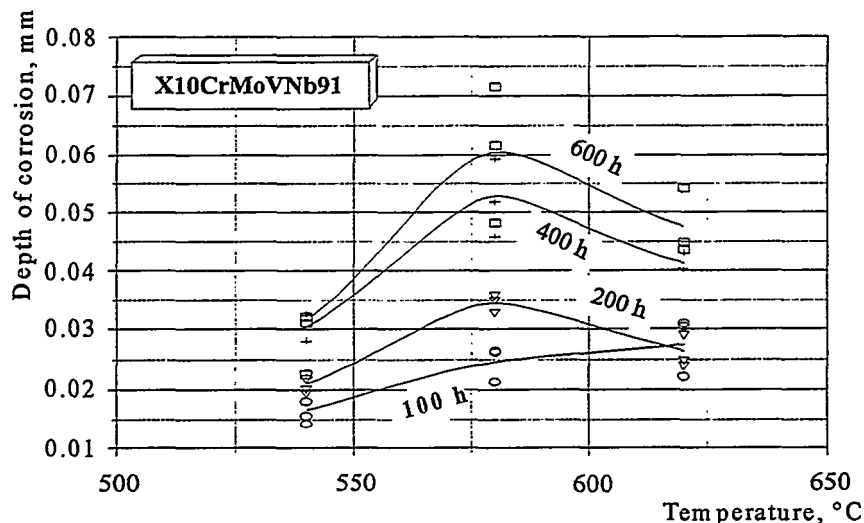
Figure 4. Corrosion depth of alloy X10CrMoVNb91 under impact of Estonian PF oil shale fly ash.

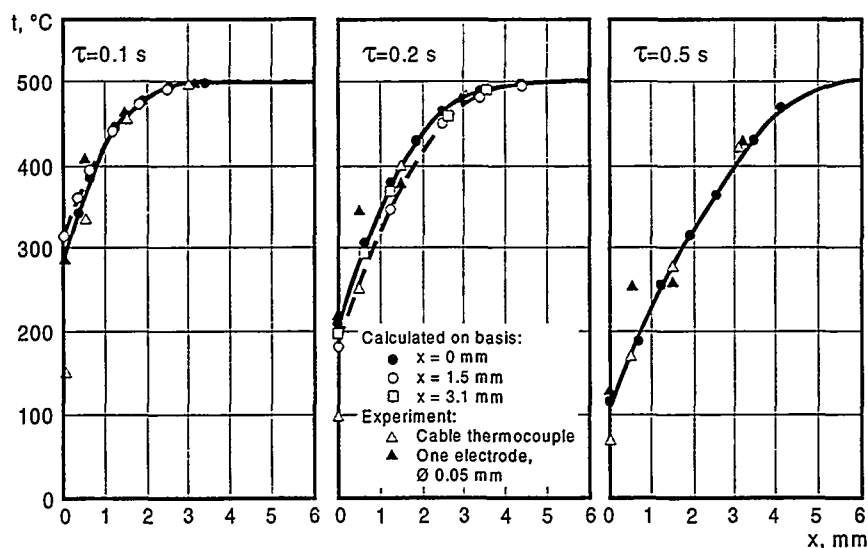
Fig. 1. Temperature field in the  $\text{Ø}32 \times 4.5$  mm tube wall made of 1CrMoV steel. Steady temperature –  $500^{\circ}\text{C}$ .

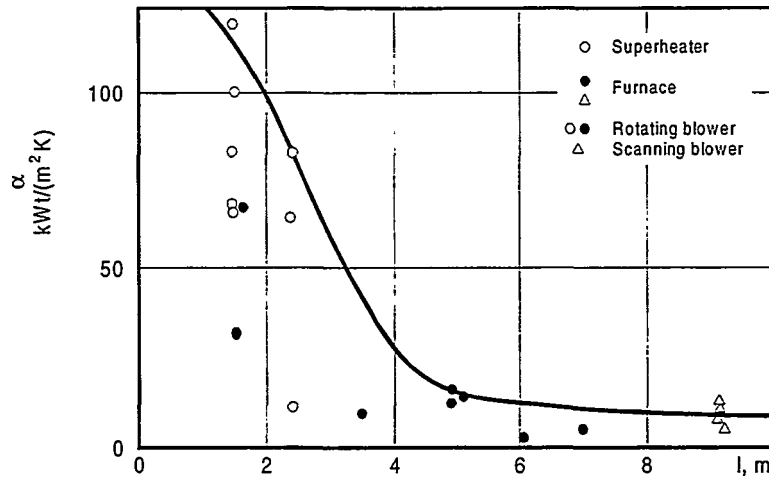
Fig. 3. The average heat transfer coefficient from outer tube surface to water jet in real boiler water washing condition depending on distance from nozzle. Temperature of tube's outer surface - 430-470°C.

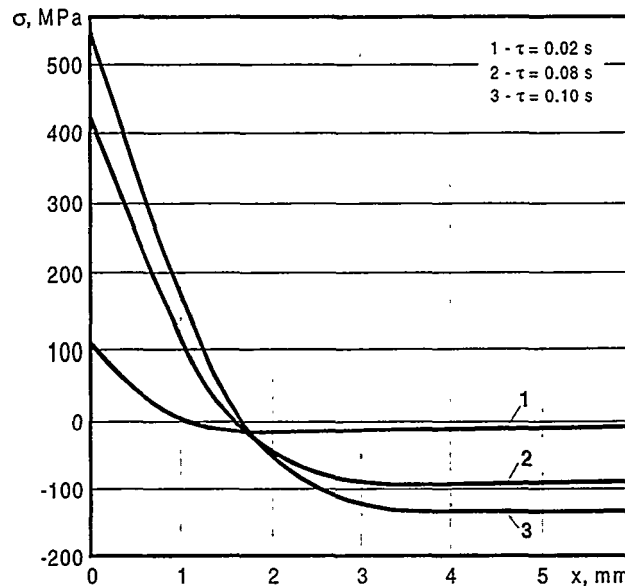
Fig. 6. The axial thermal stress field in the wall of tube  $\varnothing 42 \times 4.5$  mm made of 12Cr1MoV steel (corresponds to Figure 4). Steady temperature – 427°C.

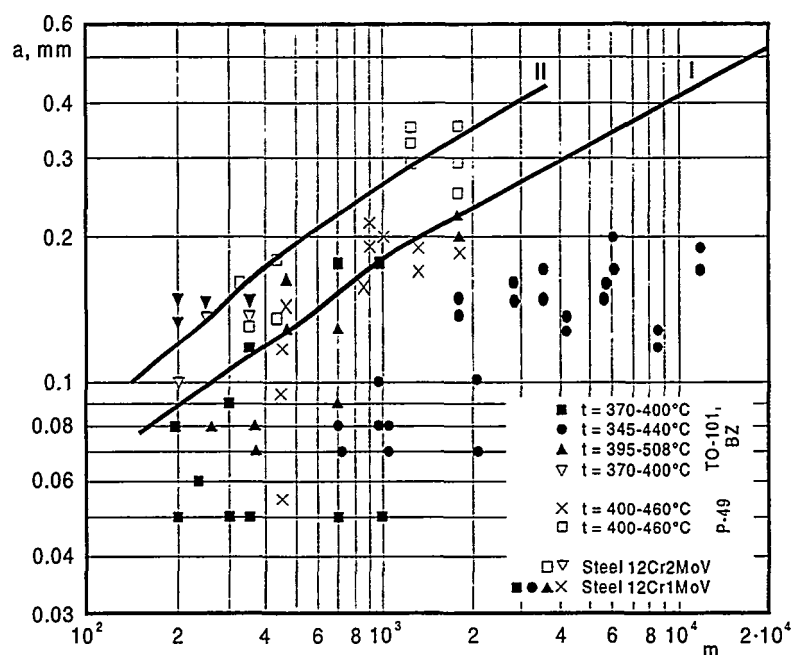
Fig. 7. Thermal fatigue crack depth depending on cleaning cycles. I – steel 12Cr1MoV, II – steel 12Cr2MoV.

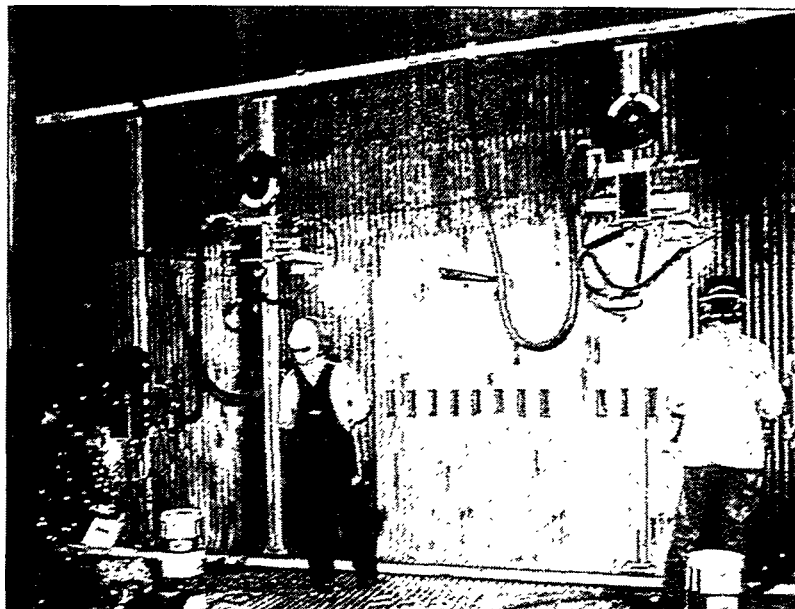
*Fig. 1. Three weld overlay machines are shown in overlaying the waterwall in the field.*

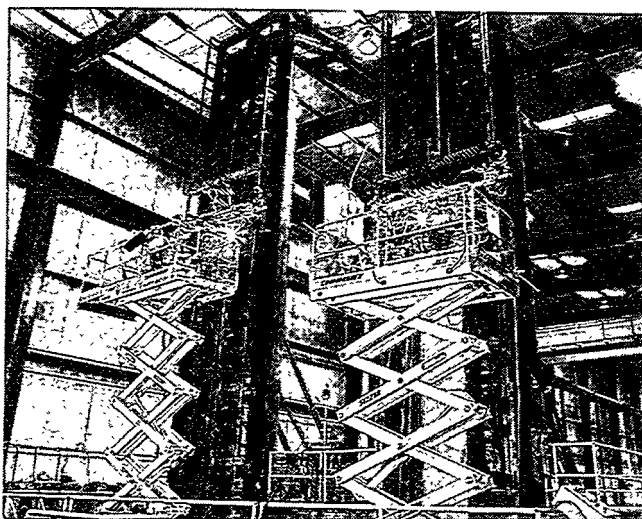
*Fig. 2. Stands for weld overlaying of panels in shop.*

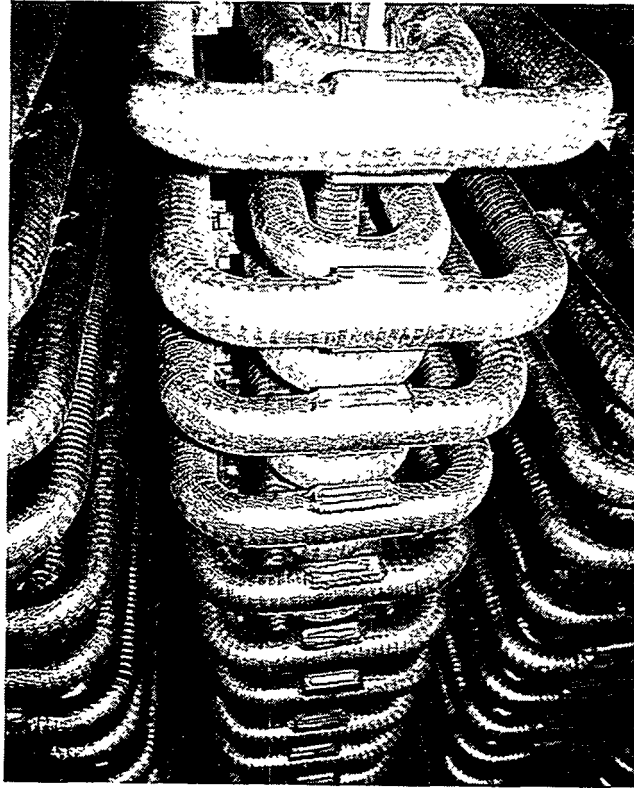
*Fig. 4. Alloy 625 overlay tubes used as superheater tubes in a waste-to-energy plant in the Netherlands.*

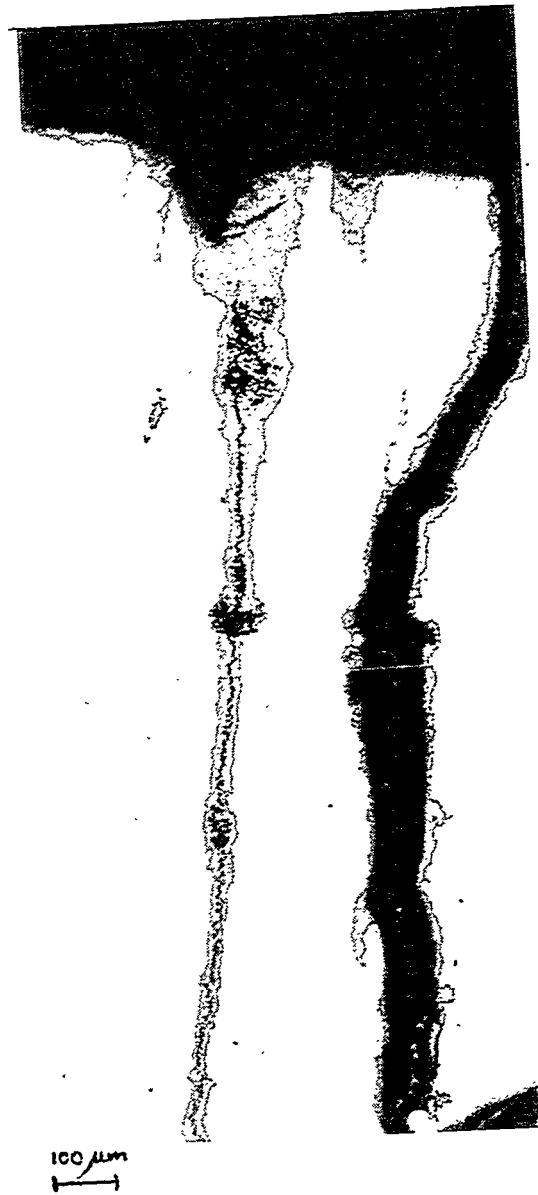
*Figure 3. Microscopic view of the cracks in the pump casing.*

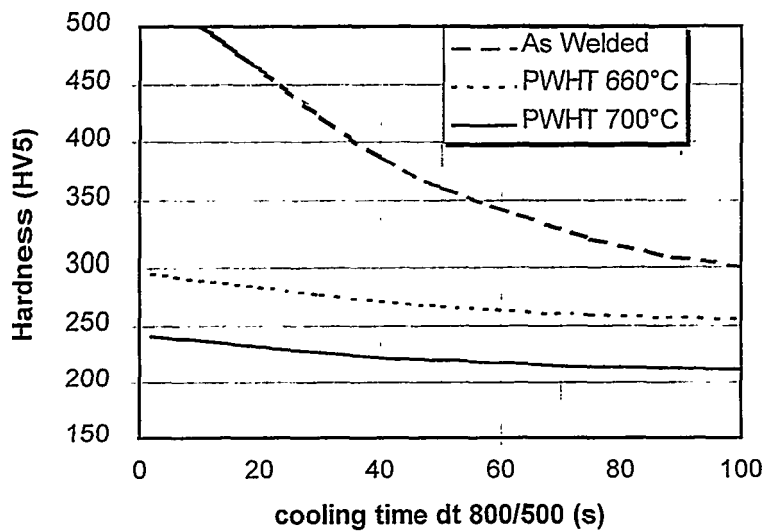
Figure 4. Maximum predicted HAZ hardness of GS-24CrNiMo325 [3].

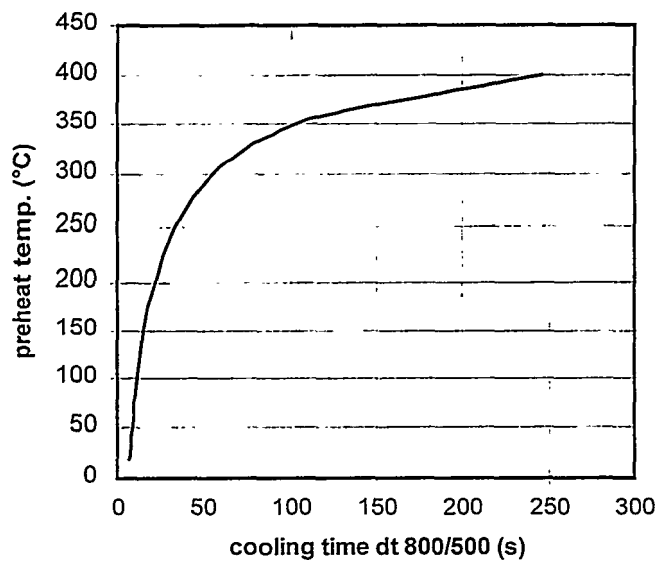
Figure 5. Recommended Preheat Temperatures related to weld cooling times.

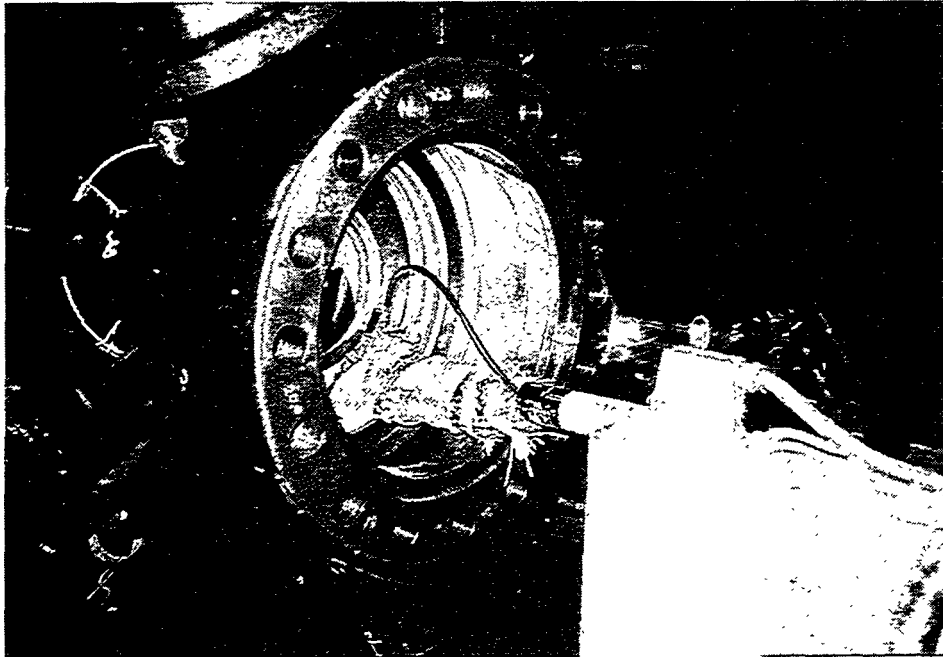
*Figure 6. View of the Plasma Arc Weld repair process.*
