AEC KENNELS

UNIVERSITY OF UTAH

Addition to Radiobiology Laboratory and Kennel Facilities

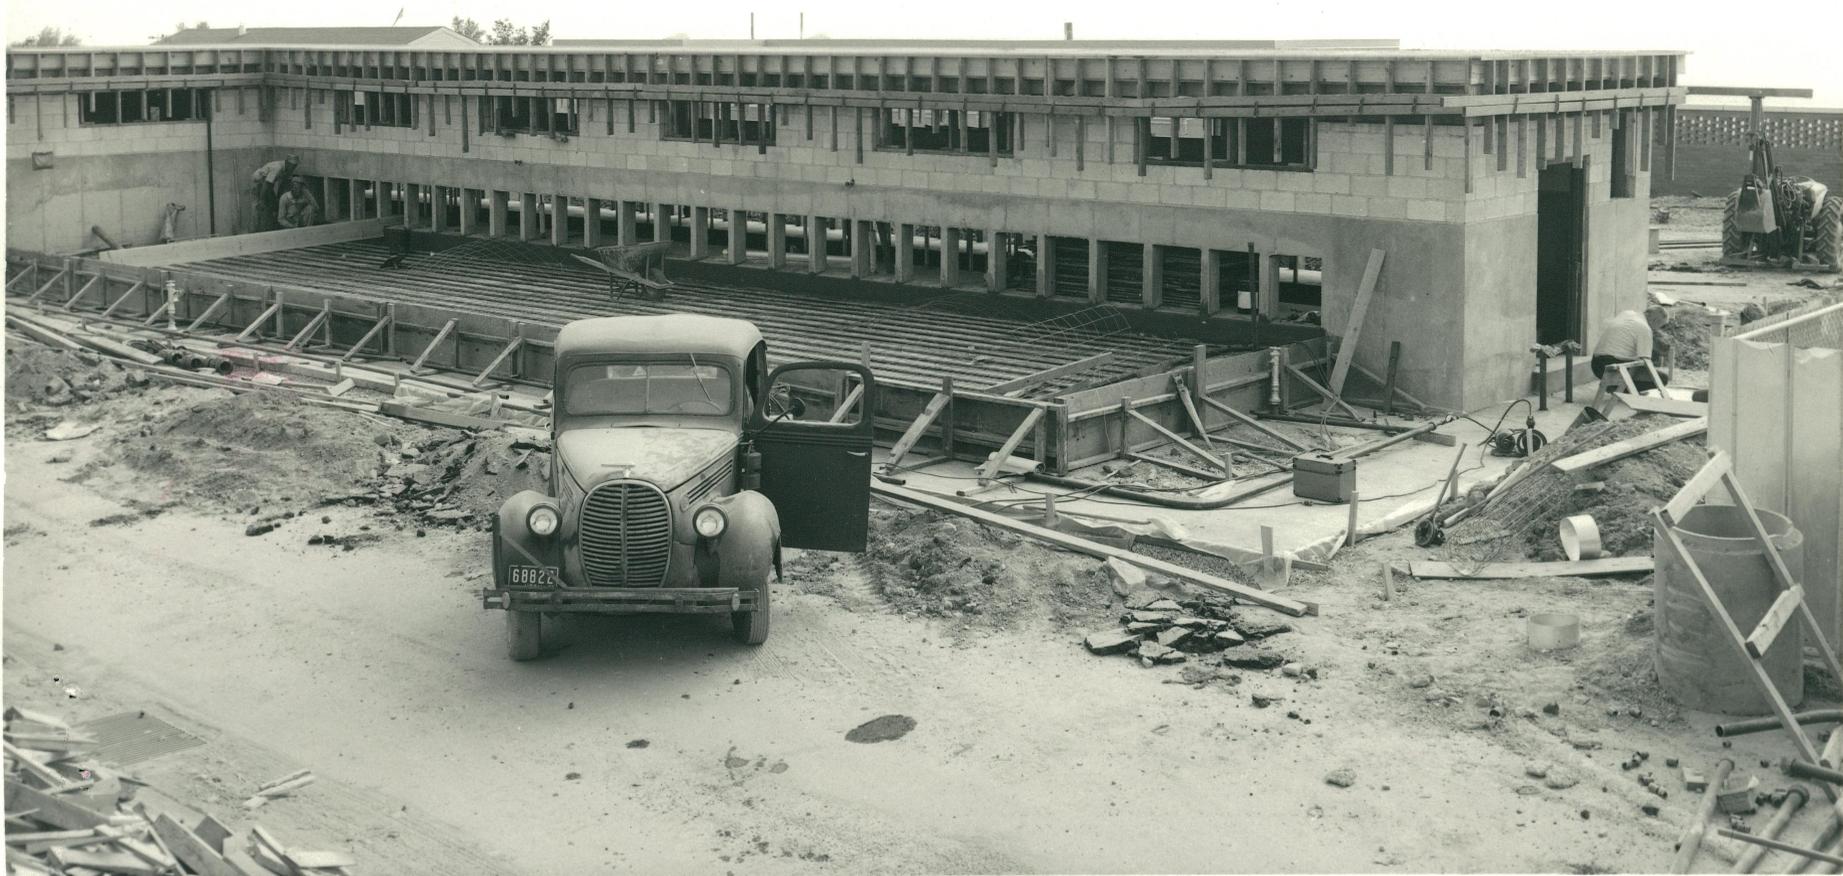
View of Kennels taken Monday, September 10, looking south-west. Shows Kennels with forms for reinforced concrete roof still in place. Also shows radiant heat pipes on east dog runs with screen mesh over pipes and forms in place ready for pouring structural concrete. Radiant heat pipe lies on insulating concrete formerly poured. Picture also shows sidewalk on north and east sides, with plastic membrane in place and some radiant heat pipe on sidewalk.
