Re: Static Test of TX-43 Parachute Attachment Assembly

Summary of Results

The object of this test was to determine the structural adequacy of a TX-43 parachute attachment assembly.

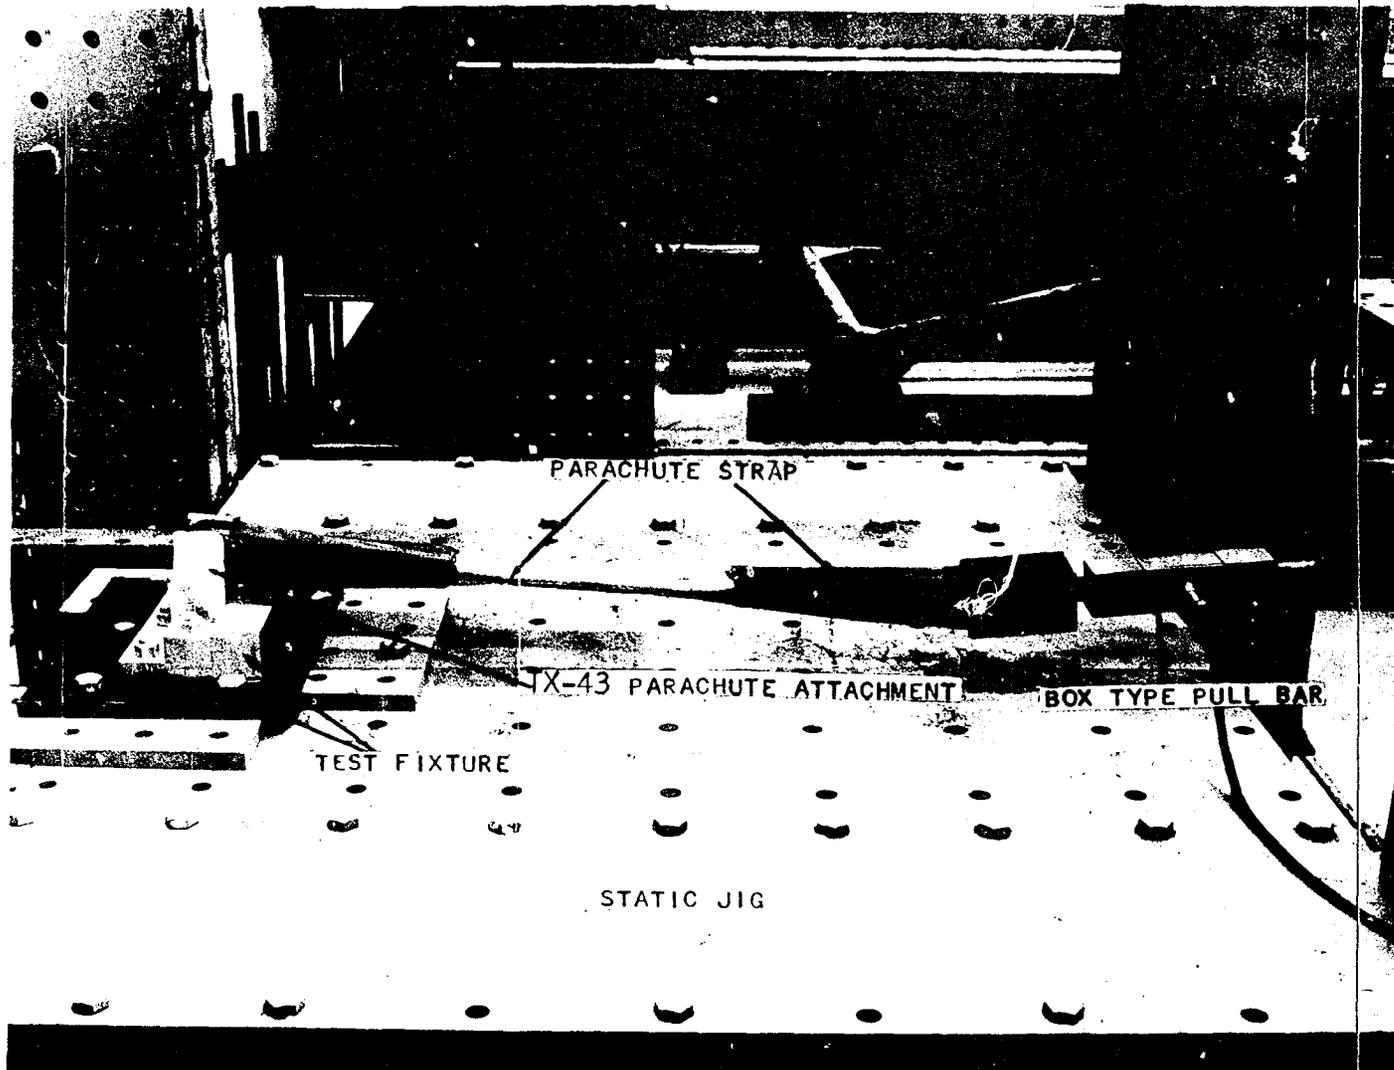
FIG. 1 -- TEST SETUP DURING STATIC TEST OF NOS. 1, 2, AND 3 TX-43 PARACHUTE ATTACHMENT.

- I. For photo of test setups see Figs. 1 and 2.
- II. The following components were used in the test:

After the setup was completed as shown in Fig. 1, for the No. 1, 2, and 3 assemblies, Stresscoat was applied to the parachute lug and a static load was applied to the nylon strap connected to the parachute attachment by means of a hydraulic ram, connecting linkage and a calibrated box type pull bar in conjunction with a Baldwin SR-4 strain indicator. The load was applied in 1000-pound increments until the first Stresscoat pattern was noted at which time the increment of loading was increased to 20 per cent of the preceding load. Since the lug failed during the test of the first assembly a redesigned lug was used during the last three tests. For test No. 4 the setup was the same except the nylon strap was replaced by a pull bar so that the ultimate strength of the remainder of the assembly could be determined.

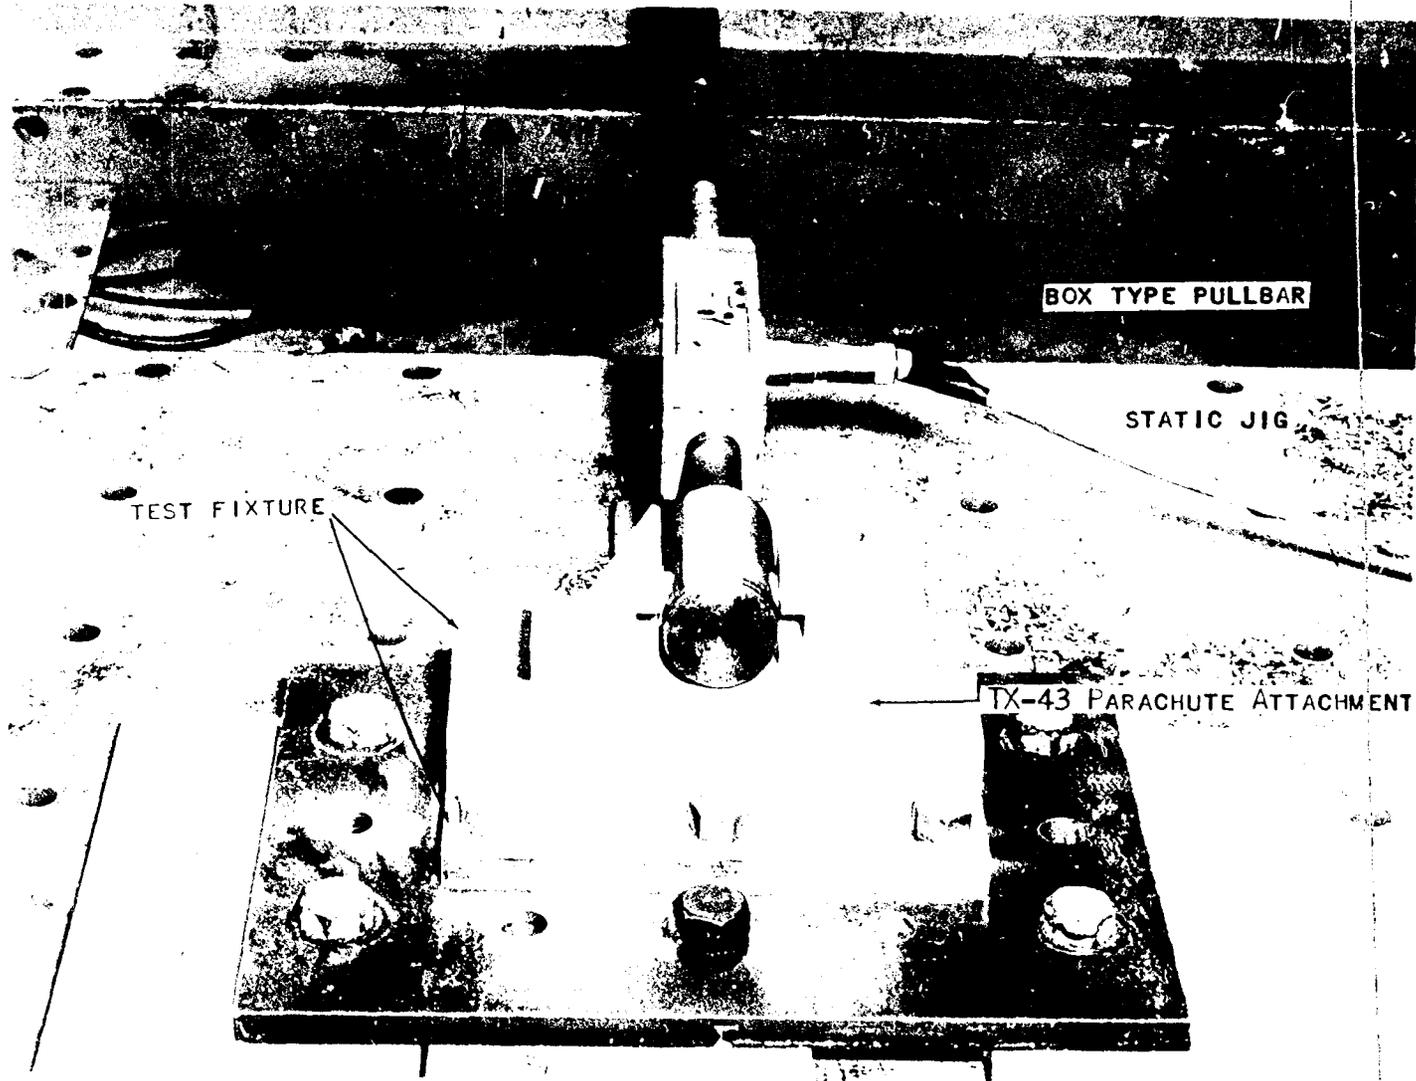
FIG. 2 -- TEST SET UP FOR STATIC TEST OF NO. 4 TX-43 PARACHUTE ATTACHMENT.

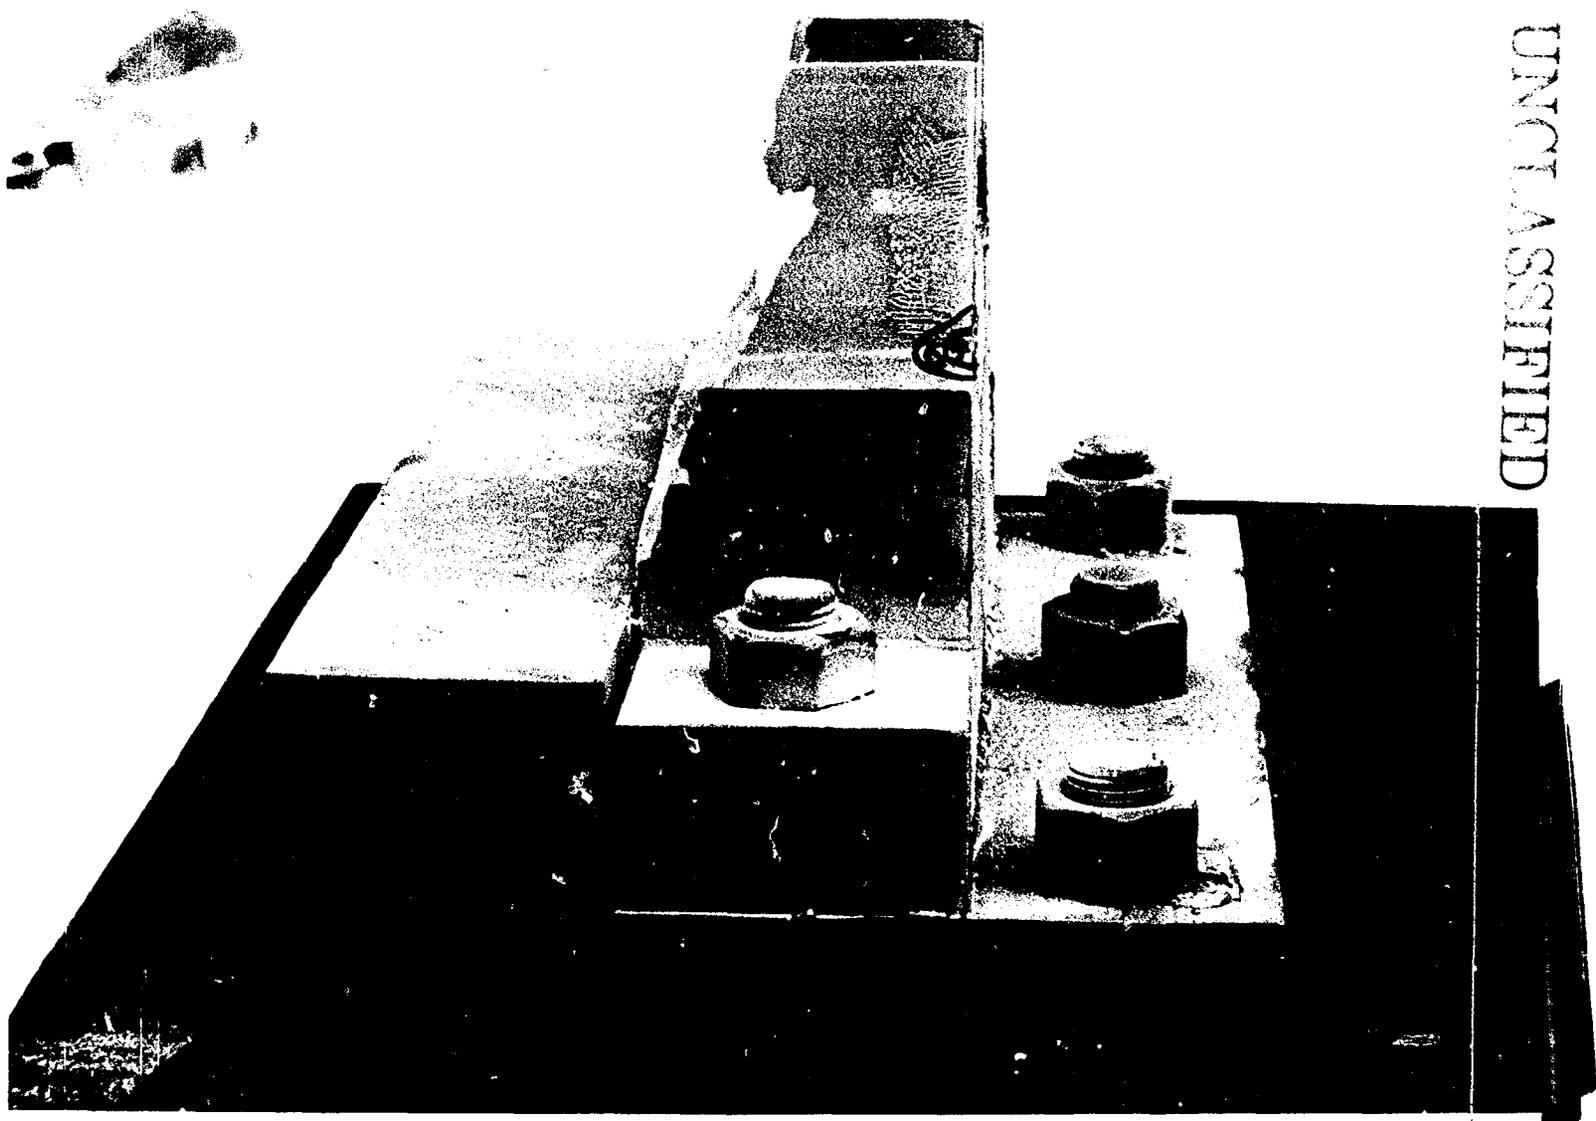
FIG. 3 -- STRESSCOAT CRACK PATTERNS AND FAILURE WHICH OCCURRED DURING STATIC TEST OF NO. 1 TX-43 PARACHUTE ATTACHMENT.

The number one parachute attachment assembly failed at 23,500 pounds. Failure occurred when the roller and inserts attached to the nylon strap pulled the loaded end of the assembly apart. The Stresscoat could not be observed in the region where failure originated since this area was obscured by the nylon straps. Figures 3, 4, 5, and 6 show the Stresscoat patterns that formed during the test. The encircled patterns were caused by tension and the unmarked patterns by compression. Table I lists the Stresscoat data and applied loads for this test. For photos of the deformation and failure, see Figs. 7, 8, and 9.

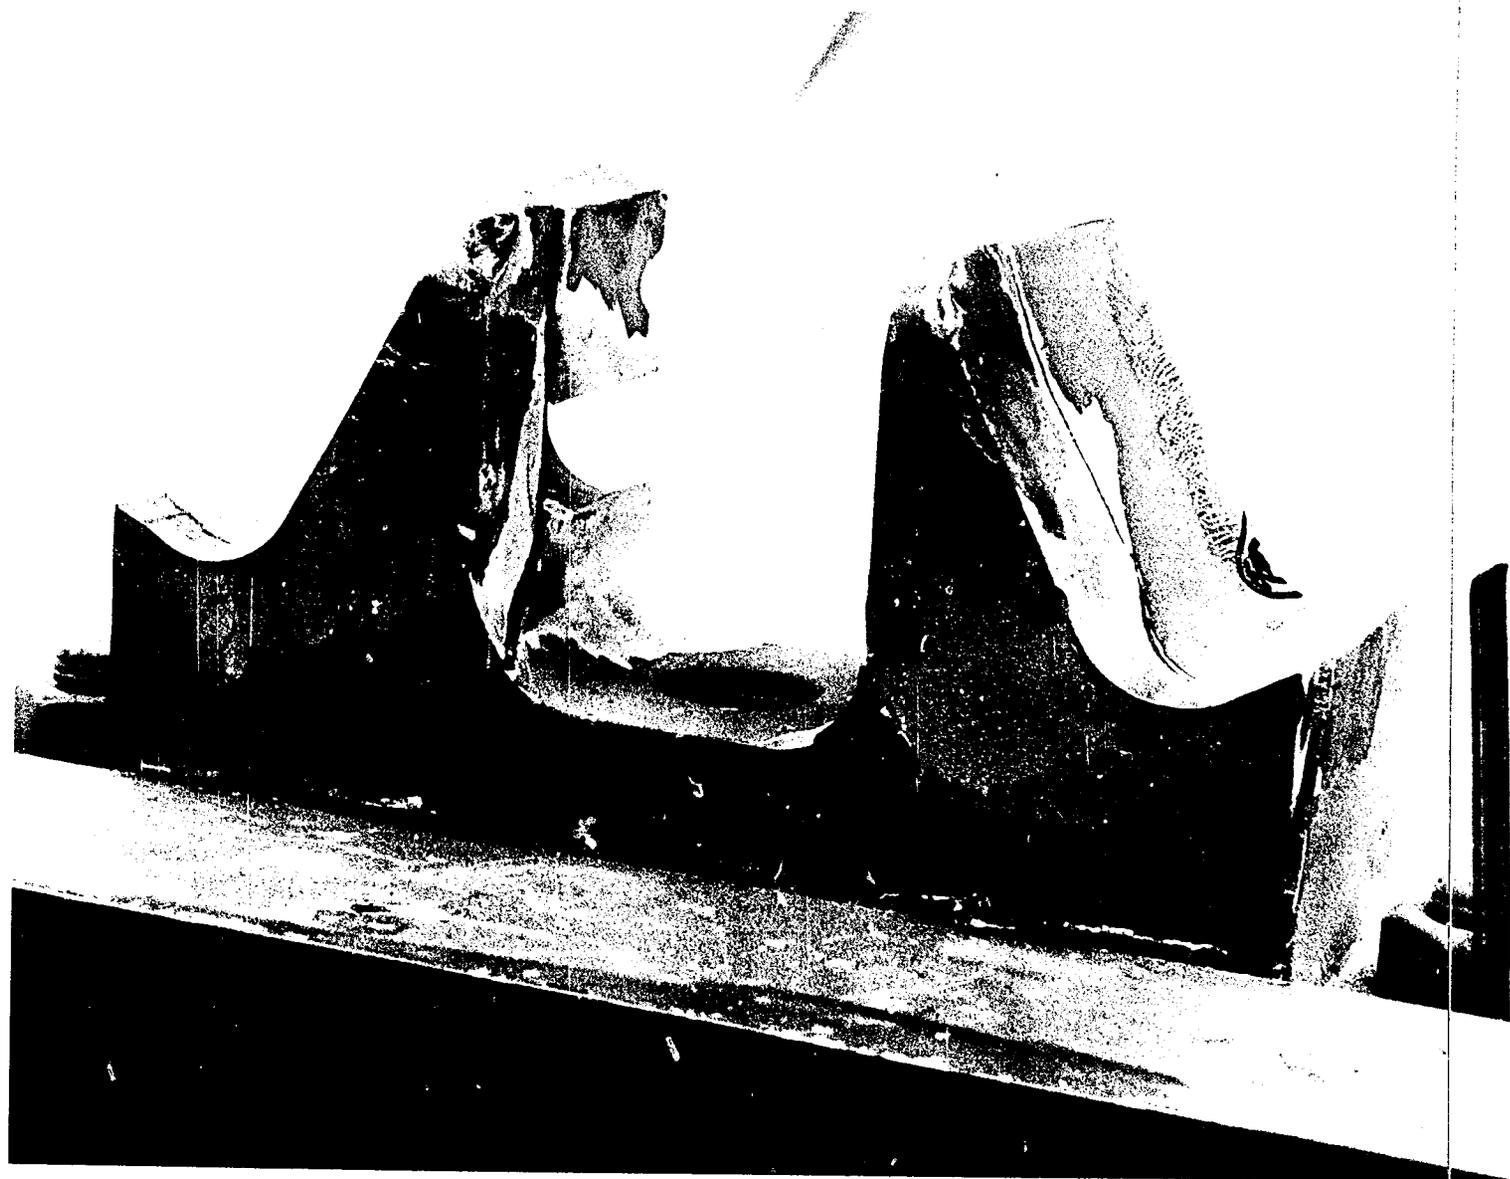
FIG. 4 -- STRESSCOAT CRACK PATTERNS AND FAILURE WHICH OCCURRED DURING STATIC TEST OF NO. 1 TX-43 PARACHUTE ATTACHMENT.

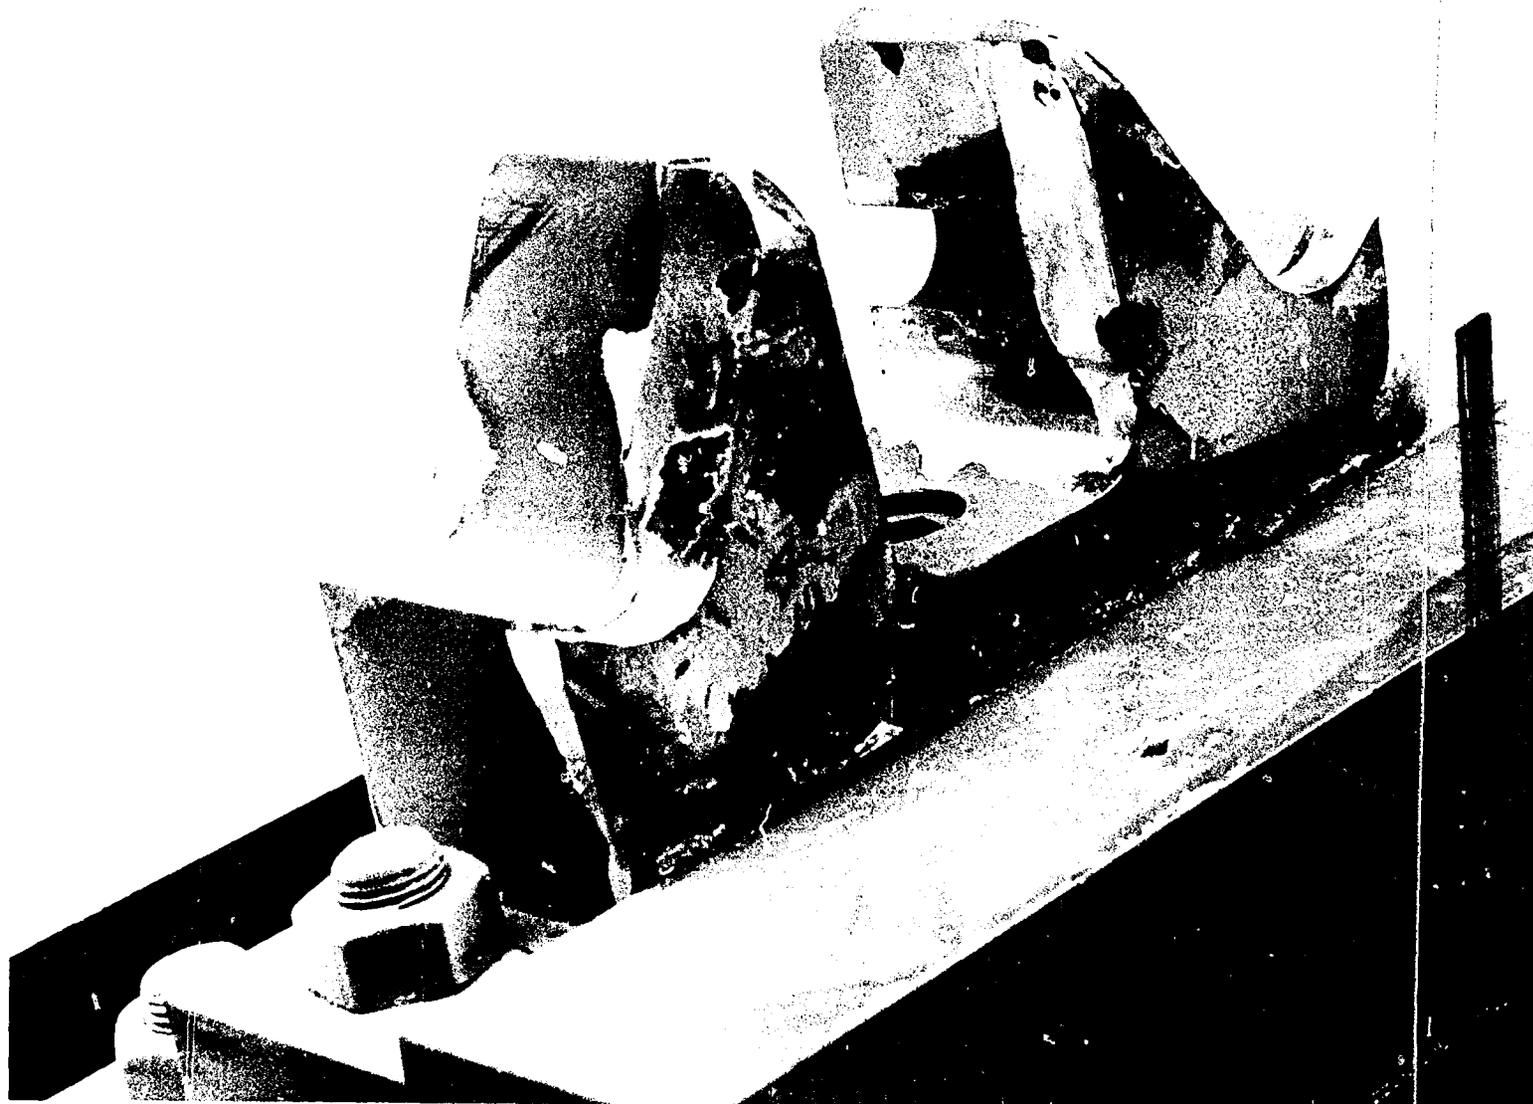
FIG. 5 -- STRESSCOAT CRACK PATTERNS AND FAILURE WHICH OCCURRED DURING STATIC TEST OF NO. 1 TX-43 PARACHUTE ATTACHMENT.

MARKED PATTERNS TENSION  
UNMARKED PATTERNS COMPRESSION

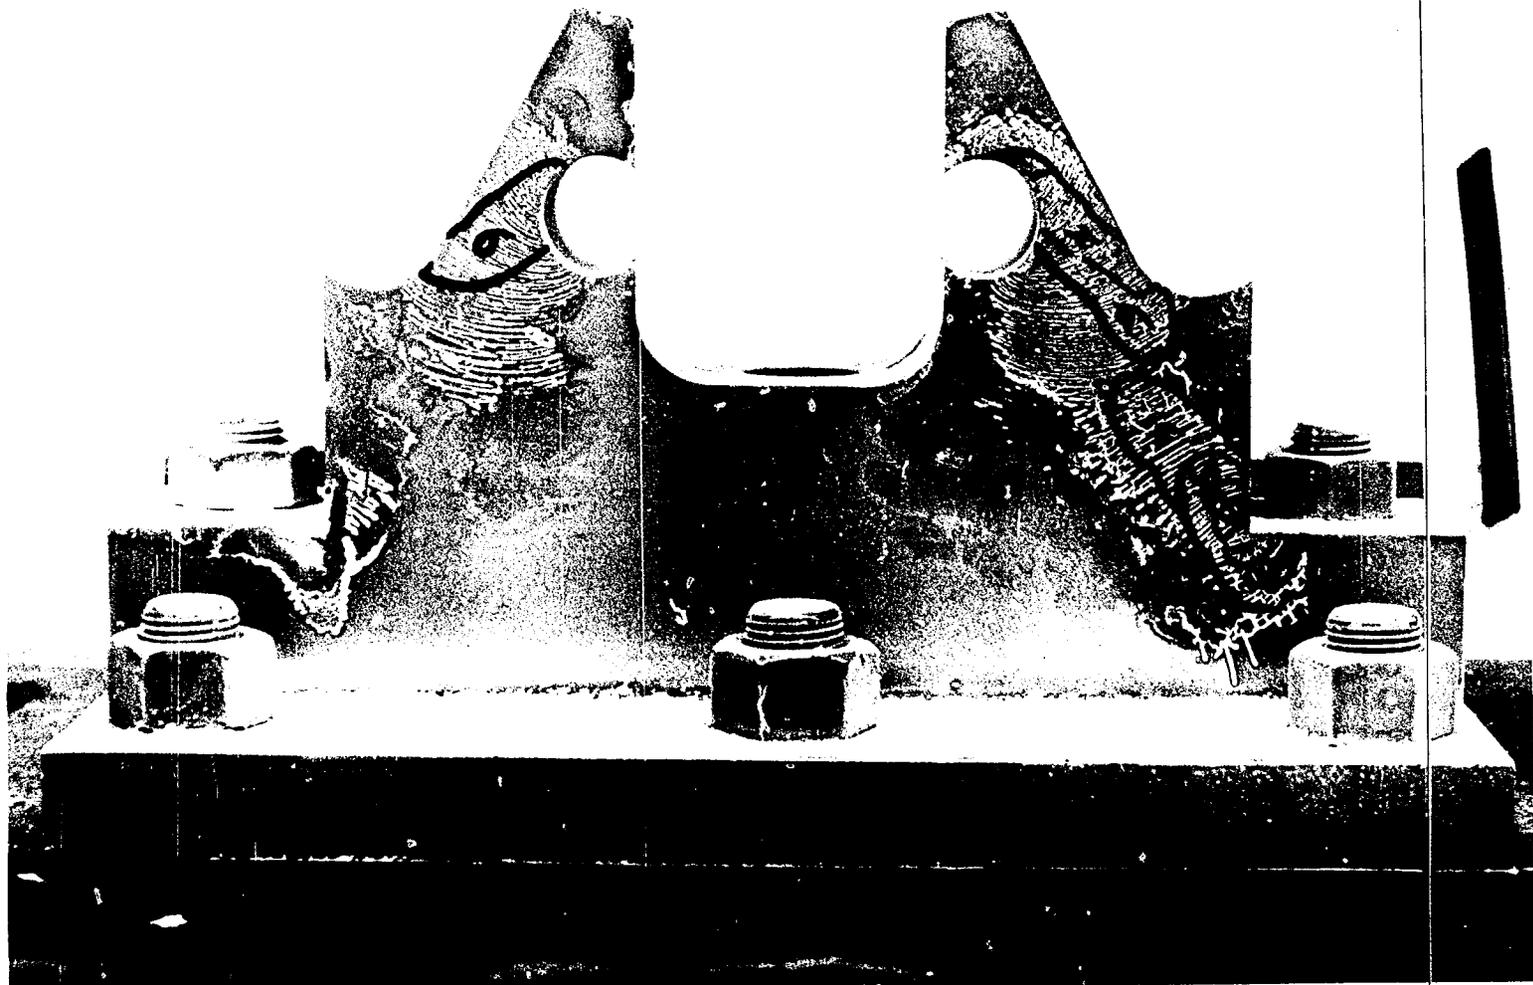
FIG. 6 -- STRESSCOAT CRACK PATTERNS WHICH OCCURRED DURING STATIC TEST OF NO. 1 TX-43  
PARACHUTE ATTACHMENT.

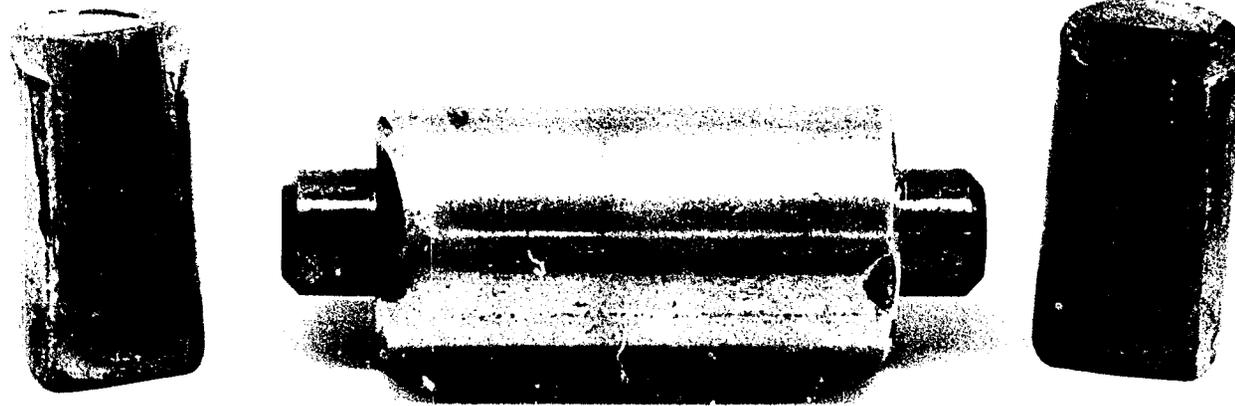
FIG. 7 -- DEFORMATION OF INSERTS AND ROLLER WHICH OCCURRED DURING STATIC TEST OF NO. 1 TX-43 PAPACHUTE ATTACHMENT.

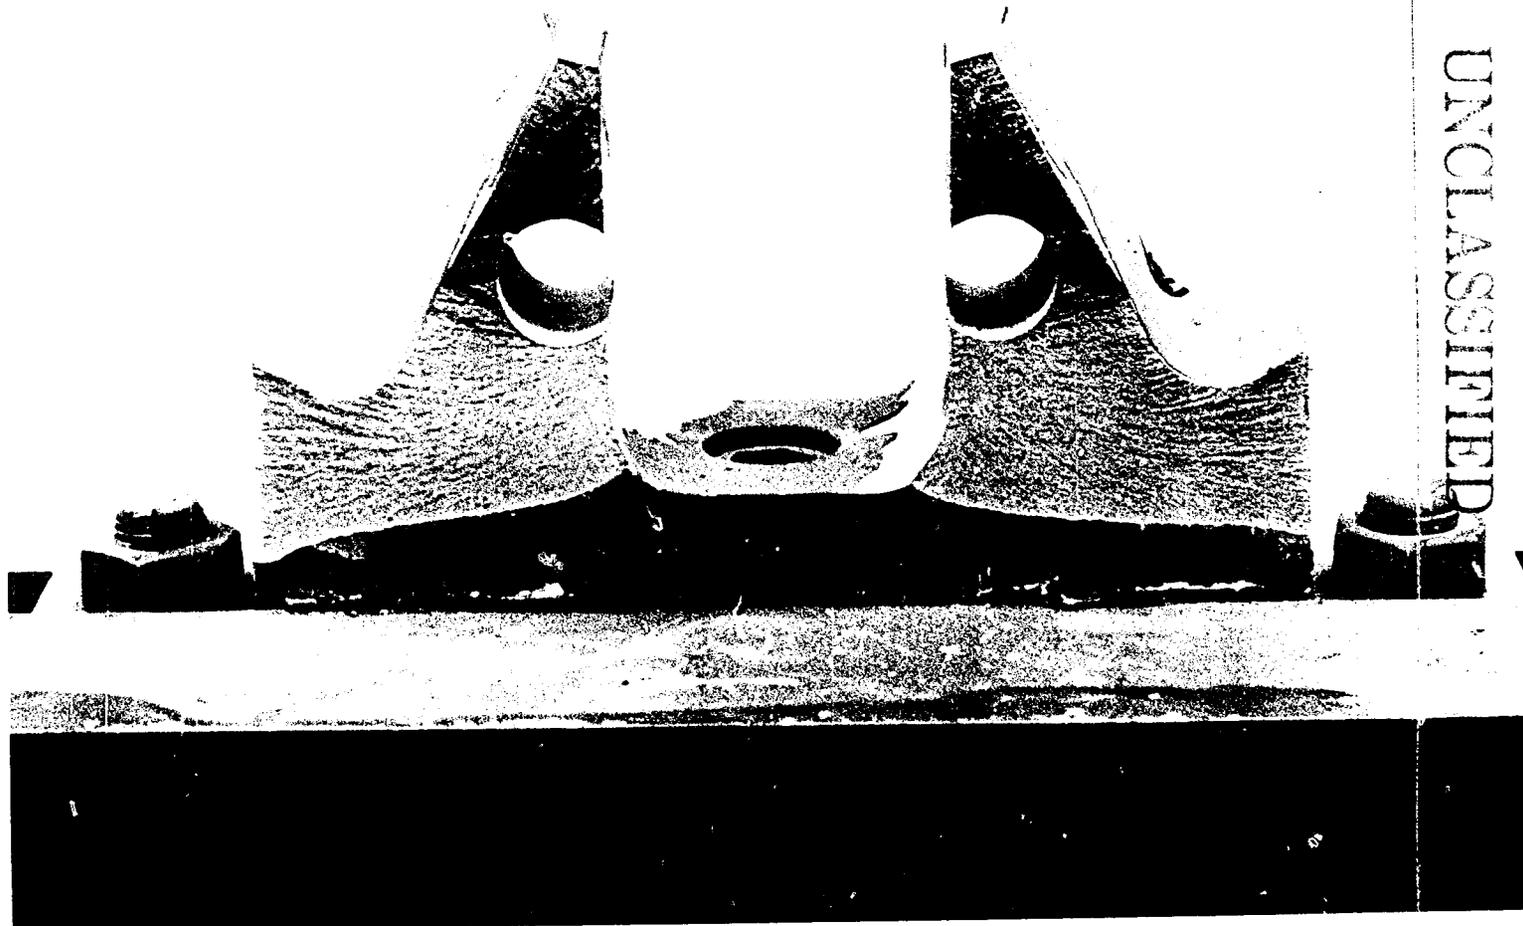
FIG. 8 -- FAILURE WHICH OCCURRED DURING STATIC TEST OF NO. 1 TX-43 PARACHUTE ATTACHMENT.

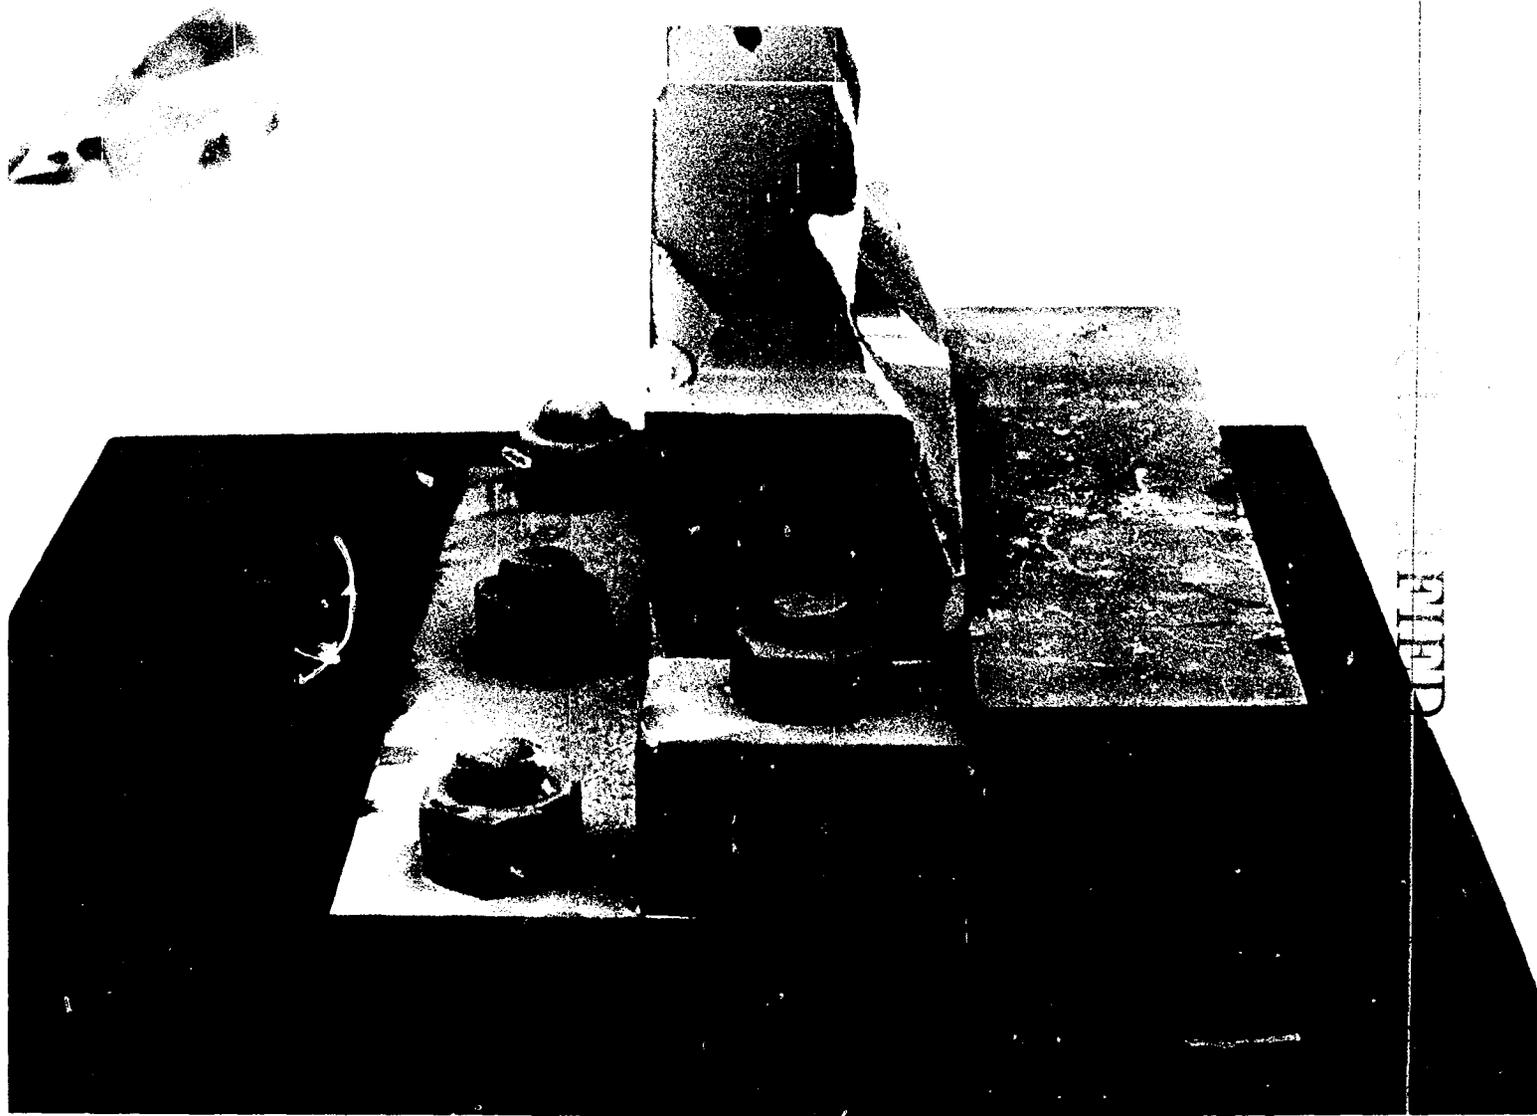
FIG. 9 -- FAILURE WHICH OCCURRED DURING STATIC TEST OF NO. 1 TX-43 PARACHUTE ATTACHMENT.

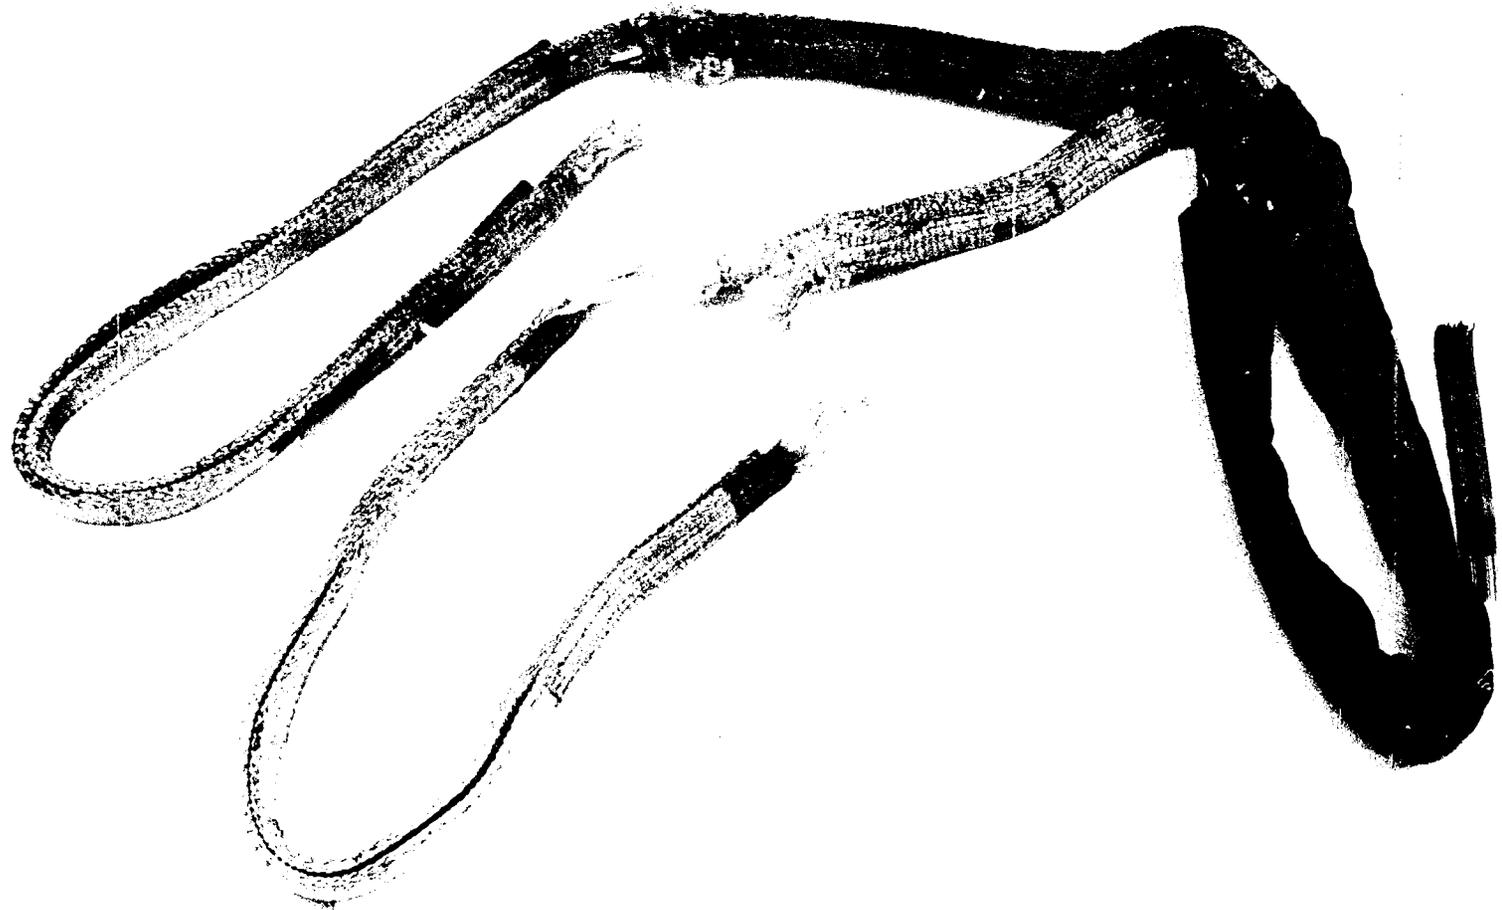
FIG. 10 -- FAILURE OF PARACHUTE STRAP DURING STATIC TEST OF NO. 2 TX-43 PARACHUTE ATTACHMENT.

The number two assembly failed when loaded to 24,300 pounds. Failure occurred when both straps of the double loop nylon strap broke at 24,300 pounds. For photo of this failure, see Fig. 10. Figures 11 through 14 show the crack patterns that developed in the Stresscoat during the test with the marked patterns being caused from tension and the unmarked patterns by compression. Table II lists the Stresscoat data for this test.

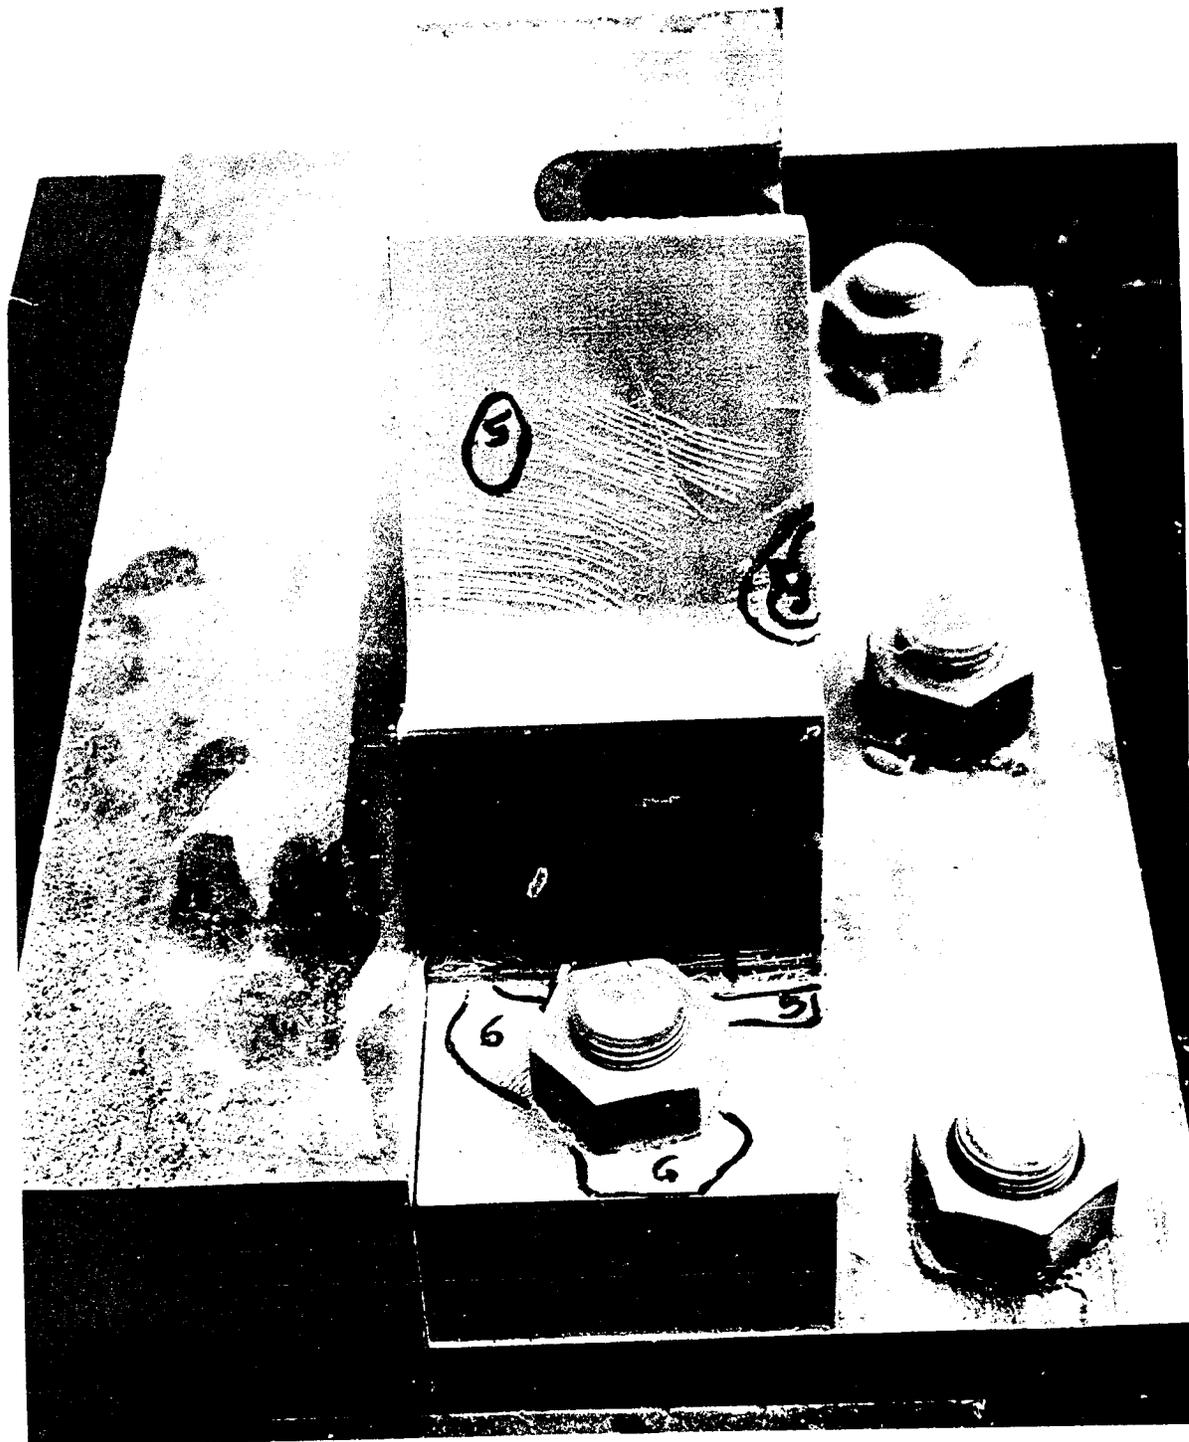
MARKED PATTERNS TENSION  
UNMARKED PATTERNS COMPRESSION

FIG. 11 -- STRESSCOAT CRACK PATTERNS WHICH OCCURRED DURING STATIC TEST OF NO. 2 TX-43 PARACHUTE ATTACHMENT.

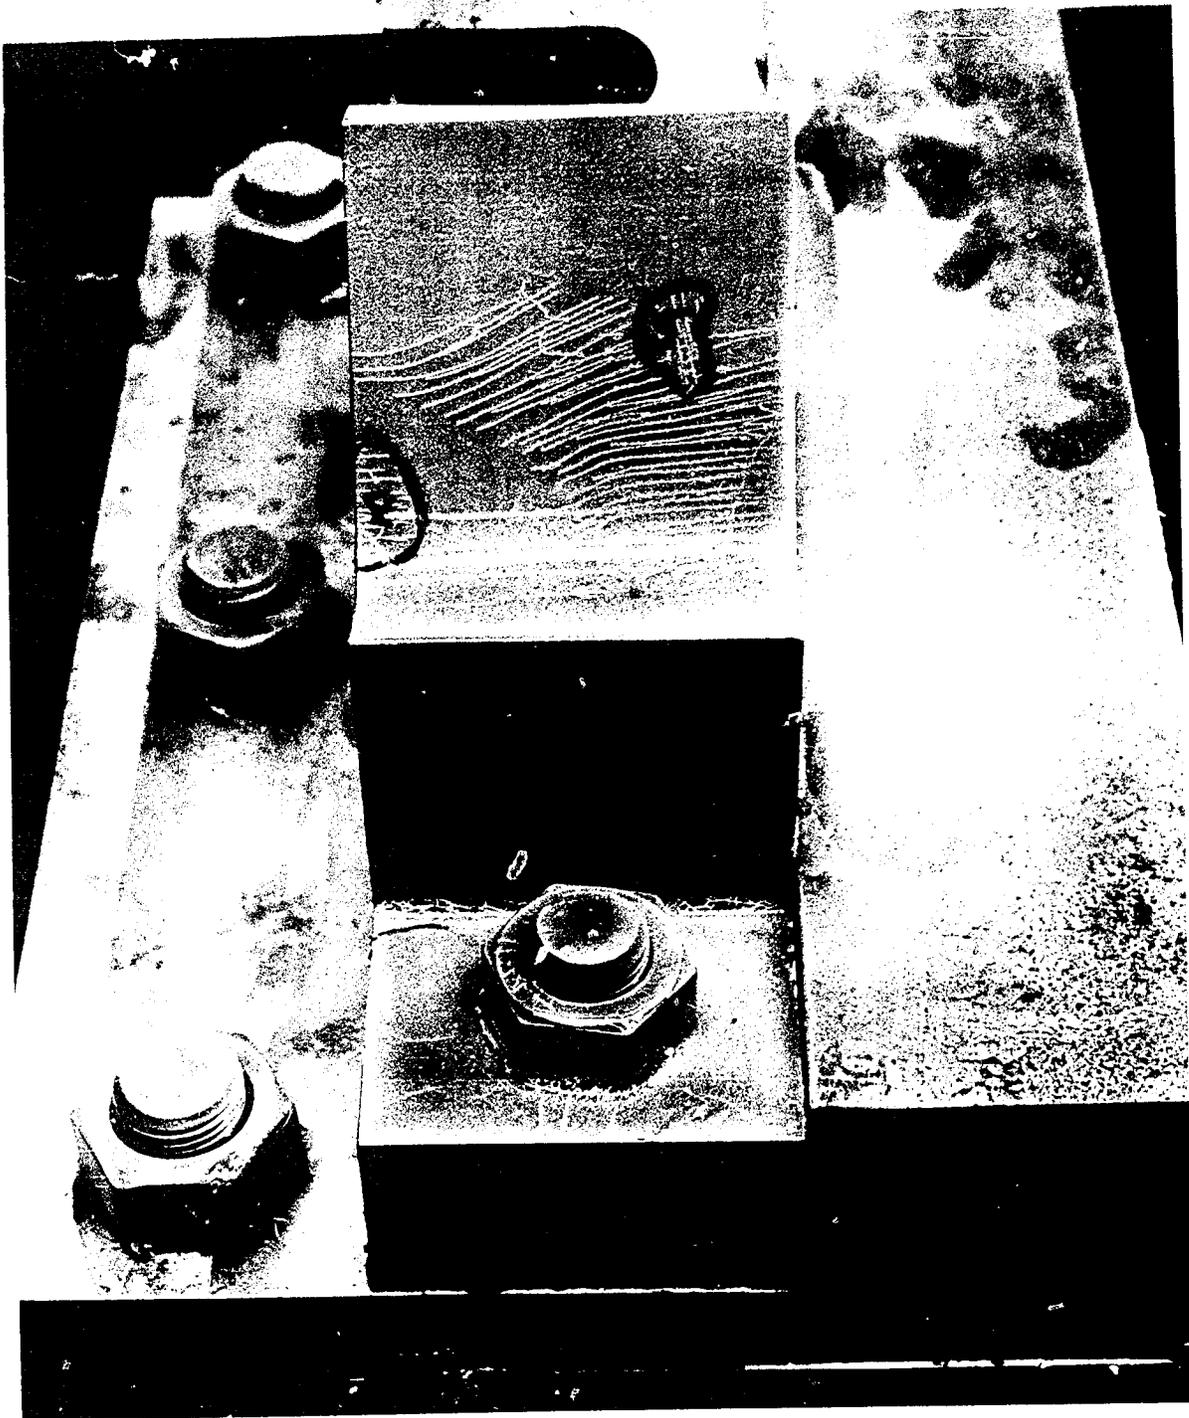
MARKED PATTERNS TENSION  
UNMARKED PATTERNS COMPRESSION

FIG. 12 -- STRESSCOAT CRACK PATTERNS WHICH OCCURRED DURING STATIC TEST OF NO. 2 TX-43 PARACHUTE ATTACHMENT

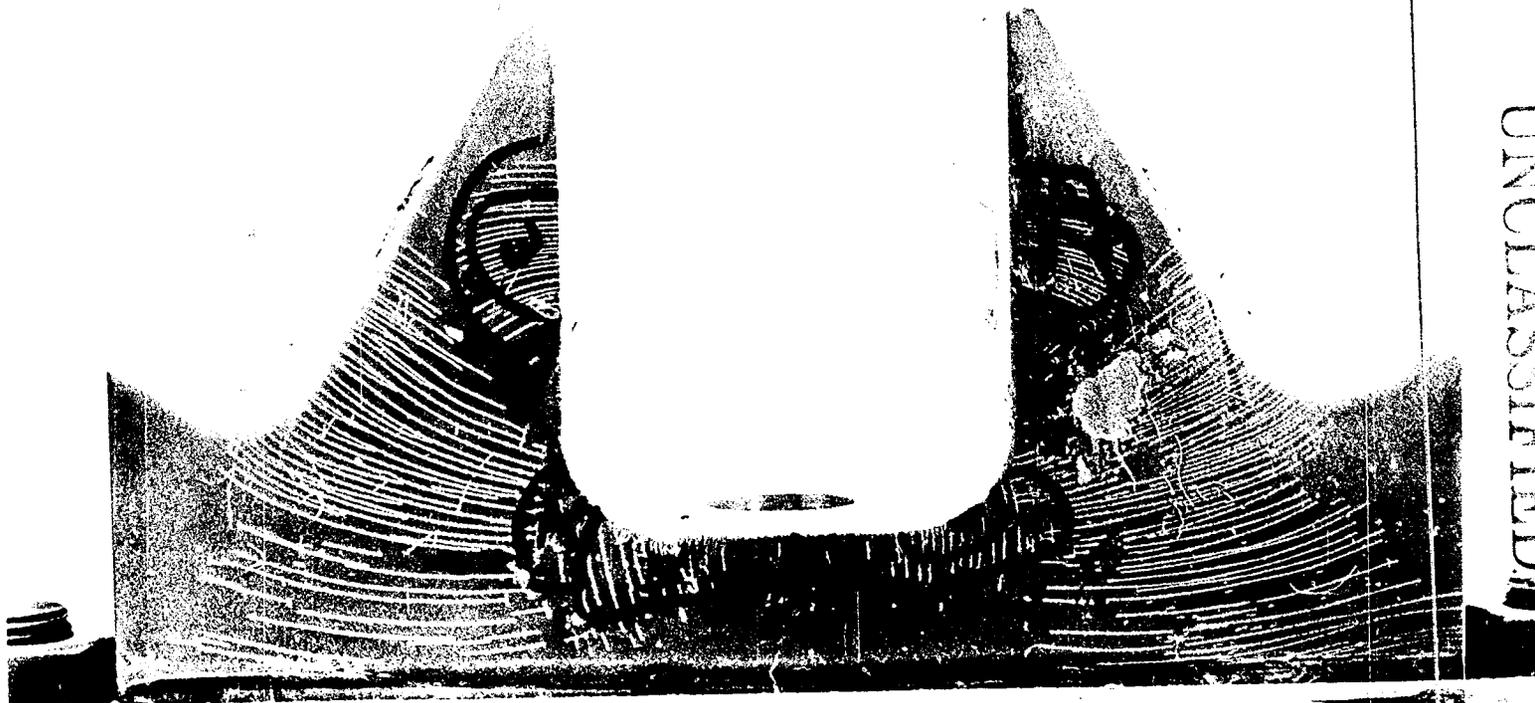
MARKED PATTERNS TENSION  
UNMARKED PATTERNS COMPRESSION

FIG. 13 -- STRESSCOAT CRACK PATTERNS WHICH OCCURRED DURING STATIC TEST OF NO. 2 X-43  
PARACHUTE ATTACHMENT.

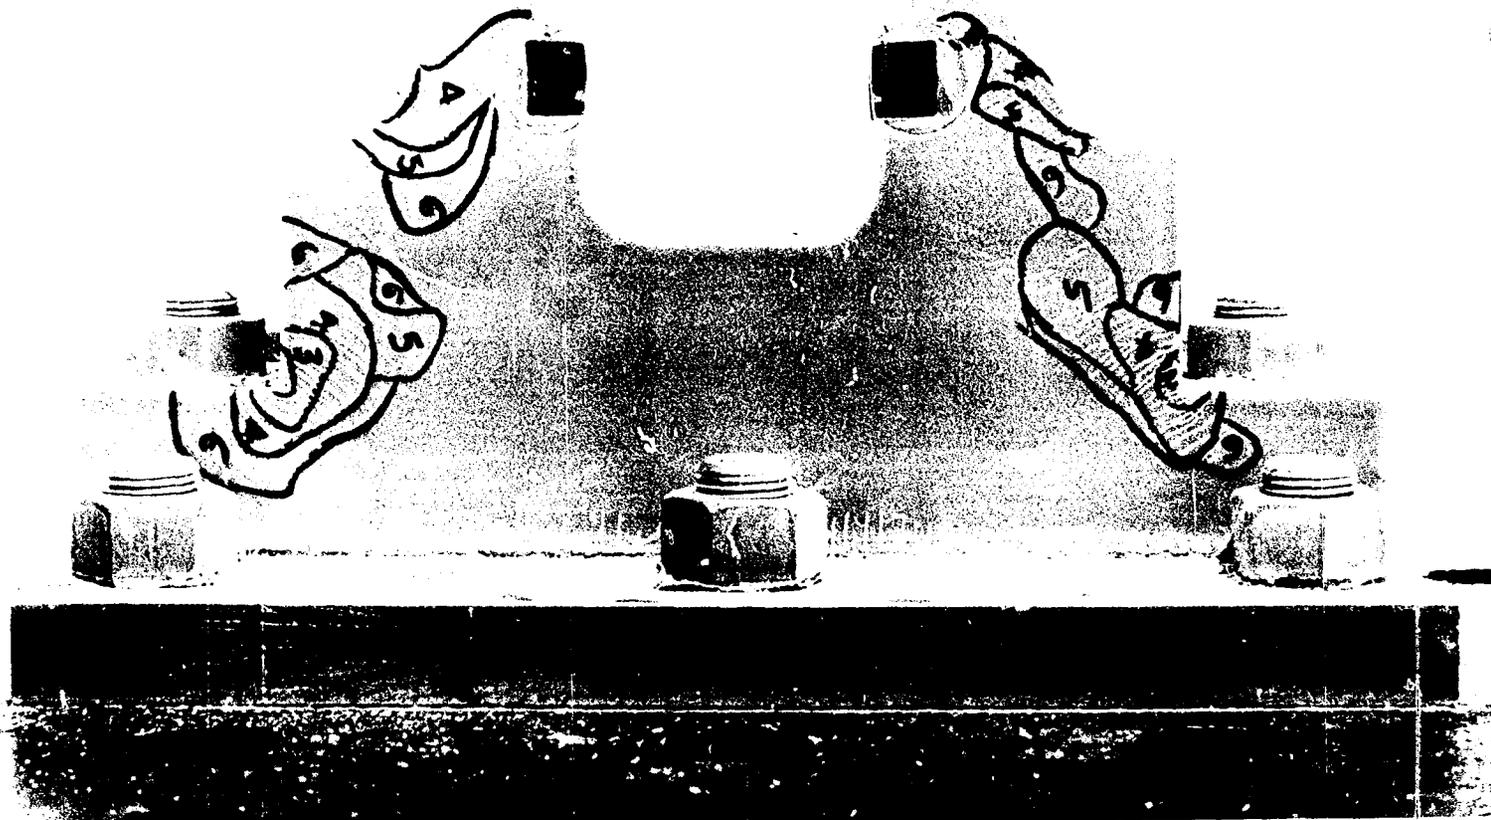
MARKED PATTERNS TENSION  
UNMARKED PATTERNS COMPRESSION

FIG. 14 -- STRESSCOAT CRACK PATTERNS WHICH OCCURRED DURING STATIC TEST OF NO. 2 TX-43 PARACHUTE ATTACHMENT.

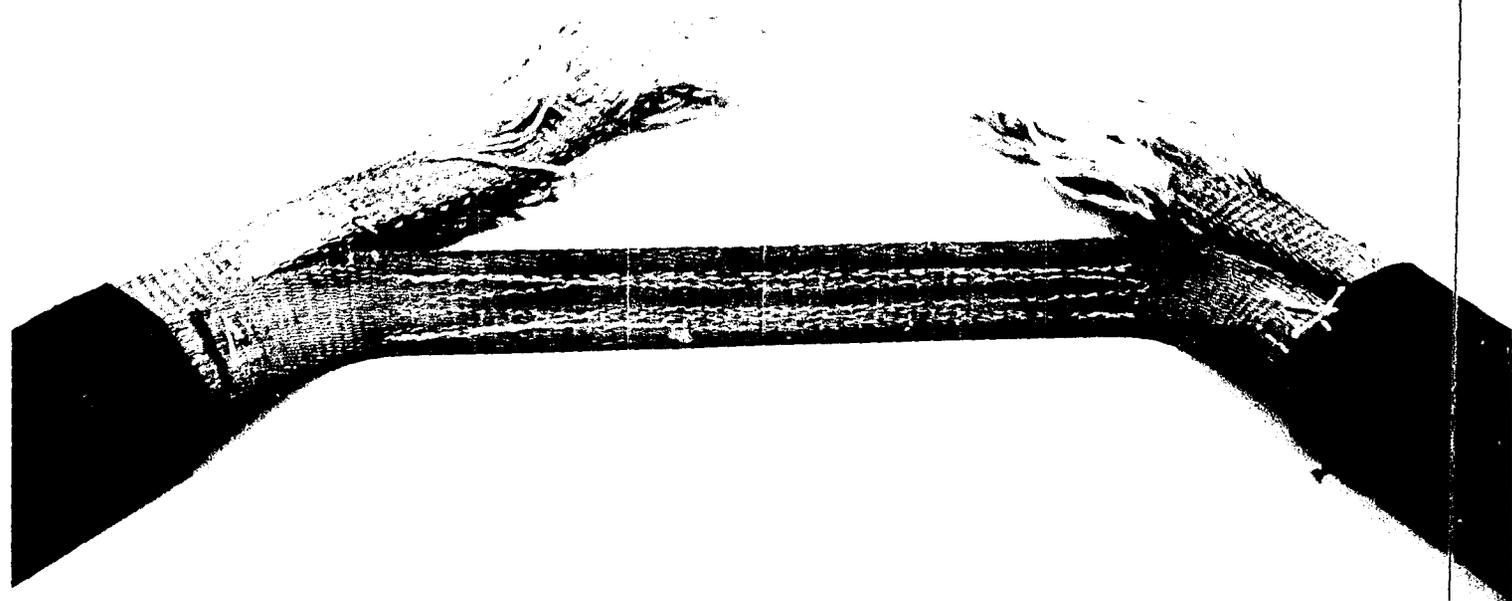
FIG. 15 -- FAILURE OF PARACHUTE STRAP DURING STATIC TEST OF NO. 3 TX-43 PARACHUTE ATTACHMENT.

The number three assembly was loaded to 15,100 pounds when failure occurred in one loop of the double loop strap. For photo of this failure, see Fig. 15. The Stresscoat patterns are shown in Figs. 16, 17, and 18 and the Stresscoat data is listed in Table III.
