Re: Static Test of TX-43 Parachute Attachment Assembly

Summary of Results

The object of this test was to determine the structural adequacy of a TX-43 parachute attachment assembly.

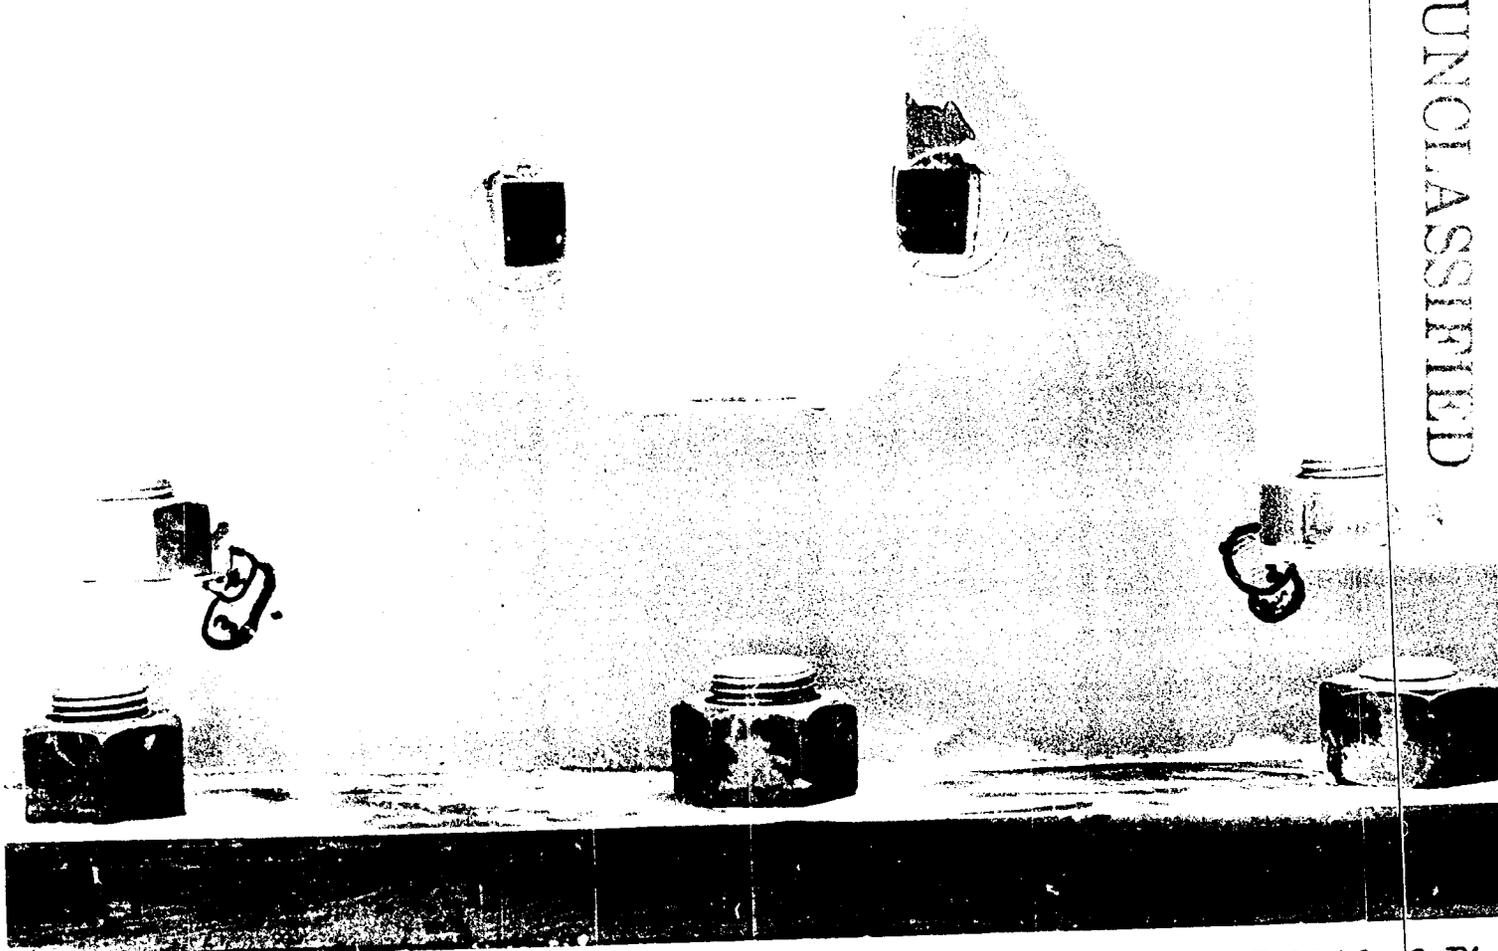
FIG. 17 -- STRESSCOAT CRACK PATTERNS WHICH OCCURRED DURING STATIC TEST OF NO. 3 TX-43 PARACHUTE ATTACHMENT.

The number three assembly was loaded to 15,100 pounds when failure occurred in one loop of the double loop strap. For photo of this failure, see Fig. 15. The Stresscoat patterns are shown in Figs. 16, 17, and 18 and the Stresscoat data is listed in Table III.

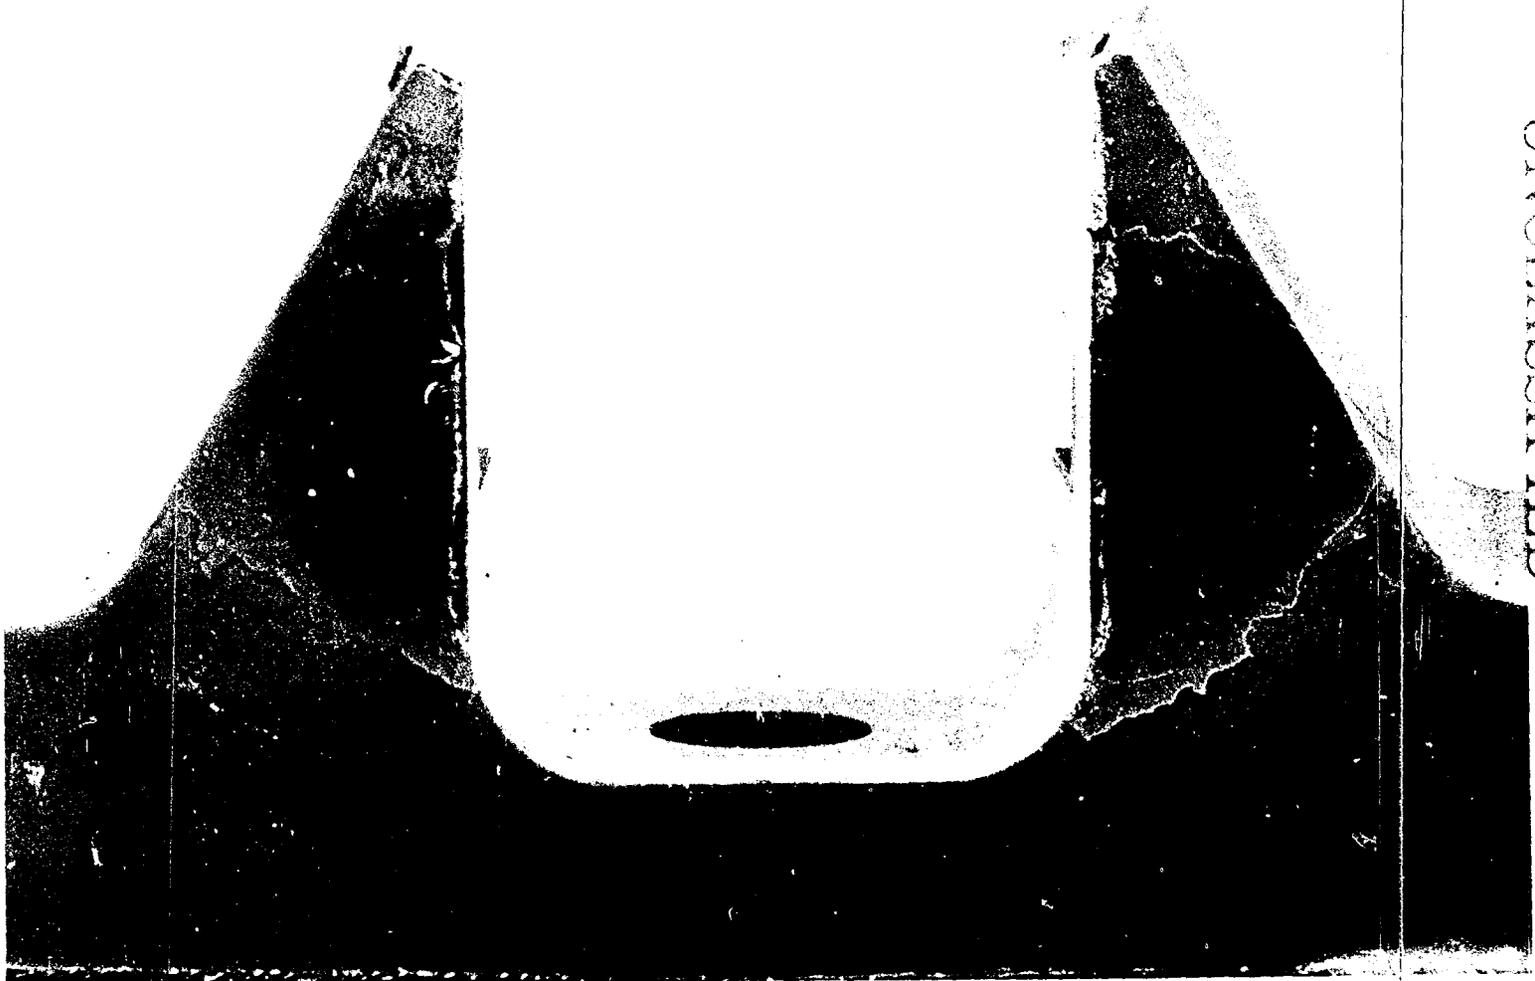
FIG. 18 -- STRESSCOAT CRACK PATTERNS WHICH OCCURRED DURING STATIC TEST OF NO. 3 TX-43 PARACHUTE ATTACHMENT.

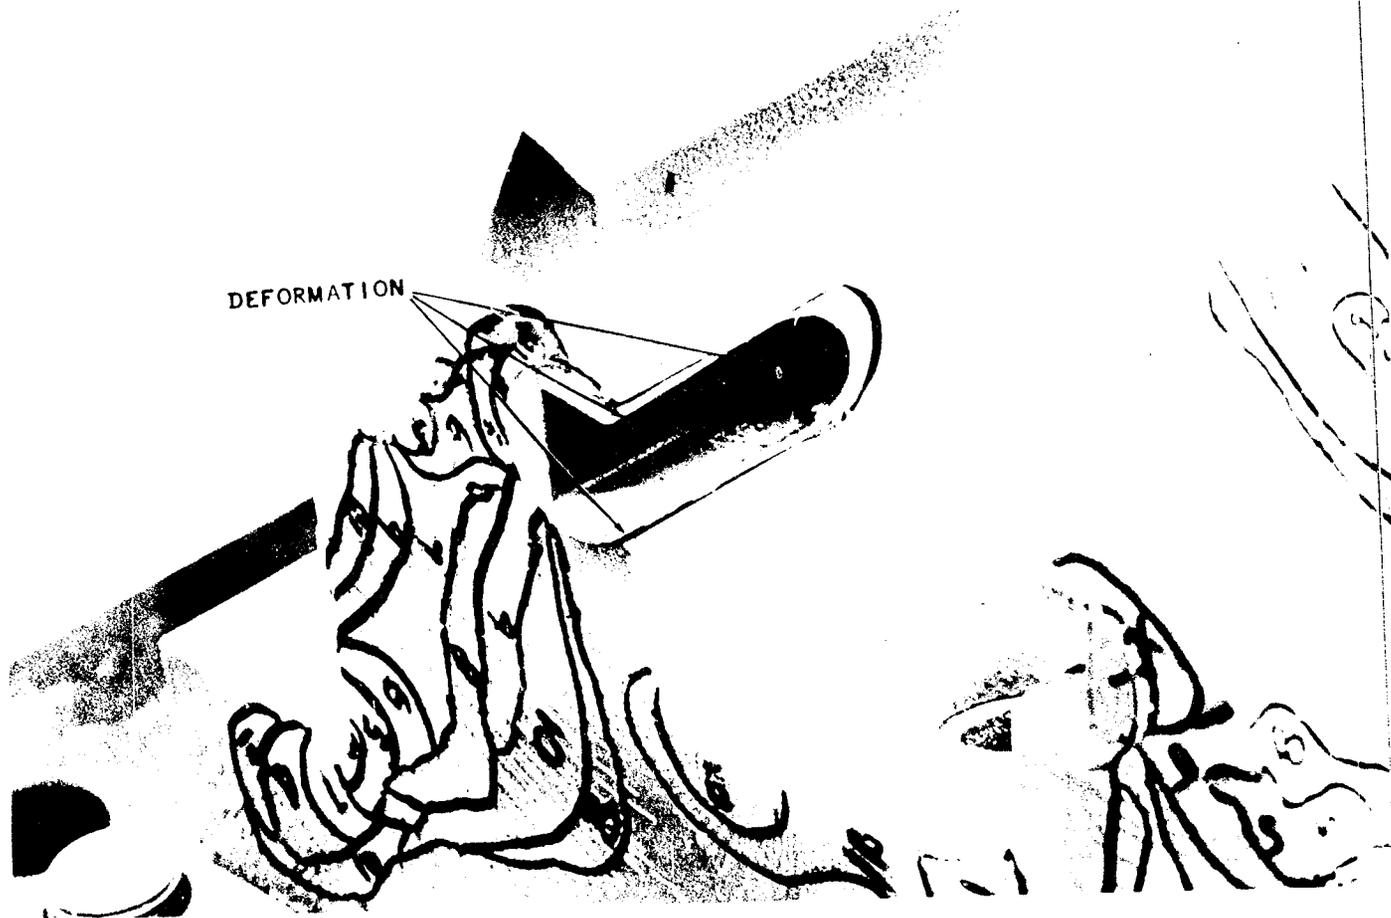
FIG. 19 -- DEFORMATION WHICH OCCURRED TO INSERT DURING STATIC TEST OF NO. 4 TX-43 PARACHUTE ATTACHMENT.

The number four assembly was loaded to failure which occurred at 41,900 pounds when the 1/2-inch diameter pins of the roller sheared off at the inserts. For deformation of the insert, see Fig. 19. For photo of failure see Fig. 20. Figures 21 through 24 show the Stresscoat patterns that formed during this test and Table IV lists the Stresscoat data.

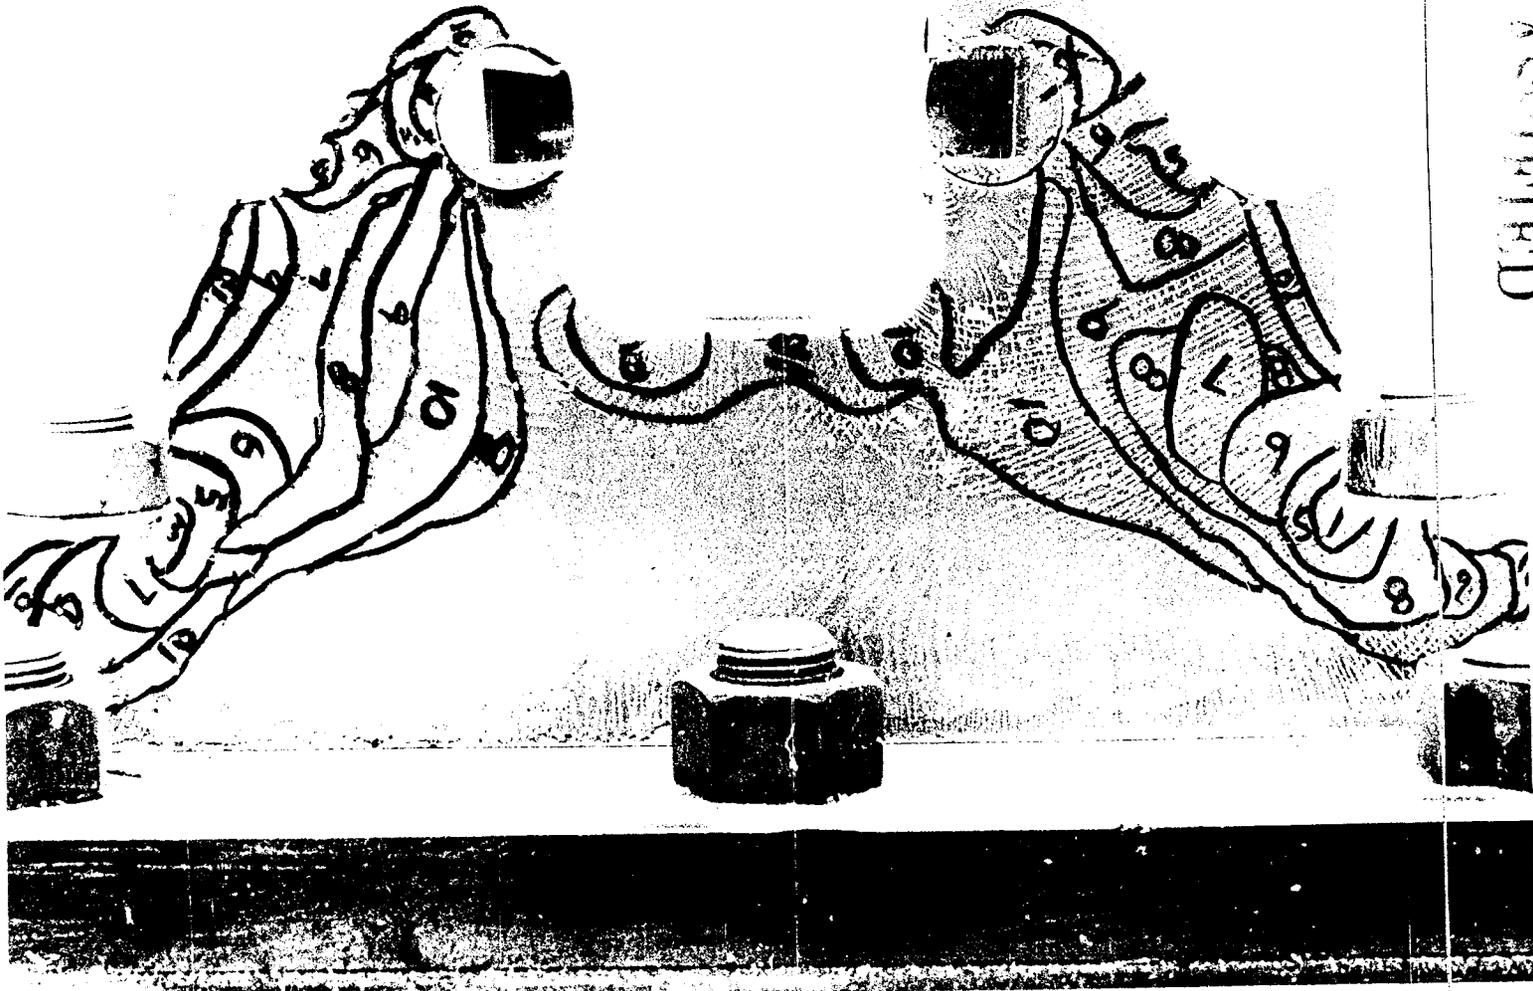
FIG. 21 -- STRESSCOAT CRACK PATTERNS WHICH OCCURRED DURING STATIC TEST OF NO. 4 TX-43 PARACHUTE ATTACHMENT.

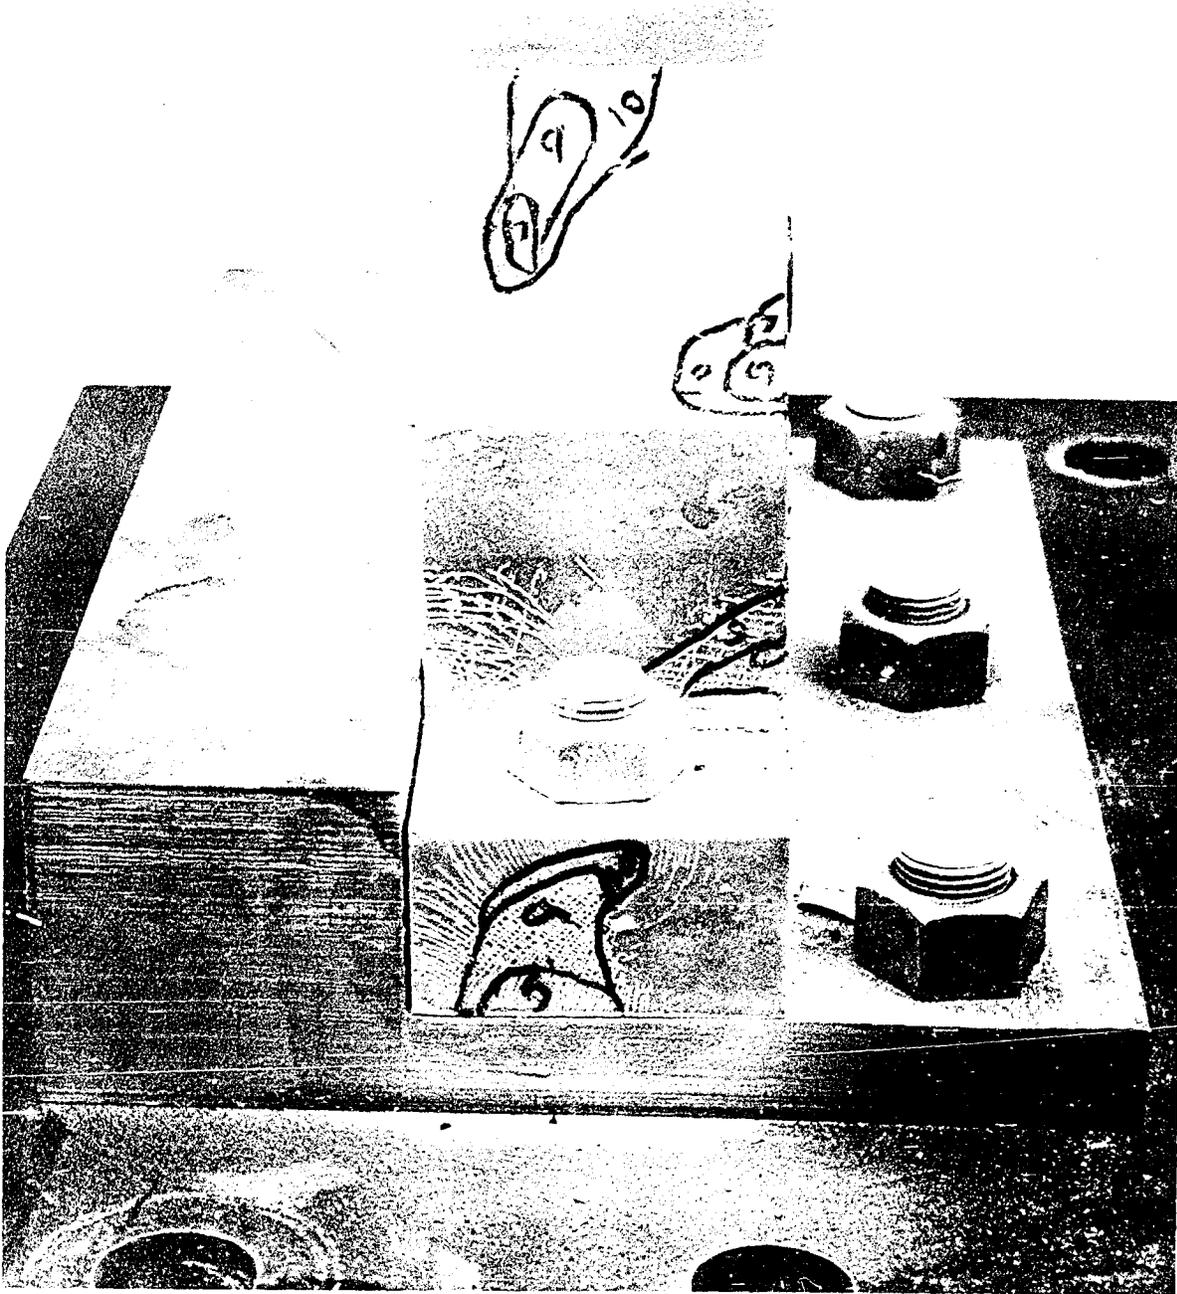
22 -- STRESSCOAT CRACK WHICH OCCURRED DURING STATIC TEST OF NO. 4 TX-43 PARACHUTE ATTACHMENT.

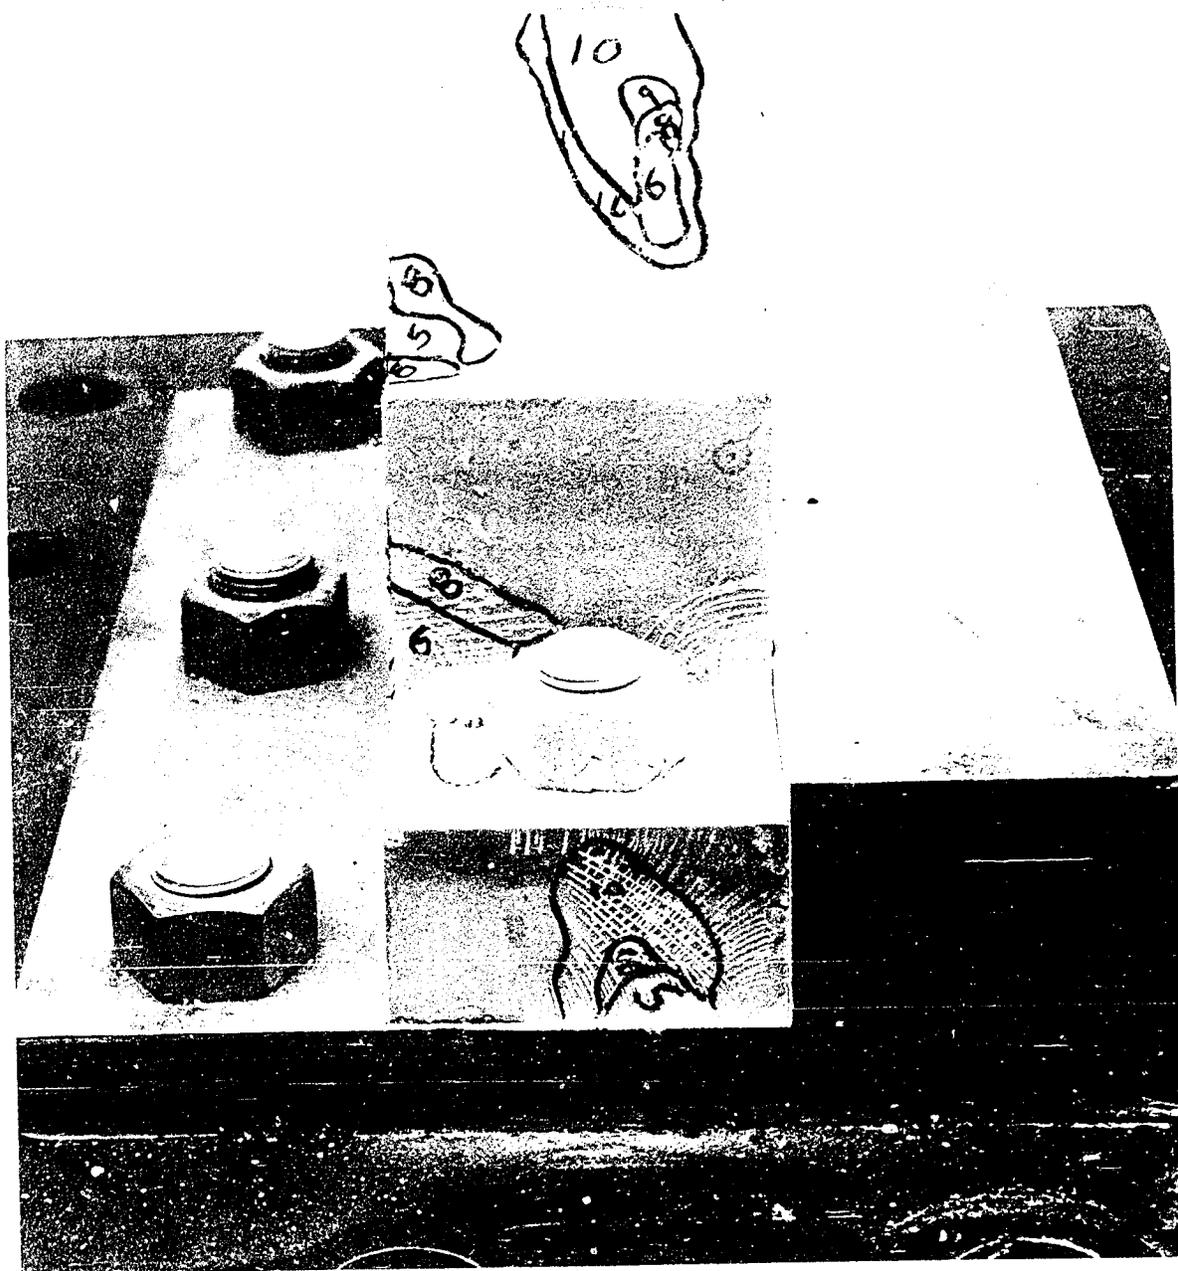
FIG. 24 -- STRESSCOAT CRACK PATTERNS WHICH OCCURRED DURING STATIC TEST OF NO. 4 TX-43 PARACHUTE ATTACHMENT.
