TX-41, 4.4
Project No: ET-5159
Case No: 746.00
Completed: 6-26-58

Evaluation of Parachute Ejection Device
for TX-41 Weapon

Summary

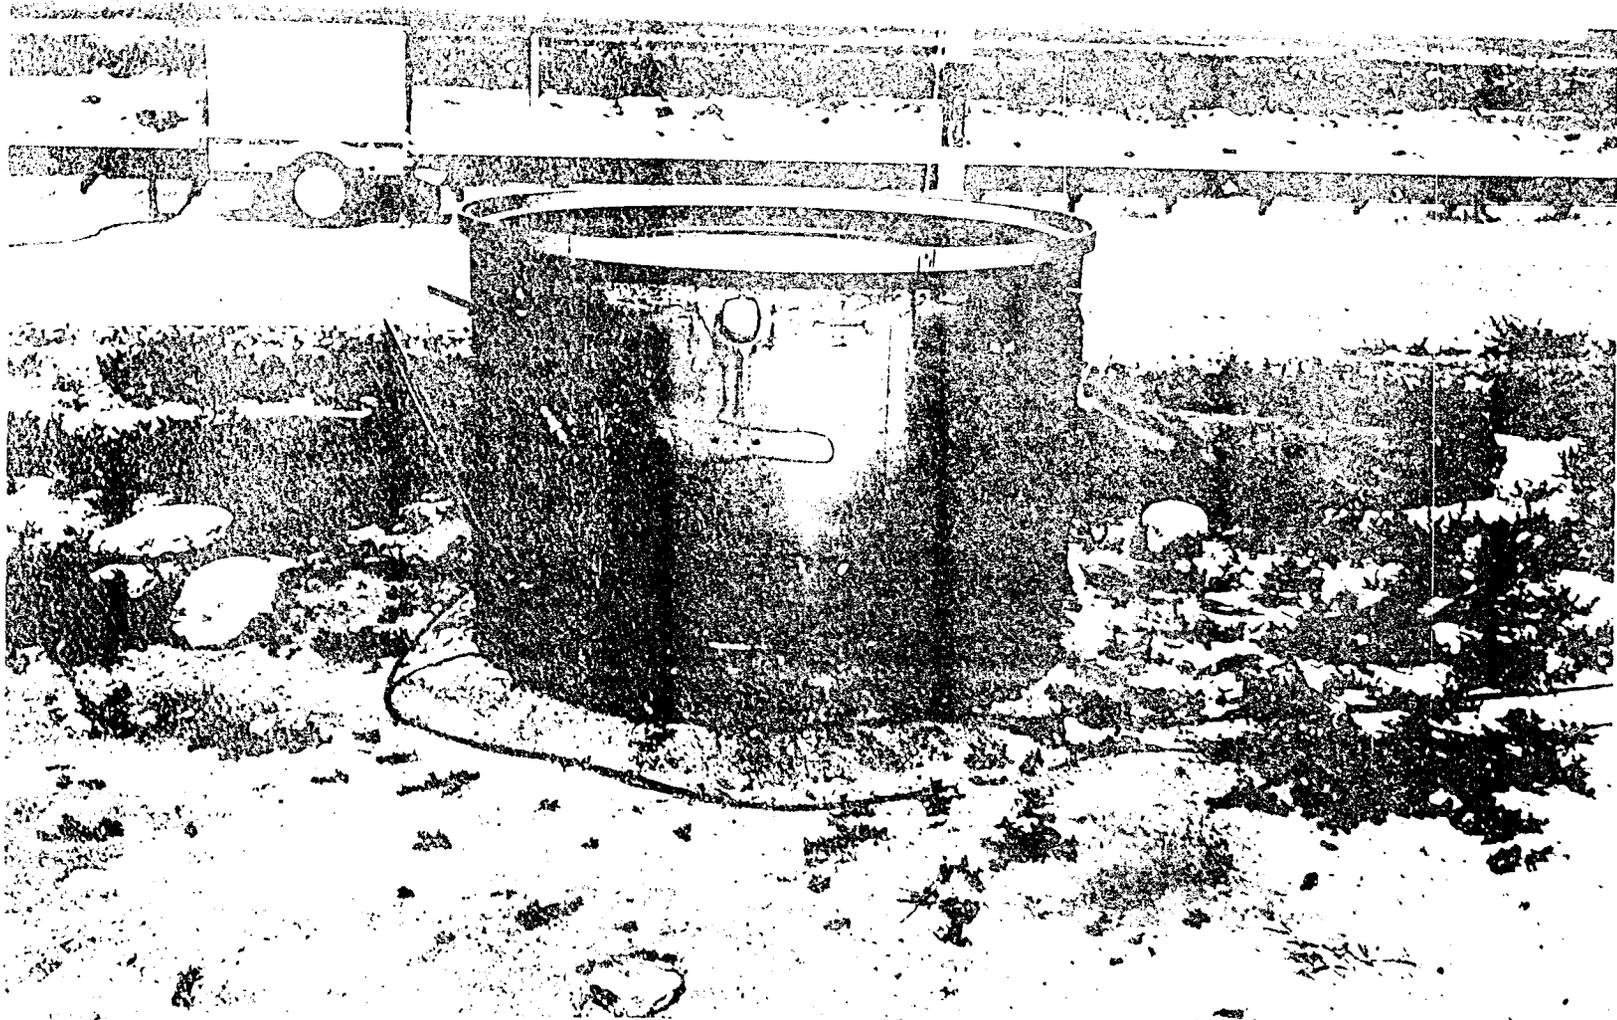
D# 113699

Shot No. 1 - Two pressure transducers were used in this shot. The pressure transducers were attached to the afterbody. The purpose of the transducers was to determine what pressures were present in the afterbody upon firing of the parachute ejection system. Readings from the pressure transducers were recorded on a 535 scope. Figure 1 is a view showing the position of the pressure transducers on the afterbody.

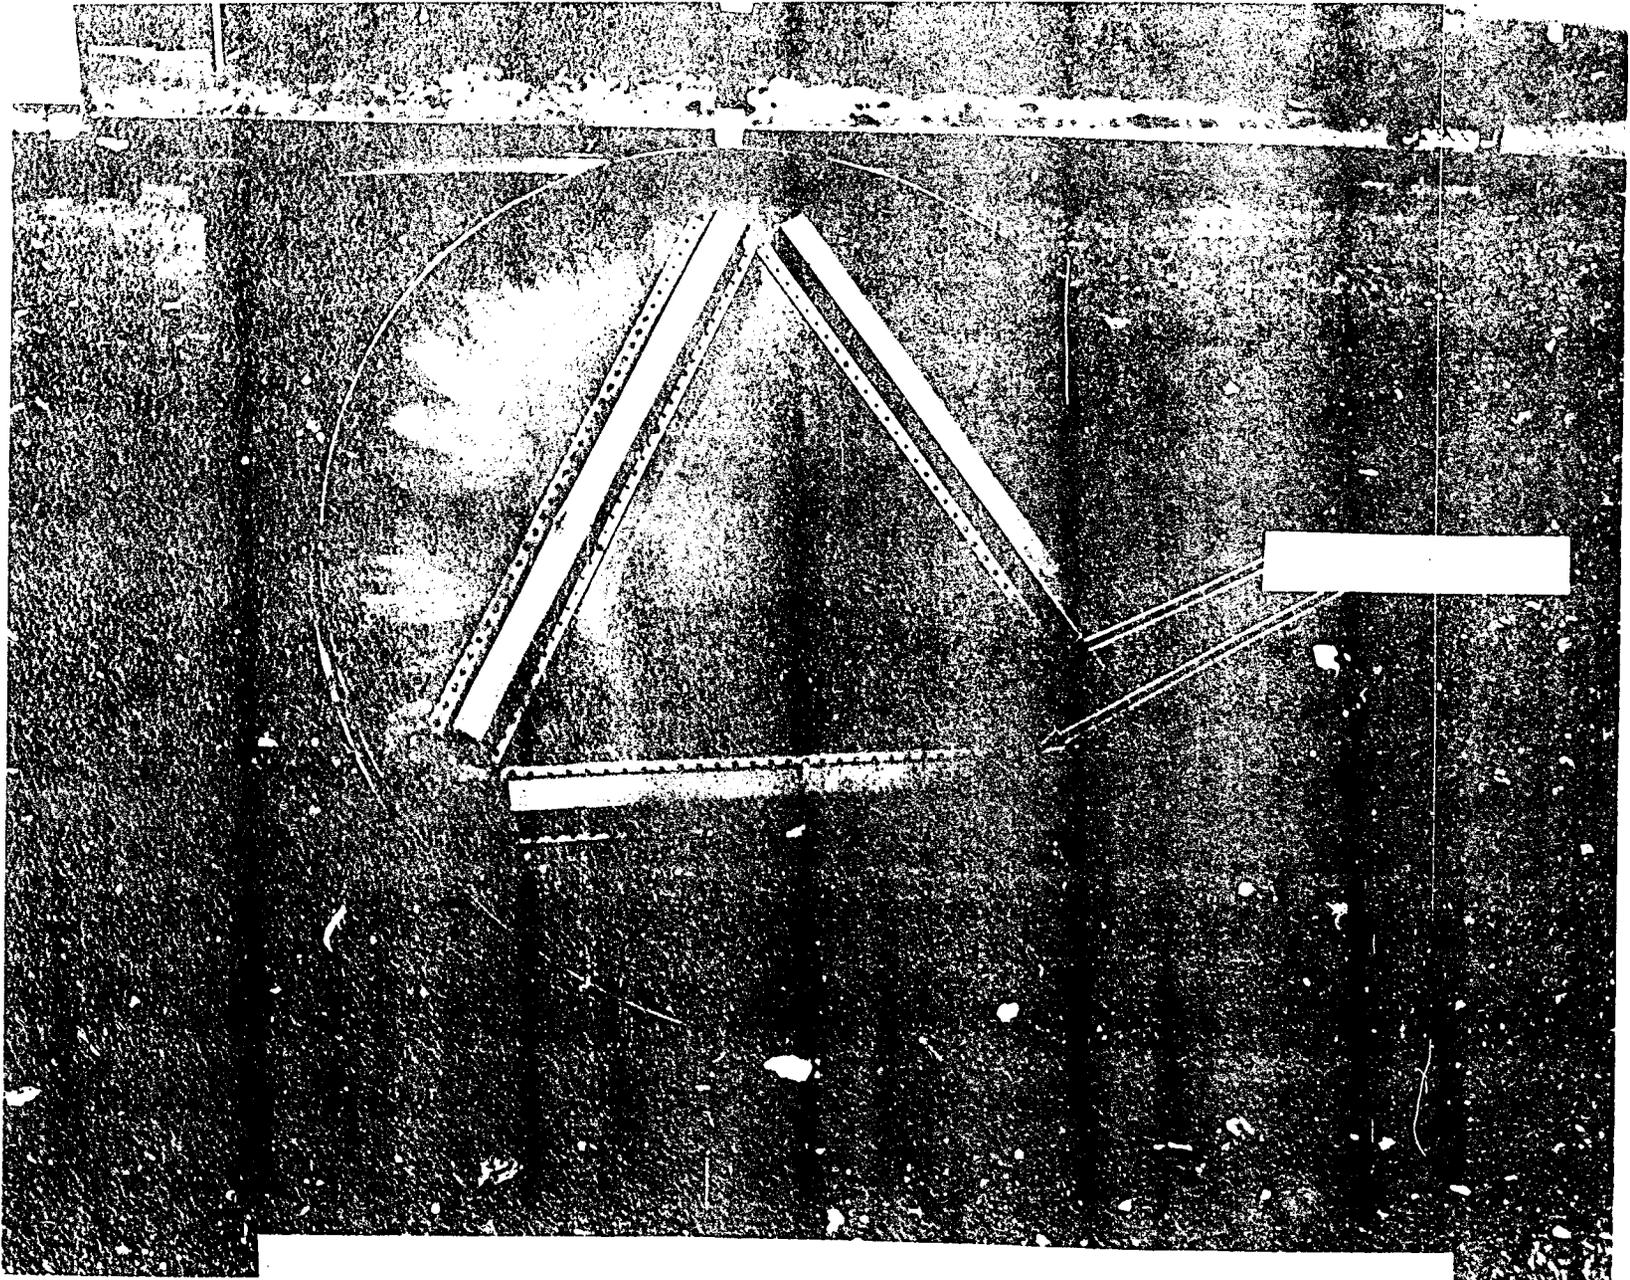
The tail plate was ejected approximately 14 feet in a vertical direction upon firing of the system. Information recorded from the pressure transducers was unreliable due to a "ringing effect" encountered. Some of the rivets used to hold the plate supports to the tail plate tore loose (Figures 2 & 3) as a result of this test. The dent in one of the plate supports in Figures 2 and 3 occurred when the cover plate landed on the afterbody.

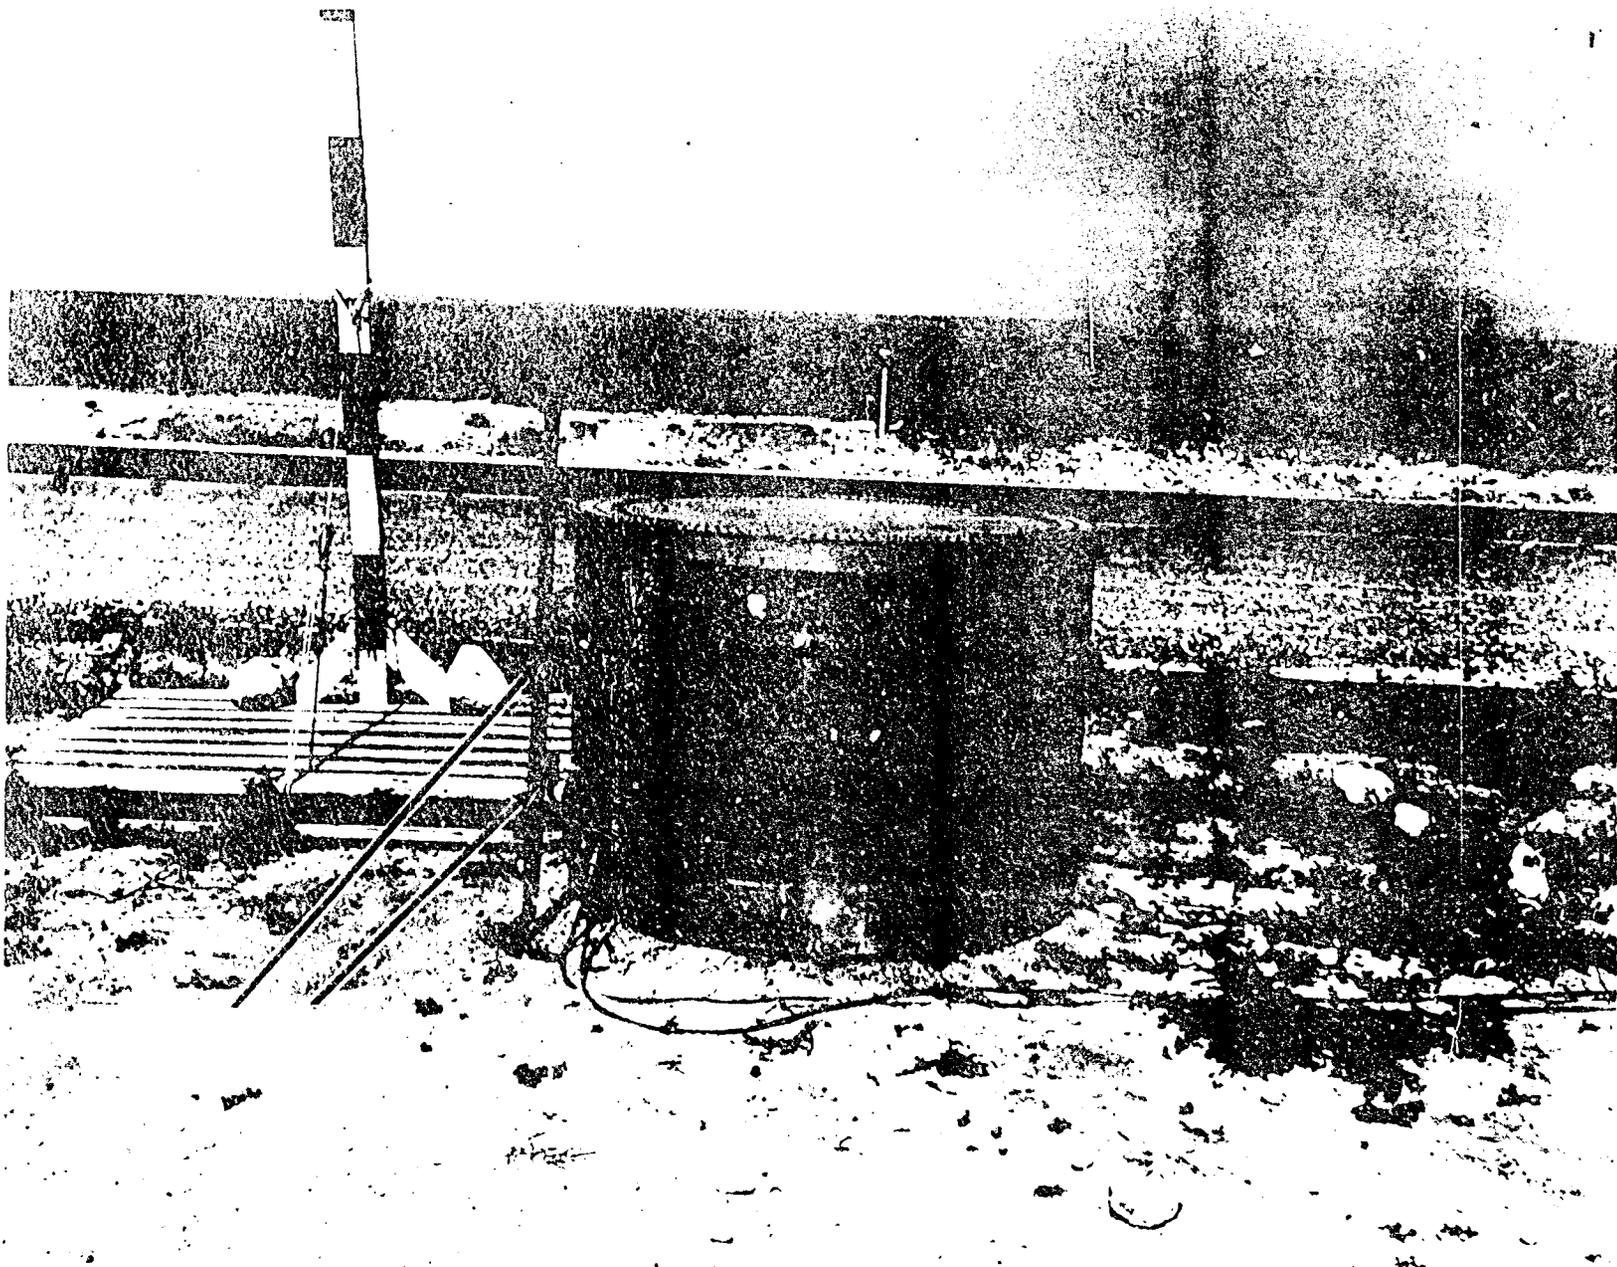
D# 113703

Shot No. 2 - Figure 4 is a view of the test set up prior to shot No. 2. A piece of rubber tubing was used in this test from the afterbody to the pressure transducers. The reason for using the rubber tubing was to try and reduce the ringing effect of the transducers obtained in shot No. 1.

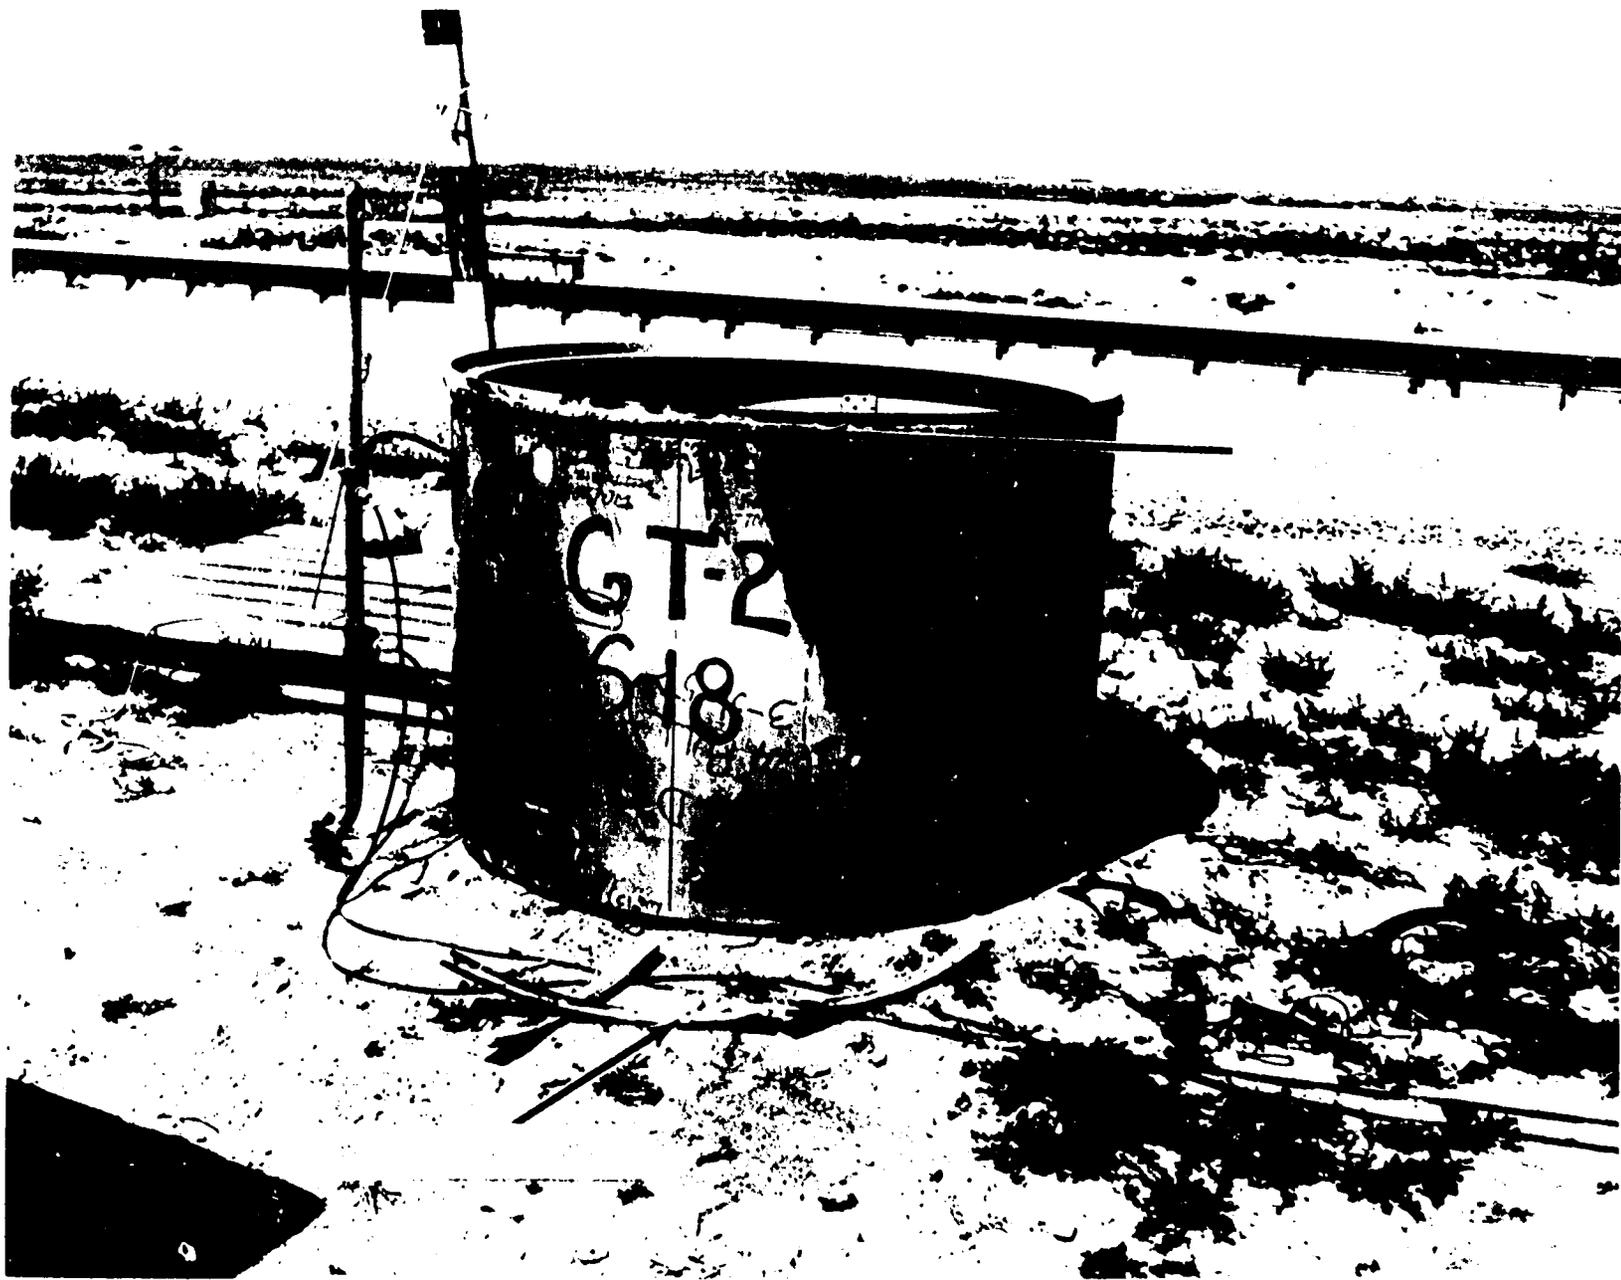
D# 113704

Twenty grain primacord was used in this test. Two Proplex No. 8 detonators were used to detonate the primacord. The cover plate was ejected approximately 20 feet in a vertical direction. The ringing effect encountered in shot No. 1 in the pressure recordings was still present in this shot. The groove of the afterbody into which the primacord was placed was damaged upon firing of the primacord. Figures 5 and 6 are views of the afterbody showing the damage which occurred. The broken parts of the afterbody groove can be seen on the ground in front of the afterbody in Figure 5.

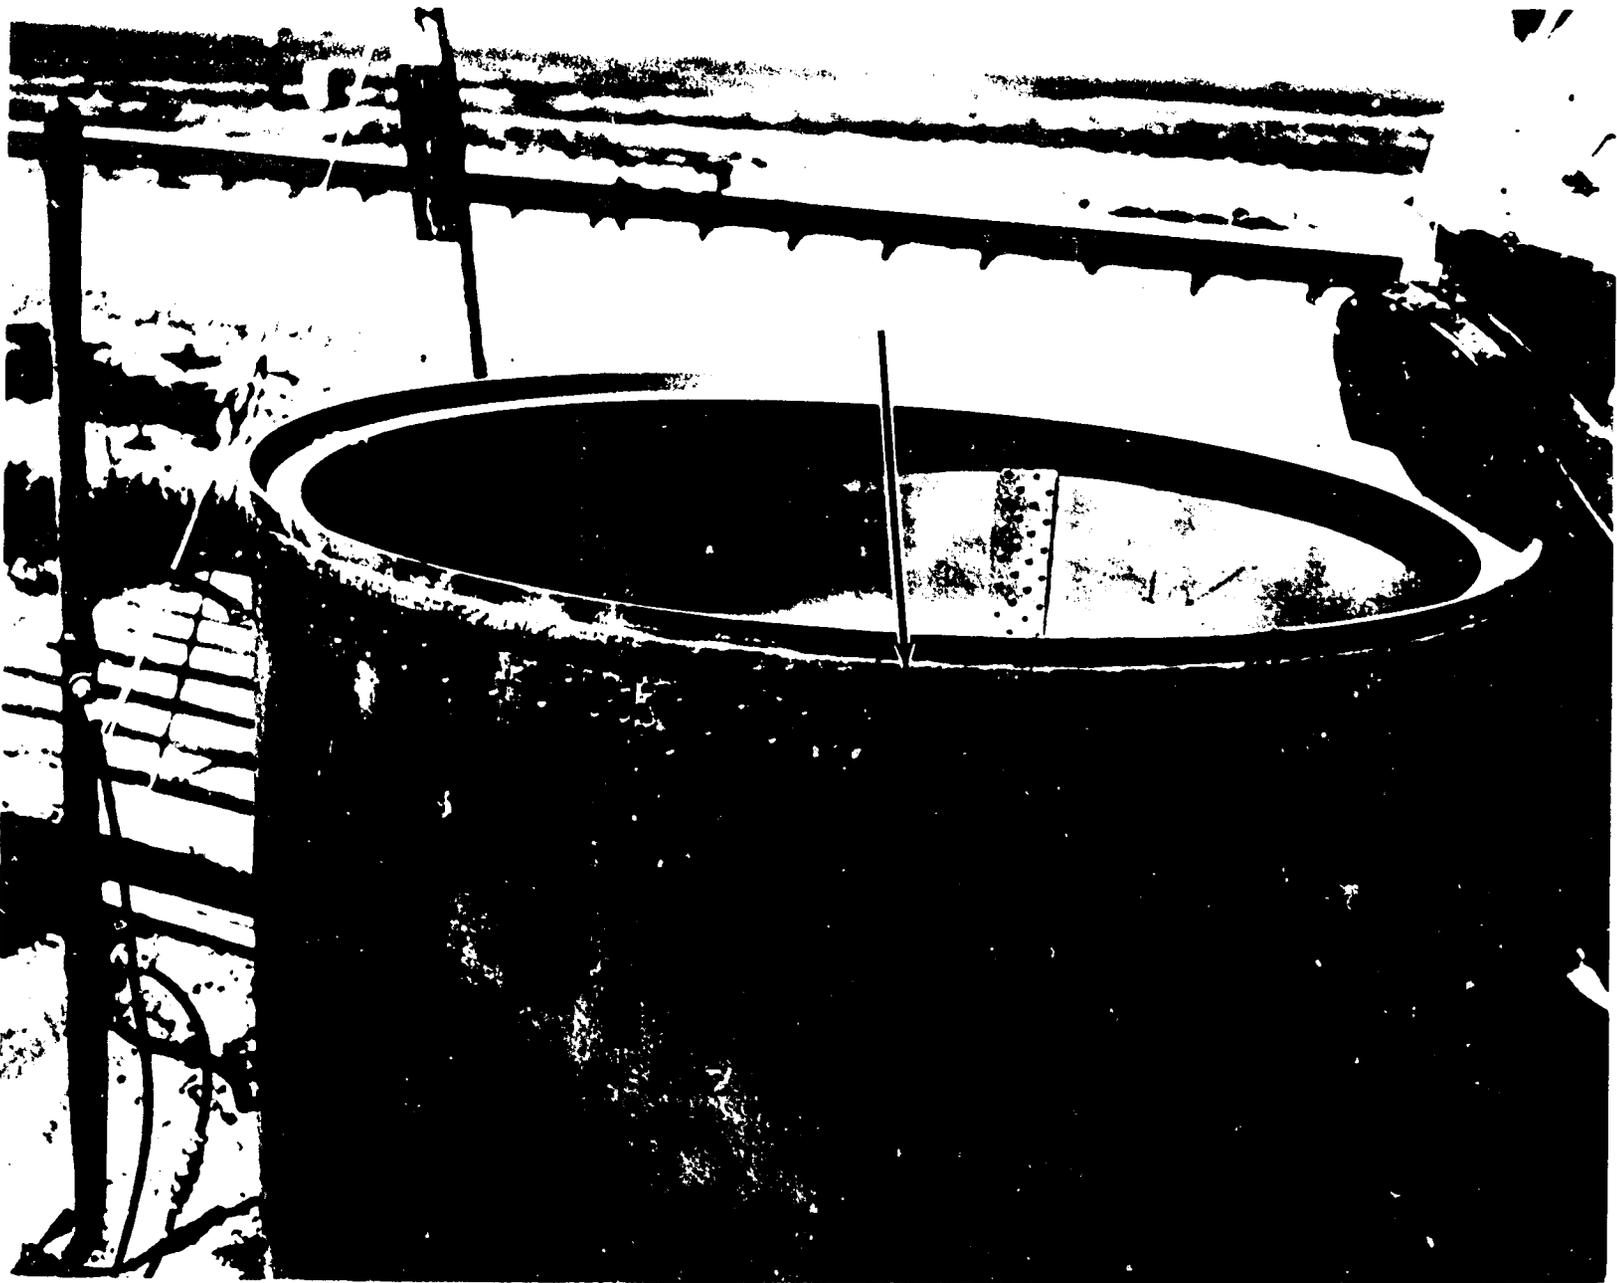
D# 113705

Shot No. 3 - One pressure transducer was used in this shot. Figure 6 is a view showing its position.
