# **A Field Study Setup of Four Homes having Non-Ventilated and Semi-Conditioned Sealed Attics**

**WA Miller, Ph.D., Philip Boudreaux, Simon Pallin, Ph.D., Kaushik Biswas, Ph.D., Tony Gehl, Jerry Atchley, Nicklas Karlsson, Dominic Bednar, Roderick Jackson, Ph.D.**  
Oak Ridge National Laboratory (ORNL), Building Technology Research Integration Center (BTRIC)

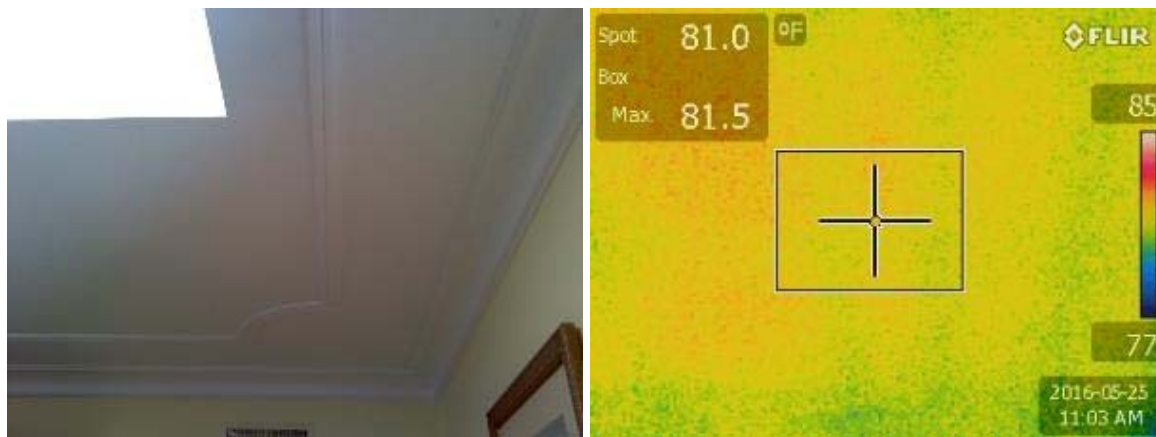
Figure 4: Digital and Infrared Picture of West-facing Ceiling and Wall

An infrared image of the ceiling shows the gypsum to have a temperature of about 81°F, Figure 4. The ceiling is not insulated and is only about R-0.45 for ½-in gypsum. Miller et al. (2016) observed that sealing the attic with less than code level of insulation causes the heat flowing through the ceiling to be almost double that crossing the ceiling for an unconditioned, ventilated attic. Digital and infrared images of the attic were taken to view heat leakage into the attic, Figure 5. The south-facing roof deck reads about 32.2°C (90°F). Radiation is the major contributor of heat transfer from the roof deck to the ceiling, and the 9°C (5°F) temperature gradient shows there is significant heat flux entering the conditioned space. More spray foam insulation would improve the thermal performance of the attic.

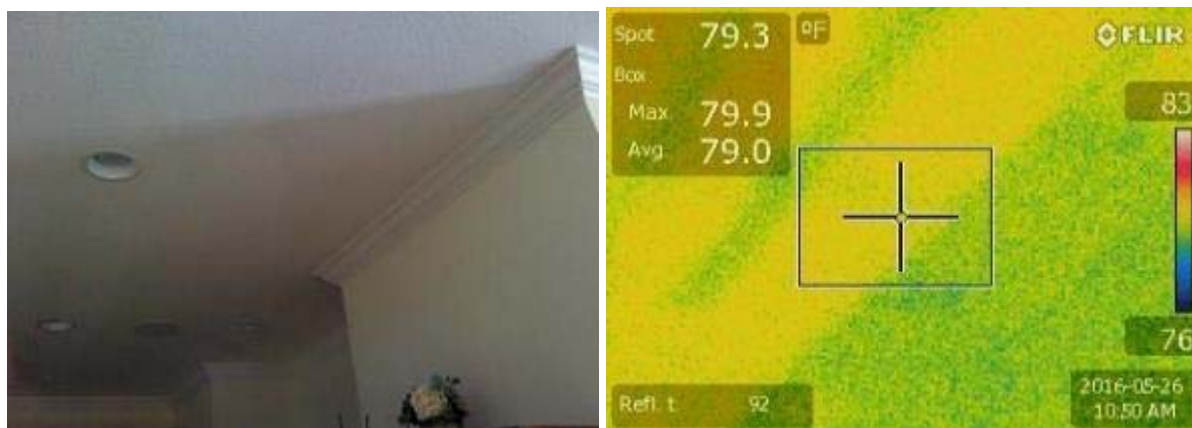
Figure 9: Digital and Infrared pictures of the attic under the South-facing roof

Infrared image of the ceiling shows the gypsum to have a temperature of about 79°F, Figure 9. The ceiling is not insulated and is only about R-0.45 for ½-in gypsum. Digital and infrared images of the attic were taken to view heat leakage into the attic, Figure 10. The south-facing roof deck reads about 84°F. Again, radiation is the major contributor of heat transfer from the roof deck to the ceiling, and the 5°F temperature gradient shows there is less heat flux entering the conditioned space as compared to House 1. However, more spray foam insulation would improve the thermal performance of the attic.
