Tests with High-Bismuth HLW Glasses

**Final Report VSL-10R1780-1, Rev. 0;
12/13/10**

Office of River Protection

K. S. Matlack
Vitreous State Laboratory
The Catholic University of America

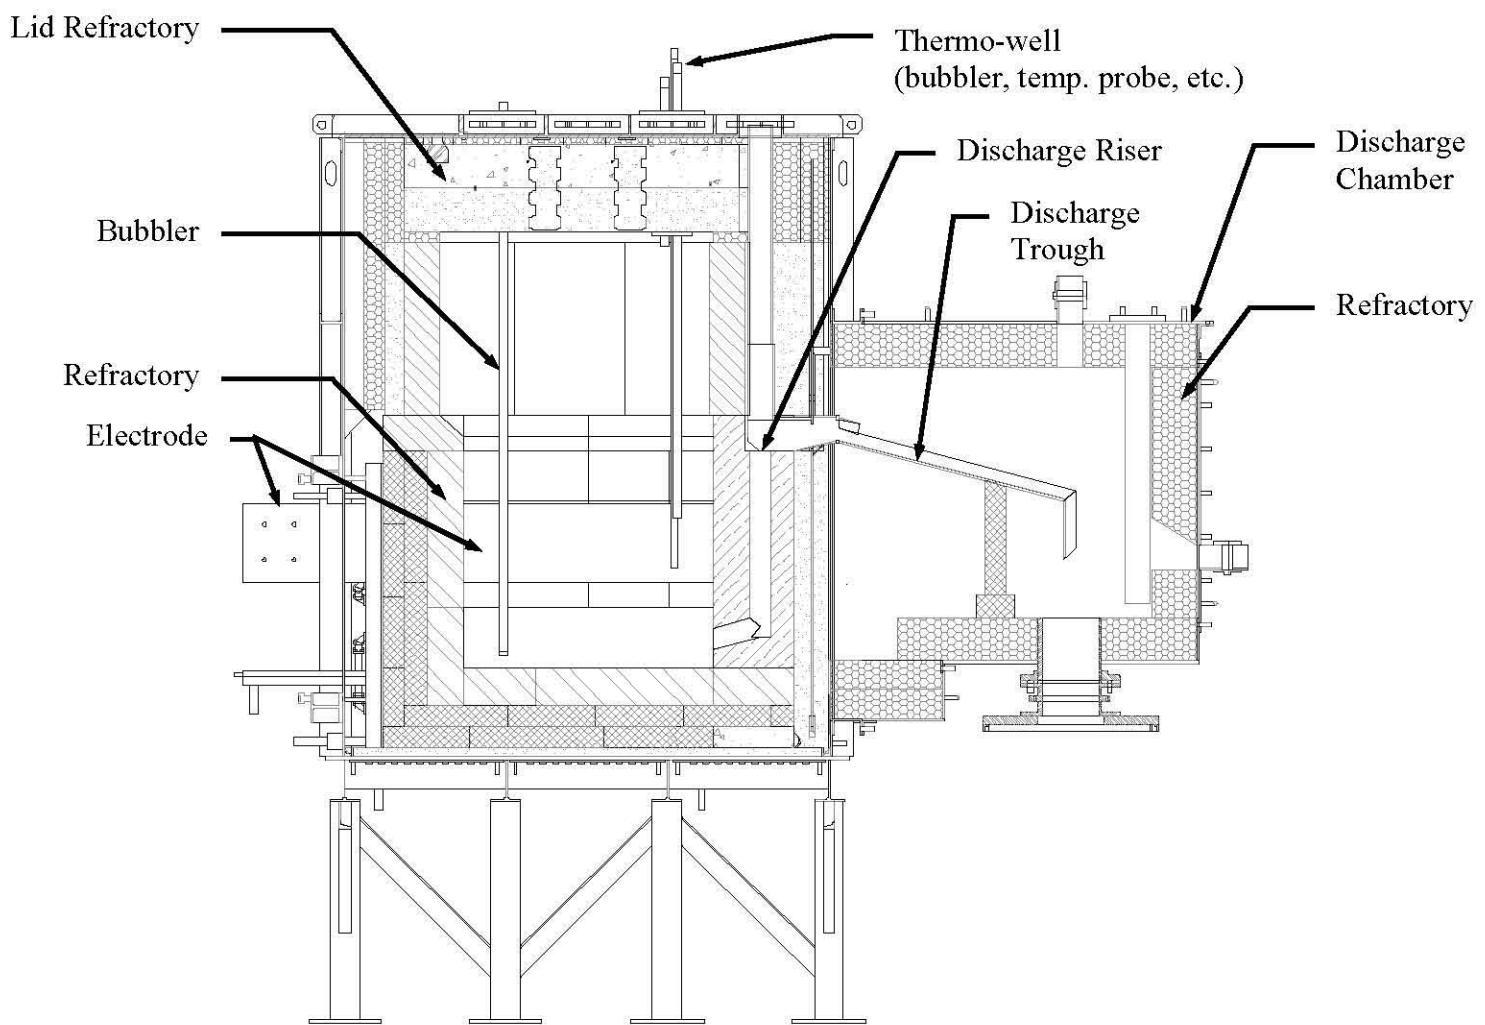
Figure 1.1. Cross-section of the DM1200 melter through the discharge chamber.

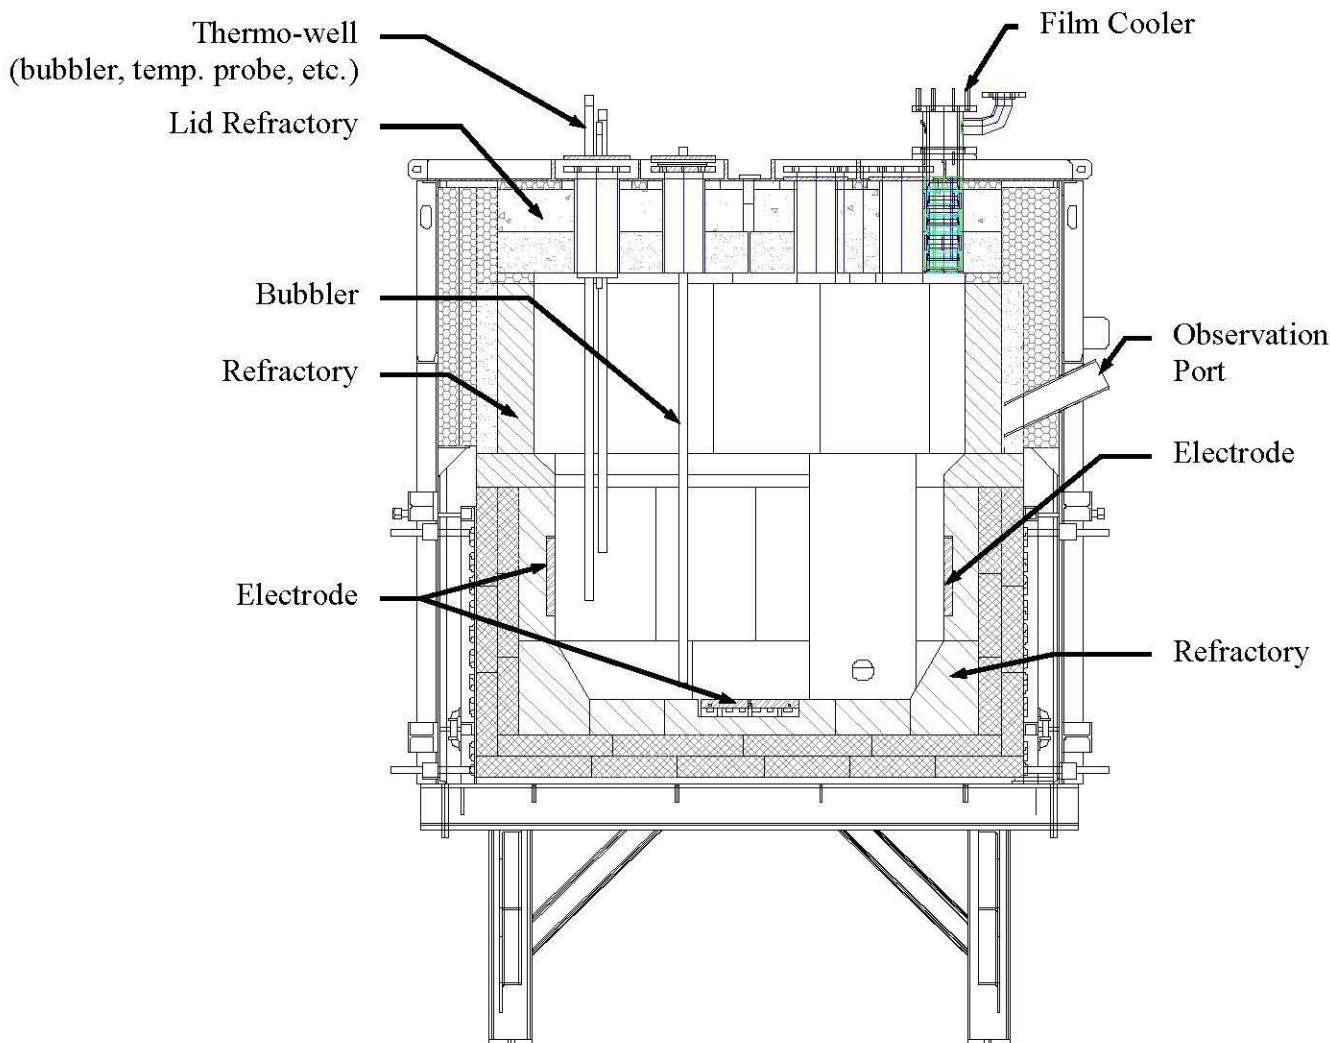
Figure 1.2. Cross-section through the DM1200 melter showing electrodes.

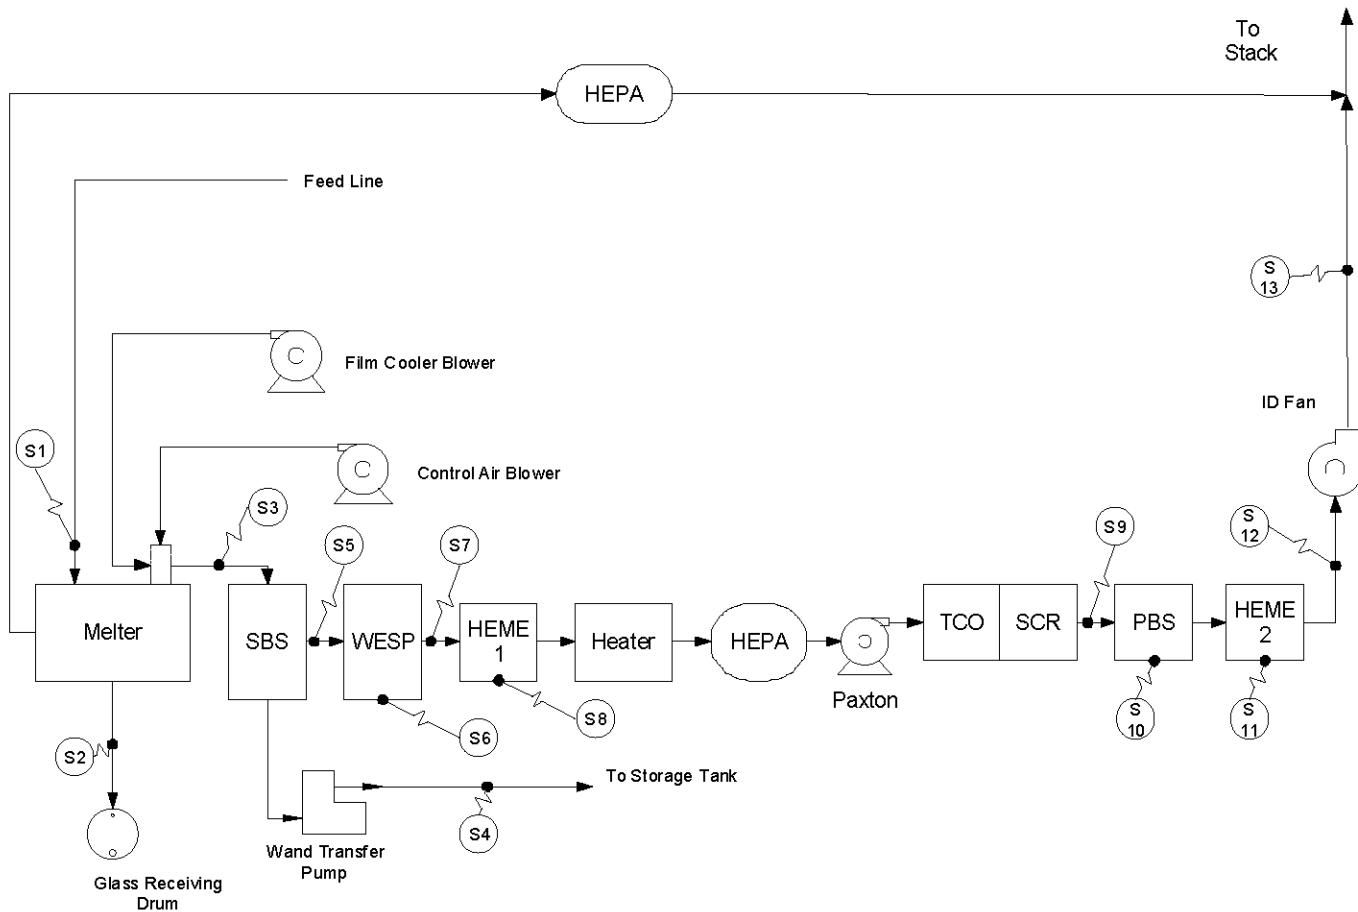
Figure 1.5. Schematic diagram of DM1200 off-gas system. "Sx" indicates sampling point.

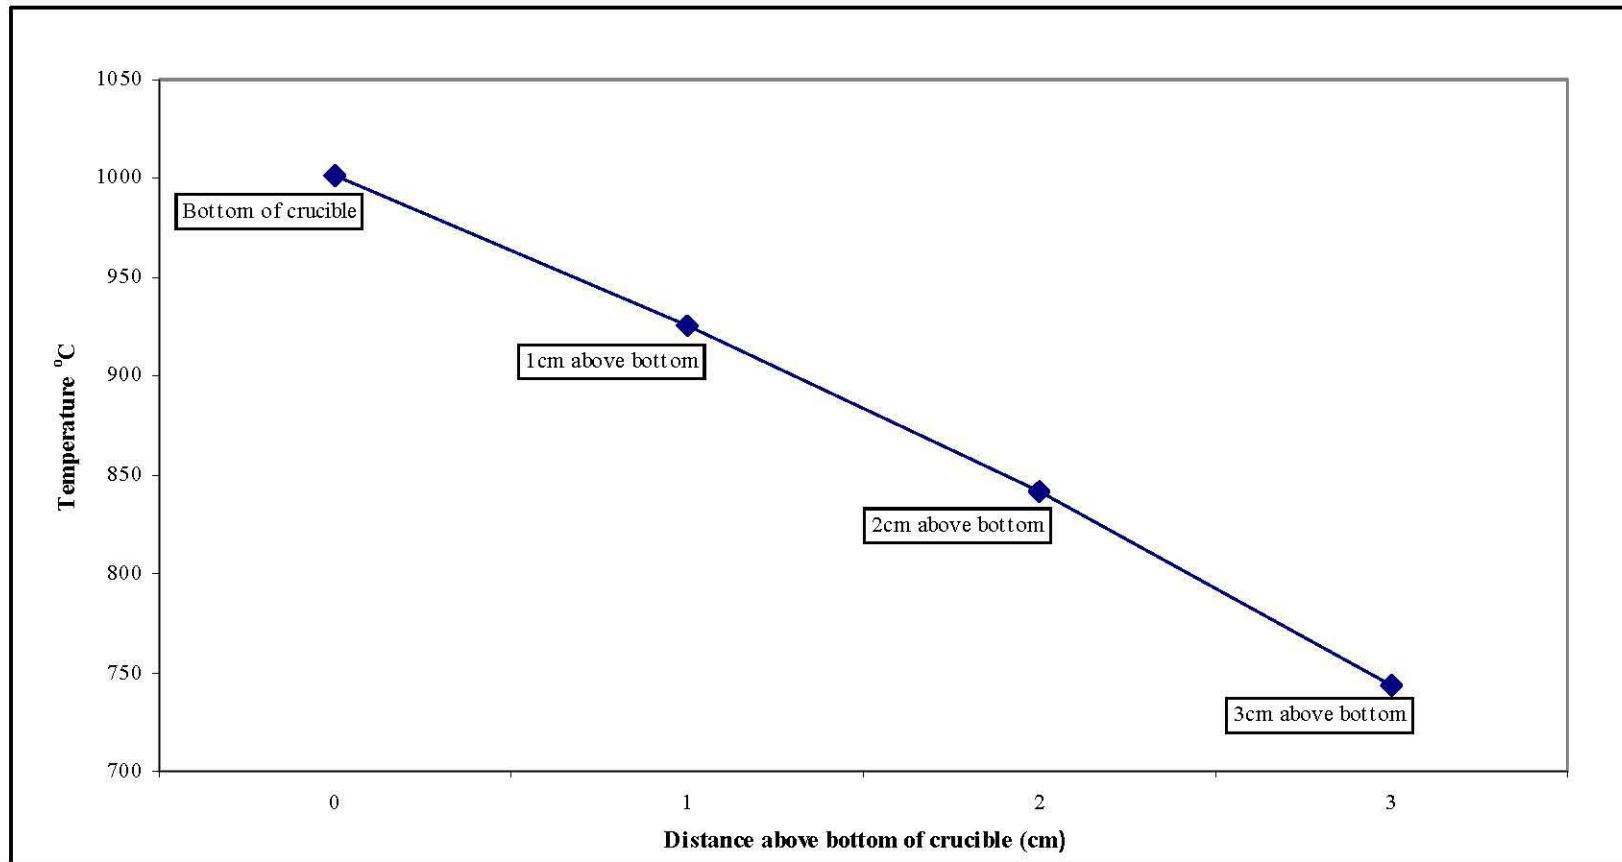
Figure 3.2. Temperature gradient (inside the loaded ceramic crucible) of the Vertical Gradient Furnace (VGF).

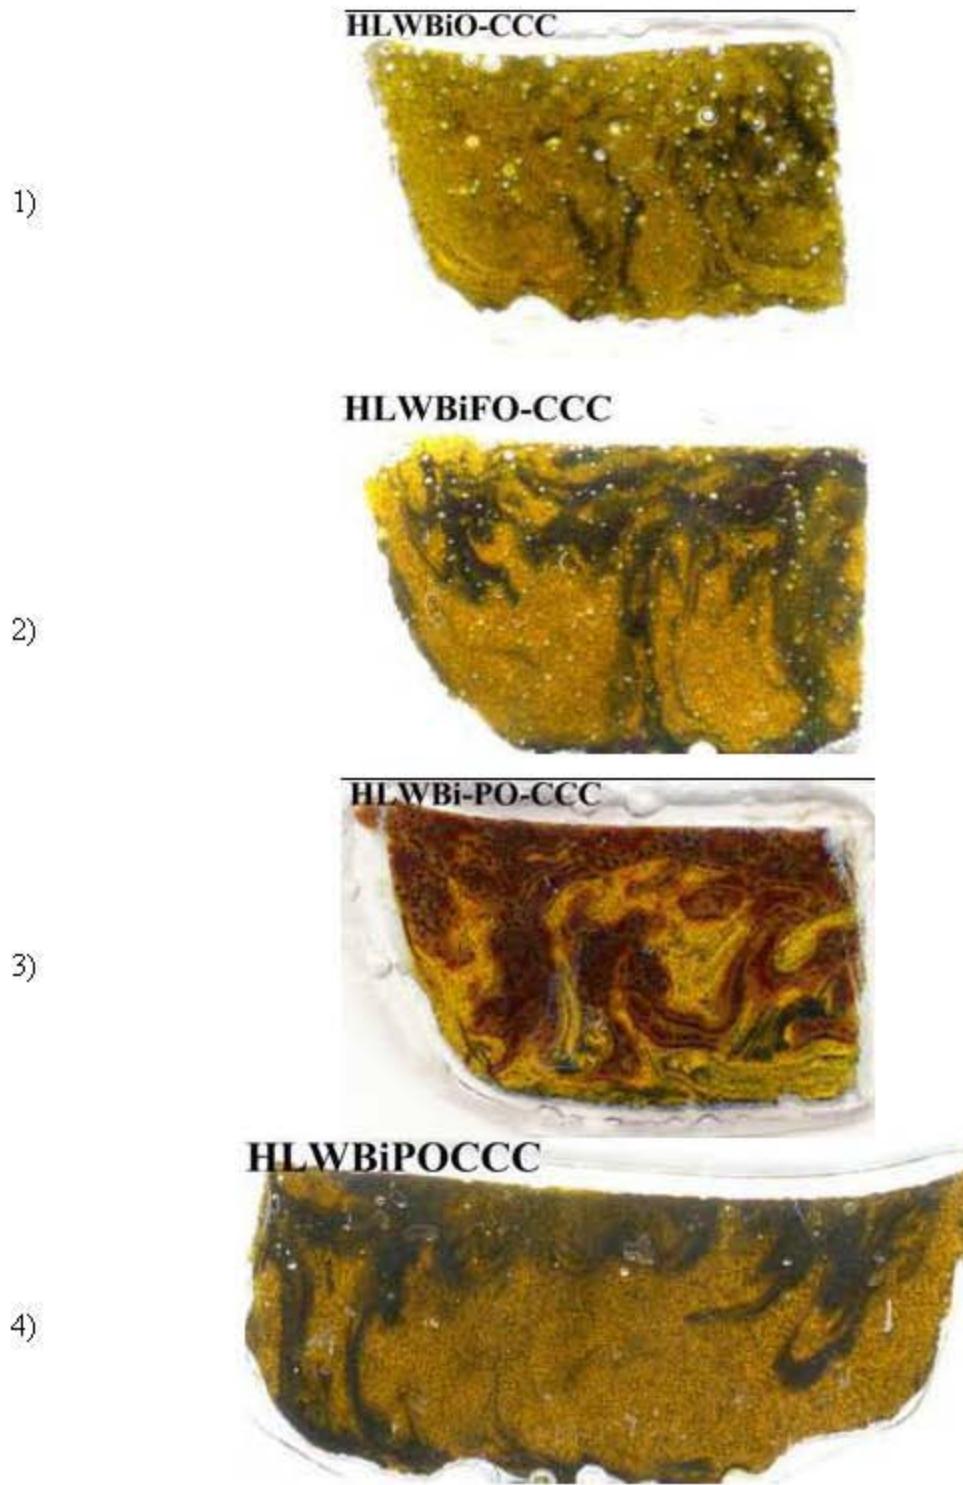
Figure 3.3e. 1) Scanned image of thin section of HLW-Bi-Bi0 after CCC; 2) Scanned image of the thin section of HLW-Bi-F0 after CCC; 3) Scanned image of the thin section of HLW-Bi-P0 after CCC; 4) Scanned images of the thin section of HLW-Bi-BiP0 after CCC.

The cross section of **HLW-Bi-Bi0** (without Bi_2O_3) after CCC looks very much like that of HLW-Bi-F2 and both are similarly populated with gas bubbles. The F-free version **HLW-Bi-F0** also appears similar but with smaller gas bubbles than in HLW-Bi-F2. The crystals in the two CCC samples are small spinel crystals in the translucent glass matrix (Figures 3.3e and 3.4m, n). In contrast, no gas bubbles were observed in the P-free **HLW-Bi-P0** melt. Moreover, the cross section of the CCC sample is dominated by dark-brown streaks intertwined with black streaks comprised mostly of spinel crystals. Under an optical microscope, opaque acicular crystals are seen forming radiating star-shaped centers inside lighter colored spheres that are dispersed within a thick matrix of dark brown glass. Overall, the texture in the dark brown portion is similar to that observed in the melter discharged glass BLL-G-46A (Figures 3.3e and 3.4o, p).

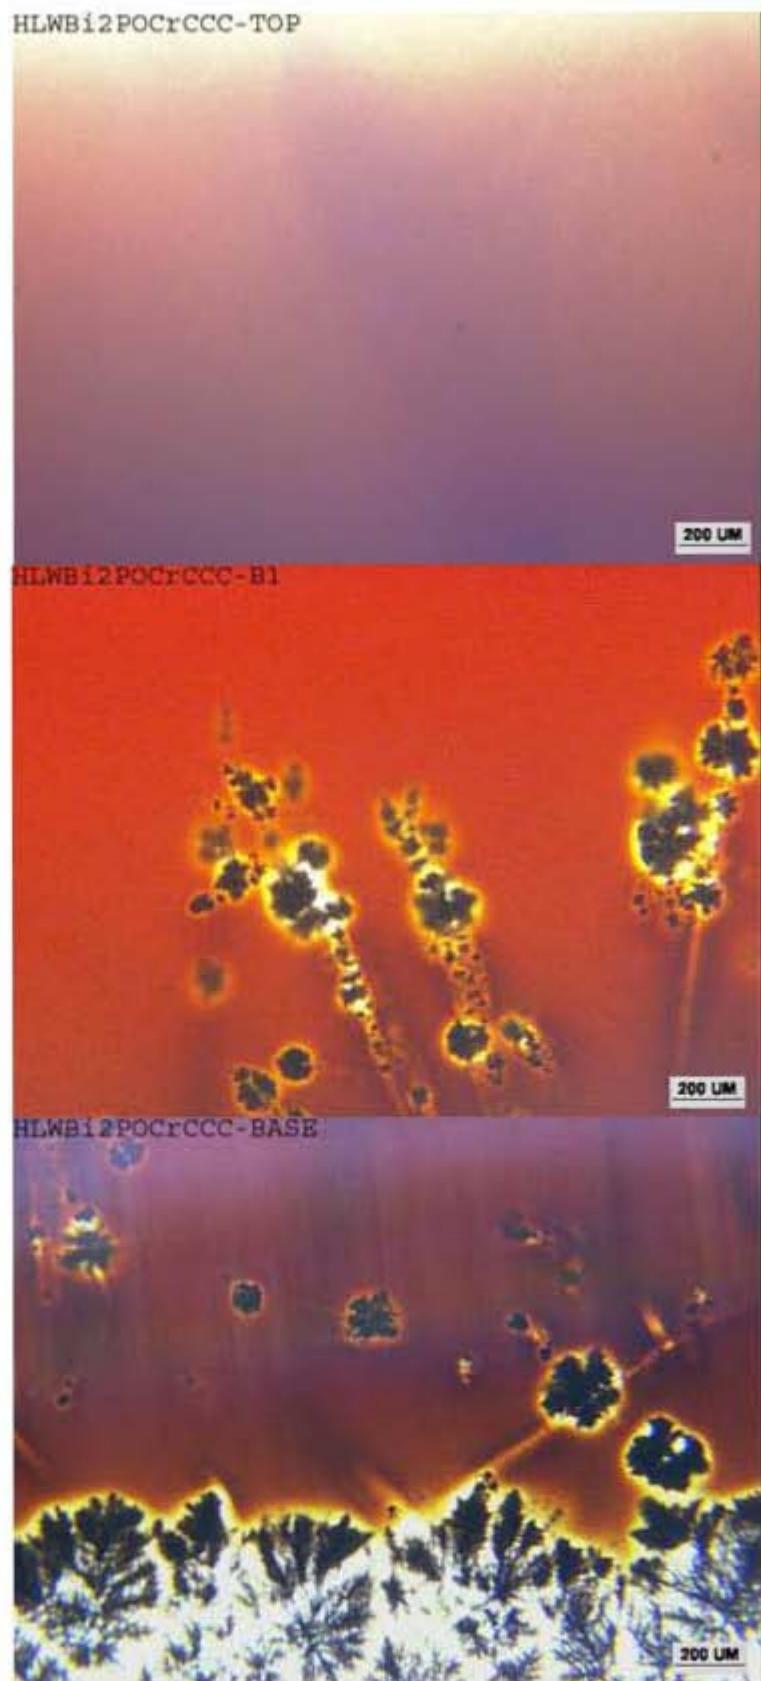
Figure 3.4s. Transmission optical microscopic images of HLW-Bi-2P0Cr after CCC.

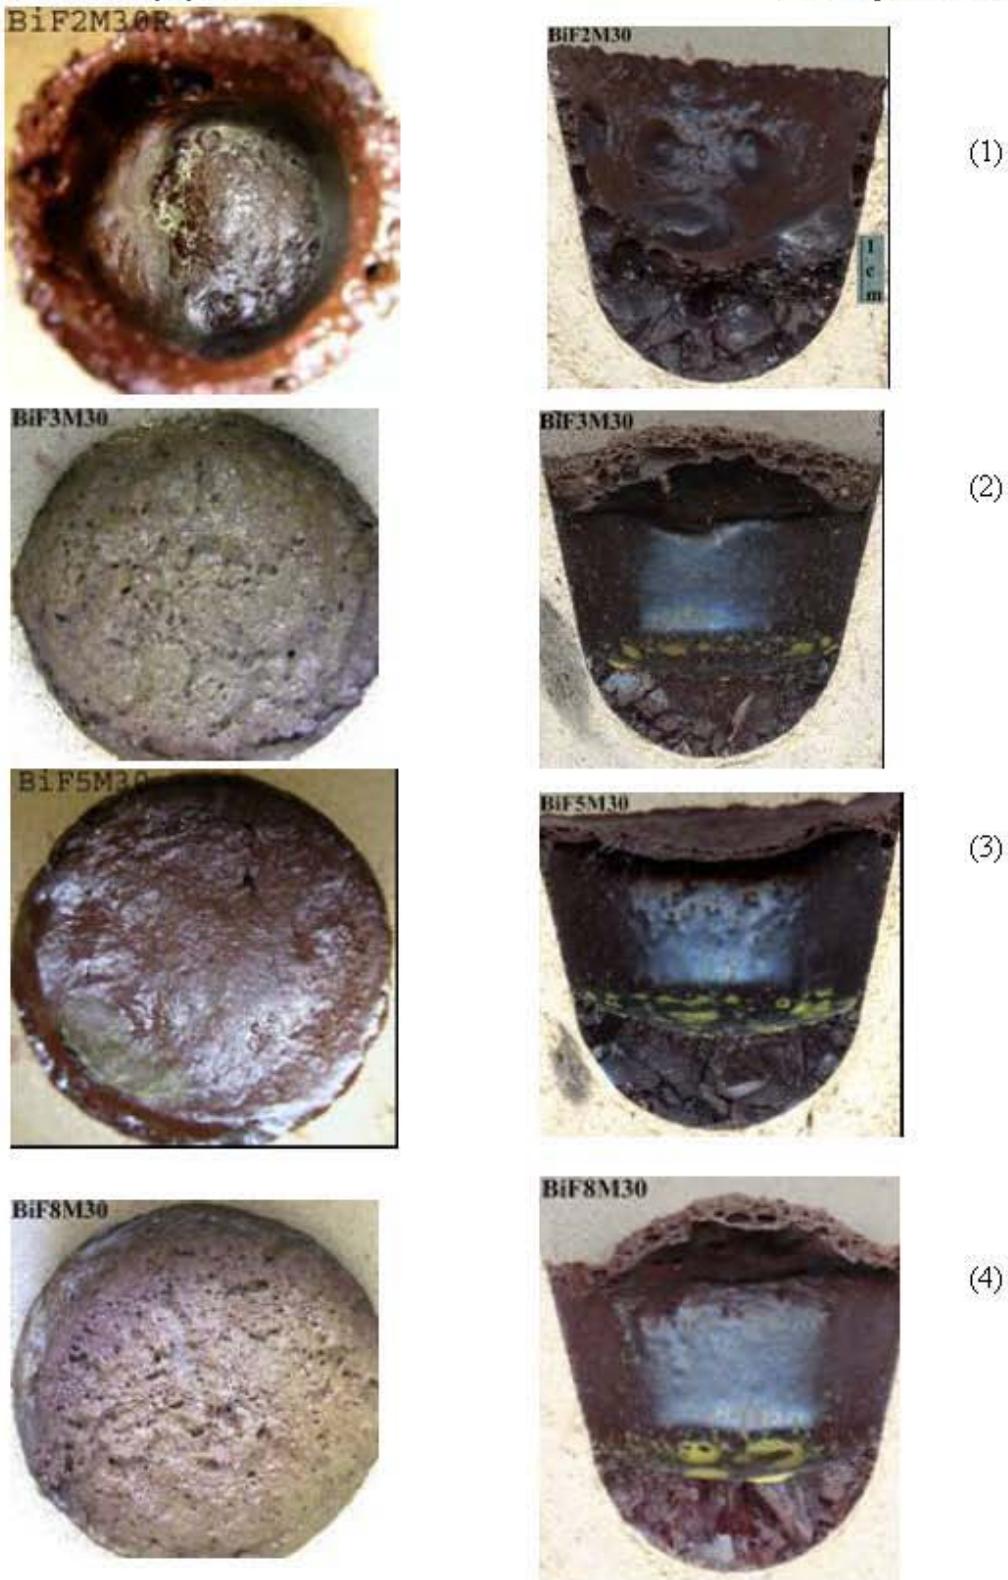
Figure 3.5b. Feed conversion after 30 minute VGF experiments: top view and cross section of 1) HLW-Bi-F2; 2) HLW-Bi-F3; 3) HLW-Bi-F5; and 4) HLW-Bi-F8.

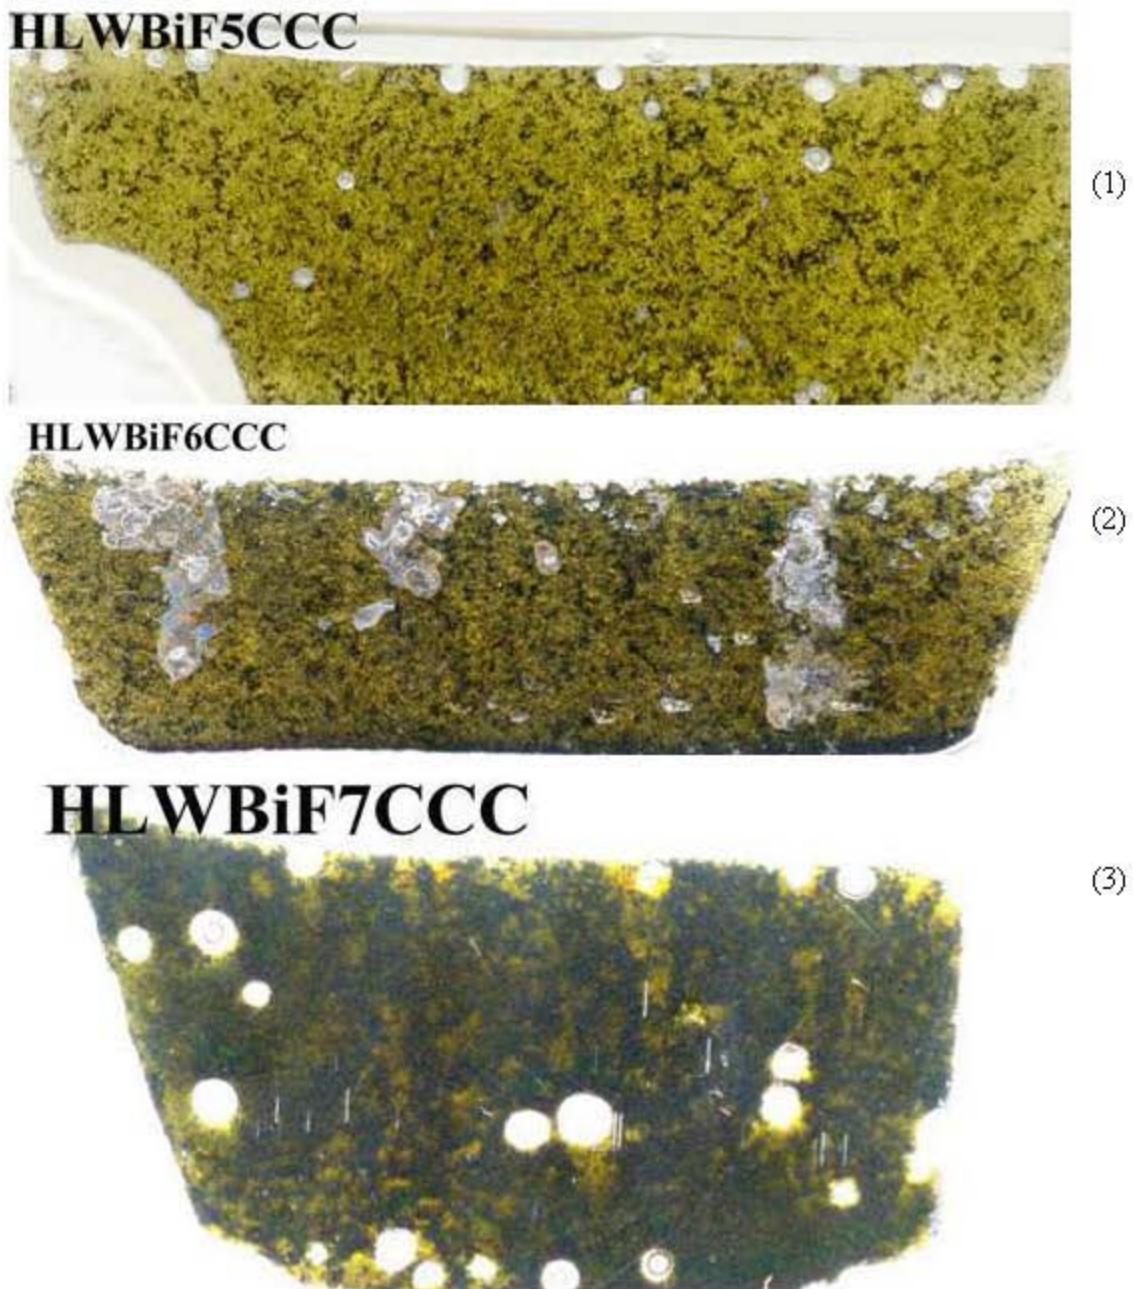
Figure 3.6b. Scanned images of thin sections of 1) HLW-Bi-F5 after CCC;
2) HLW-Bi-F6 after CCC; 3) HLW-Bi-F7 after CCC.

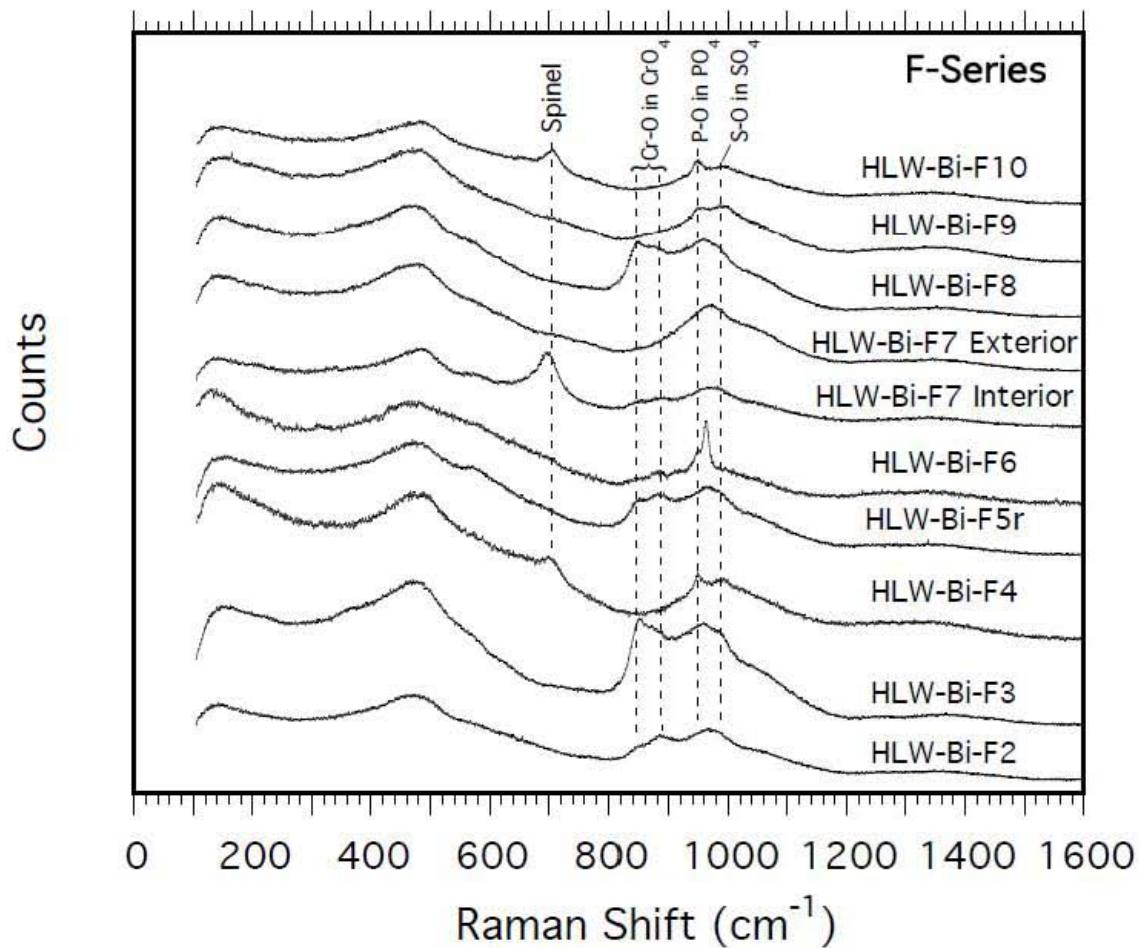
Figure 3.11. VV polarized spectra of the waste glasses (F-series) where Bi_2O_3 and P_2O_5 waste-loading was varied; these spectra were collected at points having the least amount of crystals. HLW-Bi-F7 Interior is a representative spectrum of an interior fracture surface of the sample; HLW-Bi-F7 Exterior is a representative spectrum of the outer sample surface. Several spectra are rescaled to highlight differences. Some vibrational assignments are indicated.

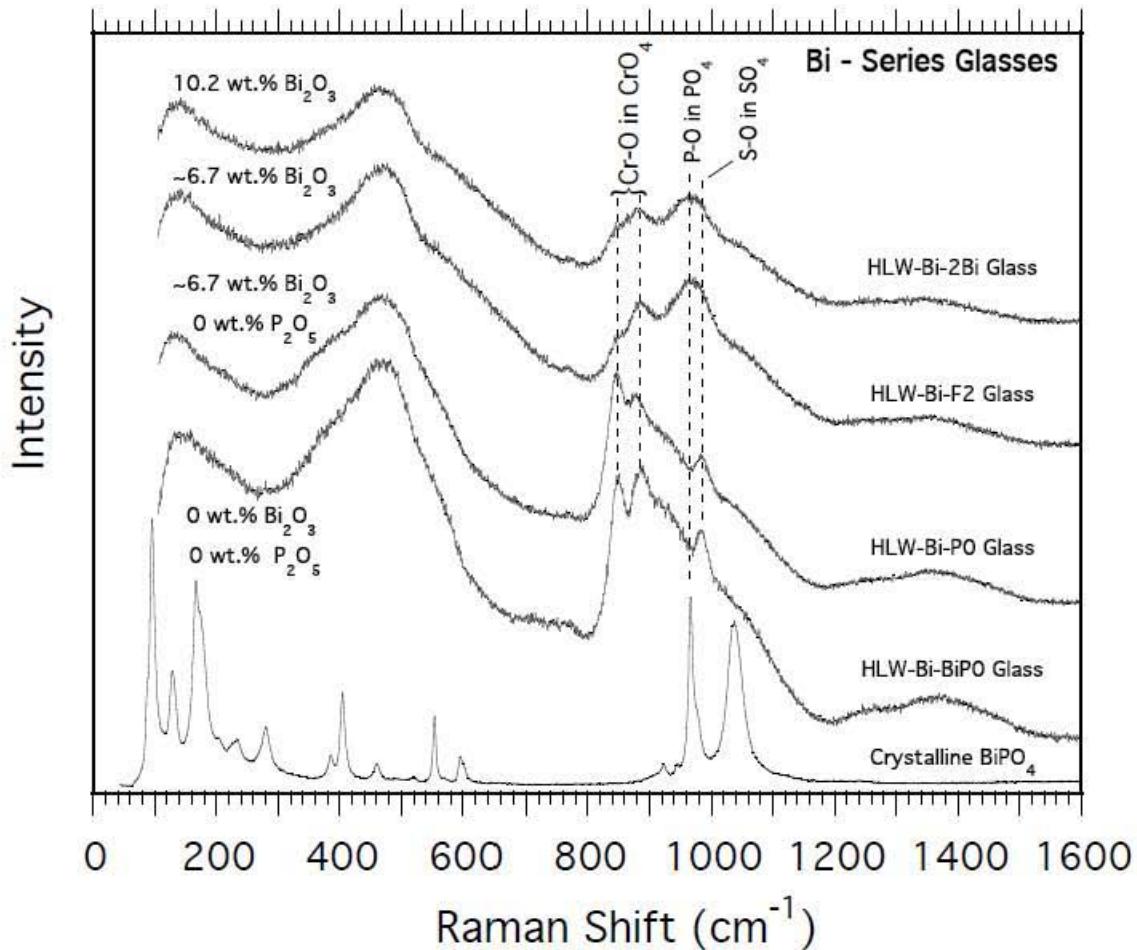
Figure 3.12. VV polarized spectra of the Bi-series glasses where Bi_2O_3 content was varied. Some of the higher frequency glass vibration assignments are indicated.

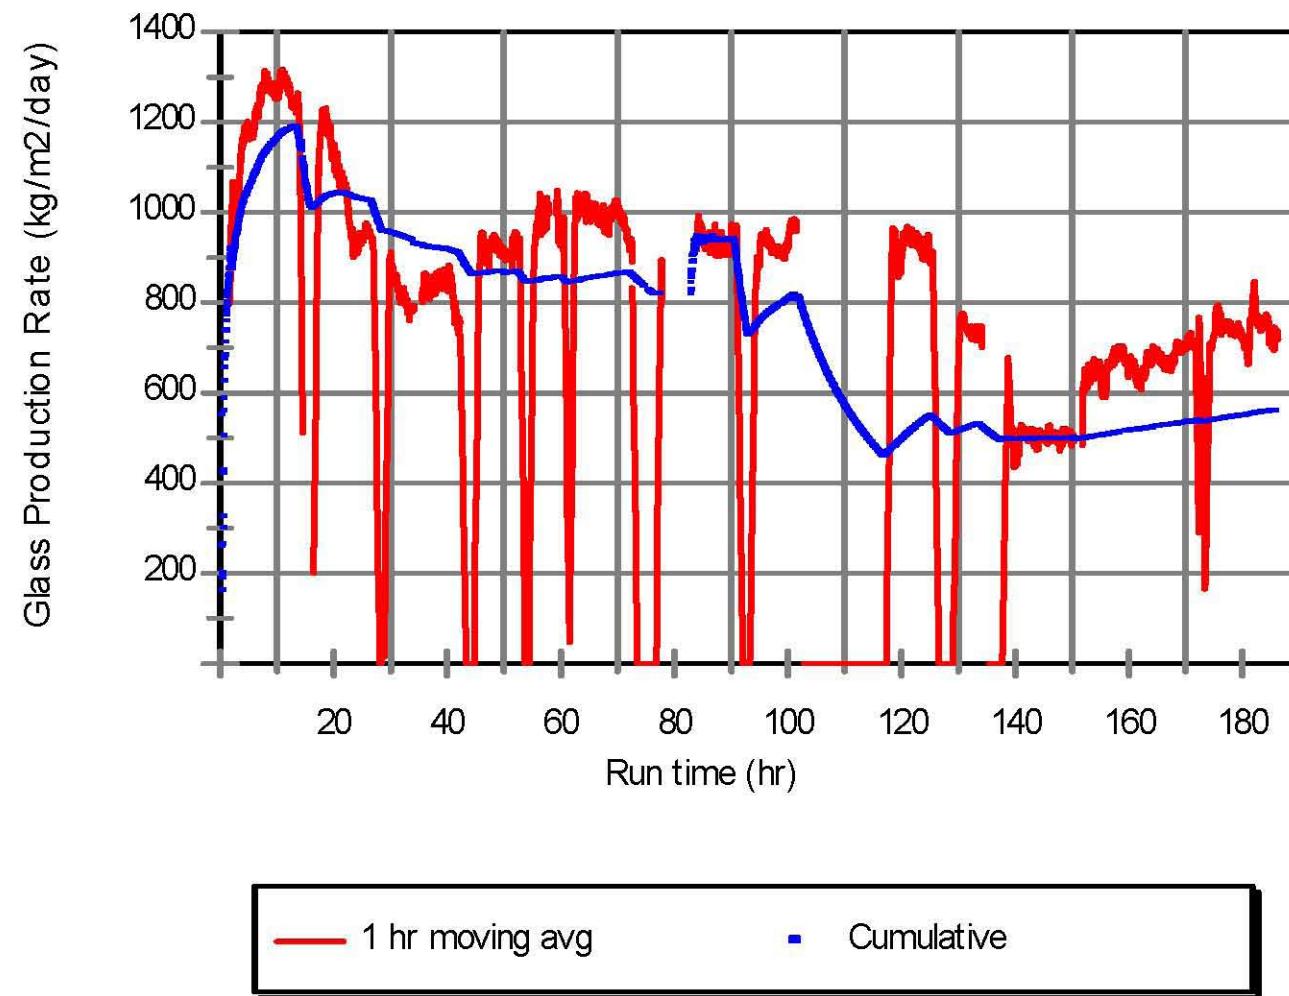
Figure 4.1. Production rates for DM1200 Tests.

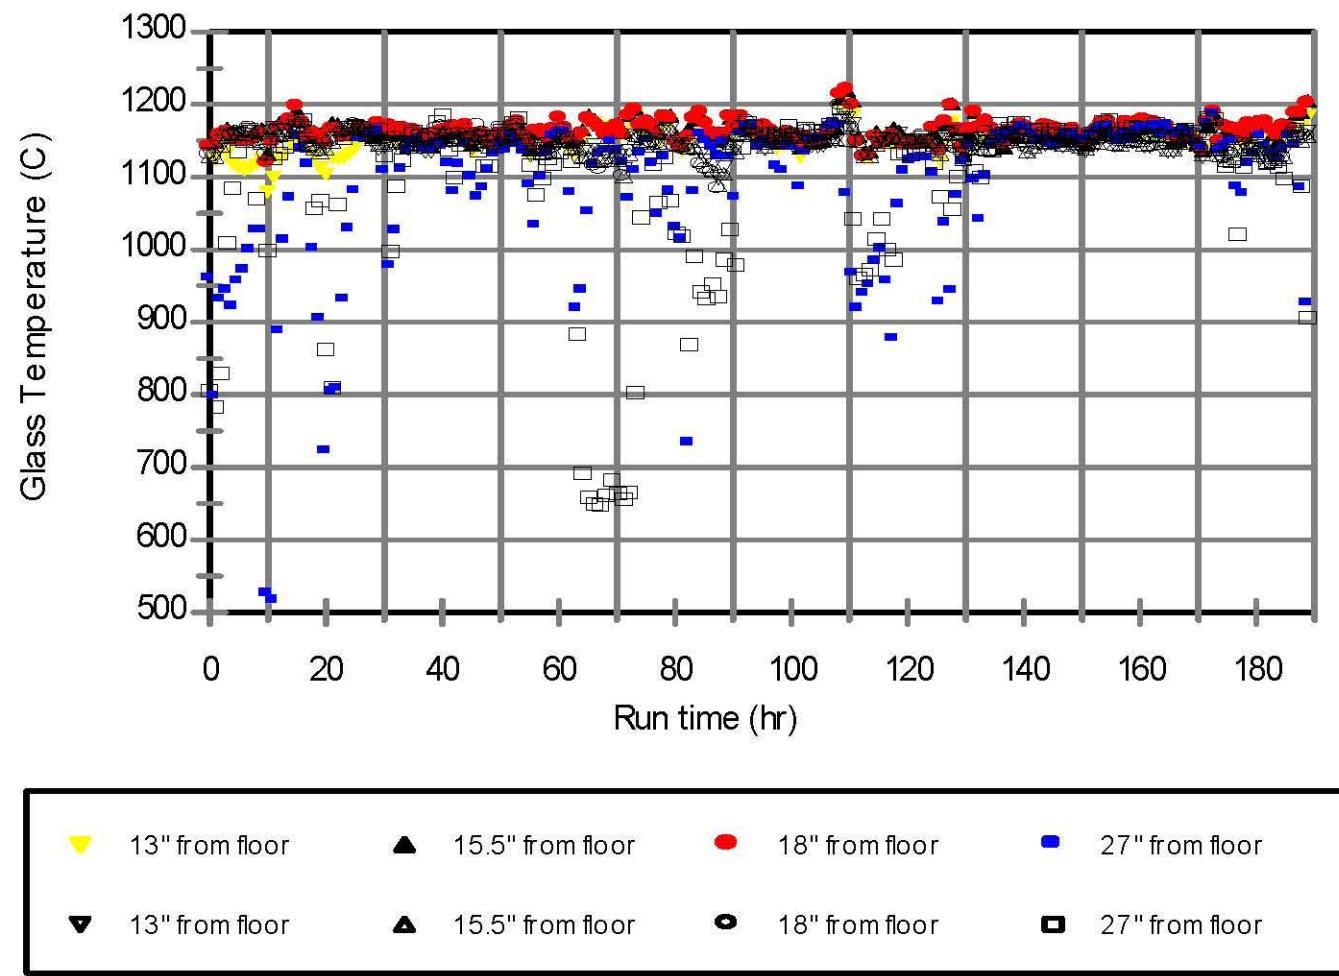
Figure 4.2. Glass temperatures (hourly averages) for DM1200 Tests.

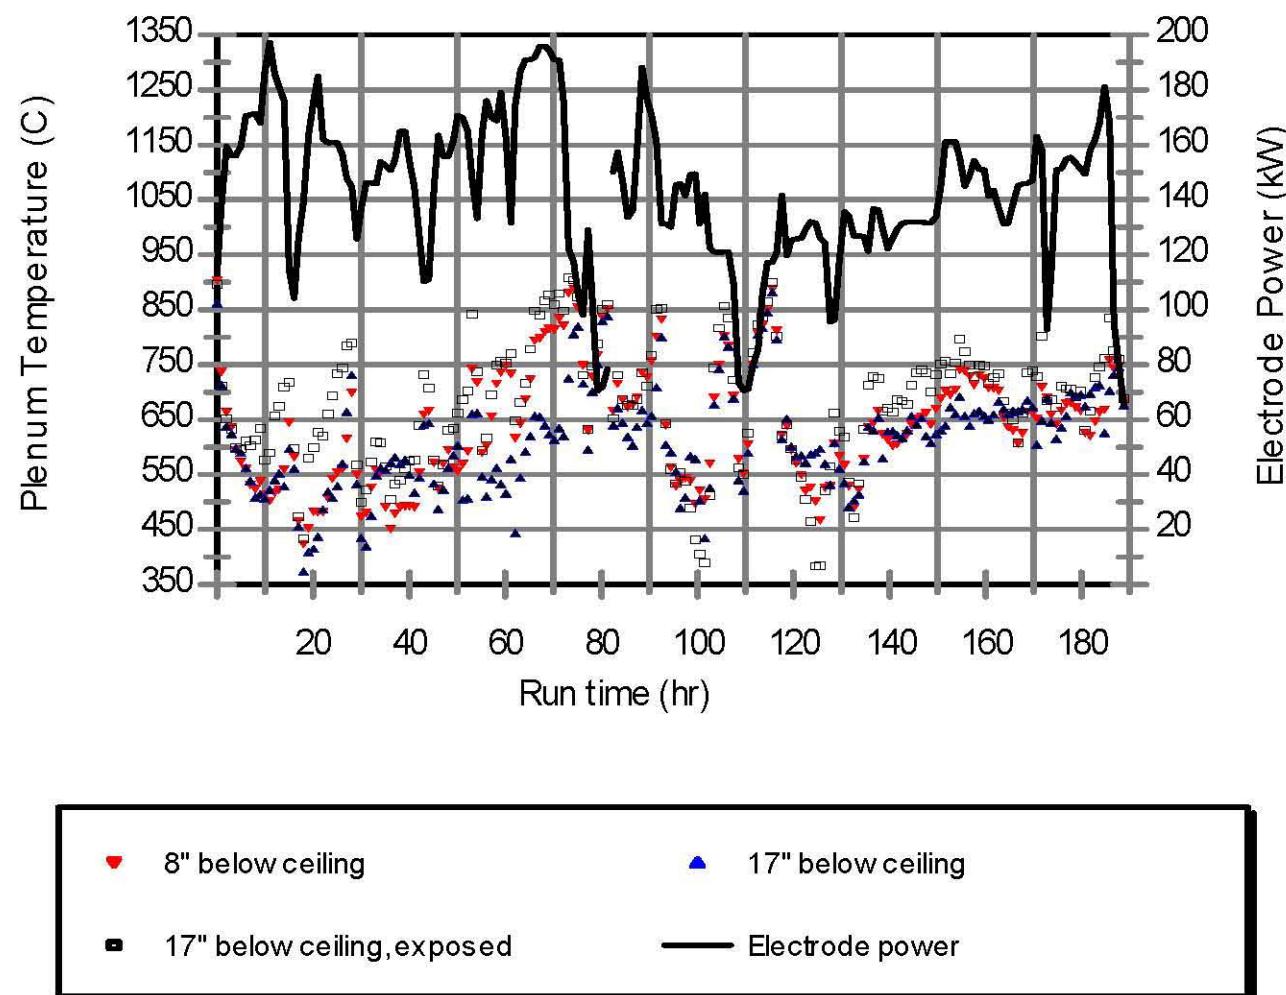
Figure 4.3. Plenum temperatures and electrode power (hourly averages) for DM1200 Tests.

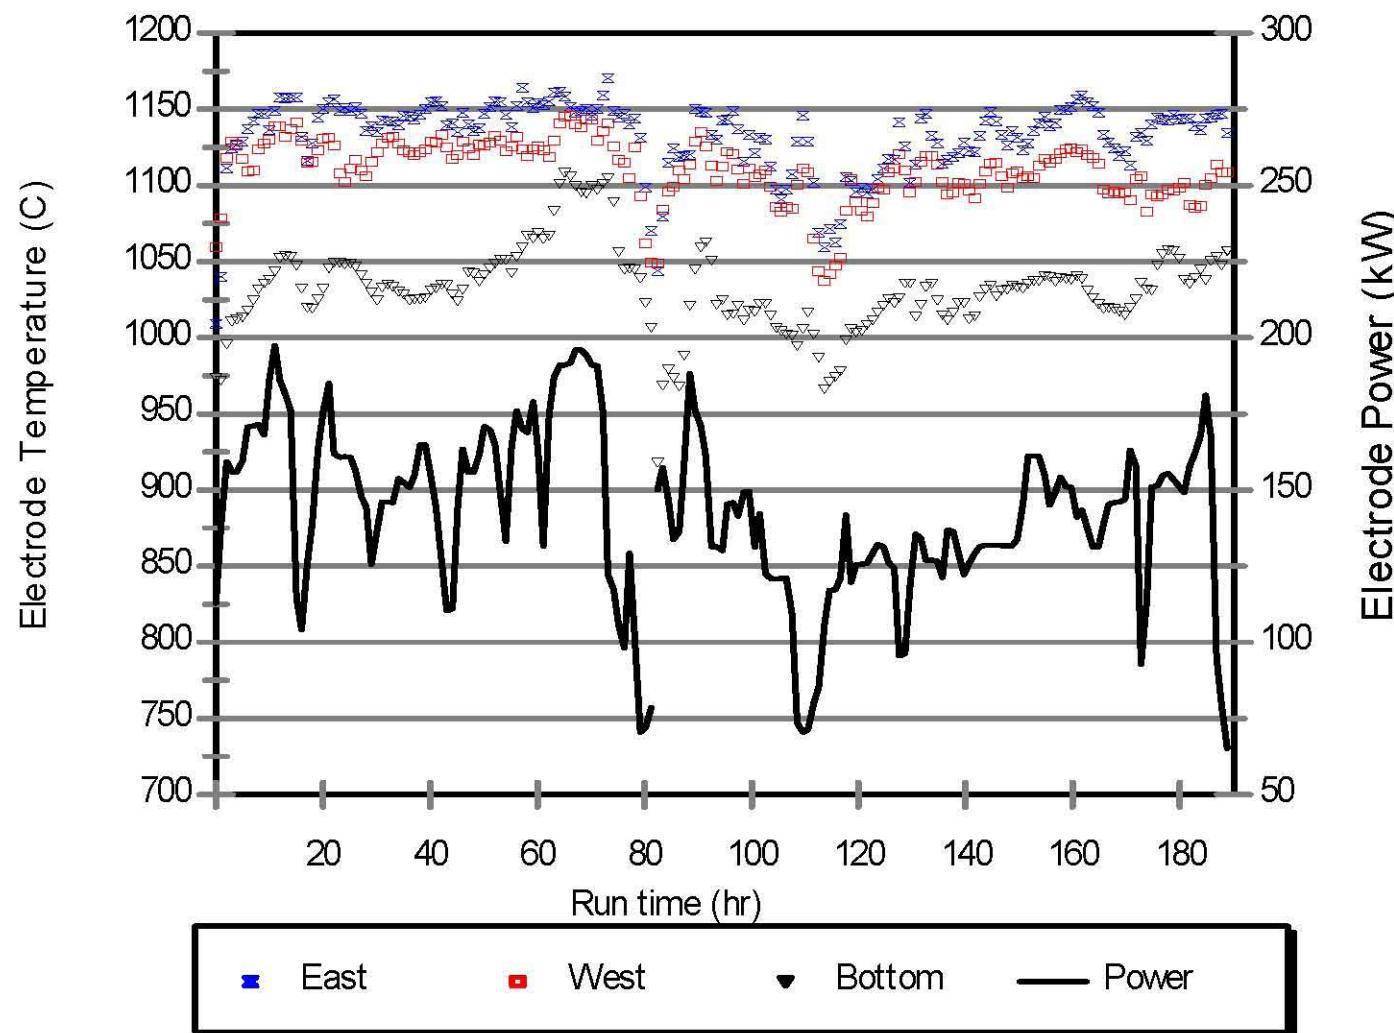
Figure 4.4. Electrode temperatures and power (hourly averages) for DM1200 Tests.

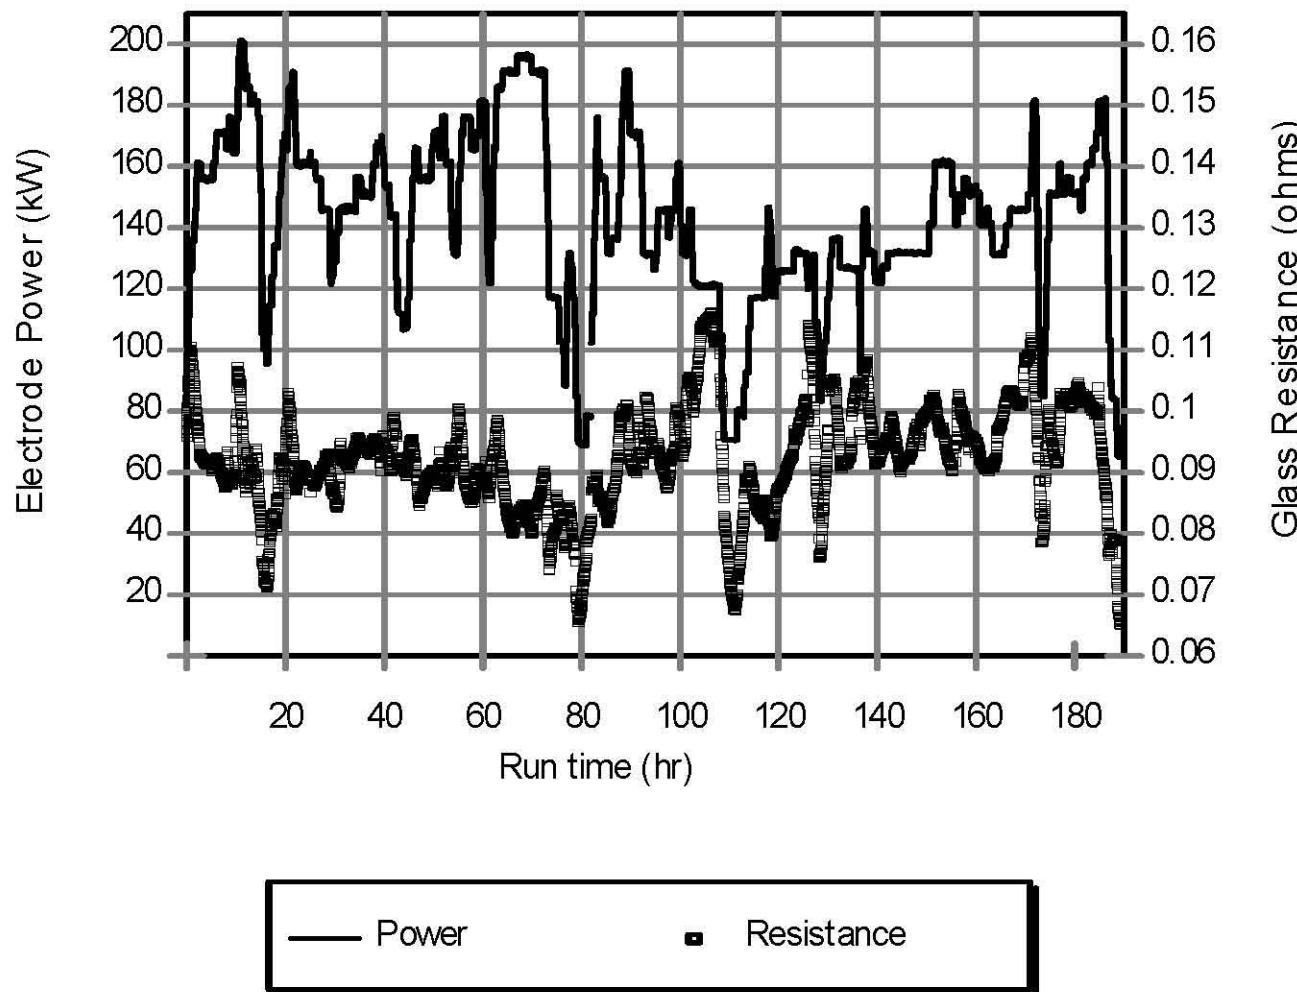
Figure 4.5. Electrode power and glass resistance for DM1200 Tests.

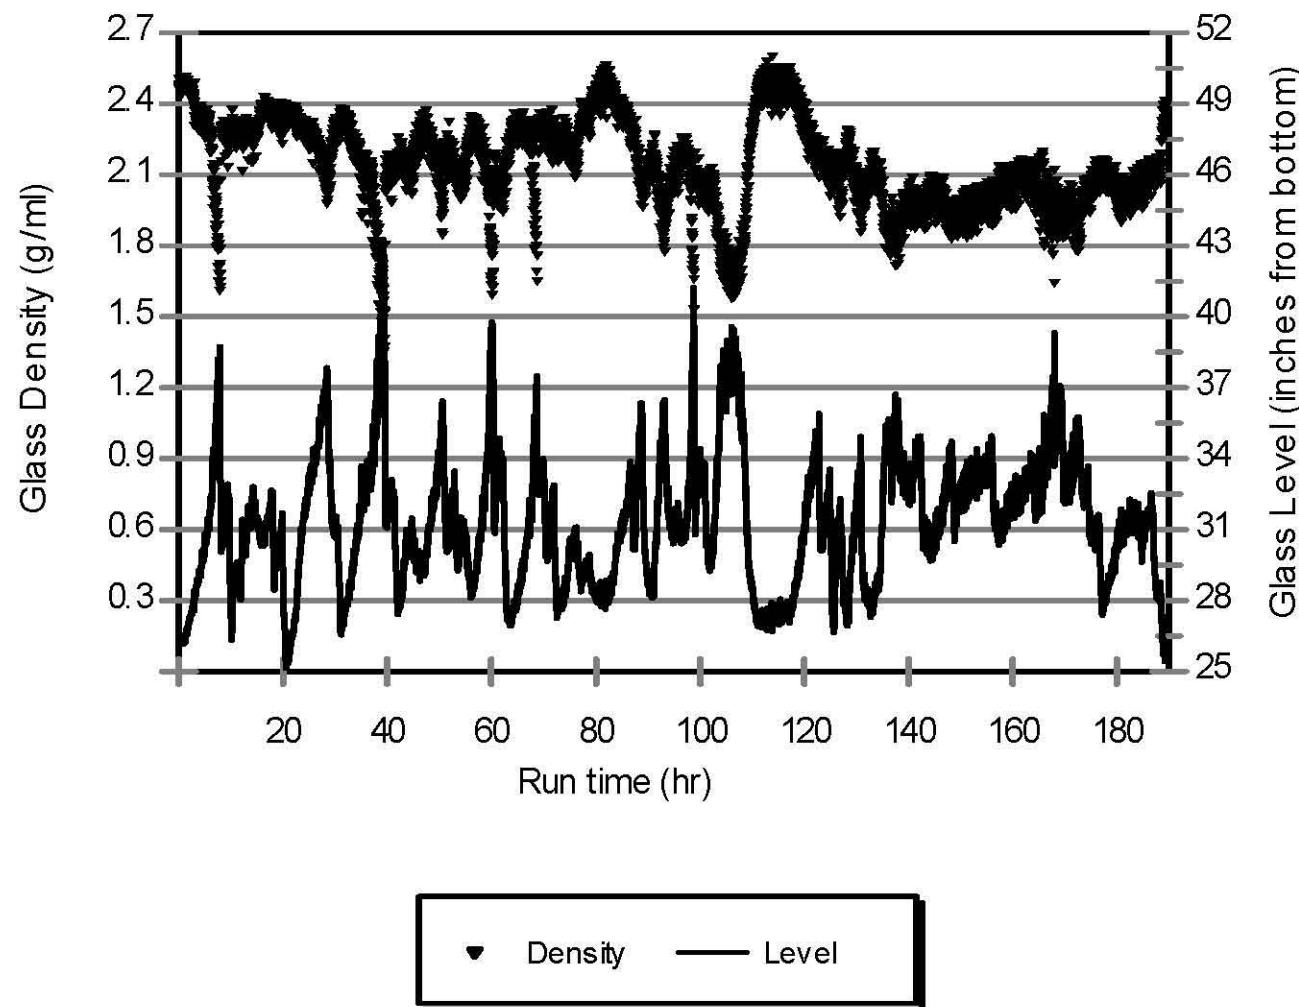
Figure 4.6. Glass density and level for DM1200 Tests.
