Tests with High-Bismuth HLW Glasses

**Final Report VSL-10R1780-1, Rev. 0;
12/13/10**

Office of River Protection

K. S. Matlack
Vitreous State Laboratory
The Catholic University of America

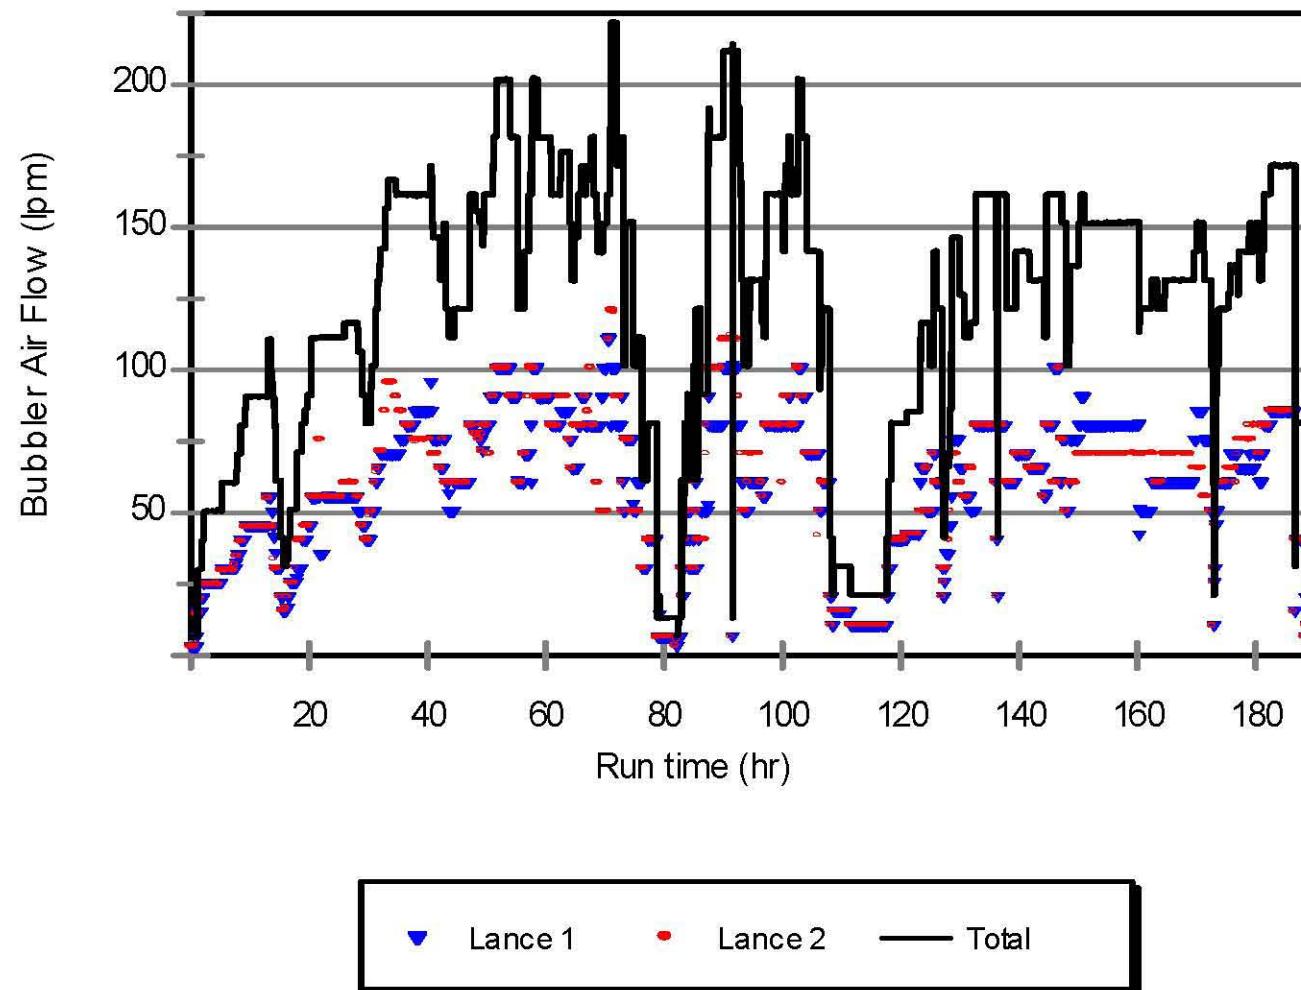
Figure 4.7. Glass pool bubbling for DM1200 Tests.

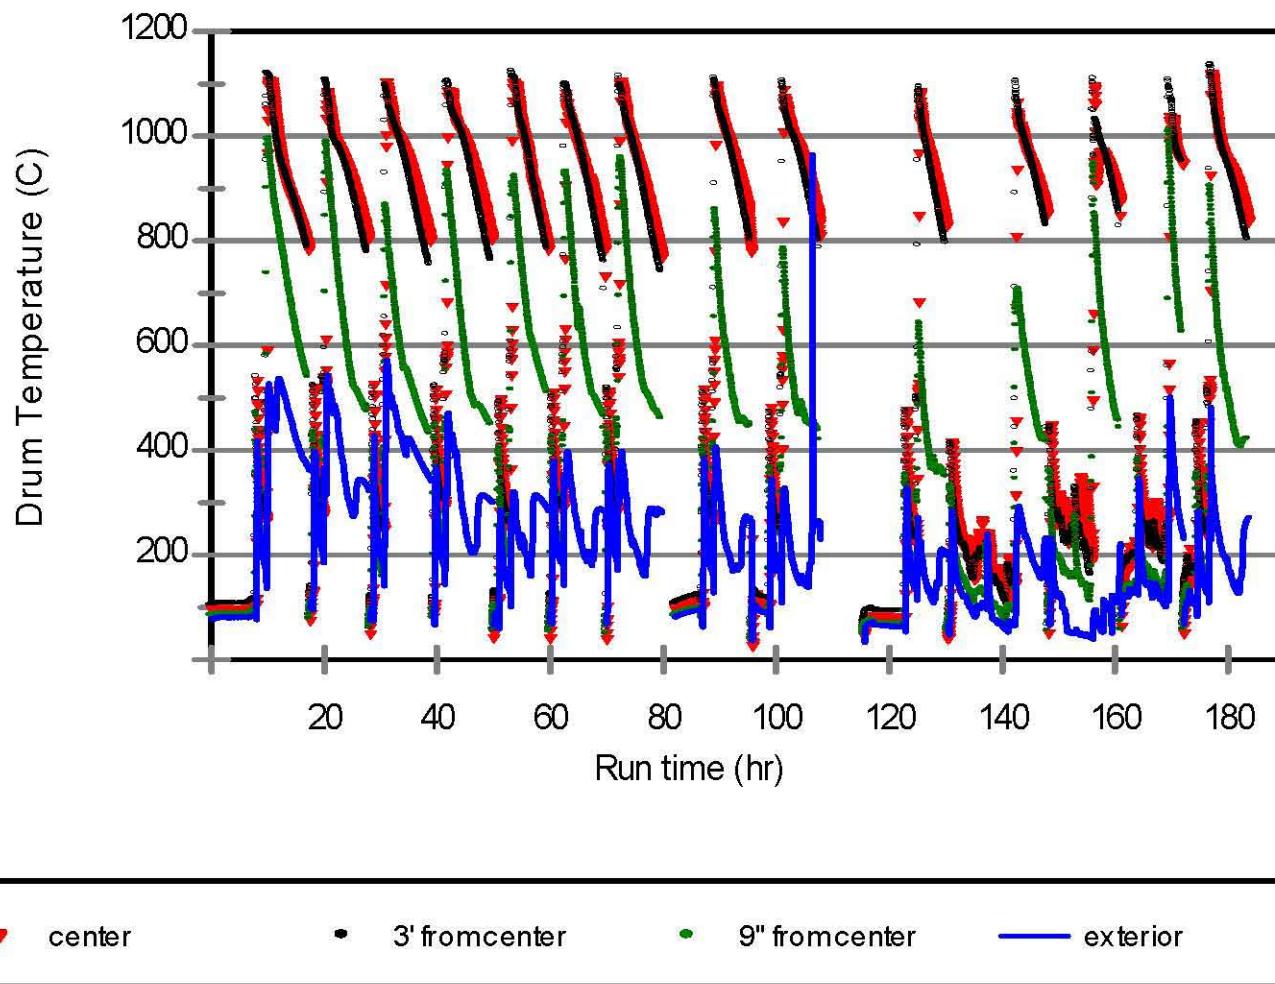
Figure 4.8. Measured temperatures from canister cooling experiments.

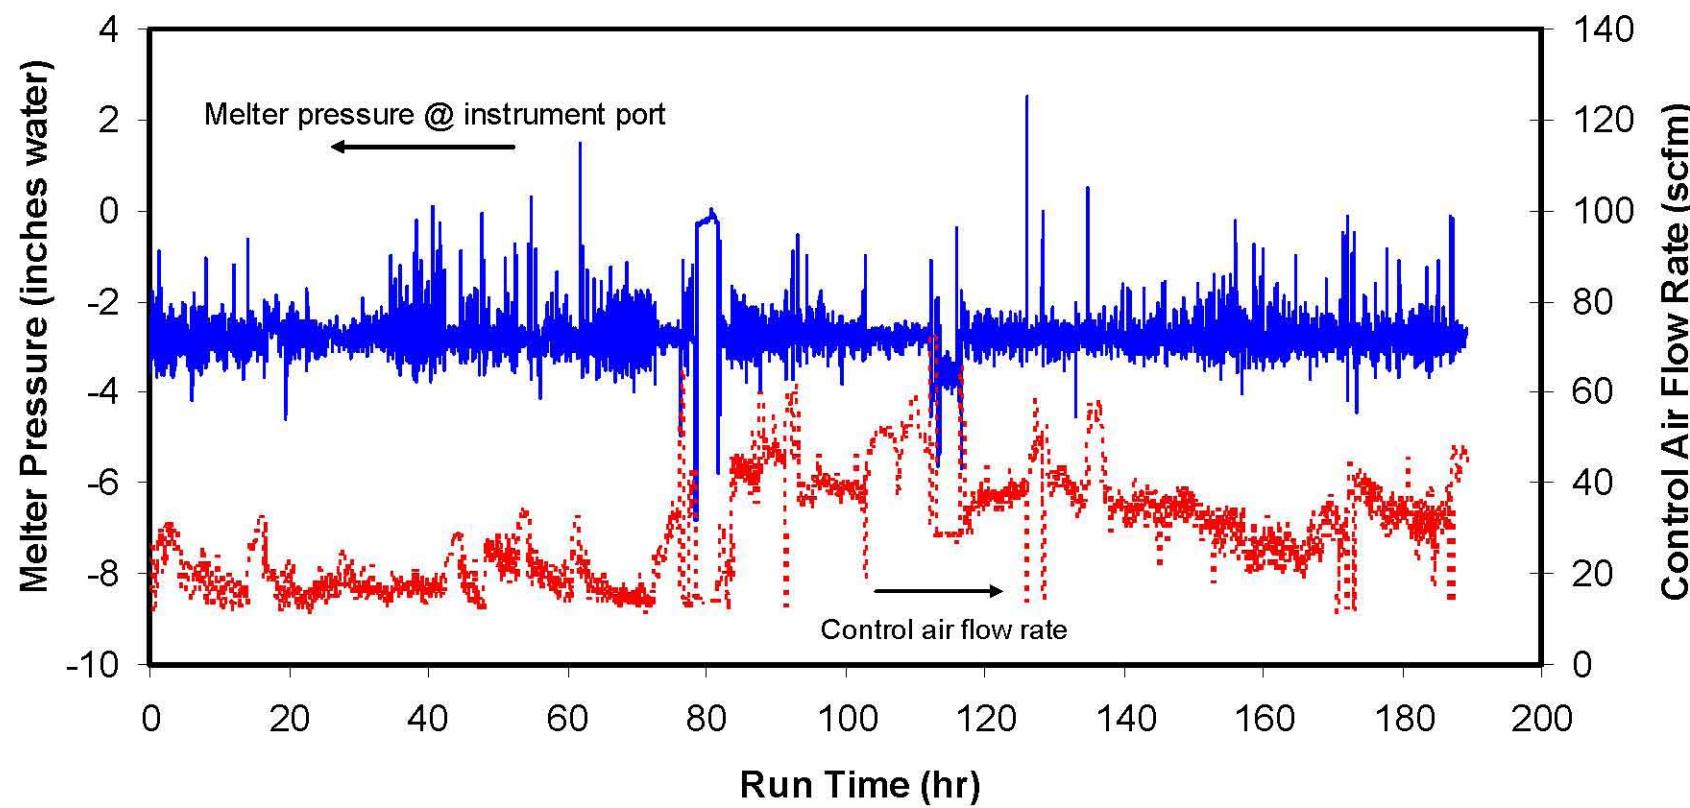
Figure 4.11. Melter pressure at instrument port and control air flow rate during testing.

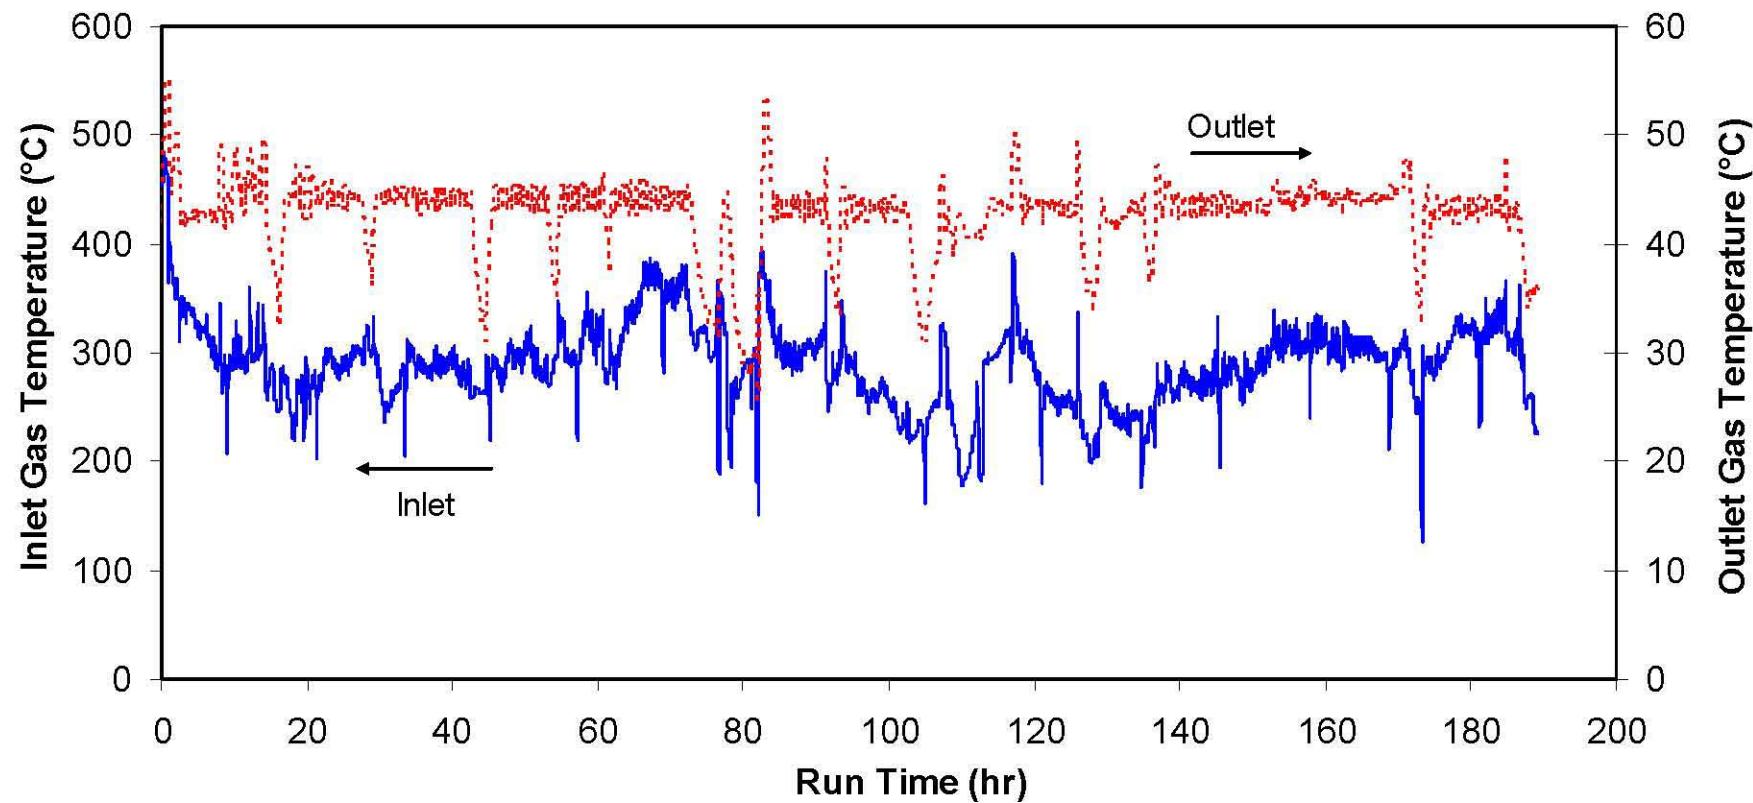
Figure 4.13. SBS inlet and outlet gas temperatures during testing.

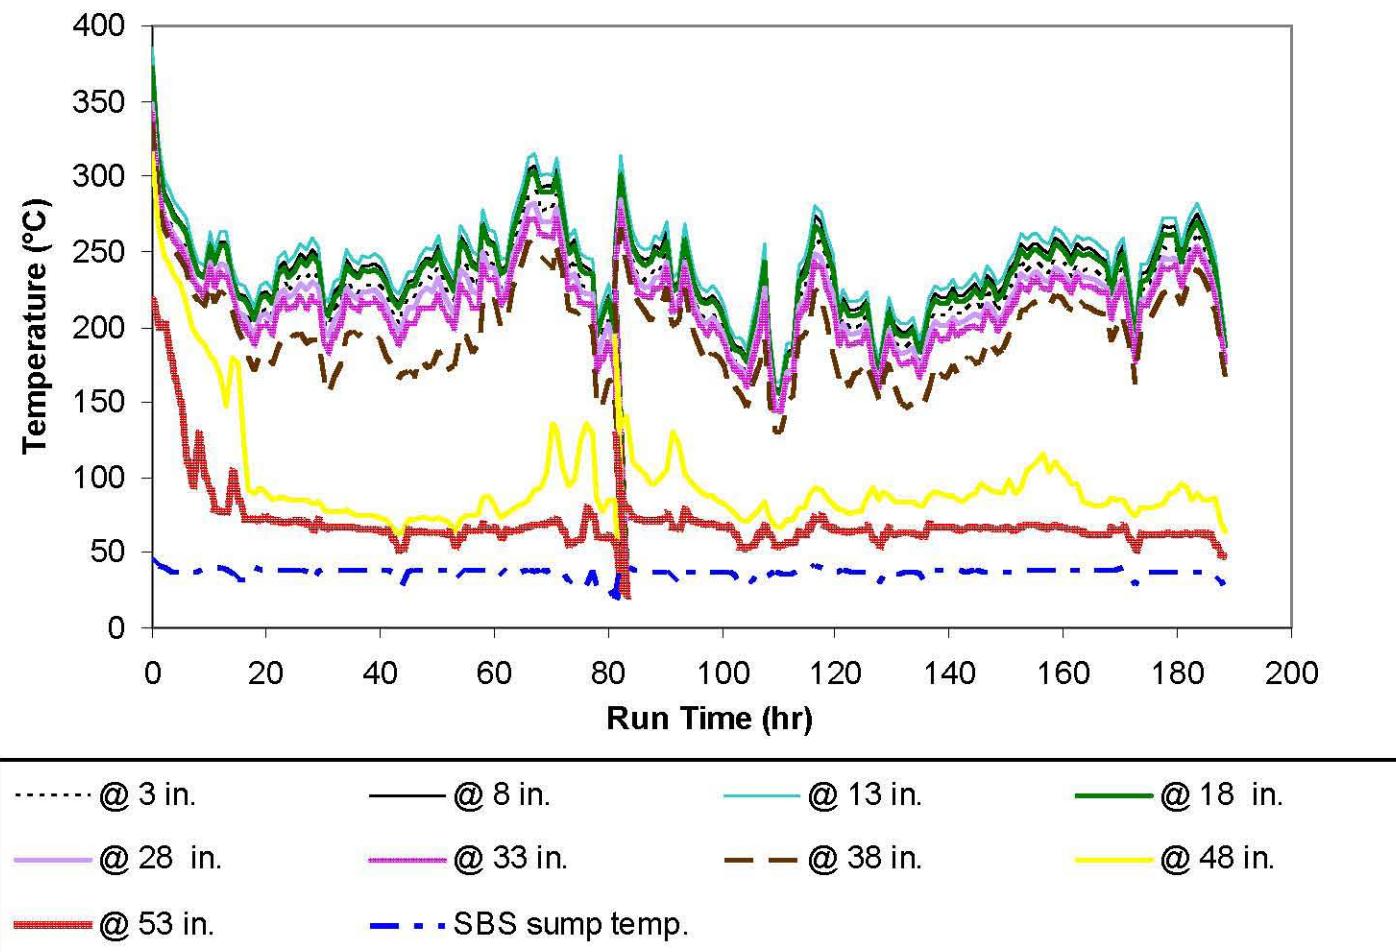
Figure 4.16. Off-gas temperatures in the SBS downcomer and sump water temperatures (hourly average values) during testing.

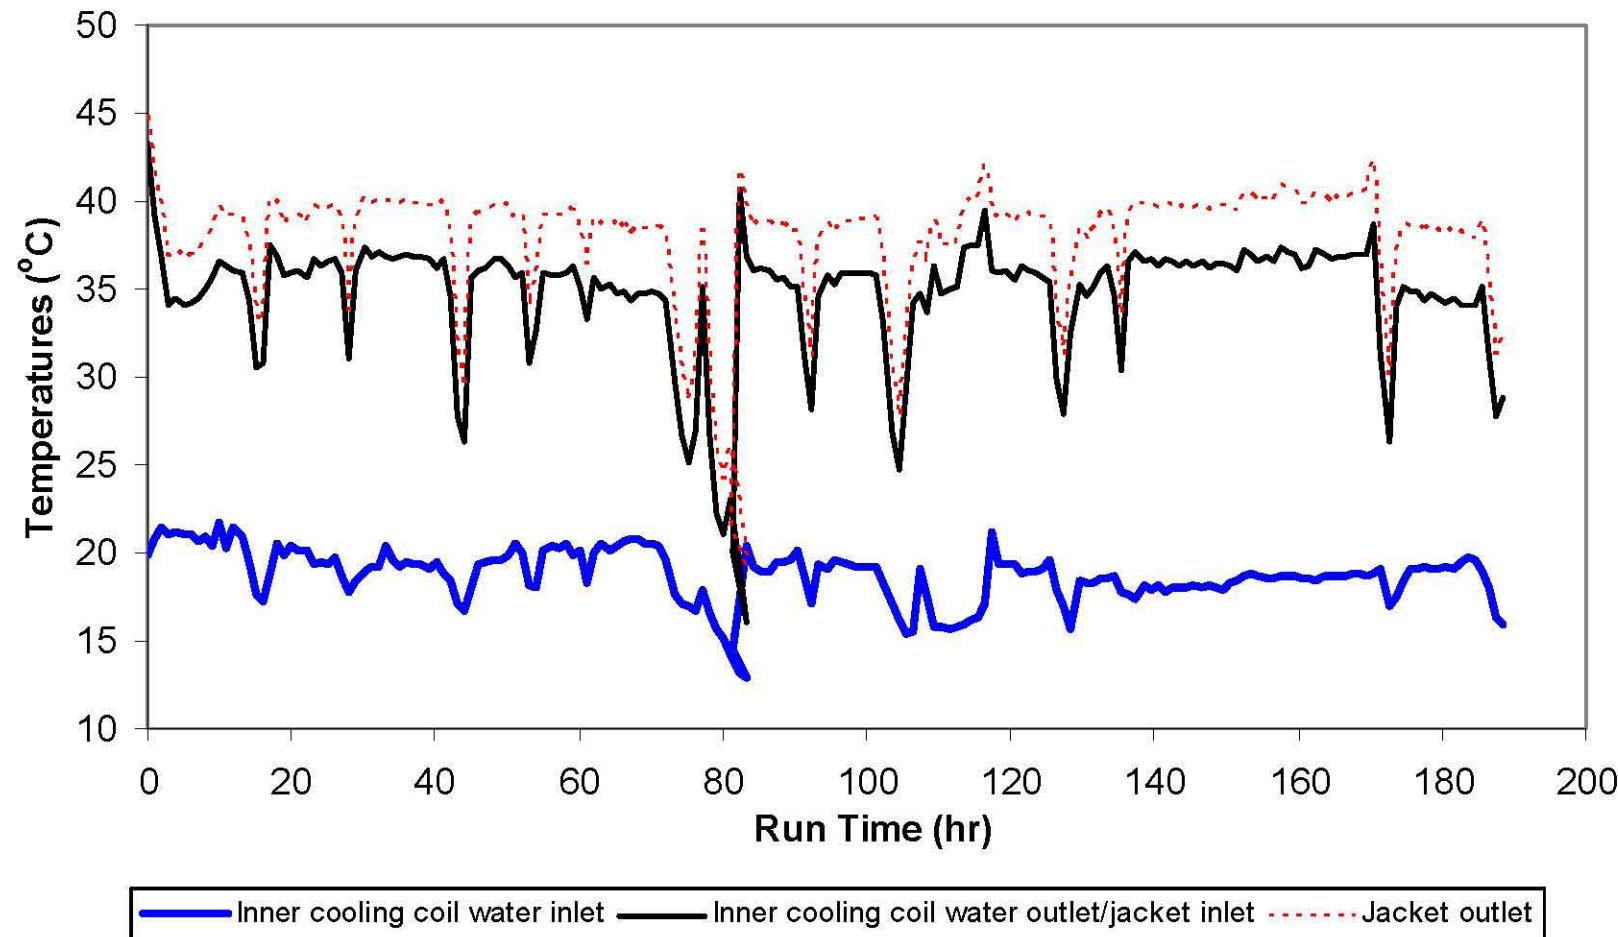
Figure 4.17. SBS cooling coil inlet, cooling coil outlet/jacket inlet and jacket outlet water temperatures (hourly average values) during testing.

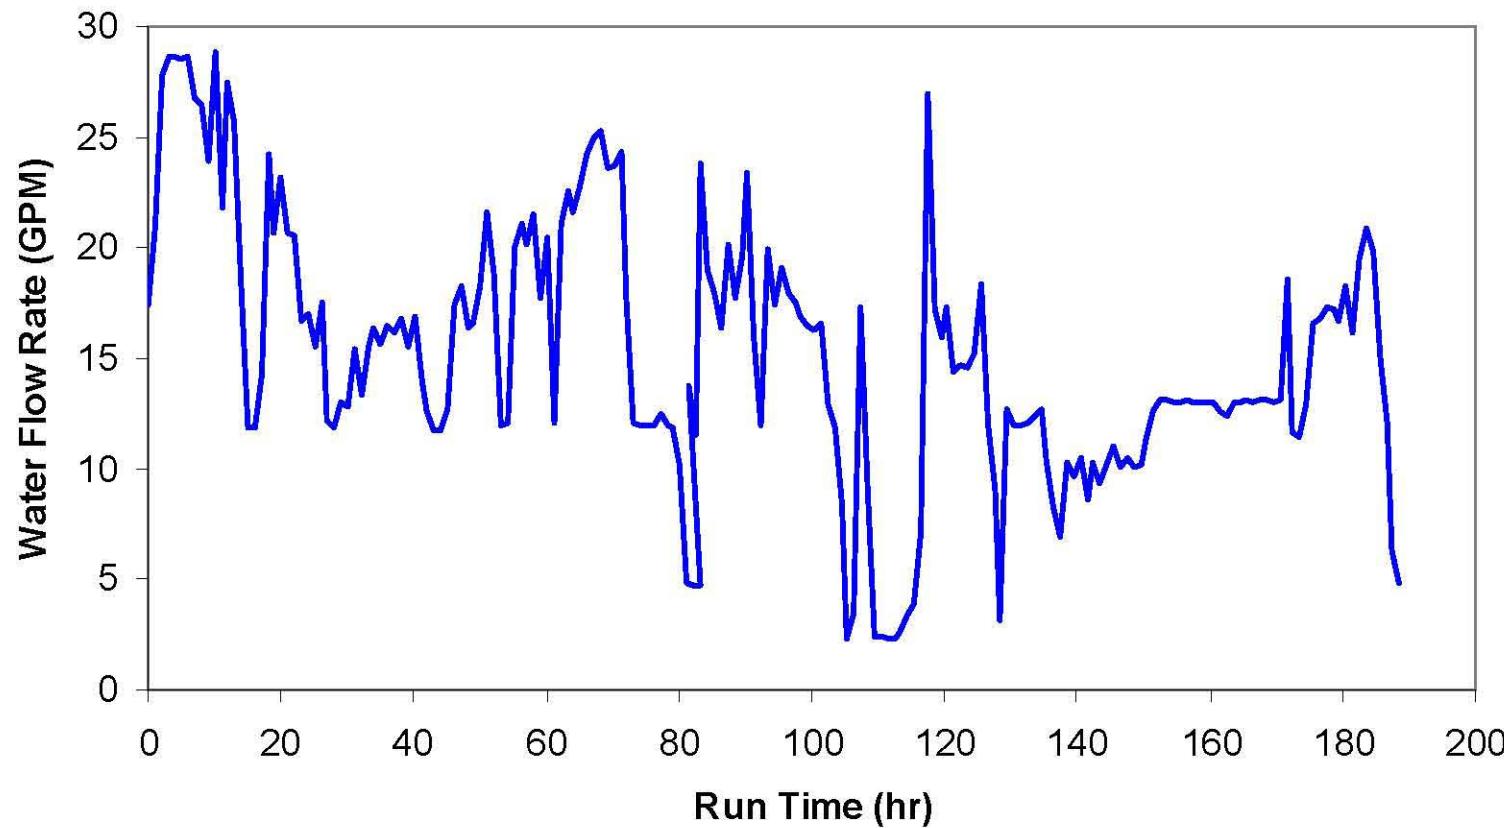
Figure 4.18. SBS cooling coil/jacket water flow rate (hourly average values) during testing.

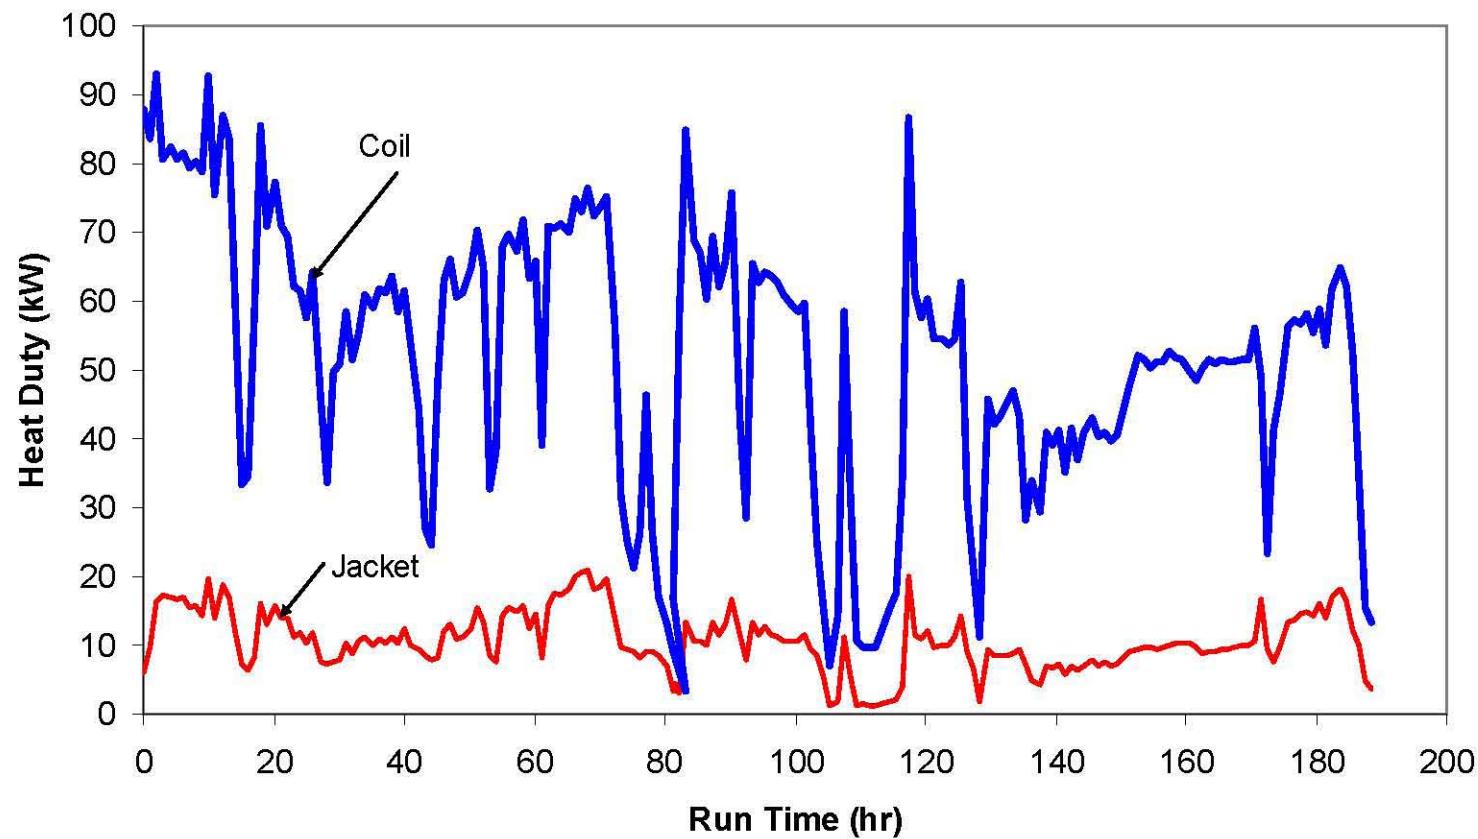
Figure 4.19. Calculated heat loads on the inner coil and jacket (hourly average values) during testing.

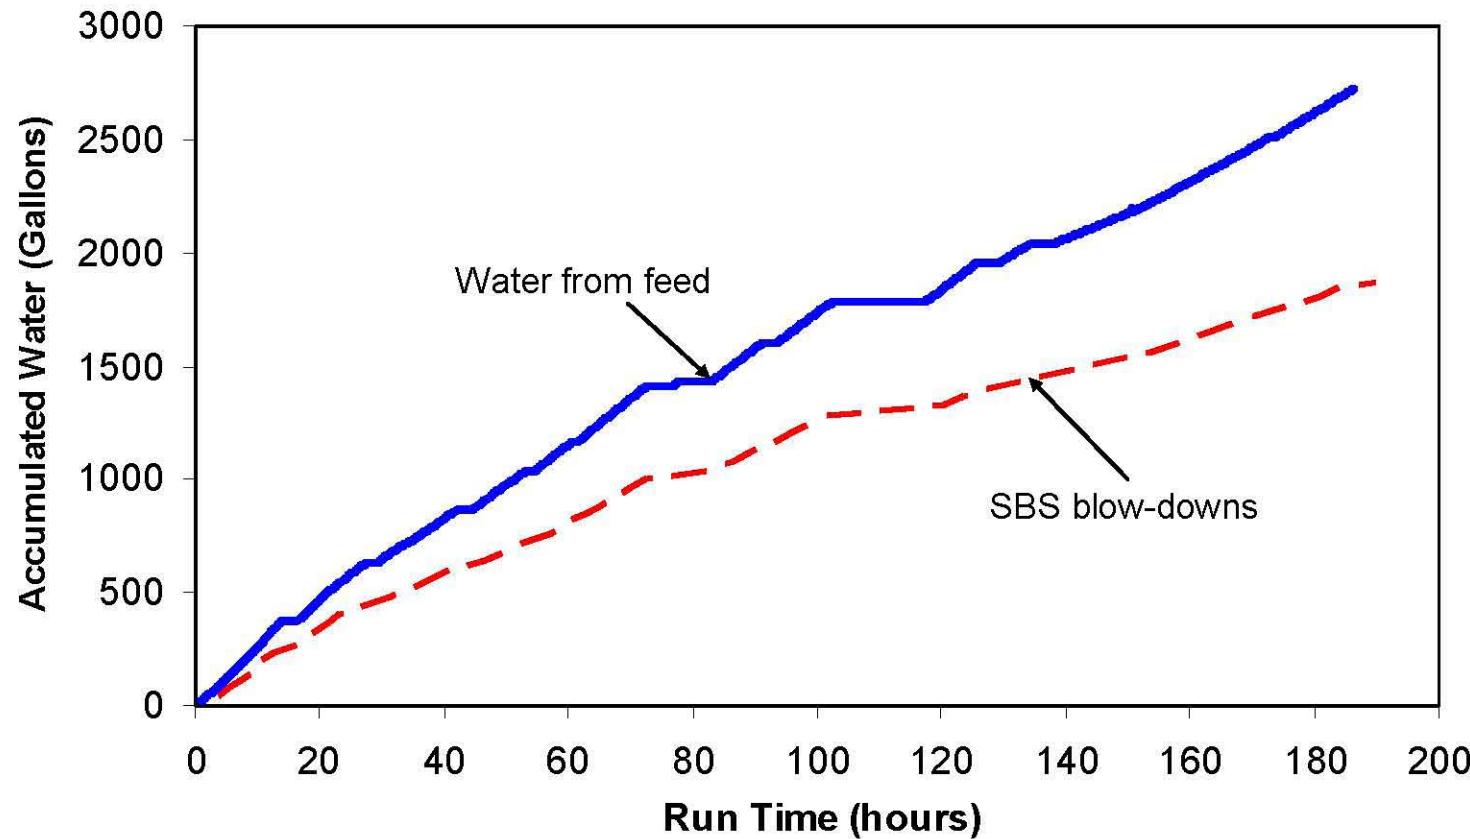
Figure 4.20. Accumulated SBS blowdown volume and accumulated feed water during testing.

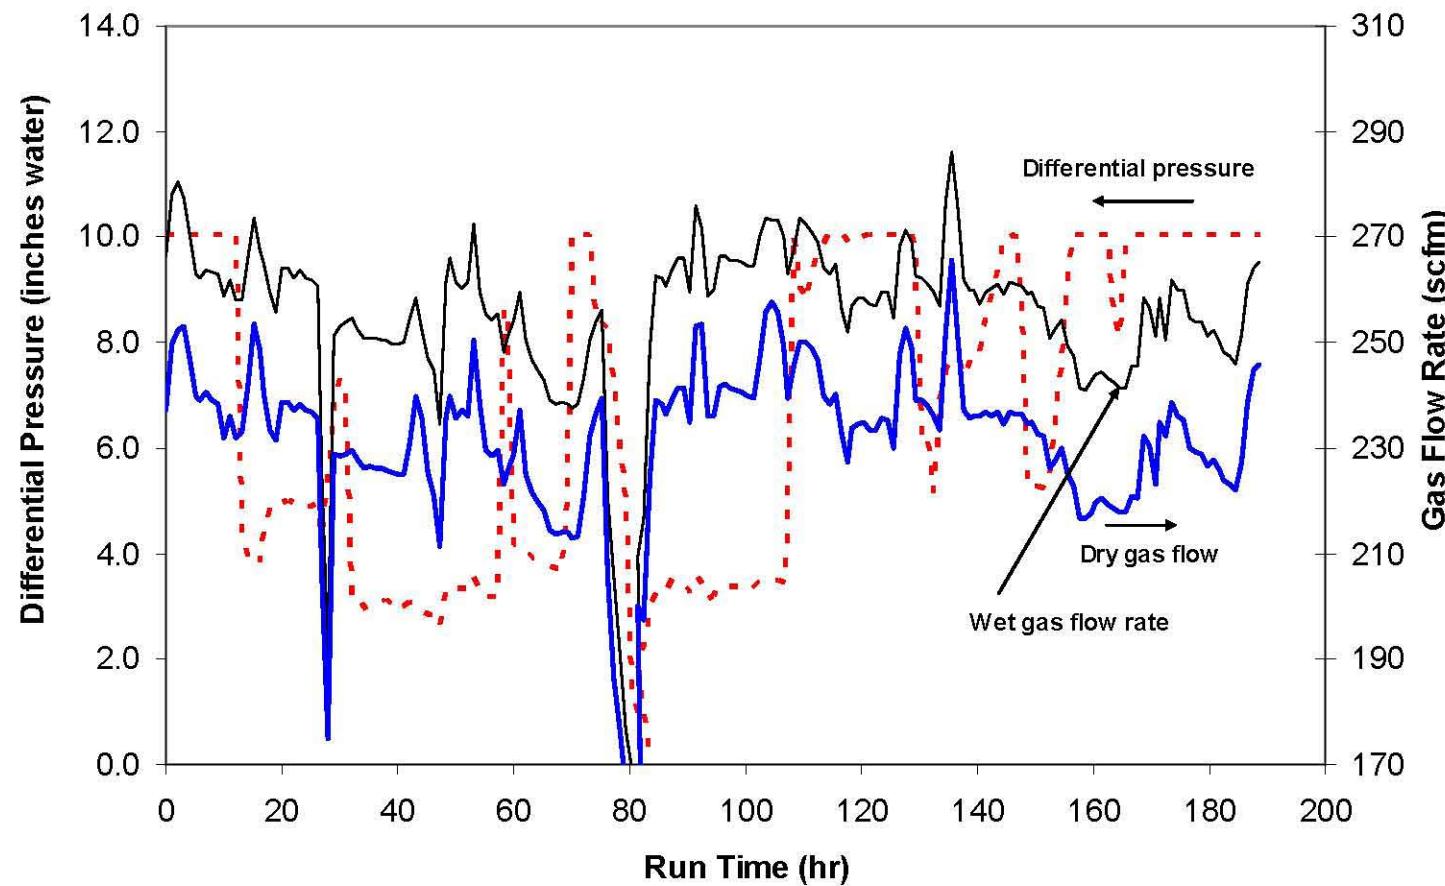
Figure 4.22. WESP differential pressure and outlet gas flow rate (hourly average values) during testing.

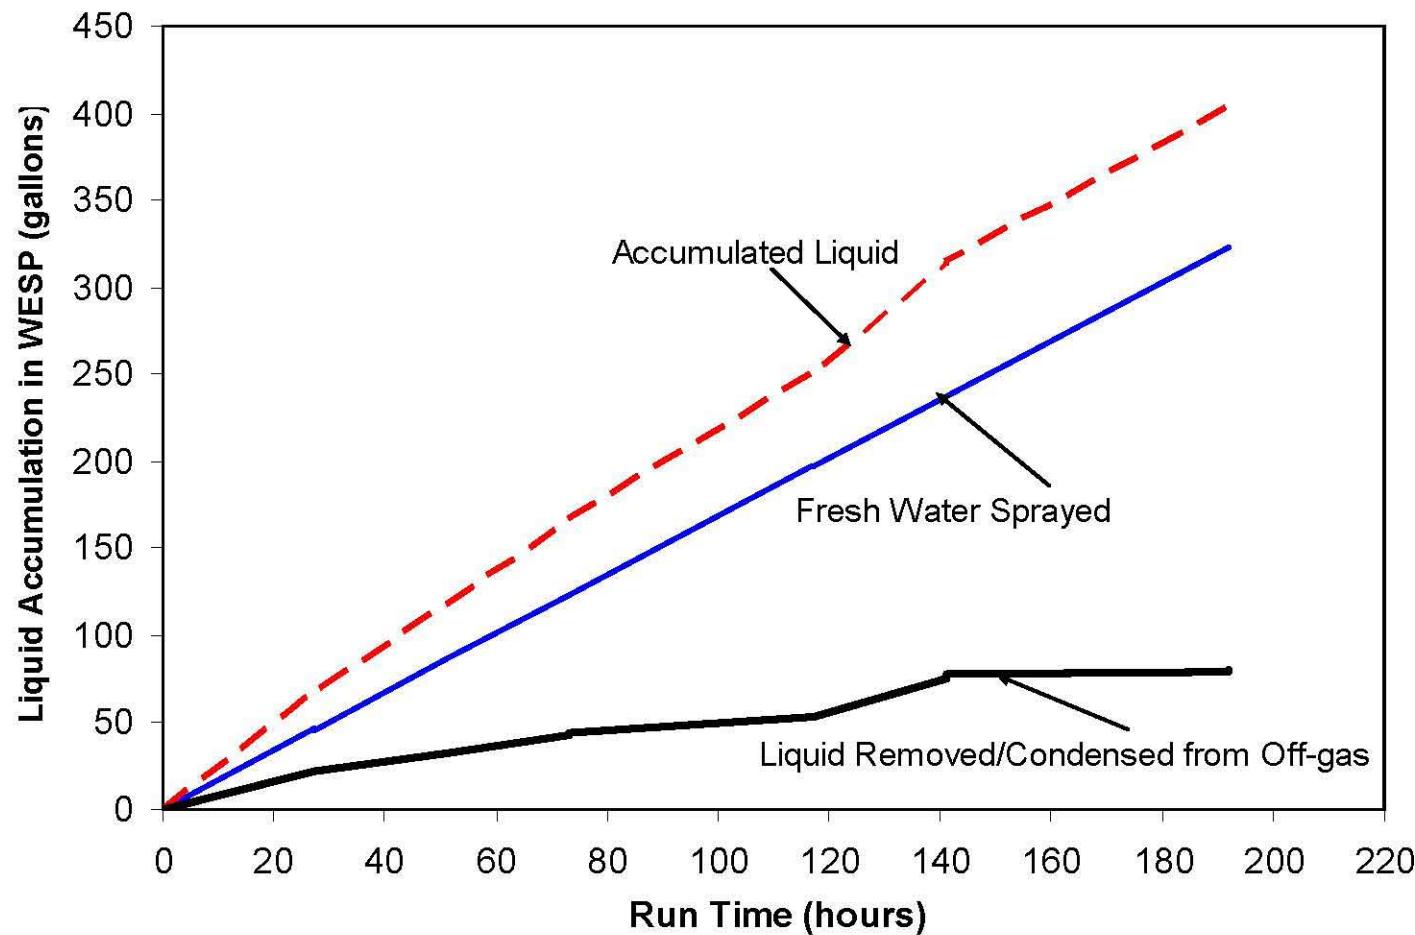
Figure 4.23. Accumulated WESP blowdown volume, accumulated fresh spray water, and water removed from off-gas during testing.

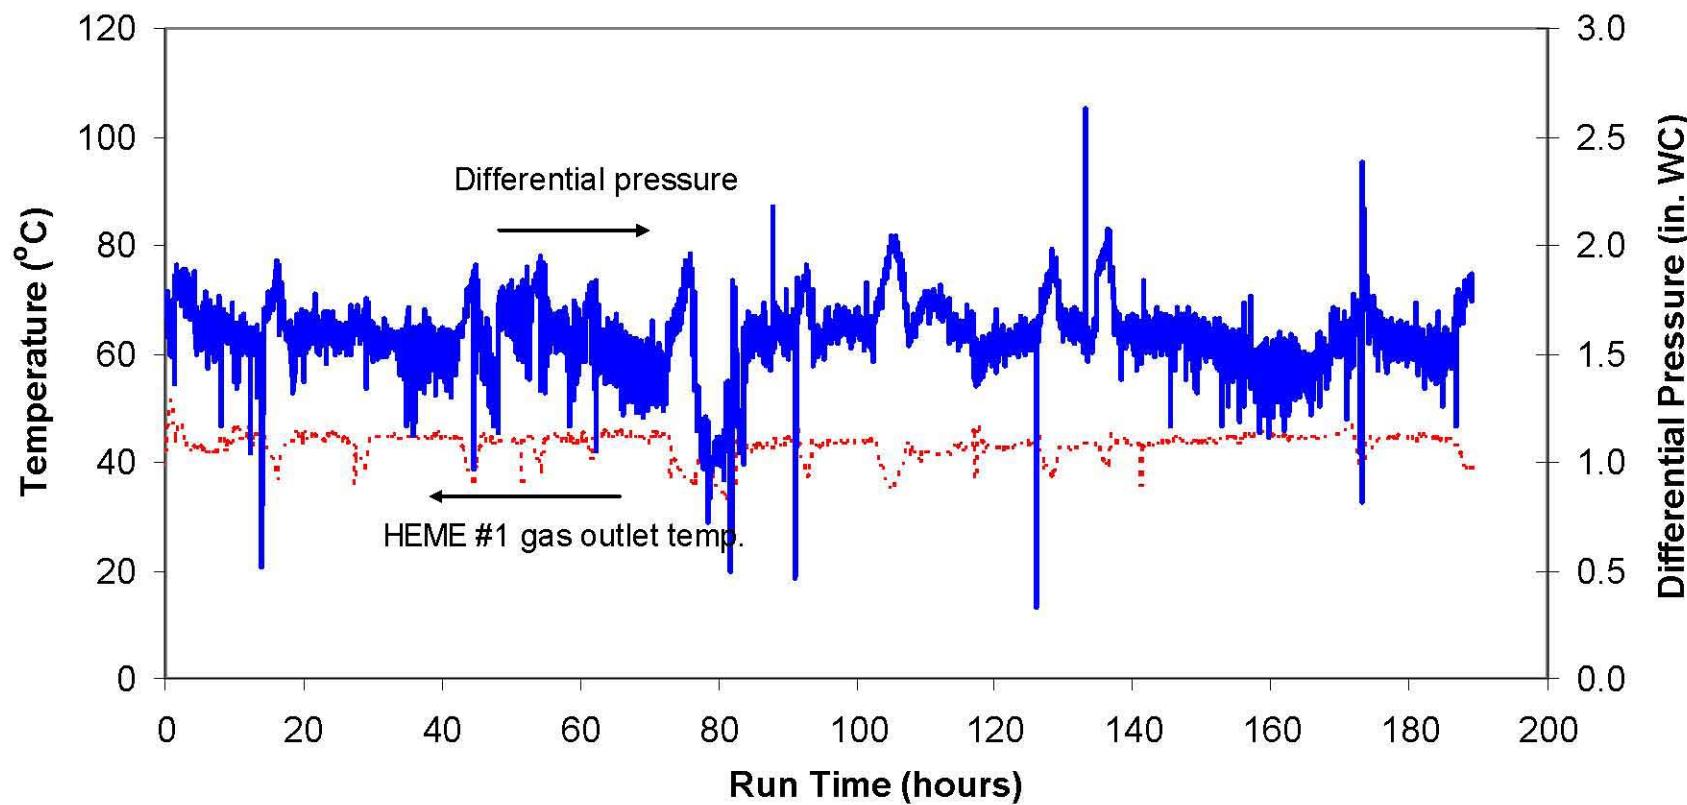
Figure 4.25. Outlet gas temperature and differential pressure for HEME #1 during testing.

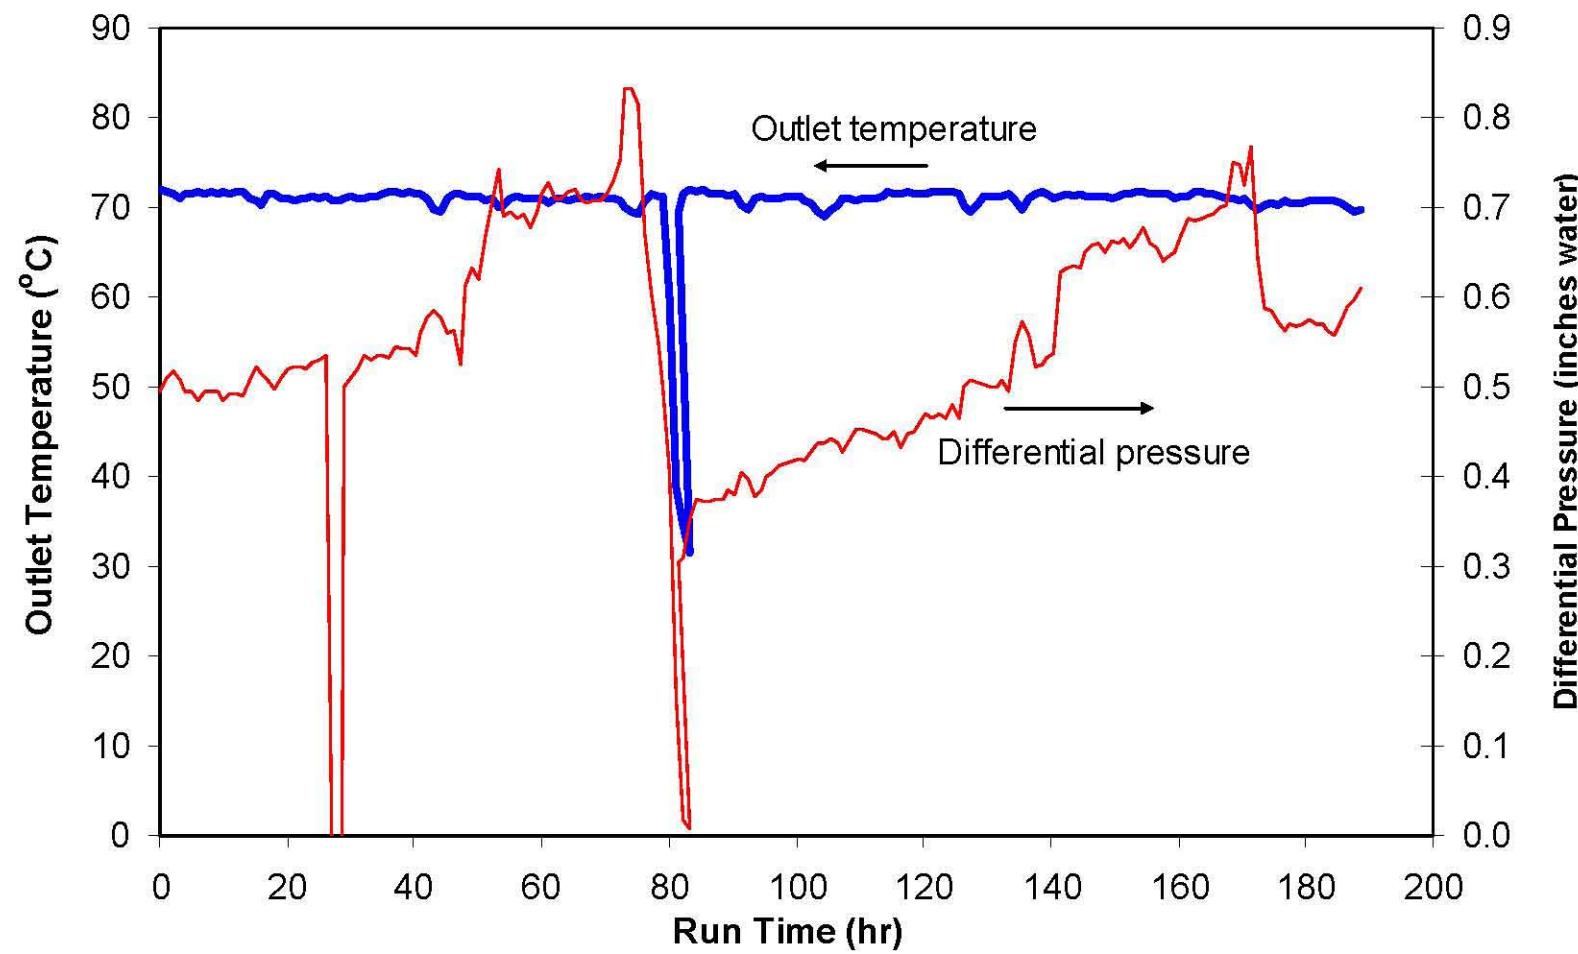
Figure 4.26. Outlet temperature and differential pressure for HEPA #1 (hourly average values) during testing.

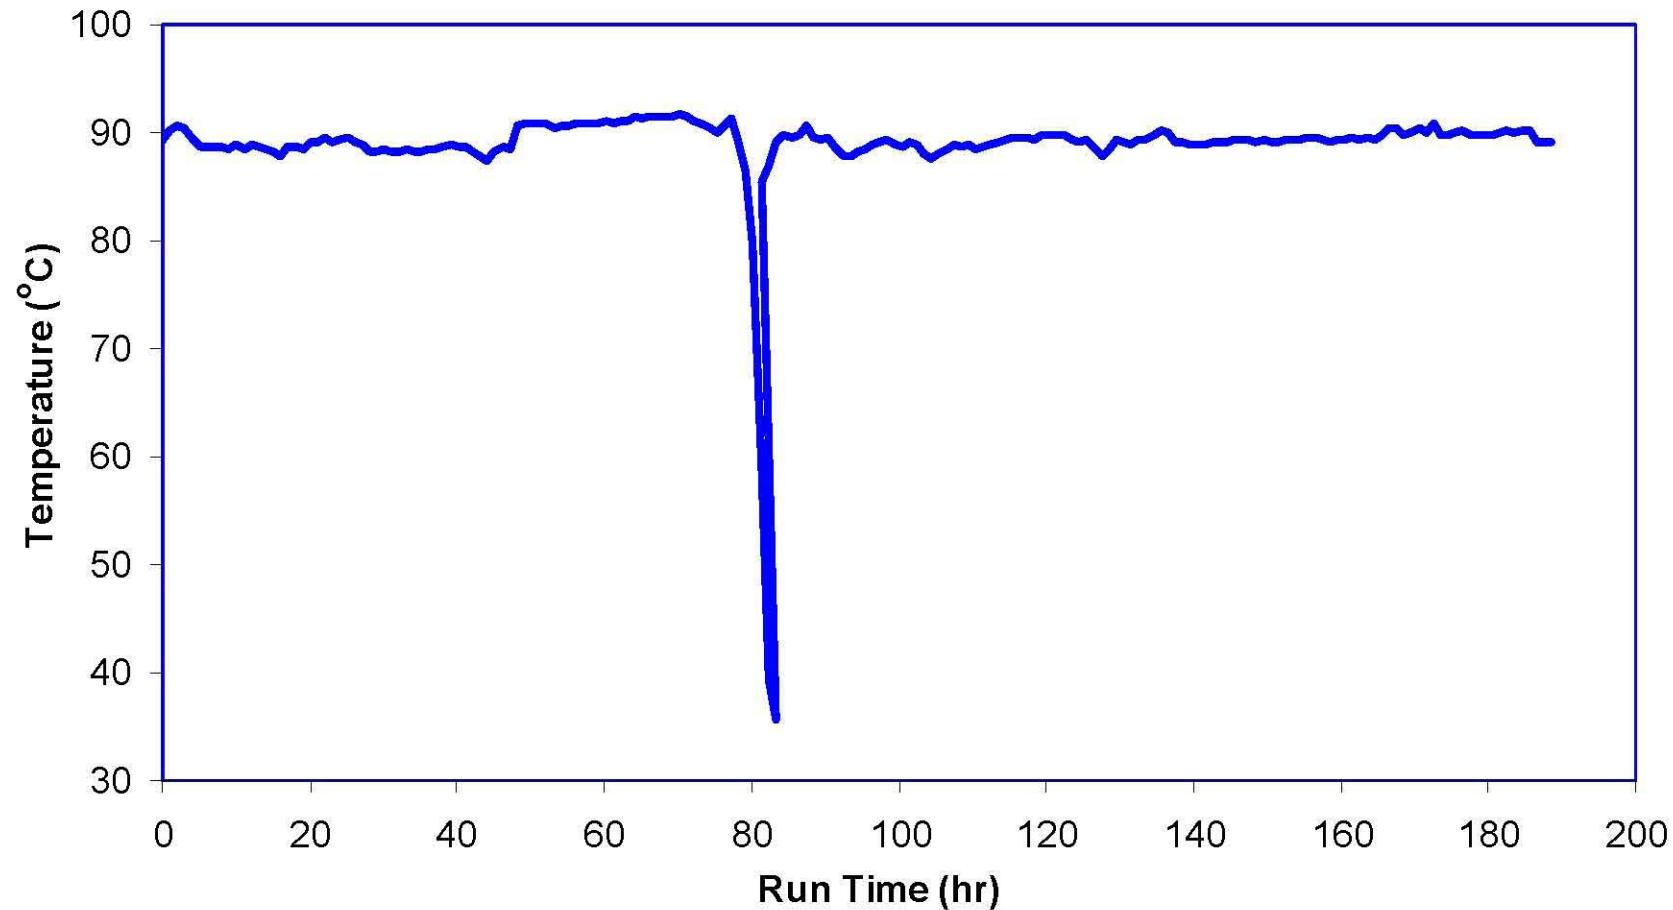
Figure 4.27. TCO/SCR heater gas inlet temperatures during testing.

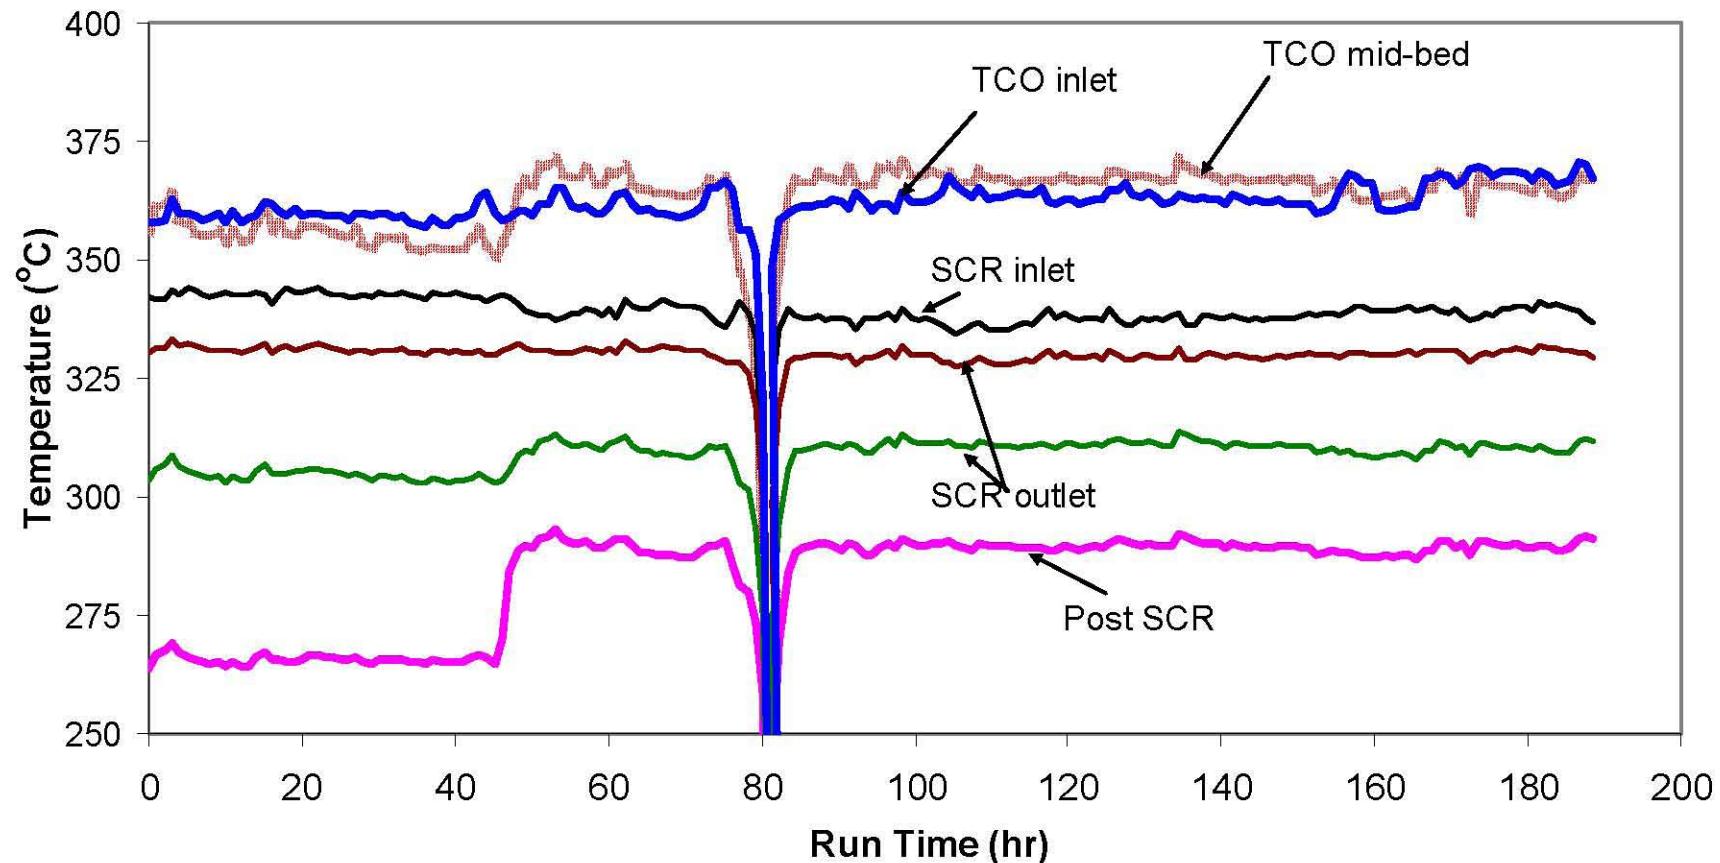
Figure 4.28. TCO/SCR temperatures (average hourly values) during testing.

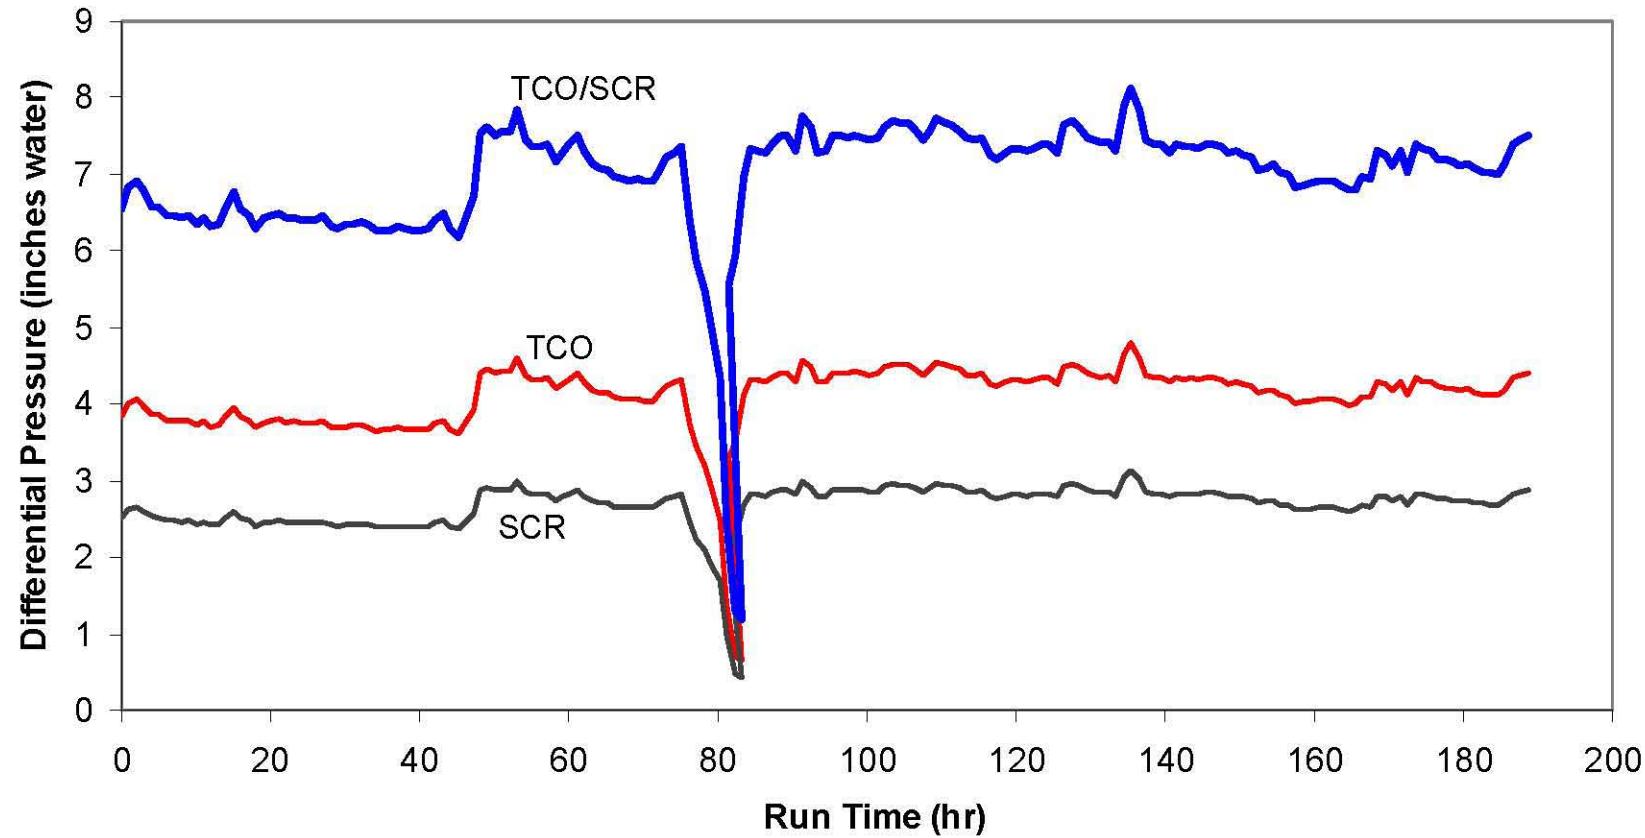
Figure 4.29. TCO/SCR differential pressures (average hourly values) during testing.
