Tests with High-Bismuth HLW Glasses

**Final Report VSL-10R1780-1, Rev. 0;
12/13/10**

Office of River Protection

K. S. Matlack
Vitreous State Laboratory
The Catholic University of America

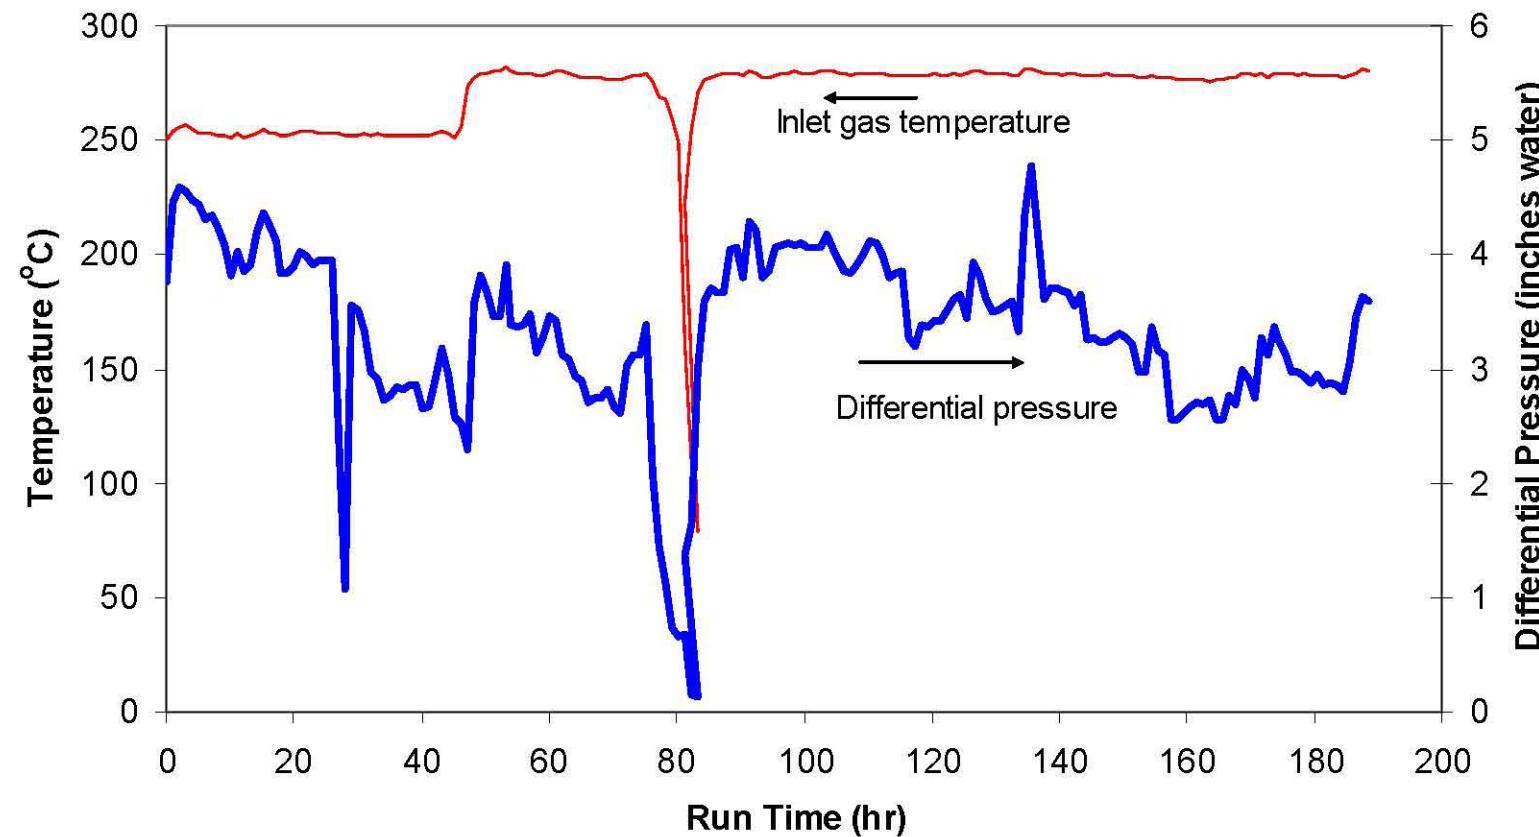
Figure 4.30. Inlet gas temperature and differential pressure for PBS (hourly average values) during testing.

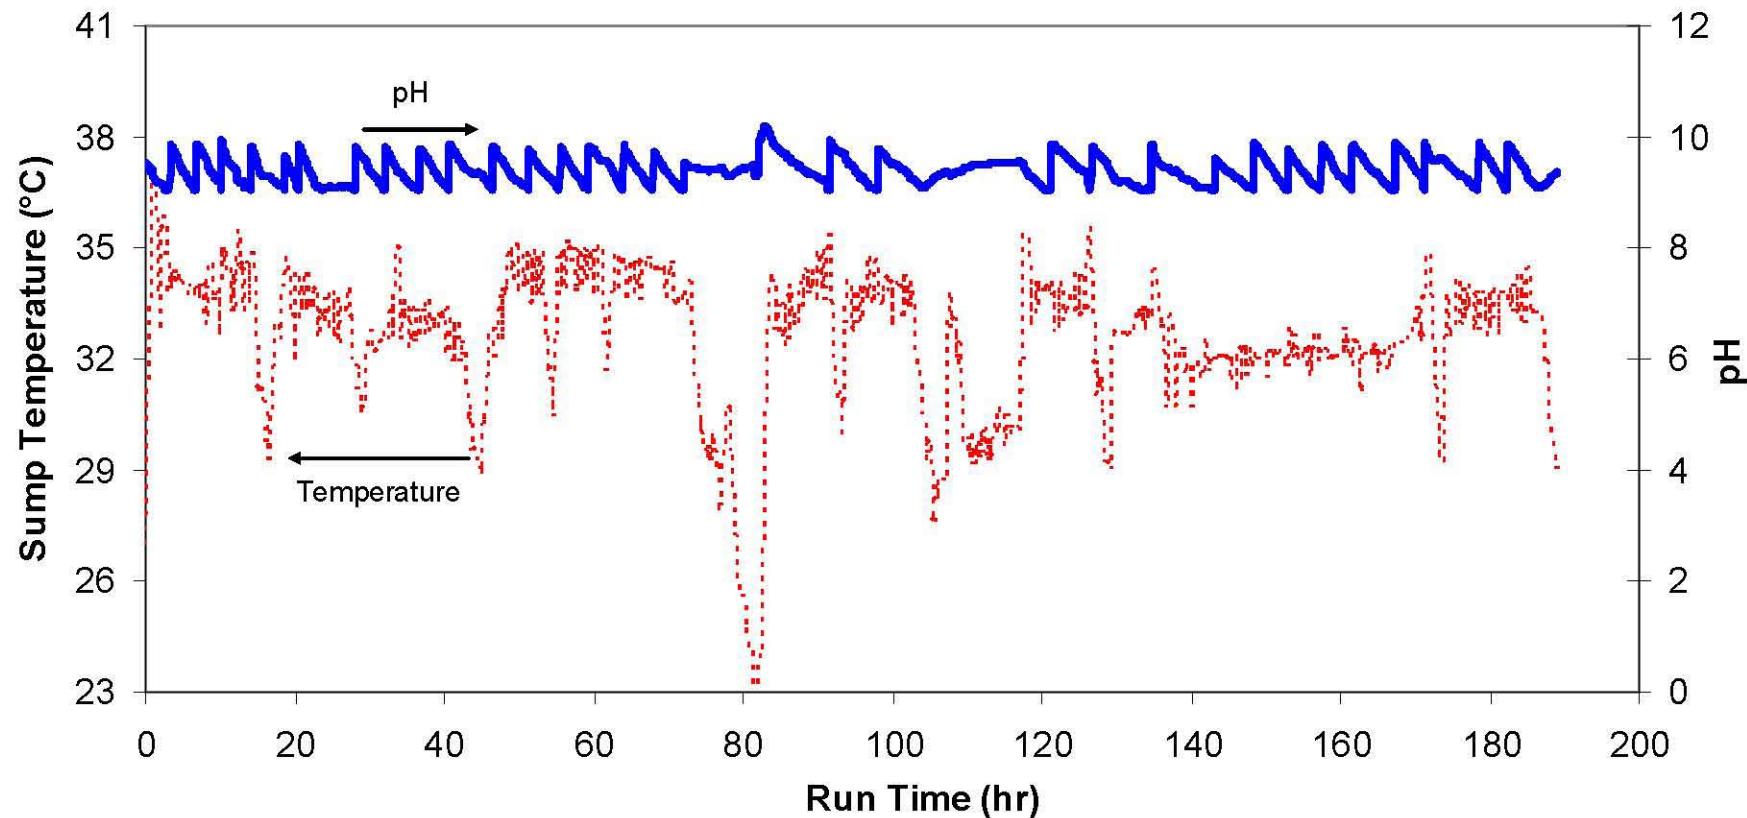
Figure 4.31. Sump temperature and pH for PBS (hourly average values) during testing.

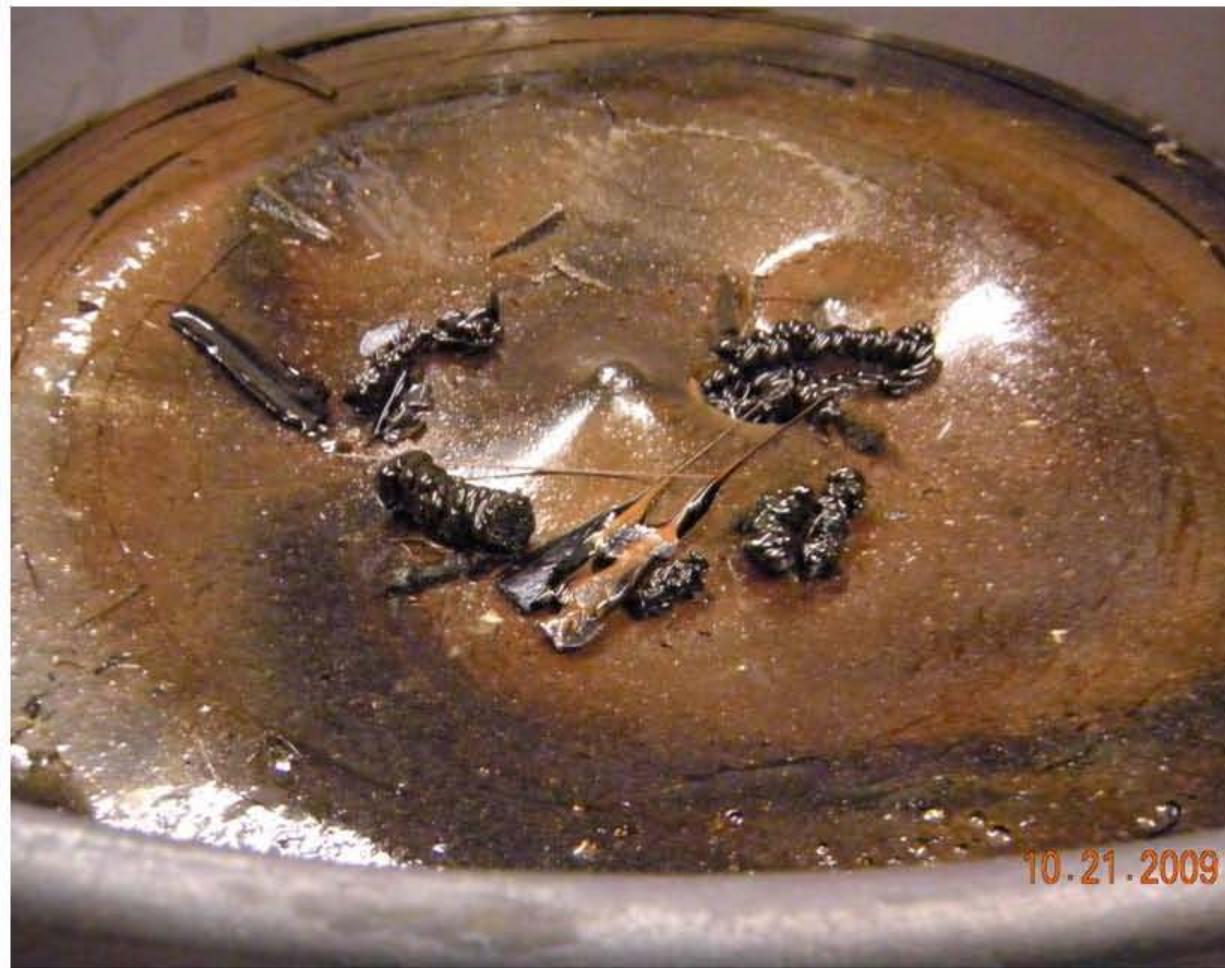
Figure 5.1. Discharge glass G-12N-151A. No foamy glass observed.

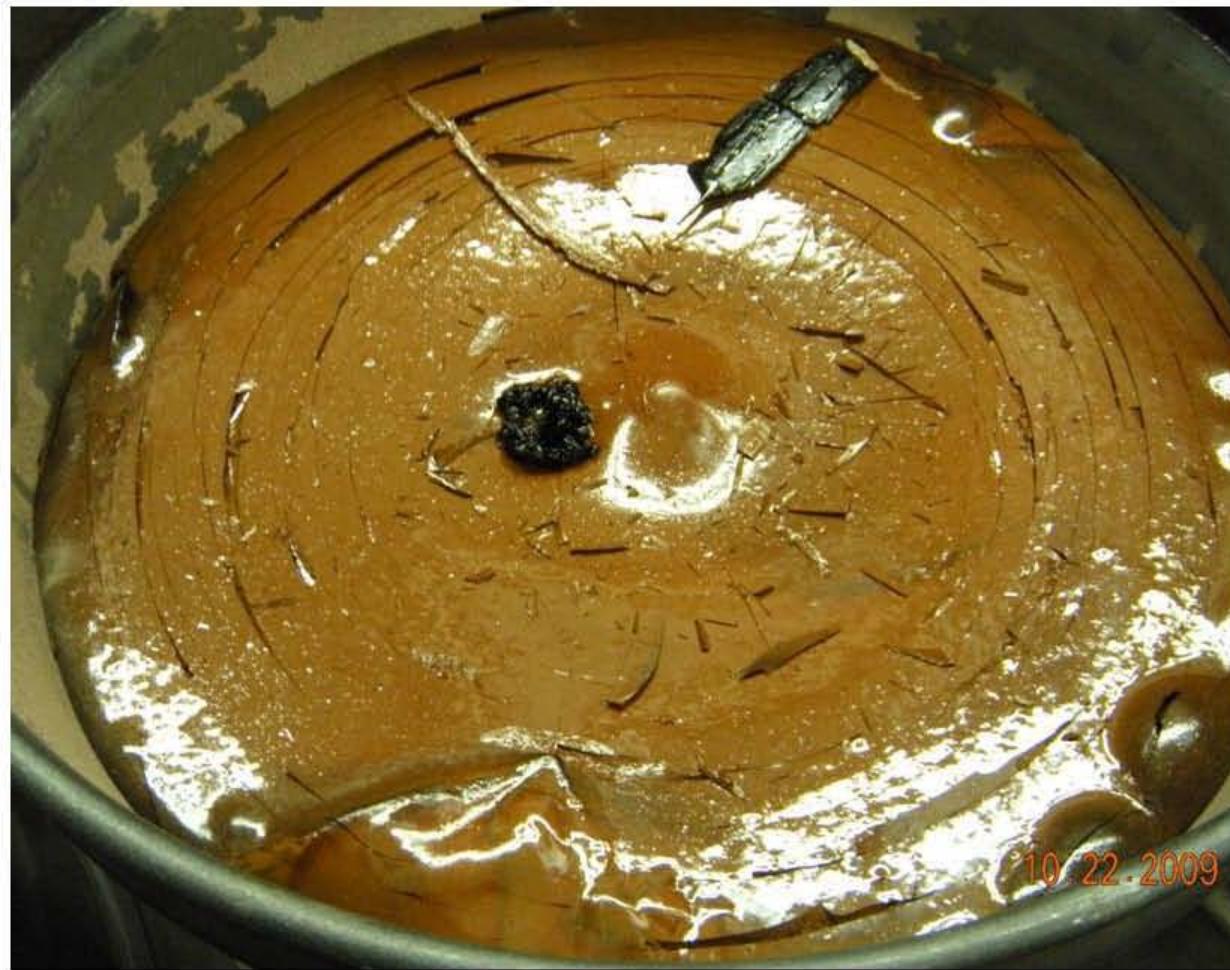
Figure 5.2. Discharge glass G-12O-20A. No foamy glass observed.

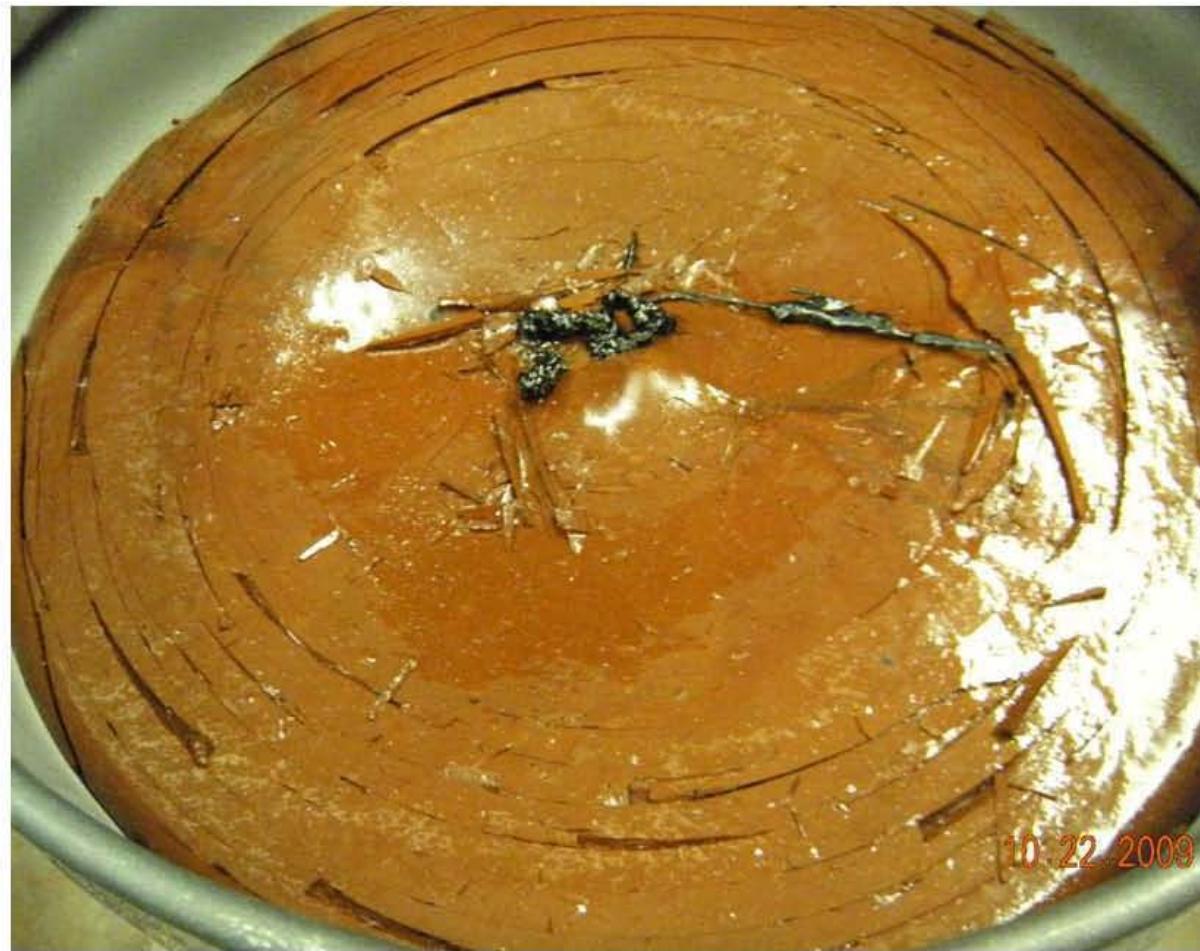
Figure 5.3. Discharge glass G-12O-37A. No foamy glass observed.

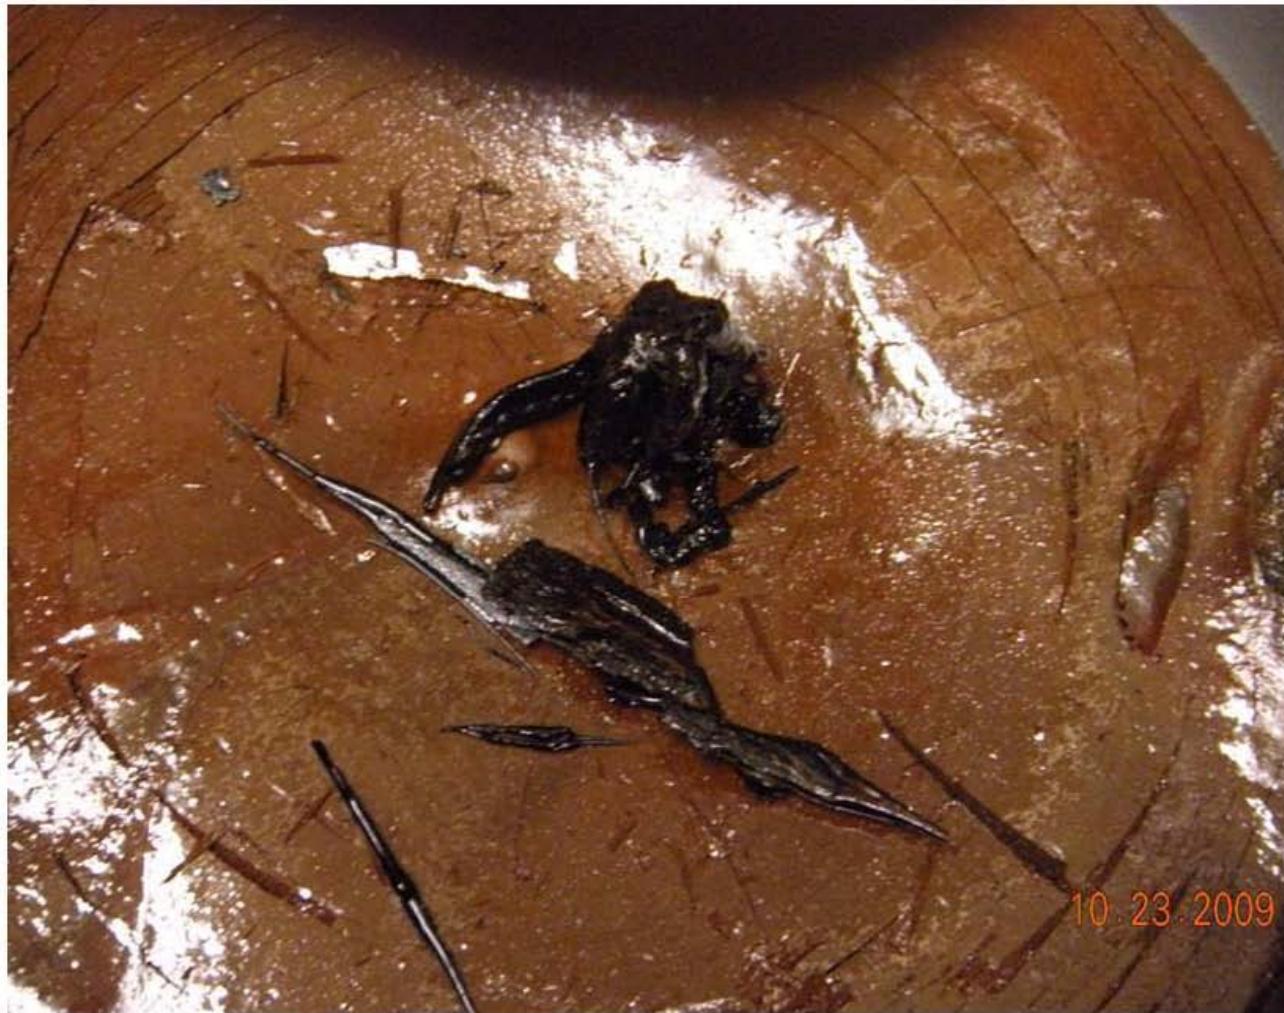
Figure 5.4.a. Discharge glass G-12O-53A. Foam observed.

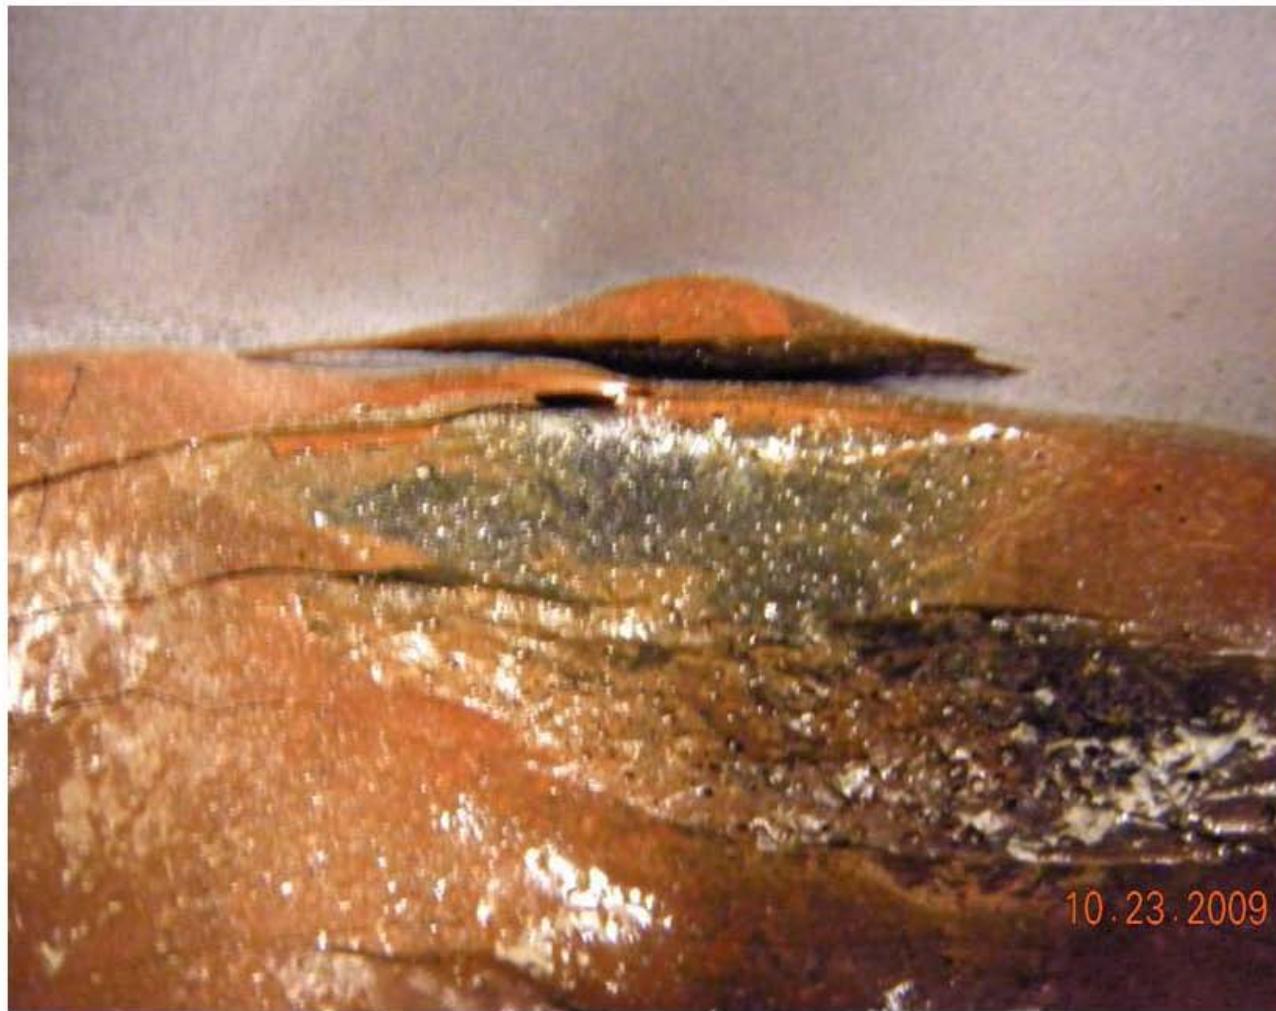
Figure 5.4.b. Foam in discharge glass G-12O-53A.

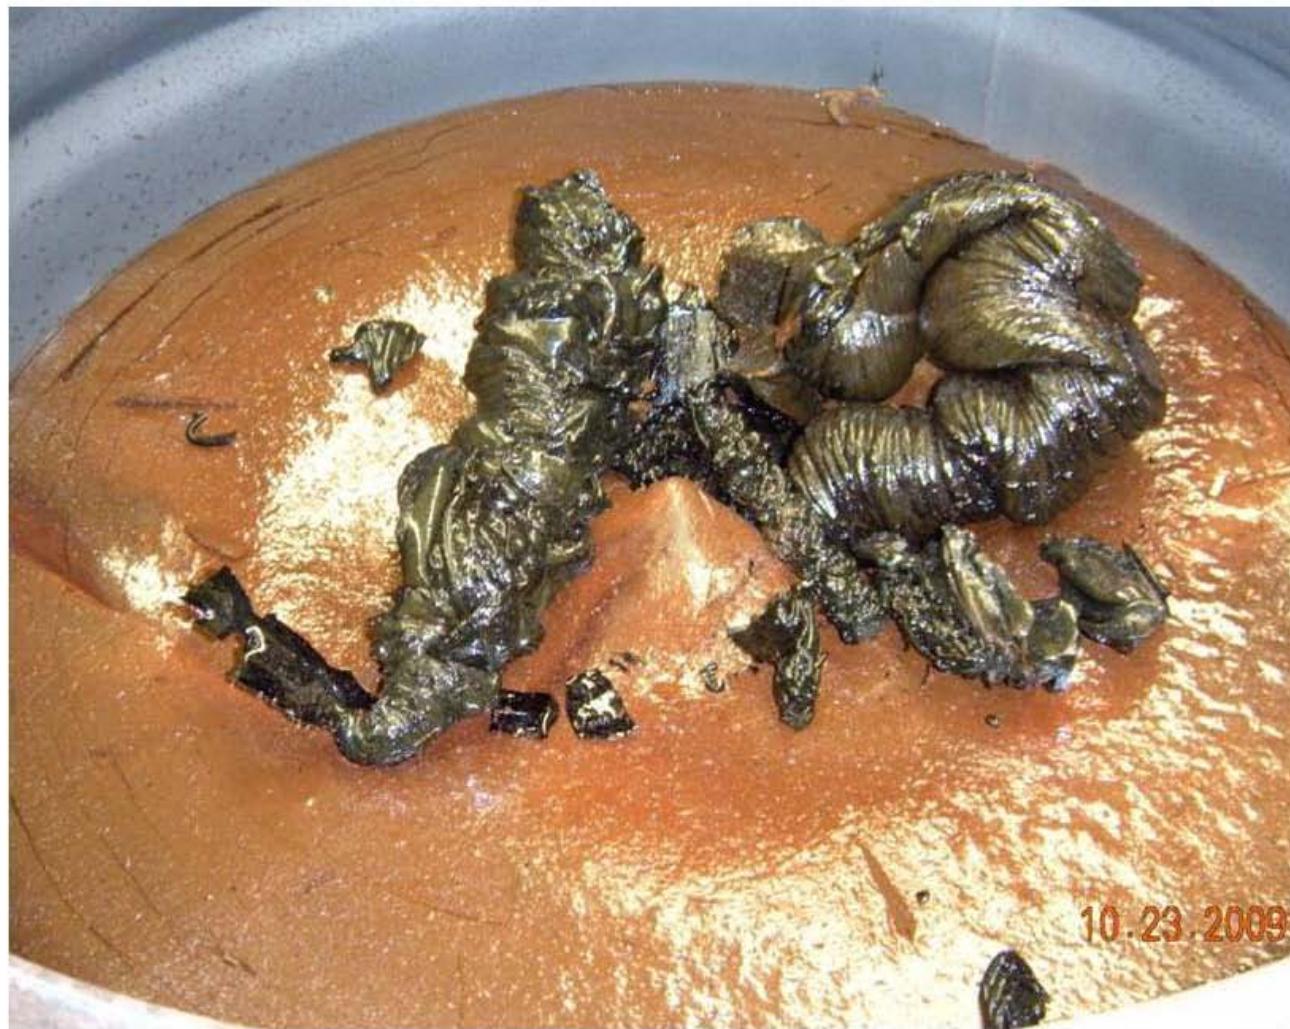
Figure 5.5. Discharge glass G-12O-69A. Foam observed.

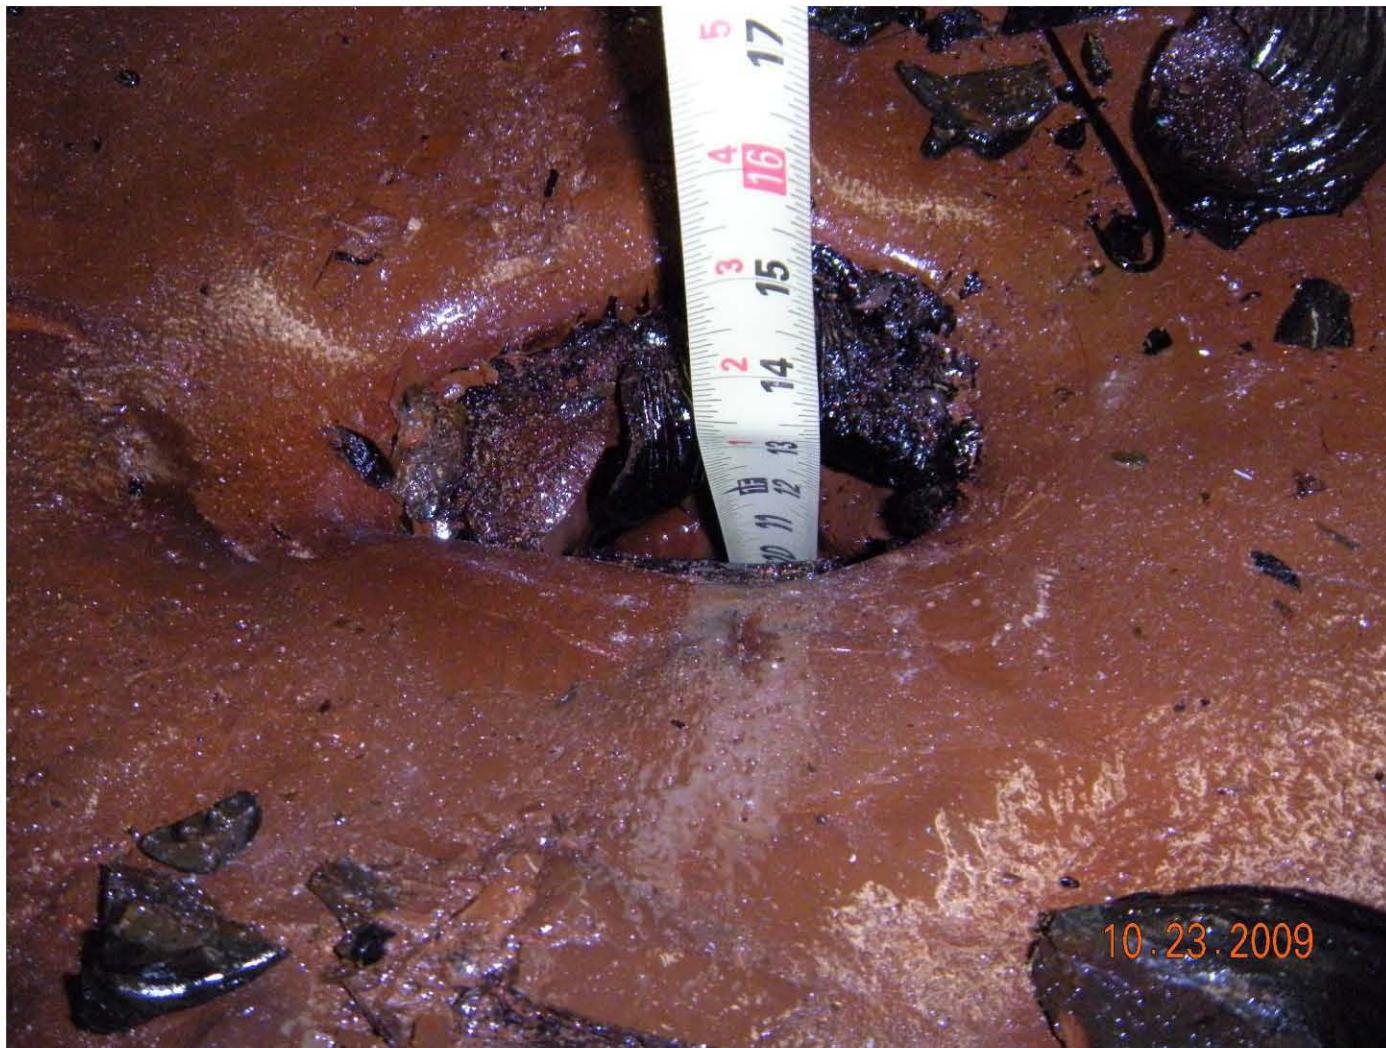
Figure 5.6. Discharge glass G12O-85A. Foam and large cavity observed.

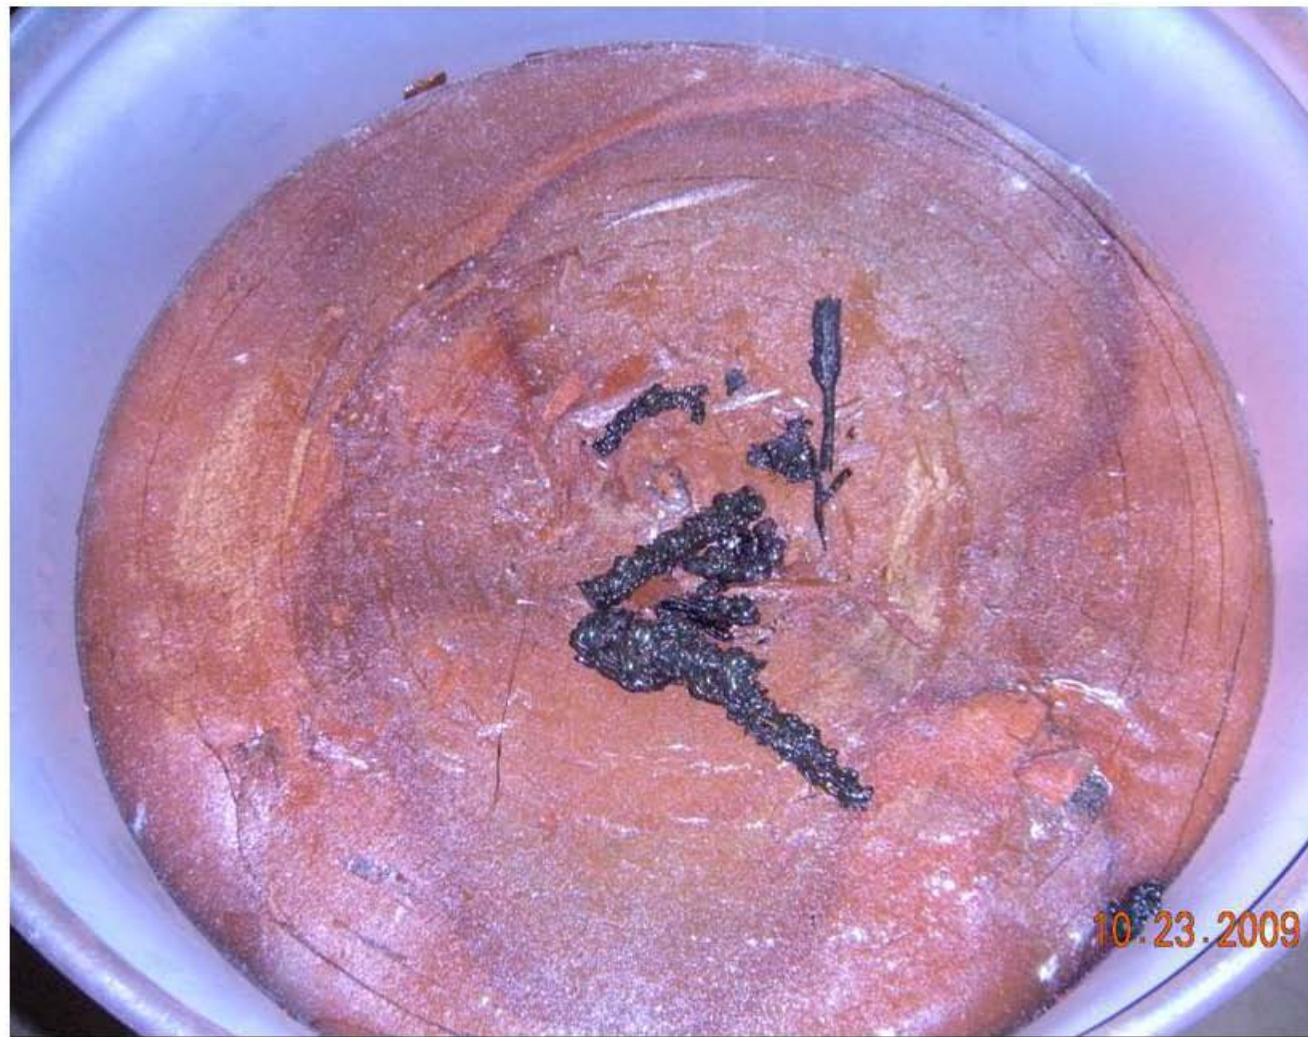
Figure 5.7. Discharge glass G12O-101A. Foam observed.

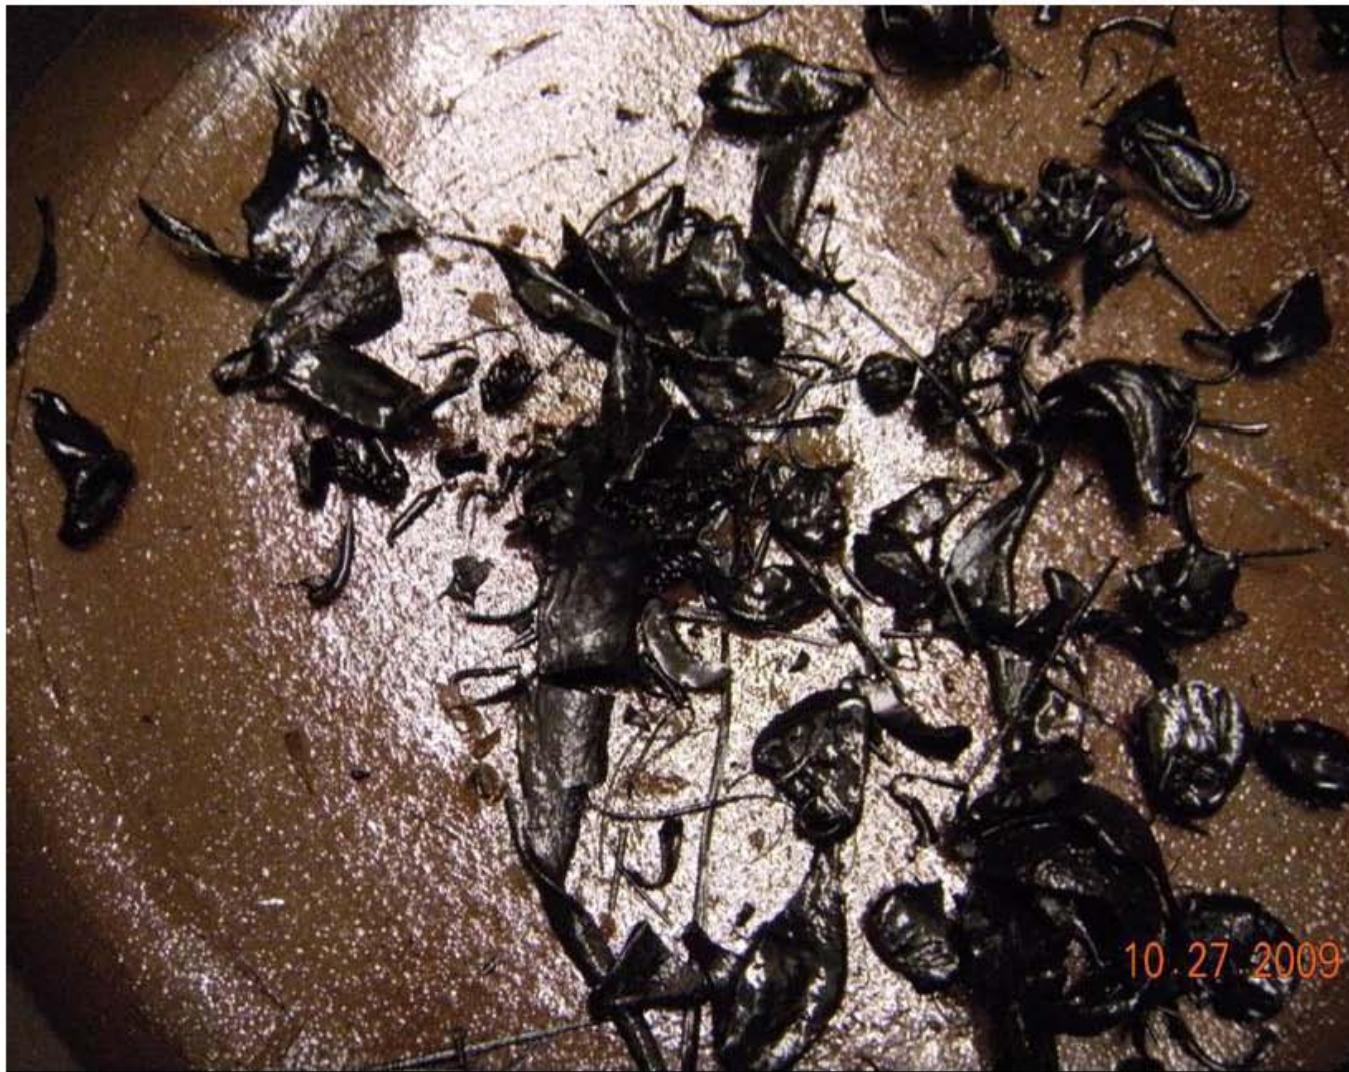
Figure 5.8. Discharge glass G12O-133A. Foam observed.

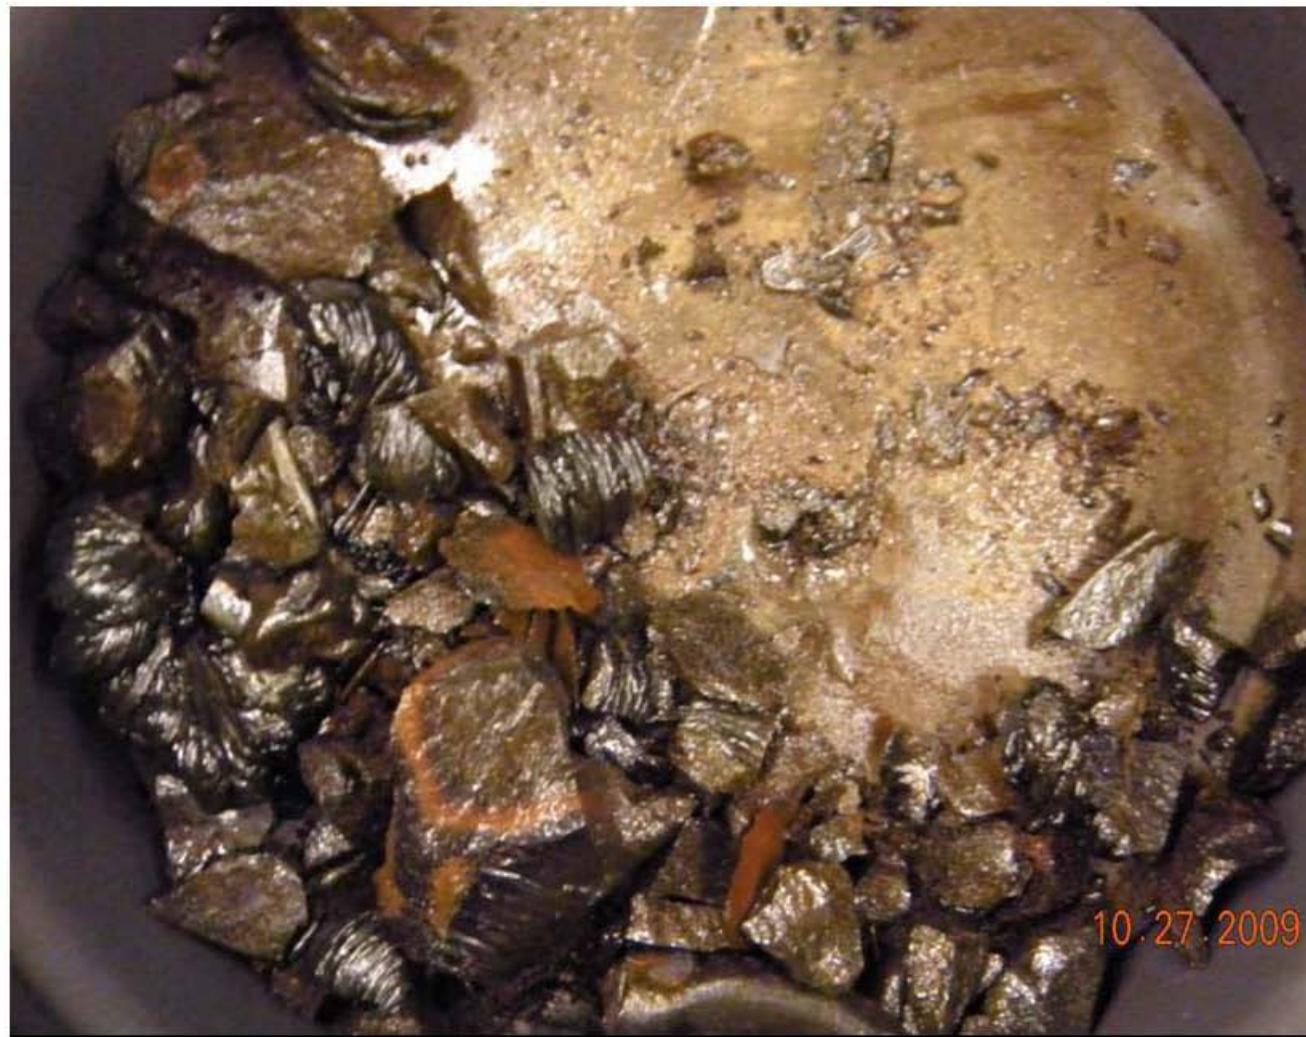
Figure 5.9. Discharge glass G12O-150A. Foam observed.

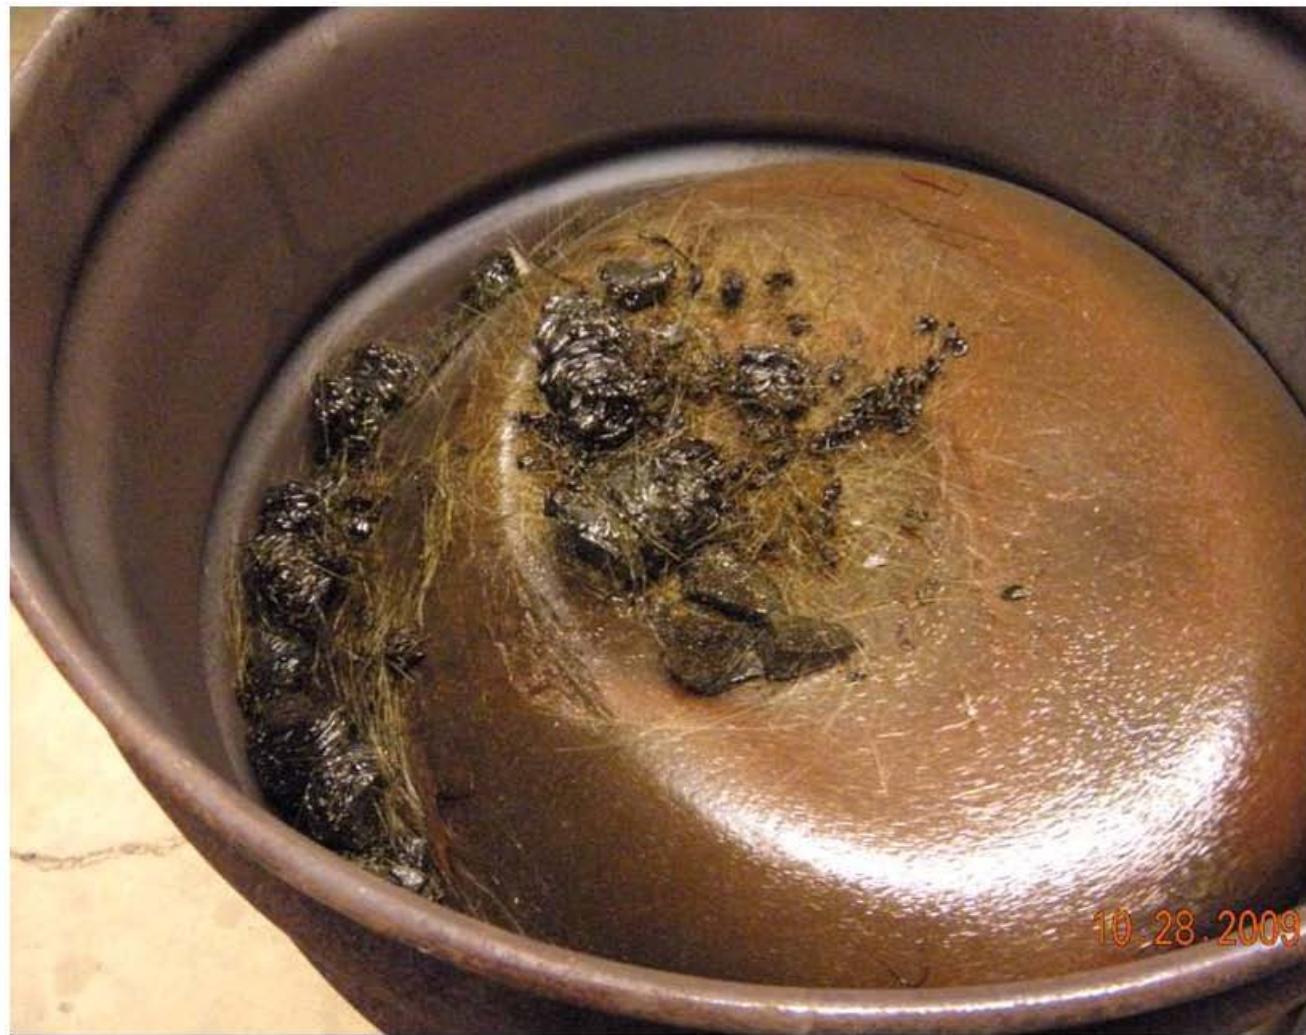
Figure 5.10. Discharge glass G-12P-32A. Foam observed.

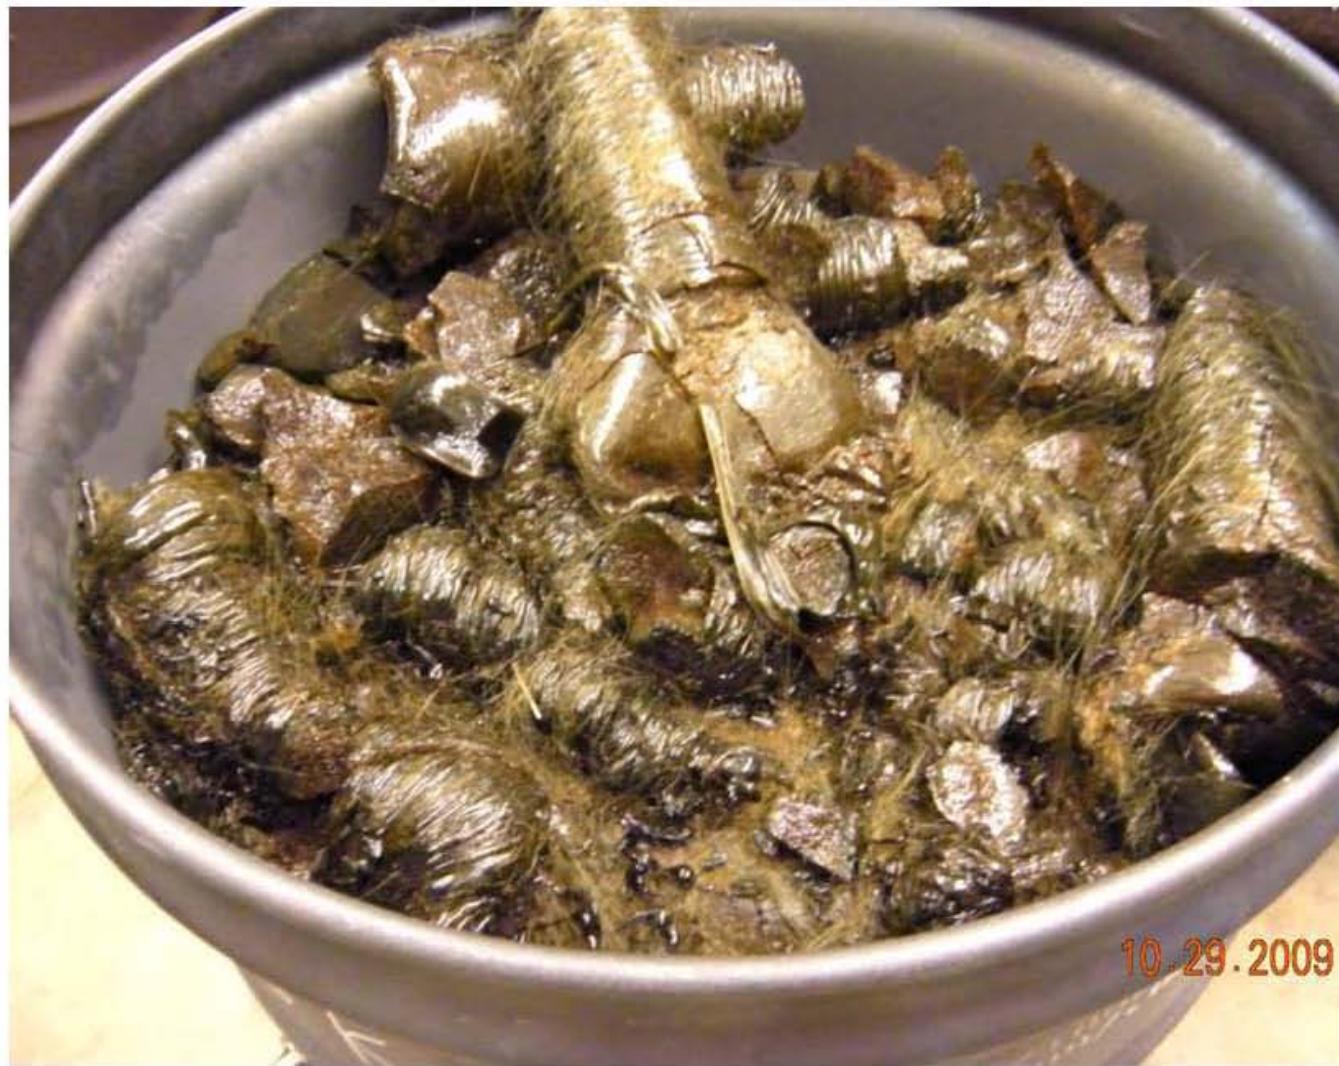
Figure 5.11a. Discharge G-12P-53A. Foam observed.

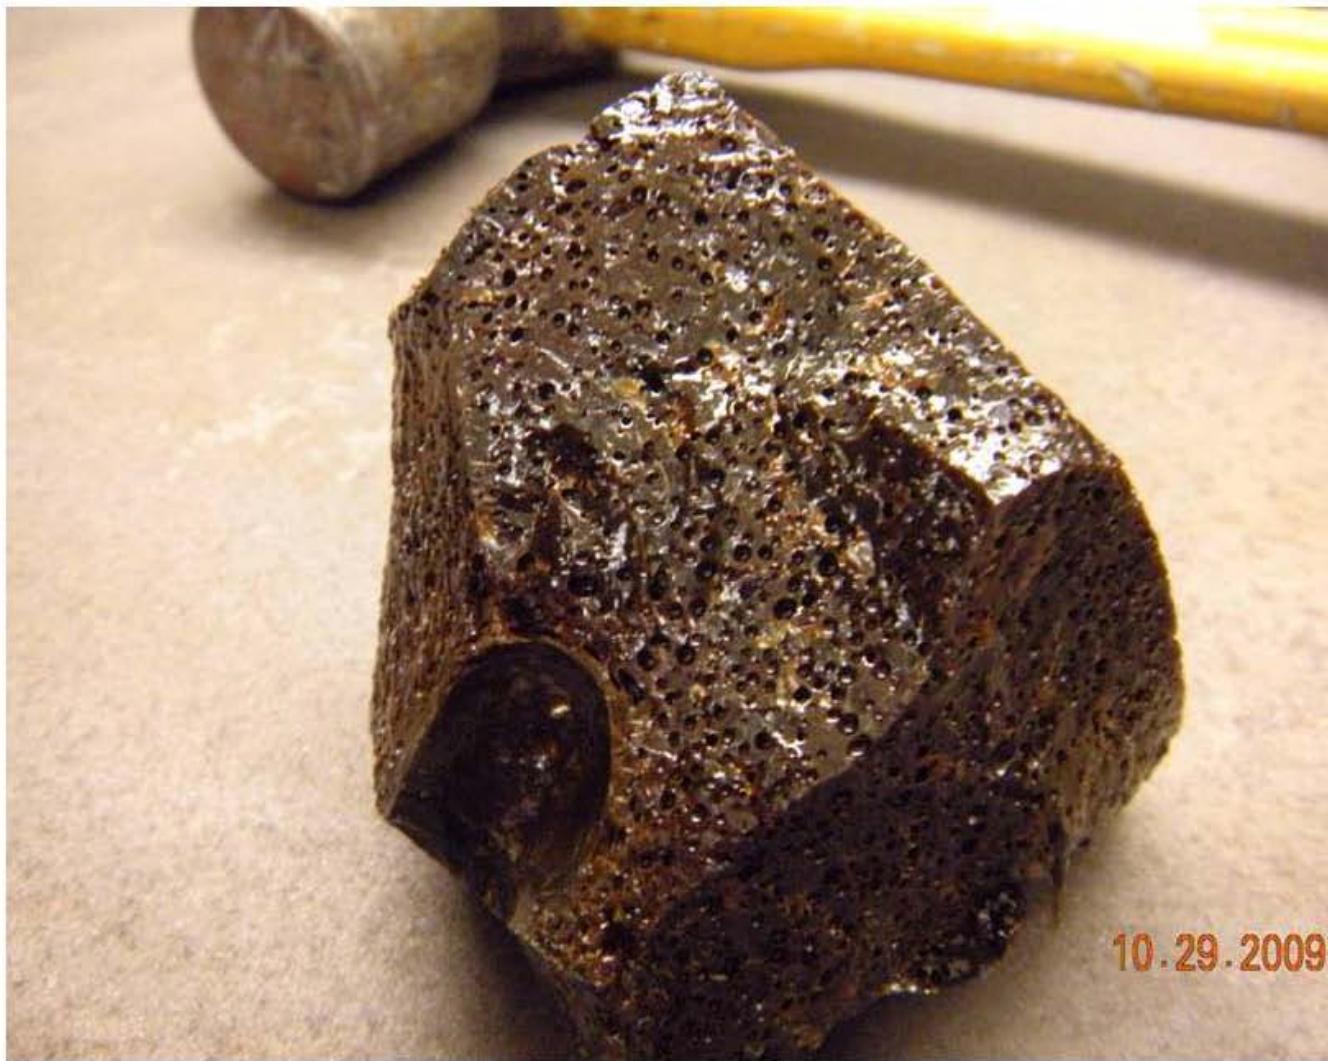
Figure 5.11.b. Foam in discharge glass G-12P-53A.

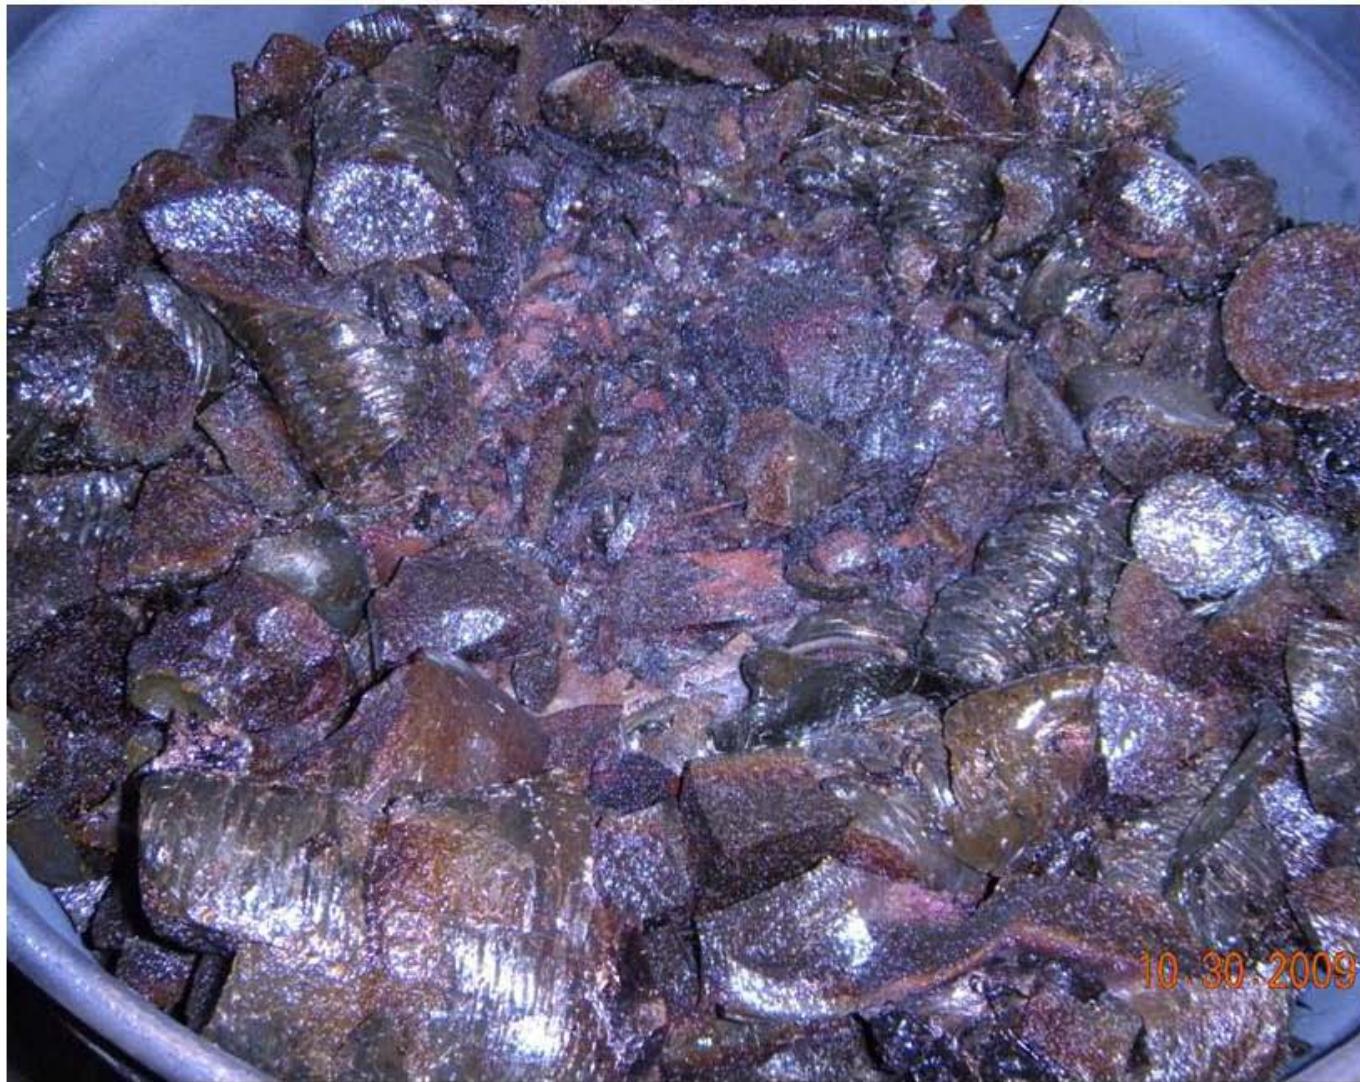
Figure 5.12. Discharge glass G-12P-72A. Foam observed.

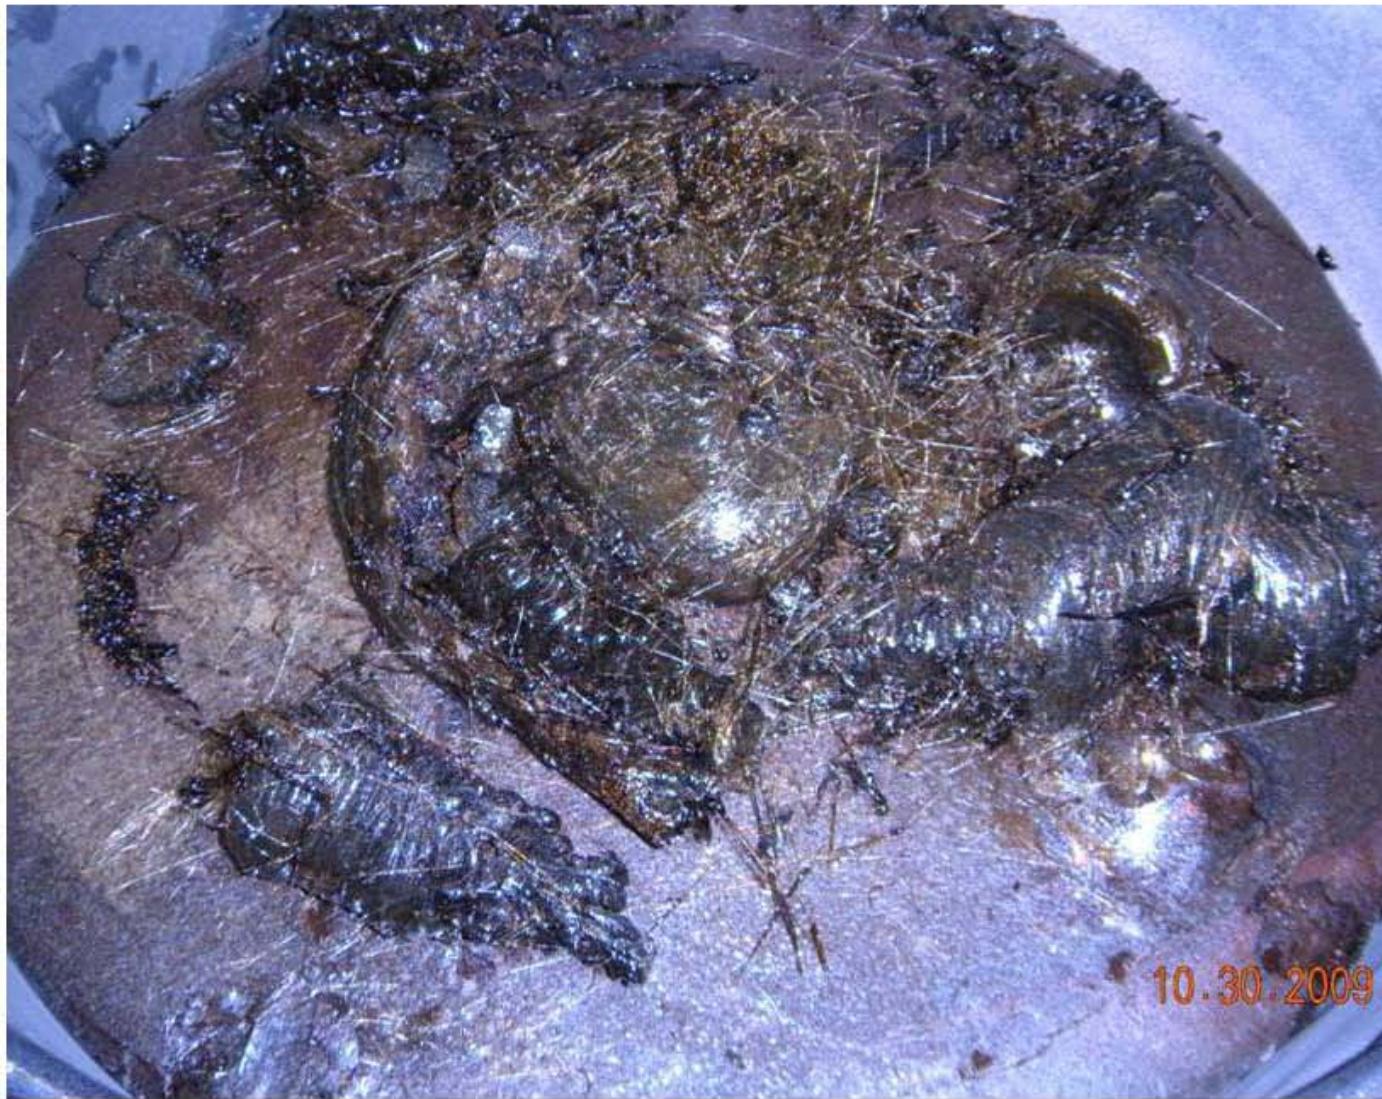
Figure 5.13. Discharge glass G-12P-88A. Foam observed.
