Tests with High-Bismuth HLW Glasses

**Final Report VSL-10R1780-1, Rev. 0;
12/13/10**

Office of River Protection

K. S. Matlack
Vitreous State Laboratory
The Catholic University of America

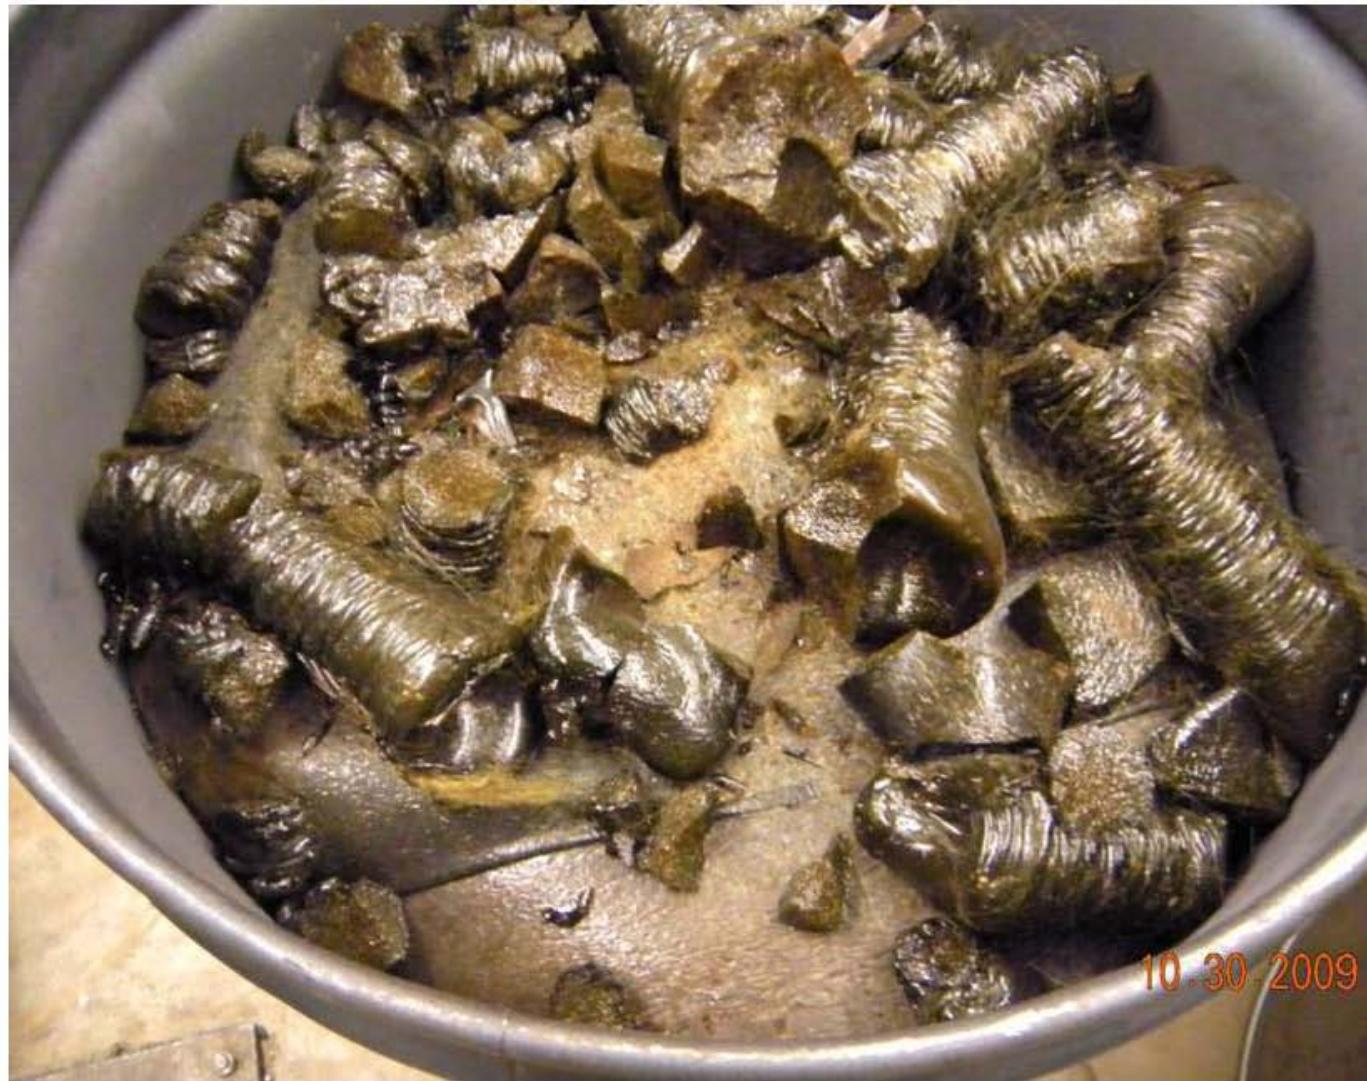
Figure 5.14. Discharge glass G-12P-101A. Foam observed.

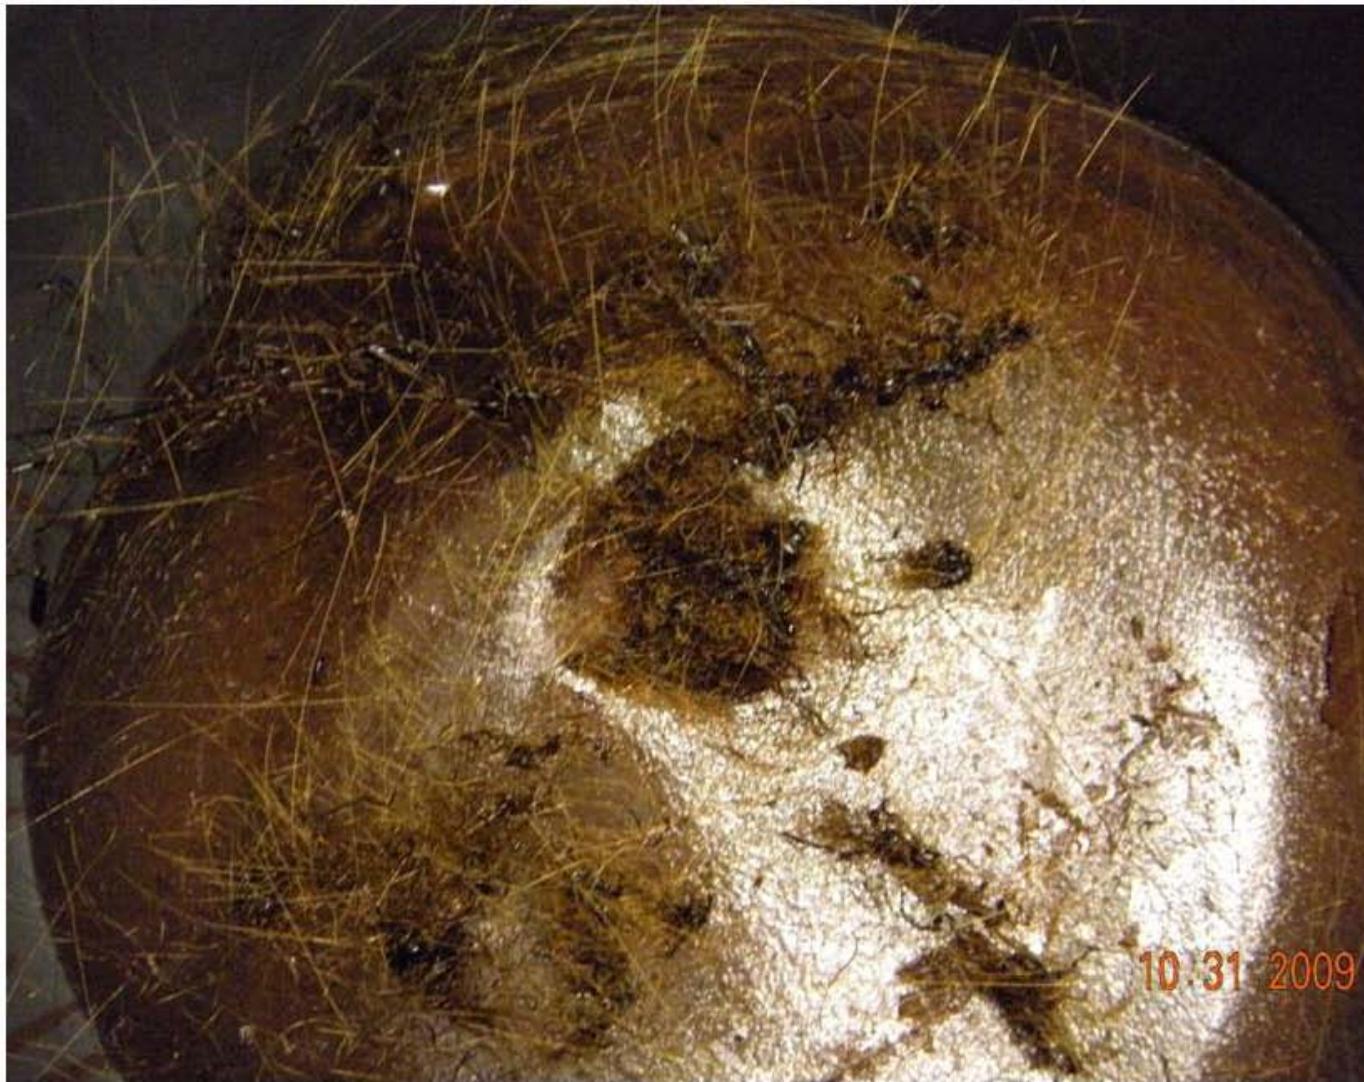
Figure 5.15. Discharge glass G-12P-116A. Foam observed.

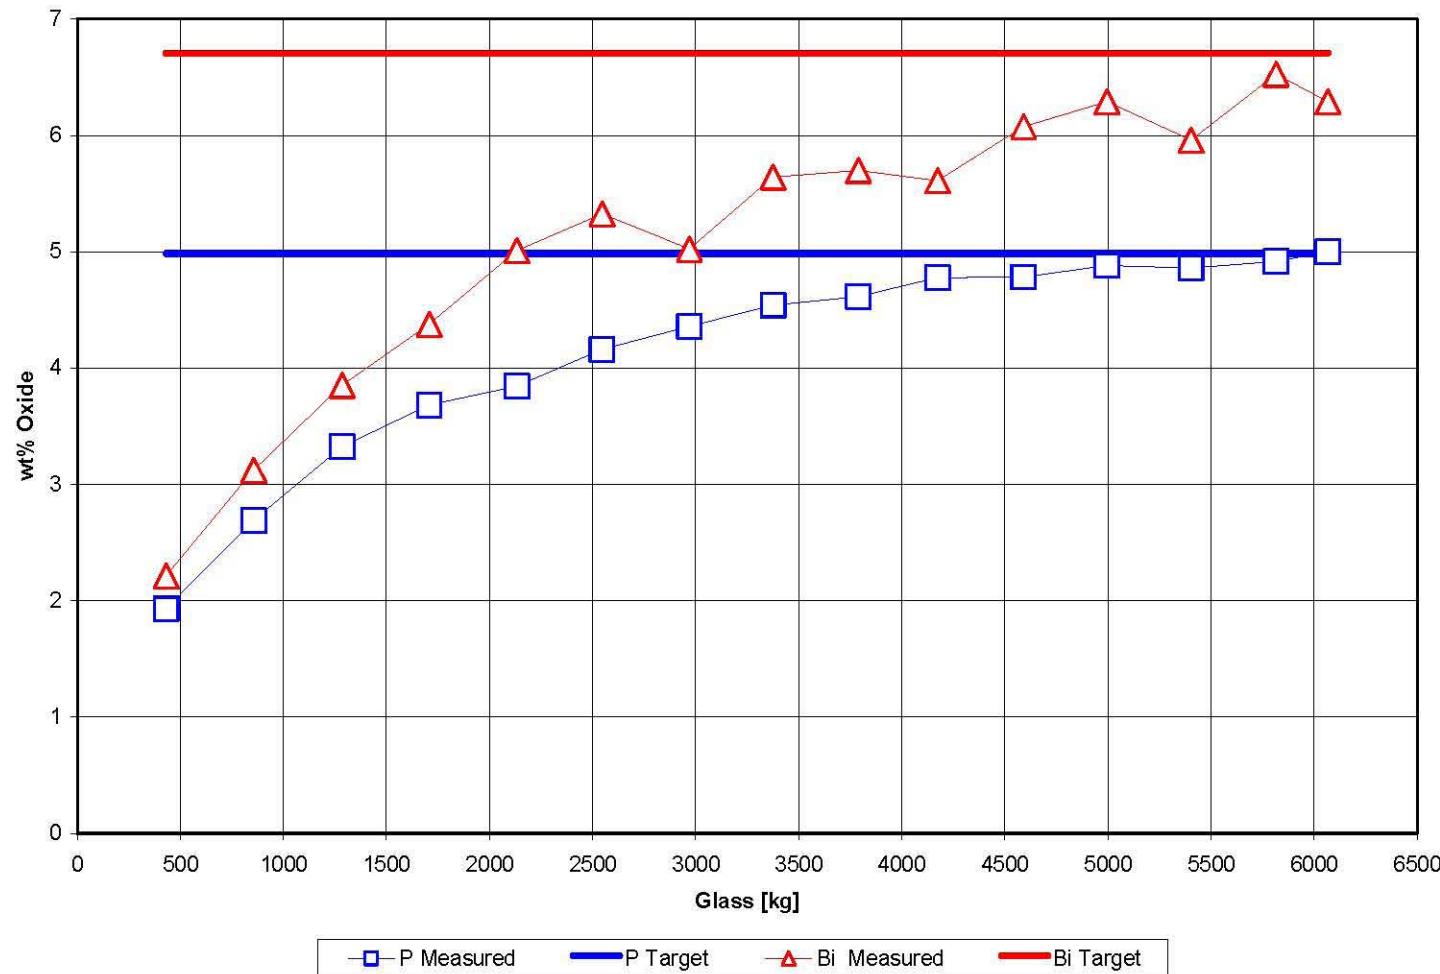
Figure 5.16.a. DM1200 product and target glass compositions determined by XRF.

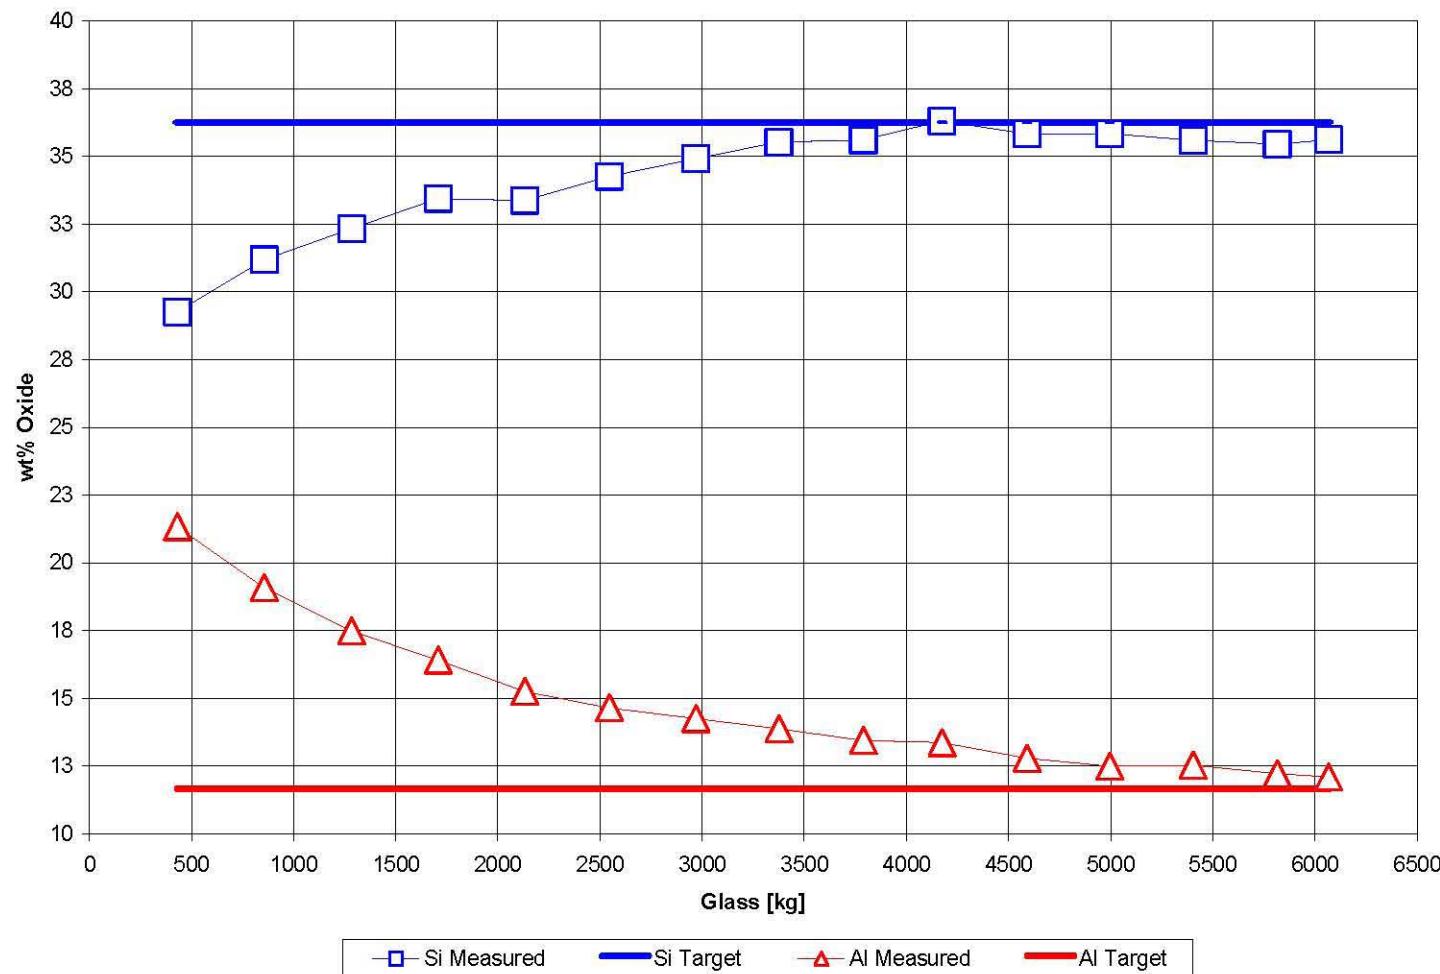
Figure 5.16.b. DM1200 product and target glass compositions determined by XRF.

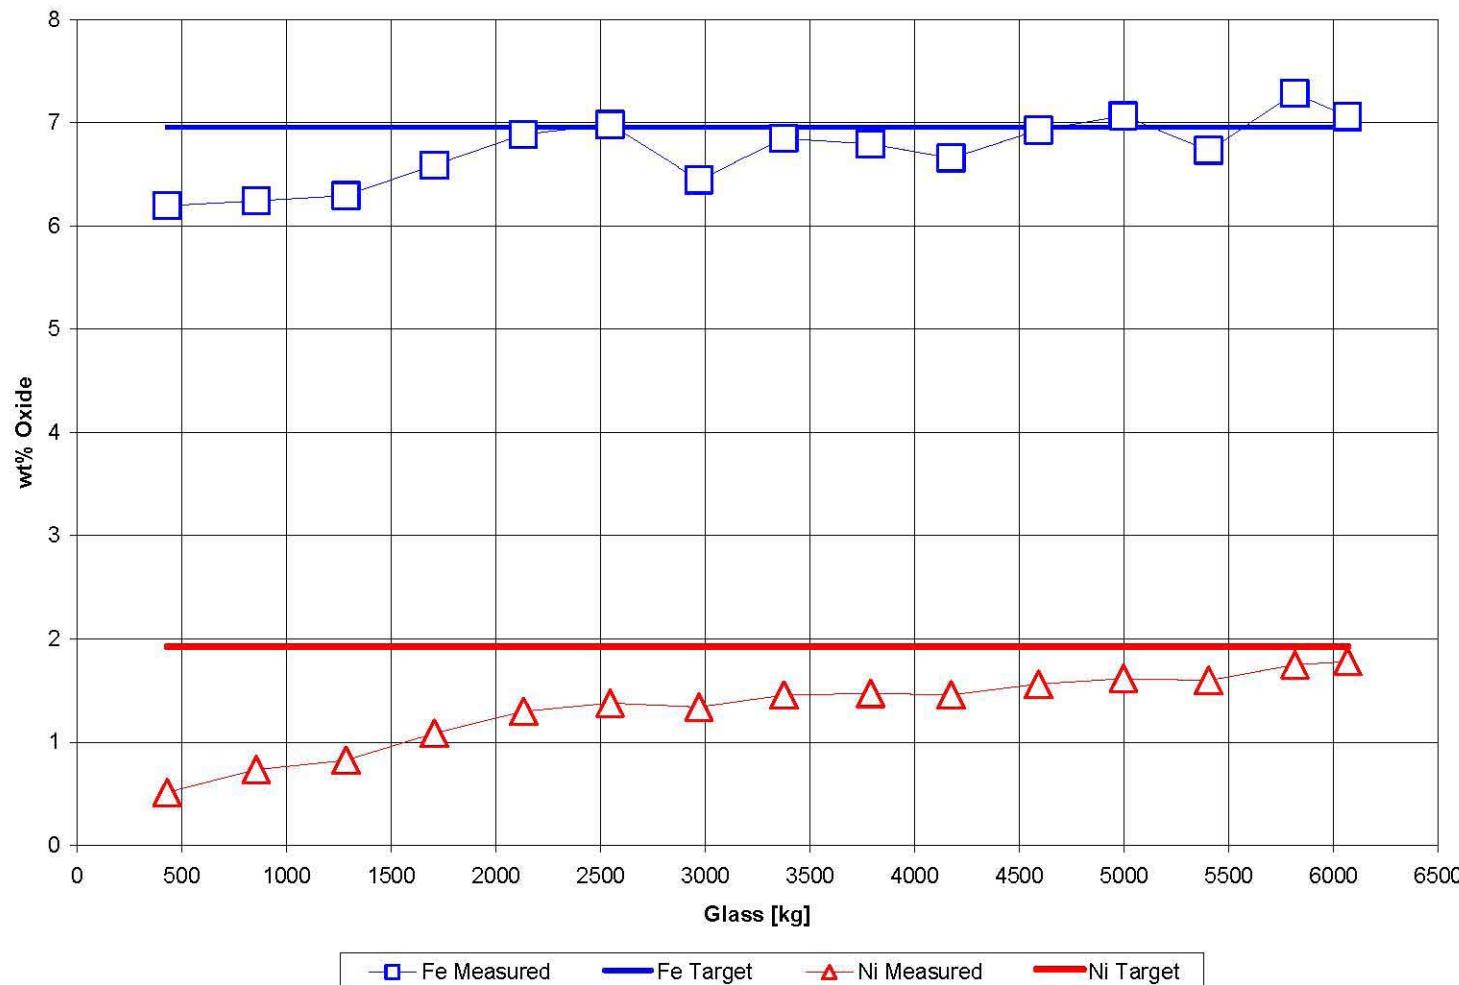
Figure 5.16.d. DM1200 product and target glass compositions determined by XRF.

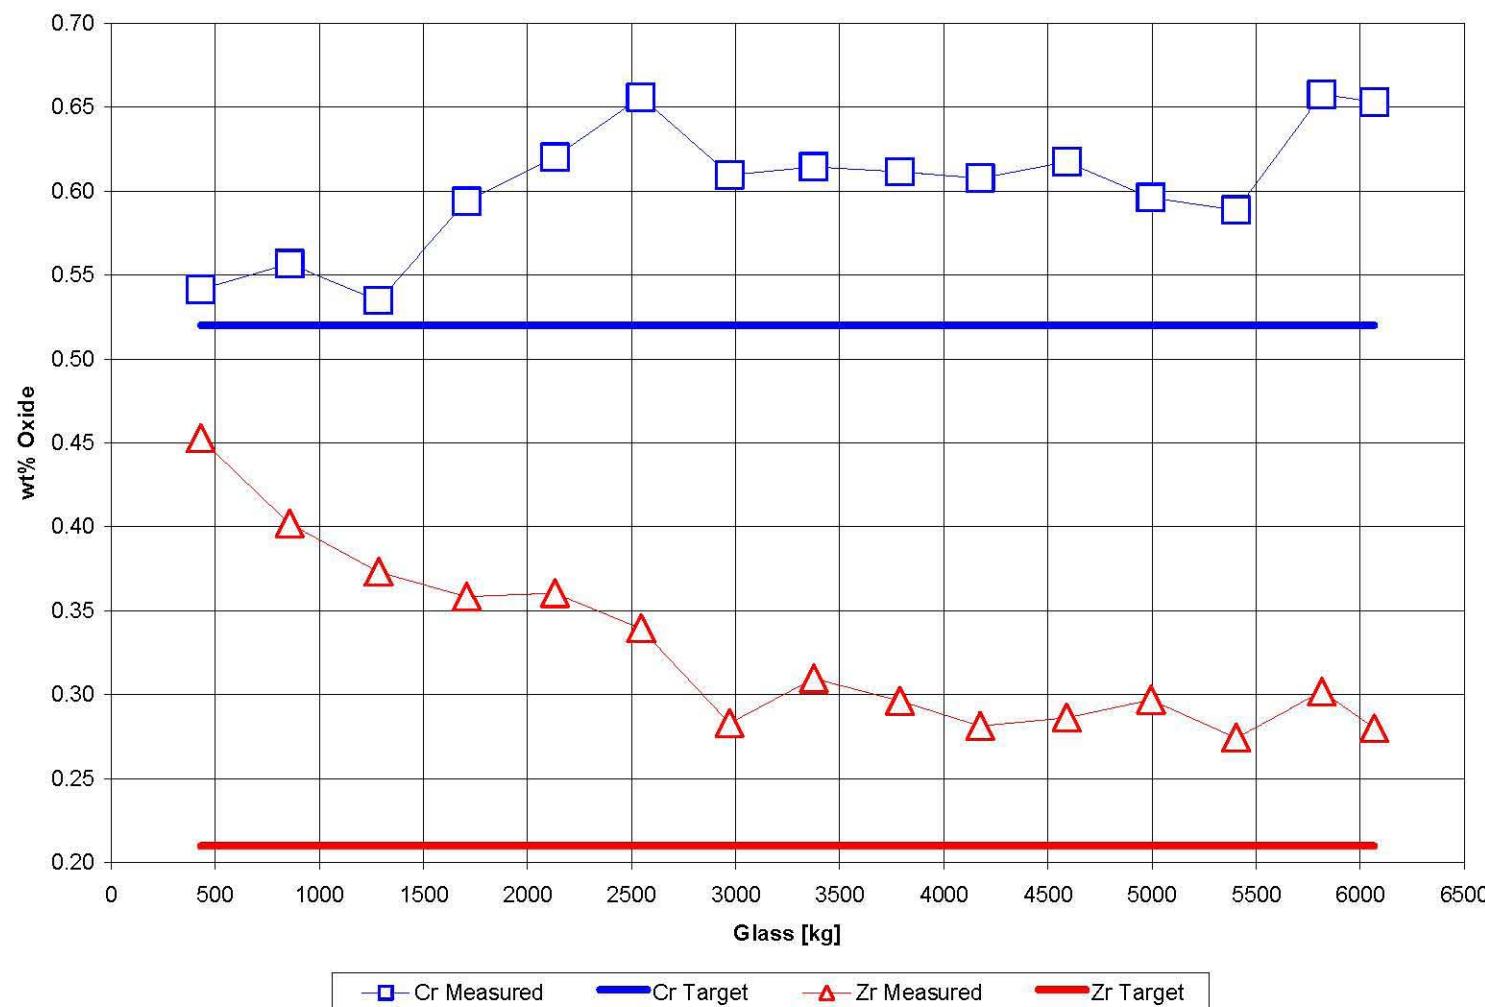
Figure 5.16.e. DM1200 product and target glass compositions determined by XRF.

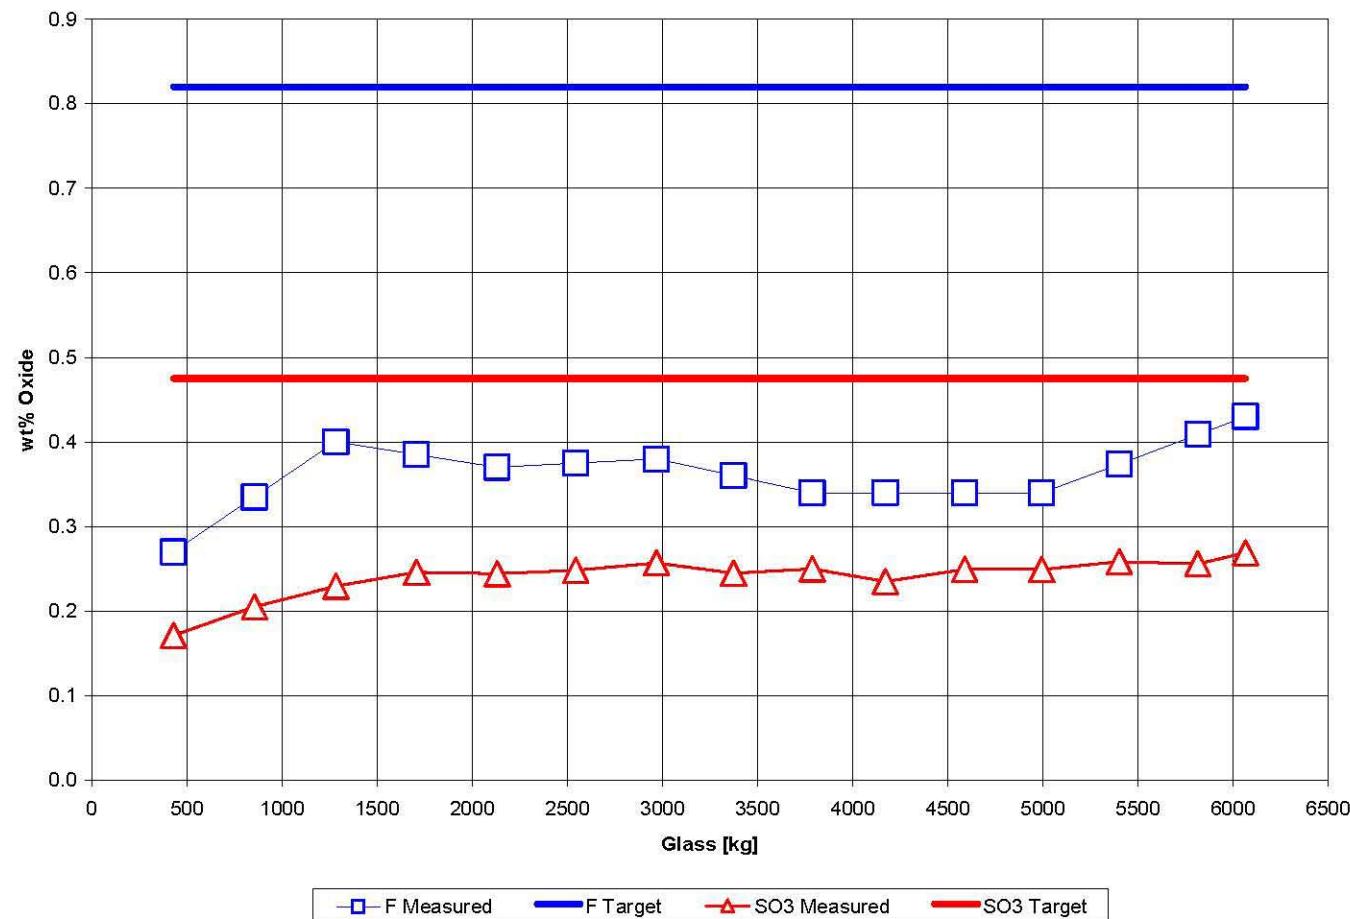
Figure 5.16.f. DM1200 product and target glass compositions determined by XRF.

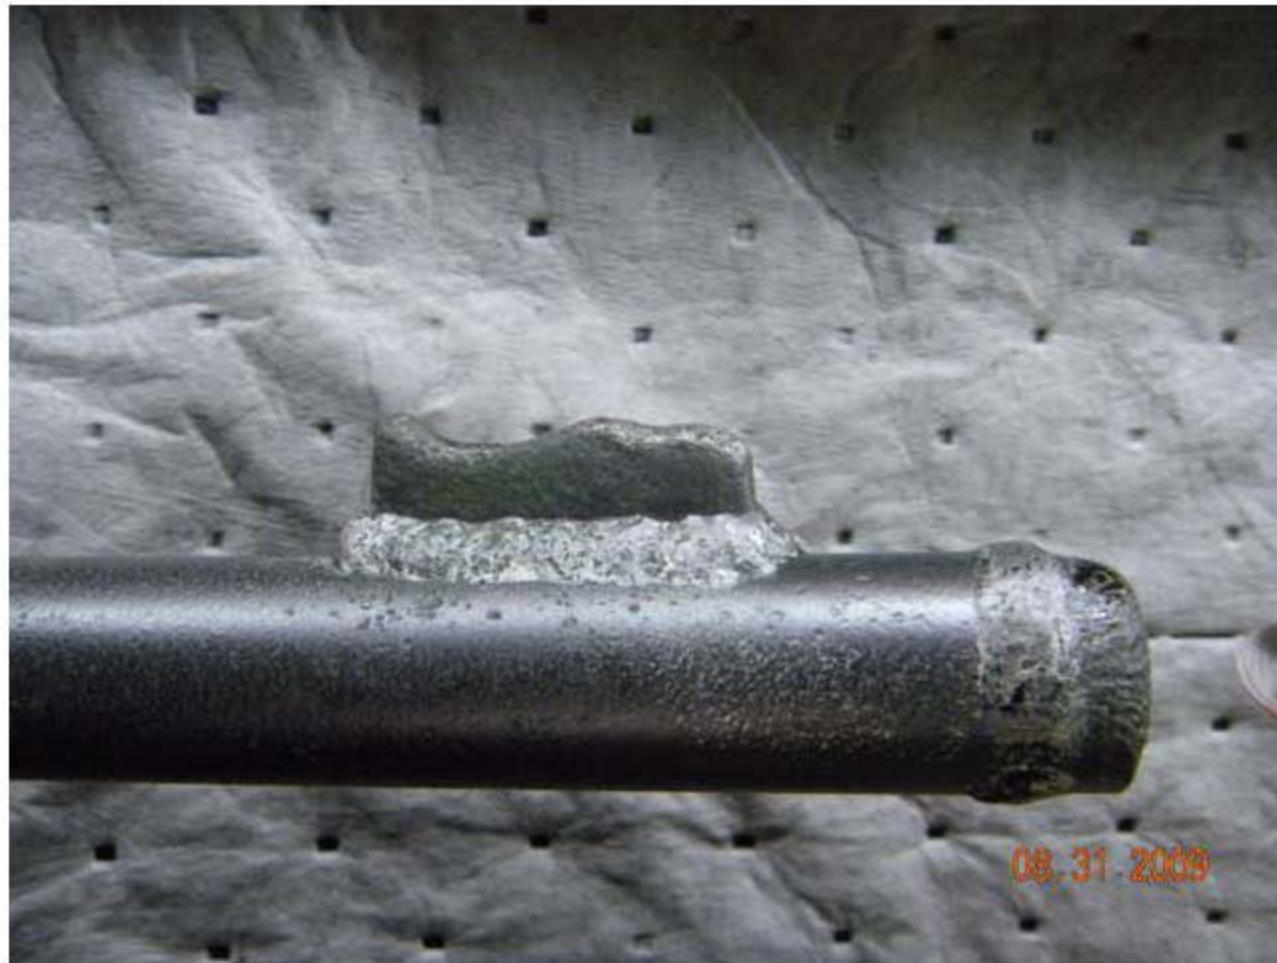
Figure 5.32. Bubbler (DB-3) tip prior to installation in the high bismuth tests.

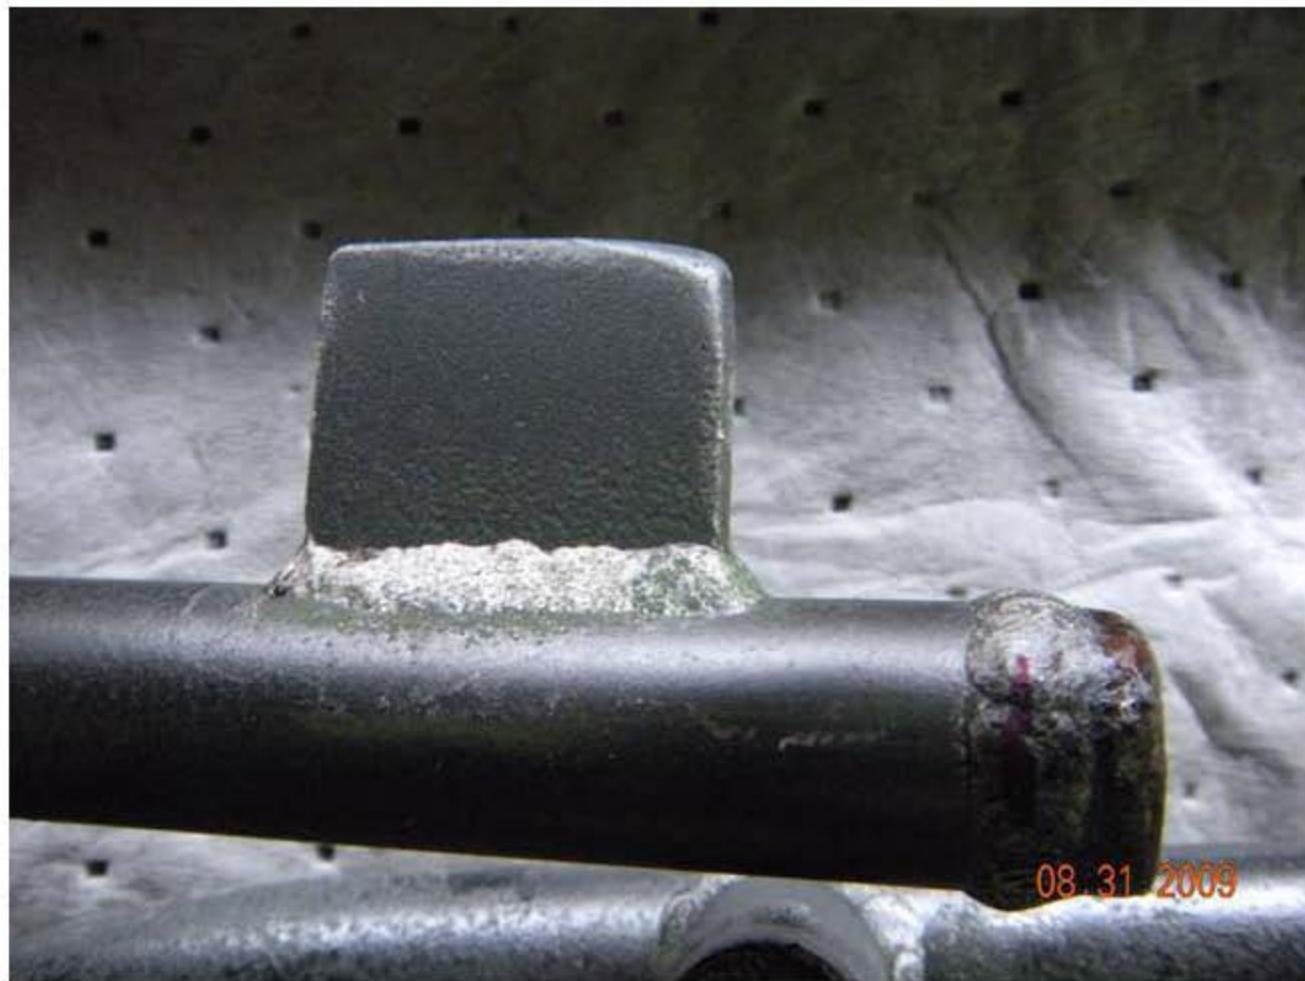
Figure 5.33. Bubbler (DB-4) tip prior to installation in the high bismuth tests.

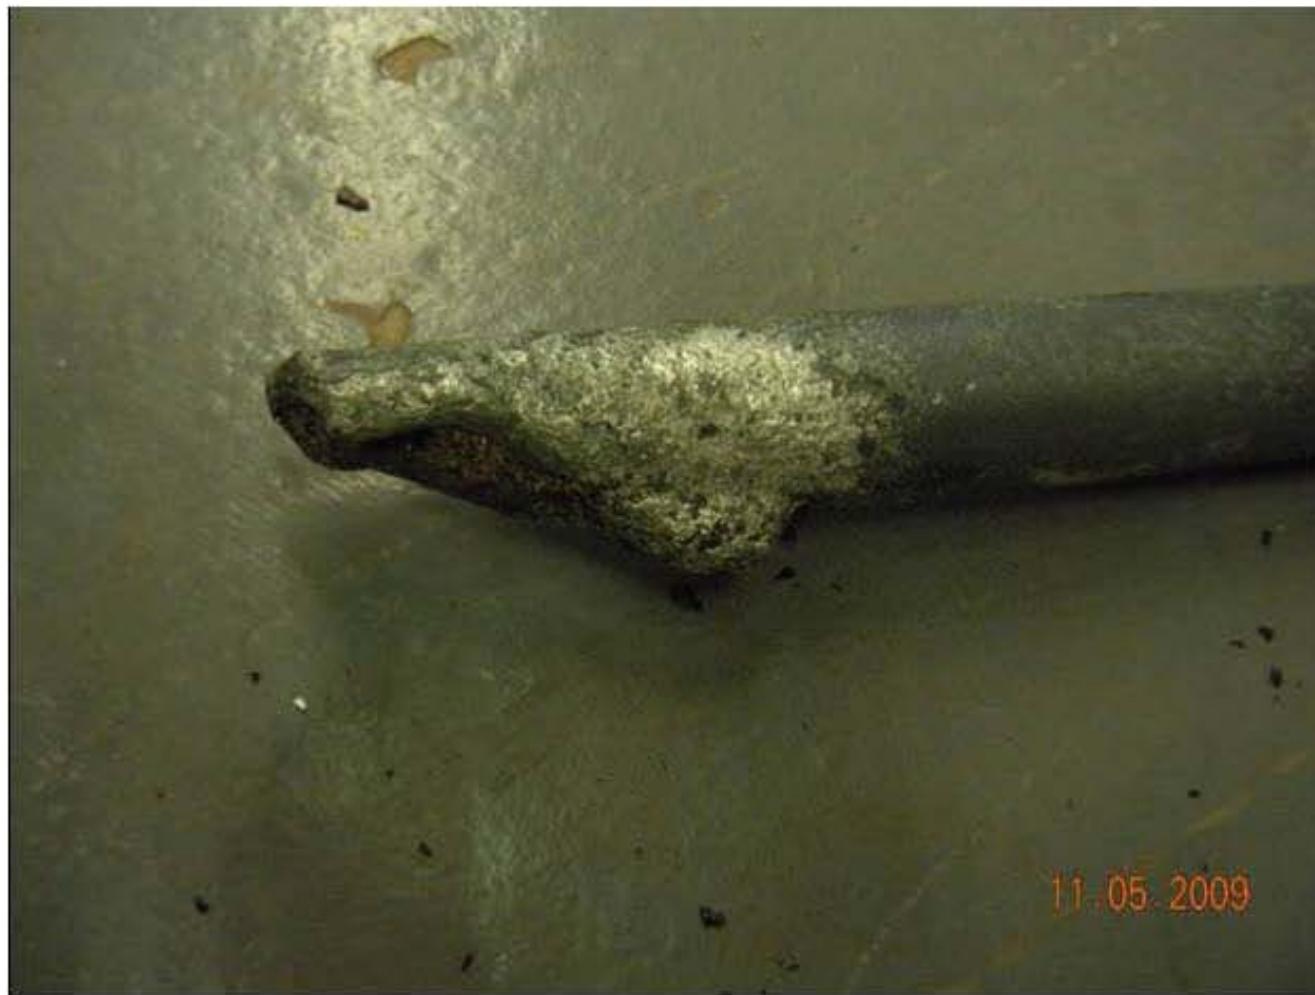
Figure 5.34. Bubbler (DB-3) tip after exposure to the high bismuth glass.

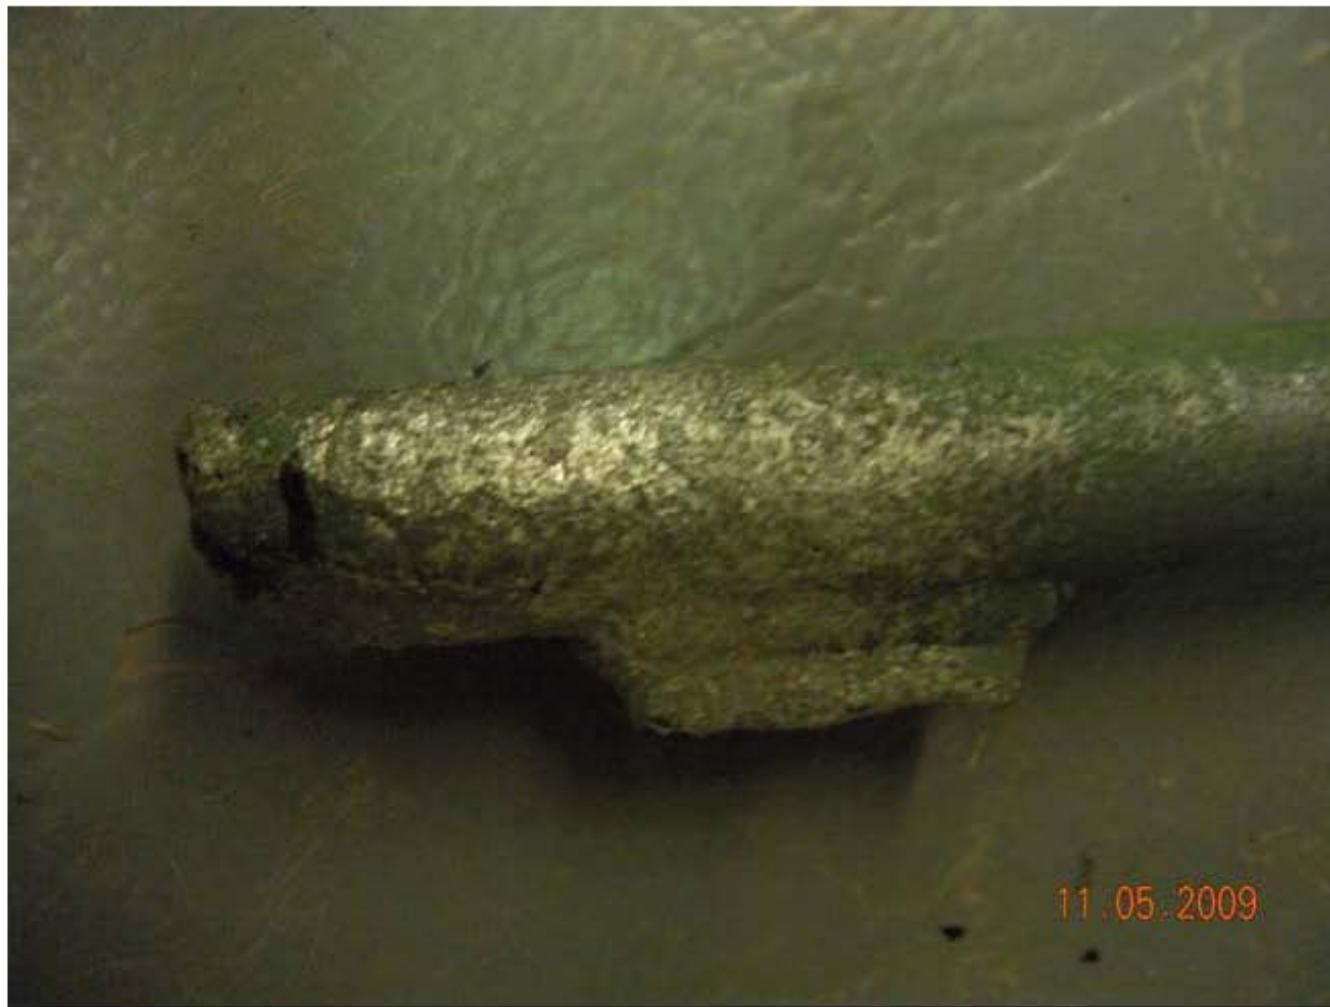
Figure 5.35. Bubbler (DB-4) tip after exposure to the high bismuth glass.

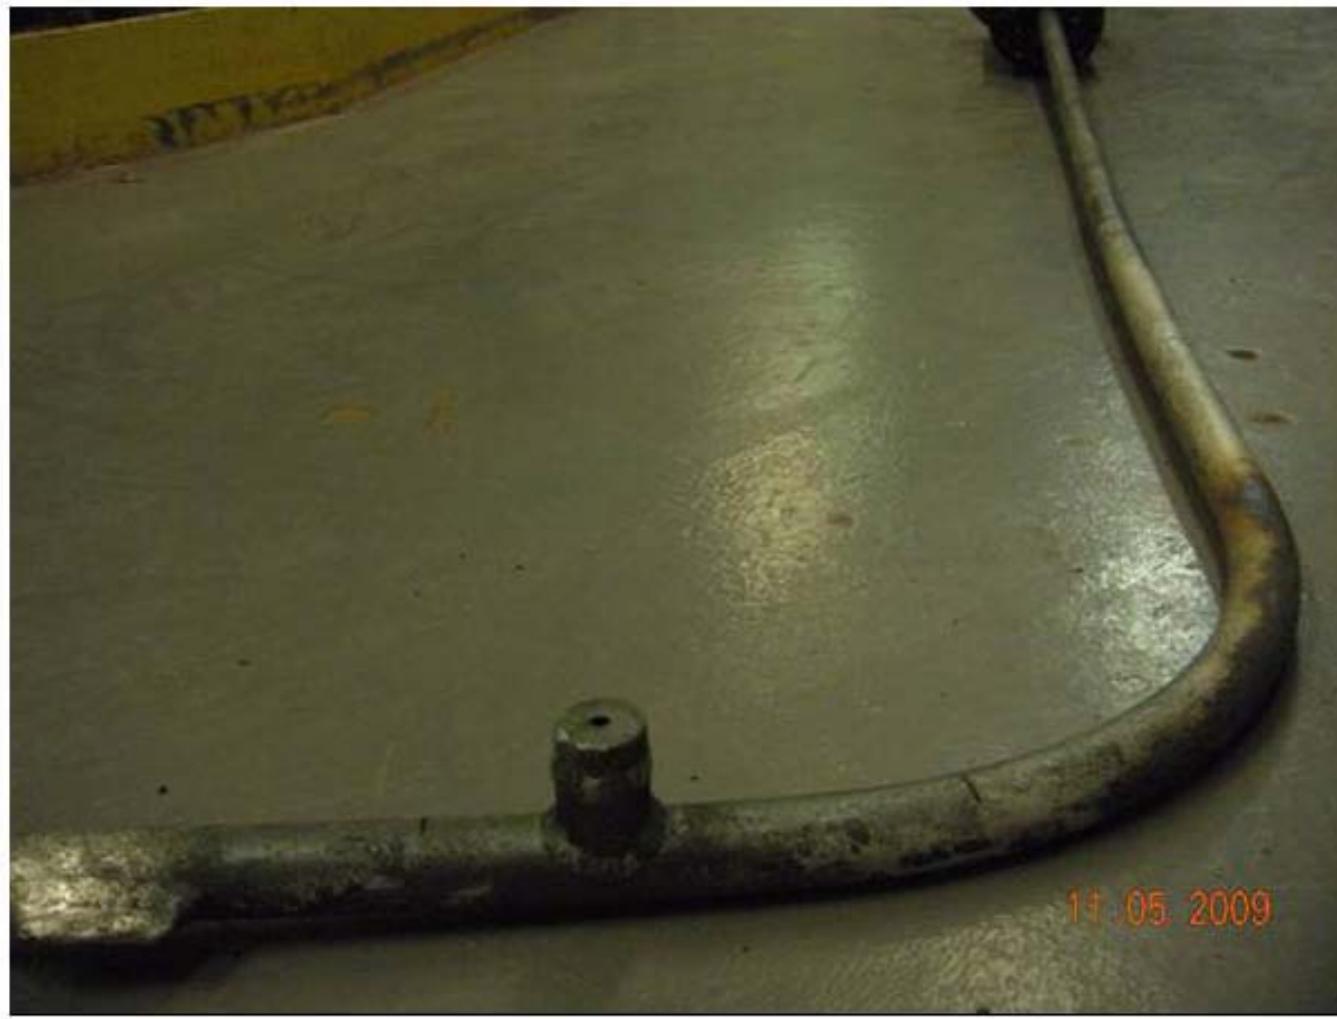
Figure 5.36. Bubbler (DB-4) after exposure to the high bismuth glass.

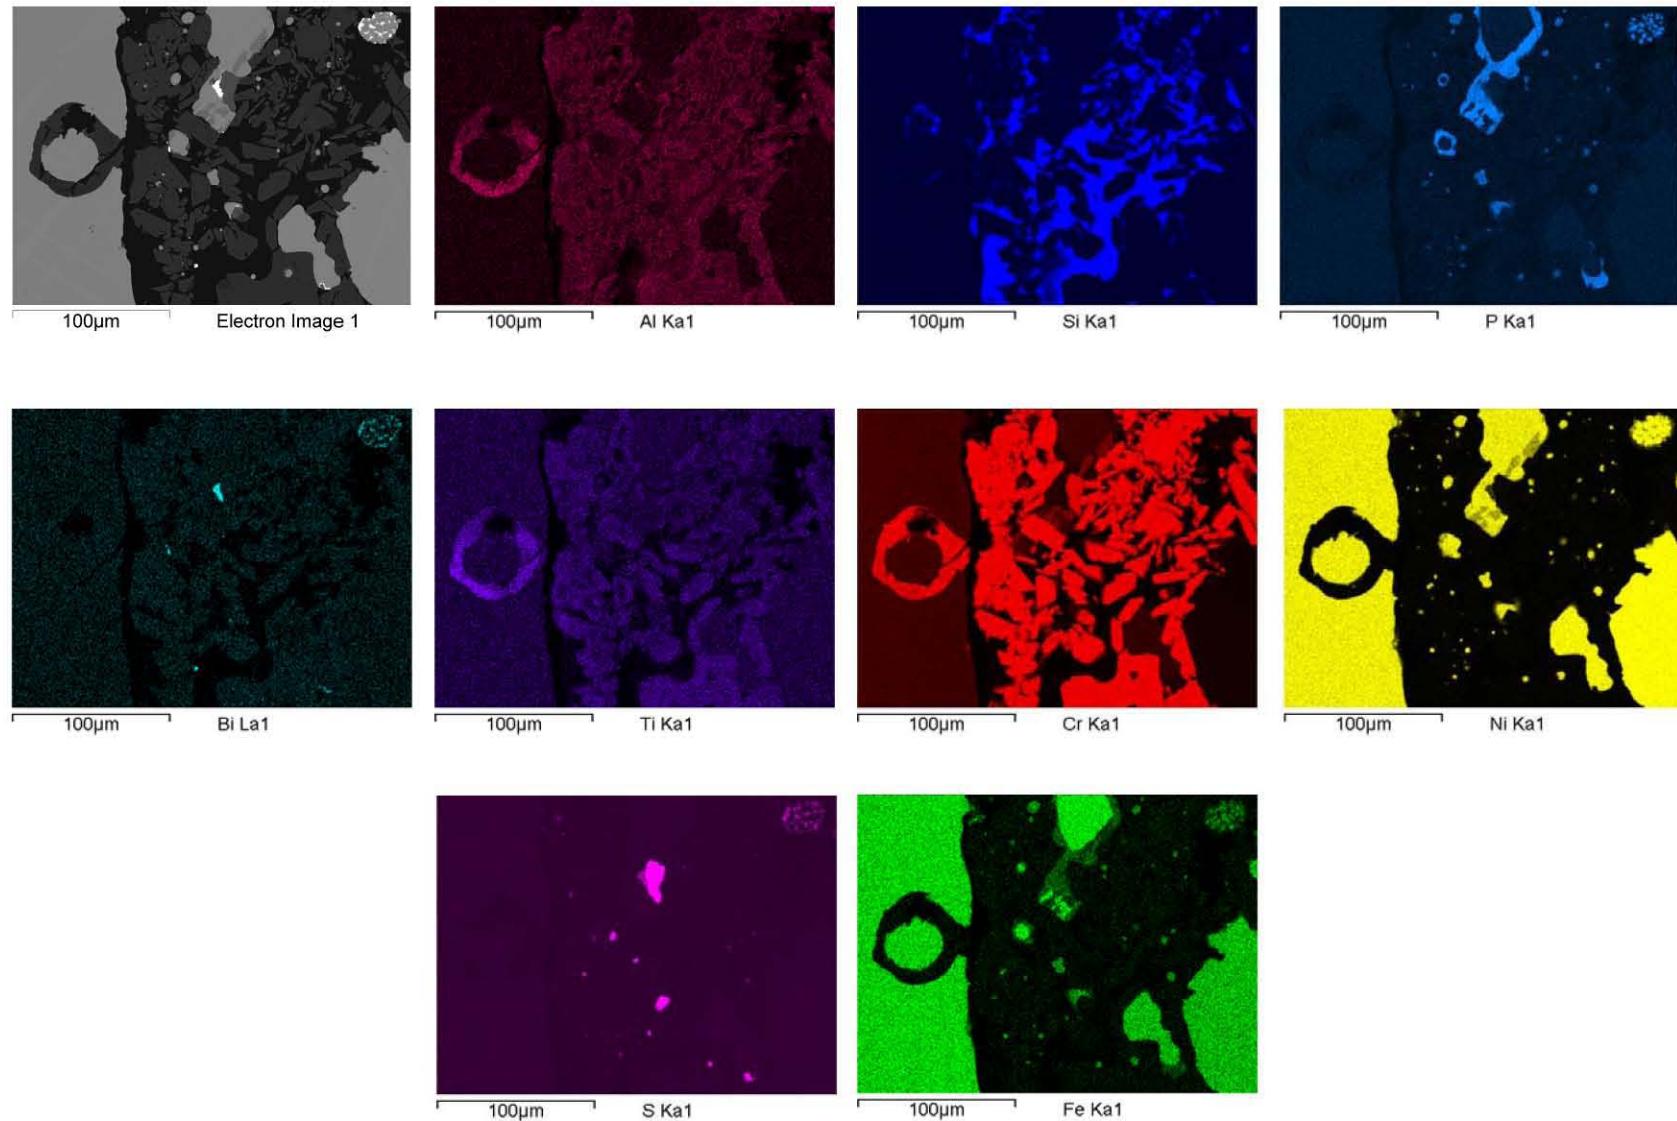
Figure 5.38. X-ray maps of reaction interface on O-12Q-31B.

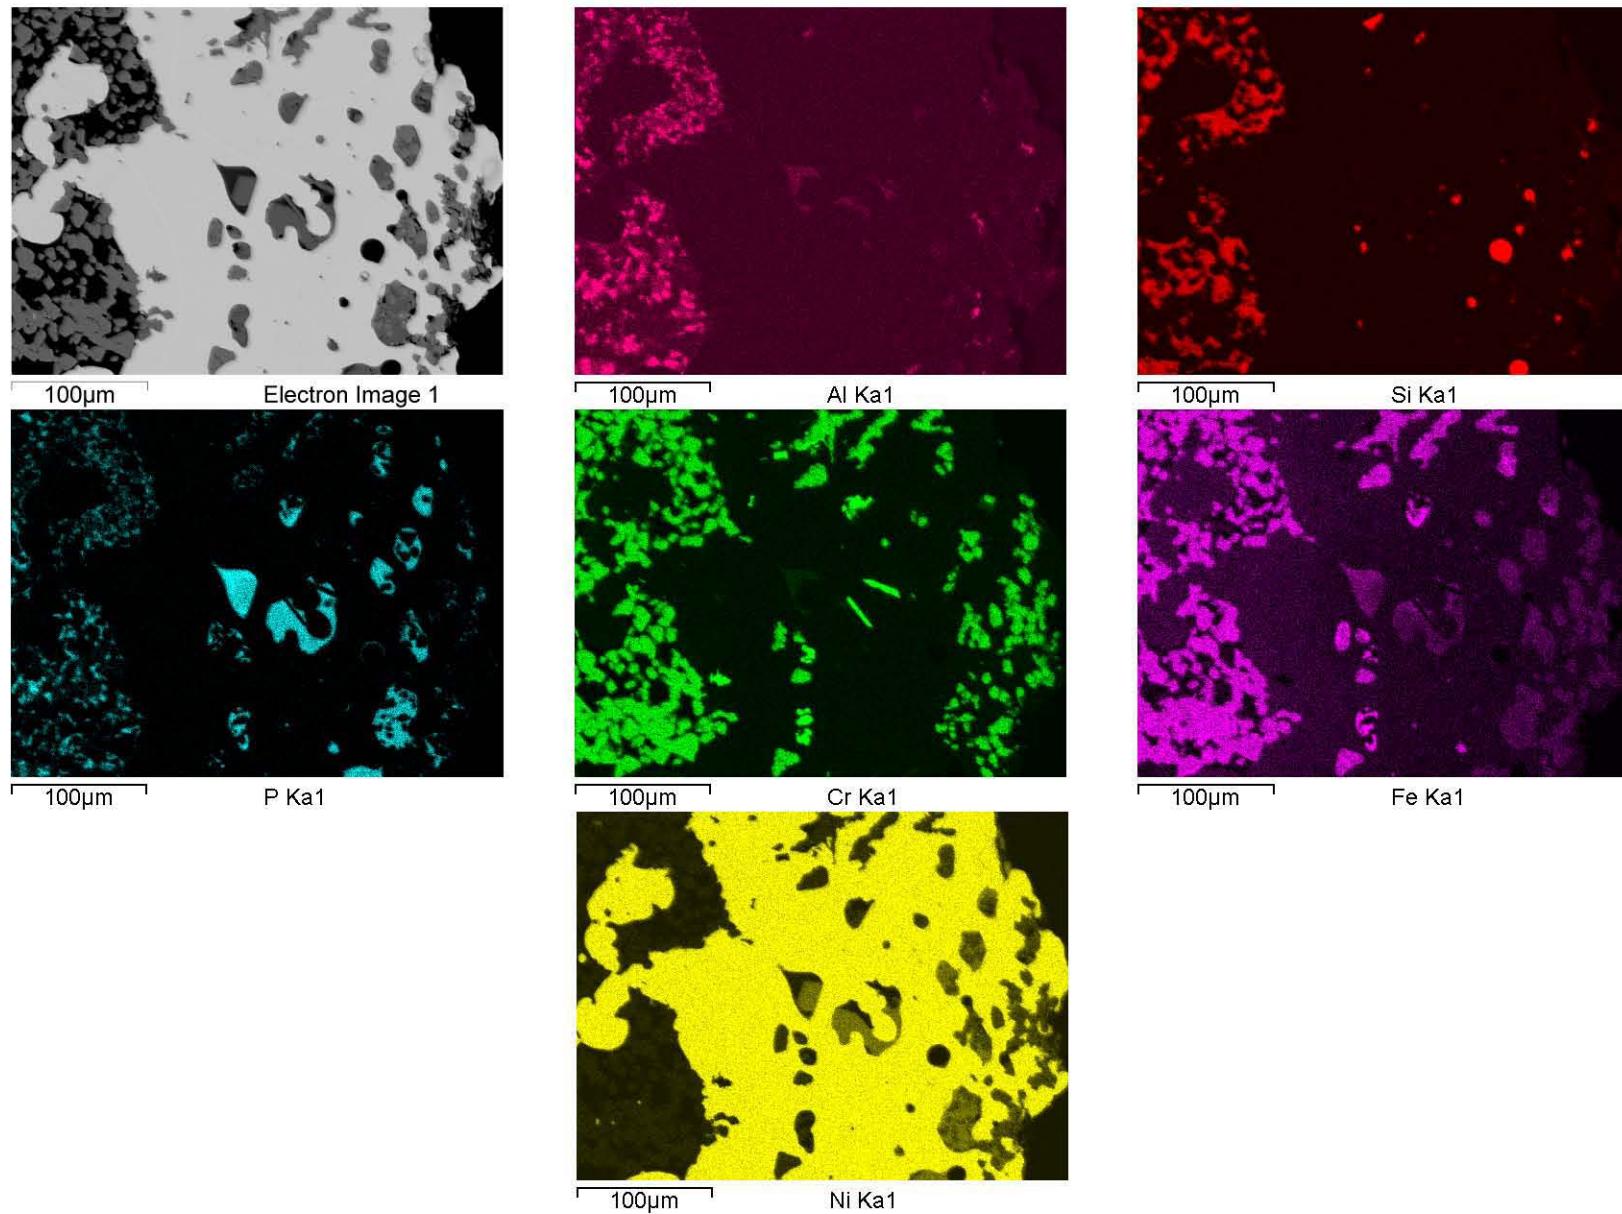
Figure 5.40. Detached nodule in corroded area of O-12Q-31C. Mixed phosphates, no bismuth, no sulfur, silicon rich areas seem to be pure silica.

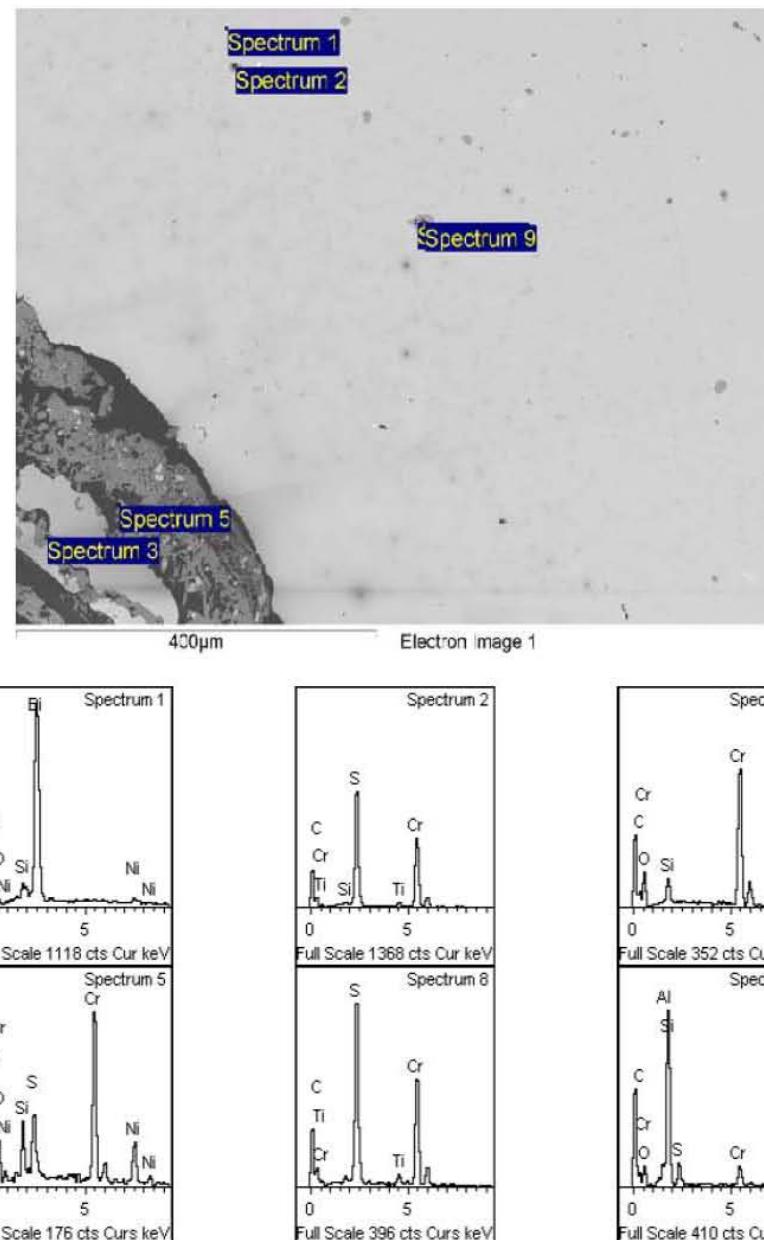
Figure 5.41. SEM image in O-12Q-31C and EDS analyses at points of interest.

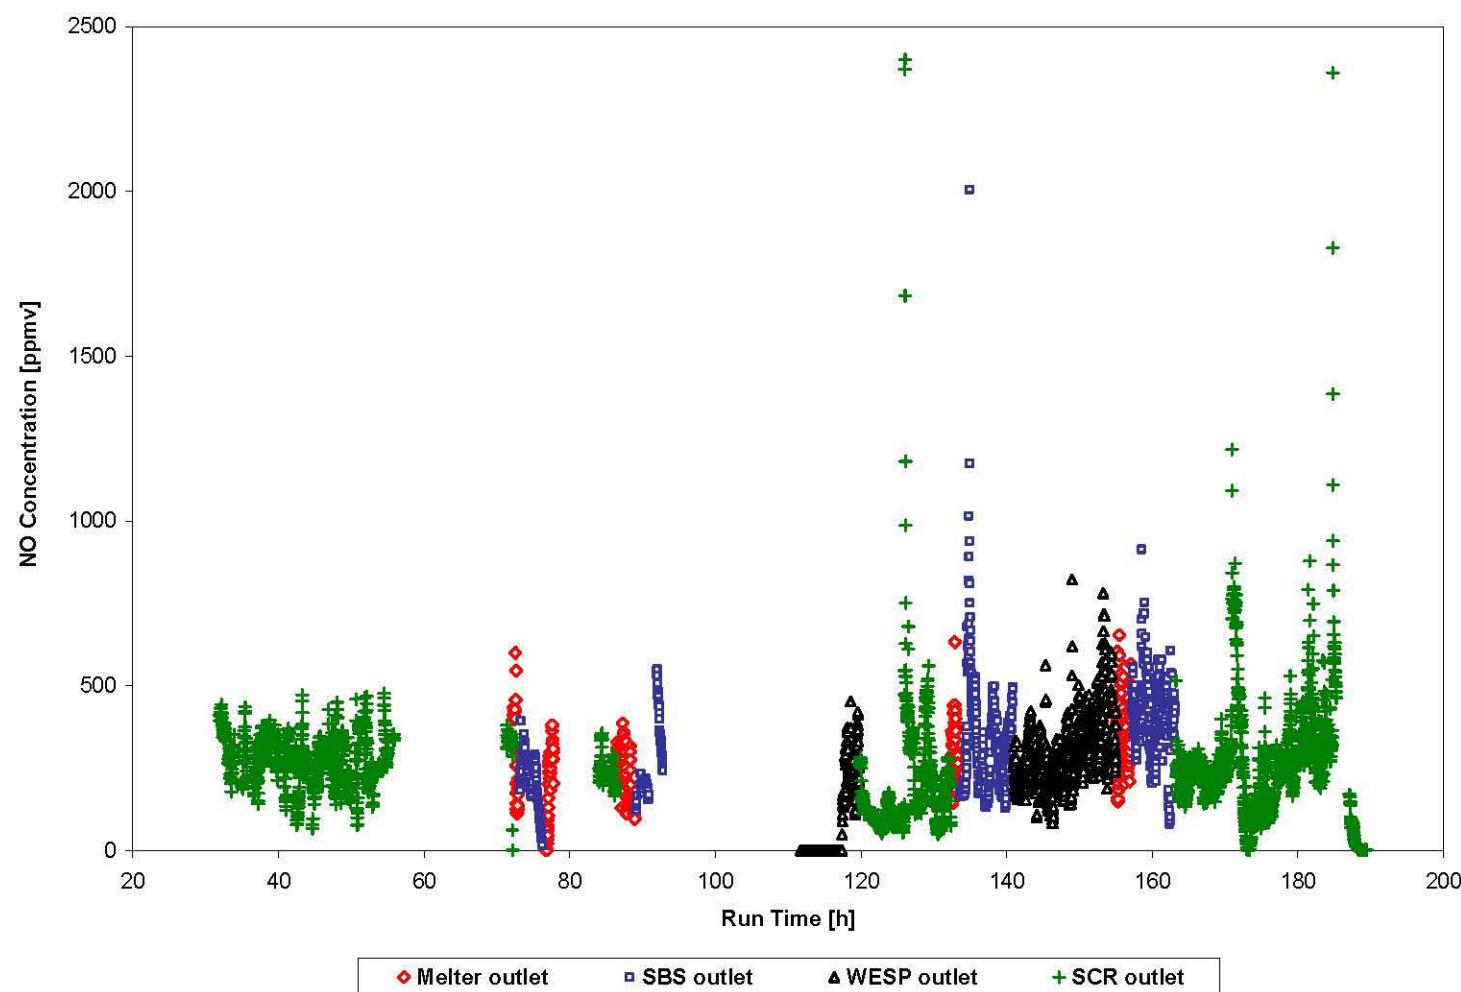
Figure 6.1. FTIR monitored NO emissions during DM1200 tests.
