Tests with High-Bismuth HLW Glasses

**Final Report VSL-10R1780-1, Rev. 0;
12/13/10**

Office of River Protection

K. S. Matlack
Vitreous State Laboratory
The Catholic University of America

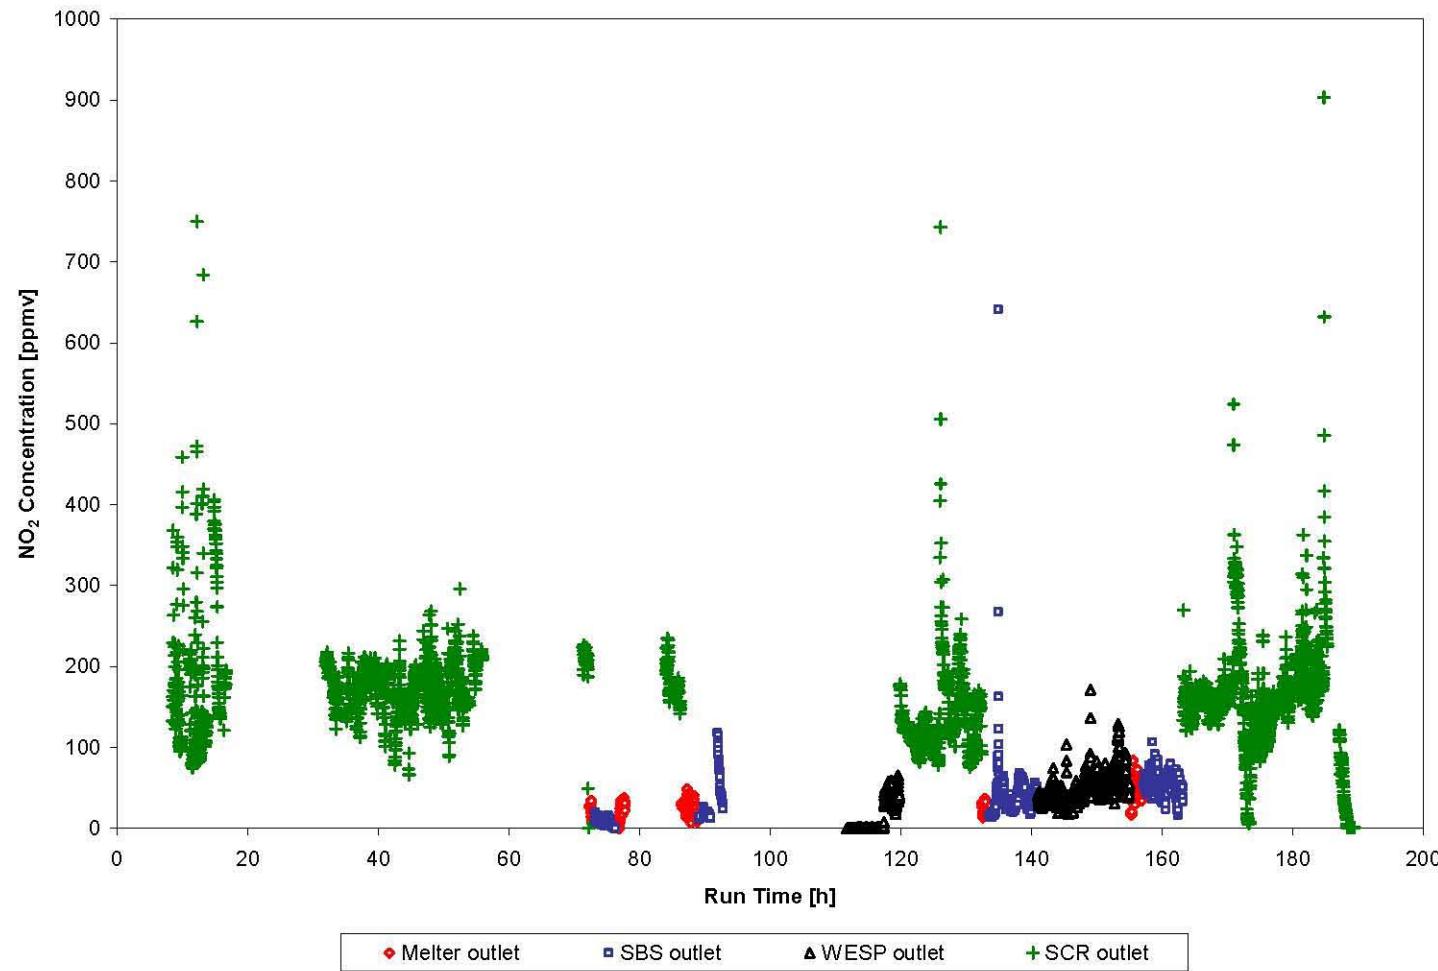
Figure 6.2. FTIR monitored NO_2 emissions during DM1200 tests.

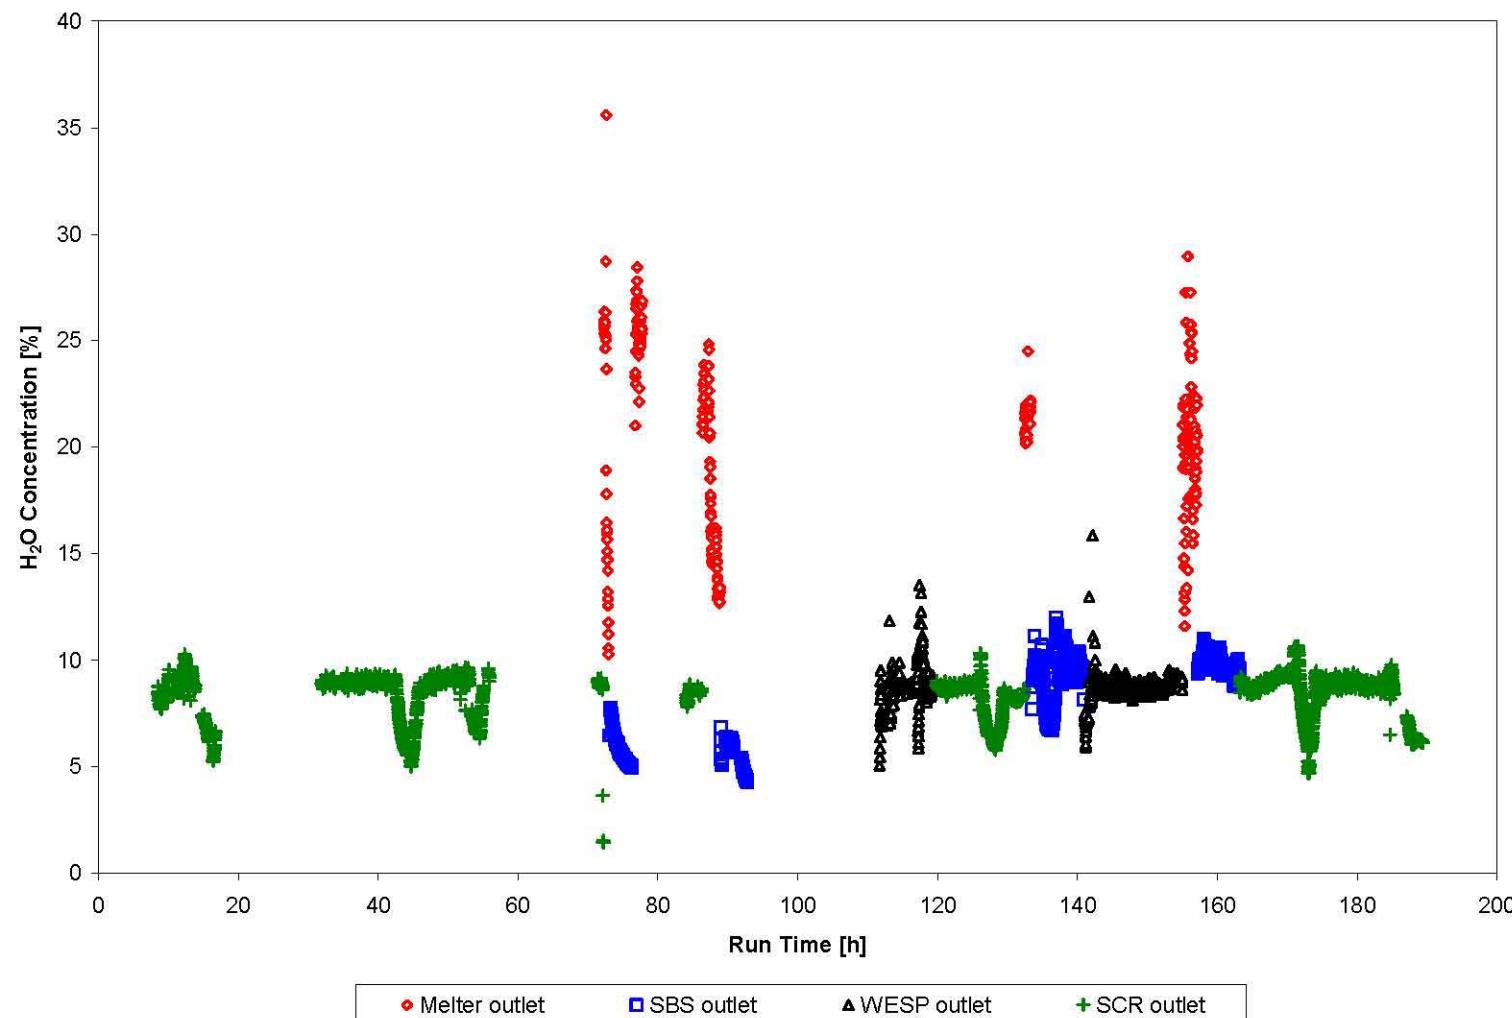
Figure 6.3. FTIR monitored H₂O emissions during DM1200 tests.

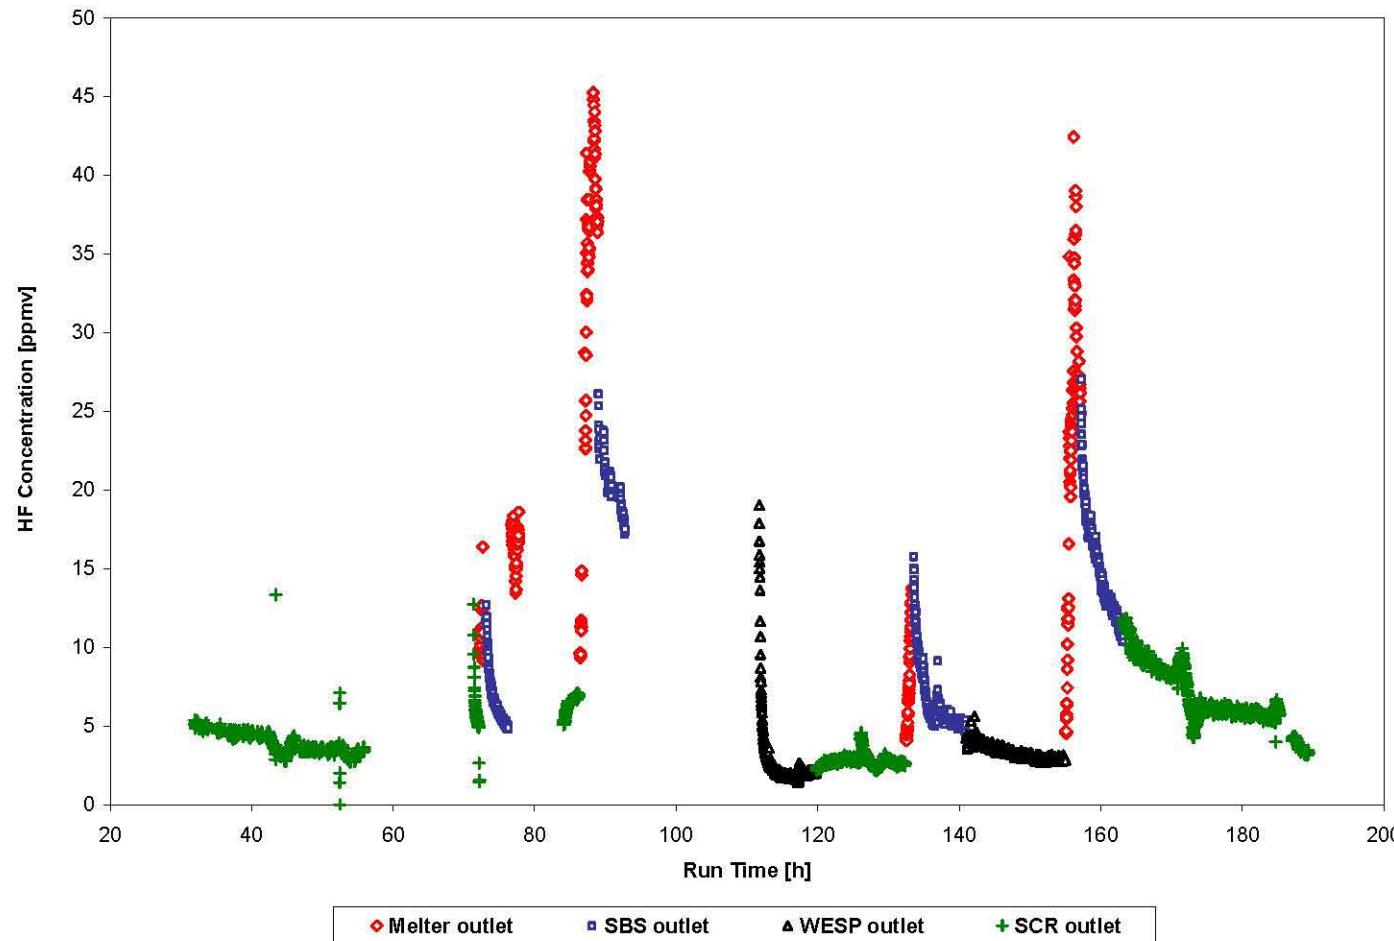
Figure 6.4. FTIR monitored HF emissions during DM1200 tests.

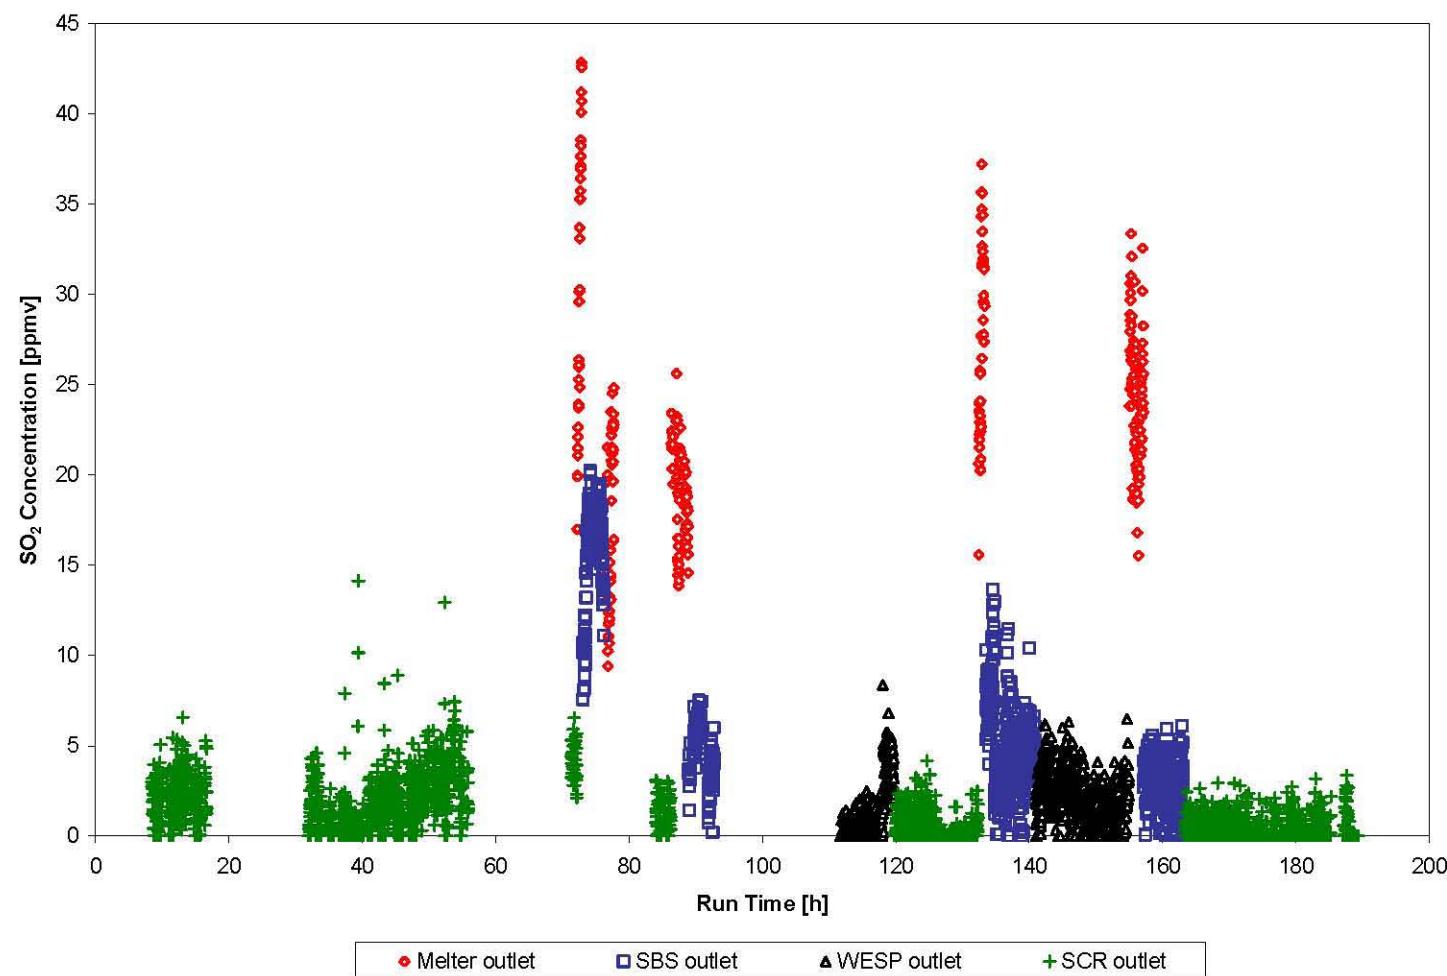
Figure 6.5. FTIR monitored SO_2 emissions during DM1200 tests.
