**FRIJOLITO WATERSHED: INTEGRATED INVESTIGATIONS
OF A RAPIDLY ERODING PINYON-JUNIPER HILLSLOPE**

**Bradford P. Wilcox, EES-15
John Pitlick, University of Colorado
Craig D. Allen, Bandelier National Monument**

**Semiarid Hydrology Conference
Tucson, AZ
November 1-3, 1994**

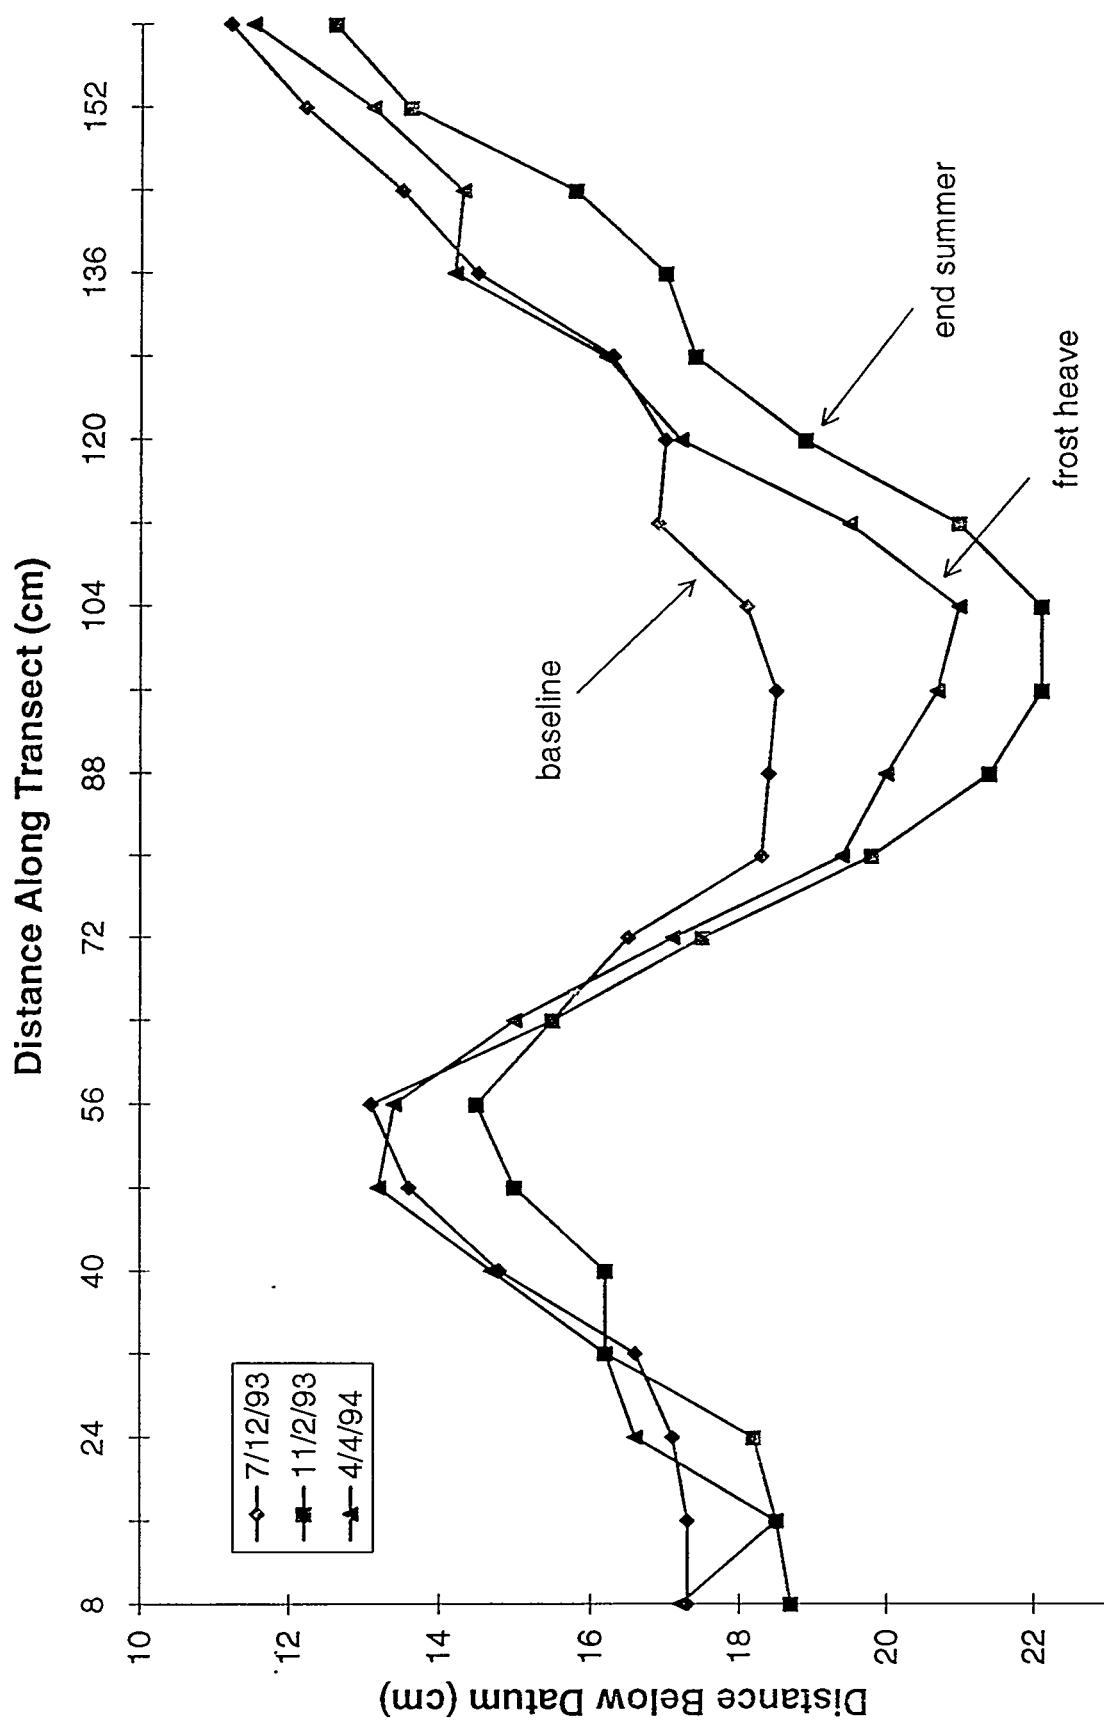
Figure 1. Microtopography measurements from one location on the catchment.

Microtopography-measurement sites: The microtopographic measurements show that in the summer of 1993, surface elevations changed substantially as a result of erosion and of frost heaving over the winter (Figure 1). Most of the soil erosion (or deposition) occurred in localized zones, which show changes in elevation of up to several centimeters. The average change in elevation at the 20 measurement sites that summer was -3.4 mm. Assuming this rate for the half of the catchment that is intercanopy space, we arrive at an average depth of erosion of 1.7 mm; this translates into 17 m^3 (or 25,500 kg). This is about

Microtopography measurements highlight the impact of frost heaving on surface elevation (Figure 1). During the one winter of observation, the surface rose an average of 7.8 mm. Measurements, made between the spring thaw and runoff-producing storms in the summer, indicate that the surface re-compacted about 5 mm as a result of raindrop impact. From the end of June until the beginning of September the surface deflated another 1.4 mm. This leads to the obvious question of how much surface deflation (during the time that runoff occurs) is due to recompaction by raindrops and how much is due to soil erosion. At this point our analyses are not complete enough and perhaps our measurements are not fine enough to answer that question. We cannot rule out the possibility that some of surface deflation measured in 1993 may have resulted from surface compaction by raindrops.
