**Fire Tests to Evaluate the Potential Fire Threat and its Effect on
HEPA Filter Integrity in Cell Ventilation at the Oak Ridge National
Laboratory Building 7920**

H.K. Hasegawa
and
K.J. Staggs, S.M. Doughty
Fire Research Discipline
Special Projects Division

Prepared for
Martin Marietta Energy Systems Inc.
Oak Ridge National Laboratory

December, 1992

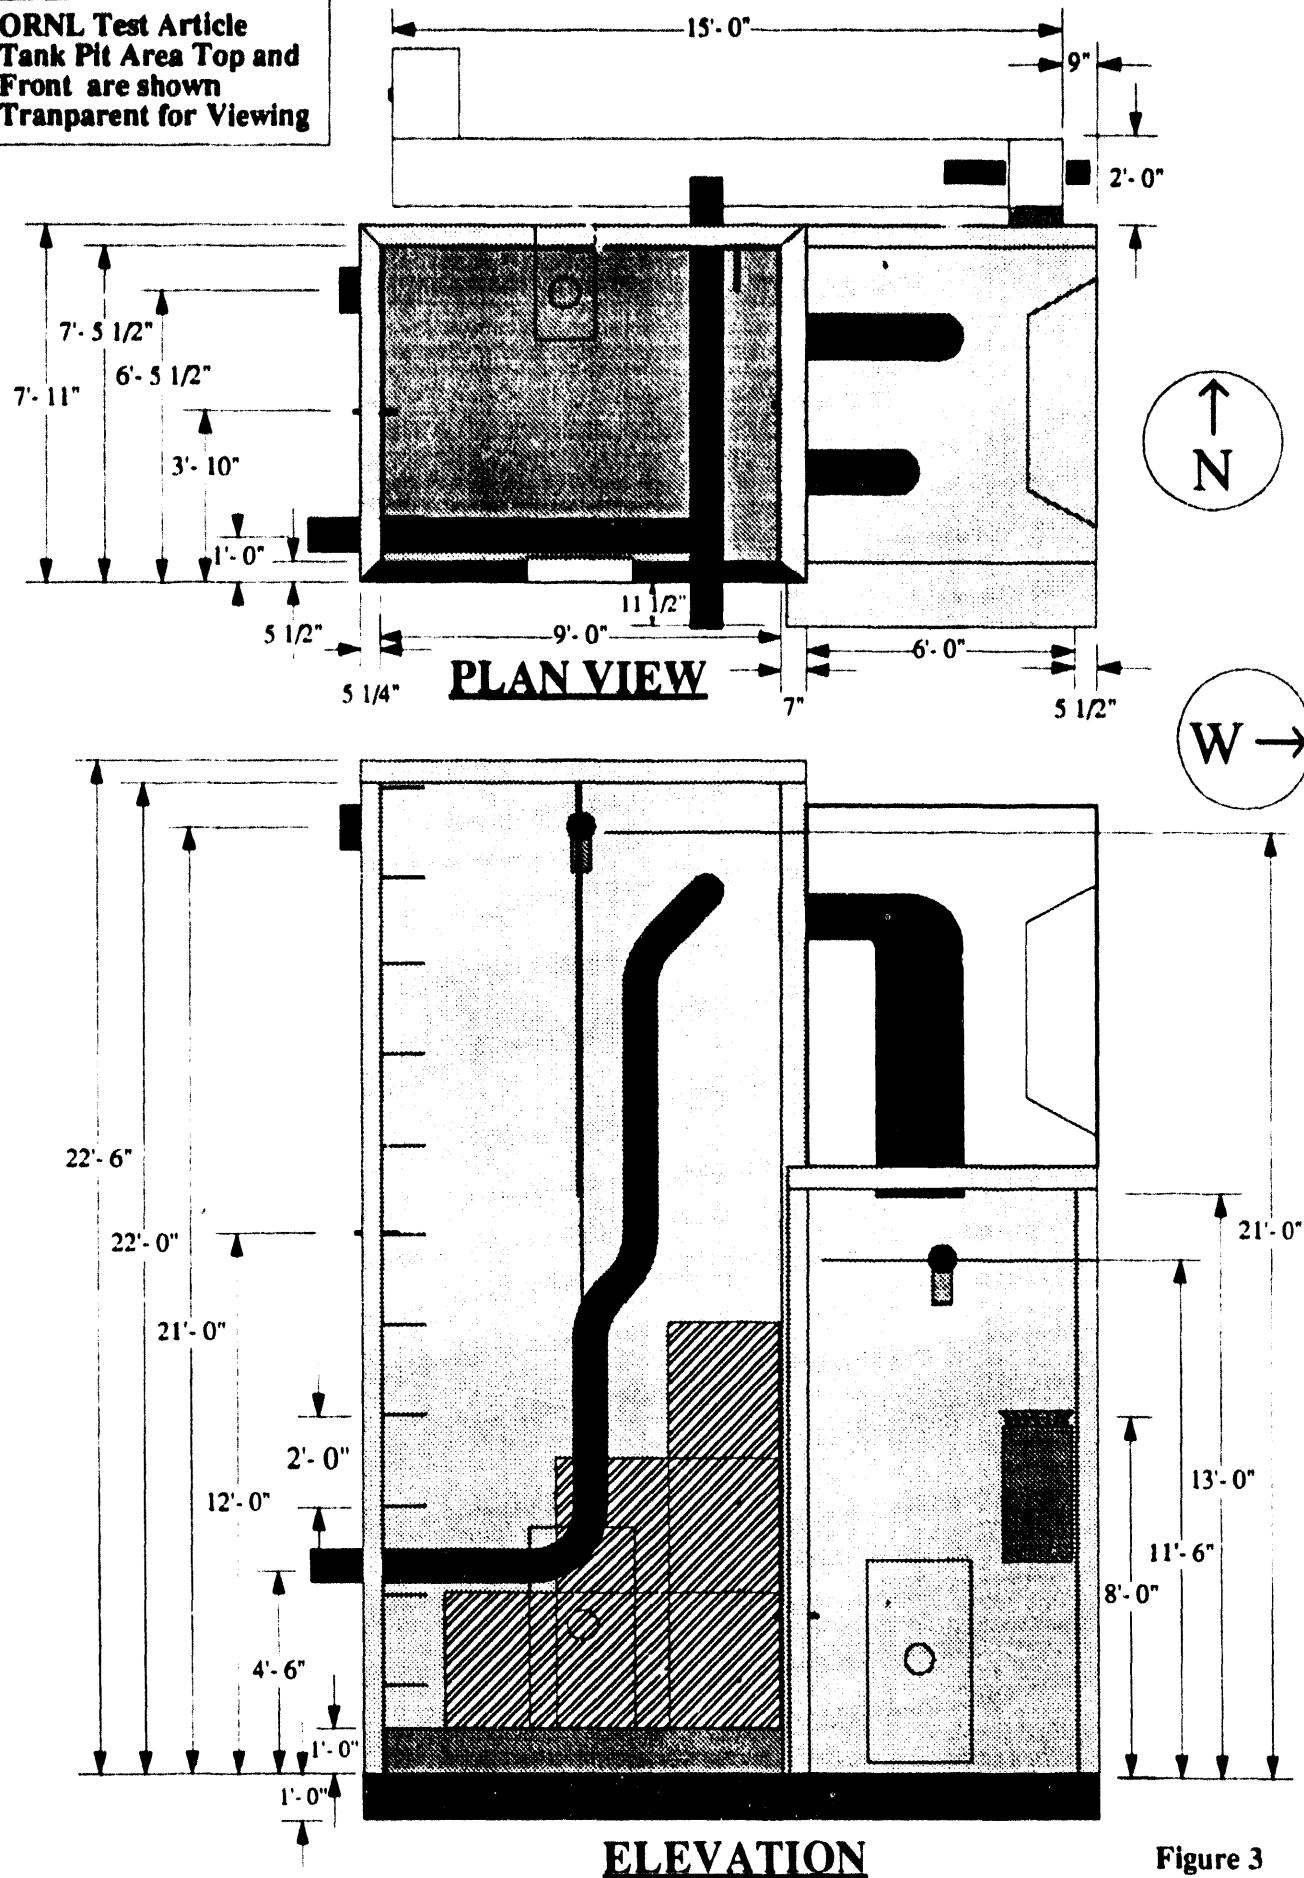
PRIMARY VENTILATION FLOW

Figure 3 displays the dimensions of the tank pit and the cell area that would be below the cubicle. In the actual facility, due to the configuration of the cubicle within the cell, a quantity of air leaks past the cubicle into the lower pit area. We have simulated this leakage airflow with the two 12" diameter snap ducts with 90° bends (total cross sectional area: 226 in²) as shown in Photo 3.

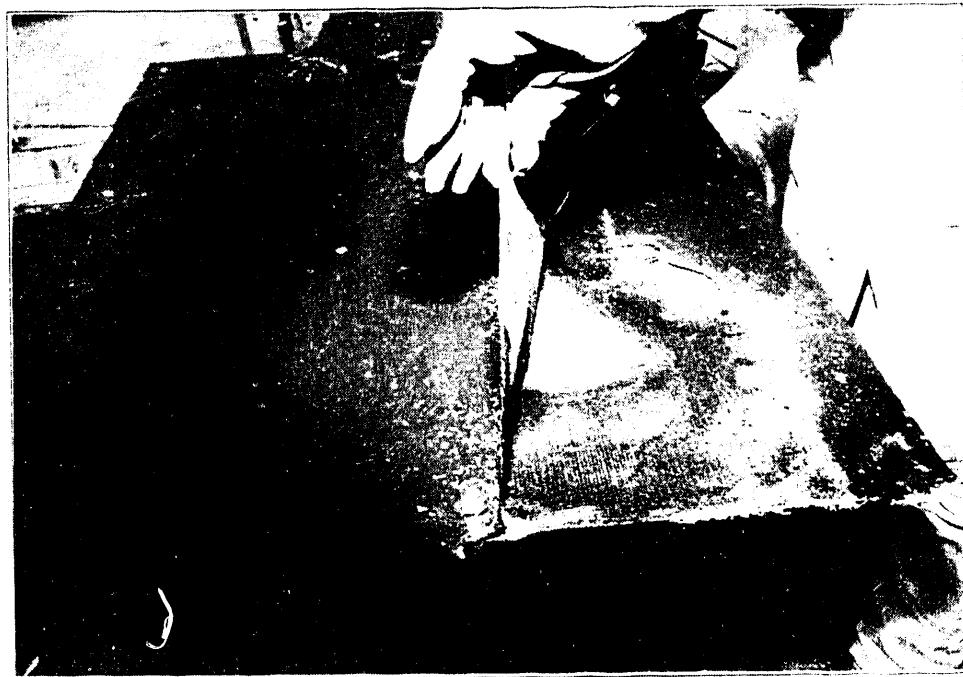
Photo 38 : Post- test close-up of epoxy coated panel

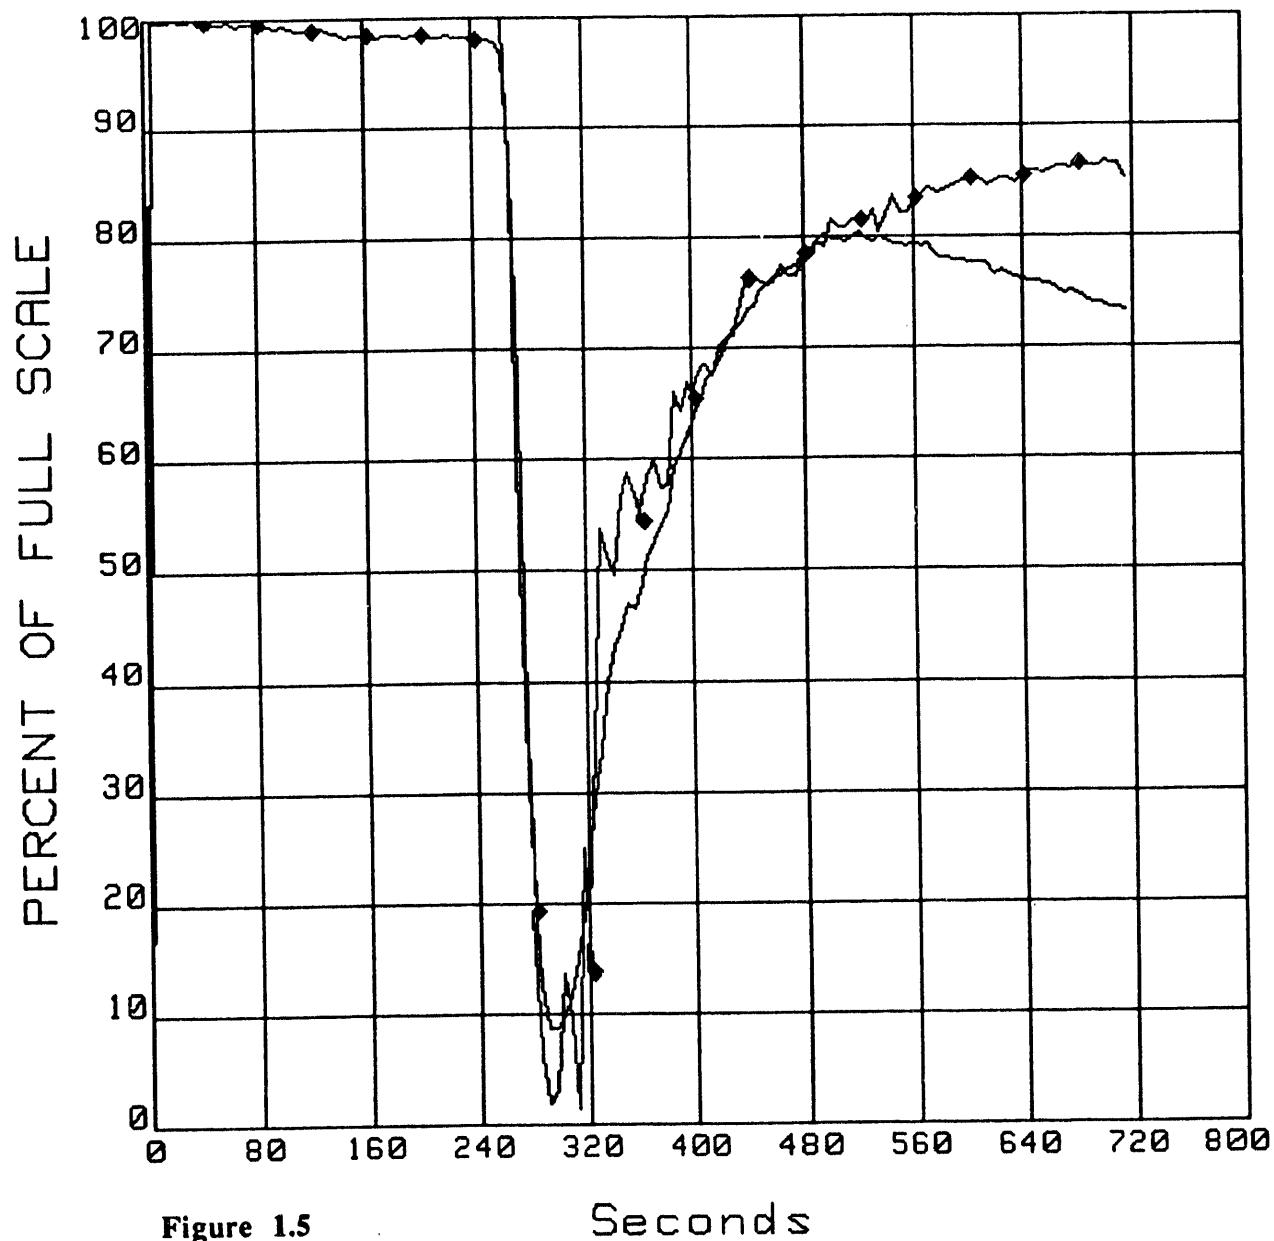
Figure 1.5

FILENAME	CHANNEL	LOCATION	UNIT OF MEASURE	SCALE
ORNL1.0	CH-95	Near Cell	% Transmittance	100
◆ ORNL1.0	CH-96	Before Filters	% Transmittance	100

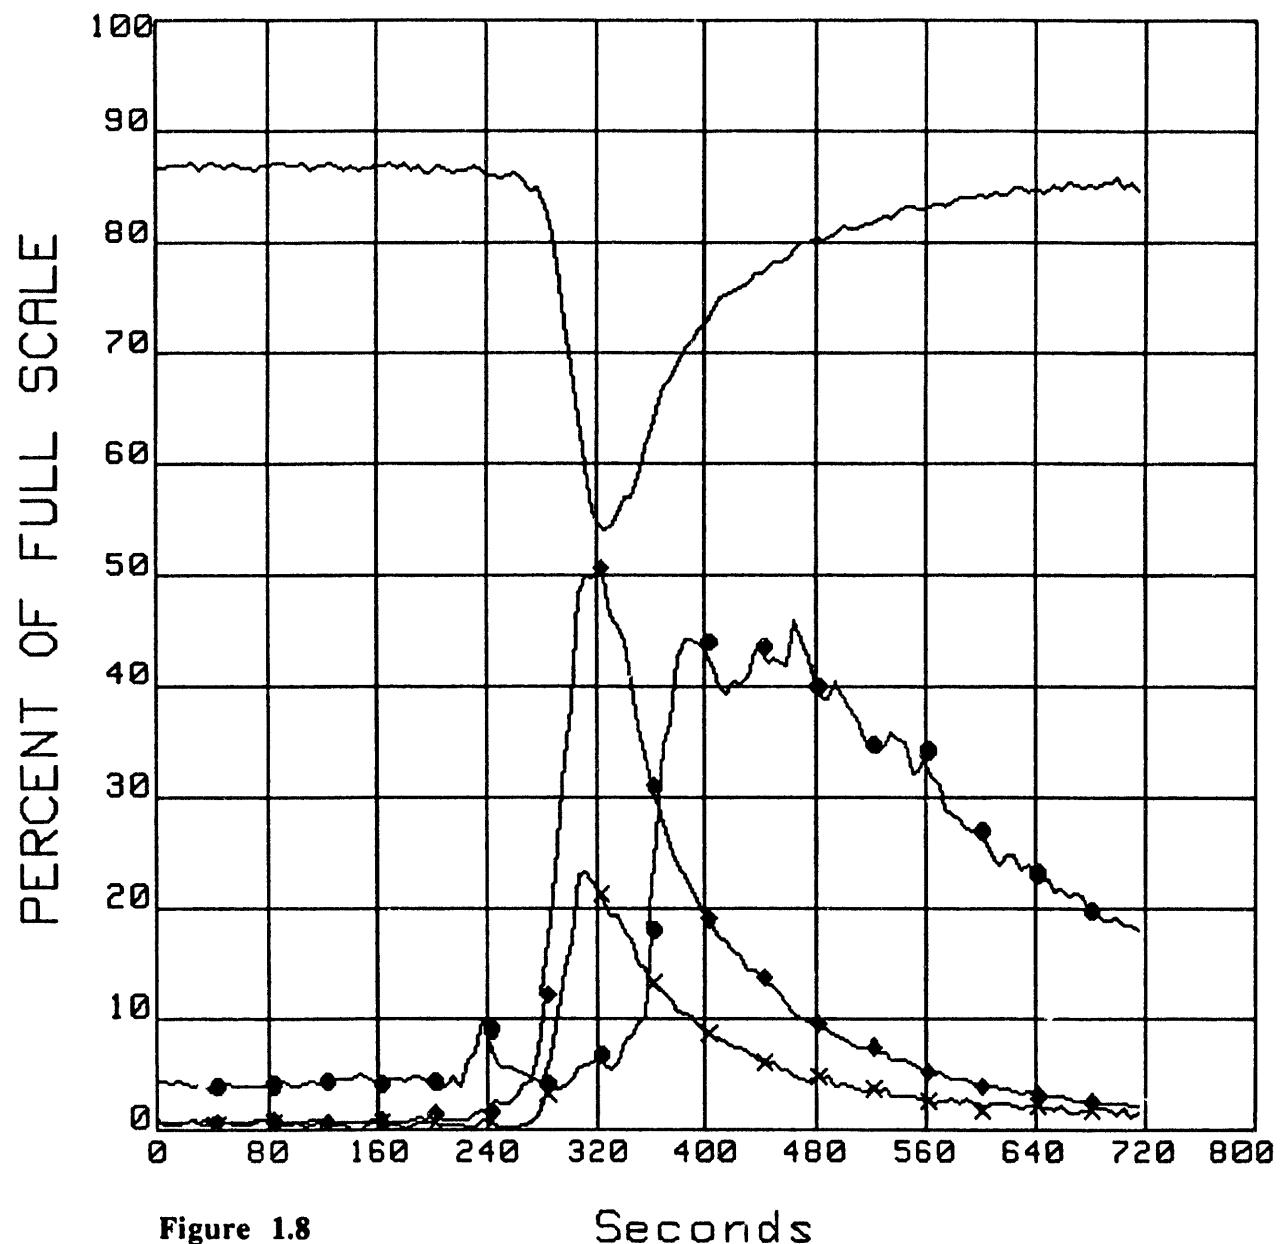
Figure 1.8

FILENAME	CHANNEL	LOCATION	UNIT OF MEASURE	SCALE
ORNL1.0	CH-80	O2 6' UP	% O2	24
◆ ORNL1.0	CH-81	CO2 6' UP	% CO2	12
× ORNL1.0	CH-82	CO 6' UP	% CO	1.2
● ORNL1.0	CH-83	HC 6' UP	PPM (=CH4)	15000

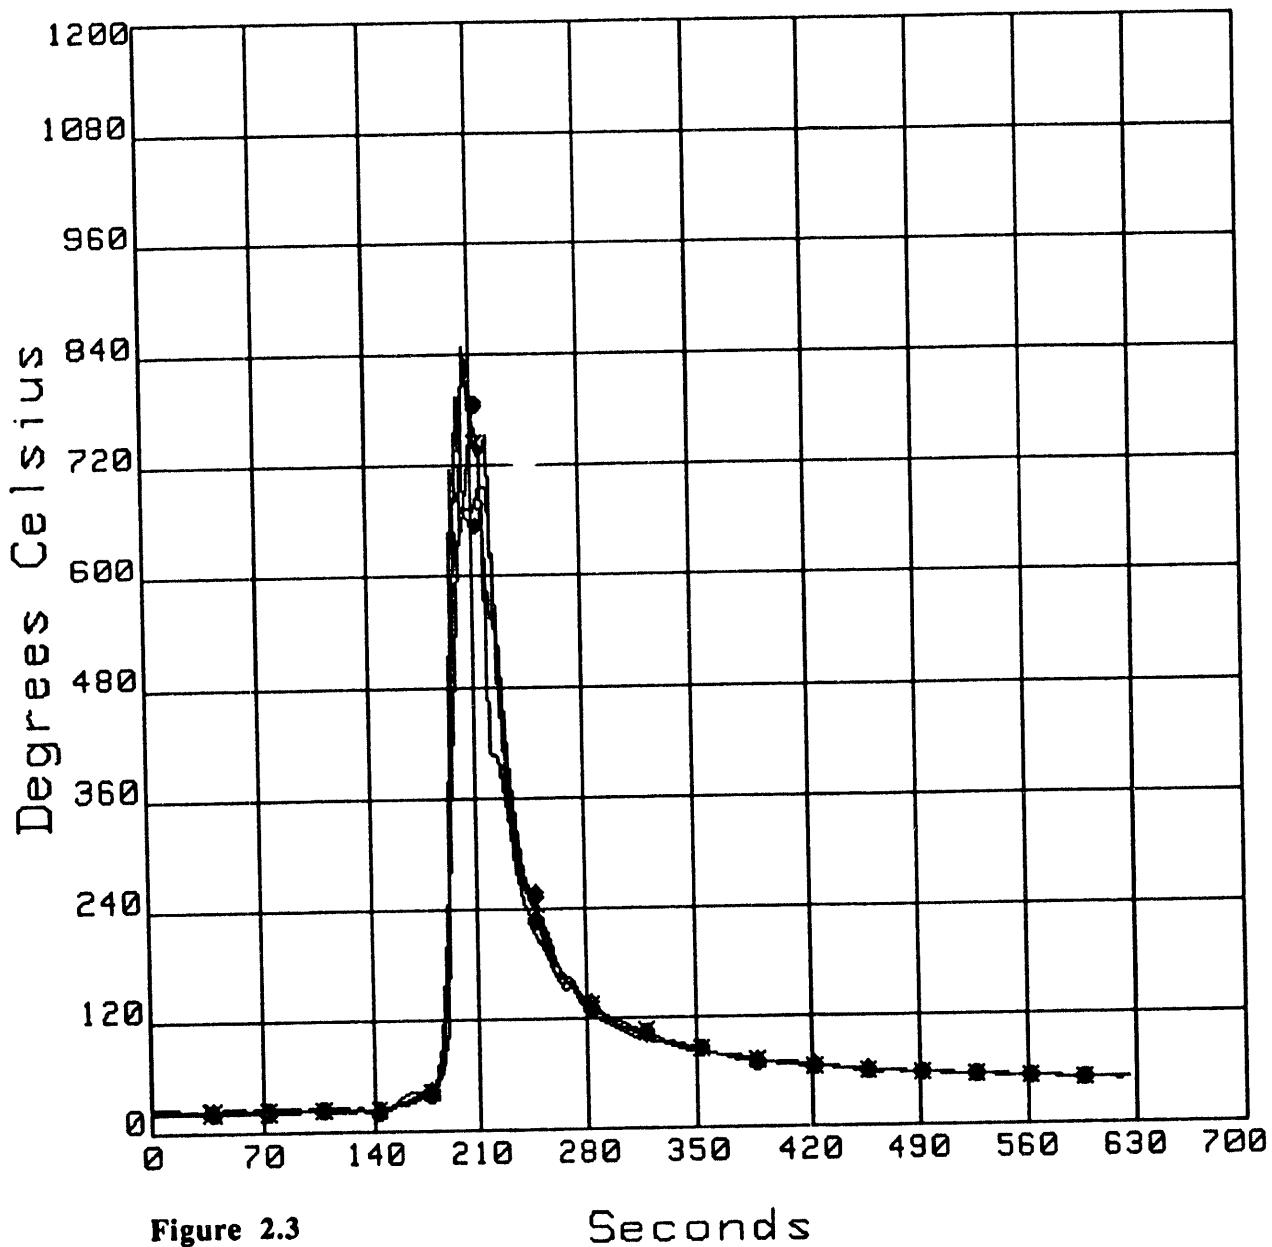
Figure 2.3

FILENAME	CHANNEL	LOCATION	UNIT OF MEASURE	SCALE
ORNL2.0	CH-20	So TC RAKE 6' UP	Degrees Celsius	1200
◆ ORNL2.0	CH-21	So TC RAKE 2' UP	Degrees Celsius	1200
× ORNL2.0	CH-22	So TC RAKE 4' UP	Degrees Celsius	1200
● ORNL2.0	CH-23	So TC RAKE 6' UP	Degrees Celsius	1200

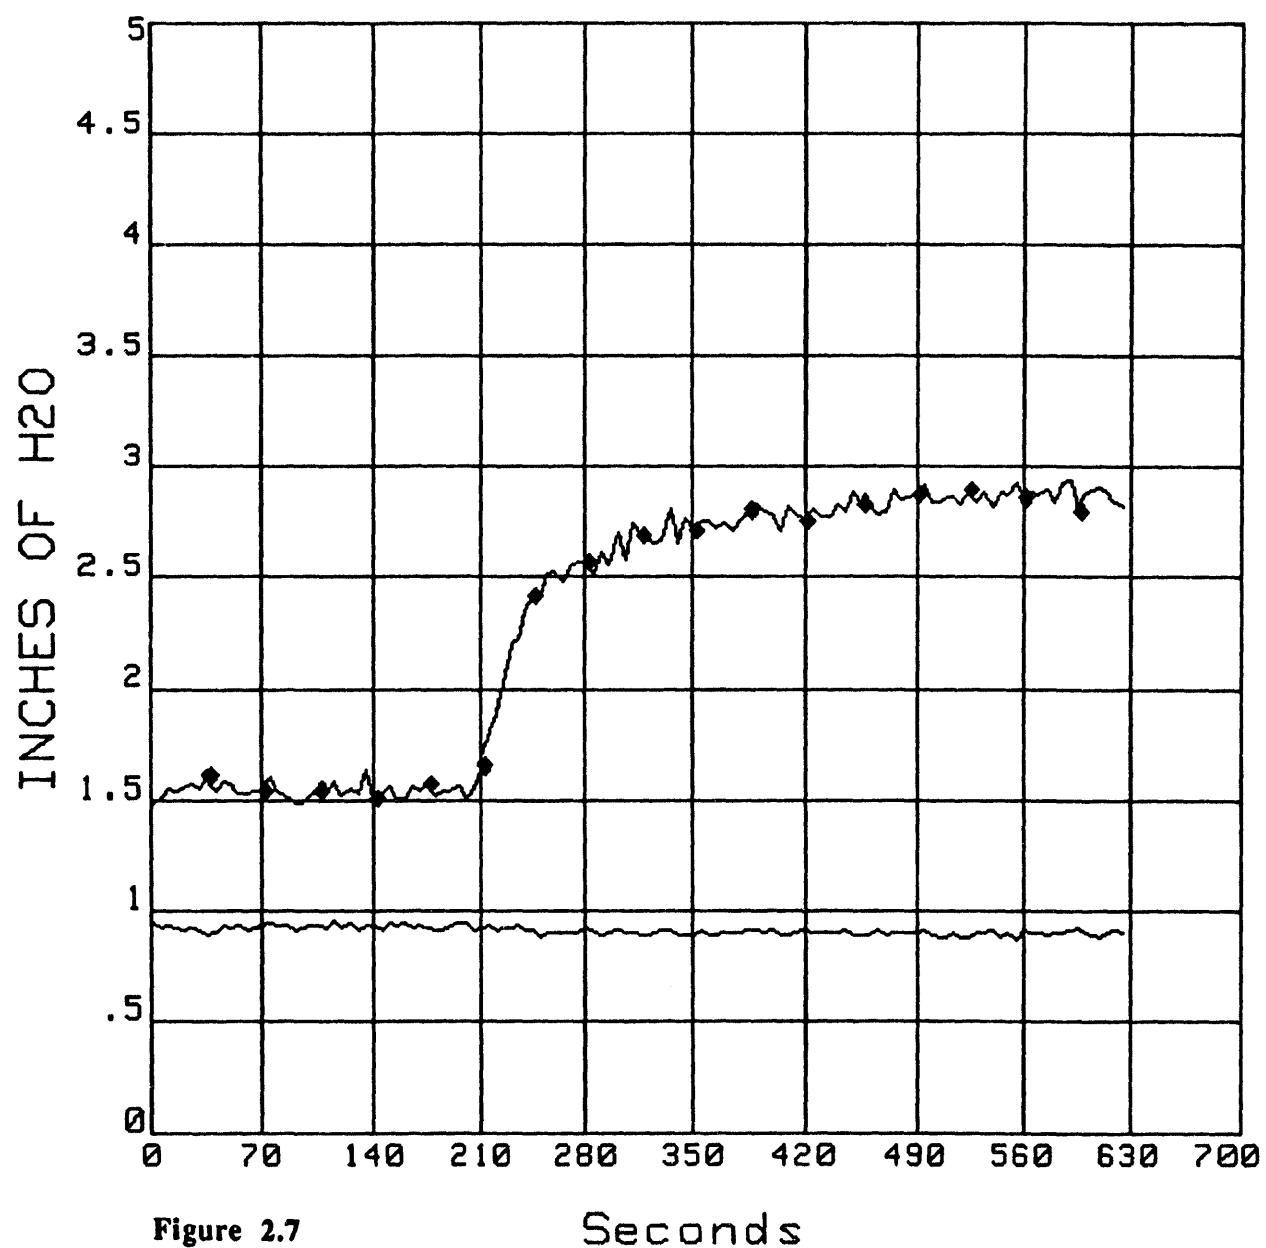
Figure 2.7

FILENAME	CHANNEL	LOCATION	UNIT OF MEASURE	SCALE
◆ ORNL2.0	CH-109	Delta P HEPA	INCHES H ₂ O	5
◆ ORNL2.0	CH-110	Delta P PreFilter	INCHES H ₂ O	5

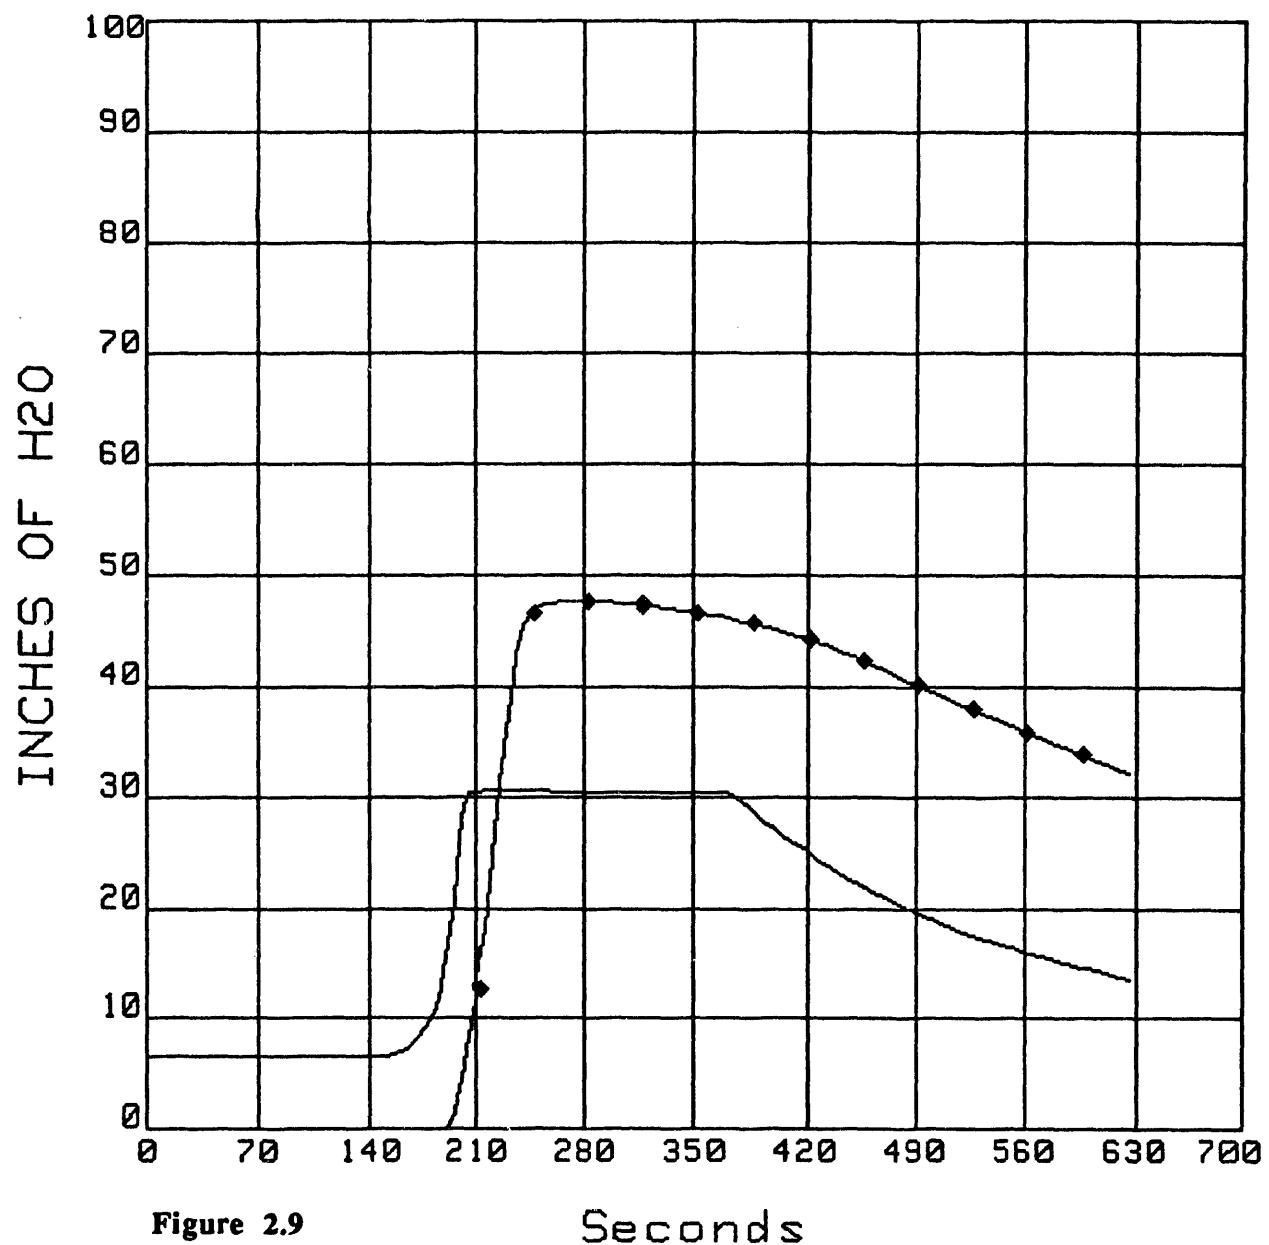
Figure 2.9

FILENAME	CHANNEL	LOCATION	UNIT OF MEASURE	SCALE
◆ ORNL2:0	CH-112	Heat Sensor 22' side	INCHES H2O	100
◆ ORNL2:0	CH-113	Heat Sensor 13' side	Inches H2O	100

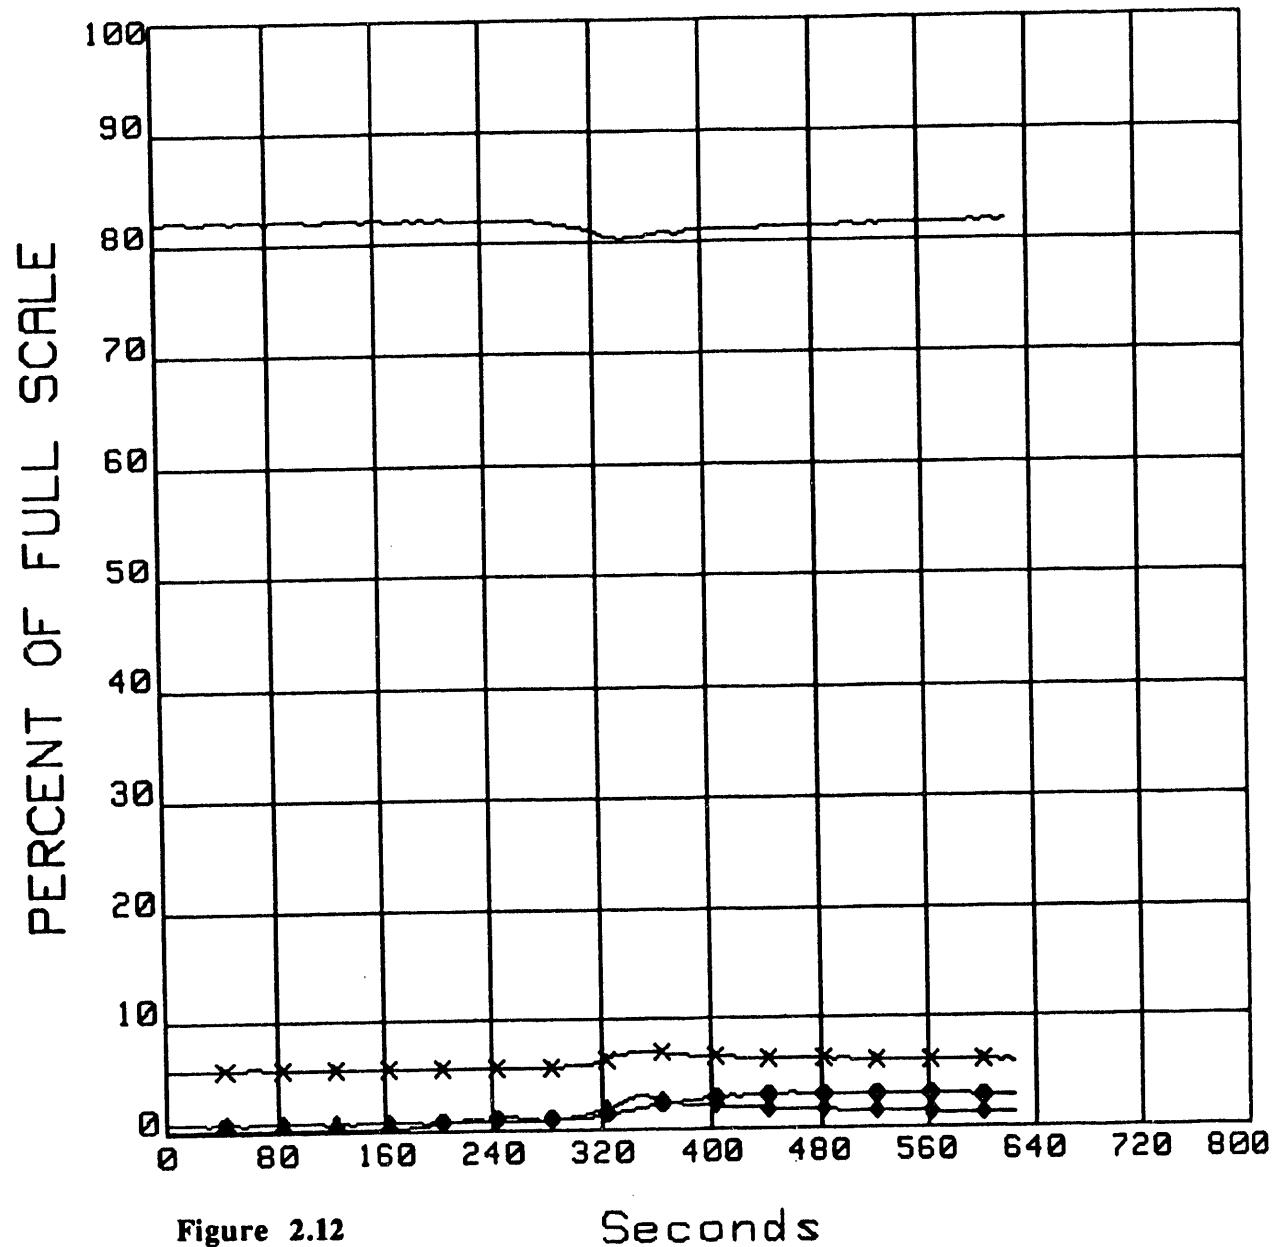
Figure 2.12

FILENAME	CHANNEL	LOCATION	UNIT OF MEASURE	SCALE
ORNL2.0	CH-88	O2 Duct Node	X O2	25
◆ ORNL2.0	CH-89	CO2 Duct Node	X CO2	12
✗ ORNL2.0	CH-90	CO Duct Node	X CO	1
● ORNL2.0	CH-91	HC Duct Node	PPM (=CH4)	5000

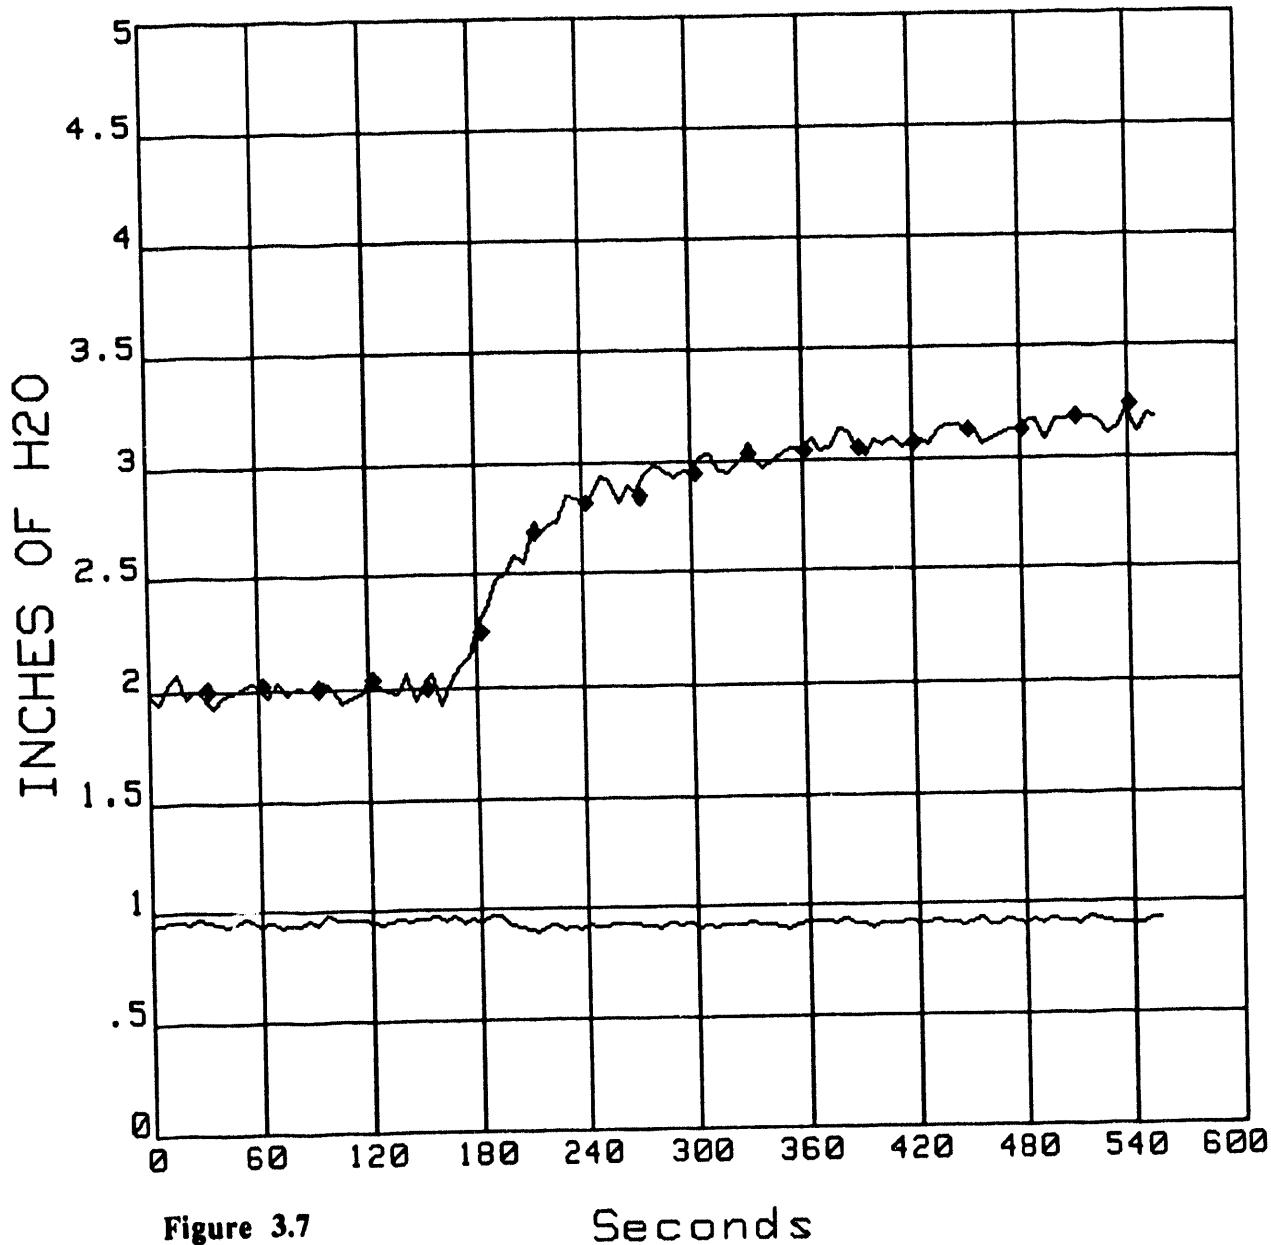
Figure 3.7

FILENAME	CHANNEL	LOCATION	UNIT OF MEASURE	SCALE
ORNL3:0	CH-109	Delta P HEPA	INCHES H ₂ O	5
◆ ORNL3:0	CH-110	Delta P PreFilter	INCHES H ₂ O	5

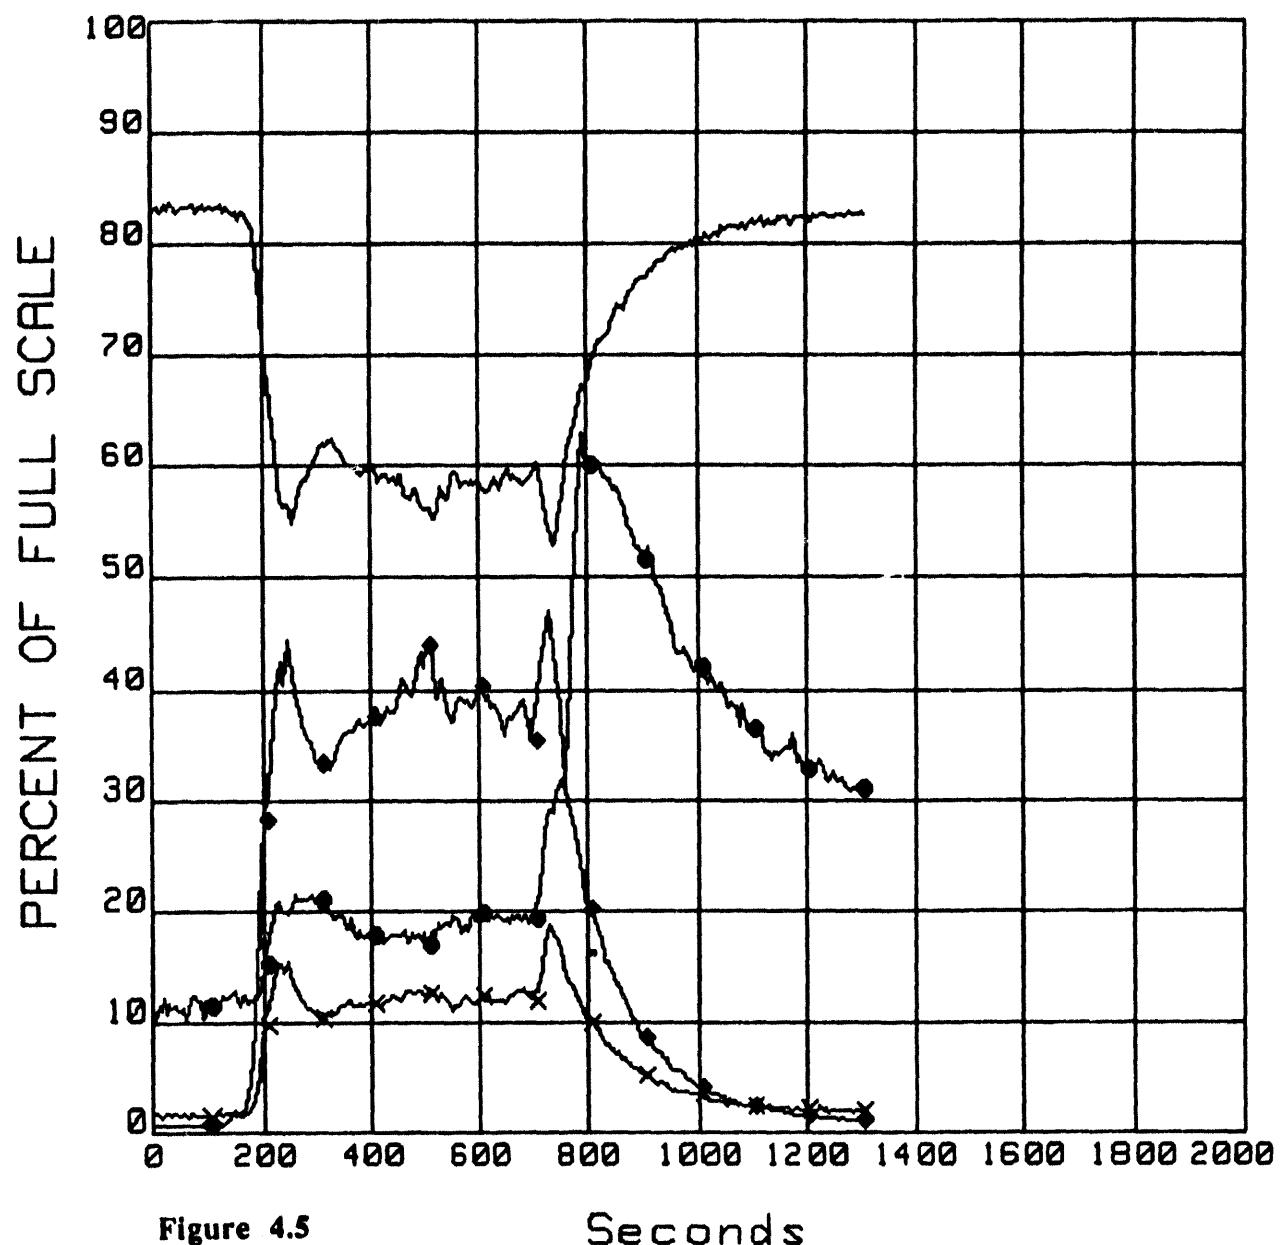
Figure 4.5

FILENAME	CHANNEL	LOCATION	UNIT OF MEASURE	SCALE
ORNL4.0	CH-80	O2 6' UP	% O2	25
◆ ORNL4.0	CH-81	CO2 6' UP	% CO2	12
× ORNL4.0	CH-82	CO 6' UP	% CO	1.5
● ORNL4.0	CH-83	HC 6' UP	PPM (=CH4)	25000

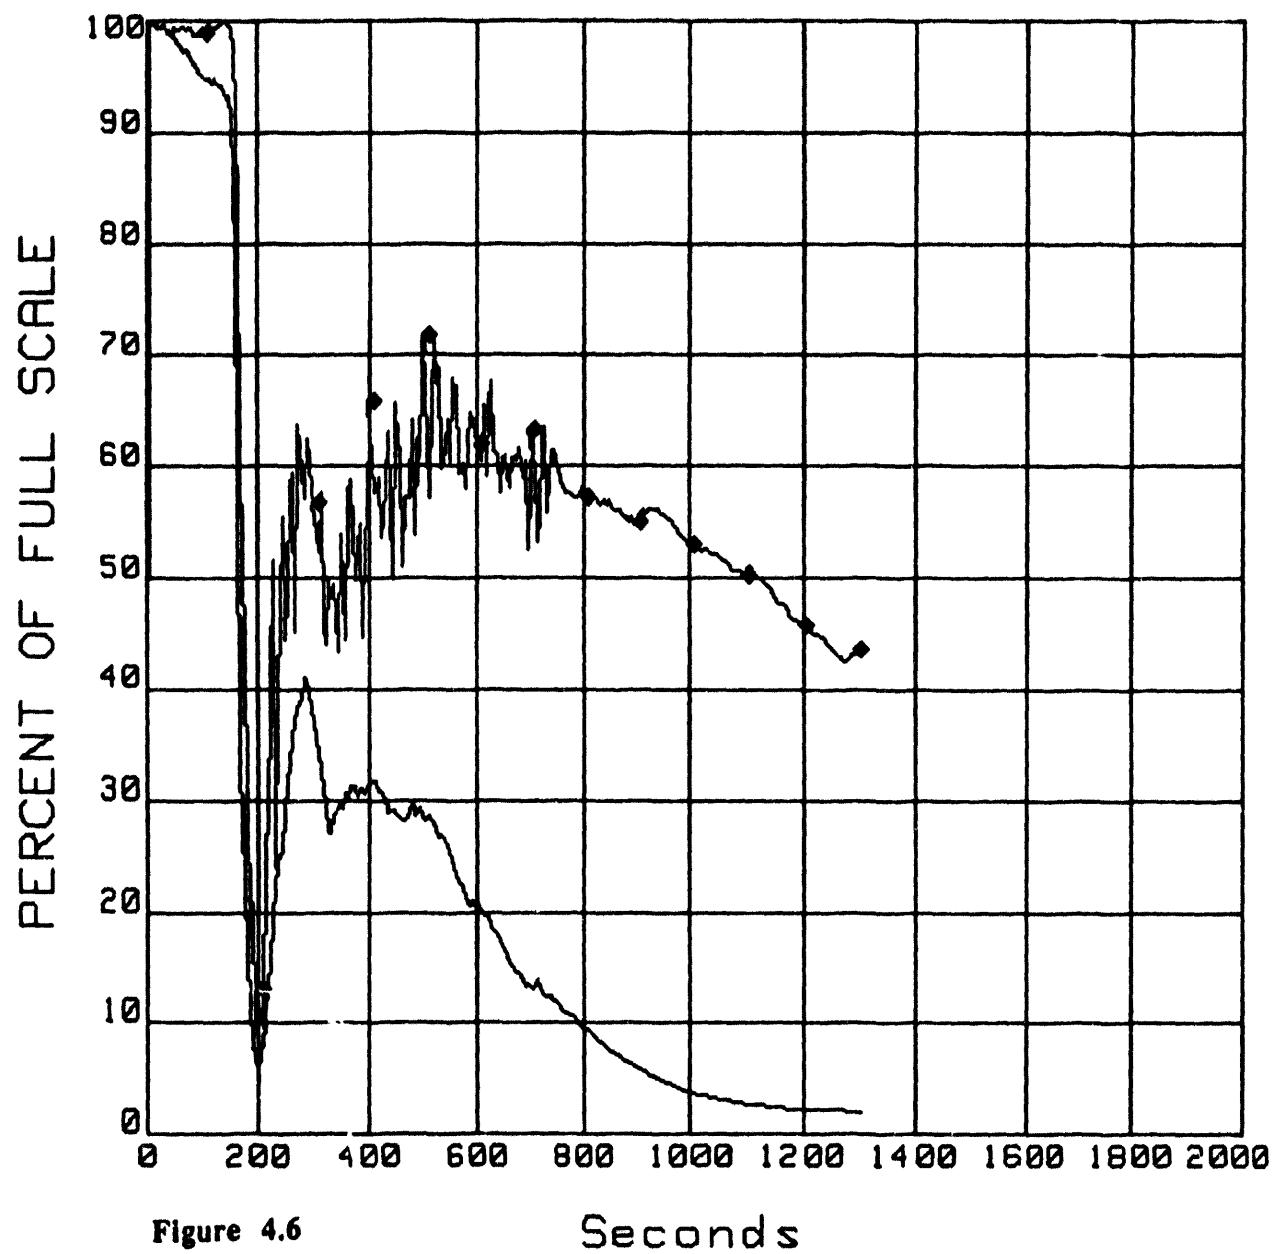
Figure 4.6

FILENAME	CHANNEL	LOCATION	UNIT OF MEASURE	SCALE
ORNL4.0	CH-95	Near Cell	% Transmittance	100
◆ ORNL4.0	CH-96	Before Filters	% Transmittance	100

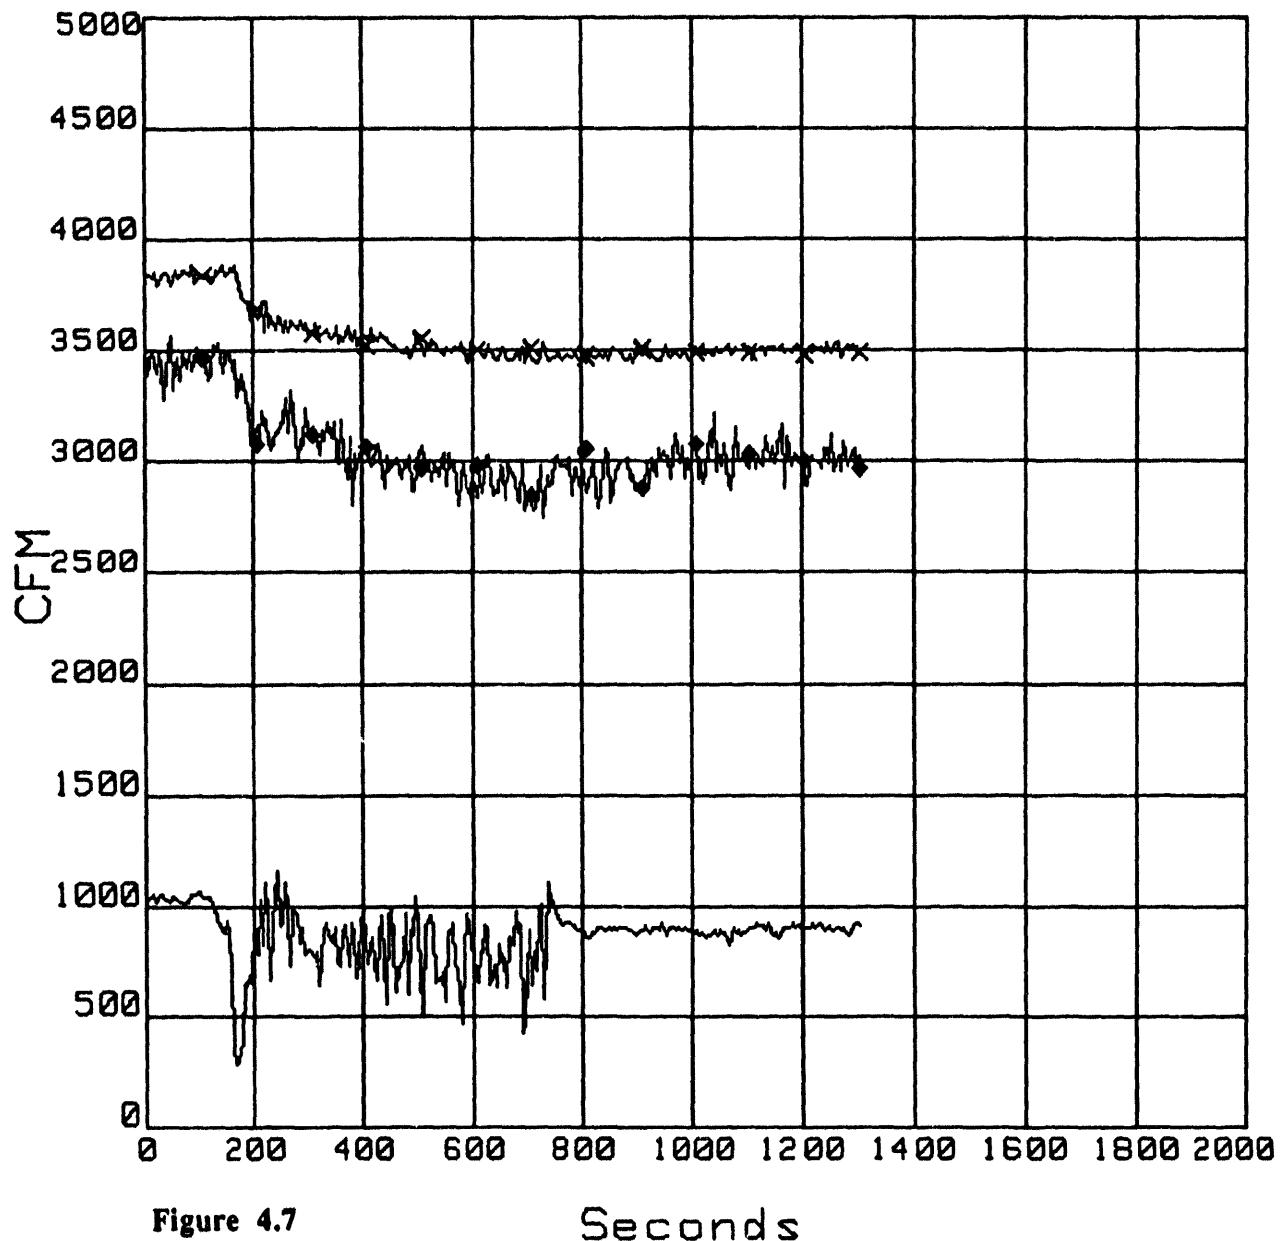
Figure 4.7

FILENAME	CHANNEL	LOCATION	UNIT OF MEASURE	SCALE
ORNL4.0	CH-102	Inlet A/F (TFM)	CFM	5000
◆ ORNL4.0	CH-104	Exit A/F (Pitot)	CFM	5000
× ORNL4.0	CH-105	Exit A/F (TFM)	CFM	5000

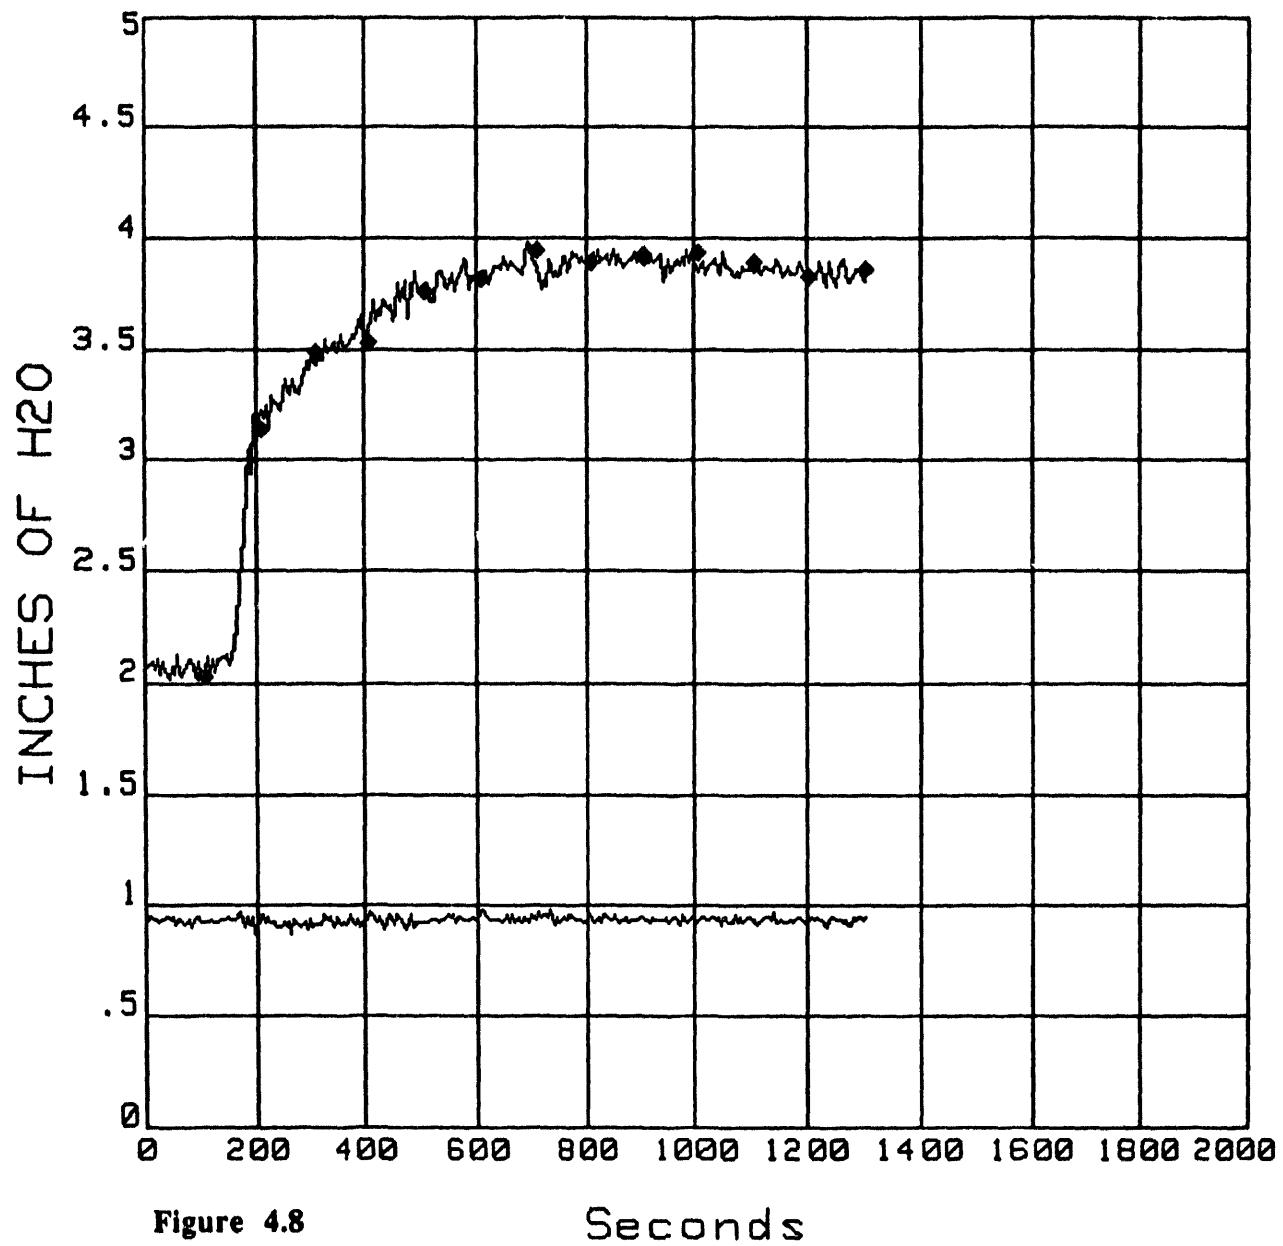
Figure 4.8

FILENAME	CHANNEL	LOCATION	UNIT OF MEASURE	SCALE
ORNL4.0	CH-109	Delta P HEPA	INCHES H ₂ O	5
◆ ORNL4.0	CH-110	Delta P PreFilter	INCHES H ₂ O	5

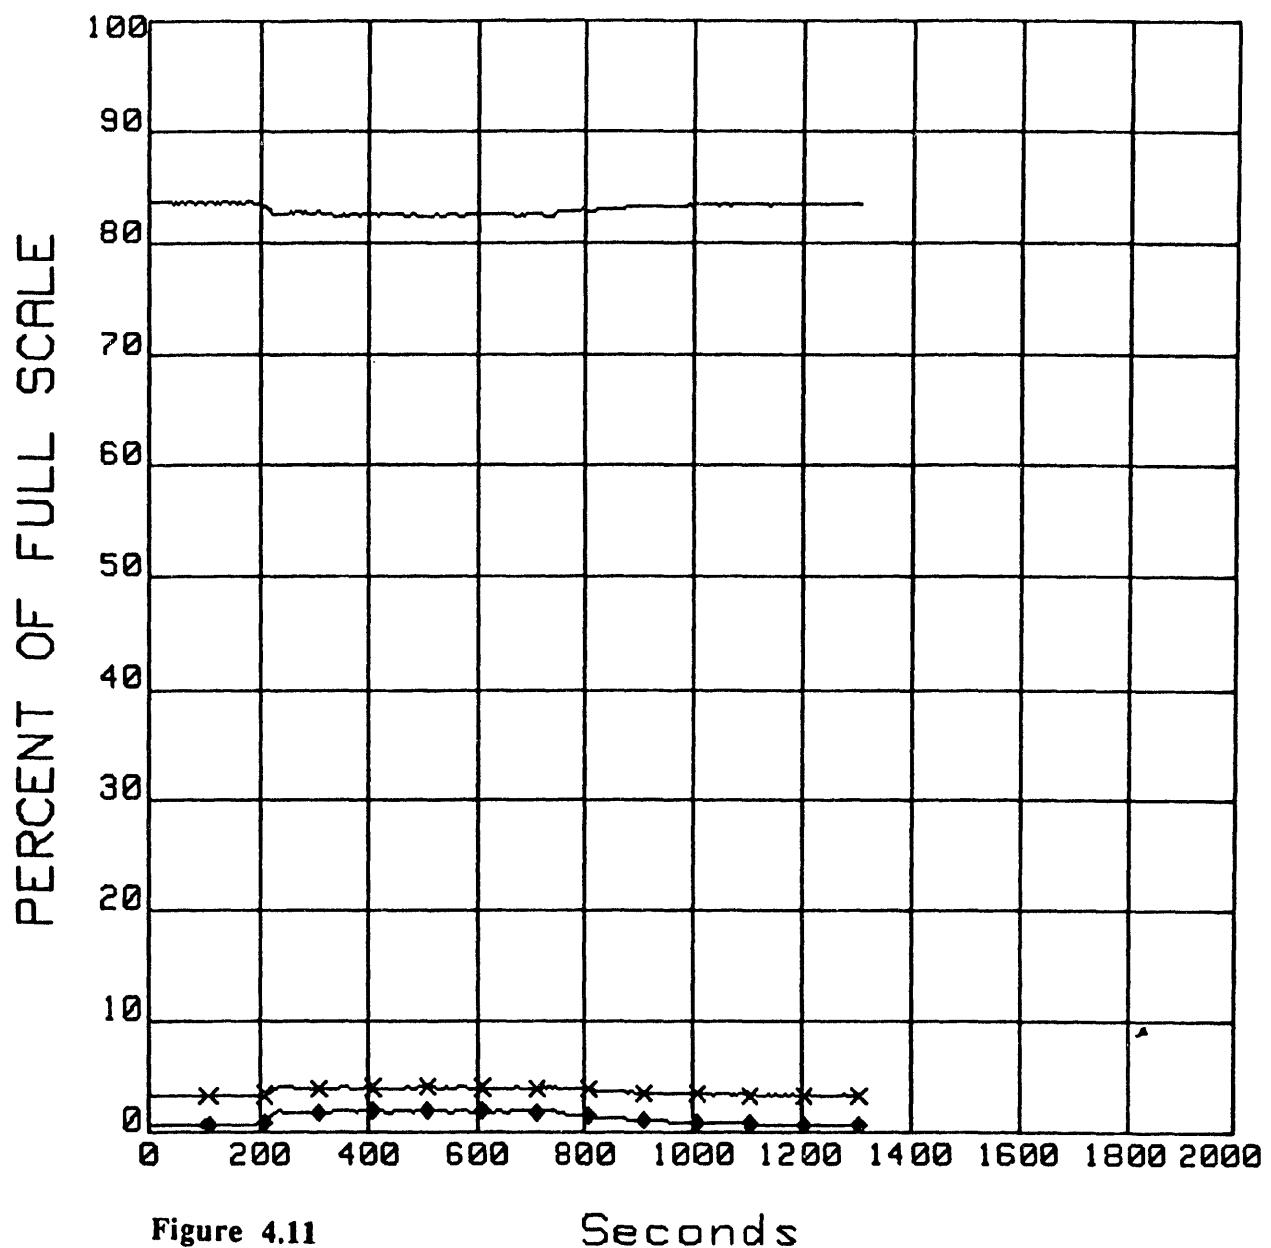
Figure 4.11

FILENAME	CHANNEL	LOCATION	UNIT OF MEASURE	SCALE
ORNL4.0	CH-84	O2 12' UP	% O2	25
◆ ORNL4.0	CH-85	CO2 12' UP	% CO2	12
× ORNL4.0	CH-86	CO 12' UP	% CO	1.5
● ORNL4.0	CH-87	HC 12' UP	PPM (=CH4)	25000
