**Fire Tests to Evaluate the Potential Fire Threat and its Effect on
HEPA Filter Integrity in Cell Ventilation at the Oak Ridge National
Laboratory Building 7920**

H.K. Hasegawa
and
K.J. Staggs, S.M. Doughty
Fire Research Discipline
Special Projects Division

Prepared for
Martin Marietta Energy Systems Inc.
Oak Ridge National Laboratory

December, 1992

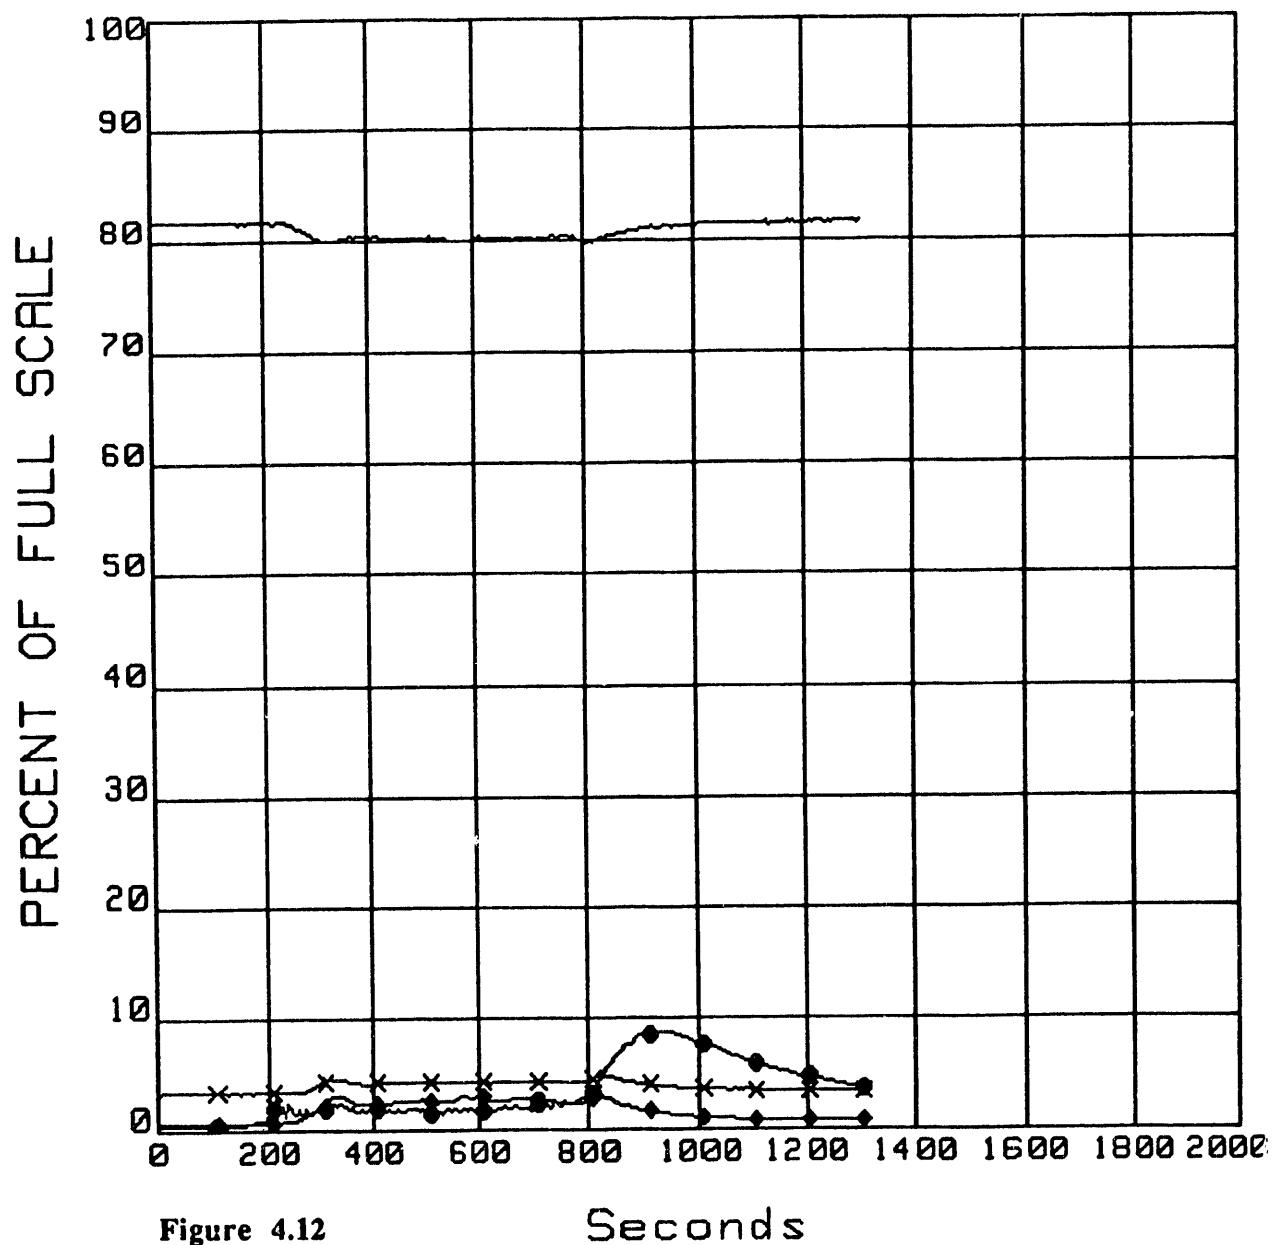
Figure 4.12

FILENAME	CHANNEL	LOCATION	UNIT OF MEASURE	SCALE
ORNL4.0	CH-88	O2 Duct Node	% O2	25
◆ ORNL4.0	CH-89	CO2 Duct Node	% CO2	12
× ORNL4.0	CH-90	CO Duct Node	% CO	1
● ORNL4.0	CH-91	HC Duct Node	PPM (=CH4)	25000

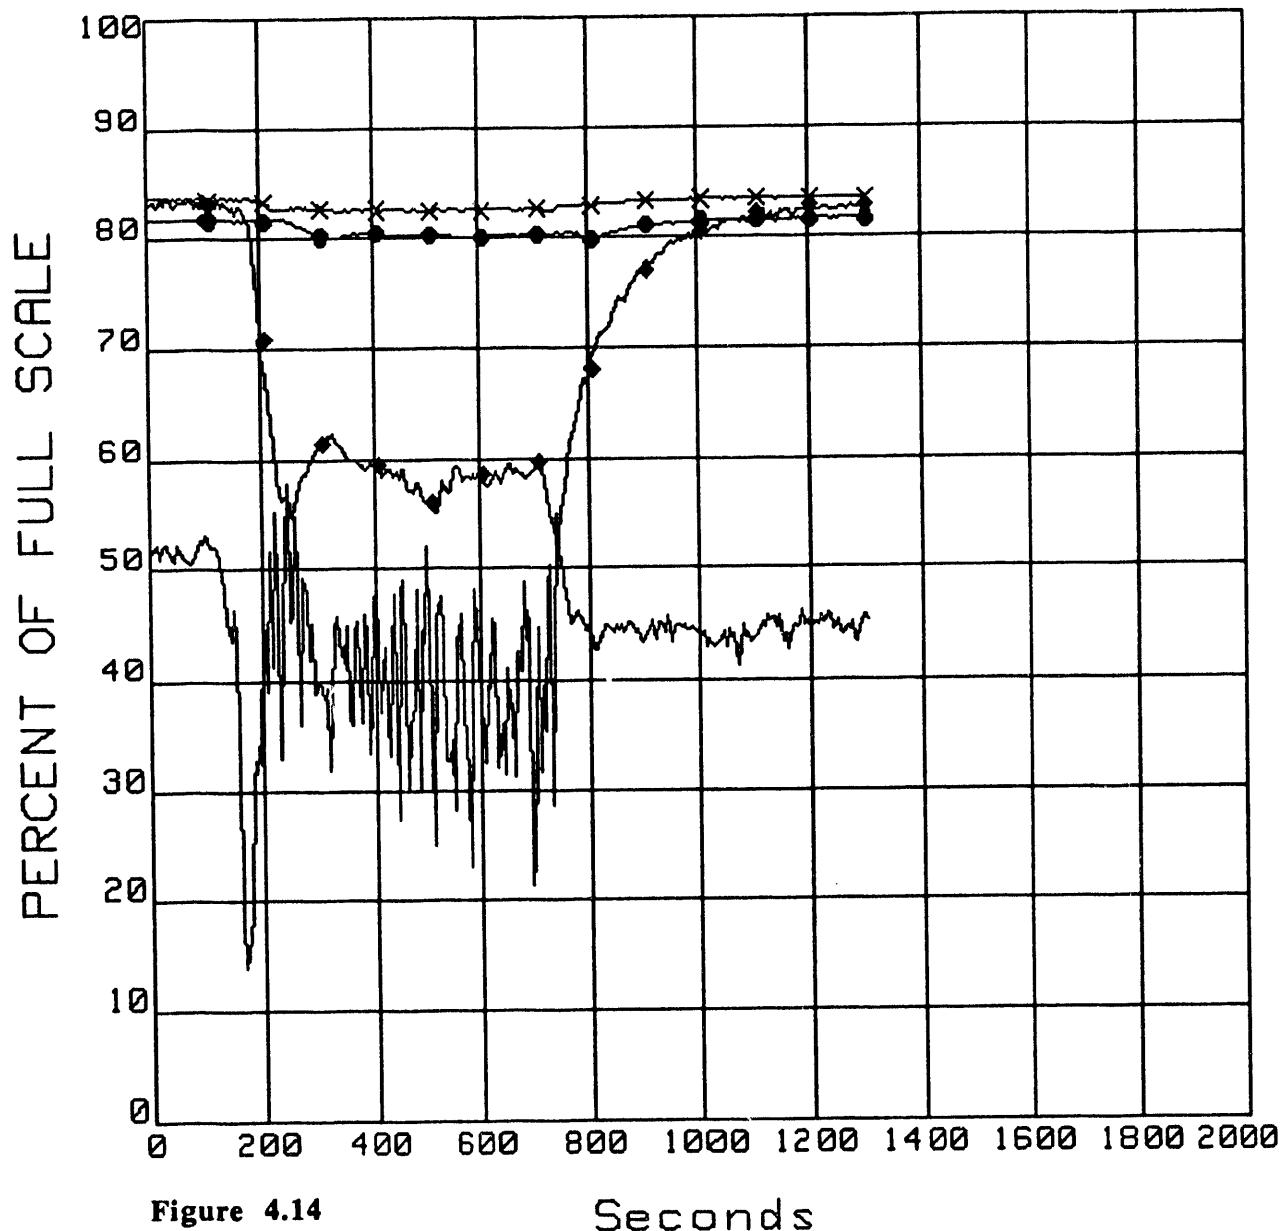
Figure 4.14

FILENAME	CHANNEL	LOCATION	UNIT OF MEASURE	SCALE
ORNL4.0	CH-102	Inlet, R/F (TFM)	CFM	2000
◆ ORNL4.0	CH-80	02 6' UP	× 02	25
✗ ORNL4.0	CH-84	02 12' UP	× 02	25
● ORNL4.0	CH-88	Duct Node	× 02	25

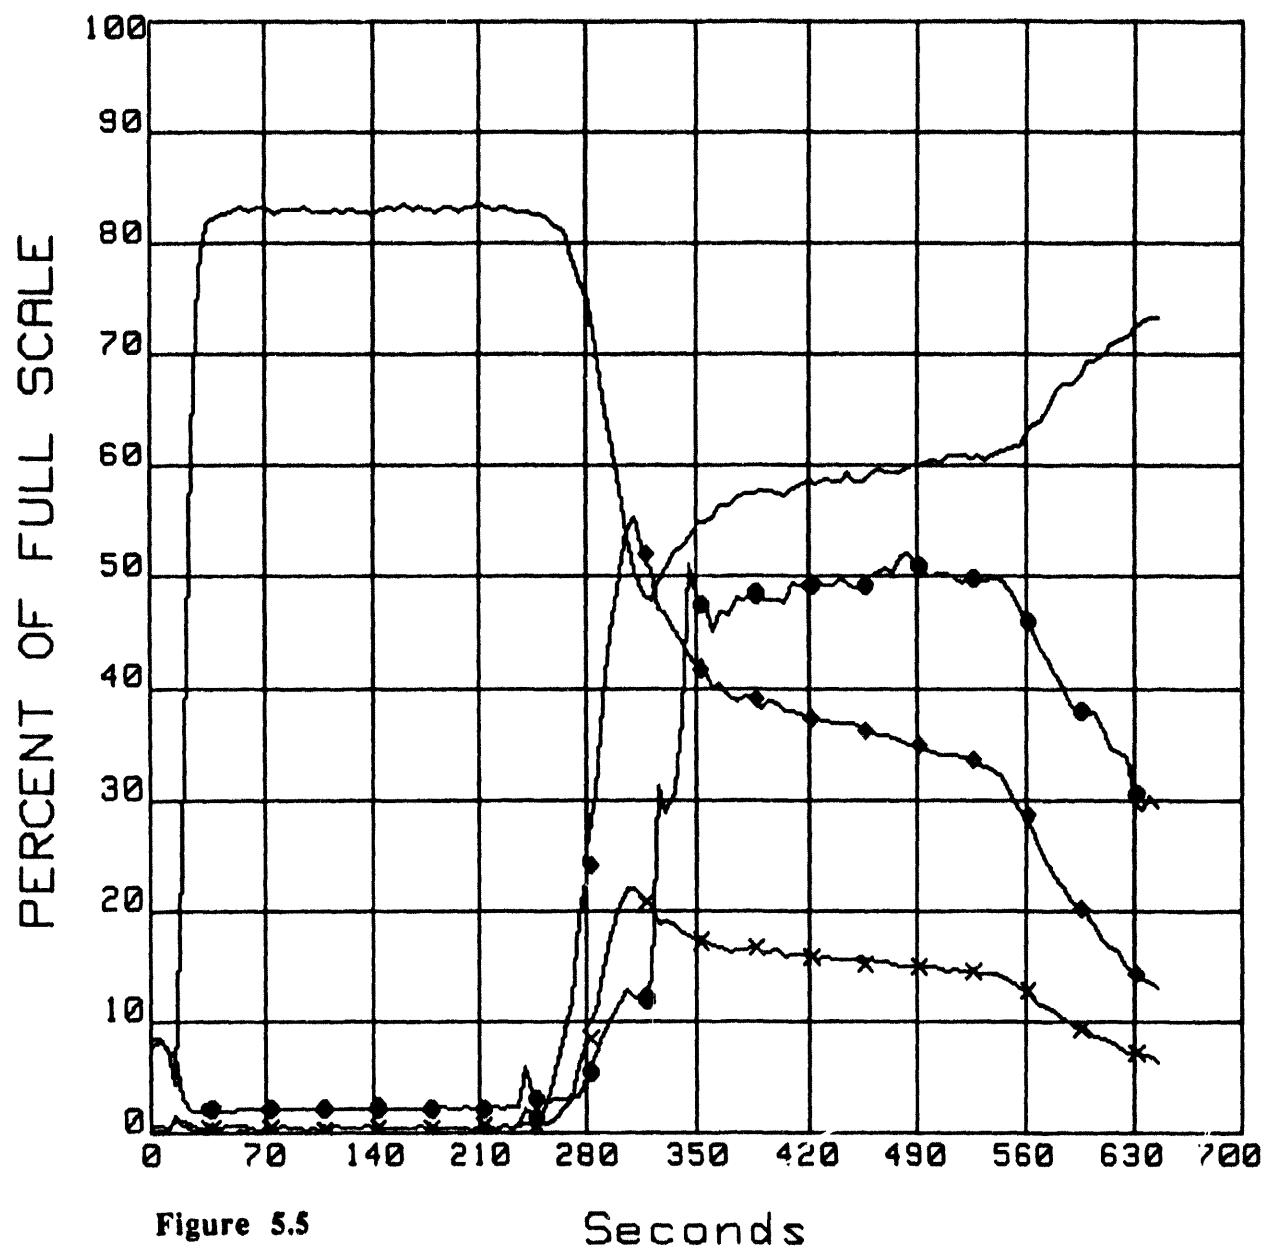
Figure 5.5

FILENAME	CHANNEL	LOCATION	UNIT OF MEASURE	SCALE
ORNL5.0	CH-80	O2 6' UP	% O2	25
◆ ORNL5.0	CH-81	CO2 6' UP	% CO2	12
× ORNL5.0	CH-82	CO 6' UP	% CO	1.5
● ORNL5.0	CH-83	HC 6' UP	PPM (=CH4)	25000

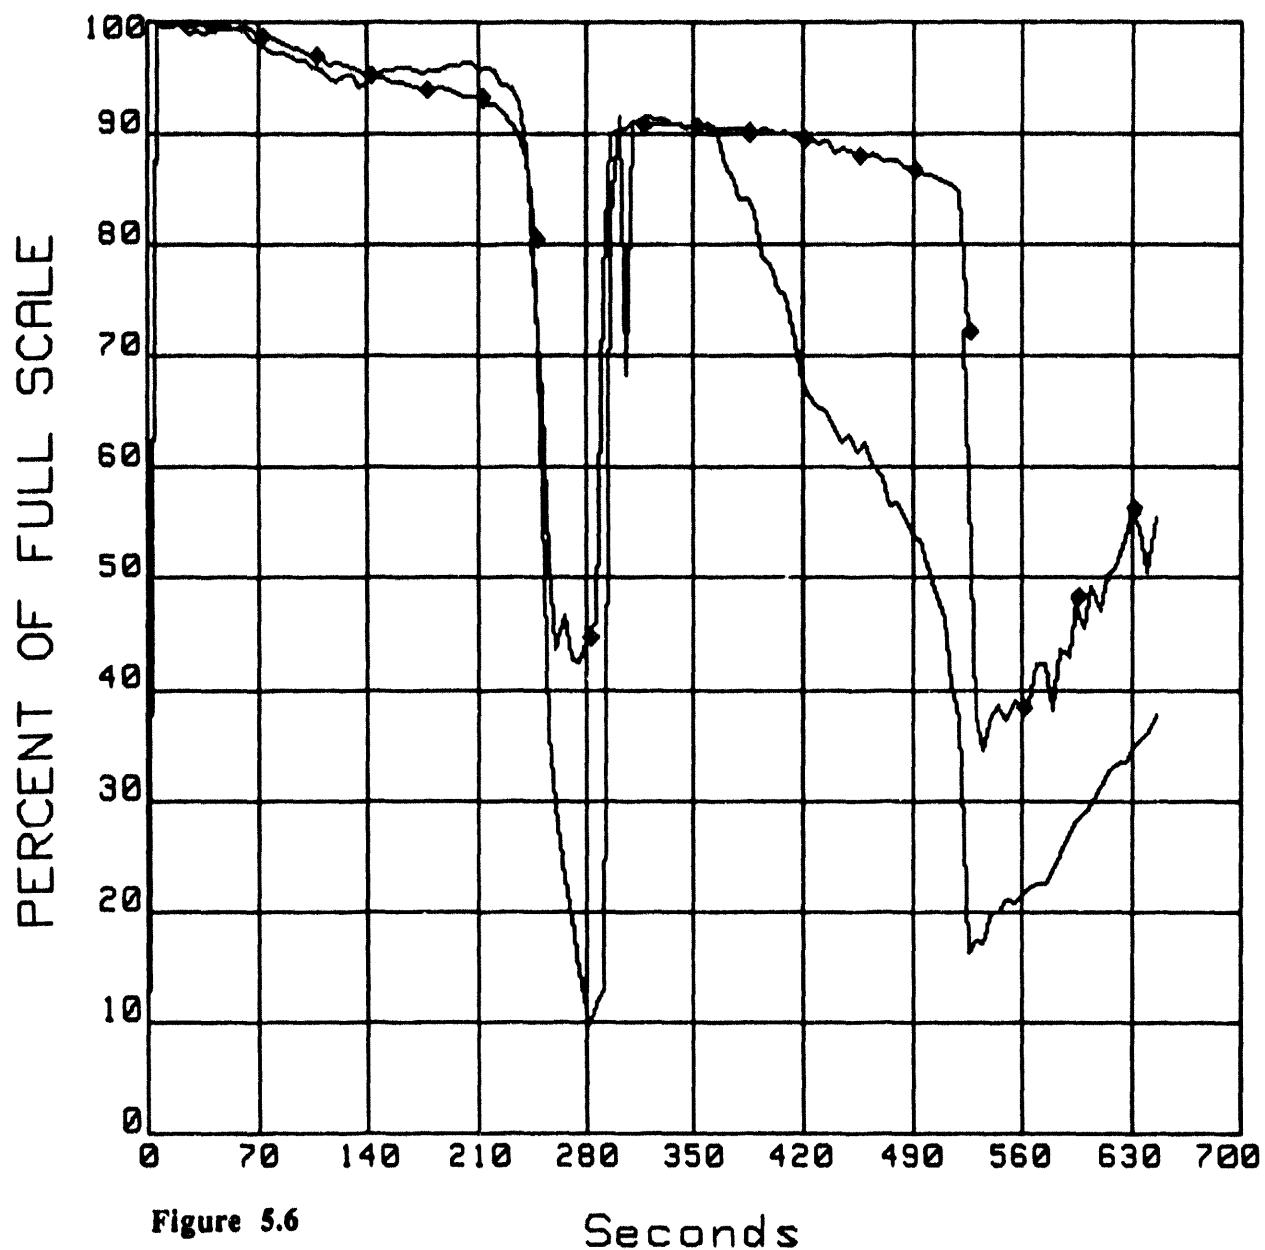
Figure 5.6

FILENAME	CHANNEL	LOCATION	UNIT OF MEASURE	SCALE
ORNL5.0	CH-95	Near Cell	% Transmittance	100
◆ ORNL5.0	CH-96	Before Filters	% Transmittance	100

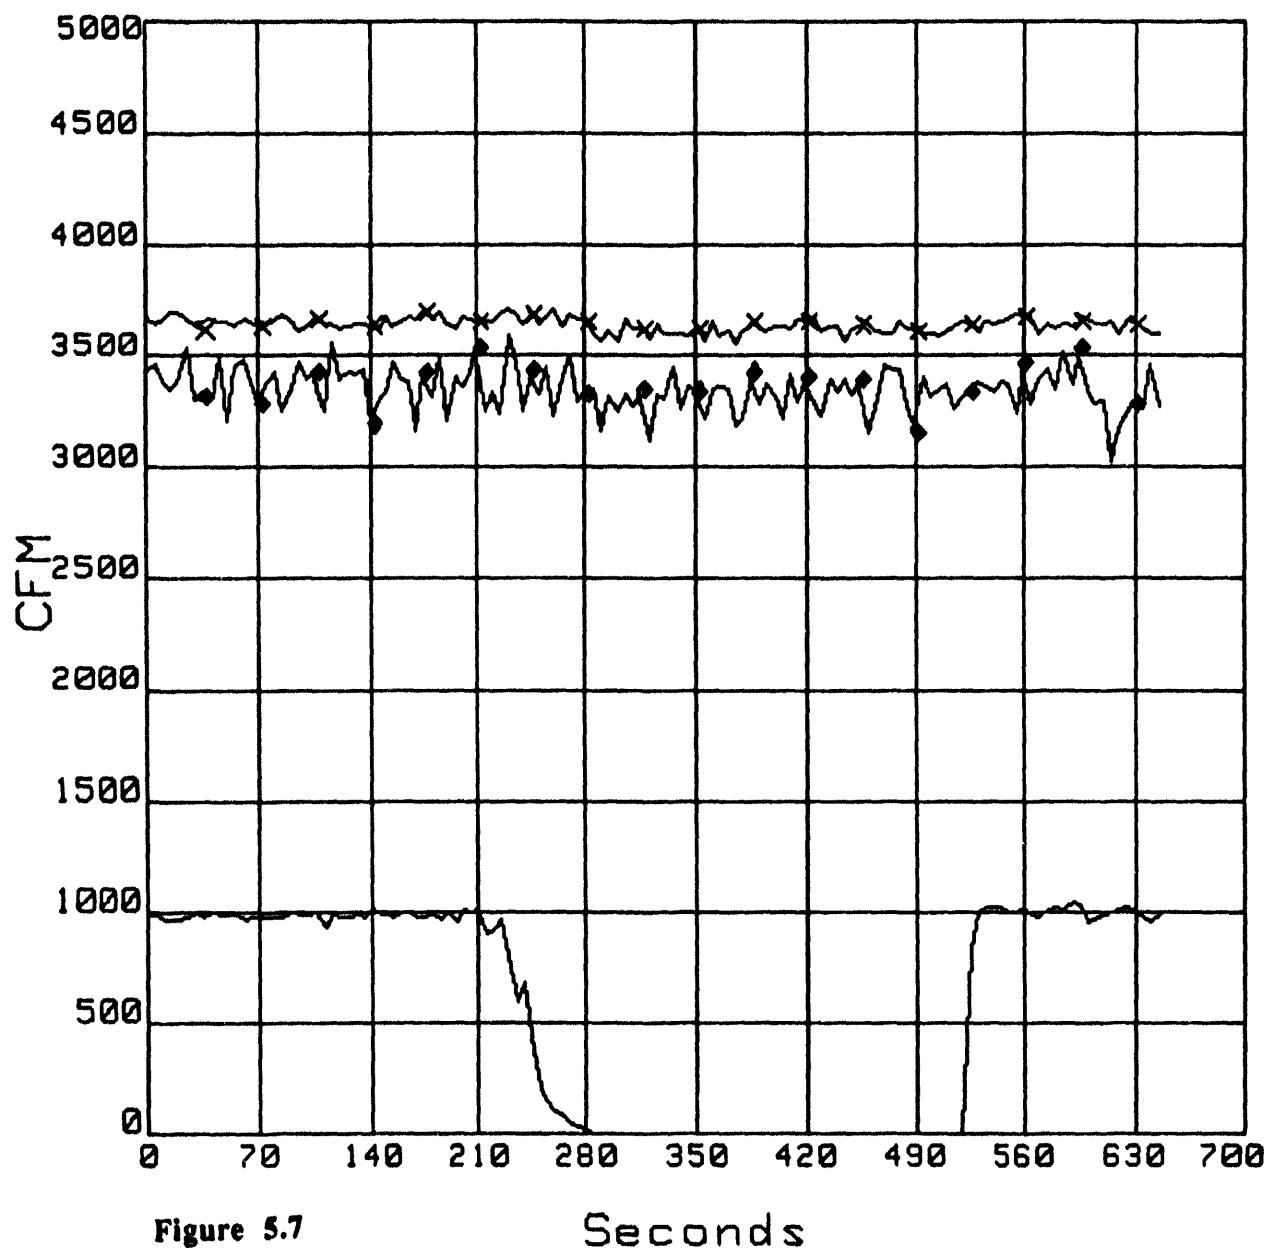
Figure 5.7

FILENAME	CHANNEL	LOCATION	UNIT OF MEASURE	SCALE
ORNL5.0	CH-102	Inlet A/F (TFM)	CFM	5000
◆ ORNL5.0	CH-104	Exit A/F (Pitot)	CFM	5000
✗ ORNL5.0	CH-105	Exit A/F (TFM)	CFM	5000

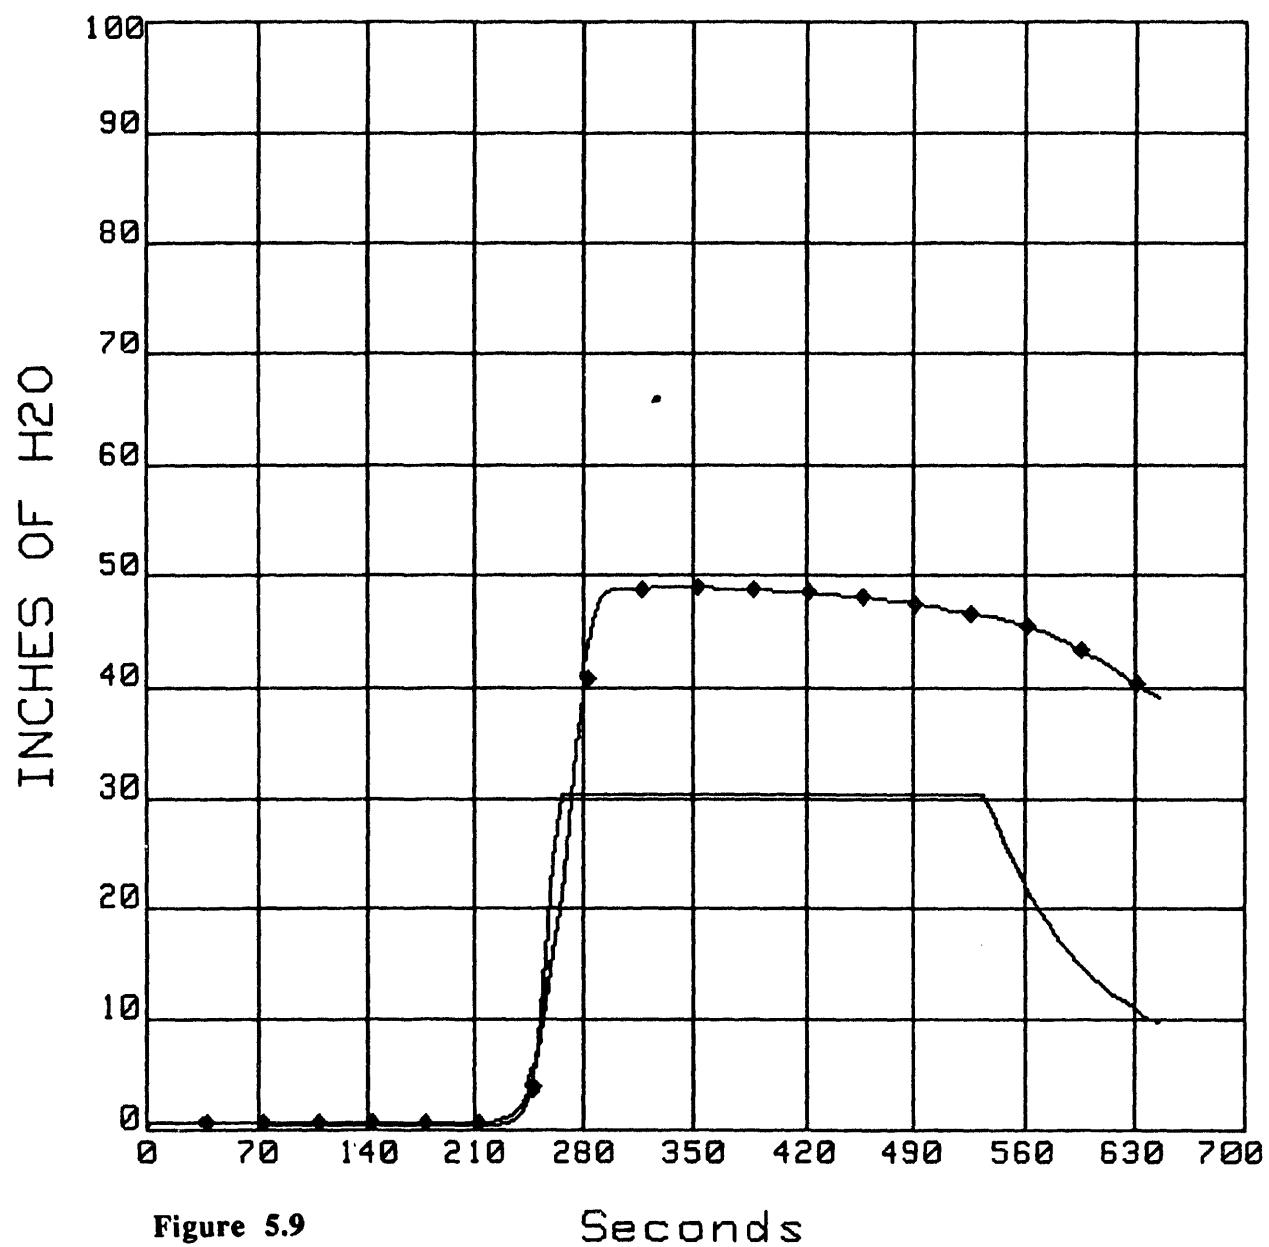
Figure 5.9

FILENAME	CHANNEL	LOCATION	UNIT OF MEASURE	SCALE
◆ ORNL5.0	CH-112	Heat Sensor 22' side	INCHES H ₂ O	100
◆ ORNL5.0	CH-113	Heat Sensor 13' side	Inches H ₂ O	100

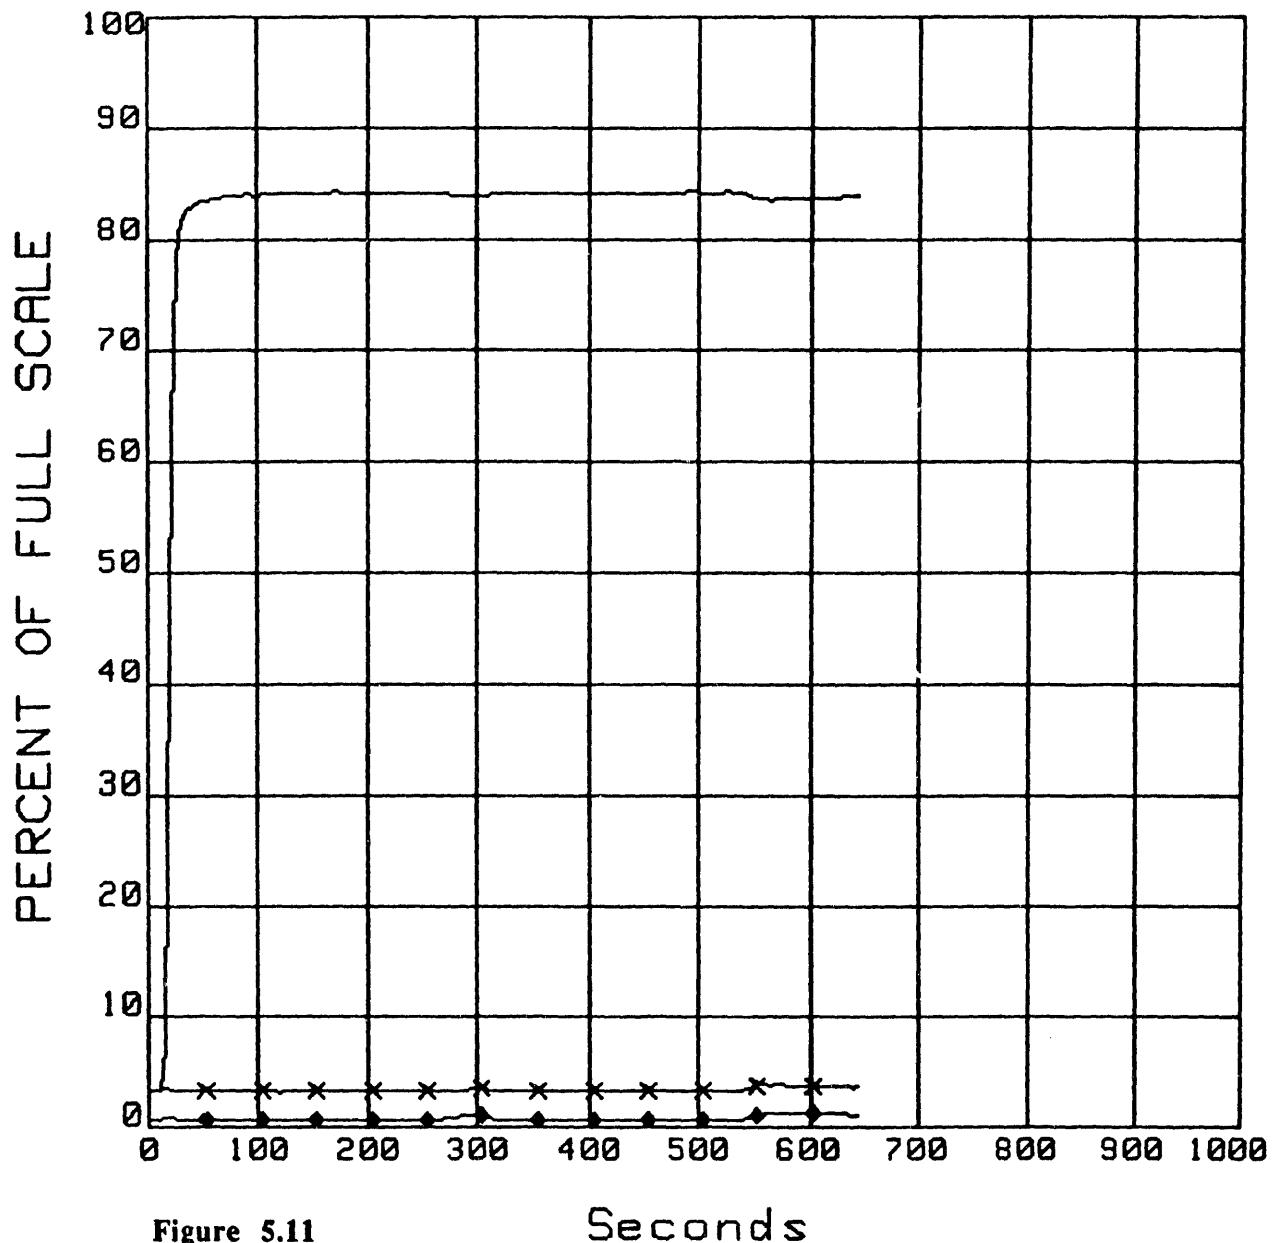
Figure 5.11

FILENAME	CHANNEL	LOCATION	UNIT OF MEASURE	SCALE
ORNL5.0	CH-84	O2 12' UP	% O2	25
◆ ORNL5.0	CH-85	CO2 12' UP	% CO2	12
× ORNL5.0	CH-86	CO 12' UP	% CO	1.5
● ORNL5.0	CH-87	HC 12' UP	PPM (=CH4)	25000

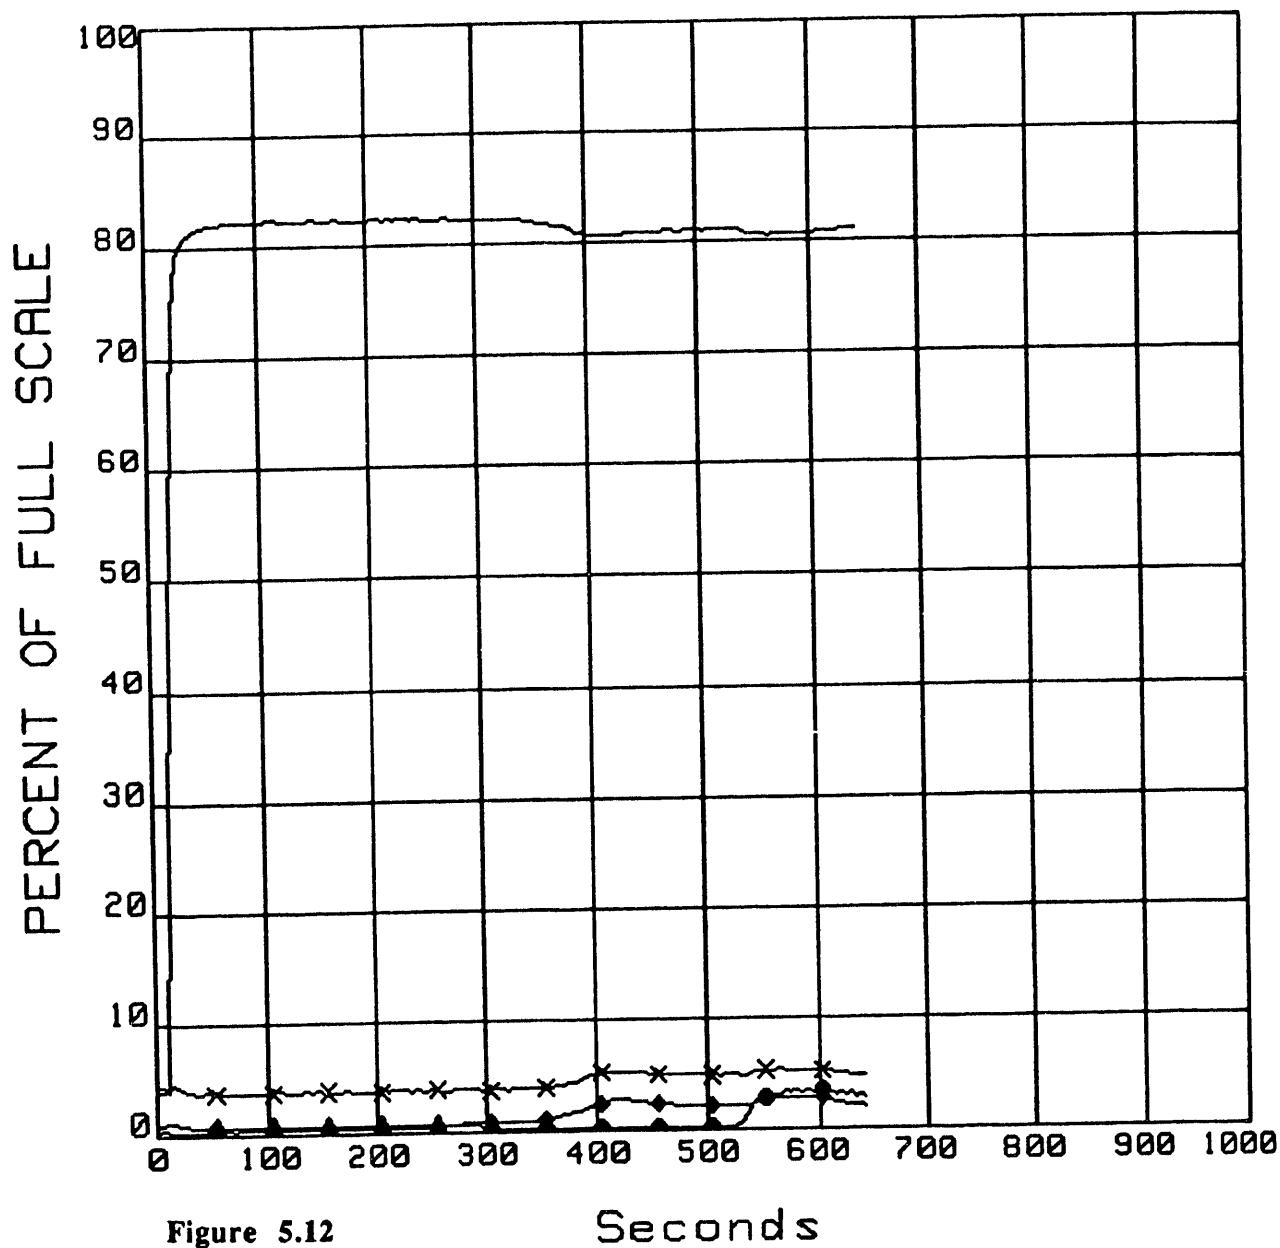
Figure 5.12

FILENAME	CHANNEL	LOCATION	UNIT OF MEASURE	SCALE
ORNL5.0	CH-88	O2 Duct Node	% O2	25
◆ ORNL5.0	CH-89	CO2 Duct Node	% CO2	12
× ORNL5.0	CH-90	CO Duct Node	% CO	1.5
● ORNL5.0	CH-91	HC Duct Node	PPM (=CH4)	25000

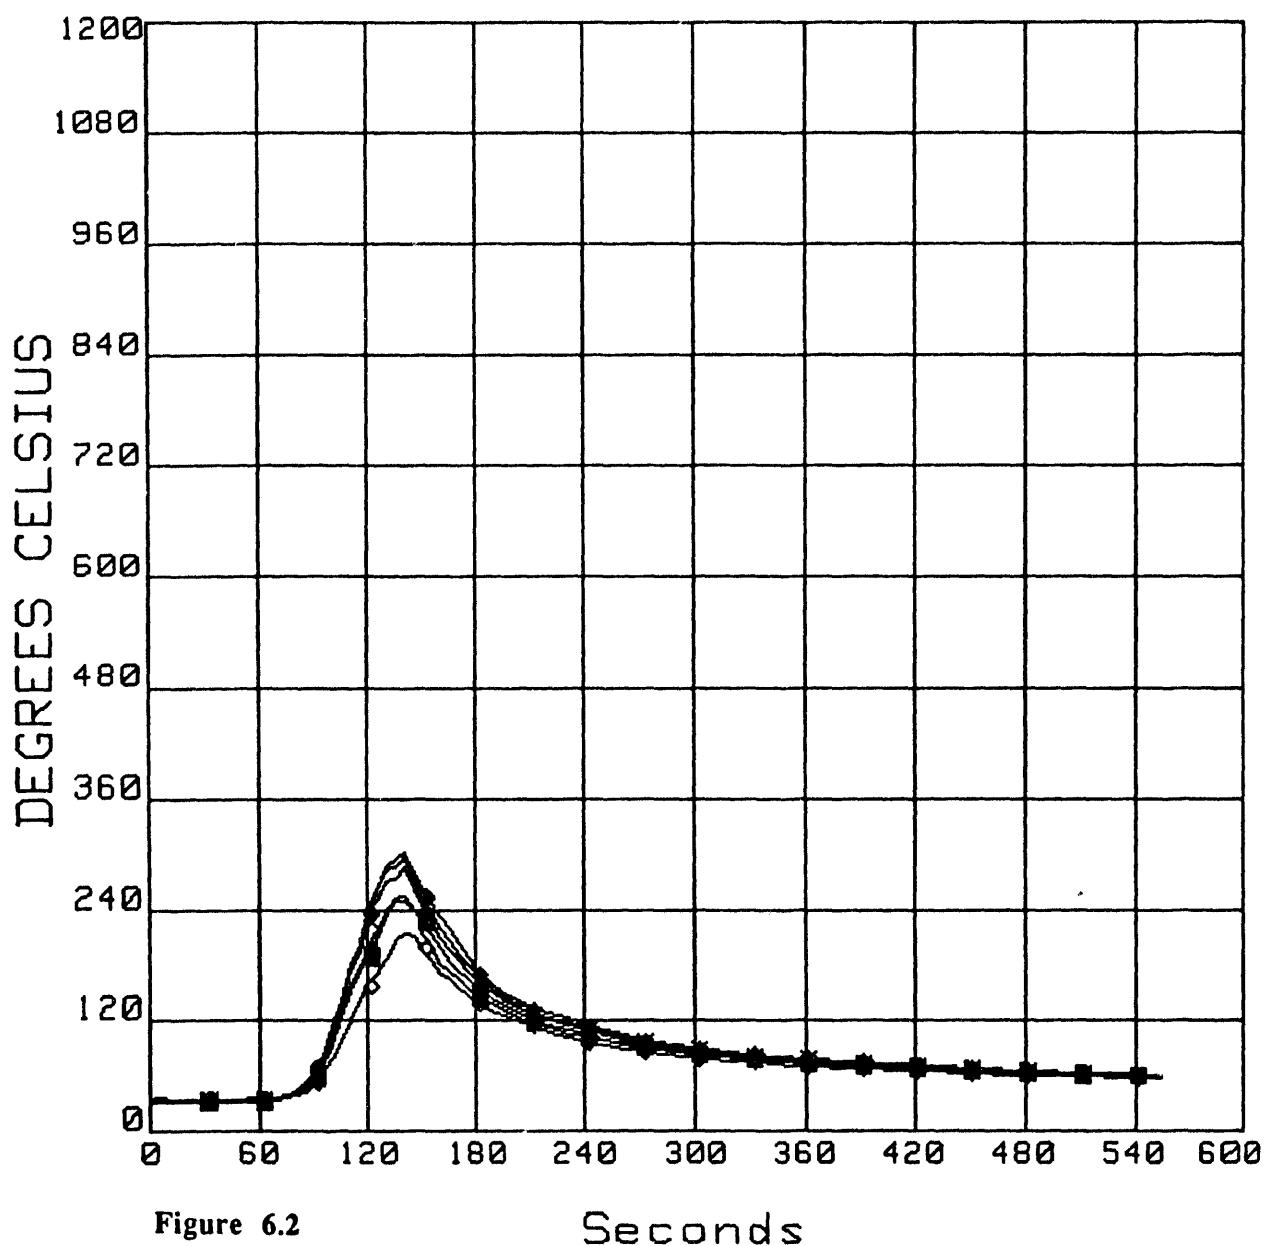
Figure 6.2

FILENAME	CHANNEL	LOCATION	UNIT OF MEASURE	SCALE
ORNL6.0	CH-6	NE TC RAKE 12' UP	Degrees Celsius	1200
◆ ORNL6.0	CH-7	NE TC RAKE 14' UP	Degrees Celsius	1200
× ORNL6.0	CH-8	NE TC RAKE 16' UP	Degrees Celsius	1200
● ORNL6.0	CH-9	NE TC RAKE 18' UP	Degrees Celsius	1200
■ ORNL6.0	CH-10	NE TC RAKE 20' UP	Degrees Celsius	1200
◇ ORNL6.0	CH-11	NE TC RAKE 6" DOWN	Degrees Celsius	1200

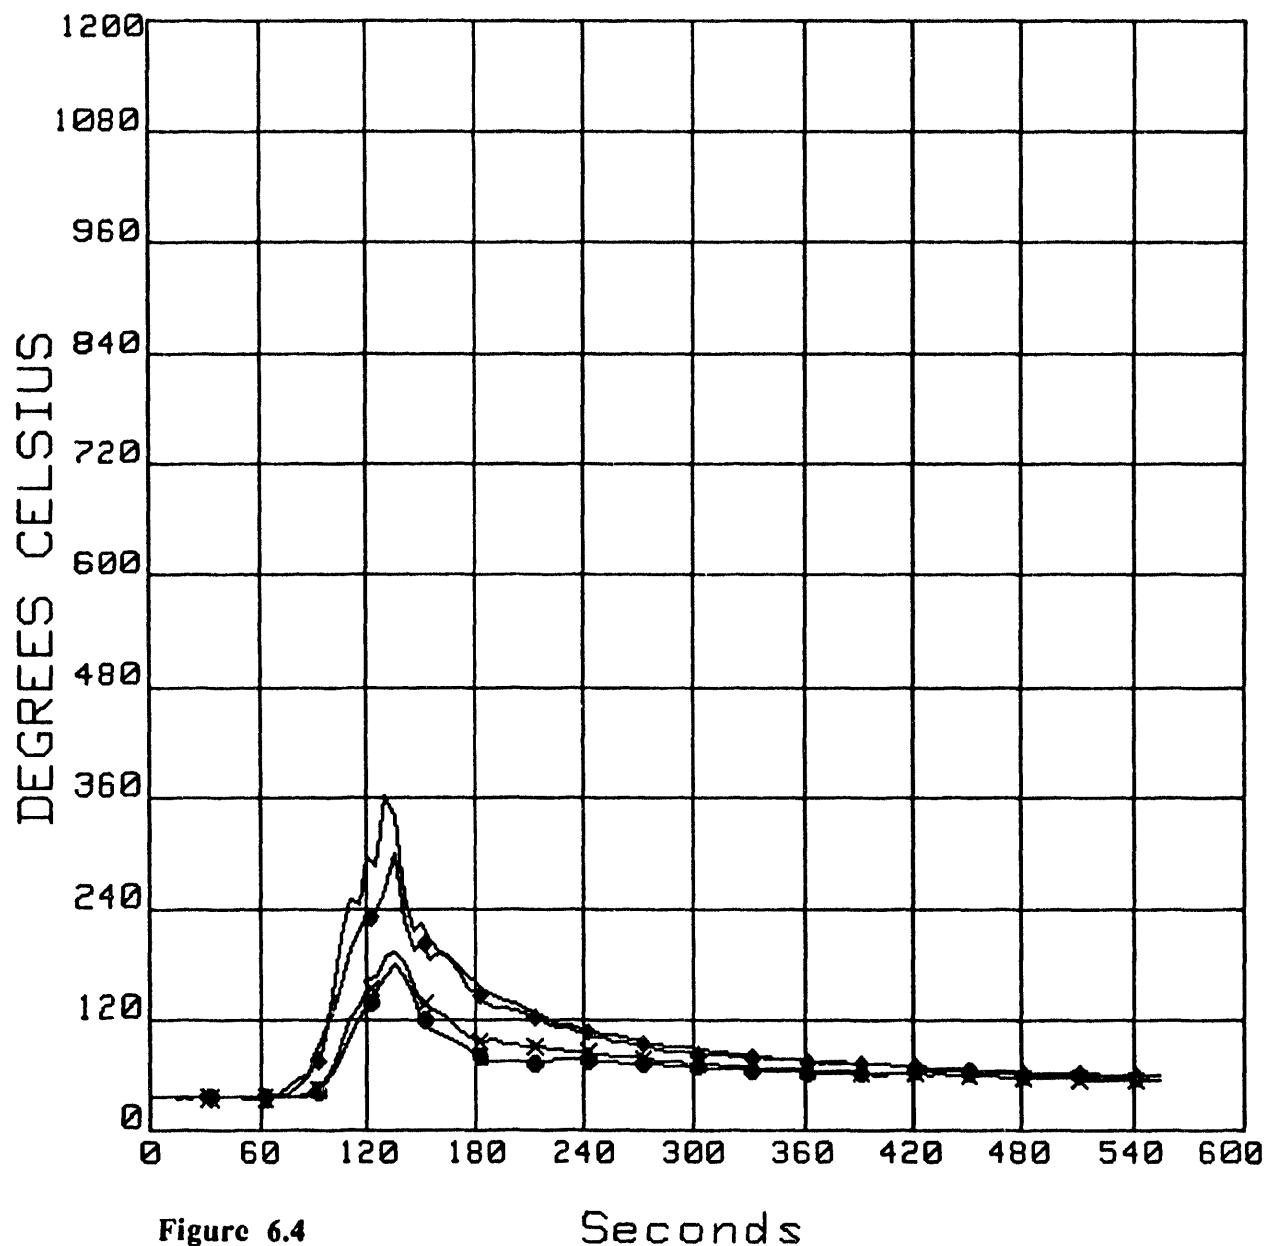
Figure 6.4

FILENAME	CHANNEL	LOCATION	UNIT OF MEASURE	SCALE
ORNL6.0	CH-27	TOP So WINDOW TC	Degrees Celsius	1200
◆ ORNL6.0	CH-28	TOP No WINDOW TC	Degrees Celsius	1200
× ORNL6.0	CH-29	BOTTOM So WINDOW TC	Degrees Celsius	1200
● ORNL6.0	CH-30	BOTTOM No WINDOW TC	Degrees Celsius	1200

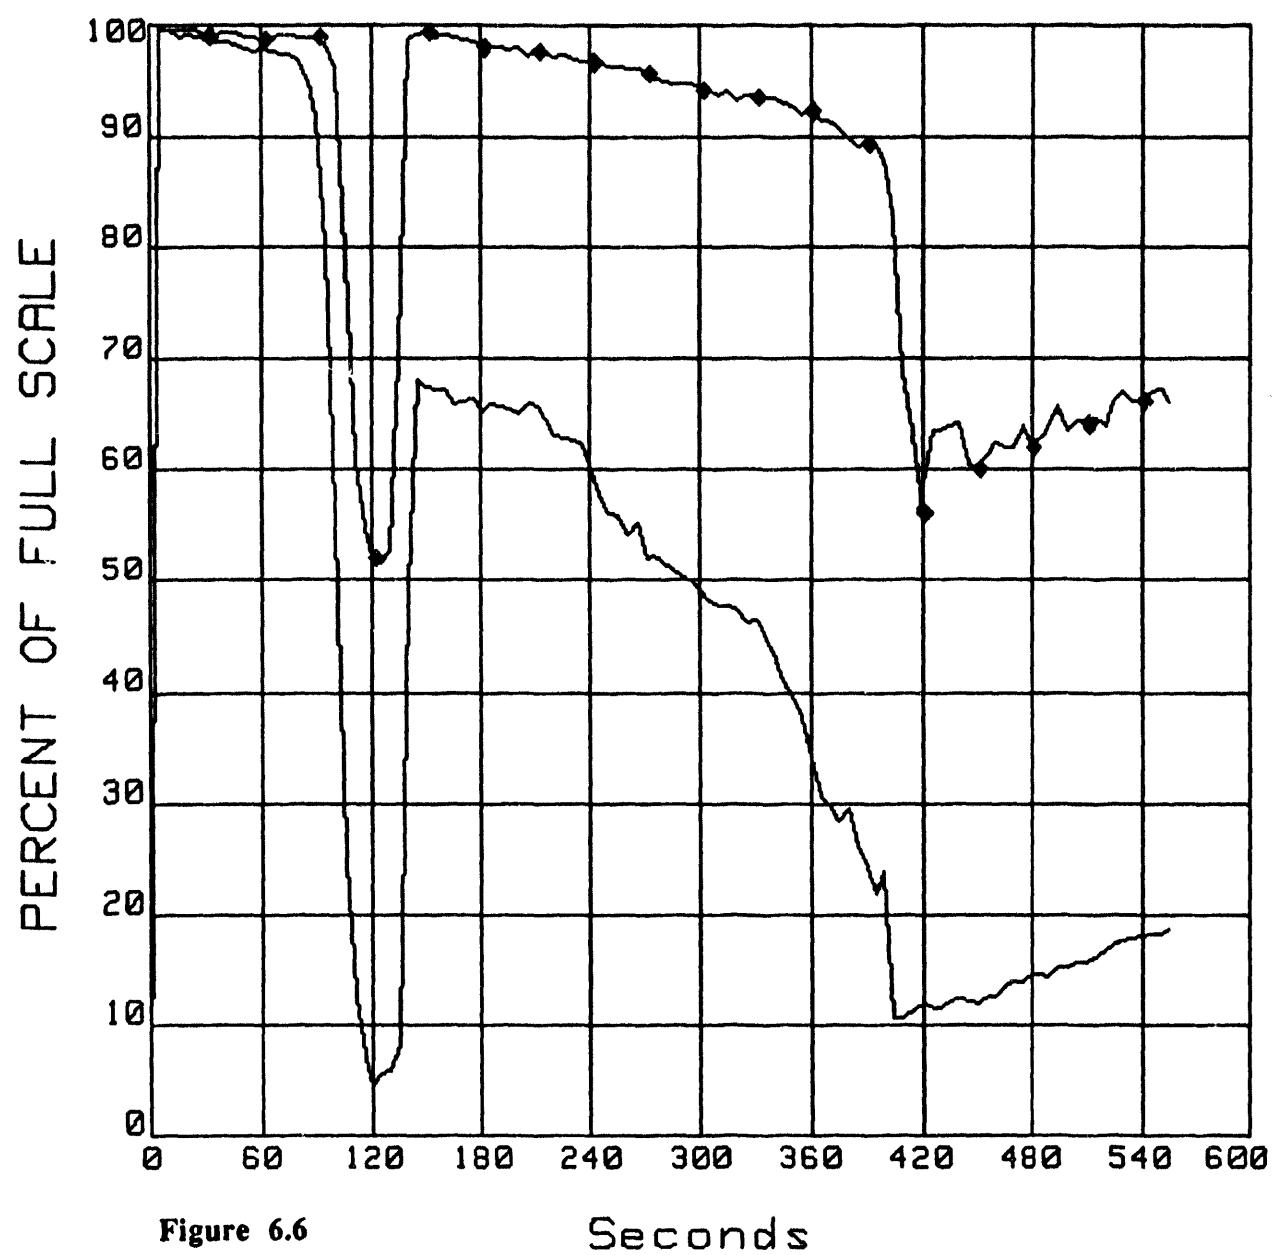
Figure 6.6

FILENAME	CHANNEL	LOCATION	UNIT OF MEASURE	SCALE
◆ ORNL6.0	CH-95	Near Cell	✗ Transmittance	100
◆ ORNL6.0	CH-96	Before Filters	✗ Transmittance	100

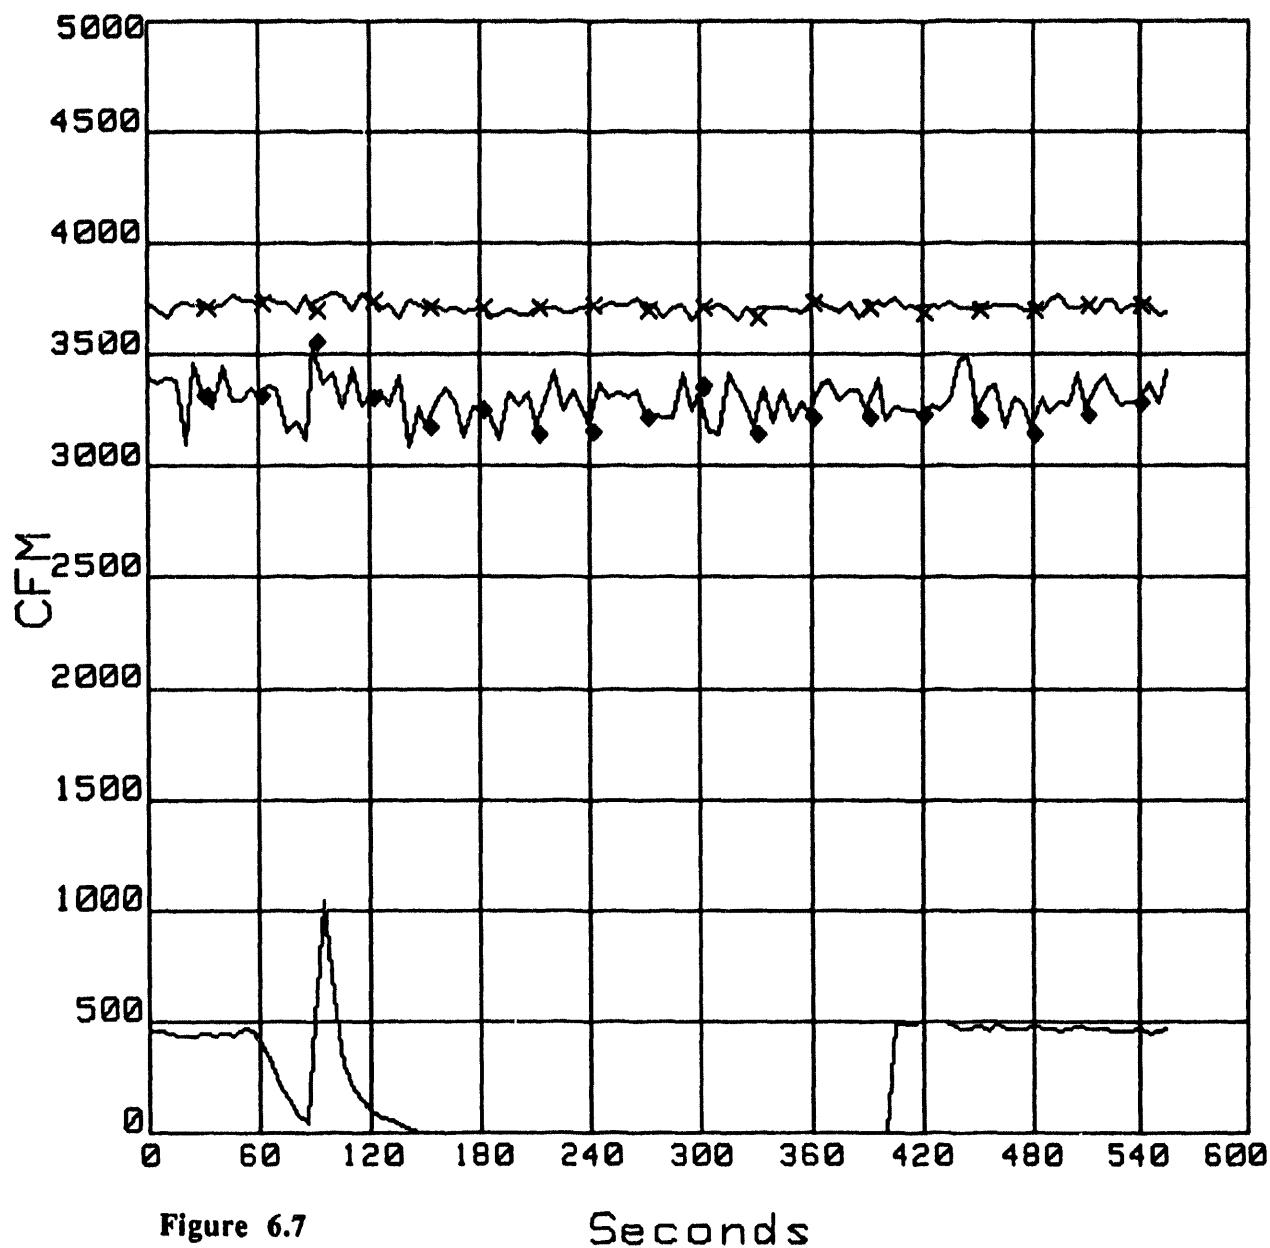
Figure 6.7

FILENAME	CHANNEL	LOCATION	UNIT OF MEASURE	SCALE
ORNL6.0	CH-102	Inlet A/F (TFM)	CFM	5000
♦ ORNL6.0	CH-104	Exit A/F (Pitot)	CFM	5000
× ORNL6.0	CH-105	Exit A/F (TFM)	CFM	5000

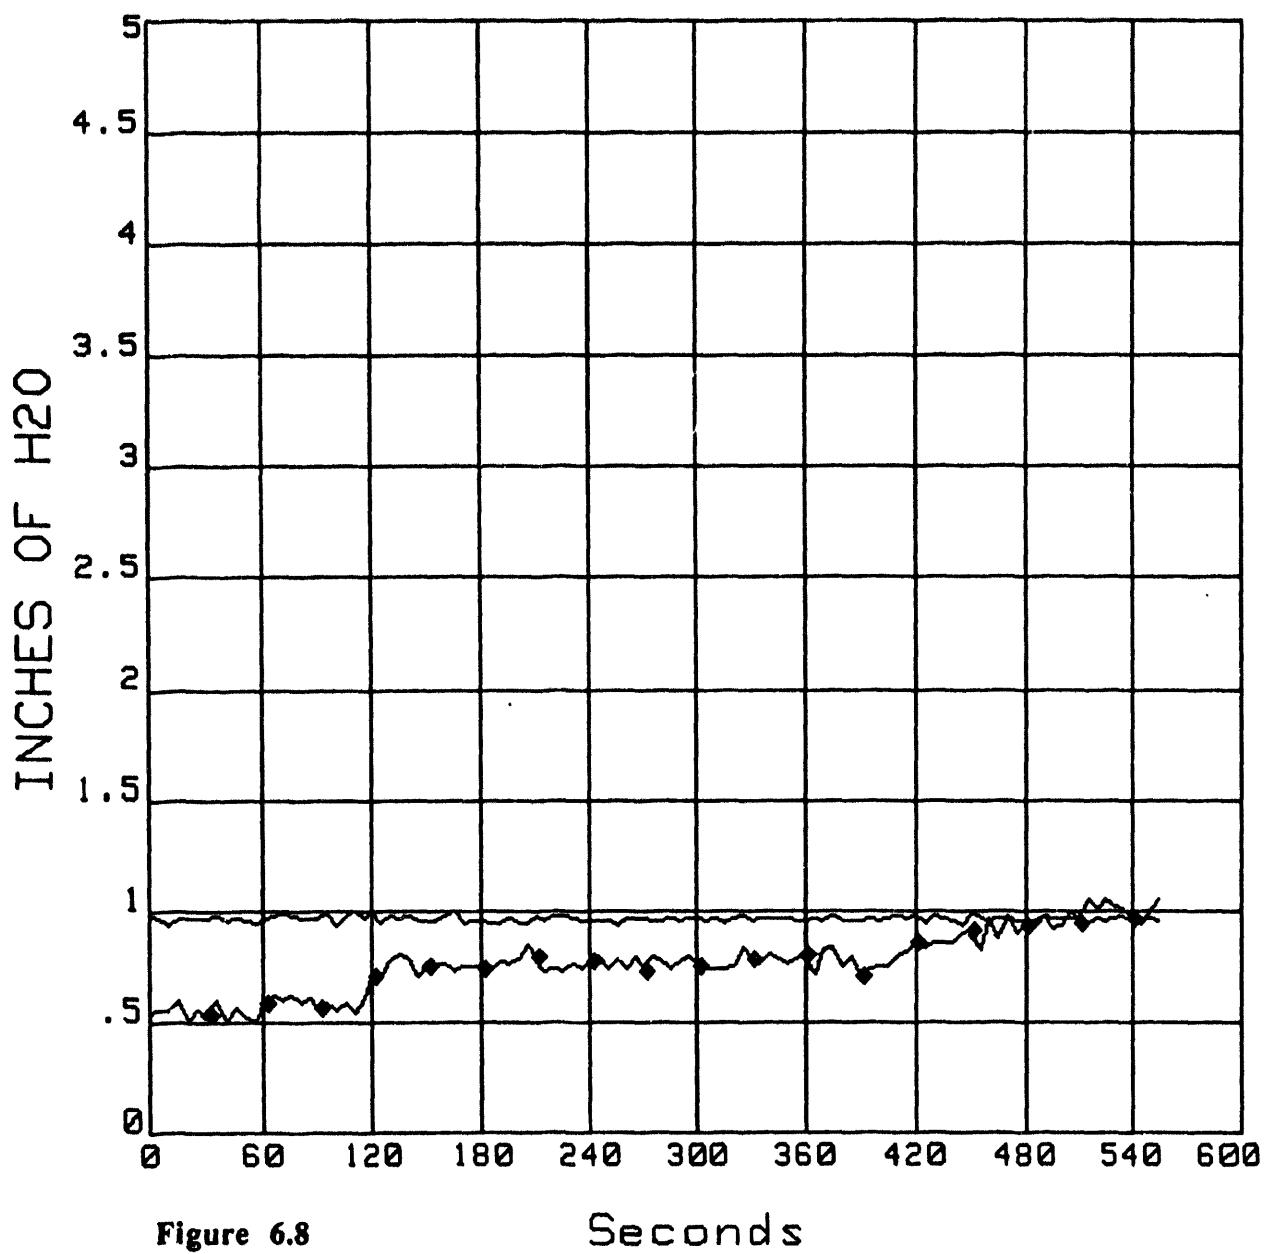
Figure 6.8

FILENAME	CHANNEL	LOCATION	UNIT OF MEASURE	SCALE
ORNL6.0	CH-109	Delta P HEPA	INCHES H2O	5
◆ ORNL6.0	CH-110	Delta P PreFilter	INCHES H2O	5

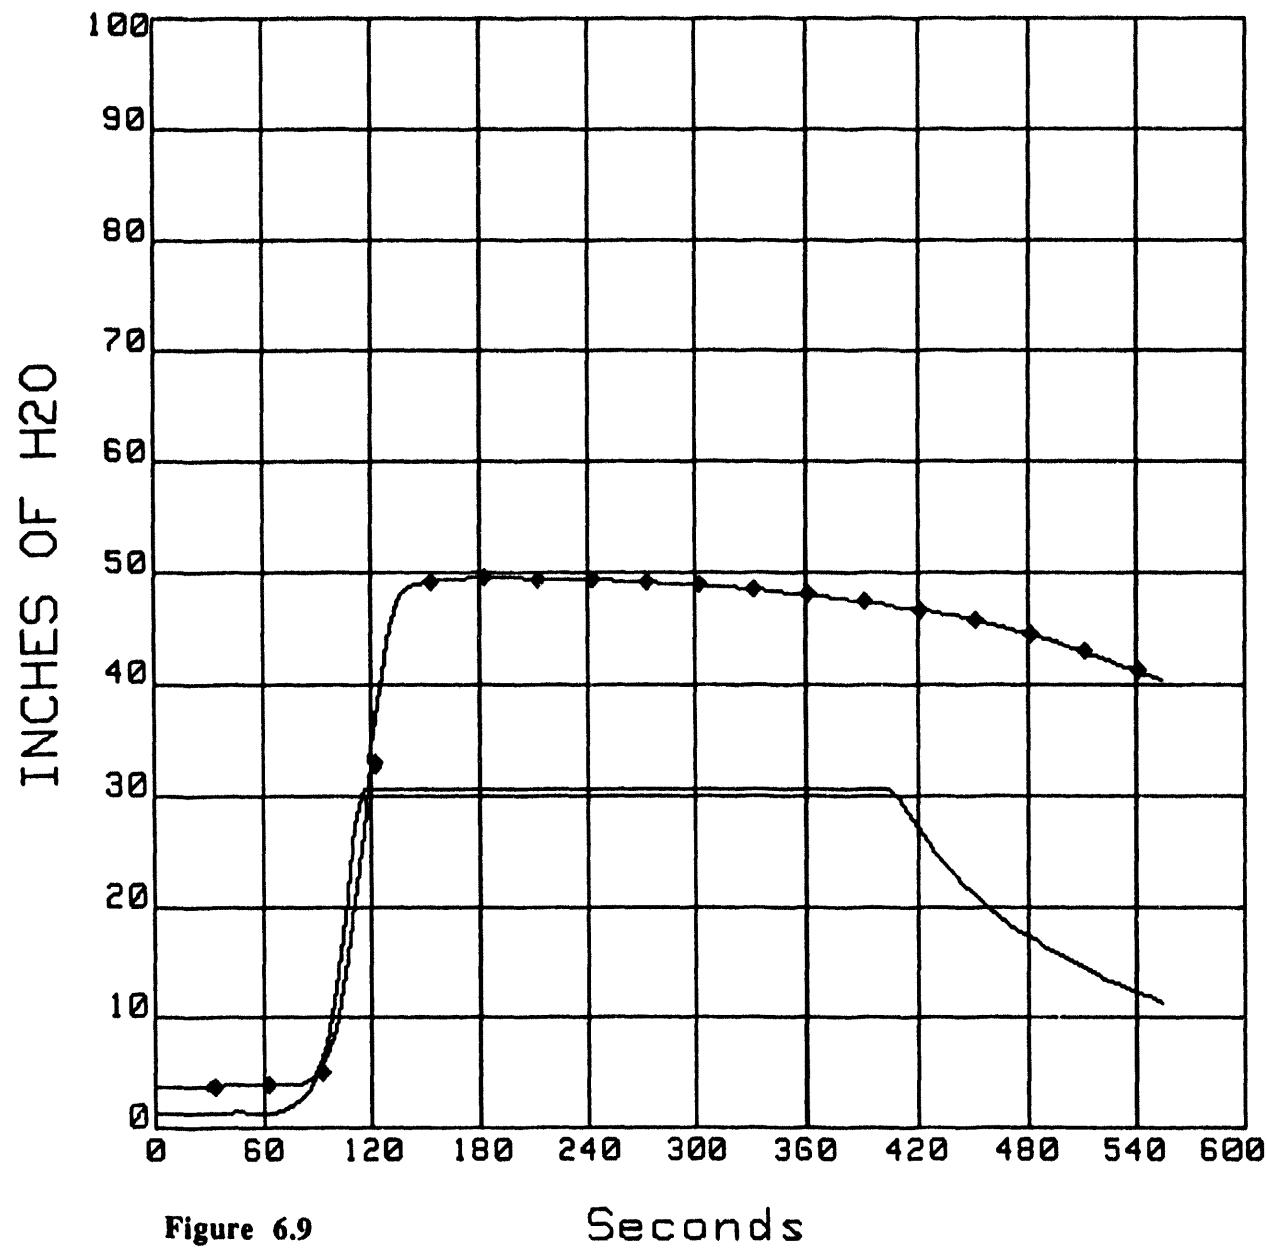
Figure 6.9

FILENAME	CHANNEL	LOCATION	UNIT OF MEASURE	SCALE
ORNL6.0	CH-112	Heat Sensor 22'side	INCHES H ₂ O	100
◆ ORNL6.0	CH-113	Heat Sensor 13'side	Inches H ₂ O	100
