**Fire Tests to Evaluate the Potential Fire Threat and its Effect on
HEPA Filter Integrity in Cell Ventilation at the Oak Ridge National
Laboratory Building 7920**

H.K. Hasegawa
and
K.J. Staggs, S.M. Doughty
Fire Research Discipline
Special Projects Division

Prepared for
Martin Marietta Energy Systems Inc.
Oak Ridge National Laboratory

December, 1992

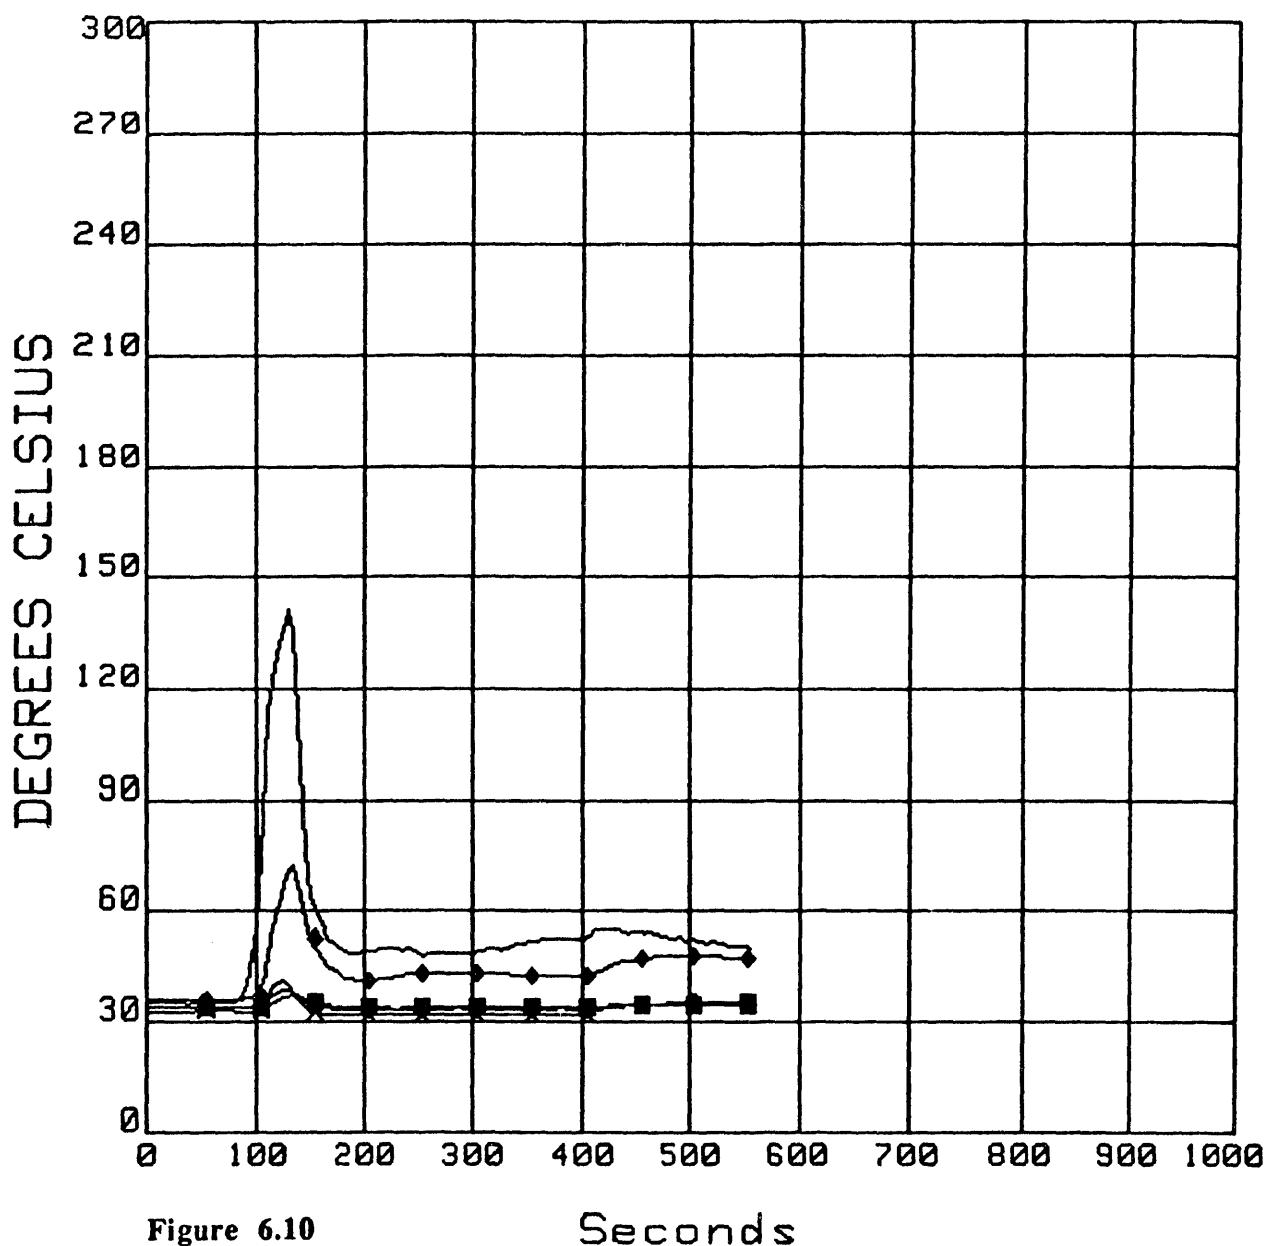
Figure 6.10

FILENAME	CHANNEL	LOCATION	UNIT OF MEASURE	SCALE
ORNL6.0	CH-32	CELL MANIFOLD TC	Degrees Celsius	300
◆ ORNL6.0	CH-34	CEL EXH DUCT TC	Degrees Celsius	300
× ORNL6.0	CH-35	EXH/MAKEUP NODE TC	Degrees Celsius	300
● ORNL6.0	CH-36	TC BEFORE PREFILTER	Degrees Celsius	300
■ ORNL6.0	CH-37	TC BEFORE HEPA	Degrees Celsius	300

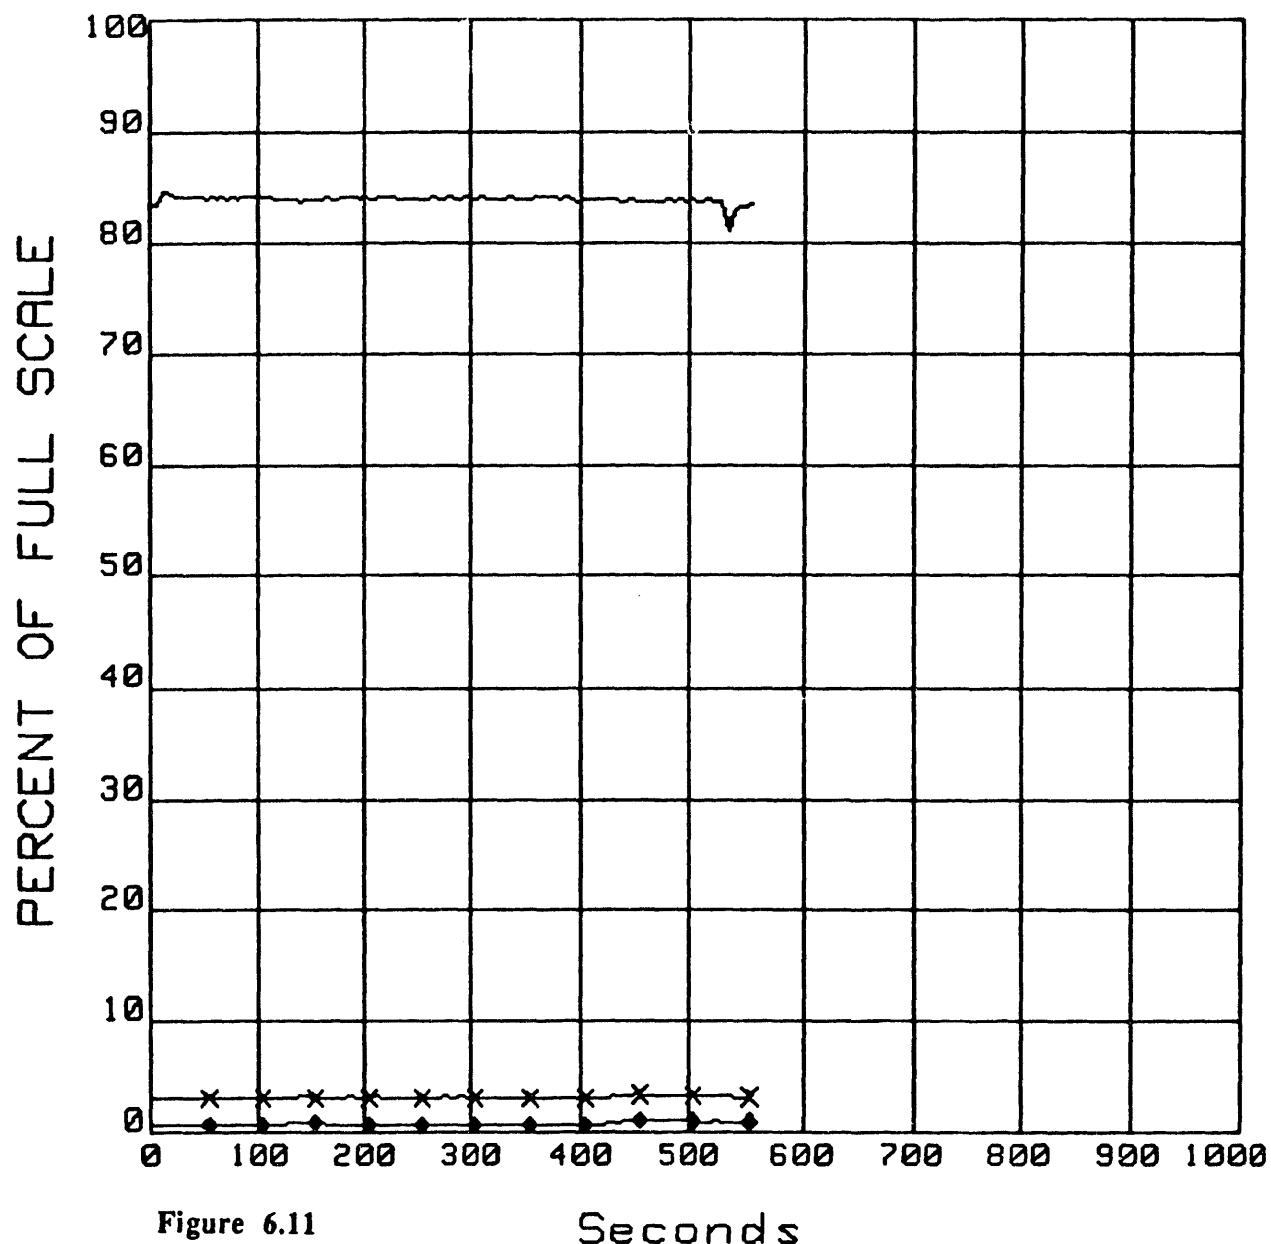
Figure 6.11

FILENAME	CHANNEL	LOCATION	UNIT OF MEASURE	SCALE
ORNL6.0	CH-84	O2 12' UP	% O2	25
◆ ORNL6.0	CH-85	CO2 12' UP	% CO2	12
× ORNL6.0	CH-86	CO 12' UP	% CO	1.5
● ORNL6.0	CH-87	HC 12' UP	PPM (=CH4)	25000

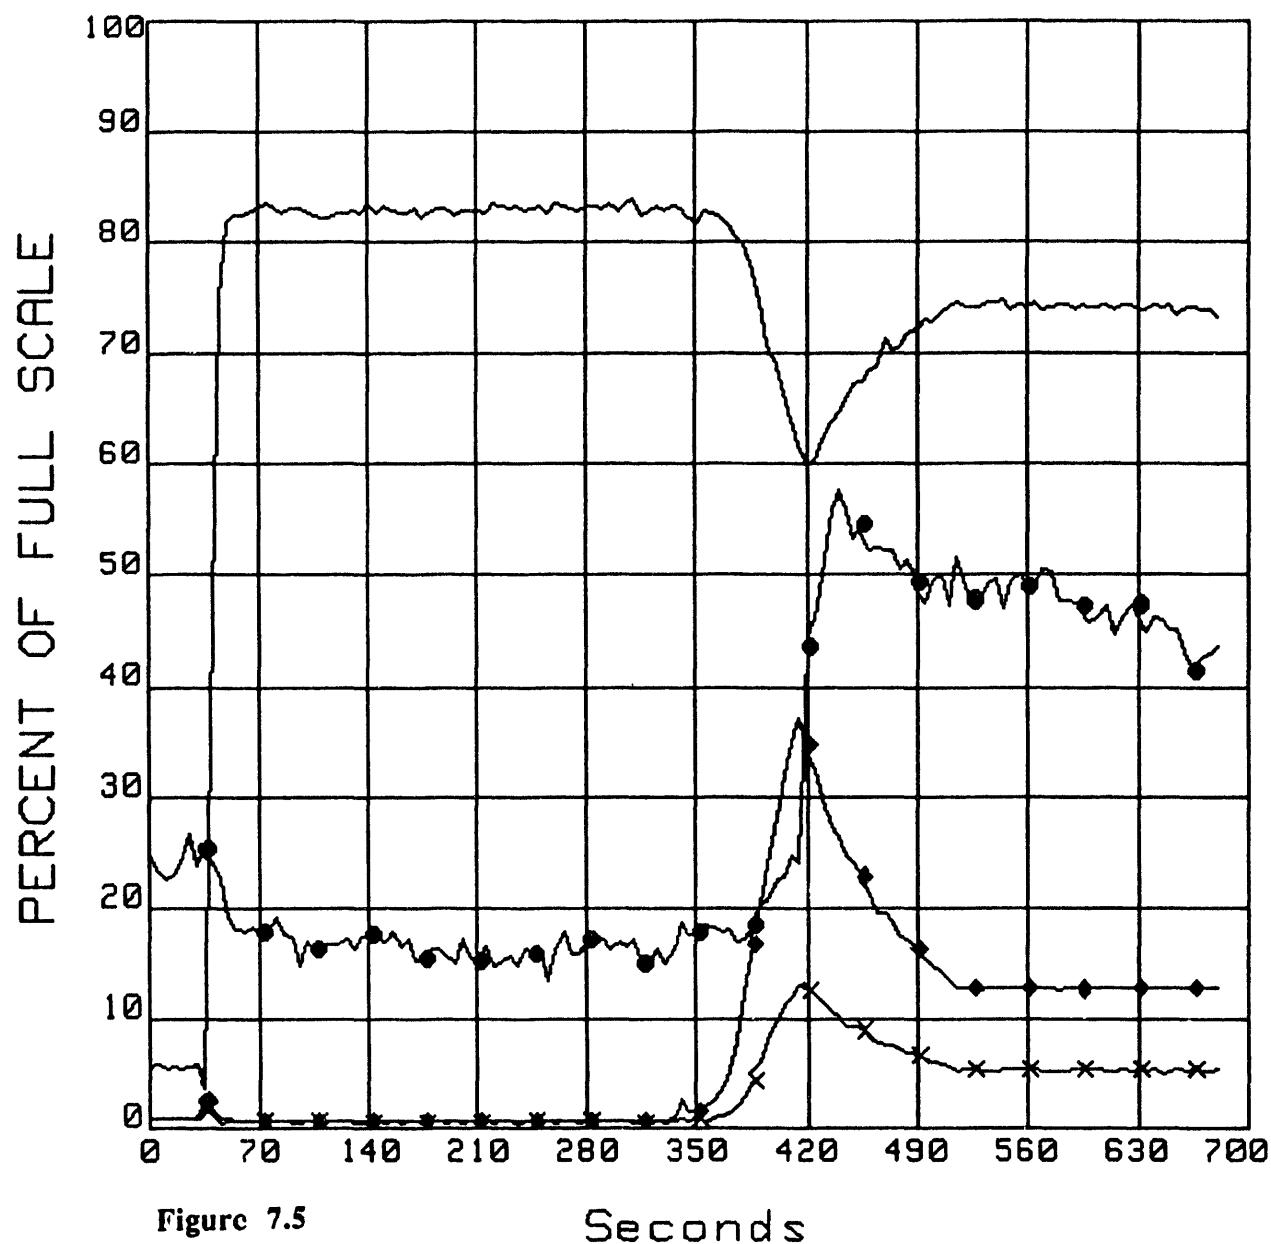
Figure 7.5

FILENAME	CHANNEL	LOCATION	UNIT OF MEASURE	SCALE
ORNL7.0	CH-80	O2 6' UP	% O2	25
◆ ORNL7.0	CH-81	CO2 6' UP	% CO2	12
× ORNL7.0	CH-82	CO 6' UP	% CO	1.5
● ORNL7.0	CH-83	HC 6' UP	PPM (=CH4)	25000

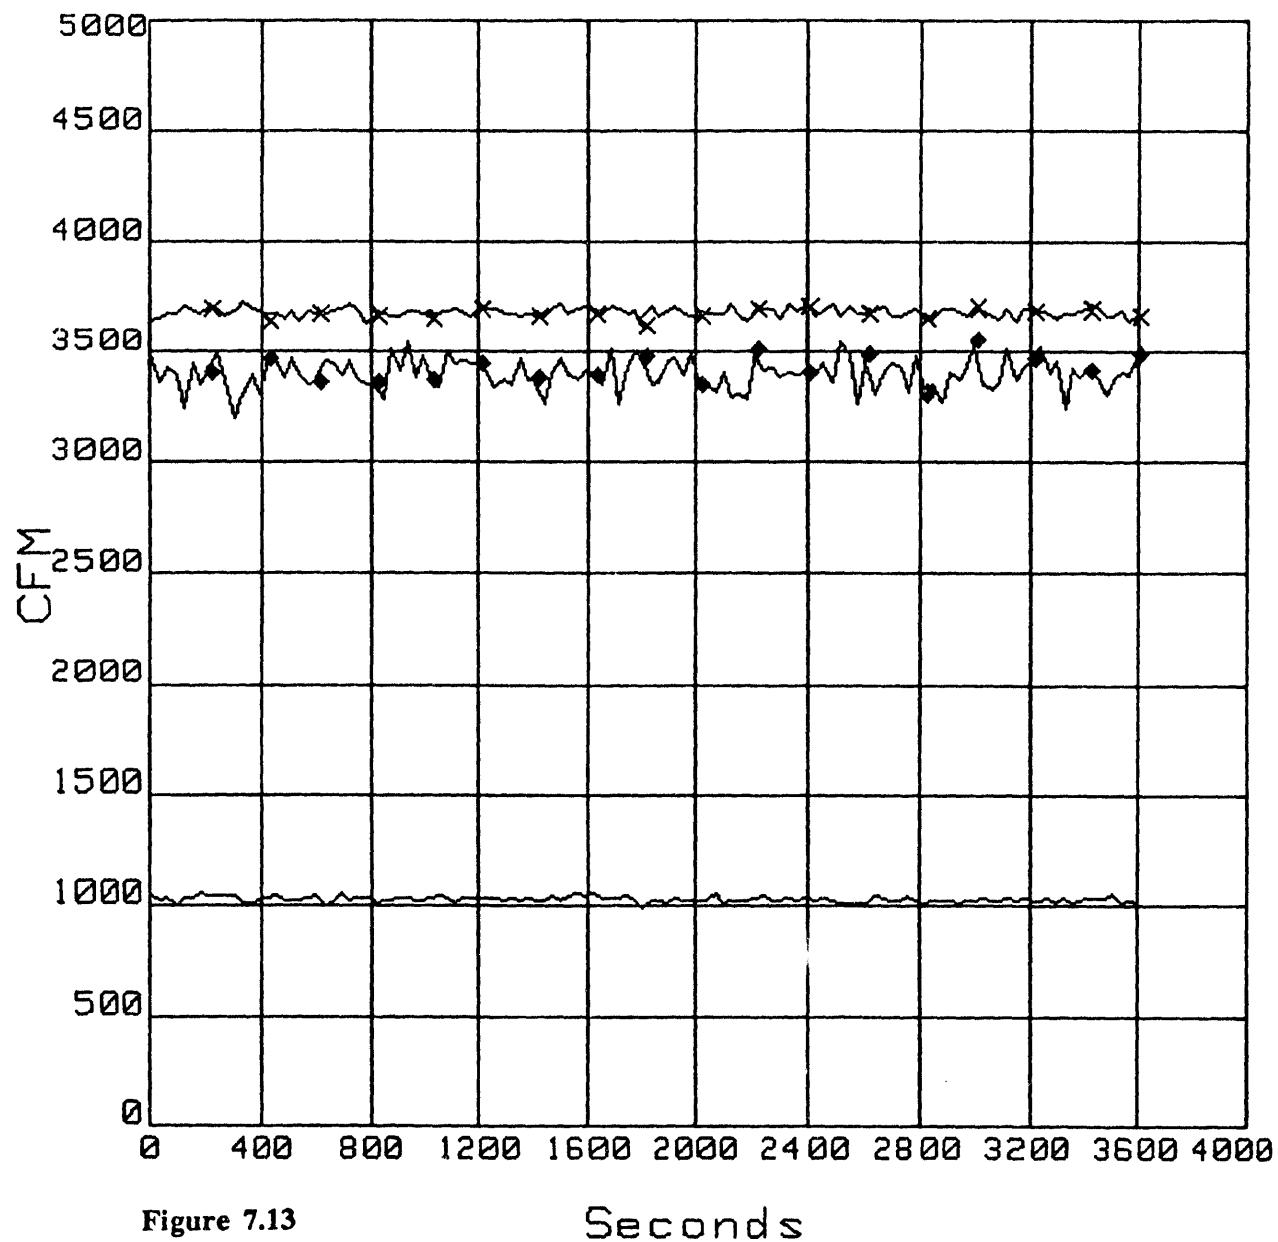
Figure 7.13

FILENAME	CHANNEL	LOCATION	UNIT OF MEASURE	SCALE
ORNL7.1	CH-102	Inlet A/F (TFM)	CFM	5000
◆ ORNL7.1	CH-104	Exit A/F (Pitot)	CFM	5000
✗ ORNL7.1	CH-105	Exit A/F (TFM)	CFM	5000

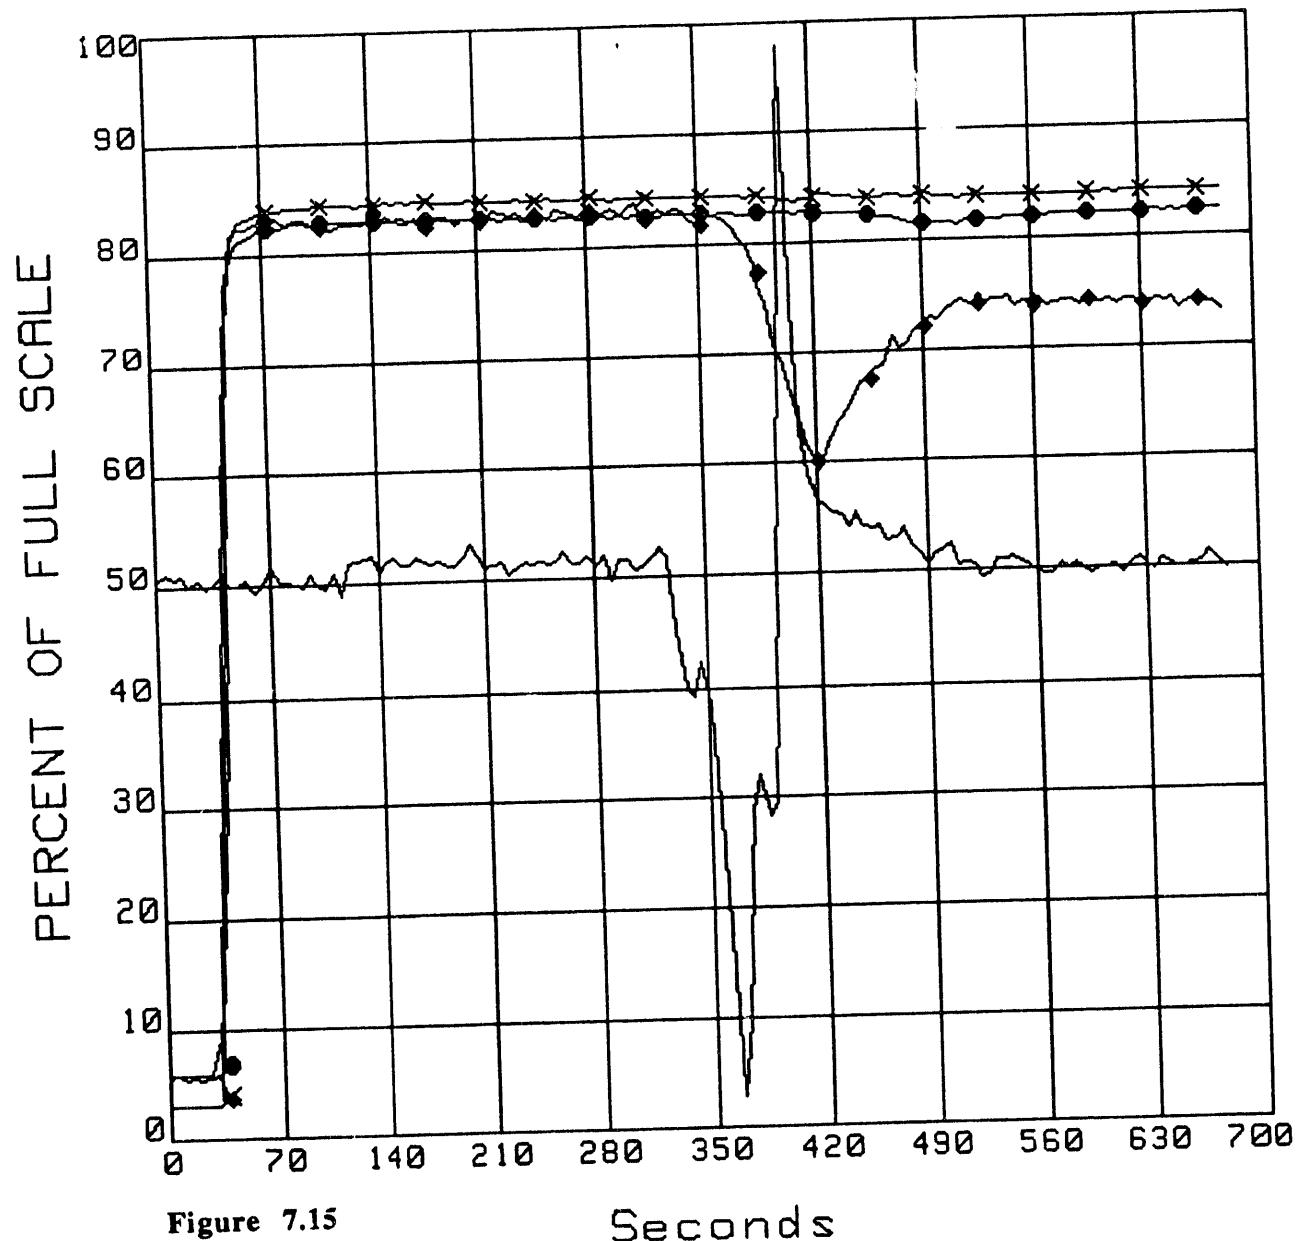
Figure 7.15

FILENAME	CHANNEL	LOCATION	UNIT OF MEASURE	SCALE
ORNL7.0	CH-102	Inlet R/F (TFM)	CFM	2000
◆ ORNL7.0	CH-80	02 6' UP	✓ 02	25
✗ ORNL7.0	CH-84	02 12' UP	✗ 02	25
● ORNL7.0	CH-88	Duct Node	✗ 02	25

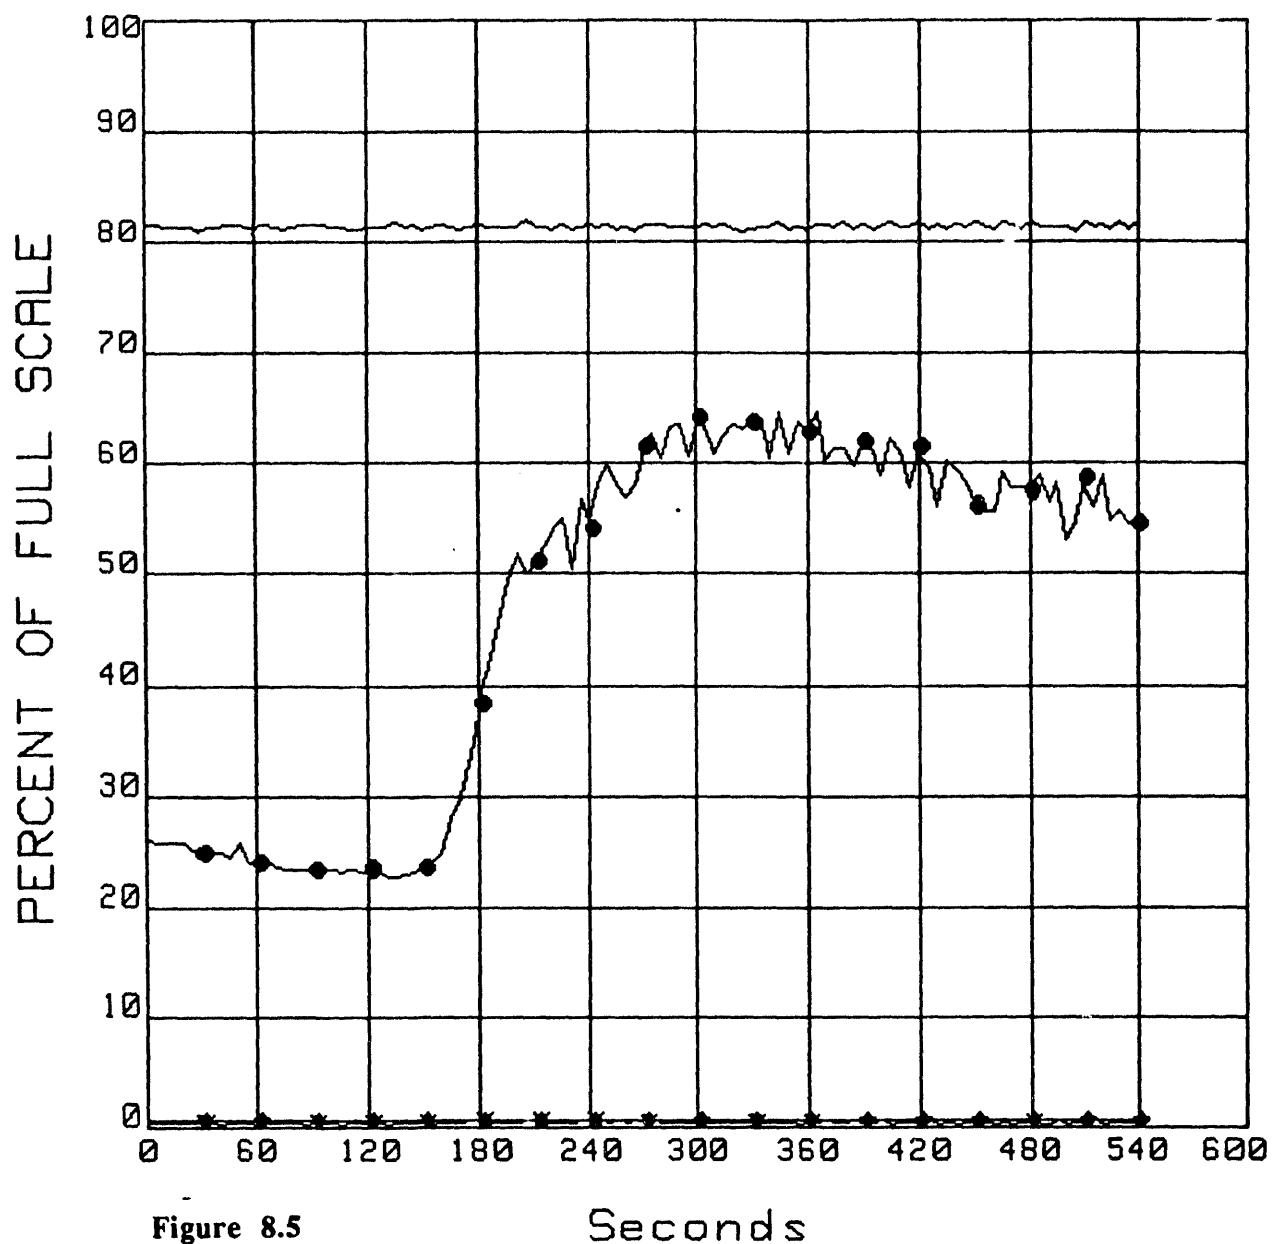
Figure 8.5

FILENAME	CHANNEL	LOCATION	UNIT OF MEASURE	SCALE
ORNL8.0	CH-80	O2 6' UP	% O2	25
◆ ORNL8.0	CH-81	CO2 6' UP	% CO2	12
× ORNL8.0	CH-82	CO 6' UP	% CO	1.5
● ORNL8.0	CH-83	HC 6' UP	PPM (=CH4)	25000

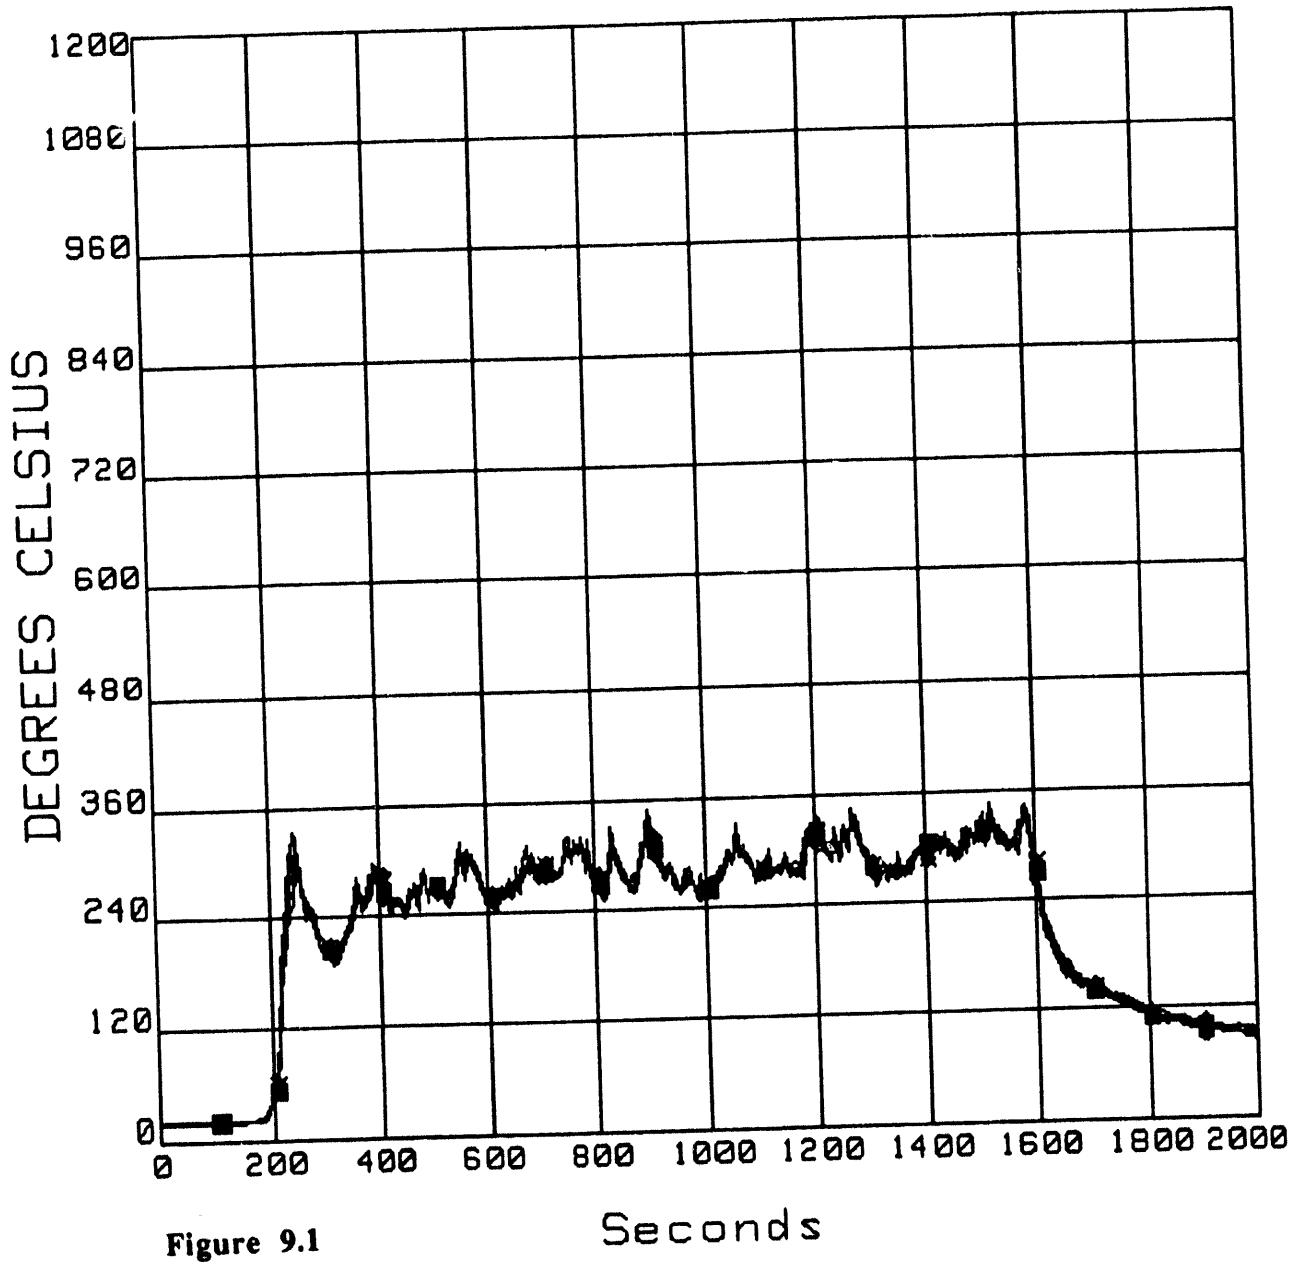
Figure 9.1

FILENAME	CHANNEL	LOCATION	UNIT OF MEASURE	SCALE
ORNL9.0	CH-0	NE TC RAKE 6" UP	Degrees Celsius	1200
♦ ORNL9.0	CH-1	NE TC RAKE 2' UP	Degrees Celsius	1200
× ORNL9.0	CH-2	NE TC RAKE 4' UP	Degrees Celsius	1200
● ORNL9.0	CH-3	NE TC RAKE 6' UP	Degrees Celsius	1200
■ ORNL9.0	CH-4	NE TC RAKE 8' UP	Degrees Celsius	1200
◊ ORNL9.0	CH-5	NE TC RAKE 10' UP	Degrees Celsius	1200

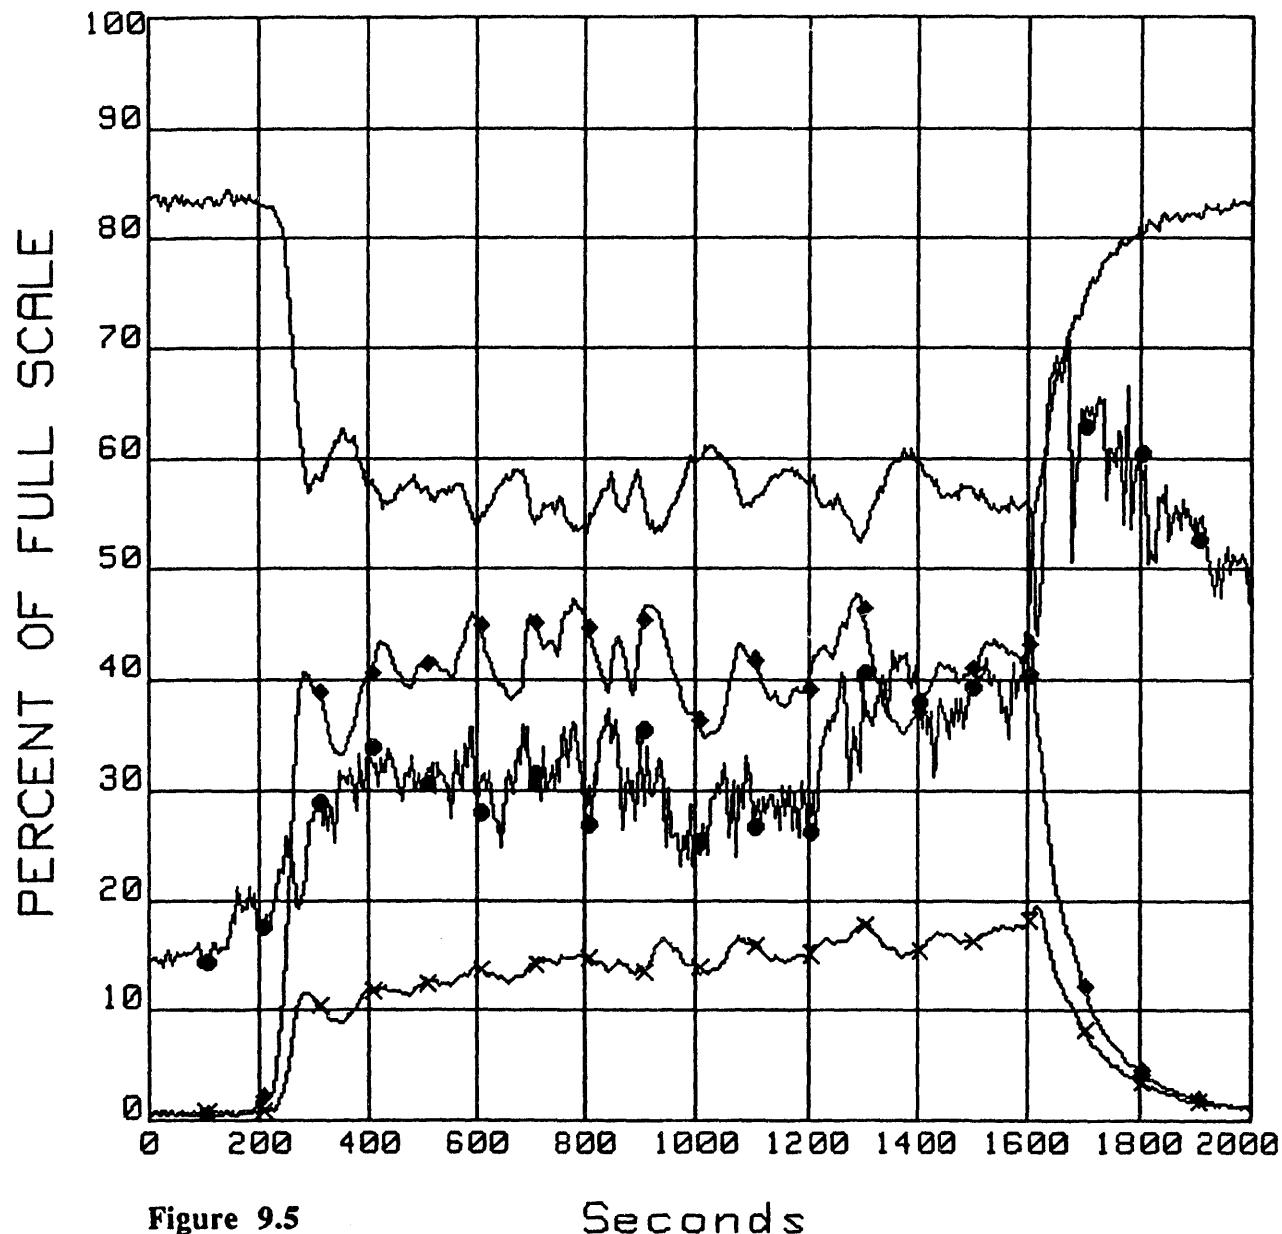
Figure 9.5

FILENAME	CHANNEL	LOCATION	UNIT OF MEASURE	SCALE
ORNL9.0	CH-80	O2 6' UP	% O2	25
◆ ORNL9.0	CH-81	CO2 6' UP	% CO2	12
✗ ORNL9.0	CH-82	CO 6' UP	% CO	1.5
● ORNL9.0	CH-83	HC 6' UP	PPM (=CH4)	25000

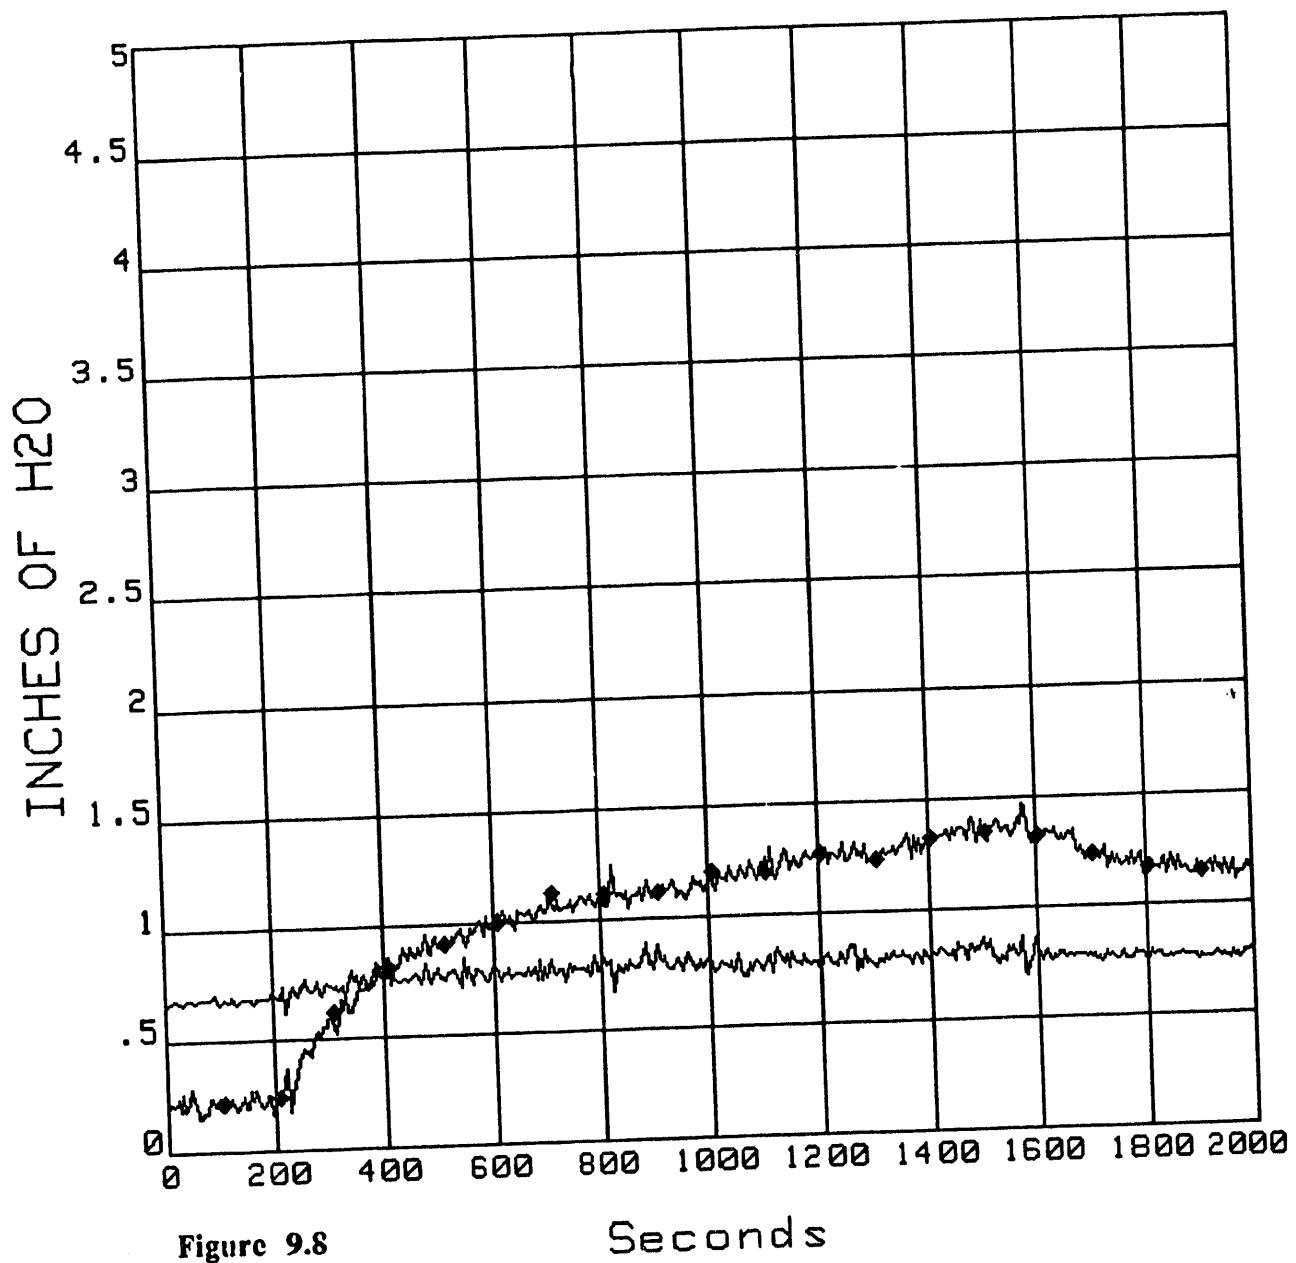
Figure 9.8

FILENAME	CHANNEL	LOCATION	UNIT OF MEASURE	SCALE
ORNL9:0	CH-109	Delta P HEPA	INCHES H ₂ O	5
◆ ORNL9:0	CH-110	Delta P PreFilter	INCHES H ₂ O	5

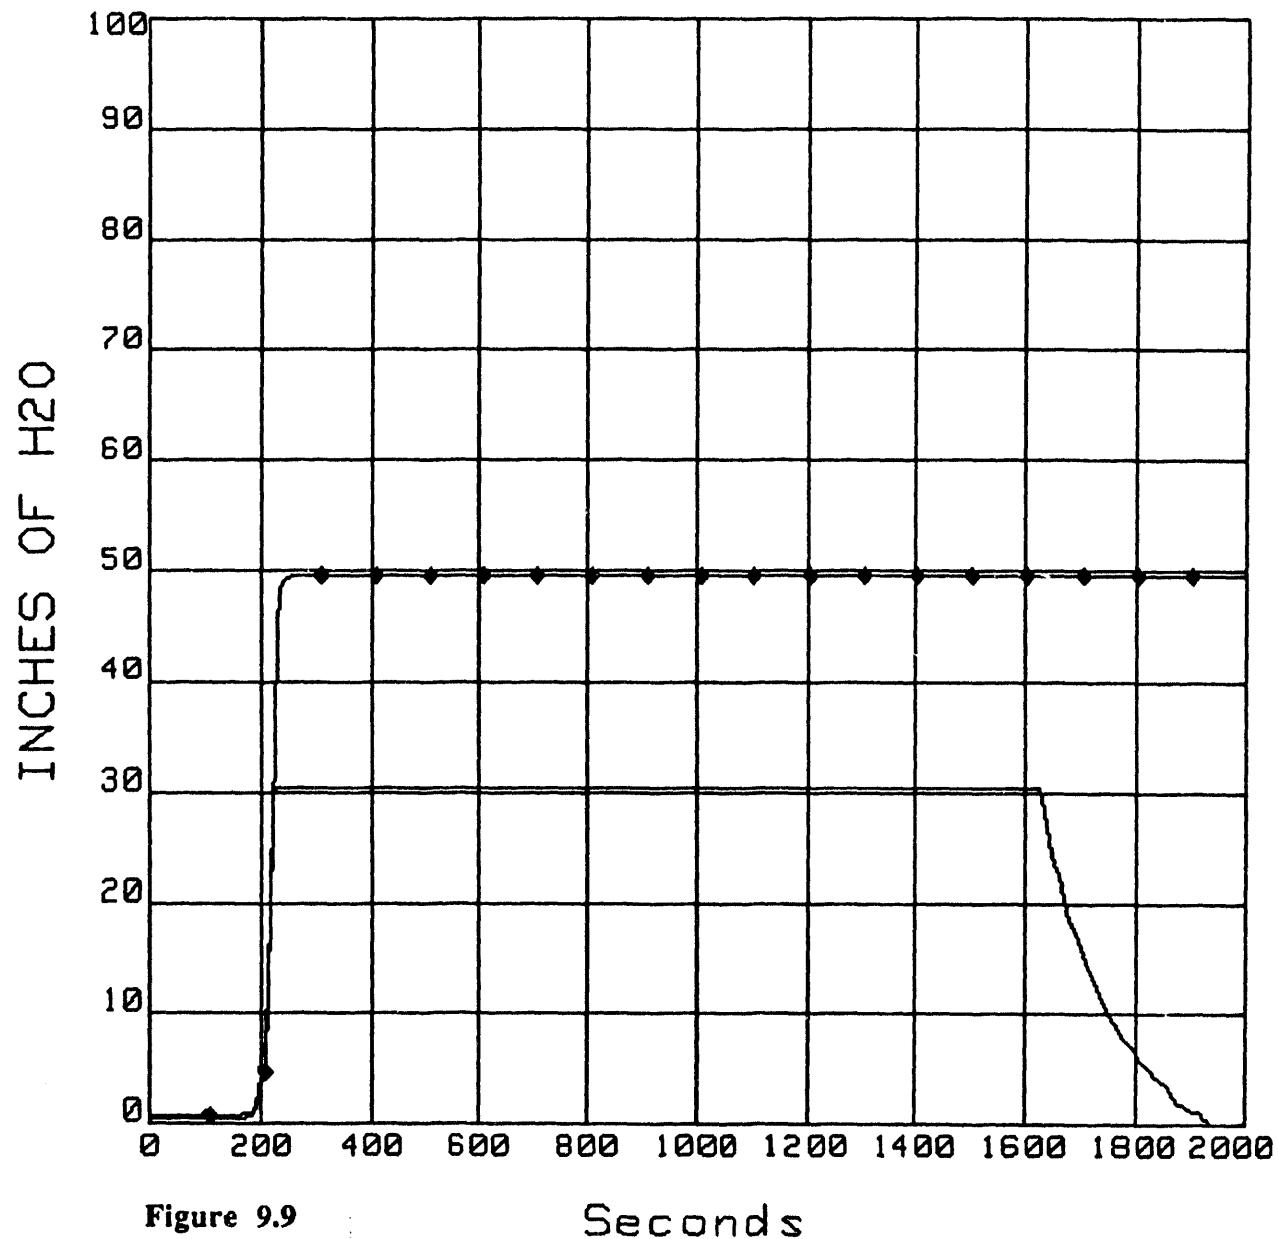
Figure 9.9

FILENAME	CHANNEL	LOCATION	UNIT OF MEASURE	SCALE
ORNL9.0	CH-112	Heat Sensor 22' side	INCHES H ₂ O	100
◆ ORNL9.0	CH-113	Heat Sensor 13' side	Inches H ₂ O	100

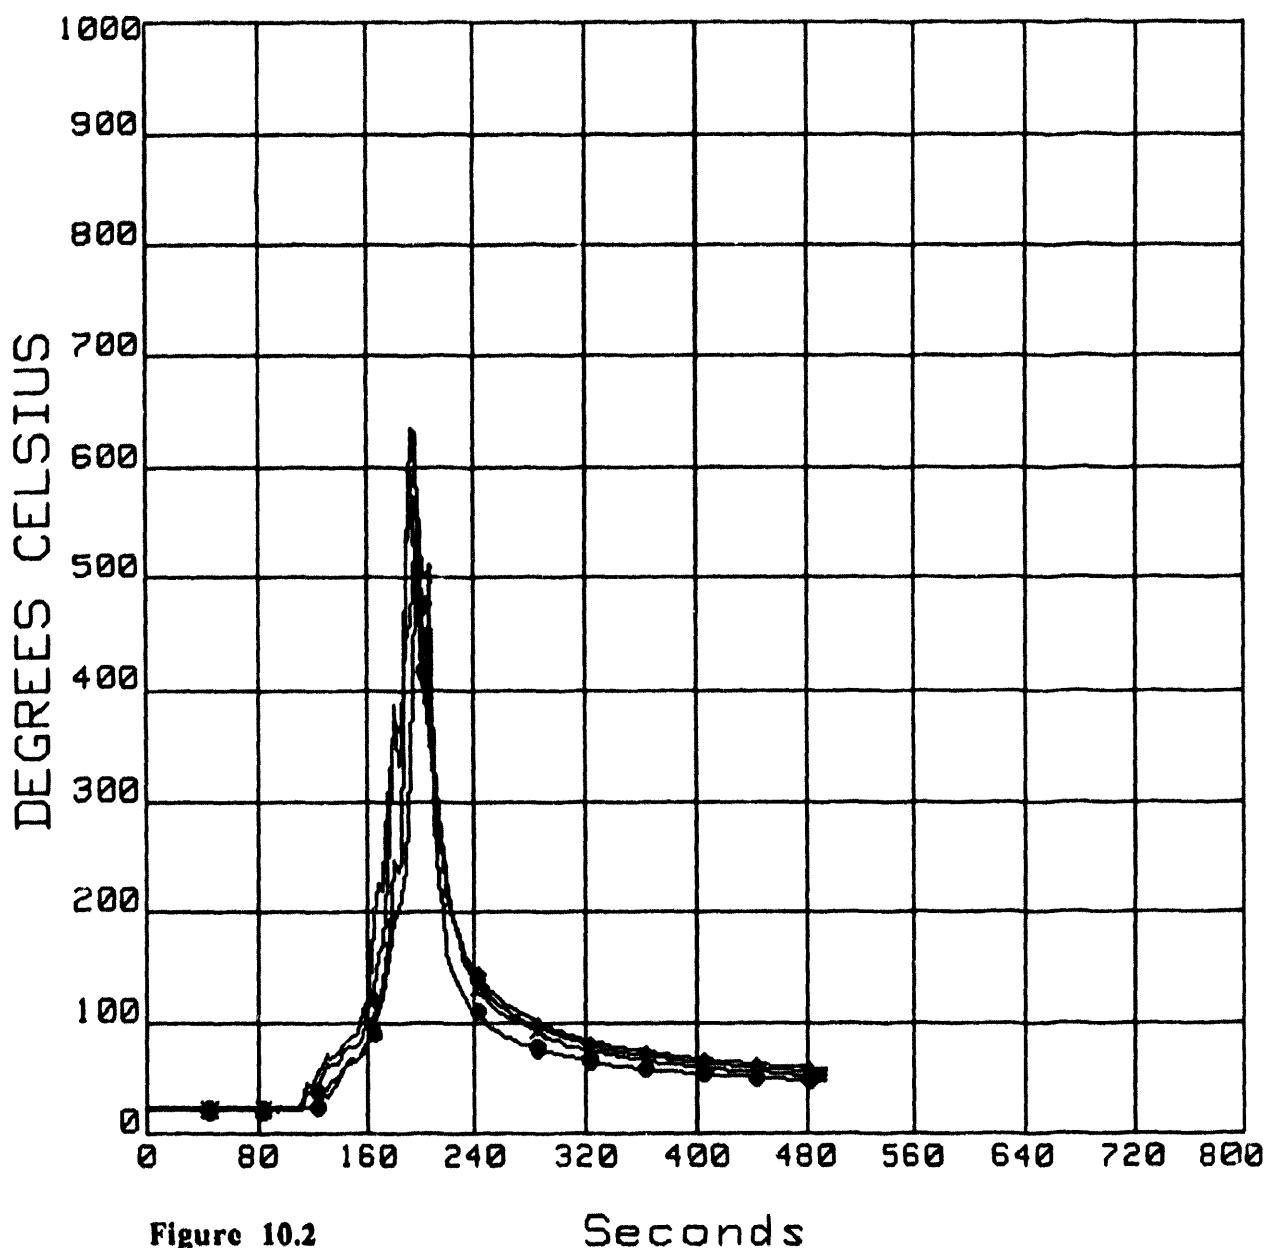
Figure 10.2

FILENAME	CHANNEL	LOCATION	UNIT OF MEASURE	SCALE
ORNL10.0	CH-20	So TC RAKE 6" UP	Degrees Celsius	1000
◆ ORNL10.0	CH-21	So TC RAKE 2' UP	Degrees Celsius	1000
× ORNL10.0	CH-22	So TC RAKE 4' UP	Degrees Celsius	1000
● ORNL10.0	CH-23	So TC RAKE 6' UP	Degrees Celsius	1000

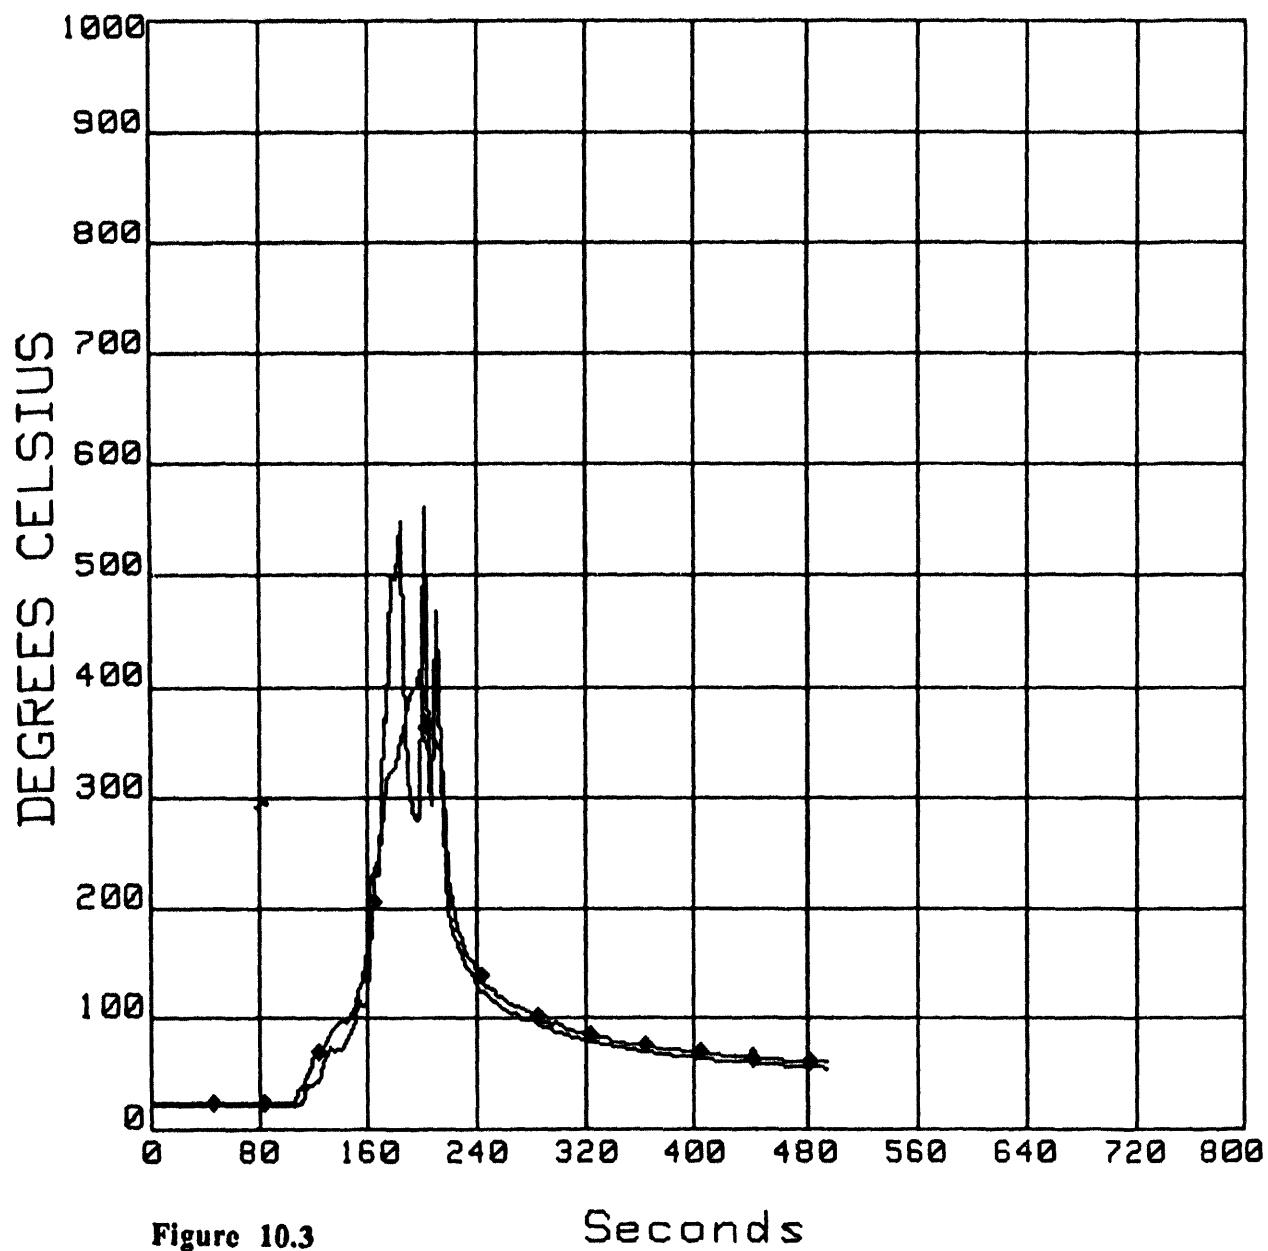
Figure 10.3

FILENAME	CHANNEL	LOCATION	UNIT OF MEASURE	SCALE
ORNL10:0	CH-25	TC BY RADIOMETER	Degrees Celsius	1000
◆ ORNL10:0	CH-30	Top Center Room	Degrees Celsius	1000

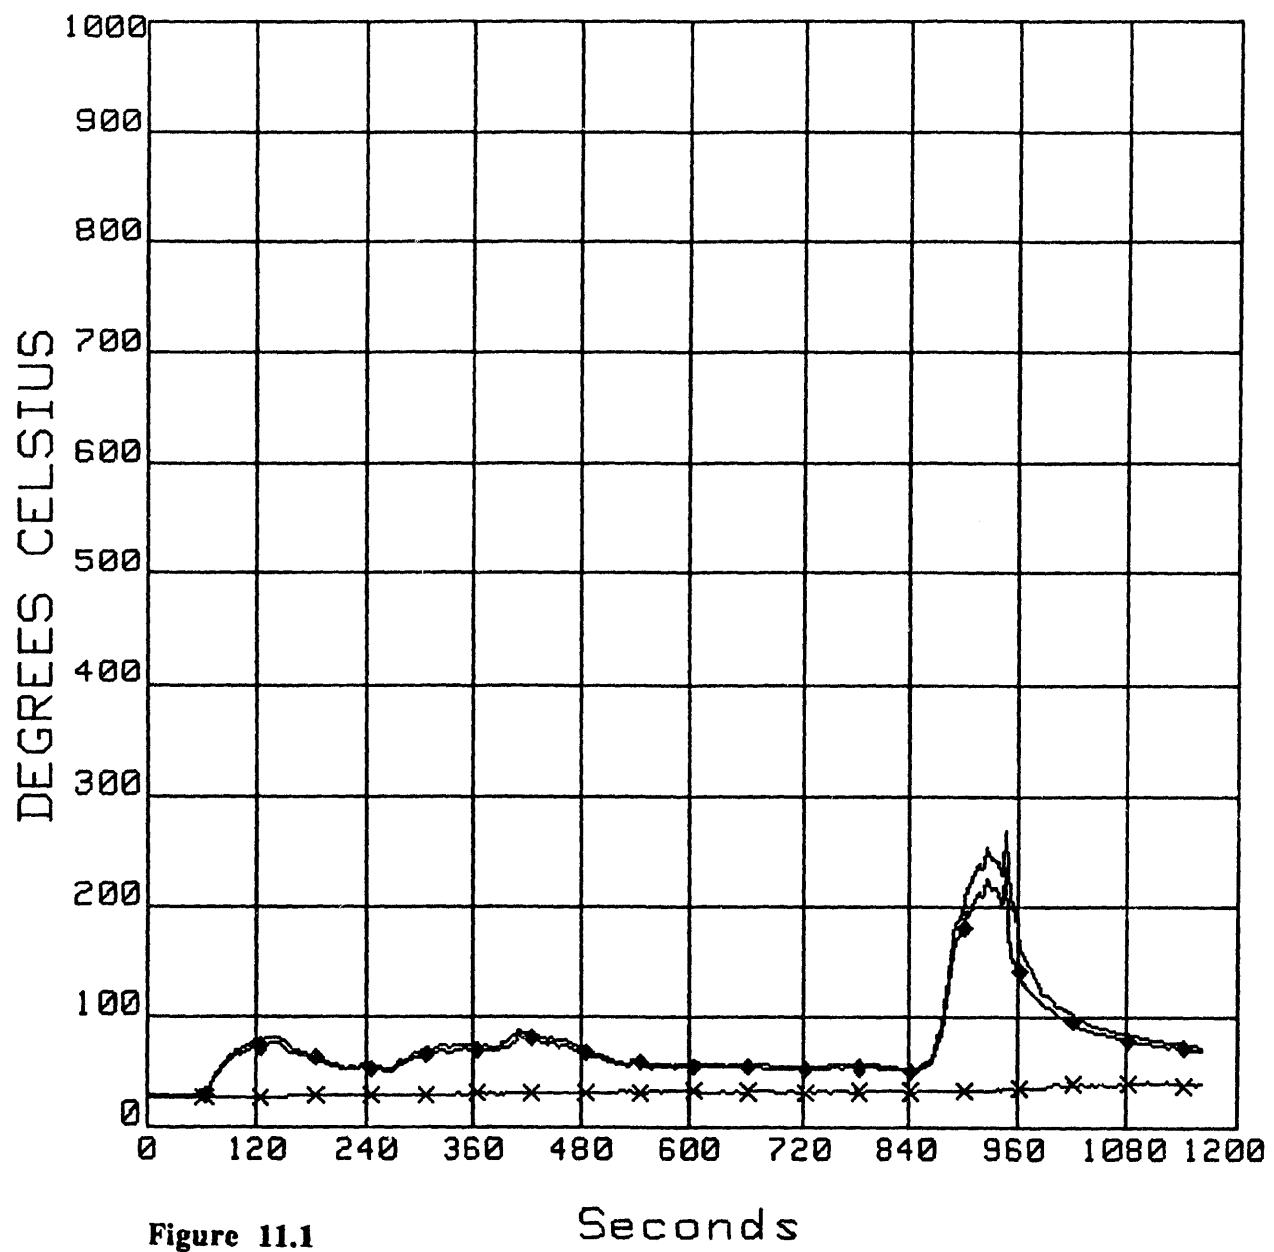
Figure 11.1

FILENAME	CHANNEL	LOCATION	UNIT OF MEASURE	SCALE
ORNL11.0	CH-27	Ex Duct Inlet	Degrees Celsius	1000
◆ ORNL11.0	CH-28	Ex Duct Elbow Flange	Degrees Celsius	1000
× ORNL11.0	CH-29	Elbow Outside	Degrees Celsius	1000

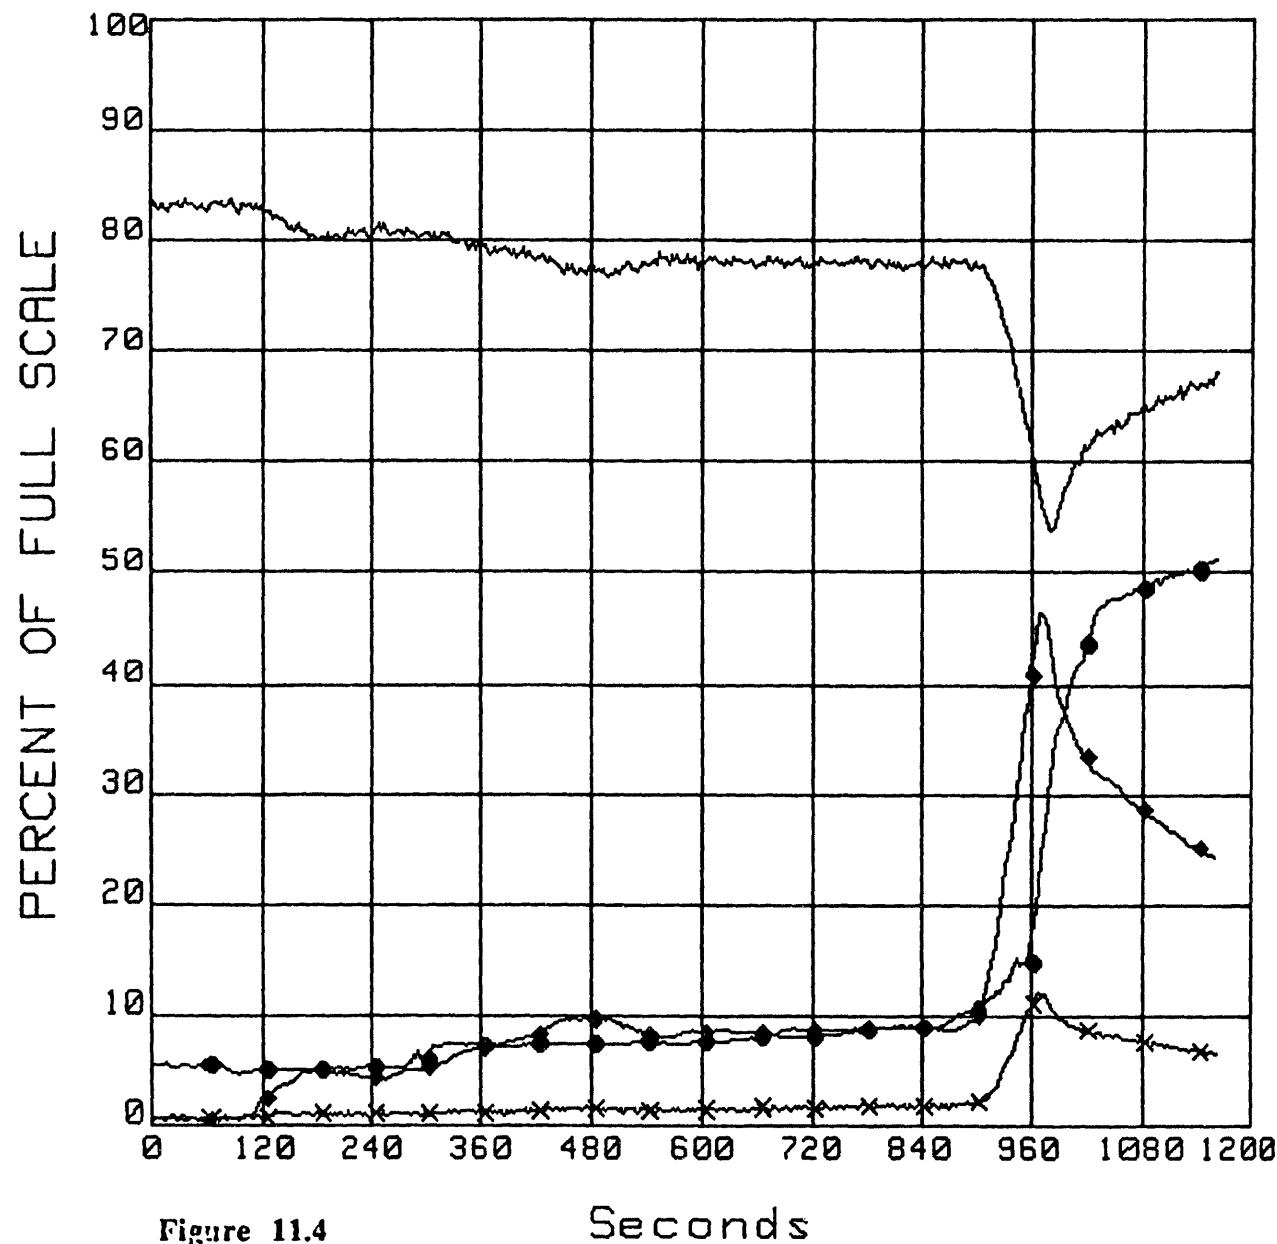
Figure 11.4

FILENAME	CHANNEL	LOCATION	UNIT OF MEASURE	SCALE
ORNL11.0	CH-80	O2 6' UP	% O2	25
◆ ORNL11.0	CH-81	CO2 6' UP	% CO2	12
× ORNL11.0	CH-82	CO 6' UP	% CO	1.5
● ORNL11.0	CH-83	HC 6' UP	PPM (=CH4)	25000
