## ISSUES FOR CONVERSION COATING OF ALUMINUM ALLOYS WITH HYDROTALCITE\*

C. A. Drewien and R. G. Buchheit  
Sandia National Laboratories  
Albuquerque, NM 87185

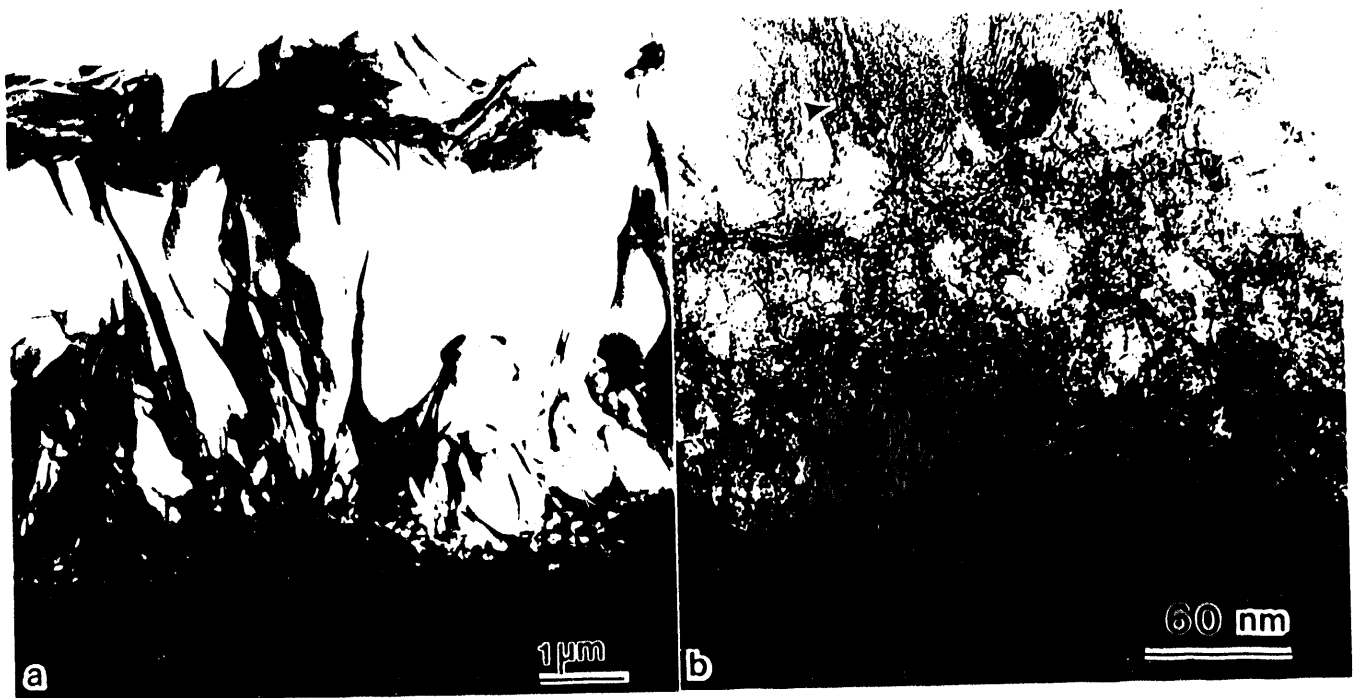
Figure 4.--Cross-sectional TEM micrographs of hydrotalcite coatings on a.) 1100 Al, b.) 2024-T3 Al, and c.) Cu profiled through 1100 Al de-oxidized in a bath containing Cu.

**Alloying Elements--**The copper-containing aluminum alloy Al 2024-T3 coated with hydrotalcite failed salt spray testing. Sputter depth profile of hydrotalcite-coated Al 2024-T3 showed the presence of both Mg and Cu in the coating (Figure 3c), and AEM analysis yielded copper throughout the thickness of the Al 1100 samples (Figure 4c) that were de-oxidized in a bath containing copper nitrate and subsequently coated. The effect of copper upon the corrosion behavior may result from its influence upon coating formation and growth. The cross-sectional TEM micrographs in Figure 4 show a.) a thick coating that formed upon Al 1100 and b.) a thin coating on Al 2024-T3. The inner and outer layers that are so obvious in the Al 1100 microstructure are not readily apparent in the Al 2024-T3 microstructure. The inner layer comprises most of the coating, and only a few small crystals of the outer layer are visible (see arrow in Figure 4b). The thickness and microstructure of the coating deposited on the Al 1100 de-oxidized in Cu-containing de-oxidizing bath was similar to the Al 2024 coating; only a single layer was observed and the coating thickness was about 0.5  $\mu\text{m}$ .
