THE LIVE TEST DEMONSTRATION (LTD)
OF LIGHTING RETROFIT TECHNOLOGIES
AT THE DOE FORESTAL BUILDING

Presented at the
International Energy Environ-
mental Congress Conference
August 4-5, 1993
Minneapolis, MN

The Live Test Demonstration (LTD) of Lighting Retrofit Technologies at the DOE Forrestal Building

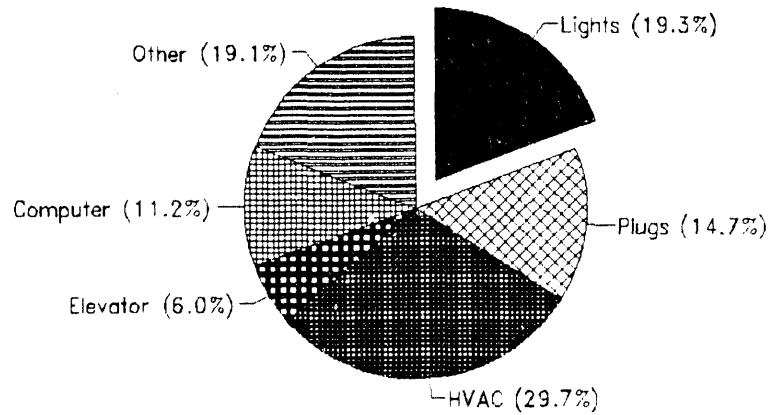
Figure 1. Baseline Annual Electricity Consumption .

Figure 1 shows the annual electrical consumption baseline, with lighting consuming about 33% of the building total, followed by fans at 25%, and plug loads at 11%. Figure 2 shows a typical working day demand profile (based on 15-minute

Forrestal Building Annual Estimated
Electrical Consumption in kWh

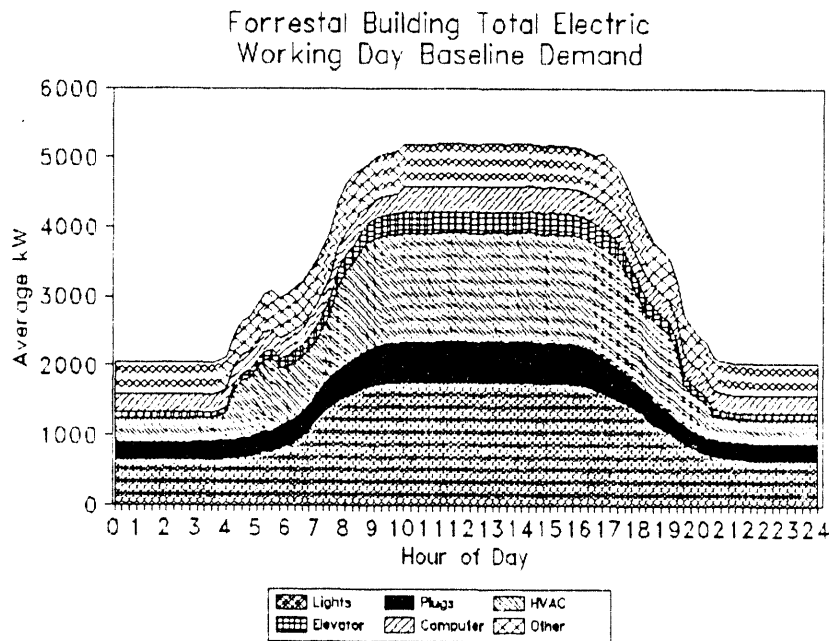
Figure 2. Baseline Working Day Electrical Demand

metered end-use data collected during the baseline work). One of the striking features of Figure 2 is the relatively large portion of the maximum lighting load that occurs 24 hours a day. It is obvious from Figure 2 that a large amount of lighting is on all the time.

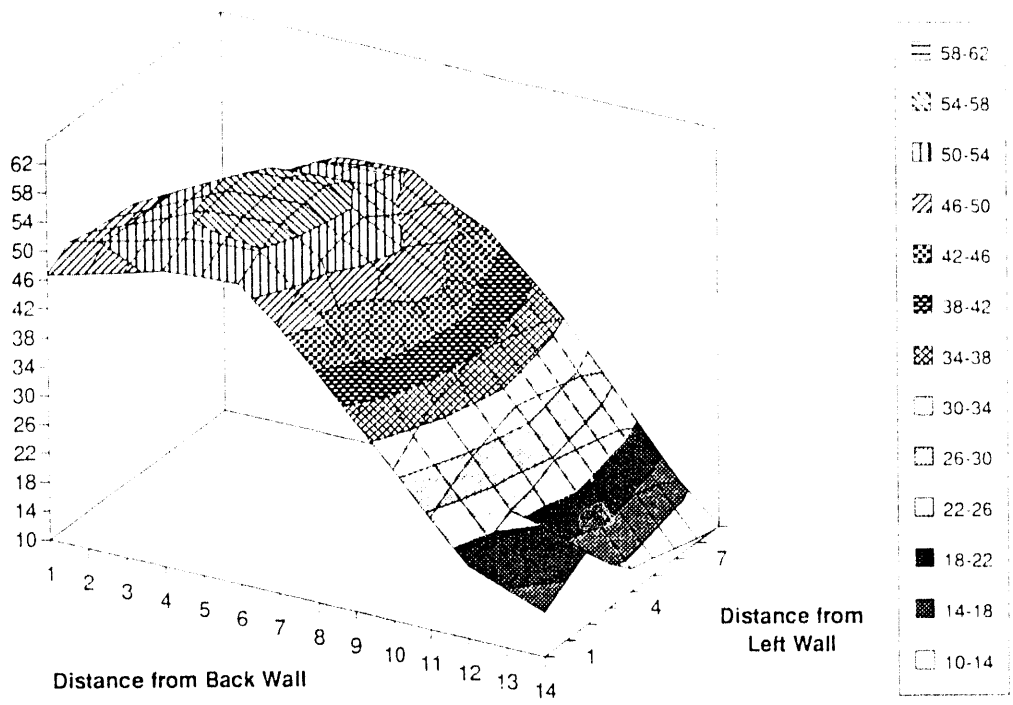
Figure 4. Contour Plot of Baseline (in footcandles)

Figure 4 shows a contour plot of the lighting levels in the test room during the baseline measurements. Figure 5 shows a contour plot of the lighting levels in the test room during testing of the winning contractor. Comparison of these two

plots shows that illumination levels in the test room were not only higher but also more uniform after the retrofit.

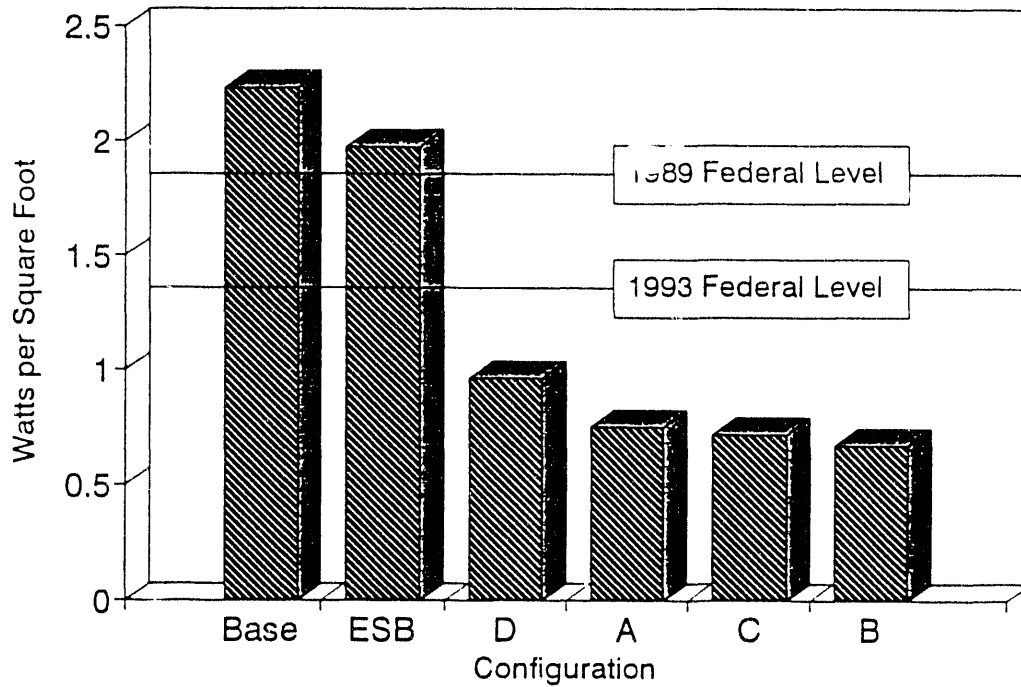
Figure 6. Forrestal Building LTD Lighting Power Density

Figure 6 compares power consumption on a per-square-foot-basis for each of the lighting configurations measured with current federal energy standards for lighting power density (10 CFR 435). The required 20% reduction in lighting power would have been just sufficient to bring the Forrestal Building down to the 1989 lighting power limits but would not have been sufficient to meet the requirements for 1993. Fortunately, all proposed retrofits have lighting power densities far below current federal standards.

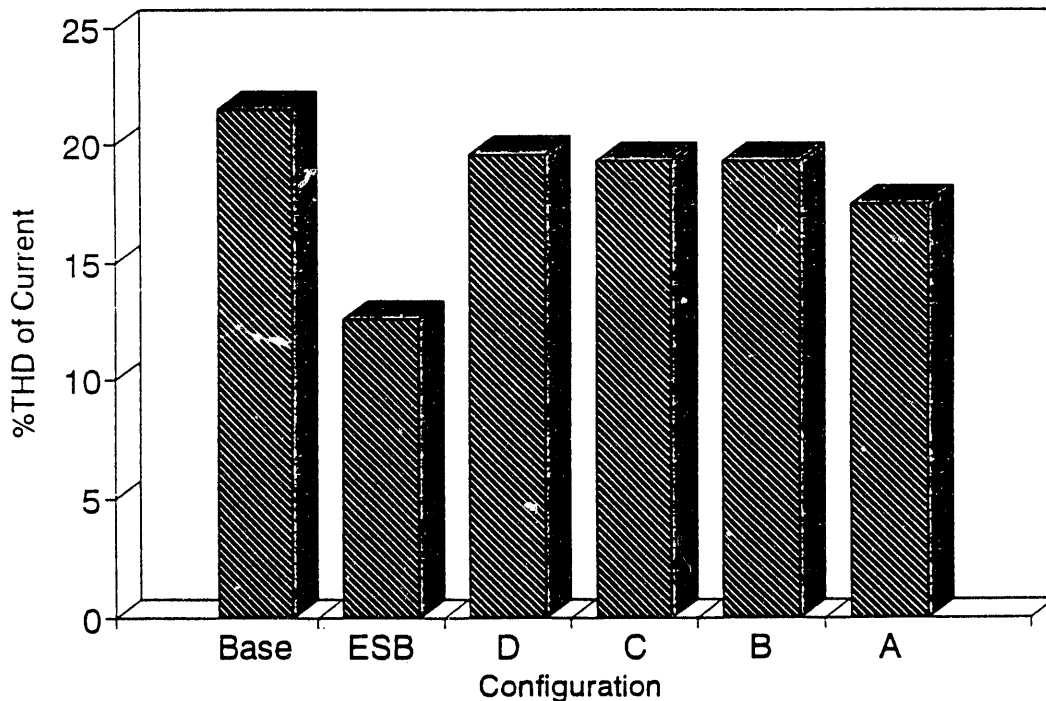
Figure 7. Comparison of THD Levels

Power harmonic measurements for each of the four proposed contractor retrofits plus the baseline and the energy saving baseline are shown in Figure 7. All contractors met the requirement that THD be held to no more than current levels in the test room.

These results are expected due to the age and nature of the ballasts involved. The baseline (Base) configuration contains older inductive ballasts originally installed in the building in 1968. The energy saving baseline (ESBase) configuration contains much newer inductive ballasts with

a lower THD. All four contractors installed electronic ballasts, which typically have higher THD than inductive ballasts.
