# **Fire Testing of 55 Gallon Metal Waste Drums For Dry Waste Storage**

Prepared for  
United States  
Department Of Energy  
Office of Environment, Safety, and Health  
Under contract with  
Westinghouse Hanford Company  
Richland, WA

July, 1993

Fire Research Discipline  
Special Projects Division  
Hazards Control Department  
Lawrence Livermore National Laboratory

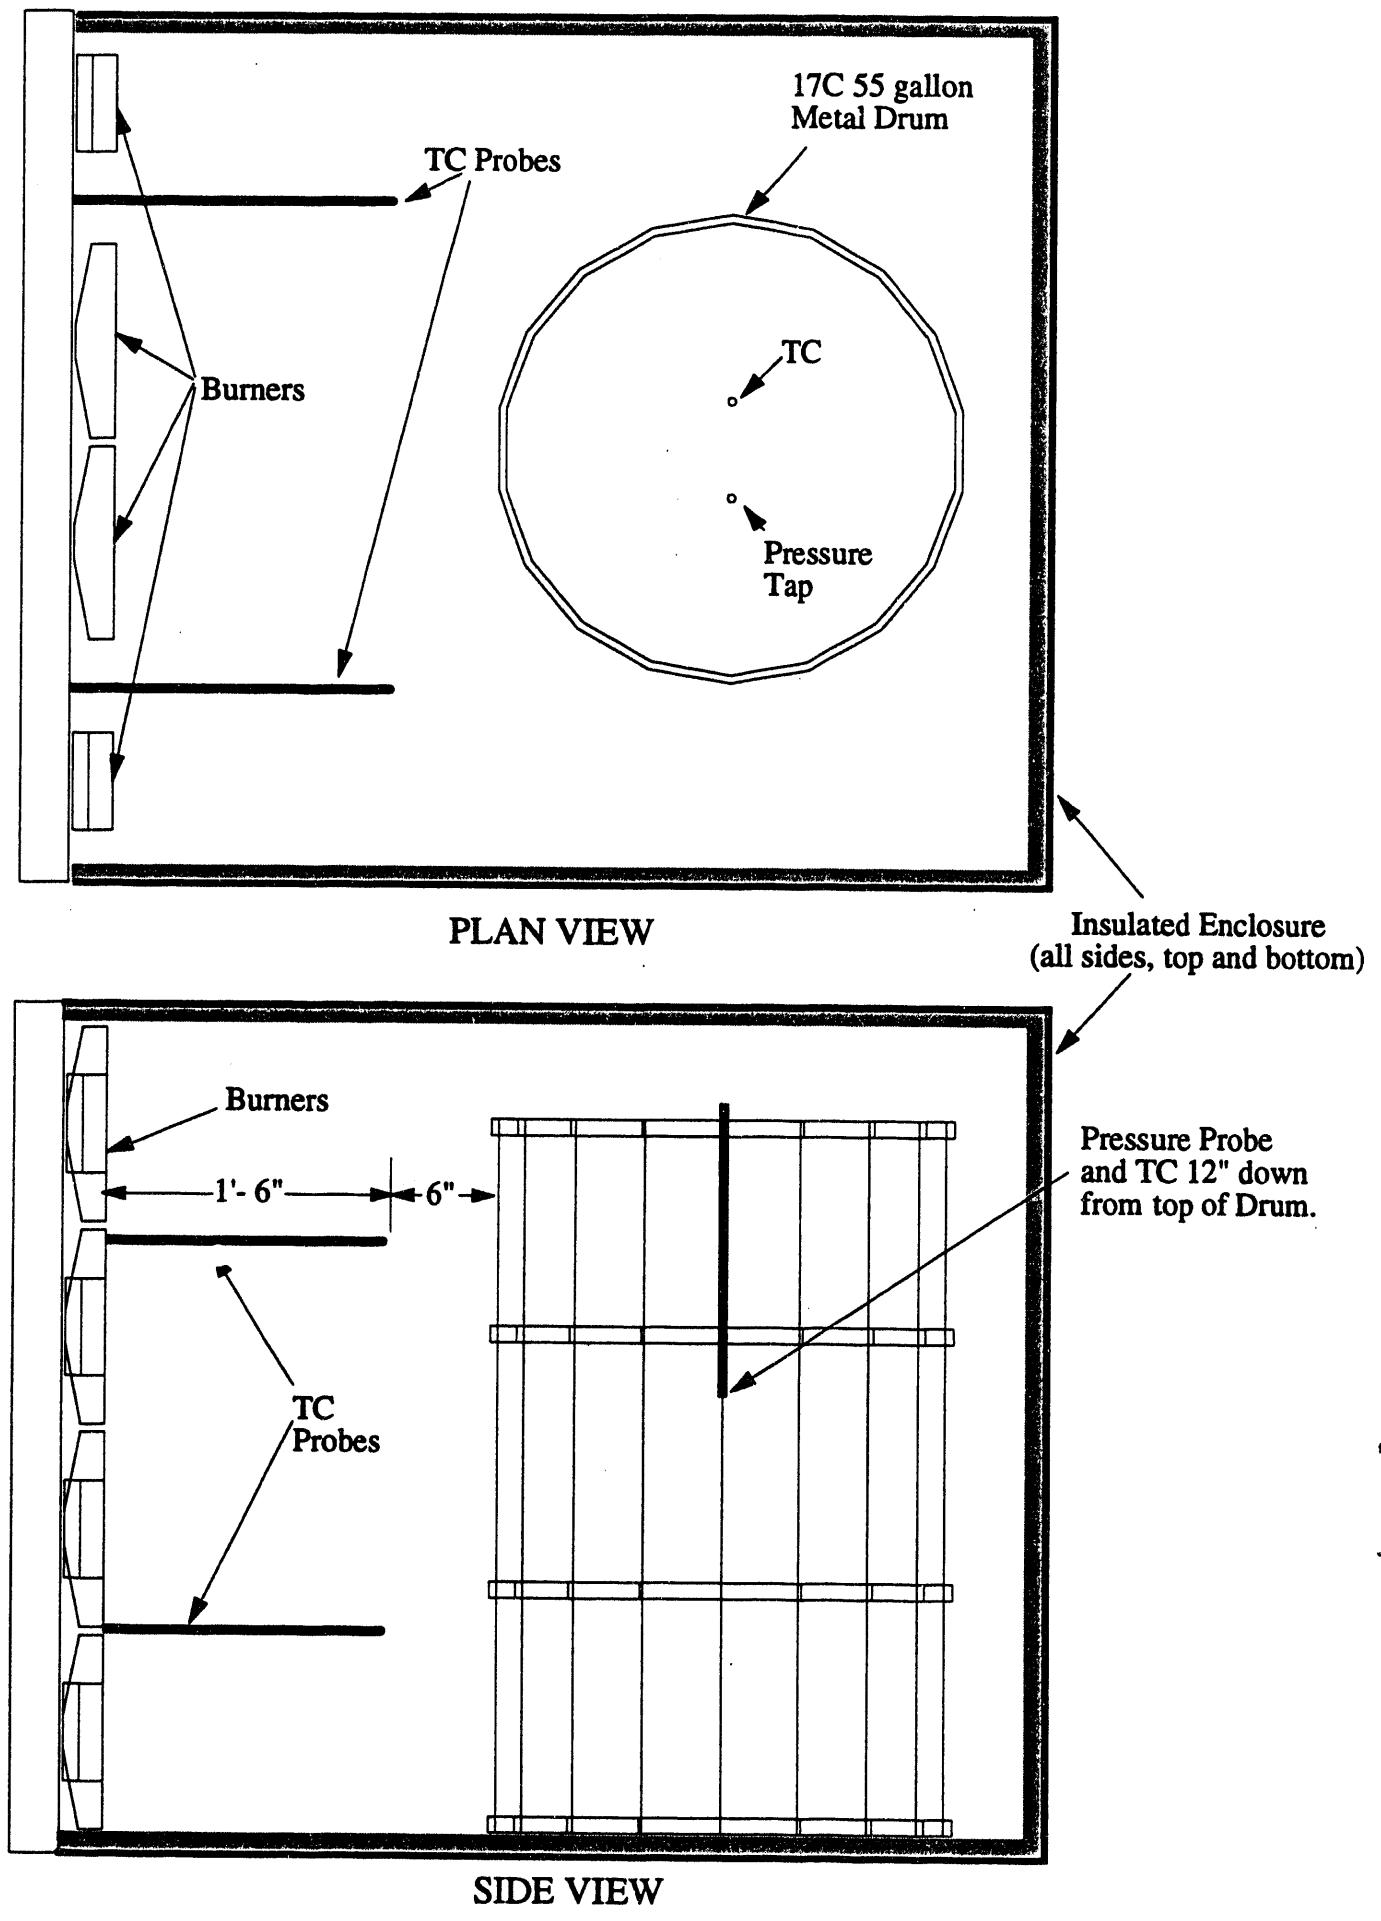
Figure 1

The ASTM E-119 exposure test configuration with a single empty 55 gallon drum in the test configuration is shown in Figure 1. The apparatus is not a full scale E-119 furnace, but rather, a scaled down version capable of reproducing an equivalent time temperature curve. Photos 1&2 show the overall set up and the placement of the drum in the furnace. The cyclone fencing shown in photo 1 was used to contain the drum and other material in the event of an explosion.

## E119 Test Configuration

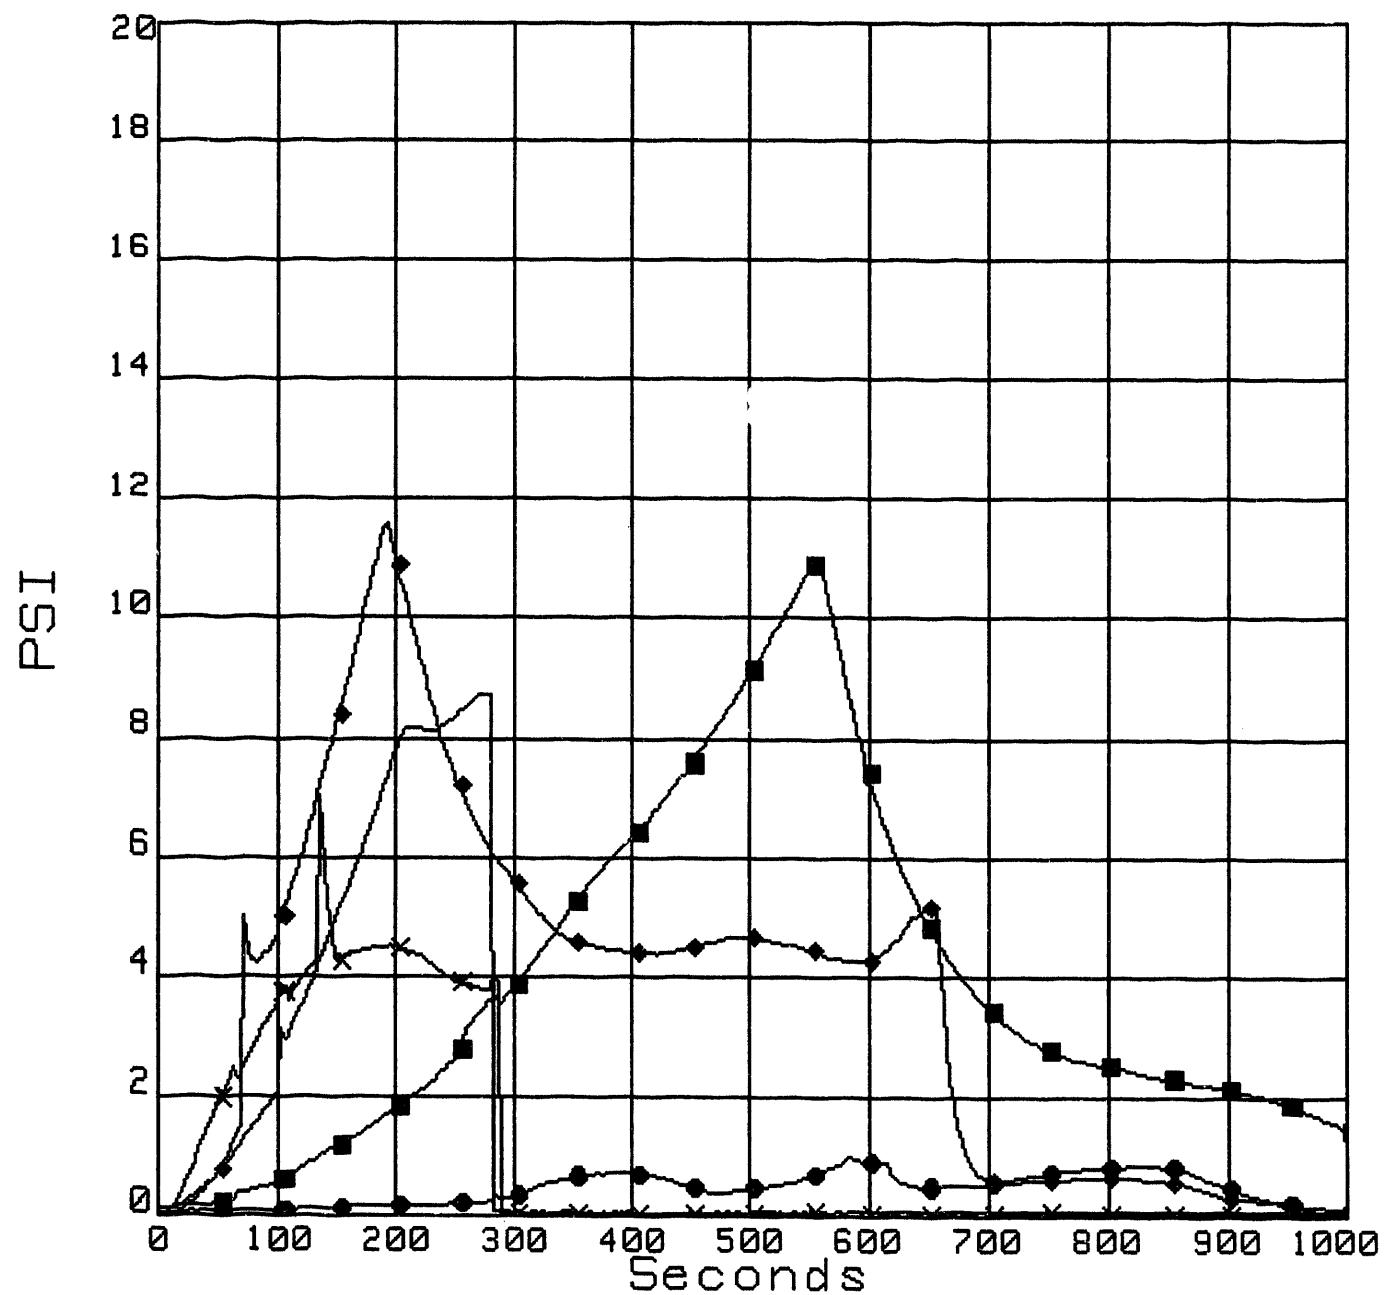
Figure 7

The plots shown in figures 7&8 are composites of the internal drum pressures and temperatures. The plots in figure 7 show that number 1 drum vented at approximately 205 seconds into the test, with a total loss of pressure occurring at approximately 275 seconds. The plots in figure 8, show that the maximum internal drum temperature at this point was 480°C. Data from these plots show that drum 2 vented at 180 seconds with an internal temperature of just over 400°C. This data also shows, that the number 3 drum started to vent at 180 seconds, with a total pressure loss occurring at 280 seconds at an internal temperature of 280°C. These plots also show, that the pressure in the number 4 drum oscillated between near zero to one psi during the test. The pressure was constantly being relieved in this drum through the nuclear grade filter that is incorporated into the lid. The temperature data shows that the maximum internal temperature achieved, in this drum, was 700°C. The final plot lines show that the number 5 drum (Inner drum) vented at 550 seconds, at just under 11 psi, with an internal temperature of approximately 350°C. Additional analysis of this data show, that the maximum internal temperature for drums 1, 4 and 5 was approximately 700°C, and drums 3 and 5 were approximately 400°C and 480°C respectively.

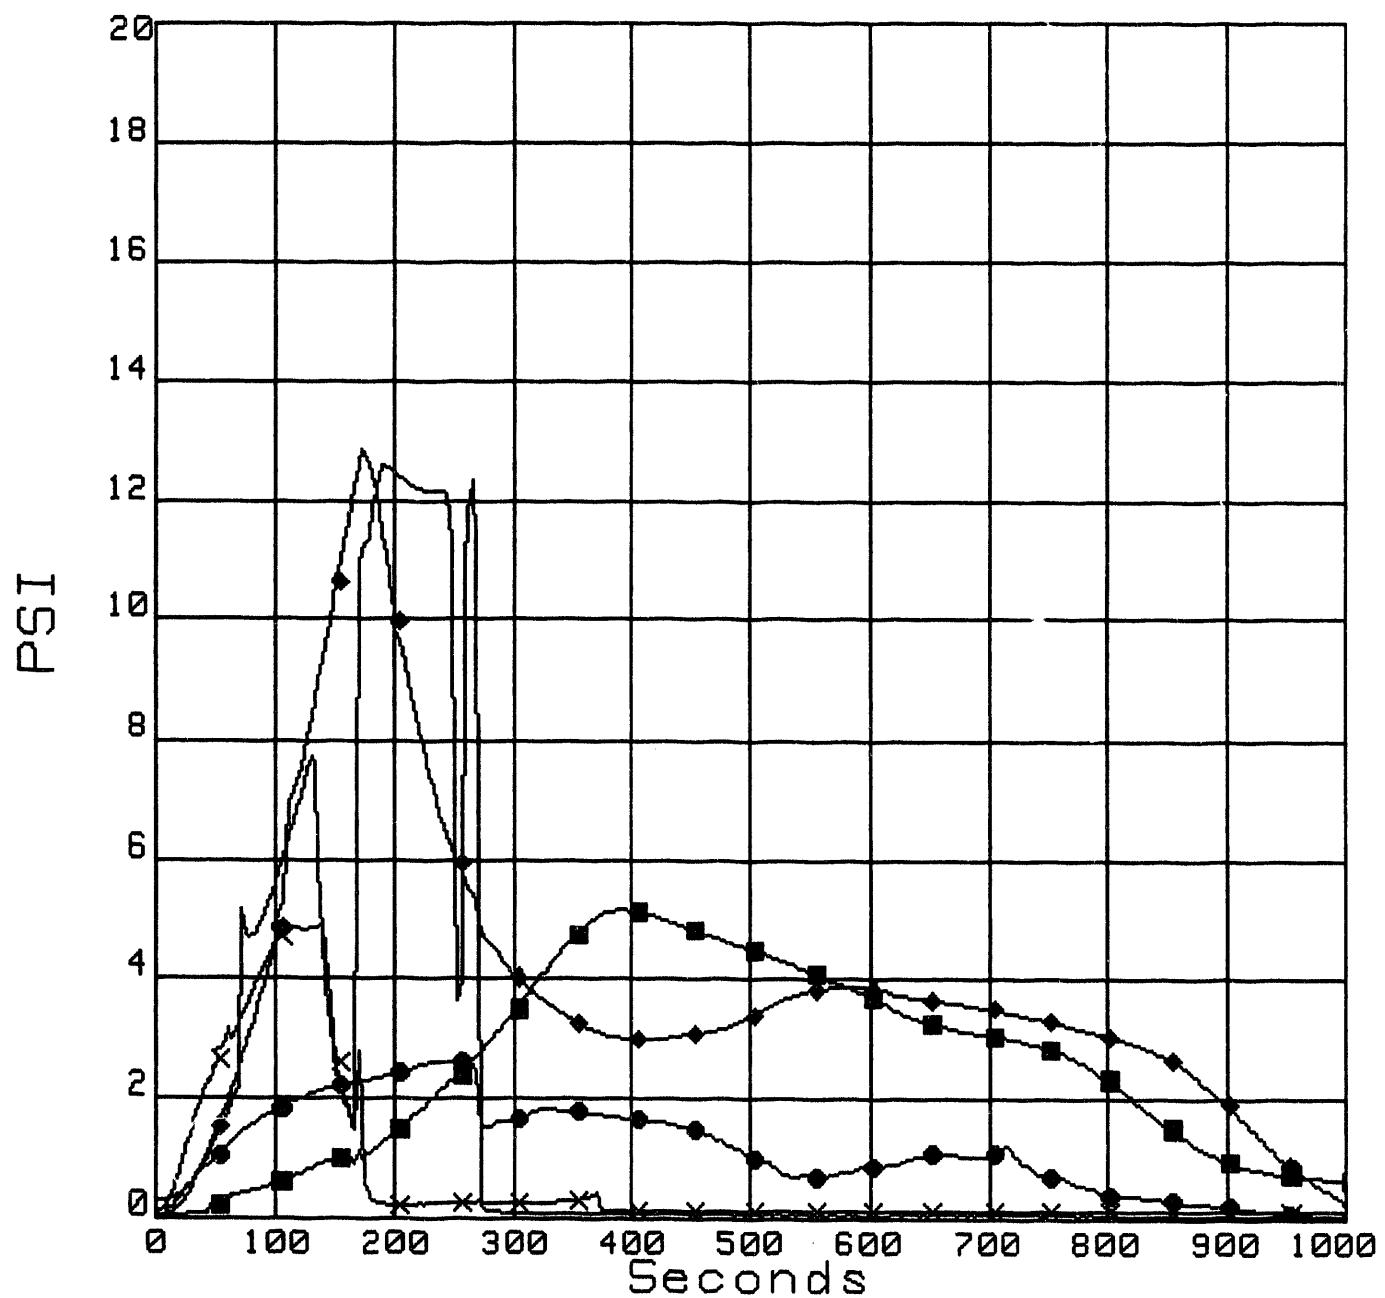
Figure 9

The plots shown in figures 9&10 are composites of the internal drum pressures and temperatures. The plots in figure 9 show that number 1 drum initially vented at approximately 130 seconds into the test. The pressure then increased to 12.5 psi and the drum started to vent again at 185 seconds, with a total loss of pressure occurring at approximately 250 seconds. The plots in figure 10 show that the maximum internal temperature of drum 1 during this period was approximately 450°C. The data also shows that drum 2 vented at 175 seconds with an internal temperature of just over 300°C. The salvage drum vented at 150 seconds at an internal temperature of approximately 150°C. The plots for the TRU drum show the pressure slowly increasing to approximately 2.75 psi then dropping down to below 2 psi at 260 seconds. The pressure continued to decline in this drum over the duration of the test and reached near 0 by the time the alcohol fire went out. The drum 5 (inner drum) vented at 390 seconds at an internal temperature of just over 220°C. Additional analysis of this data show that the maximum internal temperatures for the drums were between 400 and 600°C.

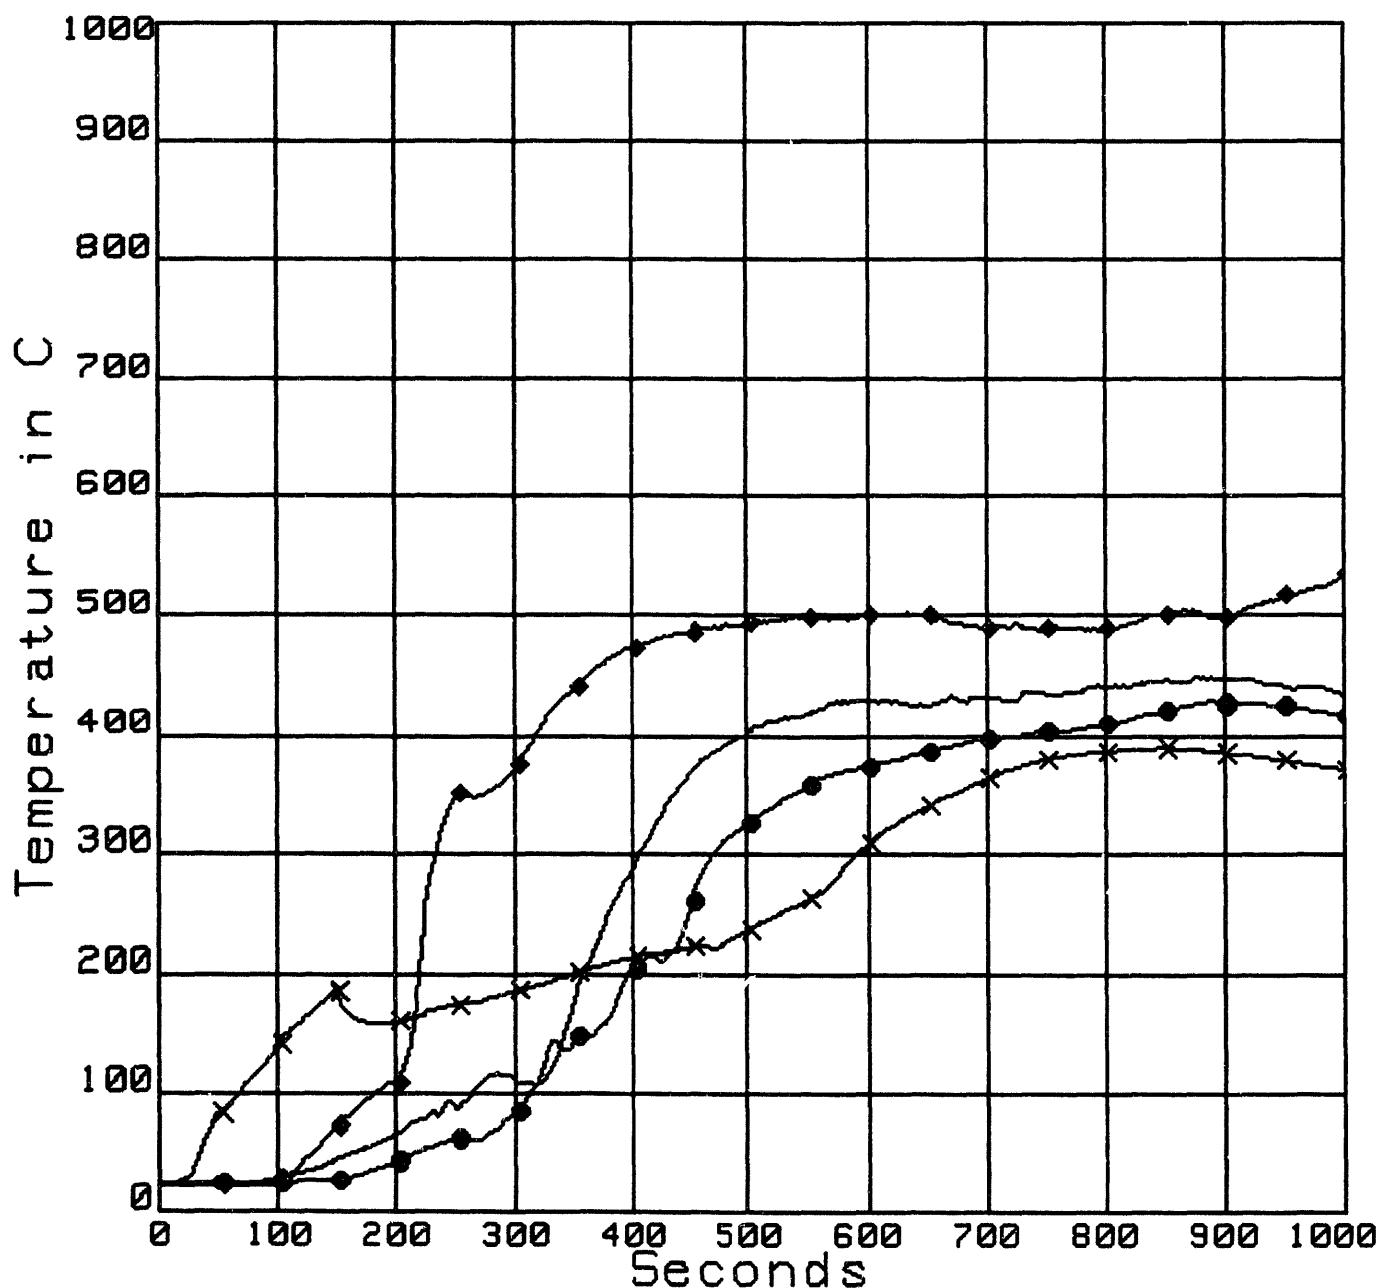
Figure 13

The plots shown in figures 12 and 13 are composite plots of the internal drum pressures and temperatures. These graphs show that drum 1 initially vented at 220 seconds with continuous venting occurring at approximately 240 seconds. Drum 2 initially vented at 150 seconds with continuous venting occurring at 225 seconds. The maximum internal drum pressures reached before continuous venting were 13.3 psi and 14.2 psi respectively. The internal temperatures for the number 1 & 2 drums at this time were approximately 100°C and 300°C respectively. The salvage drum vented at 150 seconds with an internal temperature of approximately 190°C and a maximum pressure of 7 psi. The inner drum vented at 560 seconds after reaching a maximum pressure of 15.5 psi with an internal temperature of just over 500°C. Photo 21 shows the condition of the drum after the test.

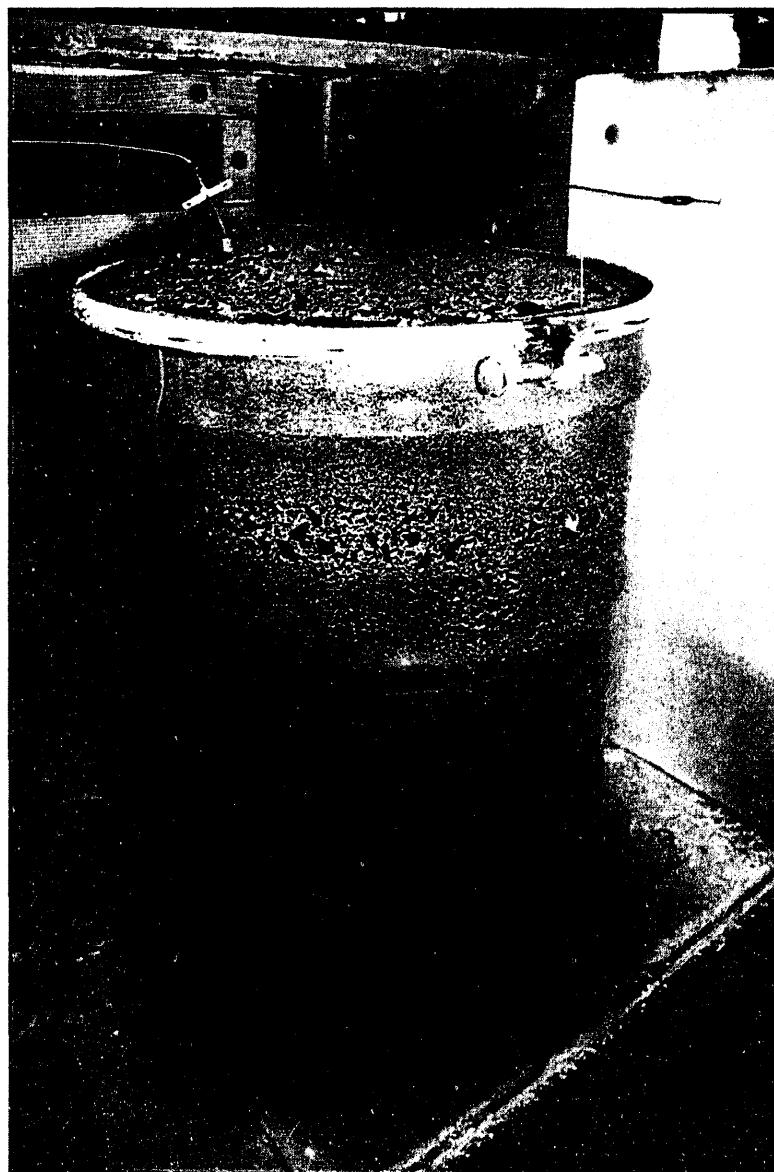
**Photo 4:** Overall view of the post test condition of the drum tested in WDE119A.

The drum instrumentation shown in photos 2&3 includes a pressure probe and thermocouple installed into the drum lid. This array was standard for each drum throughout the test series. Although there is not a formal standard for testing waste drums in an ASTM E-119 furnace, one failure criterion typically used for flammable liquid storage cabinets (NFPA-30, section 4-3) would be the time when the internal temperature exceeded 325° F (163° C). The temperature plot in Figure 2 shows that it took about 140 seconds from test initiation for the internal drum temperature to reach this point. This plot also shows that the internal temperature of the drum closely tracked the furnace temperature. The commonly used auto-ignition temperatures of 500°C, for the types of materials that would be stored in these drums, was reached at approximately 400 seconds into the test. The pressure plot also shown in figure 2, shows that the pressure within the drum peaked at 16 psi, with the seal failing at around 330 seconds from test initiation. Photos 4 & 5 display the condition of the drum post test. Photo 5 shows the bulge in the lid on the side facing the burners.

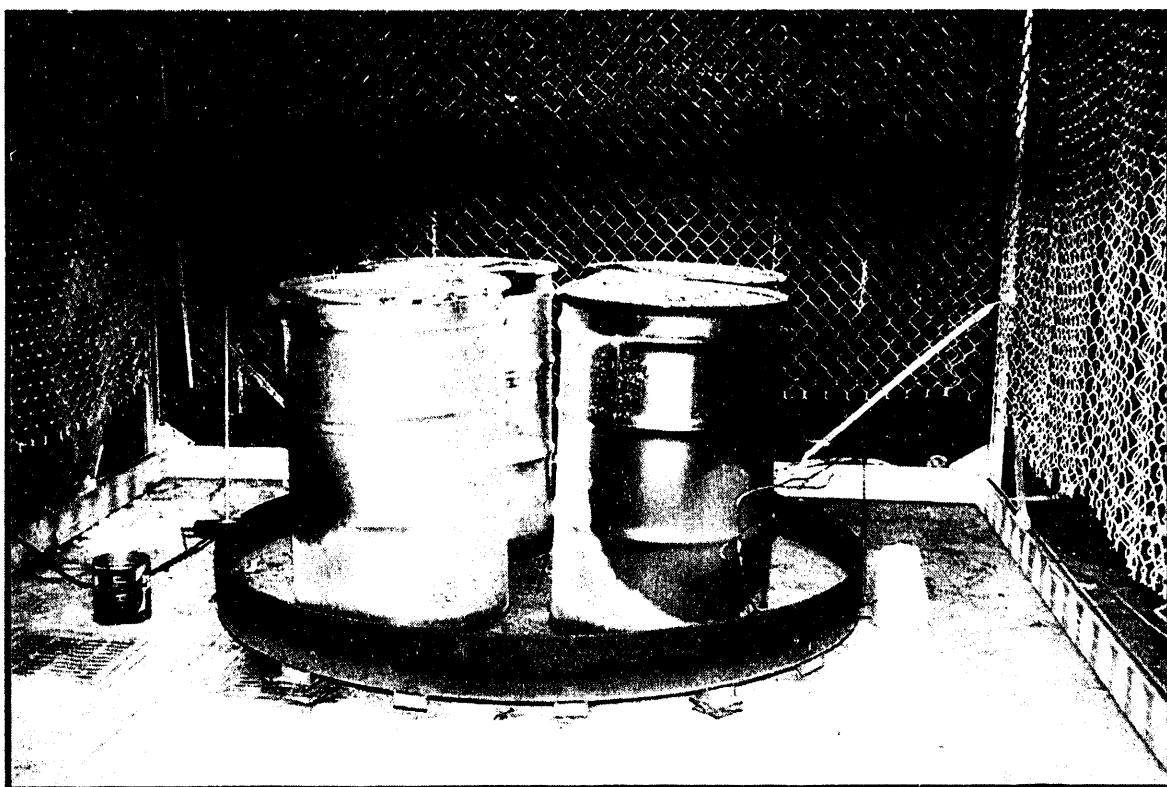
**Photo 9:** Condition of drums exposed to the alcohol fire from WDPAN1.

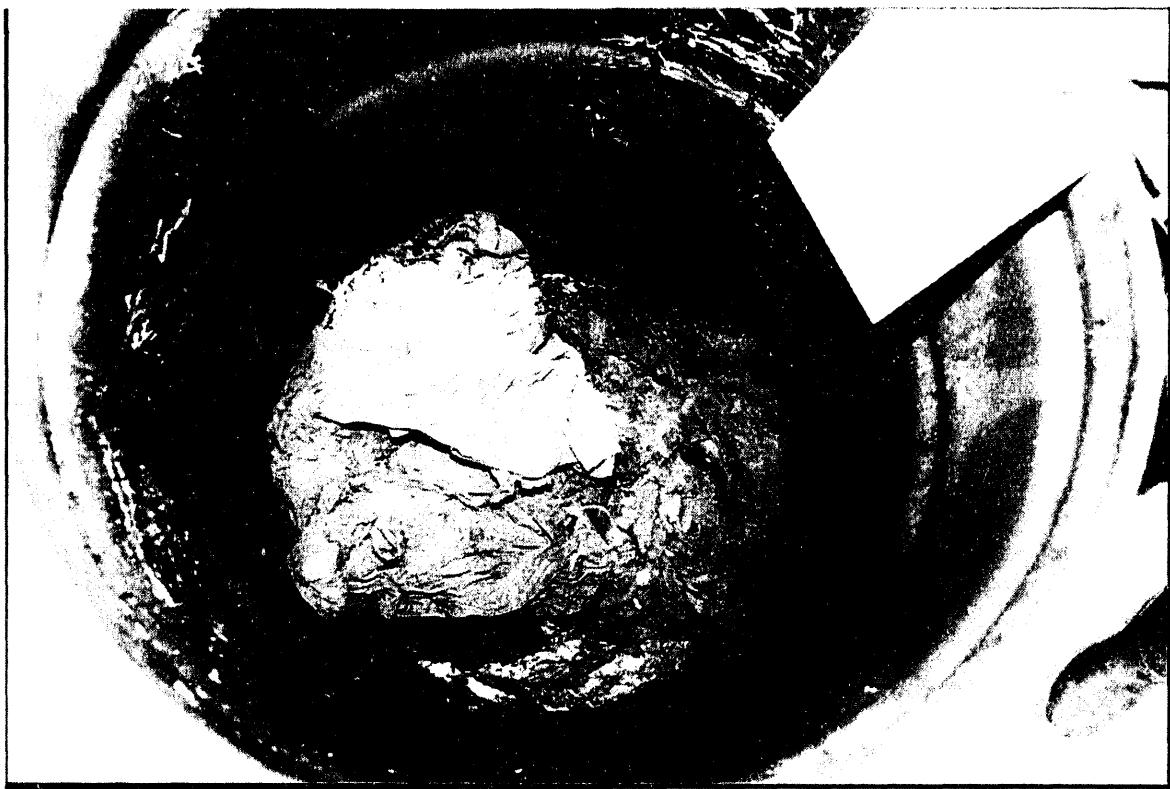
**Photo 11:** Condition of WDPAN1 drum 2 contents after the test fire.

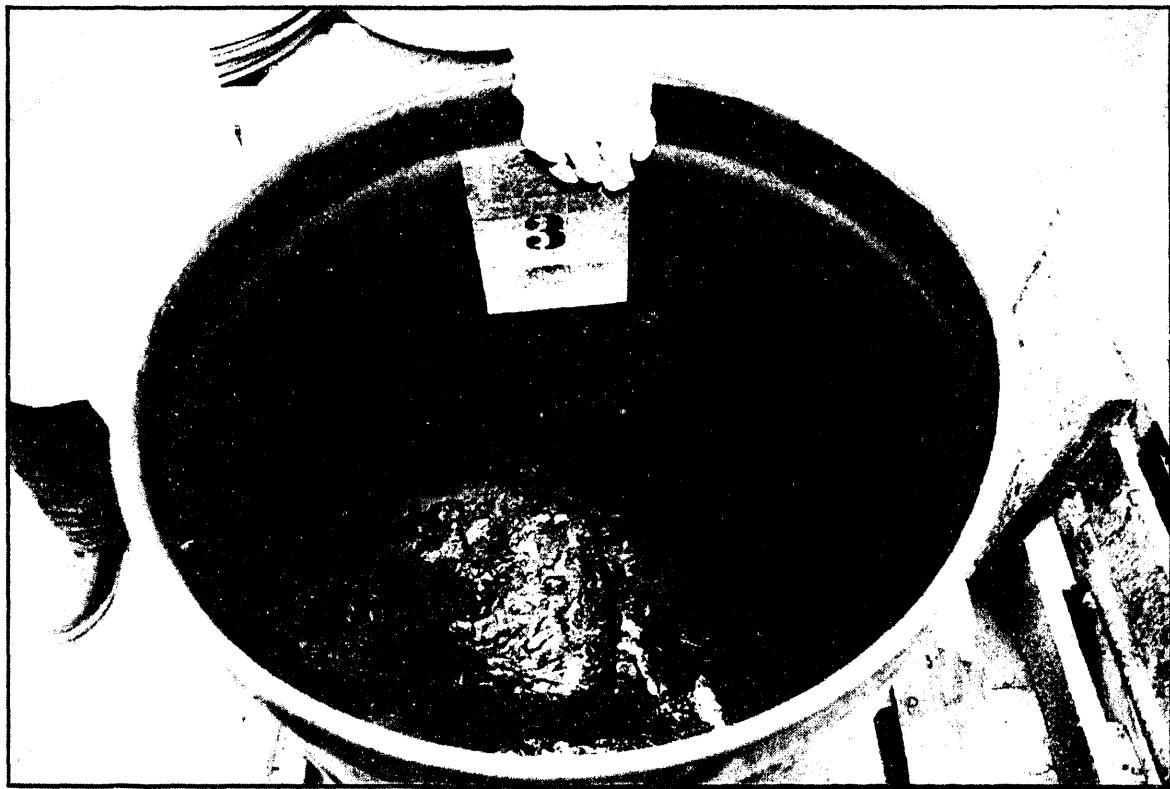
**Photo 12:** Condition of WDPAN1 drum 3 contents after the test fire.

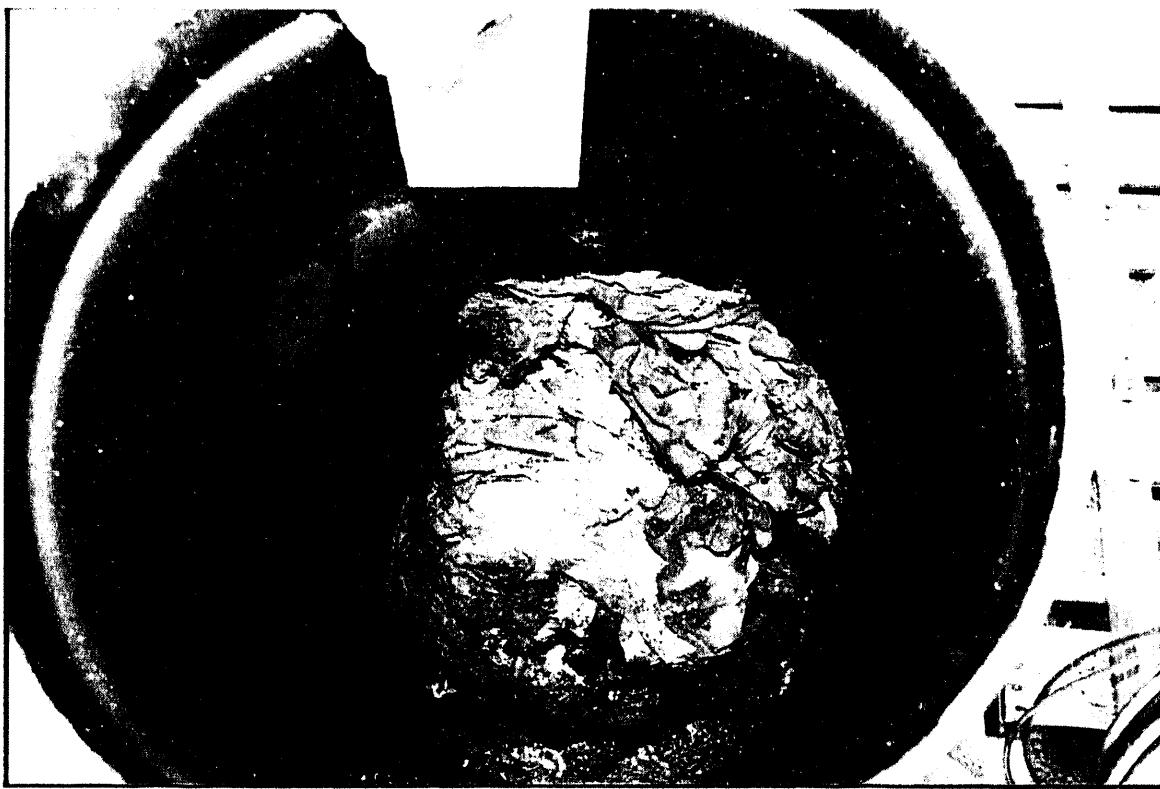
**Photo 13:** Condition of WDPAN1 drum 4 contents after the test fire.

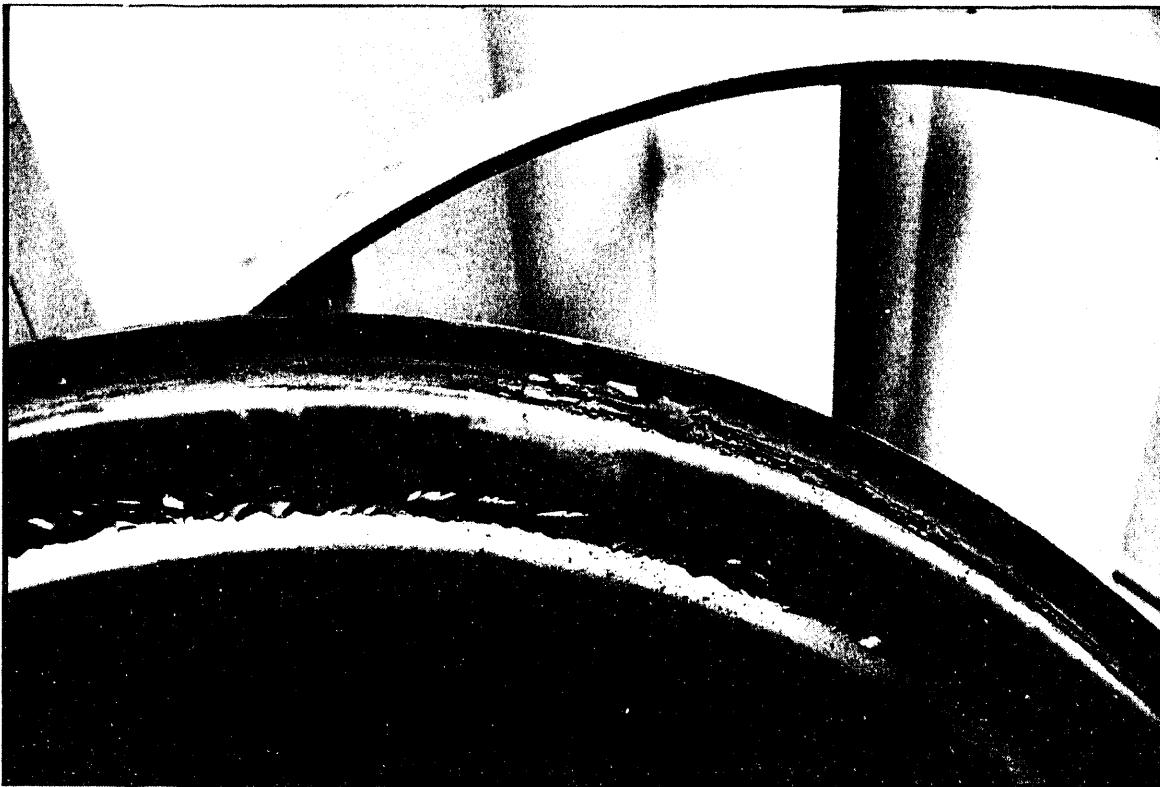
**Photo 14:** Charred remains of a lid seal from a drum tested in WDPAN1.

Figure 4 is a composite plot of the temperatures within the four drums. It shows that the ignition temperature for the drum contents was reached at about 400 second for three of the four drums. The temperature in the fourth drum appeared to follow the alcohol fire temperature almost exactly. The drum pressures are summarized in Figure 5. All drums vented around 300 seconds as indicated by the sudden drop in pressure. The test fire lasted for approximately 10 minutes without violent failure of any of the drums. Photo 9 shows that all the drum lids buckled or bulged on the side facing the center of the pan. Photo's 10-13 show that much of the drum contents were burned or charred. The charred remains of the drum lid seal are shown in photo 14.

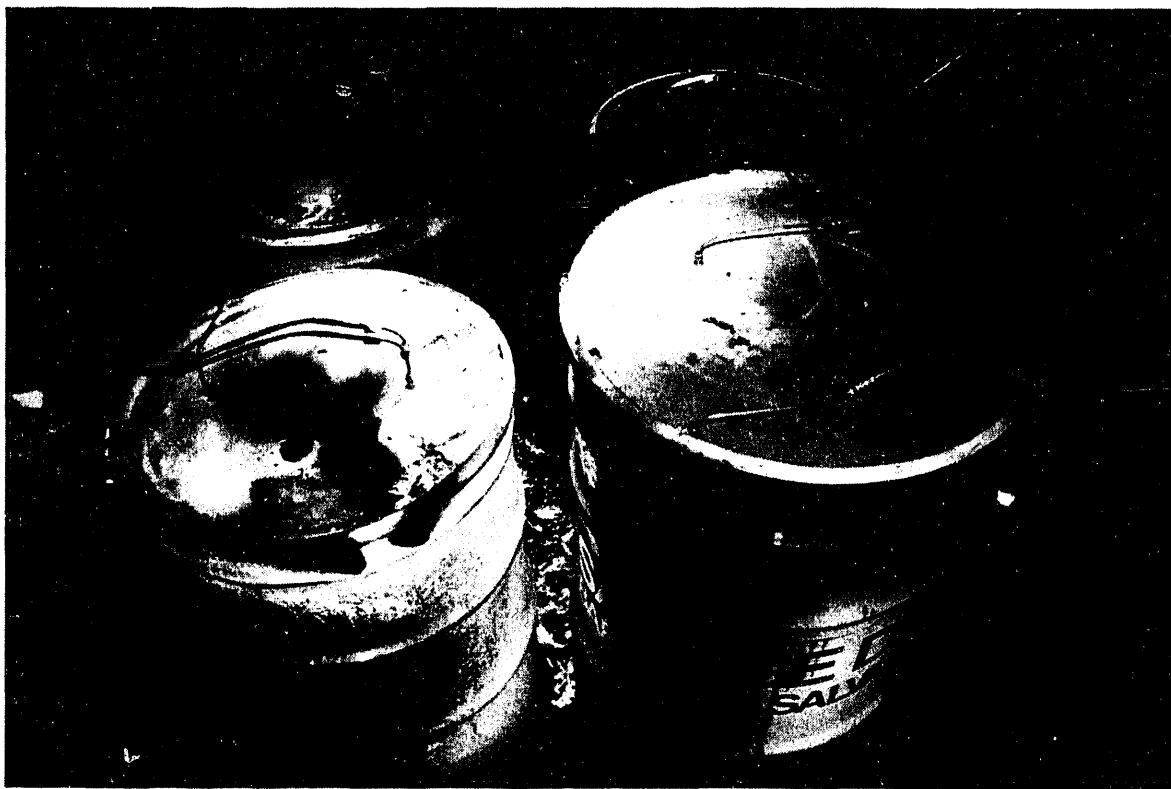
**Photo 19:** Post test condition of the drums tested in WDPAN2.

The condition of the drums after the test is shown in photo 19. Shown in photo 20 is the lid that blew off drum 1, which came to rest upside down on top of this drum. Photo 21 shows the buckling that occurred in the lid on drum 2. Photo 22 shows the opened bung hole, in the salvage drum, that had the flame extending from it as described earlier in this report.

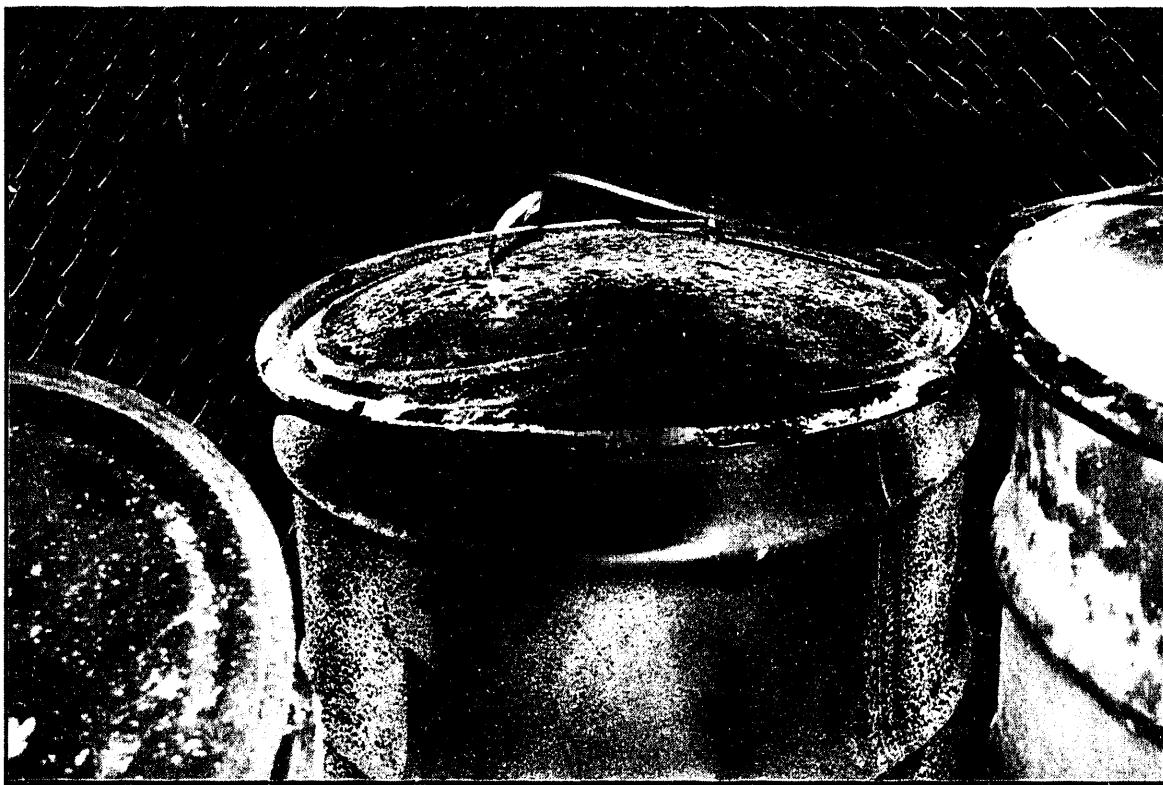
**Photo 21:** Post test condition of drum 2 tested in WDPAN2.

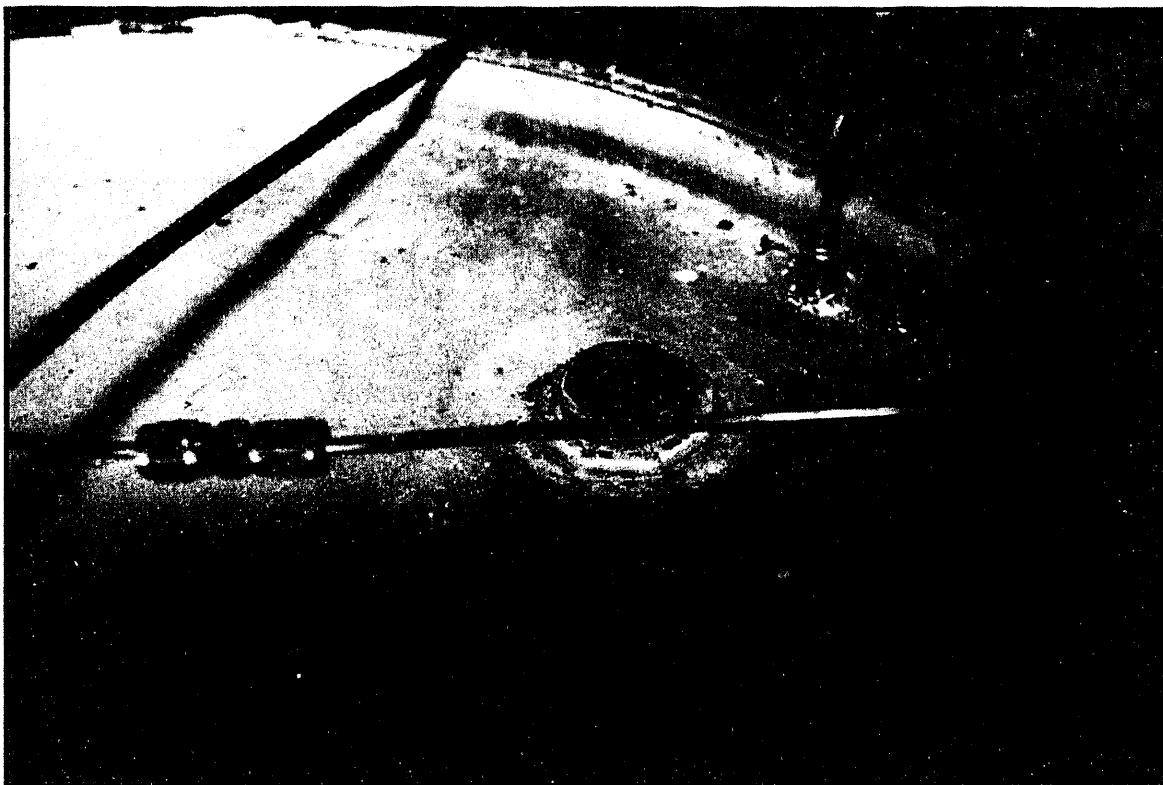
**Photo 22:** Opened bung hole after plastic plug melted and blew out during test WDPAN2.

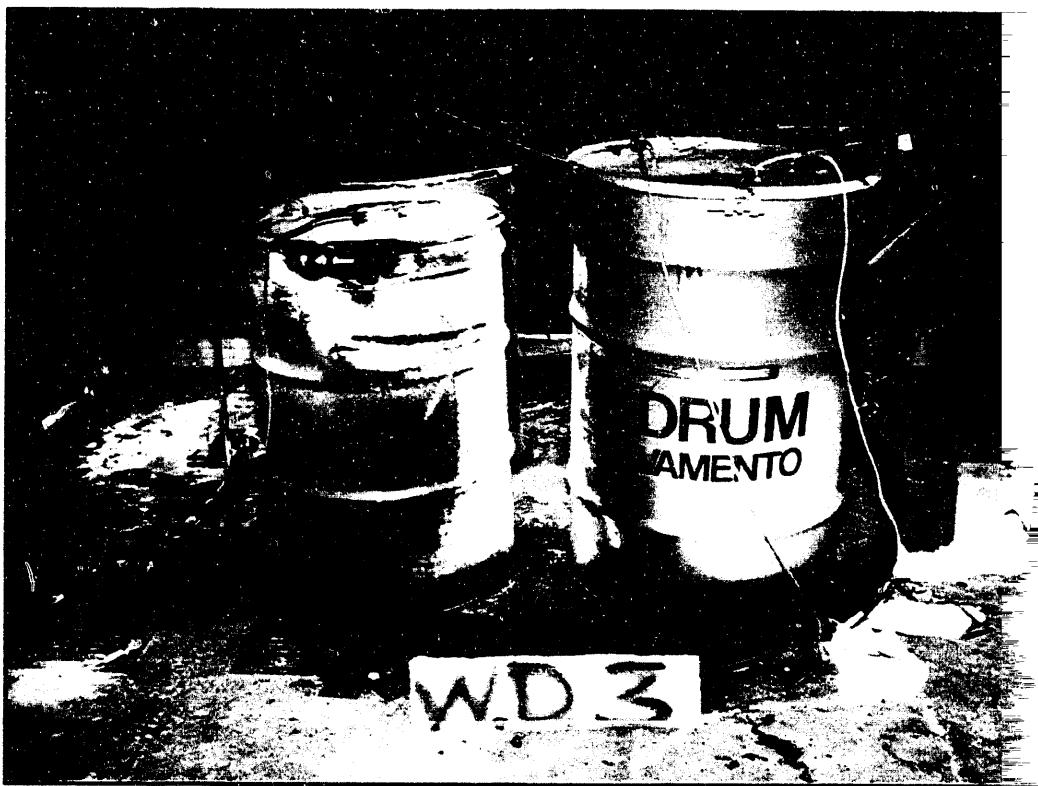
**Photo 23:** Post test condition of the drums used in WDPAN3.

The condition of the drums after the test is shown in photo 23. Photo 24 shows the lid that blew off drum number 1. The remains of the liner and materials inside the TRU drum (drum 4) are shown in photo 25.

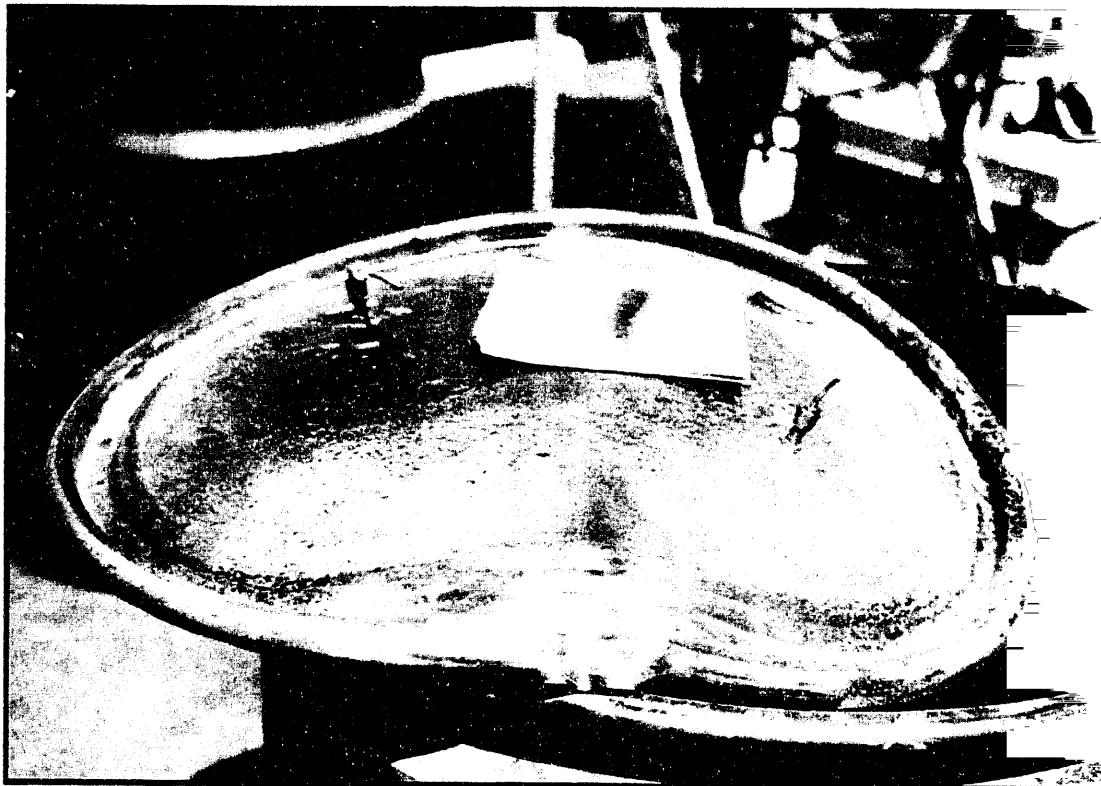
**Photo 24:** Post test condition of lid that blew off of drum 1 in test WDPA

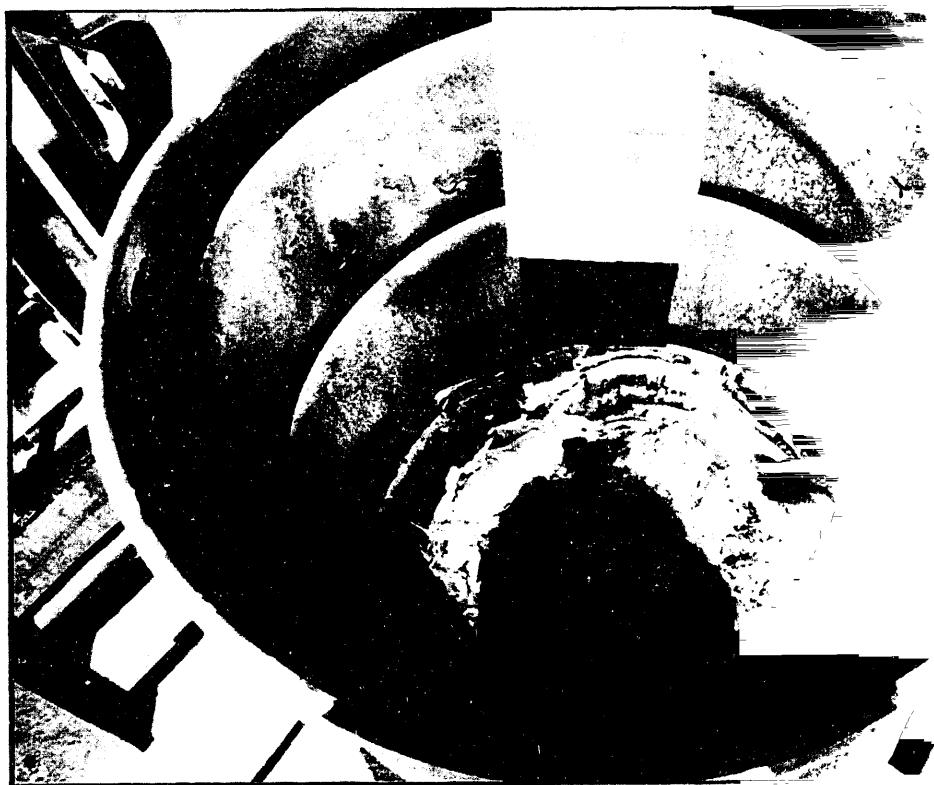
**Photo 25:** Post test condition of WDPAN3 TRU (drum 4) conte

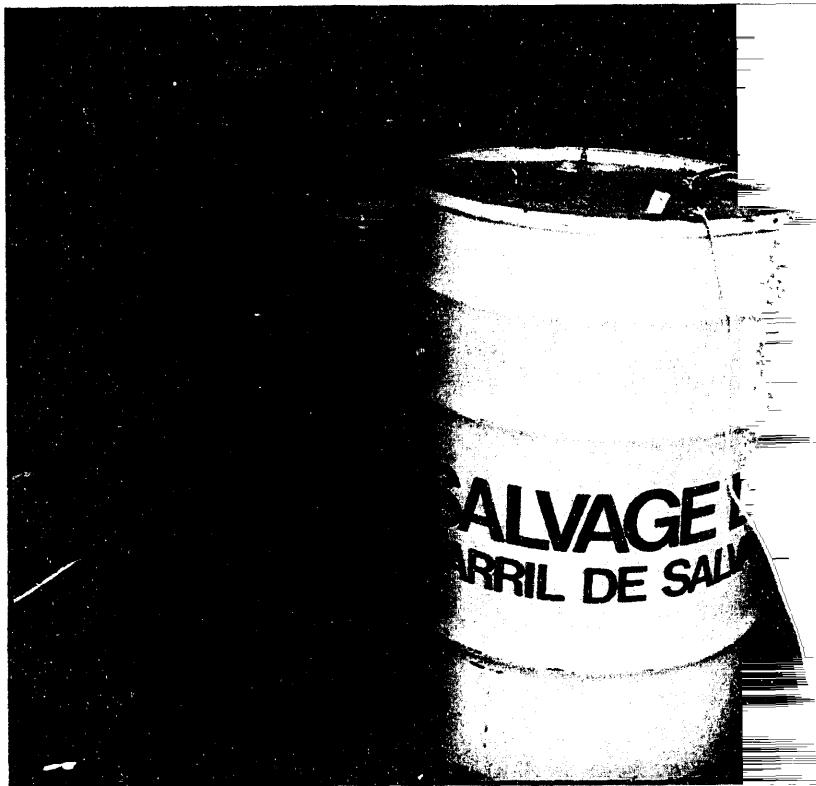
**Photo 26:** Overview of test set up for WDPAN4&

Two identical tests were conducted for this test series, WDPAN4 and WDPAN5. The setup for these tests is shown in figure 11 and photo 26. This set up is similar to WDPAN2&3 except the TRU drum was eliminated, and each drum was lined with a 10 mil polyethylene (PE bag) liner as shown in photo 27. The PE liner was a standard drum liner used for 55 gallon metal waste drums, and was folded over at the top as shown in photo 28. The numbering sequence for the salvage and inner drum was changed from 3/5 to 3/4, number 3 being the salvage drum and number 4 being the inner drum. The drums were positioned in a triangular configuration. Each drum was packed as described earlier in this report.

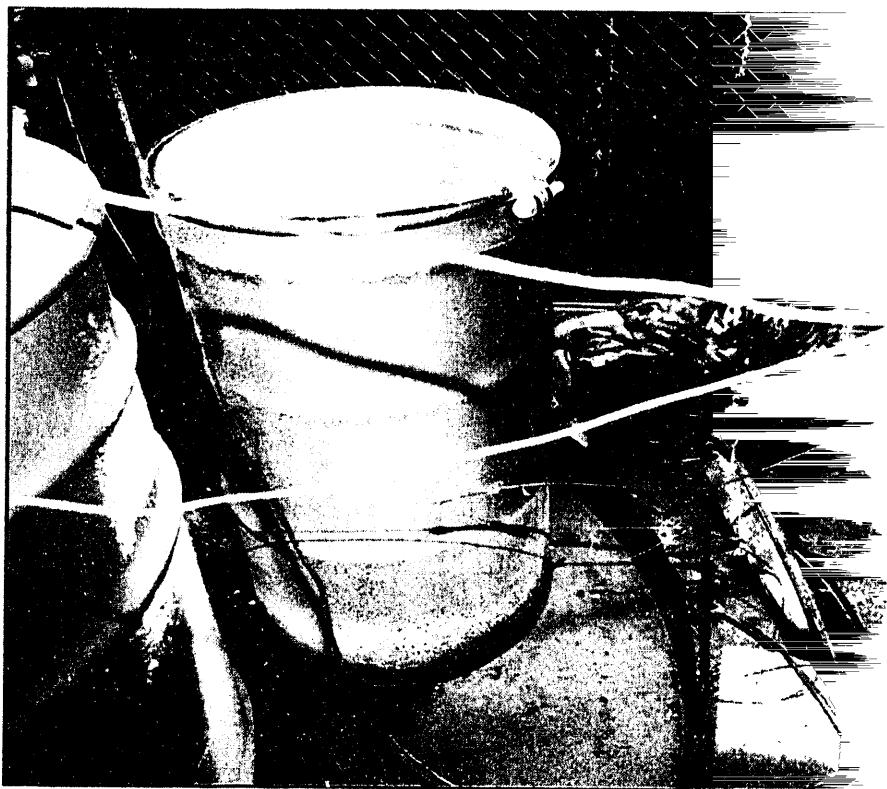
**Photo 31: Location and condition of the lid that blew off of drum 2.**

The condition of the drums after the test is shown in photo 30. The lid from number 2 drum was found next to the pan as shown in photo 31. Photos 32 show the number 2 drum lid after it was placed back into position on top of the drum.
