# **Fire Testing of 55 Gallon Metal Waste Drums For Dry Waste Storage**

Prepared for  
United States  
Department Of Energy  
Office of Environment, Safety, and Health  
Under contract with  
Westinghouse Hanford Company  
Richland, WA

July, 1993

Fire Research Discipline  
Special Projects Division  
Hazards Control Department  
Lawrence Livermore National Laboratory

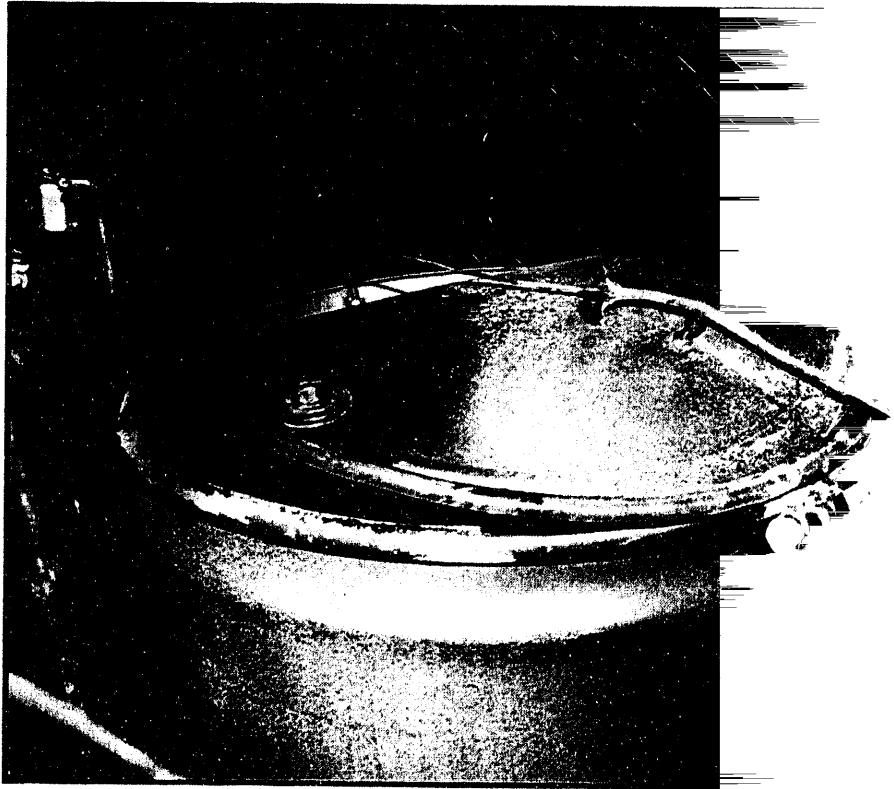
**Photo 32: Lid from drum 2, of test WDPAN5, after it was placed on the drum.**

The condition of the drums after the test is shown in photo 30. The lid from number 2 drum was found next to the pan as shown in photo 31. Photos 32 show the number 2 drum lid after it was placed back into position on top of the drum.
