ISOTHERMAL CORROSION TESTING OF STEELS IN MOLTEN NITRATE SALTS *

Michael R. Prairie, Sammy R. Dunkin, James M. Chavez

Advanced Energy Technology Center
Sandia National Laboratories
Albuquerque, New Mexico

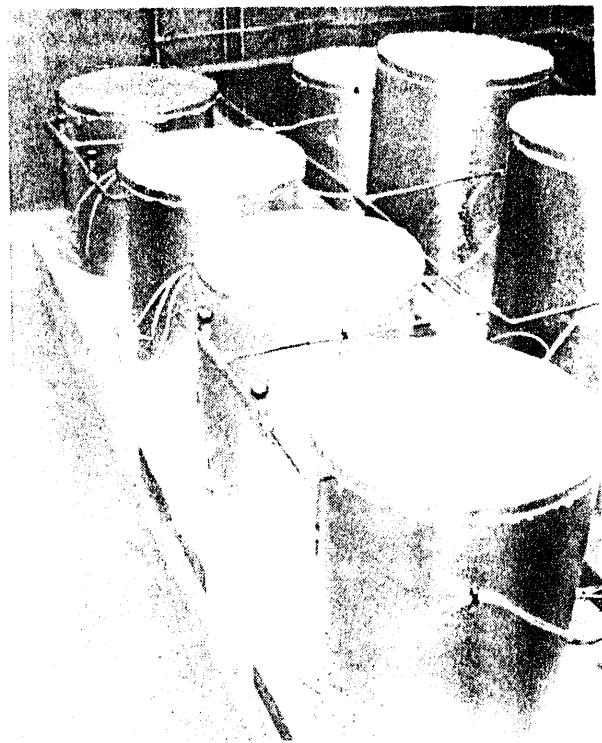
Figure 1. External view of several of the salt crucibles. The wires are for the three thermocouples monitoring salt and viewing temperatures. The valves and associated tubing are for the air sparge system.

Before use, all the crucibles were oxidized for 24 hr at about 530 °C in a pre-existing molten salt sump. After being cooled and rinsed, each crucible was loaded with about 10 Kg of salt and allowed to stabilize at temperature for up to one week before the experiment was started. Figure 1 shows the external appearance of several of the crucibles and Fig. 2 shows the top view looking into one of the crucibles.
