**Dynamic Thermal Tomography
for Nondestructive Inspection of Aging Aircraft**

**N. K. Del Grande, K. W. Dolan, P. F. Durbin
M. R. Gorvad and A. B. Shapiro**

This paper was prepared for submittal to the
SPIE International Symposium on Optical Applied Science
San Diego, California
July 11-16, 1993

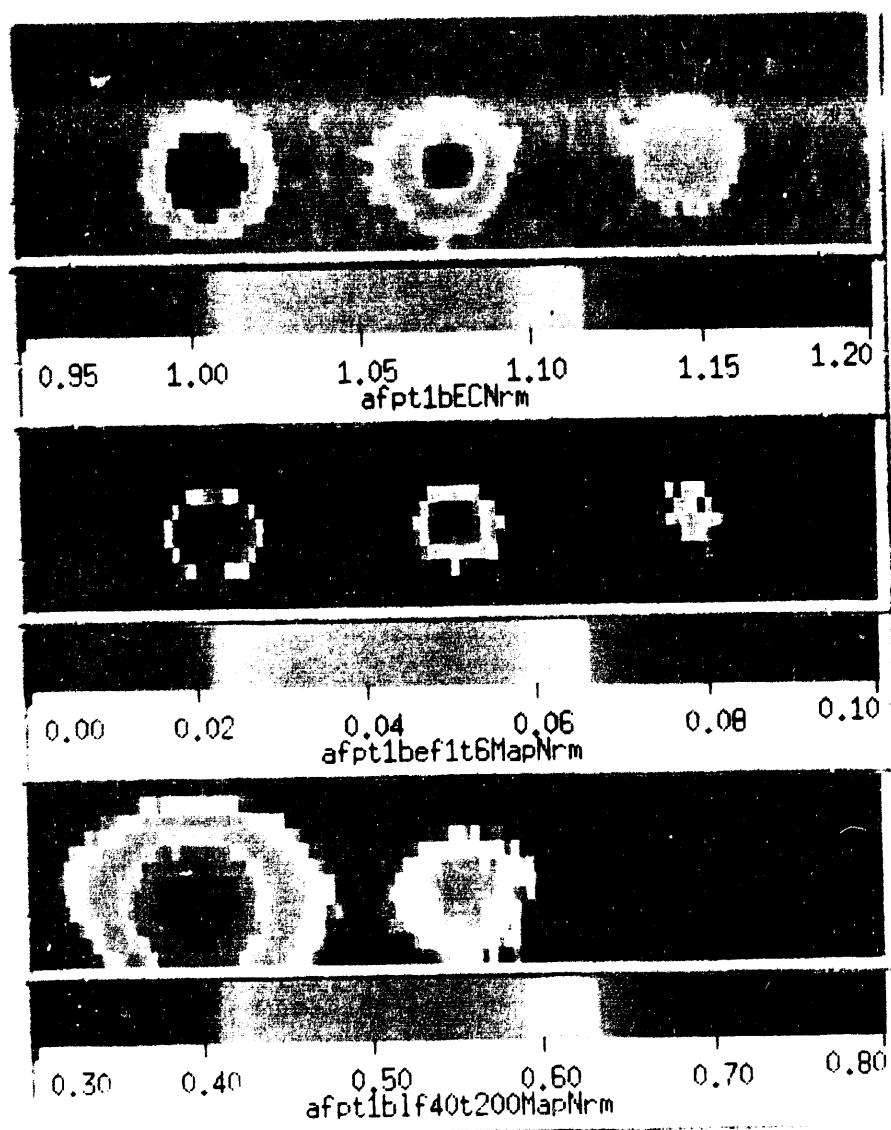
Figure 2. Top: relative temperature response 40 ms after heat flash; center and bottom: thermal inertia at early times (0.0 to 0.2 s) and late times (1.6 to 8.0 s) for 63%, 42% and 21% (left to right) flat-bottom holes in 0.95 mm aluminum plate.

Figure 2 (left to right, top row) shows the color-coded relative temperature response at 40 ms after the heat flash for an aluminum plate (1 mm thick) with 20%, 40% and 62% thickness loss, relative to surroundings, for milled flat-bottom holes. Early-time (less than 0.3 s, middle row) and late-time (more than 0.4 s, bottom row) composite thermal inertia maps in Figure 2 are based on the (inverse) slope of the temperature versus inverse square root of time responses. Heavily corroded lap splice sites with the most material loss are red (hot) in Figures 5 and 6 but green in Figures 3 and 4 since they have low composite thermal inertia and change temperature more readily than their thicker (uncorroded) surroundings.

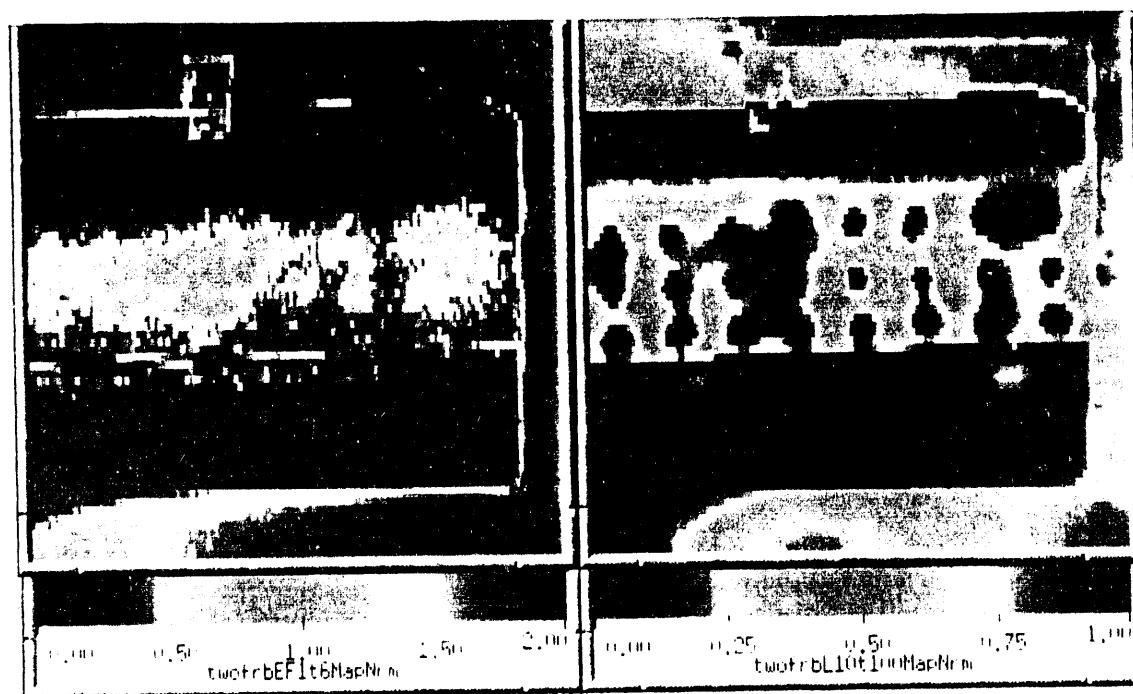
Figure 4. Boeing KC-135 relative thermal inertia maps, showing at left: early-time (0.0 to 0.2 s) and at right: late-time (0.4 to 4.0 s) defect sites within the (~2 mm) aluminum skin lap splice from material losses and by-products of corrosion. Red areas (with less material loss from corrosion) have bulk thermal properties more resistive to temperature change at late times.

In Figure 4, six early-time (less than 0.24 s, on the left) and 90 late-time (0.40 s to 4.0 s, on the right) images were used to produce composite thermal inertia maps of Panel 2 (2FR, at the right edge) shown above. Low thermal inertia sites (with the most material loss from corrosion and the least resistance to temperature change) appear green, whereas high thermal inertia sites (with the smallest percentage of material loss from corrosion and the most resistance to temperature change) appear red.

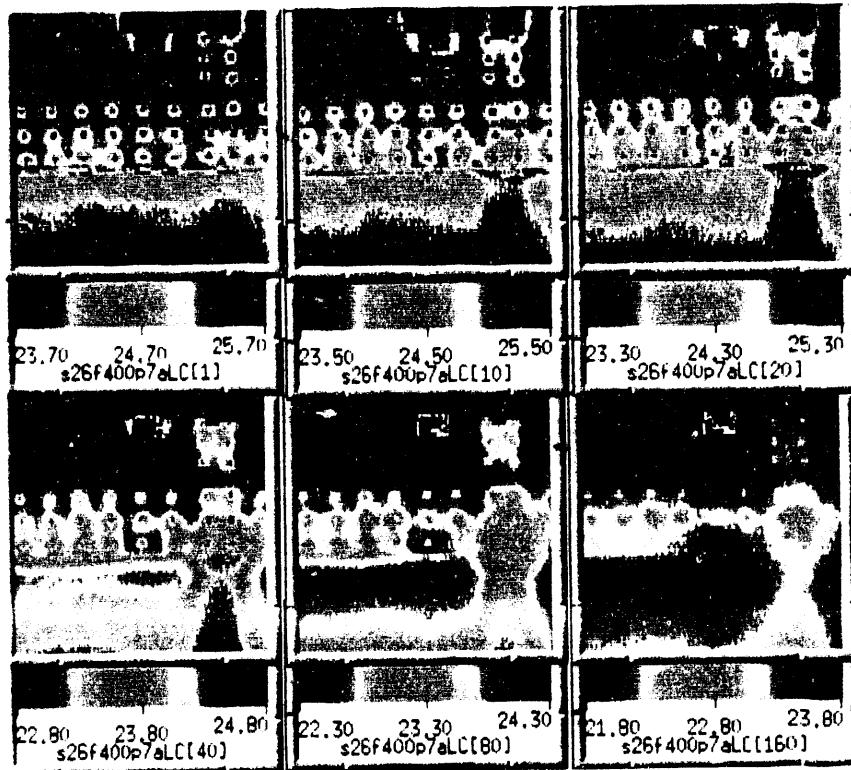
Figure 5. Boeing 737 aircraft lap splice surface temperatures imaged after heat flash. Top (left to right) at 0.04, 0.40 and 0.80 seconds. Bottom (left to right) at 1.6, 3.2 and 6.4 seconds.

Temperature variations with time (after the heat flash) are compared for the Boeing 737 Stringer 26, Station 400 (s26f400.7) in Figure 5 and the Boeing KC-135 Panel 2 (2FR, at the right edge of the 30 inch panel) in Figure 6. We note the 2 $^{\circ}\text{C}$ range at 0.04 s, 0.40 s, 0.80 s (top row, left to right) and at 1.60 s, 3.20 s and 6.40 s (bottom row, left to right), emphasizes dynamic thermal contrast differences between the Boeing 737 and the Boeing KC-135 at (warm, red) lap joint defect sites.

In Figure 5, the dynamic temperature ($^{\circ}\text{C}$) variations for the Boeing 737 aircraft fuselage, Stringer 26, Station 400, centered 0.7 of the way toward the next larger station (s26f400.7) at 0.04 s, 0.40 s, 0.80 s (top left to right) and at 1.60 s, 3.20 s and 6.40 s (bottom left to right) are based on the 10 μm apparent temperature maps. Note minimal change in lap splice above-ambient temperature contrast at (corrosion-related) disbond site (beneath blue, cold, tape marker) from 0.4 s to 3.2 s.

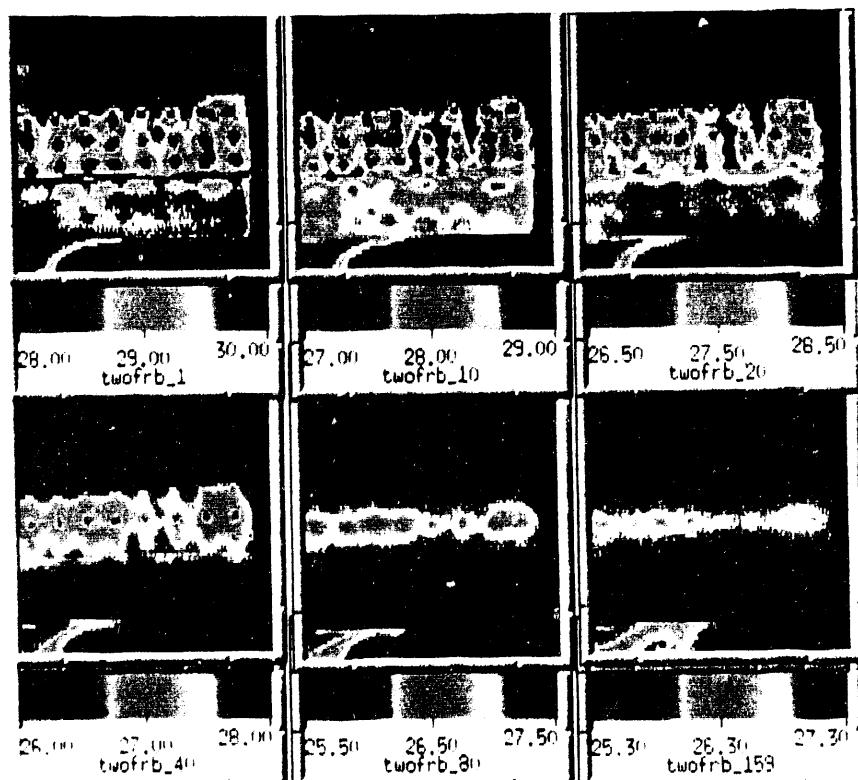
Figure 6. Boeing KC-135 aircraft lap splice surface temperatures imaged after heat flash. Top (left to right) at 0.04, 0.40 and 0.80 seconds. Bottom (left to right) at 1.6, 3.2 and 6.4 seconds.

In Figure 6, the dynamic temperature variations for the Boeing KC-135 Panel 2 (2FR, at the right edge) at 0.04 ms, 0.40 s, 0.80 s (top left to right) and at 1.60 s, 3.20 s and 6.40 s (bottom left to right) are based on the 10 μm apparent temperature maps. Whereas the Boeing KC-135 aircraft lap splices are held together with rivets, they have no adhesive bonds. The Boeing KC-135 Panel 2 (2FR, at the right edge) lap splice sites have significant material loss (35%-45%) from corrosion at center right of the images in Figure 6. These sites have above-ambient (1.5-1.9 $^{\circ}\text{C}$) temperature rises which remain constant from 0.4 s to 0.8 s, unlike the above-ambient (0.2-0.6 $^{\circ}\text{C}$) Boeing 737 (s26f400.7) corroded lap splice sites which remain constant from 0.4 s to 3.2 s.

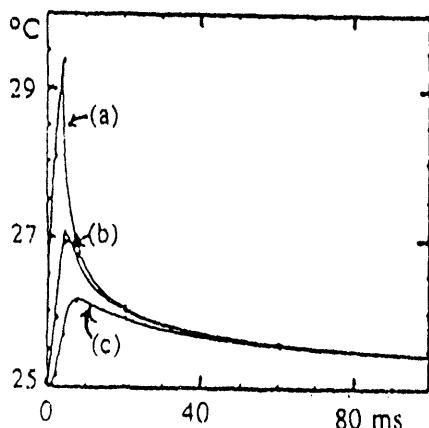
Figure 7. The temperature-time response of (Eq. 6) for a semi-infinite aluminum slab at the surface (a) and at depths of 0.50 mm (b) and 1.0 mm (c).

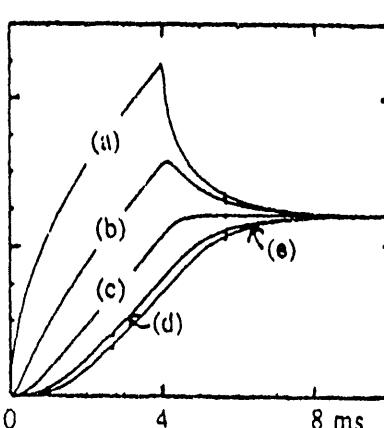
Figure 8. The temperature-time response for a 1 mm thick slab of aluminum at depths of $x = 0$ mm (a), $x = 0.25$ mm (b), $x = 0.50$ mm (c), $x = 0.75$ mm (d), $x = 1.0$ mm (e).

Temperature histories at several depth locations [(a) $x=0$, (b) $x=0.25$ mm, (c) $x=0.50$ mm, (d) $x=0.75$ mm, (e) $x=1.00$ mm] are shown in figures 8 and 9. Figure 8 is the time response for a 1.00 mm thick aluminum slab. Figure 9 is the time response for a composite slab consisting of aluminum (0.9 mm) with a corrosion layer (0.1 mm) of aluminum oxide.

The recently modified FAA/LLNL prototype DBIR system (by Bales Scientific Inc.) includes a continuous line scan capability to time-resolve thermal images from 0 to 400 ms after onset of the flash, in intervals of 550 μ s. This will be used to test the predictability of TOPAZ-2D surface temperature calculations (see Figures 8 and 9).

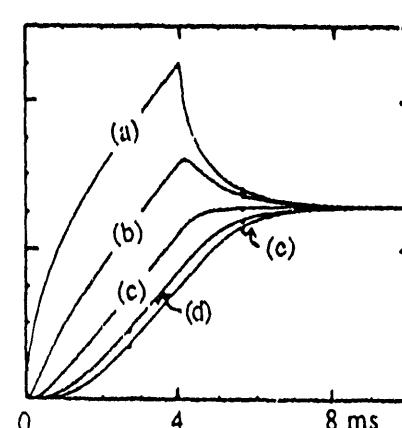
Figure 9. The temperature-time response for a 1 mm thick slab of aluminum (0.9 mm) and aluminum oxide (0.1 mm) at depths of $x = 0$ mm (a), $x = 0.25$ mm (b), $x = 0.50$ mm (c), $x = 0.75$ mm (d), $x = 1.0$ mm (e).
