**MITIGATION AND MONITORING PLAN
FOR IMPACTED WETLANDS AT THE
GUNNISON UMTRA PROJECT SITE,
GUNNISON, COLORADO**

December 1994

**Prepared by
Jacobs Engineering Group Inc.
Albuquerque, New Mexico**

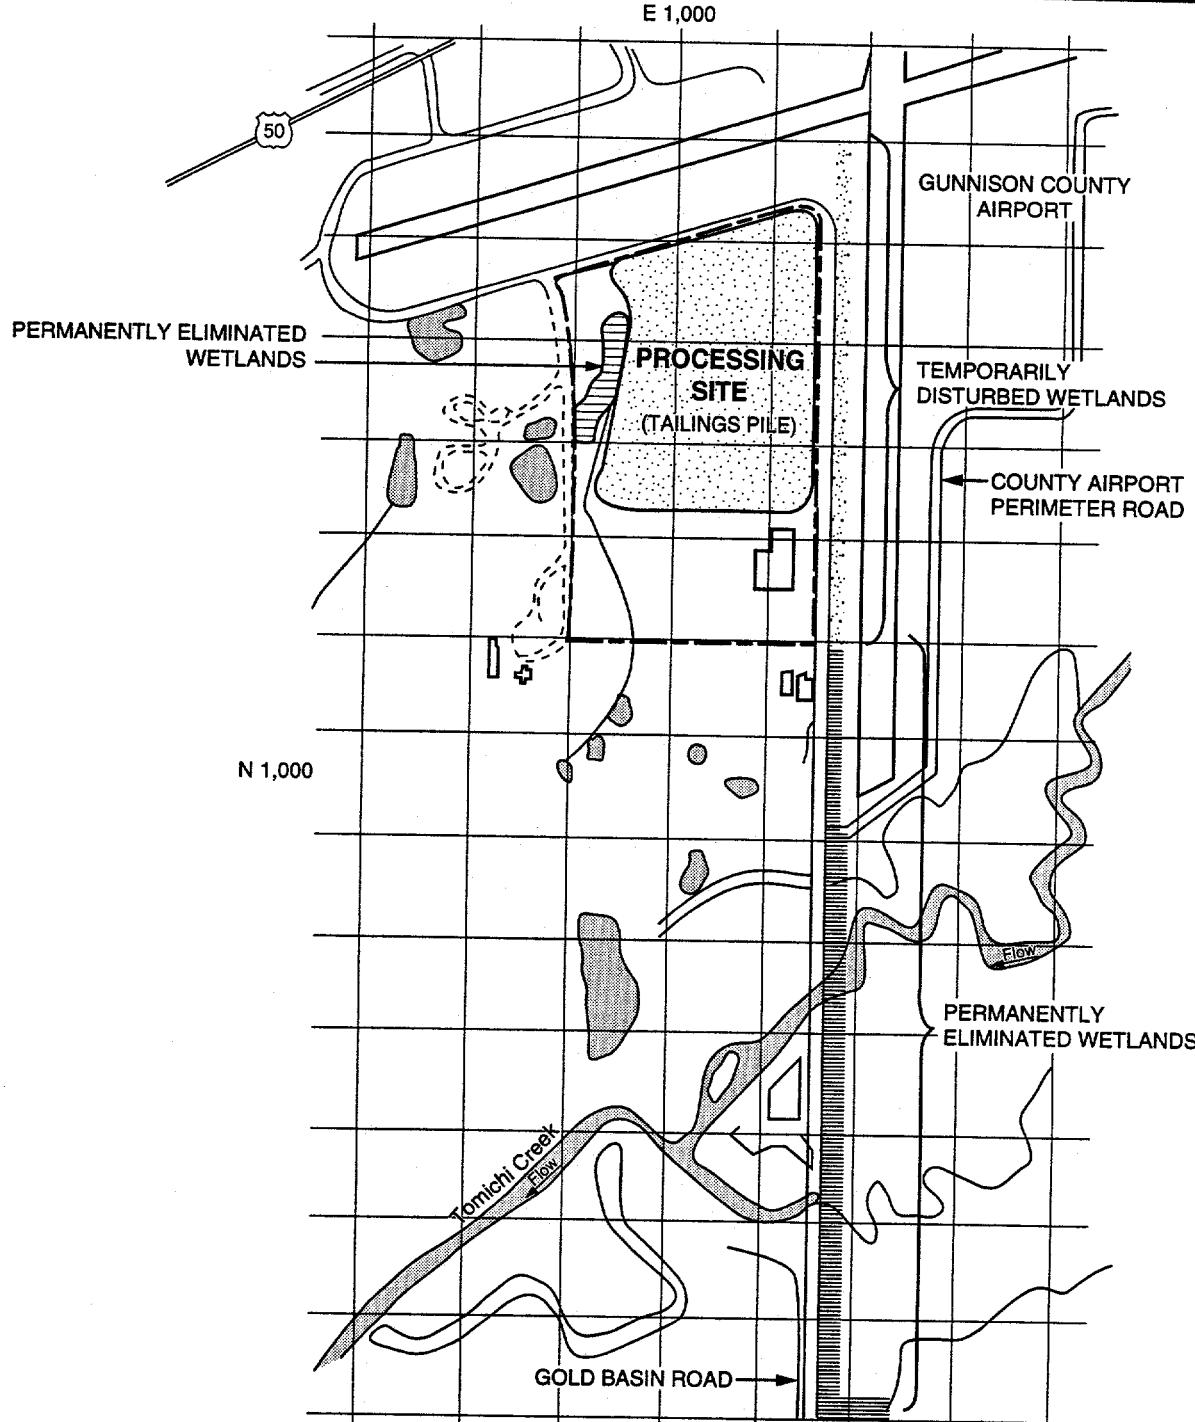
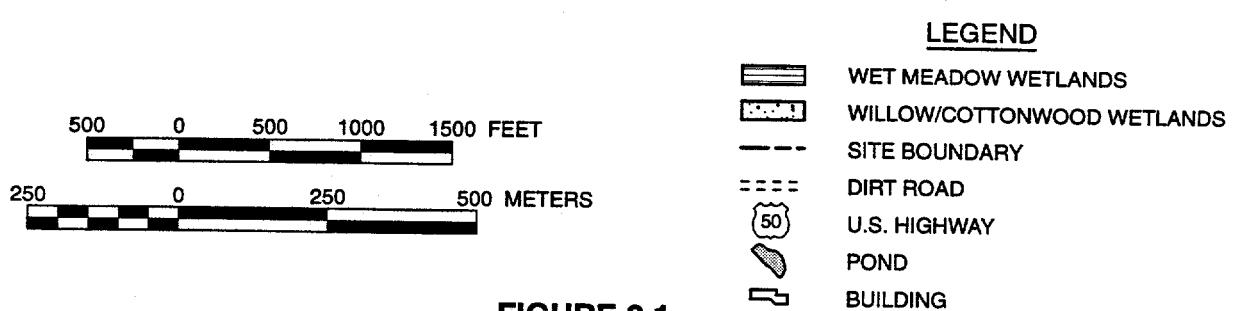
FIGURE 2.1
WETLANDS THAT WERE TEMPORARILY DISTURBED
AND PERMANENTLY ELIMINATED BY REMEDIAL ACTION
AT THE GUNNISON, COLORADO, SITE

Of the 4.3 ac (1.7 ha) permanently removed as a result of the Gunnison Project, 3.4 ac (1.4 ha) occurred in the floodplain of Tomichi Creek next to Gold Basin Road (Figure 2.1). Much of this wetland was created by irrigation and was grazed by livestock. Using the livestock forage patterns of Platts and Nelson (1985), this area was heavily used. The wildlife use of this wetland was minimal because it was heavily grazed, it was next to a paved county road, and hundreds of acres of similar wetland habitat adjacent to the impacted area are not next to areas of human disturbance such as roads.

The remaining 0.9 ac (0.4 ha) of permanently removed wetland was part of a 1.5-ac (0.6-ha) wetland adjacent to the Gunnison UMTRA Project tailings pile (Figure 2.1). This wetland exhibited a high degree of plant species richness dominated by obligate wetland species such as managrass (*Glyceria* sp.); sedge (*Carex* sp.), water parsnip (*Sium suave*), and sloughgrass (*Beckmannia*

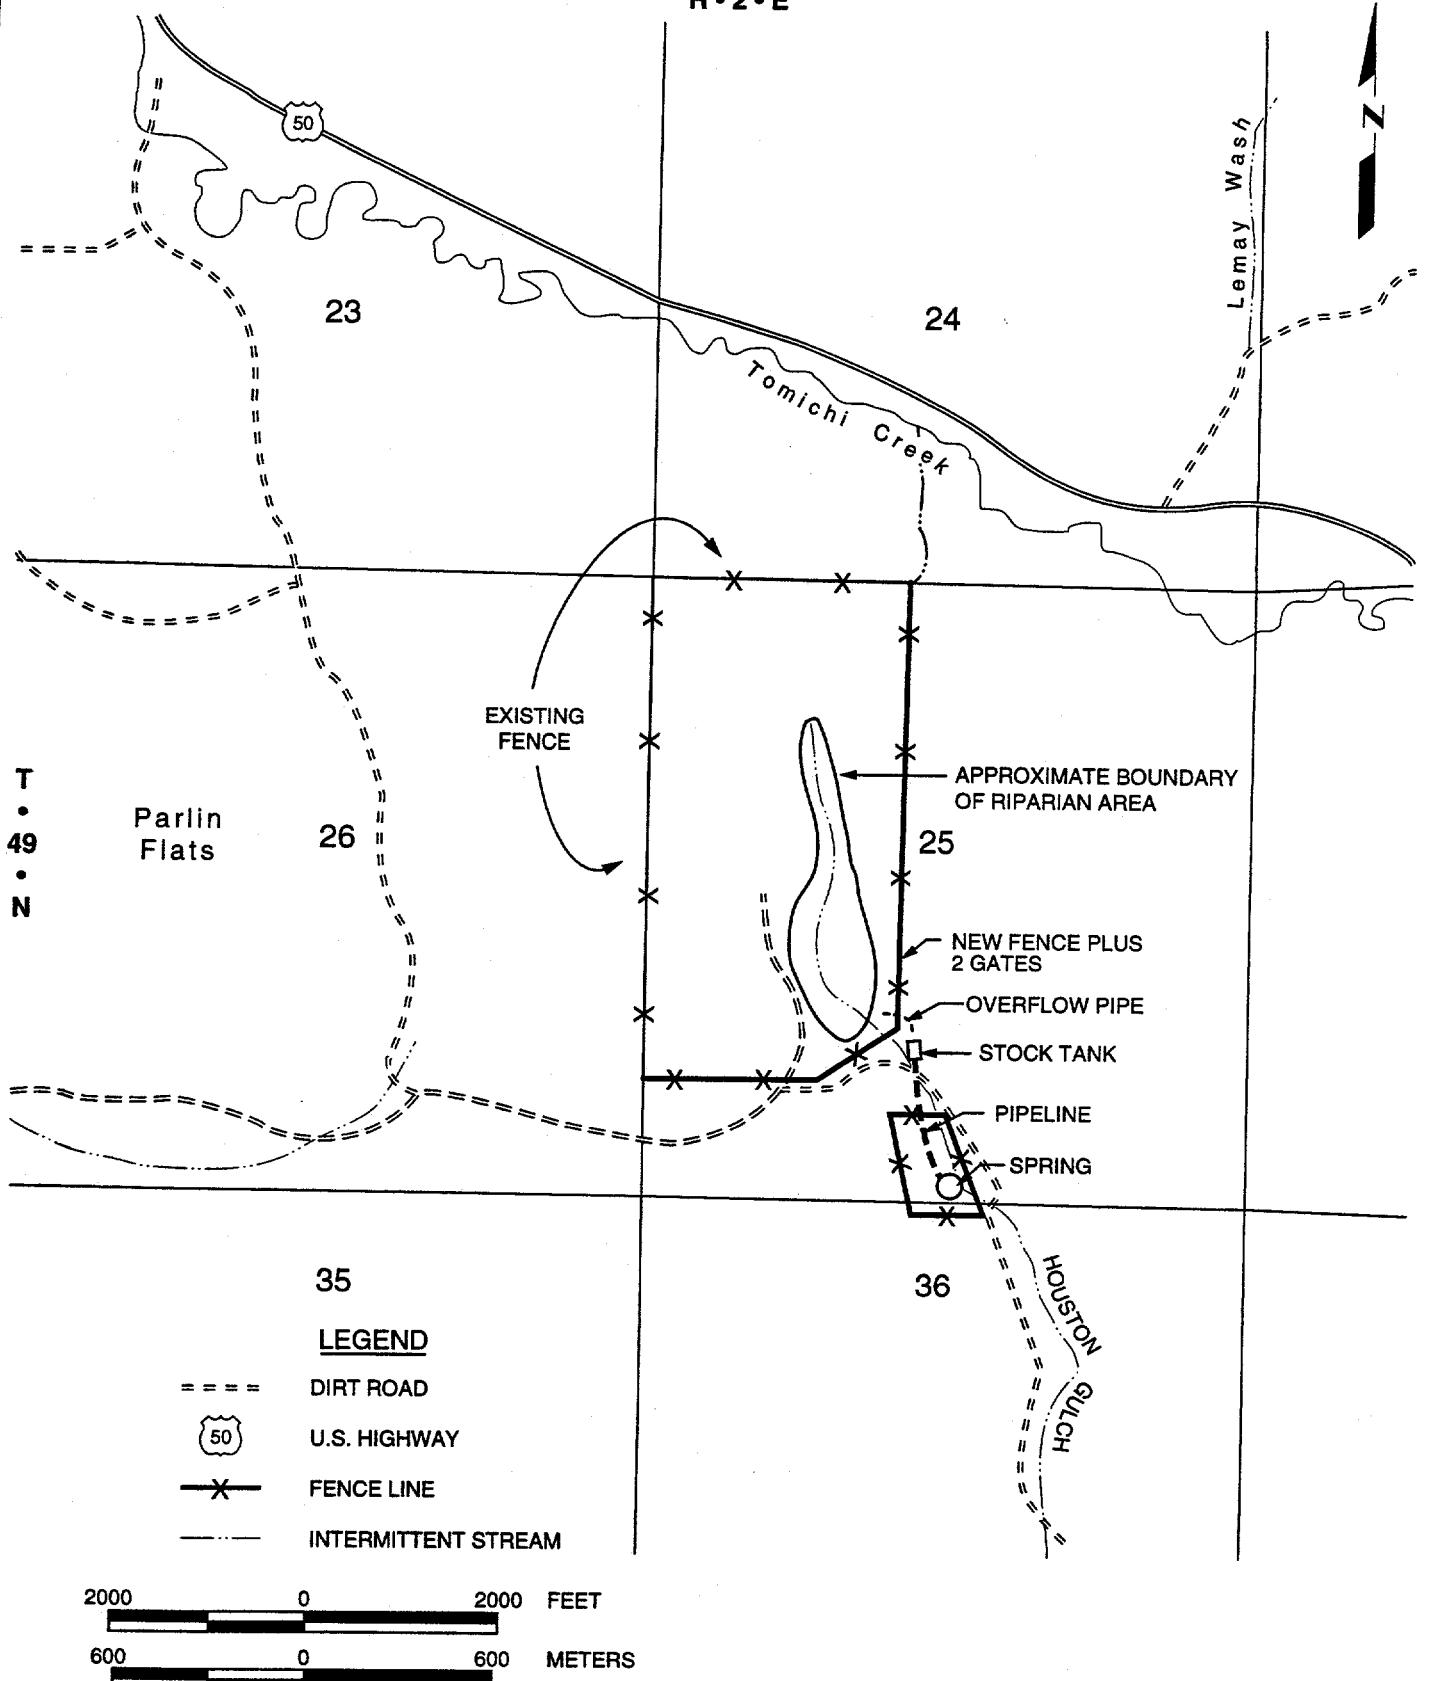
FIGURE 2.3
LOCATIONS OF FENCING AND OTHER DEVELOPMENTS
AT THE PROSPECTOR SPRING MITIGATION SITE
GUINNISON COUNTY, COLORADO

The six mitigation sites have been fenced to exclude livestock. At one site, this fencing required realigning a small segment of road. In addition, stock tanks were provided and springs were developed at some sites to ensure a continued water supply for livestock. The following description of these activities was derived from the EA prepared by the BLM (BLM, 1993) and information received from M-K Ferguson personnel who constructed the facilities. Approximately 200 ac (81 ha) were fenced at the Prospector Spring site using a combination of new and existing fencing; two gates were installed in this fence. A spring south of the site was developed and fenced to provide water for a stock tank outside the enclosure (Figure 2.3).

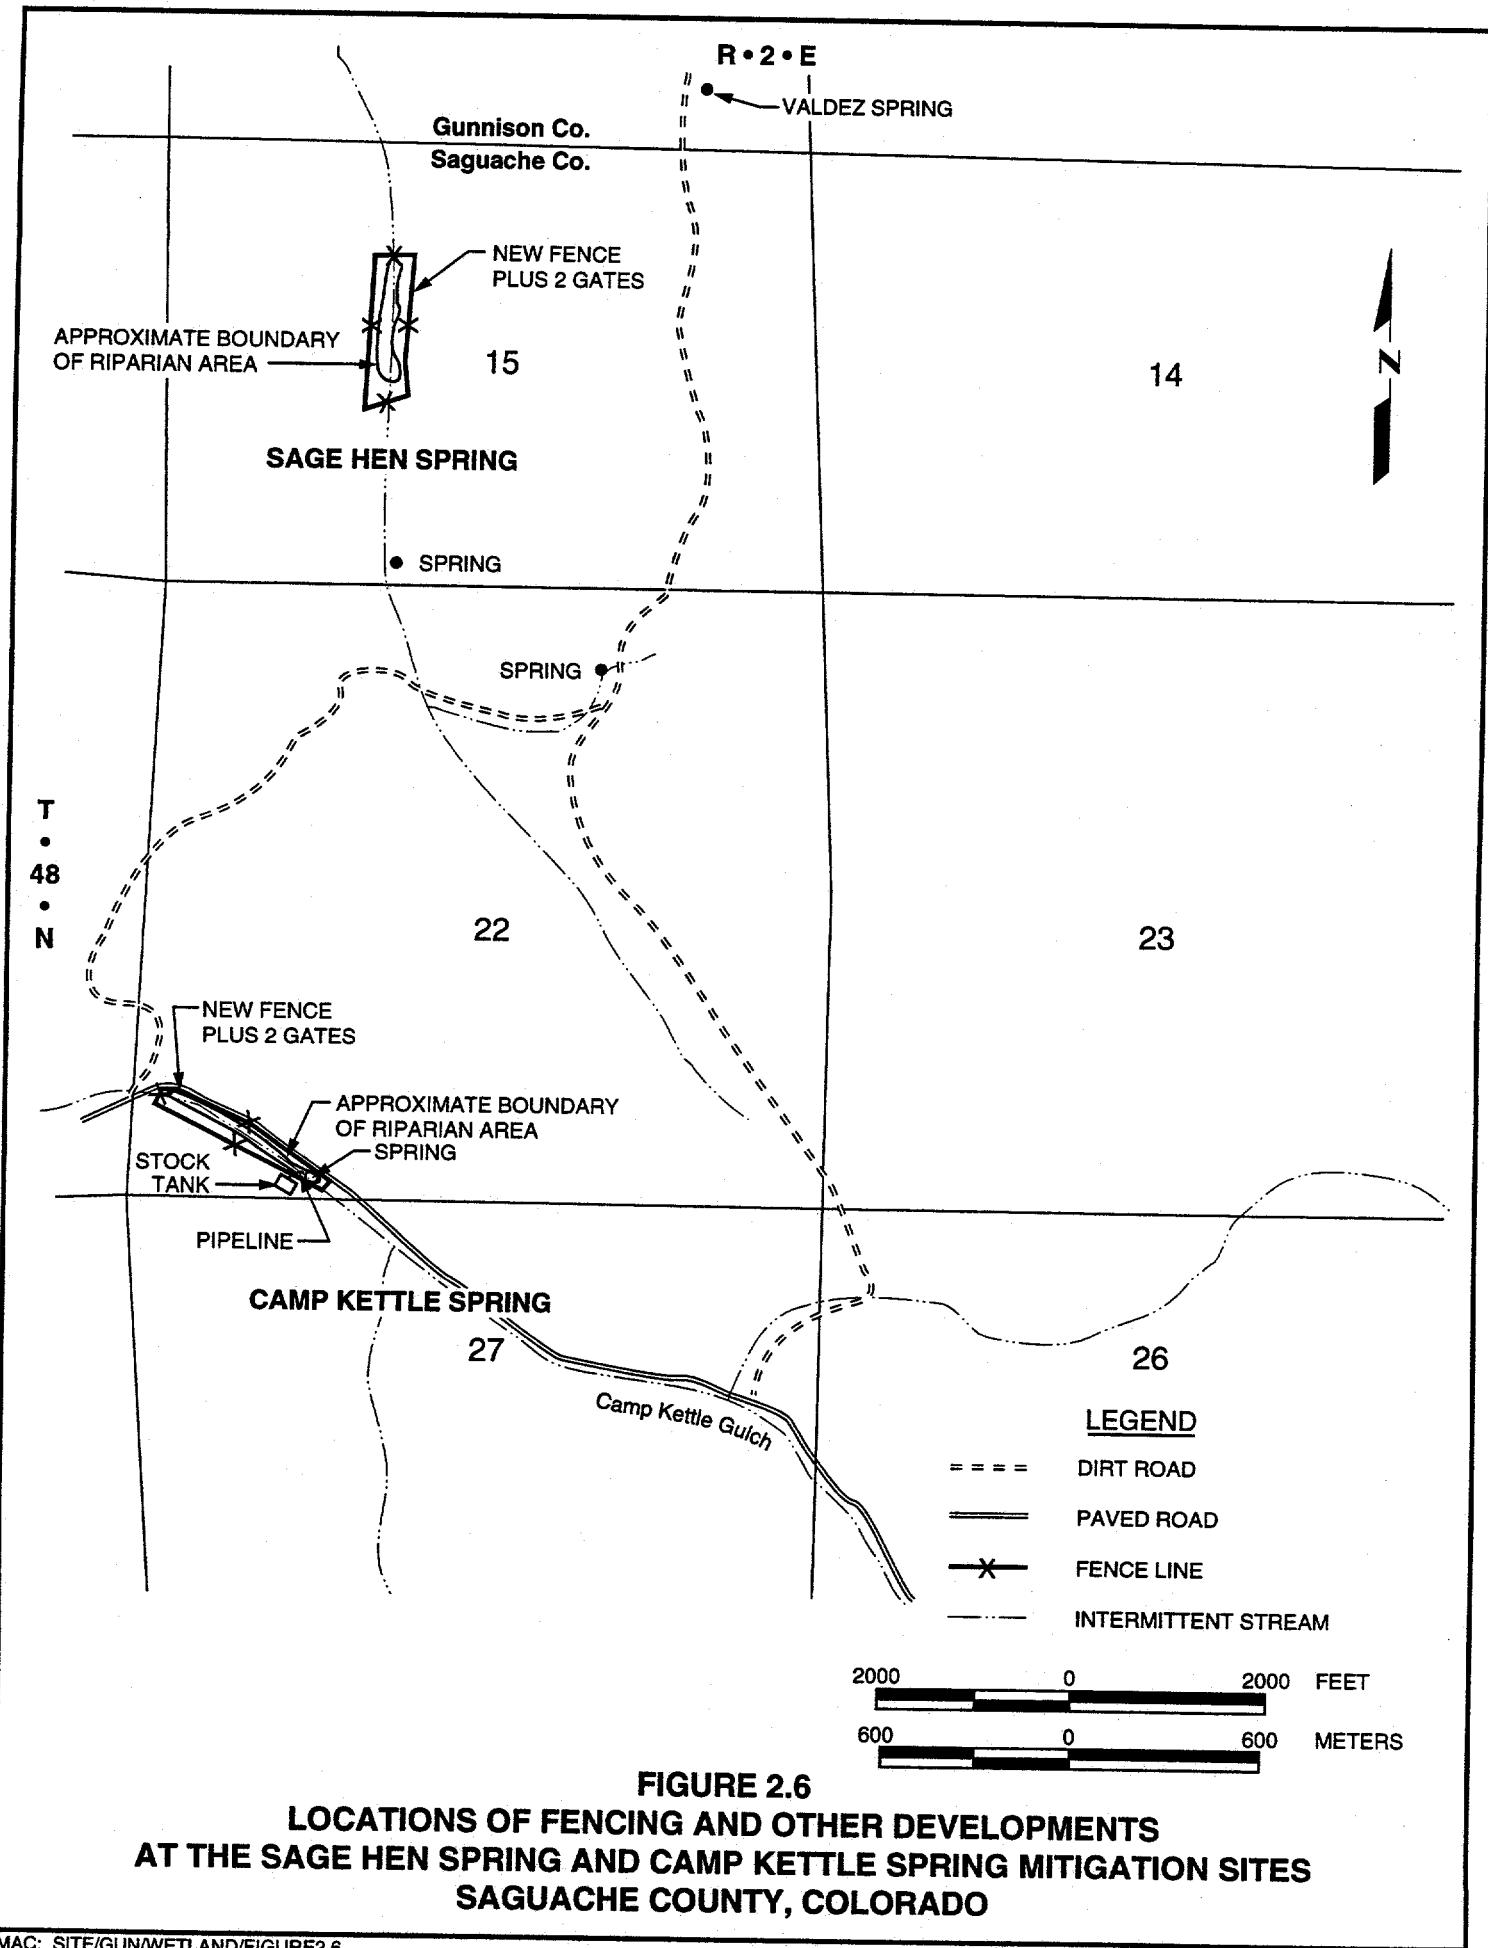
The Camp Kettle site was surrounded by new fencing and two gates. No road realignment was required. Water was piped from an existing pond inside the enclosure to a stock tank outside the enclosure (Figure 2.6).

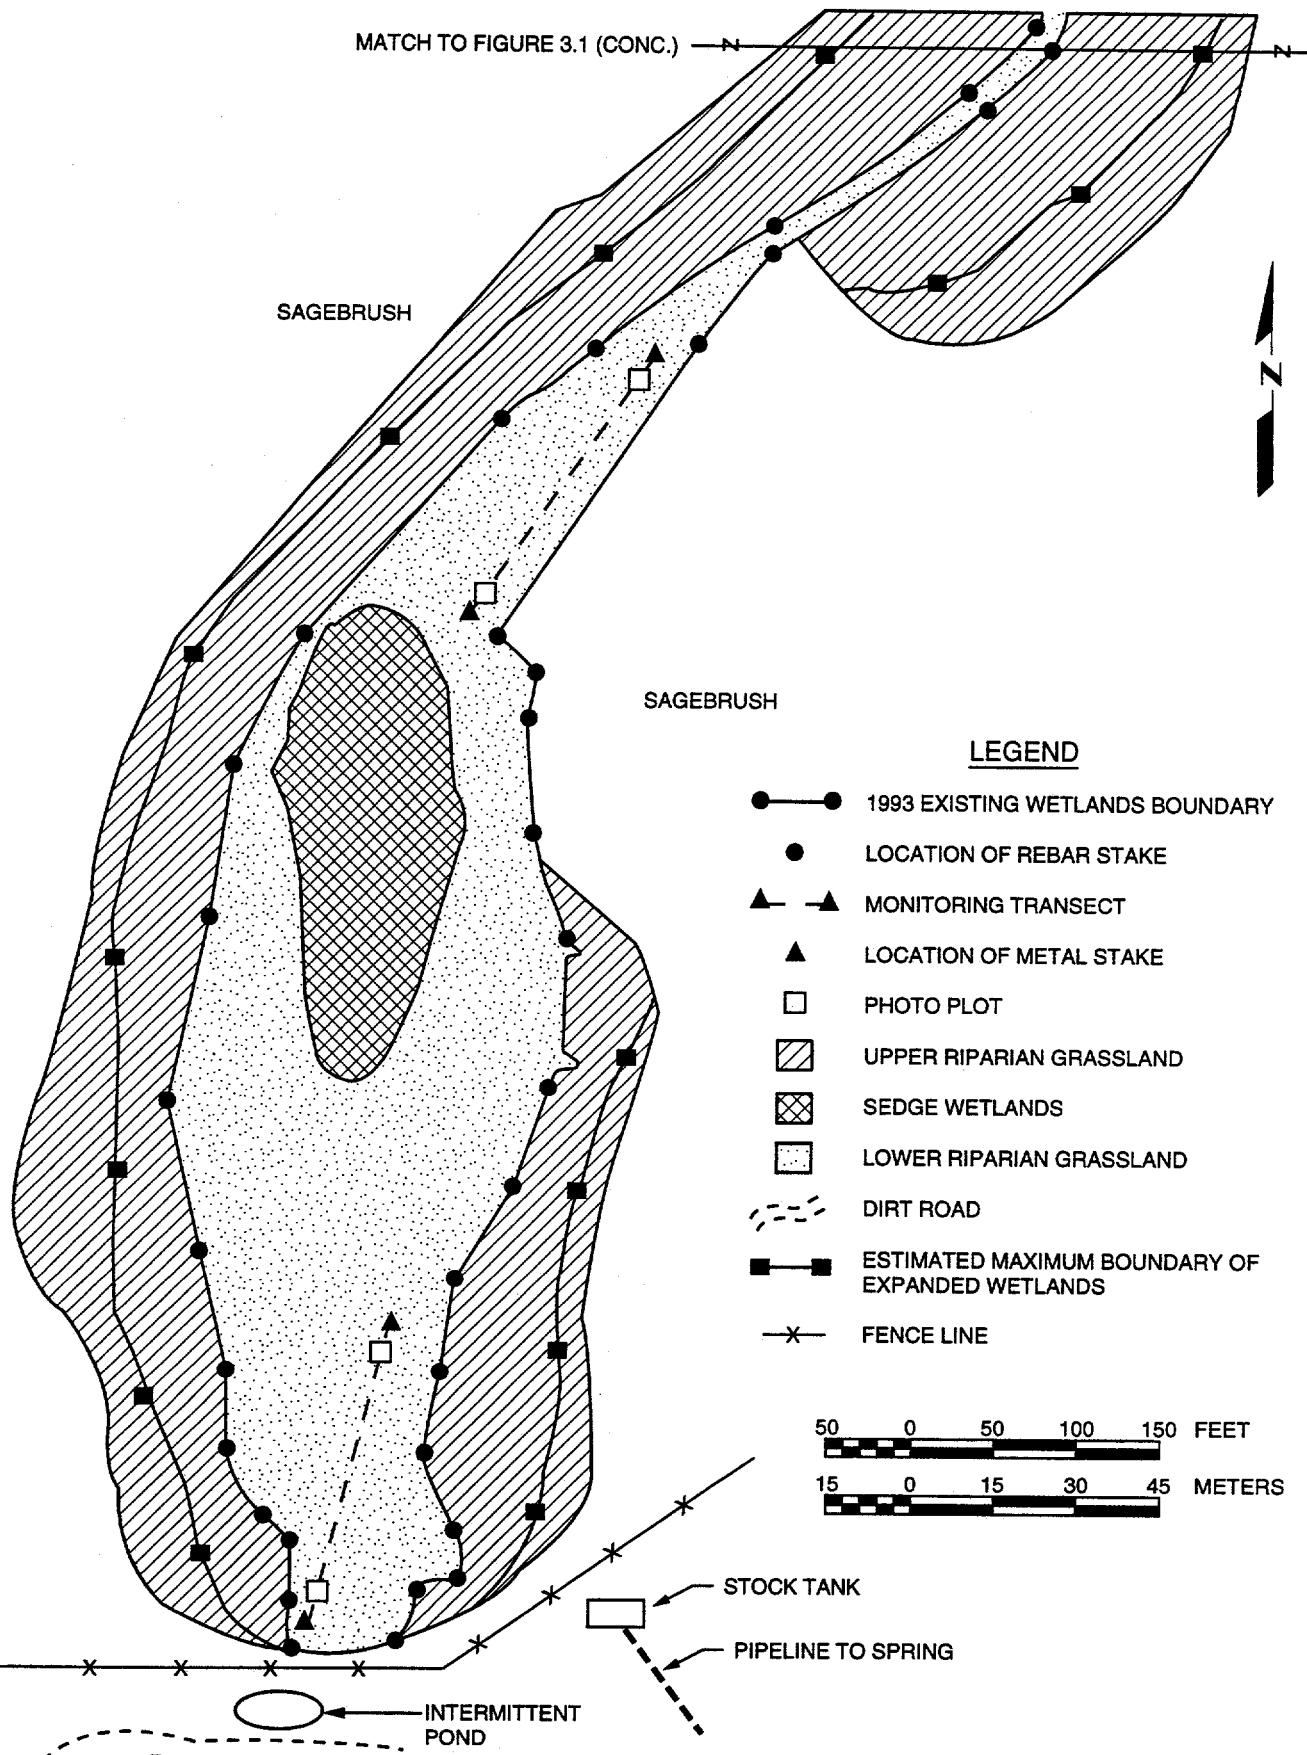
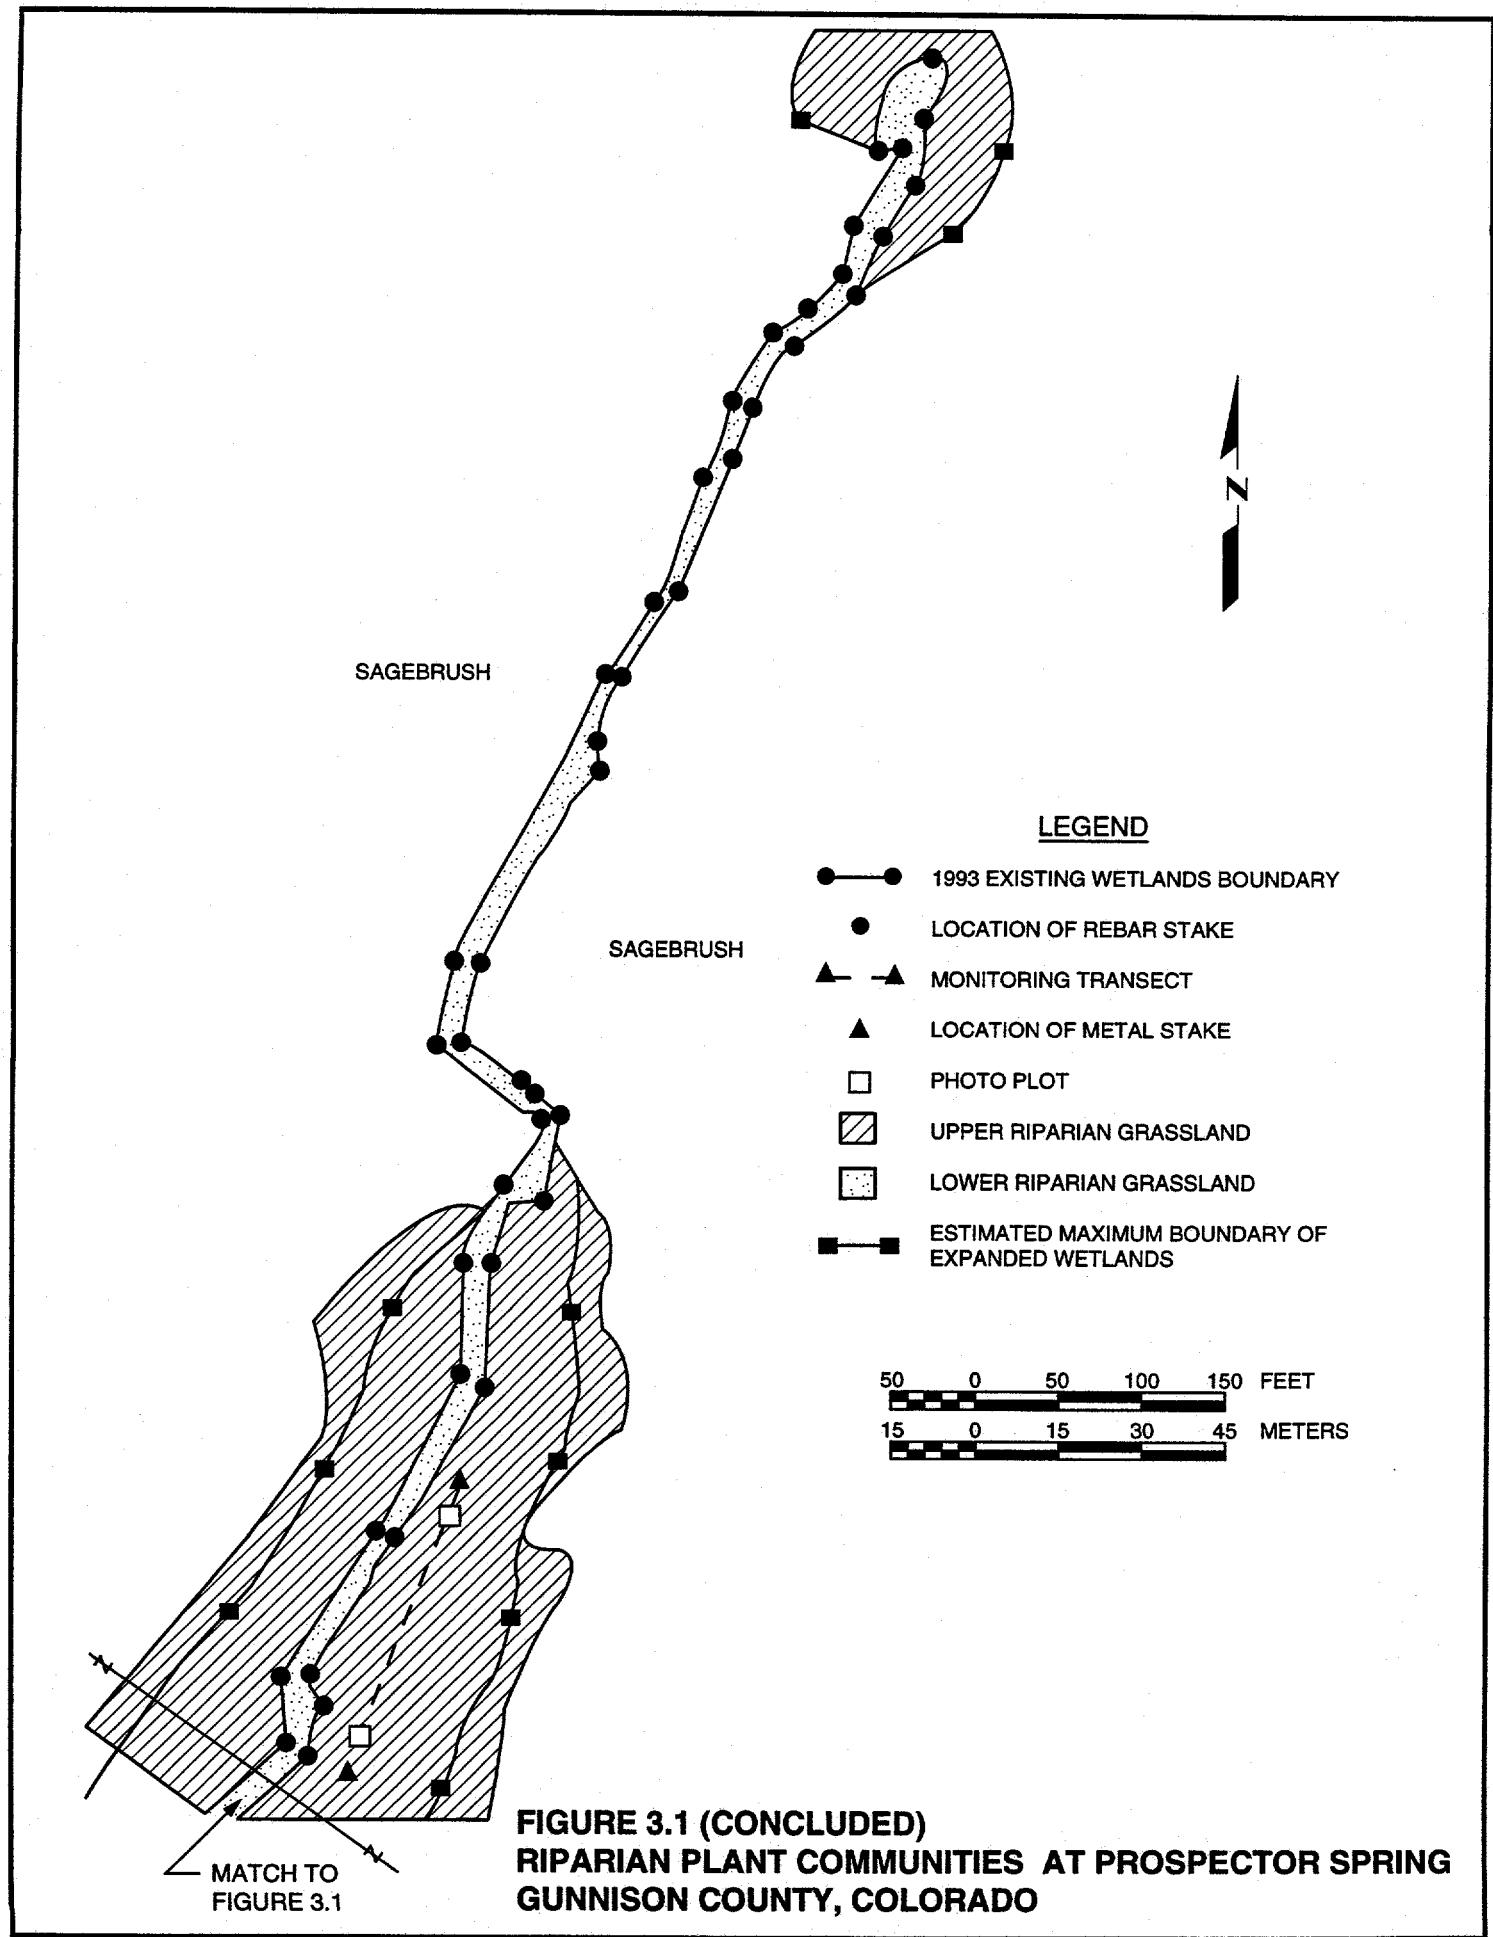
FIGURE 3.1
RIPARIAN PLANT COMMUNITIES AT PROSPECTOR SPRING
GUNNISON COUNTY, COLORADO

The 8.7-ac (3.5-ha) Prospector Spring is the largest mitigation site and consists of three plant community types (Figure 3.1). The upper riparian grassland plant community covers 5.2 ac (2.1 ha) and two wetland community types cover the

remaining area (Table 3.1). The upper riparian plant community areas are dominated by either fowl bluegrass or baltic rush. Transect 3 is in an area dominated by baltic rush. Baltic rush, dandelion (*Taraxacum officinale*), and foxtail barley (*Hordeum jubatum*) were the most frequently encountered species (Table 3.2). Baltic rush accounted for 45 percent of the vegetative cover, while the remaining species covered much less ground (Table 3.2). Bare ground was relatively low (4 percent) in this type. The average plant height for both baltic rush and foxtail barley was 7 inches (18 cm); the remaining species were 3 inches (8 cm) high or less (Table 3.3).

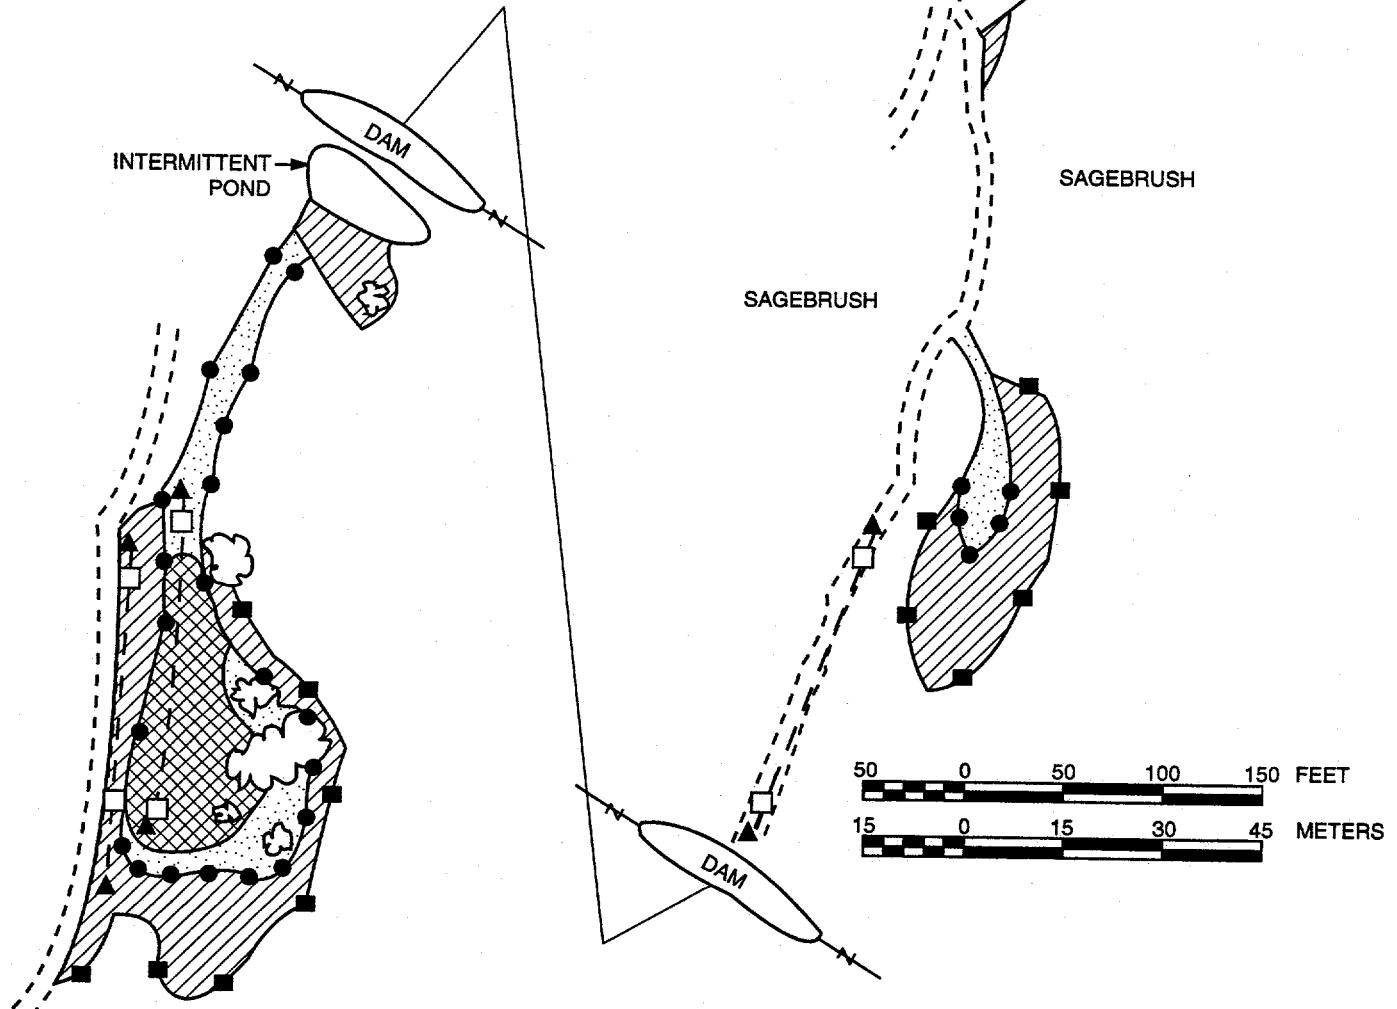
FIGURE 3.3
RIPARIAN PLANT COMMUNITY TYPES IN UPPER LONG'S GULCH SPRING
SAGUACHE COUNTY, COLORADO

Upper Long's Gulch covers 1.7 ac (0.7 ha) and has three herbaceous and one woody riparian plant community types (Figure 3.3). The upper riparian grassland plant community grows between the sagebrush plant community and the lower lying wetlands. Fowl bluegrass, dandelion, and aster (*Aster occidentalis*) were commonly observed while 41 percent of the vegetative cover was bluegrass (Table 3.2). An estimated 39 percent of this type was bare ground, mostly due to cattle trampling. The average height of bluegrass was 2 inches (5 cm); the remaining species were less than 1 inch (3 cm) (Table 3.3).

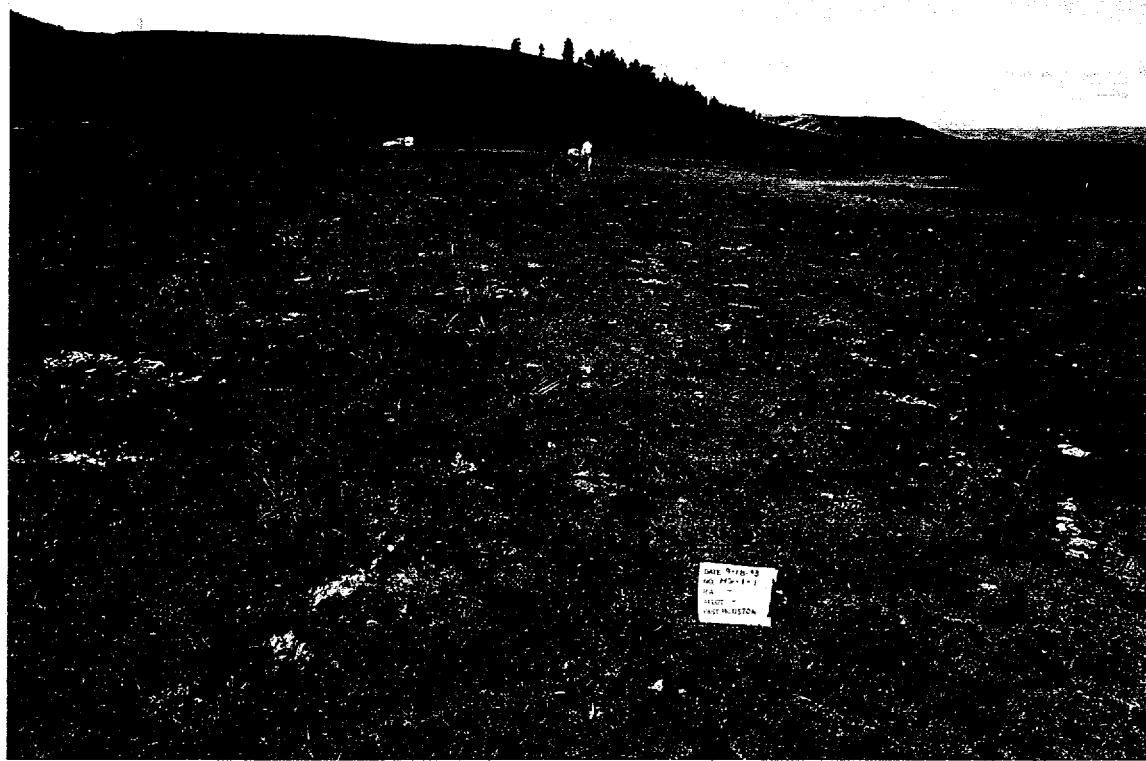
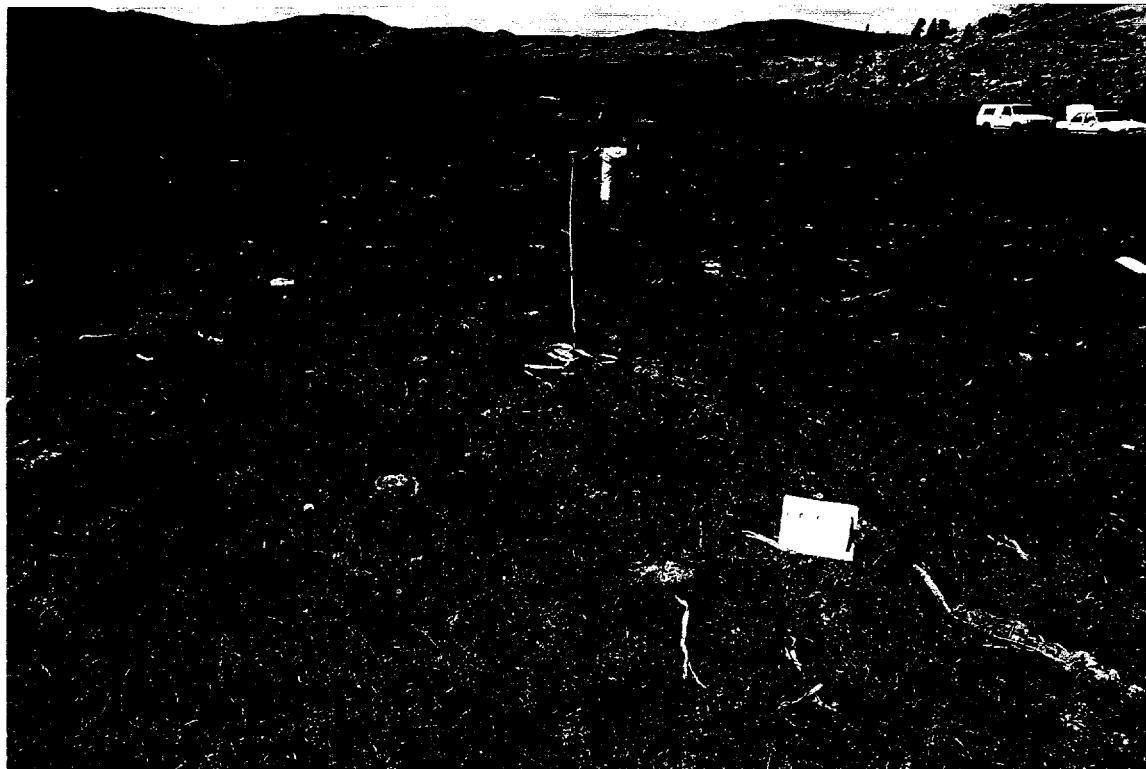
Photographic Series 1

Grazed Upper Riparian Grassland Plant Community

**UPPER RIPARIAN GRASSLAND PLANT COMMUNITY, HOUSTON GULCH
SEPTEMBER 1993**

**UPPER RIPARIAN GRASSLAND PLANT COMMUNITY, CAMP KETTLE SPRING
SEPTEMBER 1993**

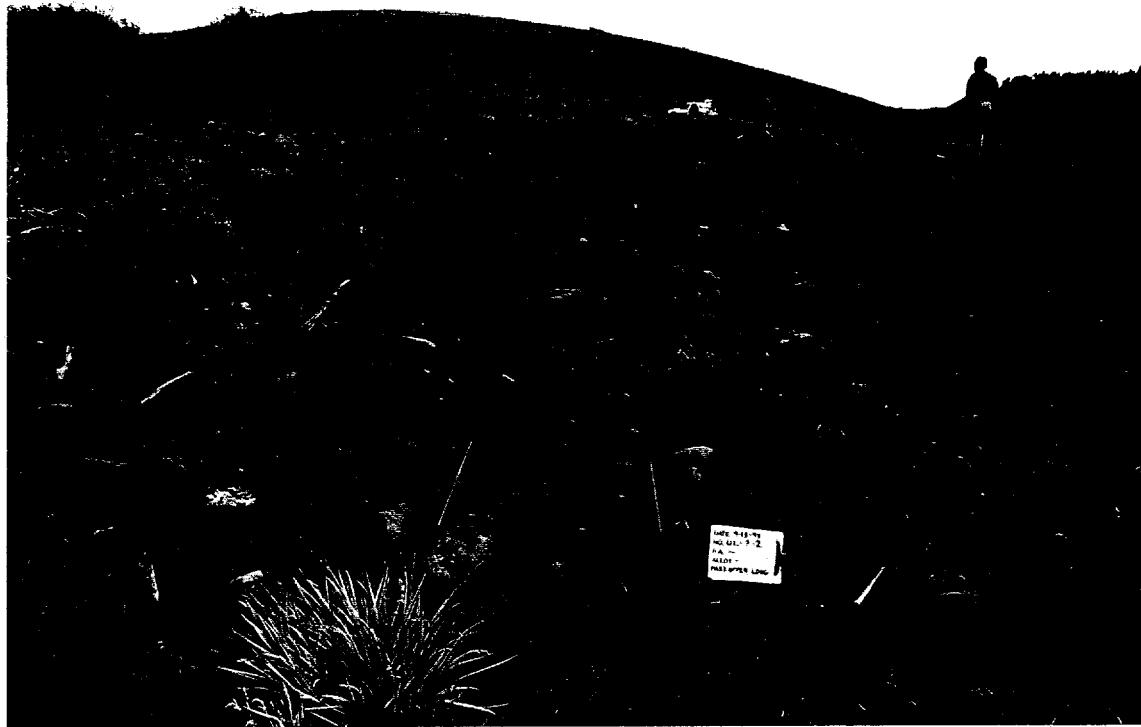
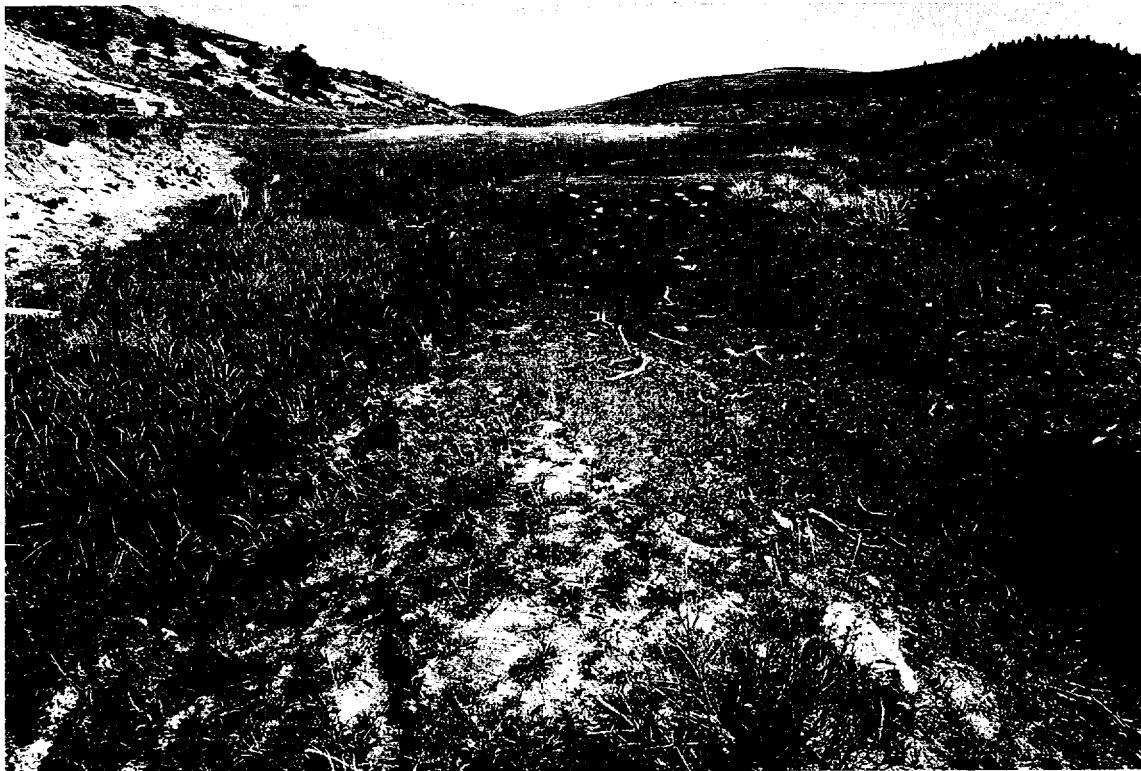
Photographic Series 2

Grazed Lower Riparian Grassland Plant Community

**LOWER RIPARIAN GRASSLAND PLANT COMMUNITY, UPPER LONG'S GULCH
SEPTEMBER 1993**

**LOWER AND UPPER RIPARIAN GRASSLAND PLANT COMMUNITY, HOUSTON GULCH
SEPTEMBER 1993**

Wetlands dominated by grass, baltic rush, and sedges occur in lower lying areas below the upper riparian plant community (Attachment C, Photographic Series 2). This lower riparian grassland plant community tends to have greater plant species diversity and more dominant plant species than the upper. Wetland hydrological conditions such as standing water, saturated soil, and gleyed soil and/or other indicators such as hummocks created by cattle activity were present.

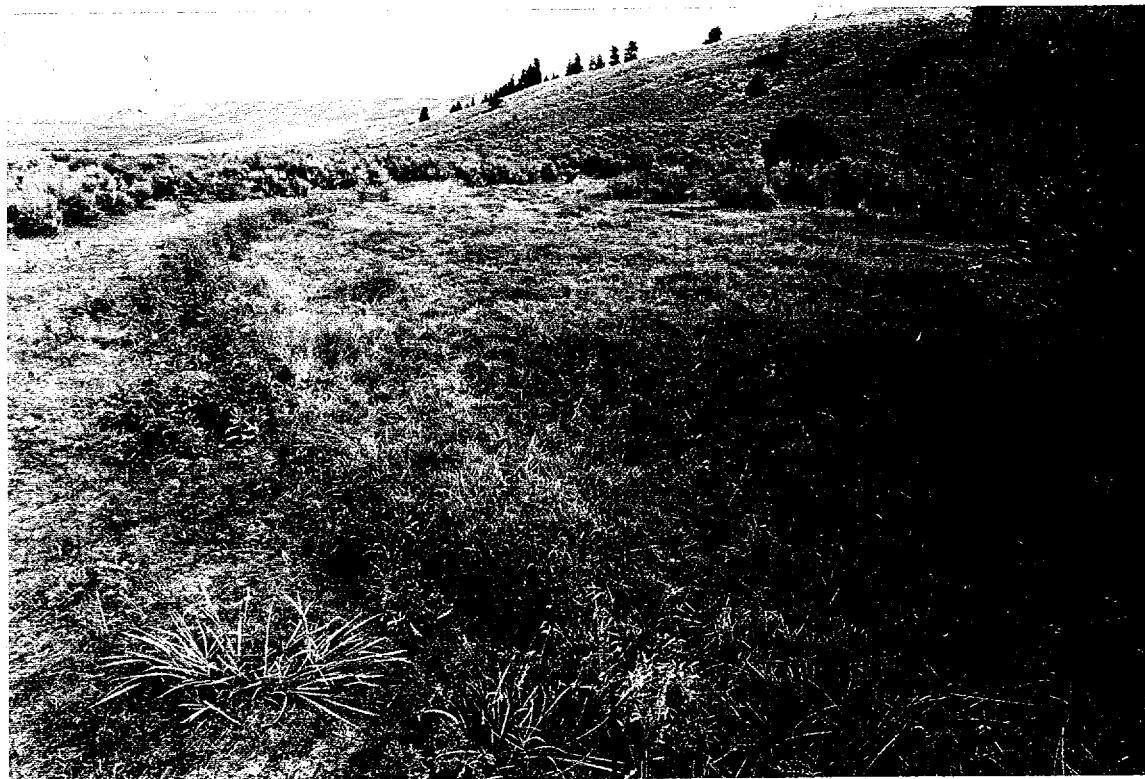
Photographic Series 3

Grazed and Ungrazed Sedge Wetlands

CAREX PLANT COMMUNITY, UPPER LONG'S GULCH, SEPTEMBER 1993

GRAZED CAREX PLANT COMMUNITY, SAGE HEN SPRING, SEPTEMBER 1993

A sedge-dominate plant community (beaked sedge [*Carex rostrata*] or water sedge [*Carex aquatilis*]) grows in the lowest lying areas at all the mitigation sites except Lower Long's Gulch (Attachment C, Photographic Series 3). This type of plant community consists of a homogenous stand of sedges with few other species. The sedge plant community grows in areas with generally permanent surface water or saturated soil conditions. This type of plant community was typically grazed only around the edges.

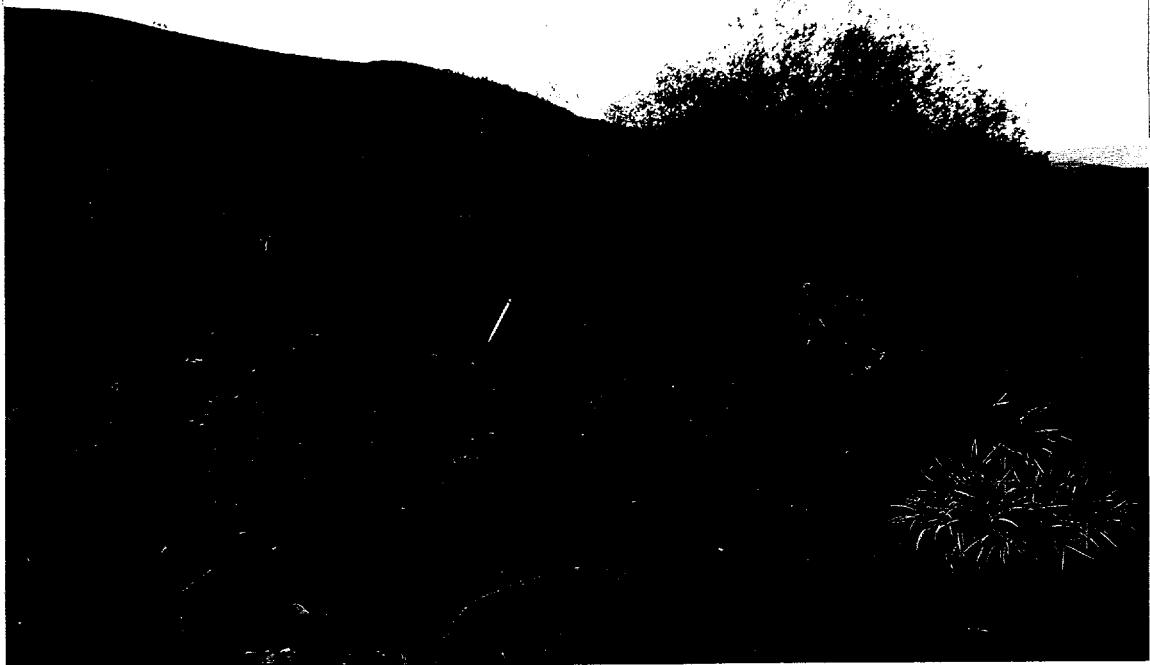
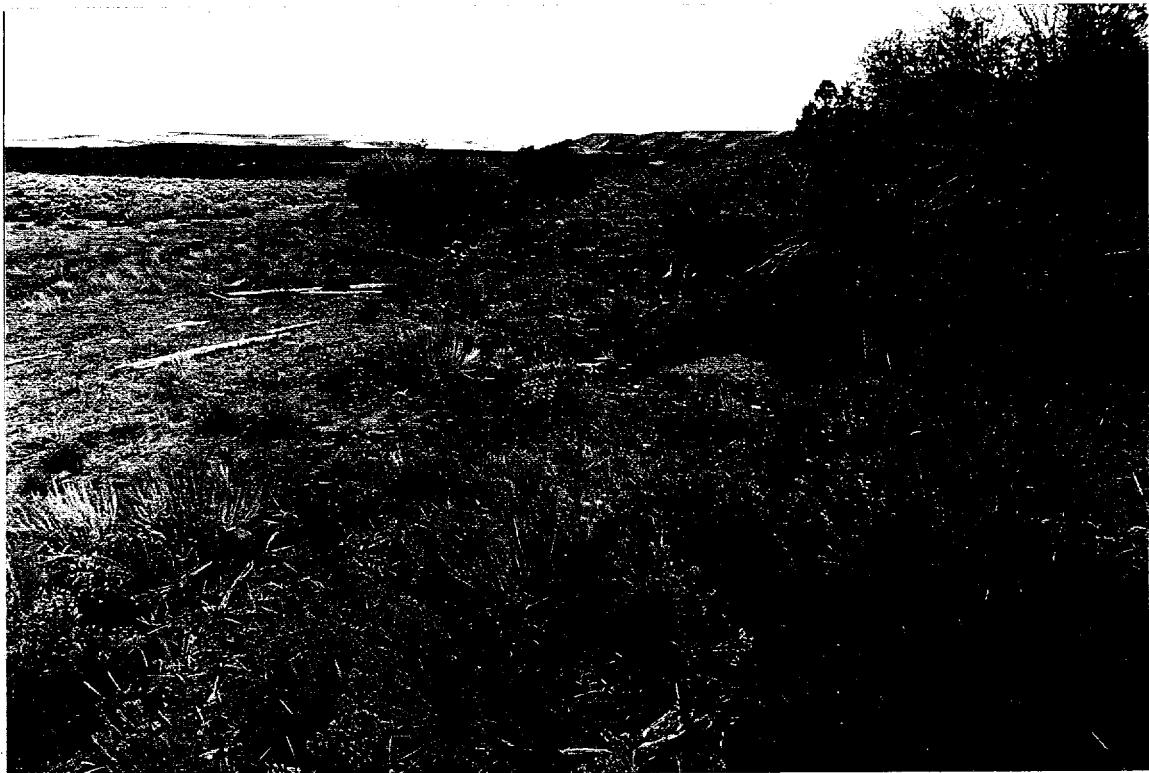
Photographic Series 4

Willow Thickets Impacted by Grazing

**WILLOW PLANT COMMUNITY, UPPER LONG'S GULCH, CAREX AND
UPPER RIPARIAN GRASSLAND PLANT COMMUNITY ALSO IN EVIDENCE
SEPTEMBER 1993**

WILLOW PLANT COMMUNITY, SAGE HEN SPRING, SEPTEMBER 1993

Willow thickets occur at three of the six mitigation sites (Attachment C, Photographic Series 4). The willows typically are damaged by cattle and are old plants. No willow reproduction was observed at these sites.

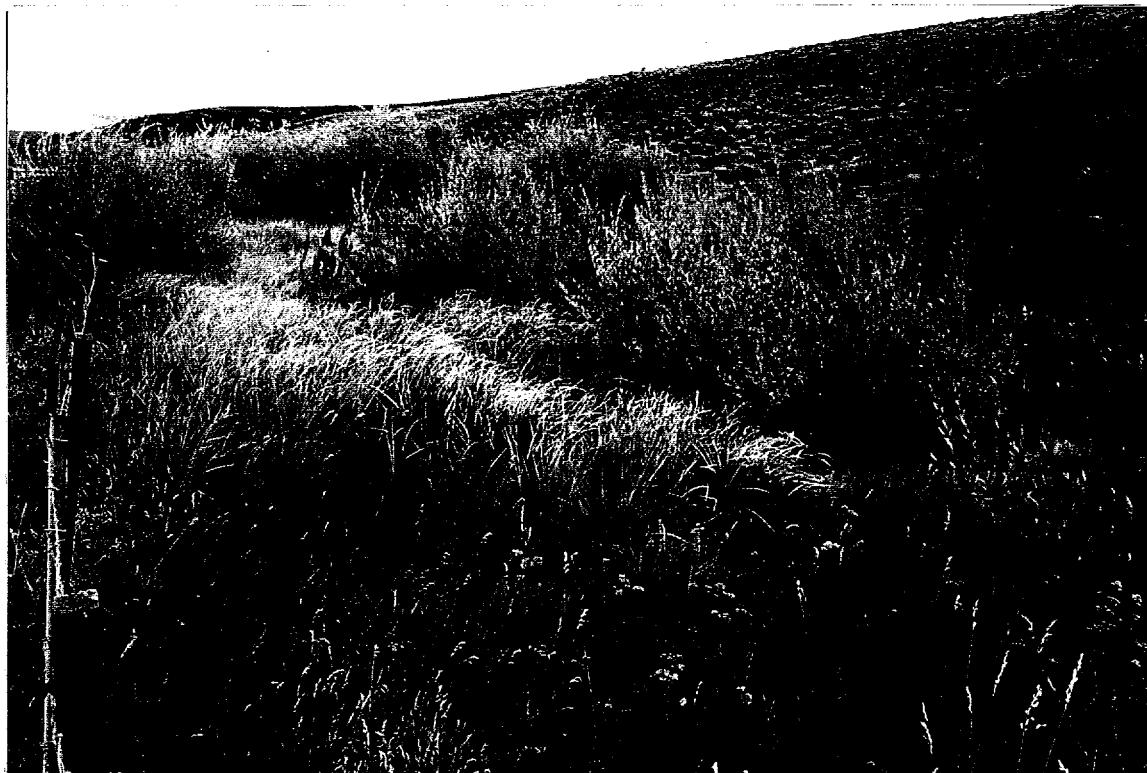
Photographic Series 5

Cattle Exclosure at Valdez Spring

VALDEZ SPRING EXCLOSURE, SEPTEMBER 1993

A cattle enclosure was placed around an approximate 0.3-ac (0.1-ha) area at Valdez Spring 10 to 12 years ago (Capodice, 1993). A marked difference between the plant growth inside and outside the fence was noted in September 1993 (Attachment C, Photographic Series 5). The plant community outside the fence looked like the heavily grazed upper and lower riparian grassland plant communities at the mitigation wetland sites. Fowl bluegrass grazed down to 1 to 2 inches (3 to 5 cm) was dominant. Inside the fence directly adjacent to this heavily grazed grassland was a dense growth of baltic rush 12 to 15 inches (30 to 38 cm) high. Very little bluegrass was observed; other frequently observed species in the upper riparian grassland type of the mitigation sites such as dandelion, aster, and yarrow were greatly reduced within the enclosure. Elsewhere inside the fence, a healthy stand of *Carex* sp. (probably beaked or water sedge) had developed. This sedge was not restricted to saturated ground; it grew in moist soil conditions. Willows of various ages also were scattered throughout the fenced area. Foxtail barley, which is fairly common in the six mitigation sites, was very limited; it grew only in soil disturbed by gopher activity (TAC, 1993). The enclosure at Valdez Spring probably was not planted and the plant growth observed here established itself naturally. The Valdez Spring enclosure was not monitored so no information is available on how long it took this area to recover from heavy cattle grazing. However, the conditions observed at this site provide significant information regarding the vegetational changes that will occur at the mitigation sites.
