COMPARISON OF RESULTS OF TWO DYE-TRACER TESTS AT THE
CHESTNUT RIDGE SECURITY PITS, Y-12 PLANT, OAK RIDGE, TENNESSEE

P. M. Goldstrand
Environmental Sciences Division
Oak Ridge National Laboratory

January 1994

Oak Ridge Y-12 Plant
Oak Ridge, Tennessee 37831

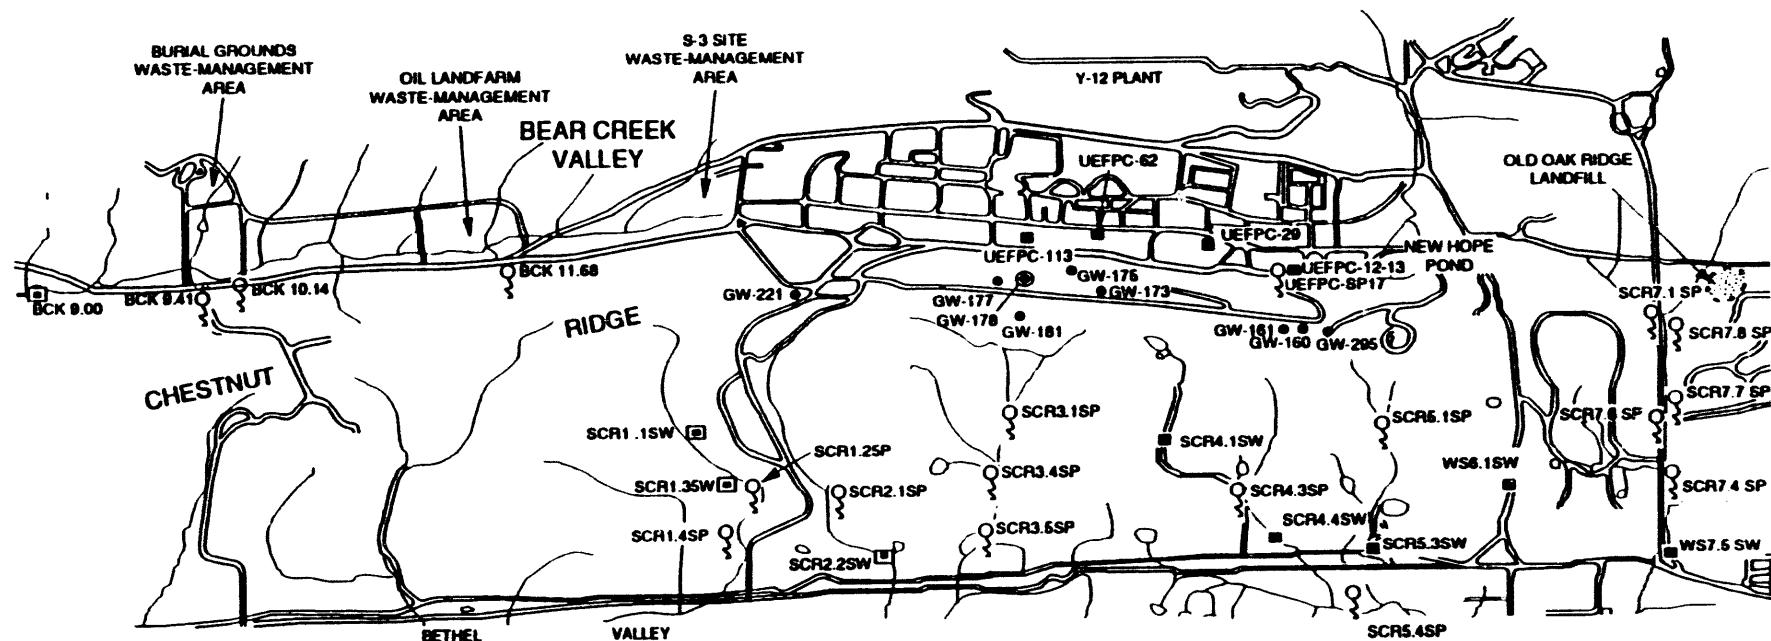
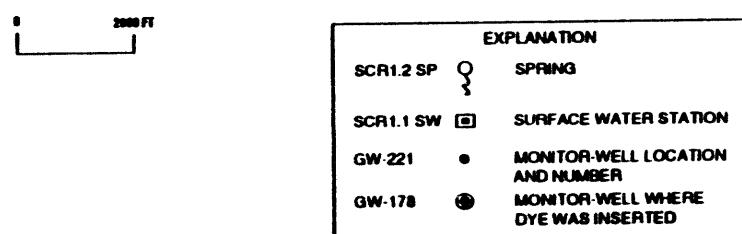
Figure 1.2: Monitoring stations for initial dye-tracer study.

A limited spring and seep survey was conducted prior to the initial test, identifying a number of springs and surface streams that may receive their discharge waters from Chestnut Ridge. Four main areas were surveyed as possible dye discharge sites: (1) Upper East Fork Poplar Creek (UEFPC), north of CRSP; (2) BCV, north and west of CRSP; (3) South Chestnut Ridge (SCR); and (4) Scarboro Creek, to the east and along strike with Chestnut Ridge (Fig. 1.2).

Sixteen springs, fifteen surface water sites, and eight groundwater monitoring wells were selected for monitoring the presence of dye (Fig. 1.2). Three weeks prior to insertion of the dye, charcoal detectors were installed at each site to monitor the natural background fluorescence. Dye detectors consisted of 10 grams of reagent-grade, activated charcoal placed within a nylon stocking and suspended in the water of the sample site by a "Quinlan Gumdrop" (Geraghty and Miller Inc., 1990). The gumdrop consisted of a 6-inch diameter concrete block, into which a wire is embedded for the attachment of the detector. Twice during the three weeks of background monitoring, the detectors were collected and analyzed for background fluorescence. All but three sites had background fluorescence below the analytical detection limit of 1 ppb (Table 2.1).

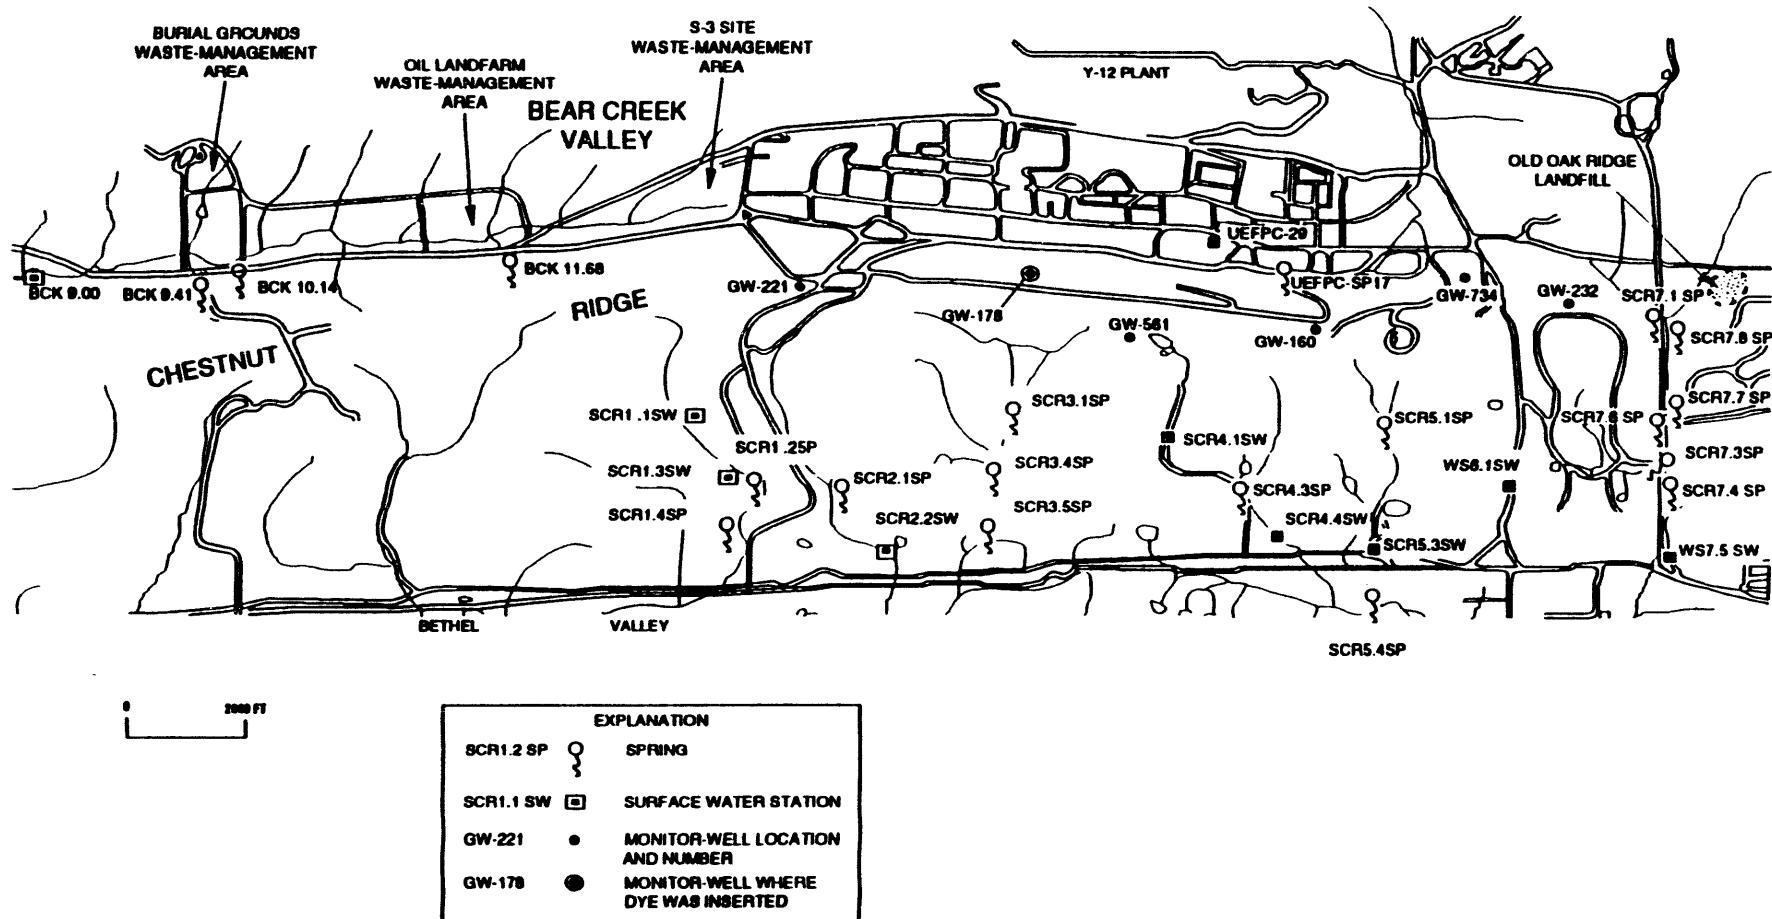
Figure 2.1: Monitoring stations for second dye-tracer study.

For verification of the first dye test results, the same injection well was used for the second test (GW-178). However, a few of the sampling locations used during the first test were considered excessive and eliminated (Science Applications International Corp., 1992b). Lack of funds prevented greater coverage of the area. The monitoring sites for the second dye-tracer test were limited to 5 groundwater wells, 11 surface water sites, and 19 springs (Fig. 2.1; Table 2.2). Wells GW-232 and GW-561 were added to monitor possible groundwater flow to the east and south, respectively. Well GW-734 was completed in a large cavity within the Maynardville Limestone, which could provide information on possible flow to the northeast, and was added to the dye sampling stations after background testing was completed.

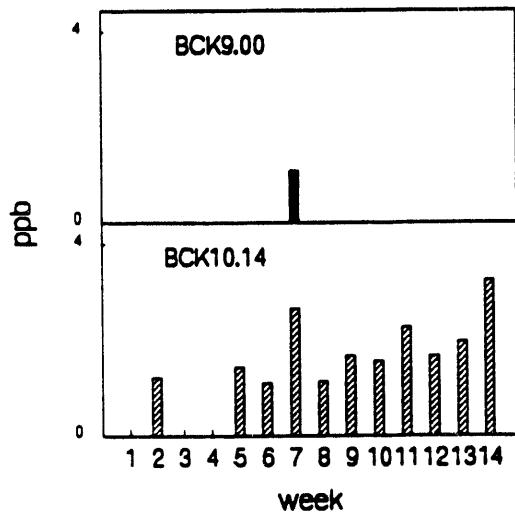
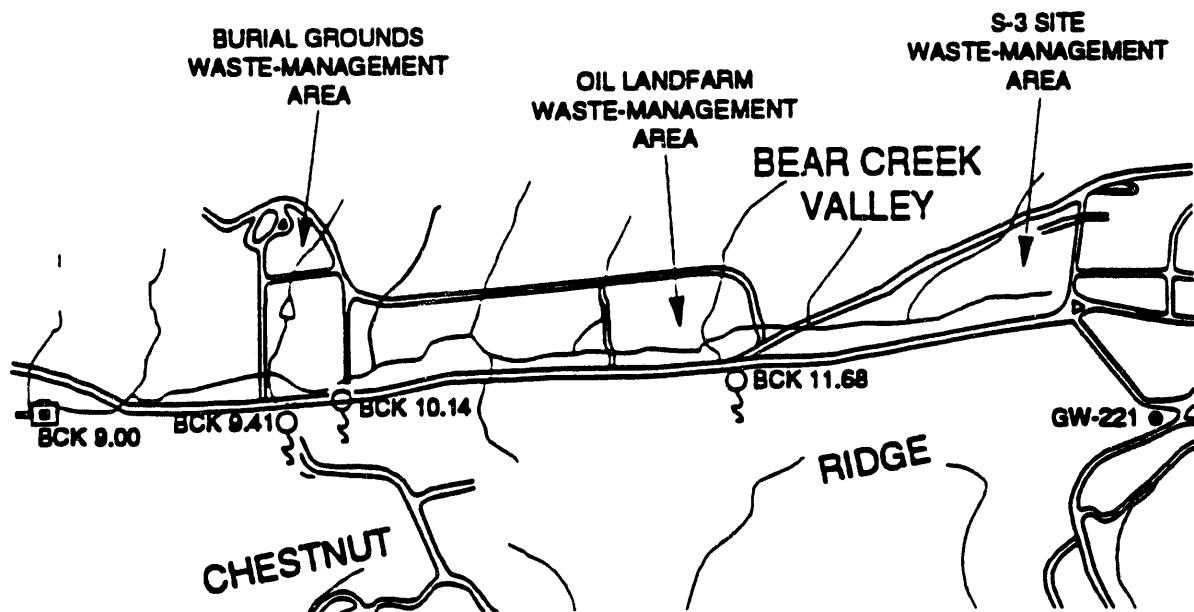
Figure 3.1: Initial test monitoring sites in Bear Creek Valley with fluorescein concentrations reported above the detection limit (1ppb) for BCK-9.00 and background fluorescence (1.1 ppb) for BCK-10.14.

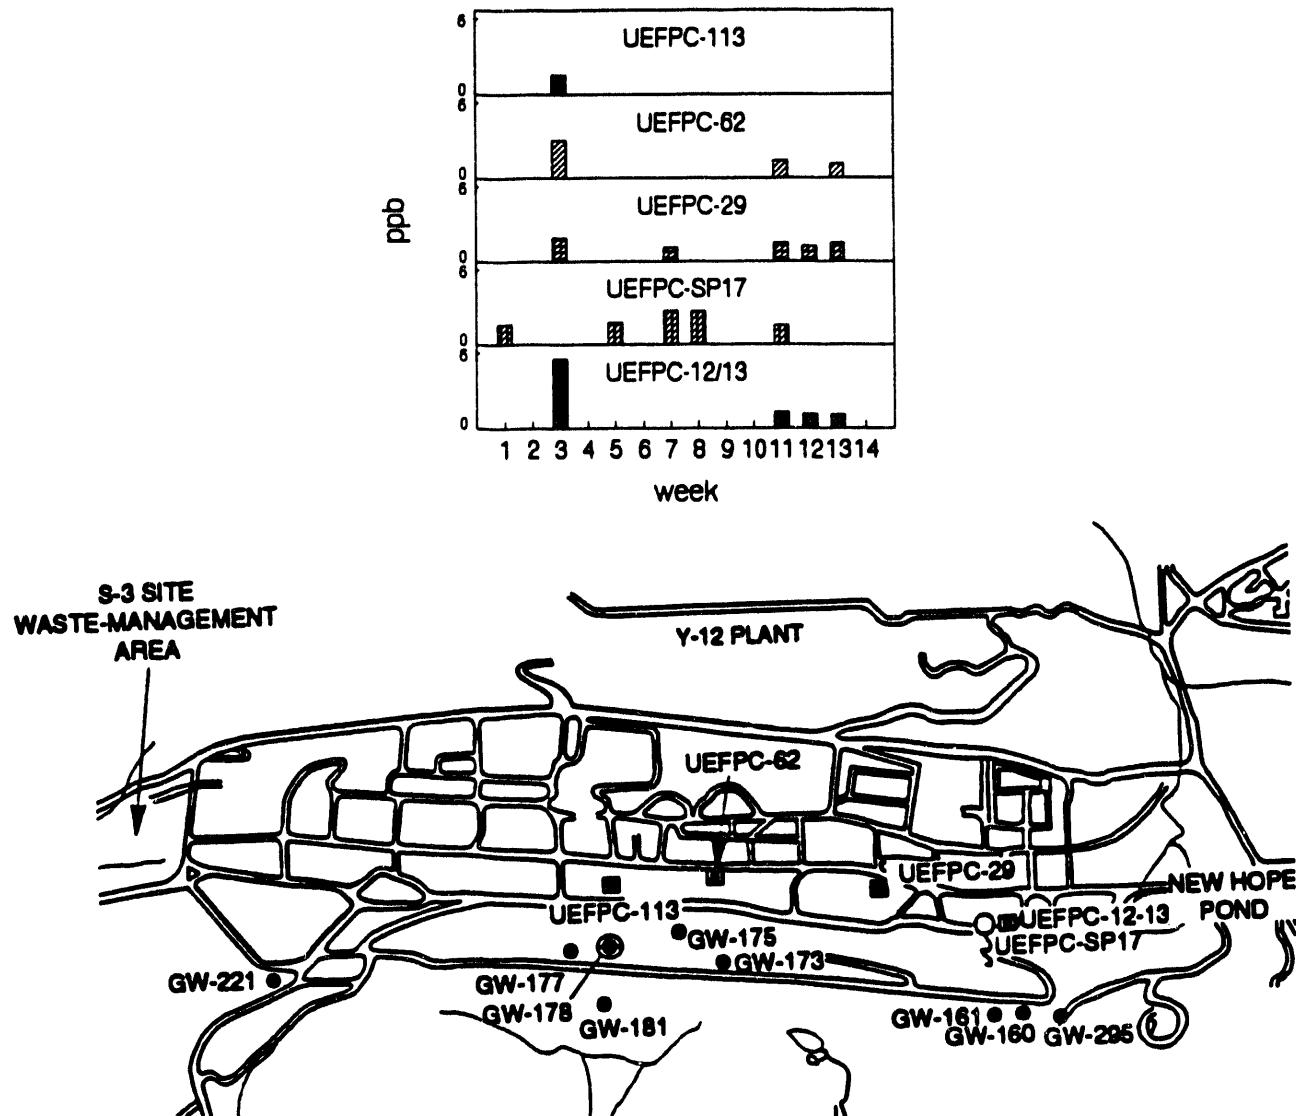
Figure 3.2: Initial test monitoring sites in UEFPC with fluorescein concentrations reported above the detection limit (1ppb) for UEFPC-113, UEFPC-62, UEFPC-29, UEFPC-12/13 and background fluorescence (1.3 ppb) for UEFPC-SP17.

All the monitoring sites in UEFPC were interpreted to have had positive dye detection at least once during the initial test (Fig. 3.2). The UEFPC-SP17 was the only spring monitored in UEFPC and had apparent fluorescence concentrations above the 1.3 ppb background fluorescence during the second week after dye injection (Fig. 3.2). Most of the observed concentrations were below 2 ppb, with slightly higher concentrations at UEFPC-12/13 and UEFPC-62 during Week 4 and at UEFPC-SP17 during Weeks 8 and 9 (Fig. 3.2).

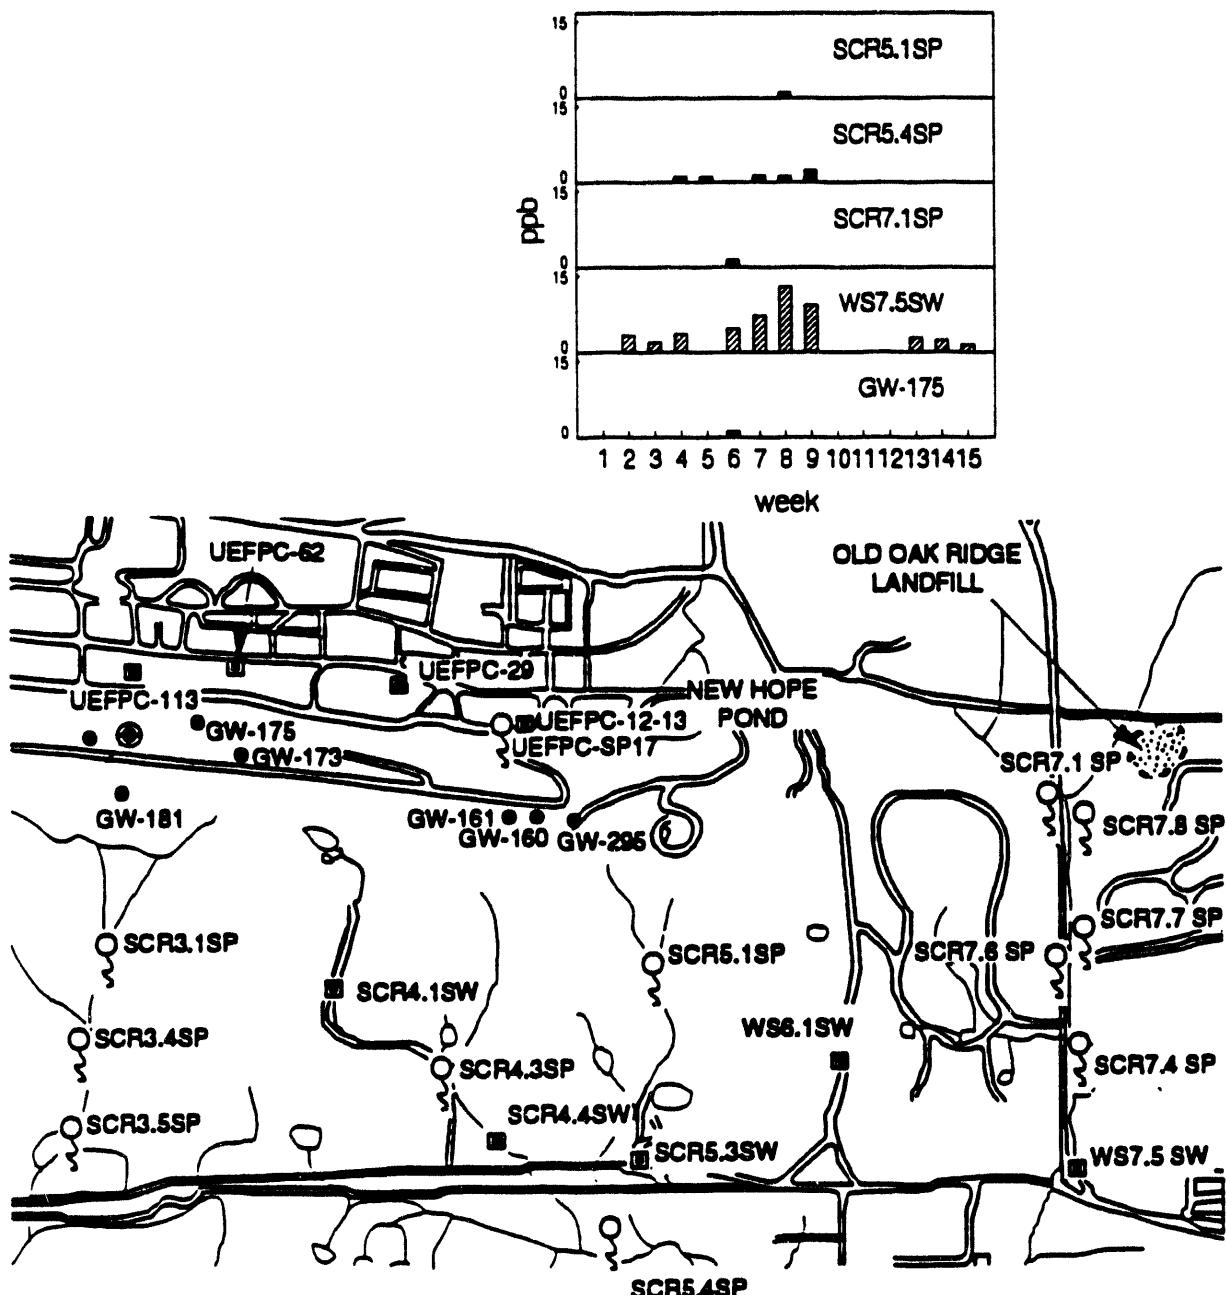
Figure 3.3: Initial test monitoring sites on south Chestnut Ridge with fluorescein concentrations reported above the detection limit (1ppb), and at Scarboro Creek with fluorescein concentrations reported above the detection limit (1ppb) for SCR-7.1SP and background fluorescence (2.6 ppb) for WS-7.5SW.

Two springs within the same drainage (SCR-5.1SP and SCR-5.4SP) had apparent fluorescence concentrations above the analytical detection limit (Fig. 3.3; Table 3.1). Most of the apparent concentrations were slightly above the detection limit, with the highest concentration of 2.45 ppb during Week 9 in SCR-5.4SP (Fig. 3.3). Also, Well GW-175 had apparent fluorescence concentrations slightly above the detection limit during Week 6 (Fig. 3.3; Table 3.1).

Along Scarboro Creek, two sites were interpreted as having dye present (Fig. 3.3). Spring SCR-7.1SP had an apparent concentration slightly above the detection limit during Week 6 (Fig. 3.3; Table 3.1). The surface stream monitoring site, WS-7.5SW, had the highest background fluorescence (2.6 ppm) of all the sites monitored during the initial test (Table 2.2) and had the highest concentrations of any site during this test (Fig. 3.3).

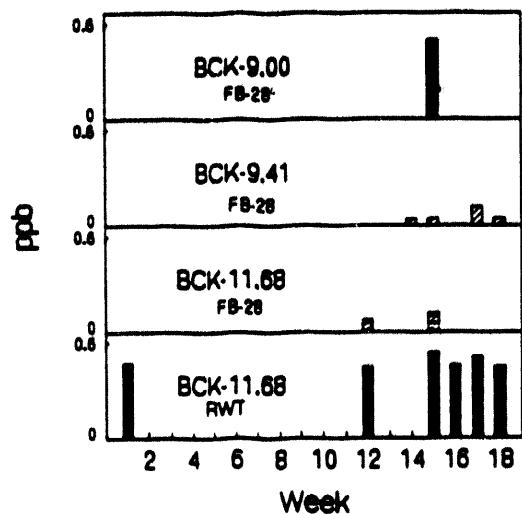
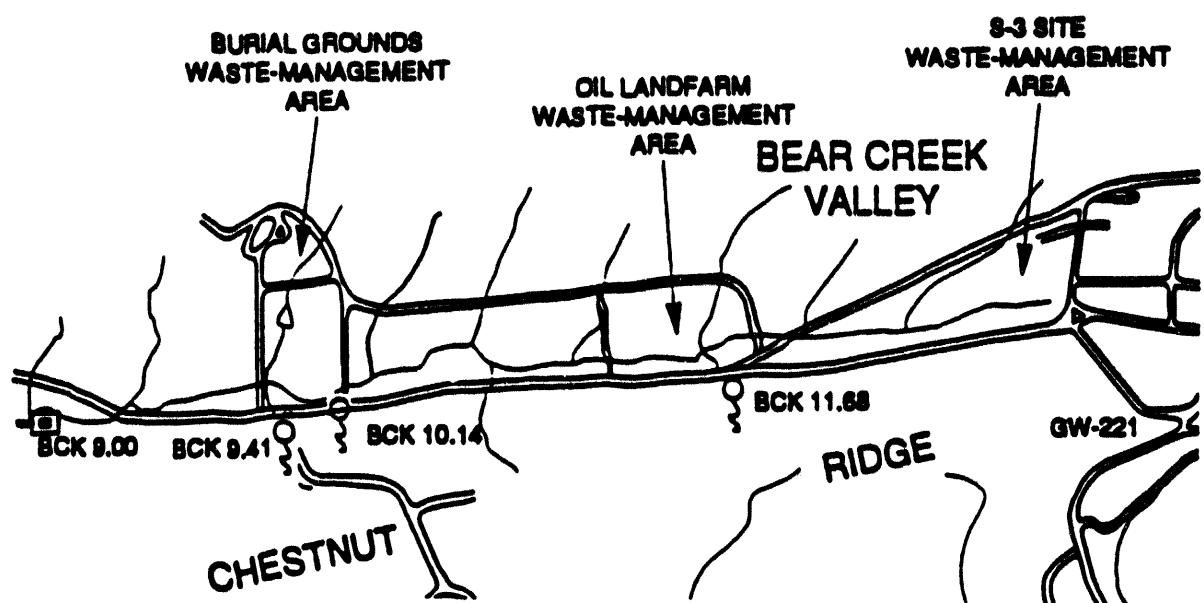
Figure 3.4: Second test monitoring sites in BCV with fluorescence concentrations above the detection criteria.

In BCV, spectral peaks in the range of FB28 and above the mean +3 standard deviation criteria were observed at BCK-9.00, BCK-9.41, and BCK-11.68 (Fig. 3.4; Table 3.3). Fluorescence peaks in the range of RWT and above the detection criteria were observed only at BCK-11.68 (Fig. 3.4). The possible presence of both FB28 and RWT fluorescence above the detection criteria occurred only at one site (BCK-11.68) during the same weeks (Weeks 12 and 15); however, total possible concentrations were extremely low (< 0.6 ppb).

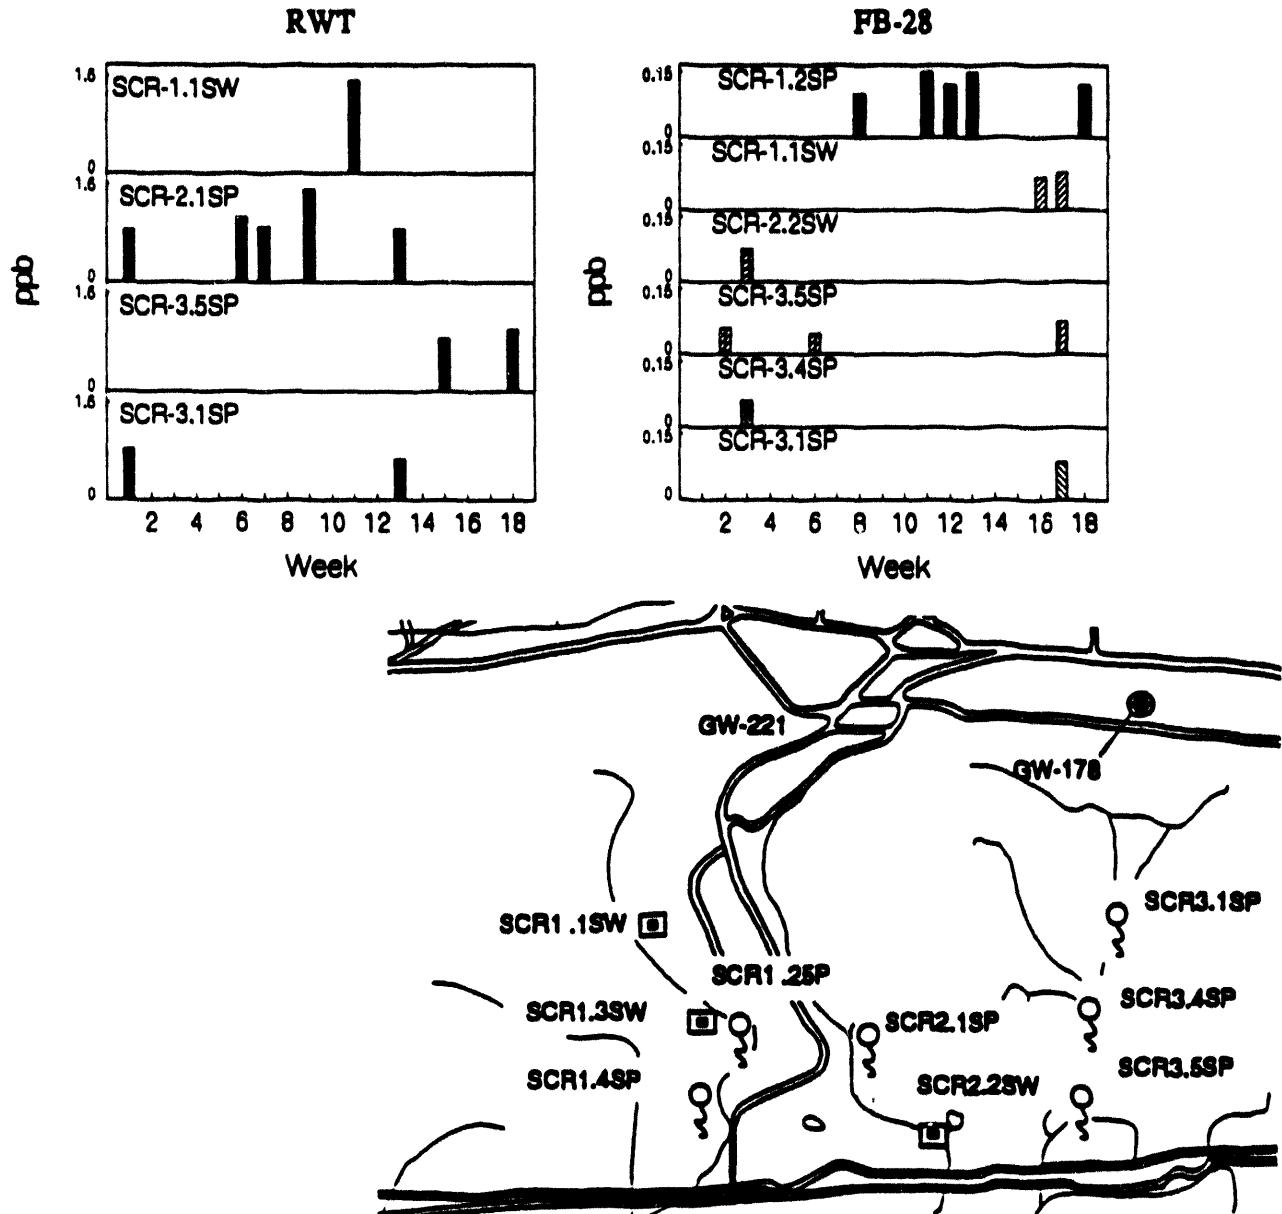
Figure 3.5: Second test monitoring sites in SCR-1, SCR-2, and SCR-3 drainages with fluorescence concentrations above the detection criteria.

In the SCR-1 drainage, apparent FB28 concentrations above the detection criteria was observed at SCR-1.2SP and SCR-1.ISW (Fig. 3.5; Table 3.3). Apparent RWT concentrations above the detection criteria occurred only during Week 11 at SCR-1.ISW (Fig. 3.5). No correlation is apparent in this drainage for both the dyes being present at the same time. If FB-28 were present in this drainage, concentrations were less than 0.2 ppb. High natural background fluorescence was observed at this surface water site during 4 of the 18 weeks of the test; thus, it is unclear if the RWT fluorescence during Week 11 is a low RWT tracer concentration, or related to a high natural background in the stream.

Possible RWT concentrations above the detection criteria was observed at SCR-3.5SP and SCR-3.1SP (Fig. 3.5; Table 3.3). Fluorescence peaks in the range of both FB28 and RWT were observed at SCR-3.1SP, but not during the same week. No apparent correlation is present between sites in this drainage, and if the dyes were present in this drainage, RWT concentrations were below 1.01 ppb and FB-28 concentrations did not exceed 0.086 ppb.

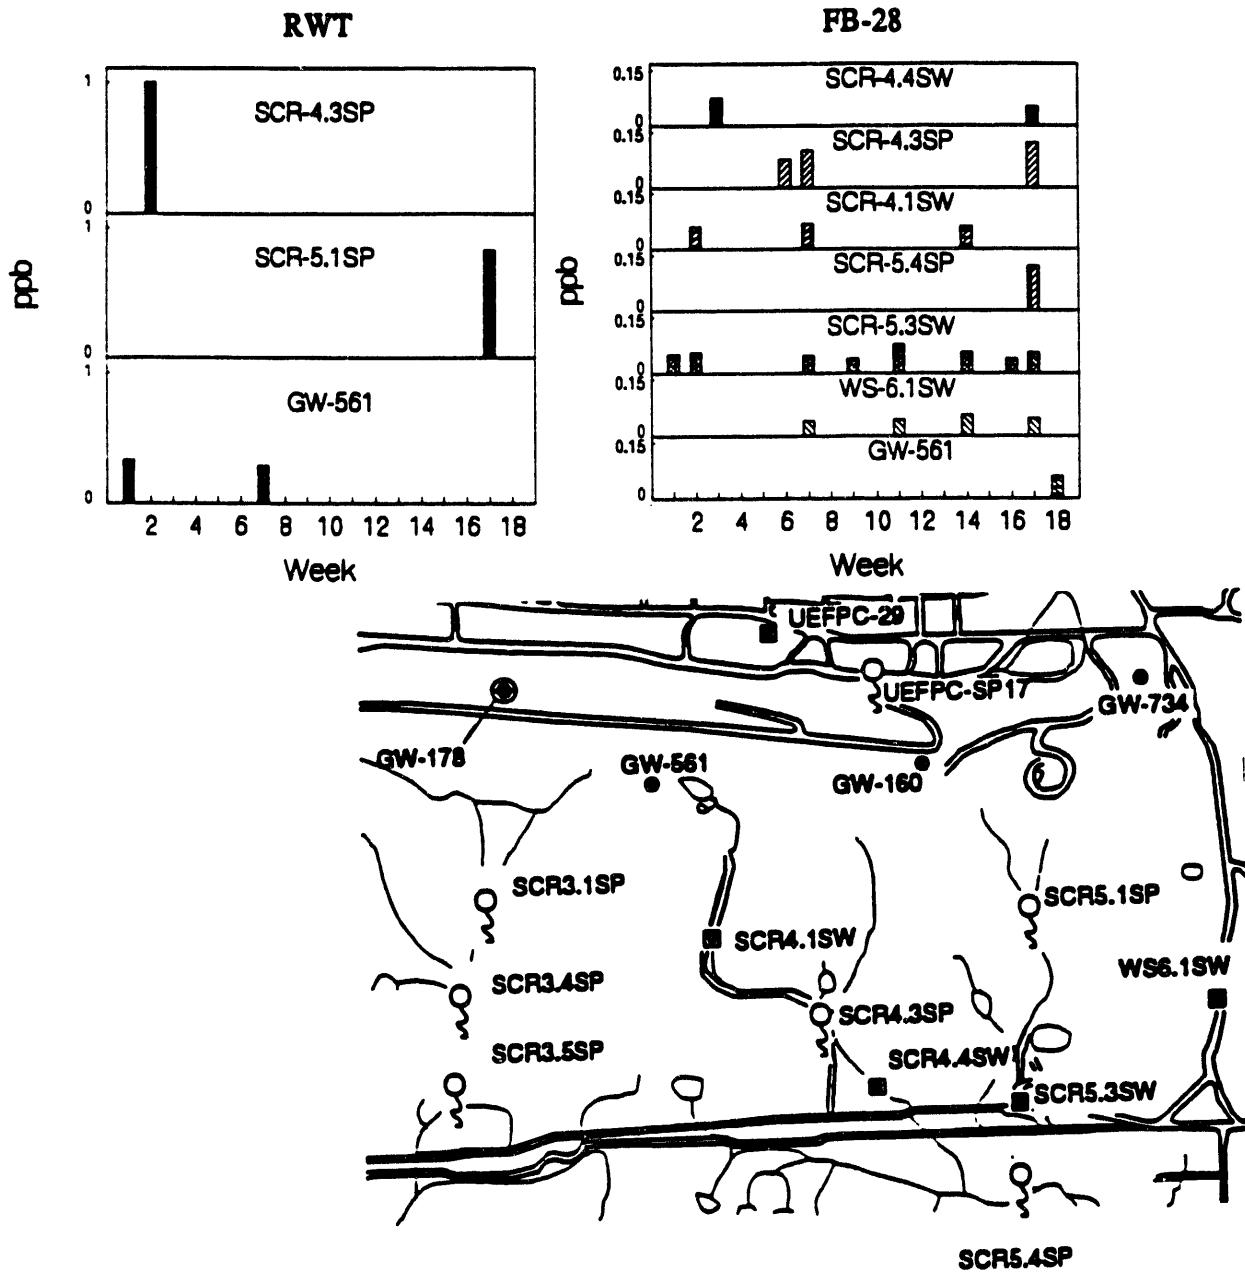
Figure 3.6: Second test monitoring sites in SCR-4, SCR-5, and WS-6 drainages and Well 561 with fluorescence concentrations above the detection criteria.

In the SCR-4 drainage, possible FB28 spectral peaks were observed at Sites SCR-4.4SW, SCR-4.3SP, and SCR-4.1SW (Fig. 3.6; Table 3.3). Apparent RWT concentrations above the detection criteria were present during Week 2 at SCR-4.3SP (Fig. 3.6). The possible presence of RWT and FB-28 in SCR-4.3SP did not coincide temporally. If the dyes were present in this drainage, concentrations of RWT were 1.0 ppb or less and FB-28 concentrations were 0.075 ppb or less.

Apparent FB28 concentrations above the detection criteria in the SCR-5 drainage were observed at SCR-5.4SP and SCR-5.3SW (Fig. 3.6; Table 3.3). A possible

RWT spectral peak was observed only at SCR-5.1SP during Week 17 (Fig. 3.6).

At the surface water Location WS-6.1 only FB28 was possibly detected at concentrations at or below 0.055 ppb (Fig. 3.6; Table 3.3). No spectral peaks in the range of RWT were observed above the detection criteria at this site.

Within the groundwater monitoring wells, apparent FB28 concentrations above the detection criteria were observed in GW-561 (Fig. 3.6), GW-160 (Fig. 3.8), and GW-221 (Fig. 3.8). Although no background analyses were available on GW-734, an apparent elevated FB28 concentration appears at Week 8 (Table 2.2). The possible presence of RWT in concentrations above the detection criteria was observed in GW-561 during Weeks 1 and 7. Within this groundwater well, the possible presences of both dyes did not occur at the same time. If the dye were present in these wells, concentrations did not exceed 0.75 ppb.

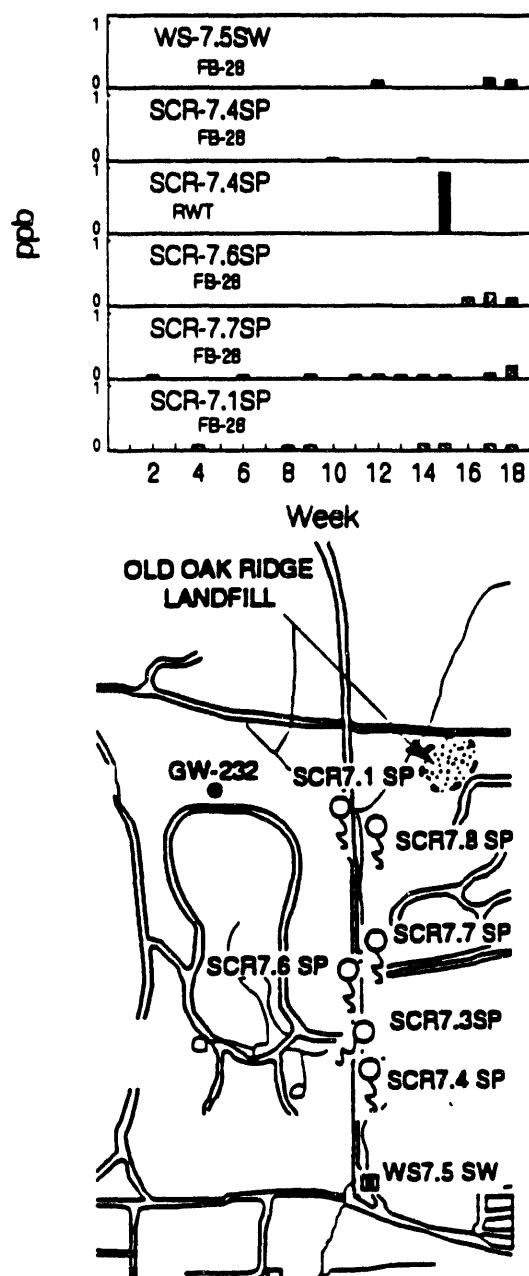
Figure 3.7: Second test monitoring sites in SCR-7 and WS-7 drainages with fluorescence concentrations above the detection criteria.

Along Scarboro Creek, apparent FB28 concentrations above the detection criteria were observed at SCR-7.1SP, SCR-7.4SP, SCR-7.6SP, SCR-7.7SP, and WS-7.5SW (Fig. 3.7; Table 3.3). Spectral peak in the range of RWT were only observed at SCR-7.4SP during week 15 (Fig. 3.7). The apparent FB28 and RWT spectral peaks do not appear at the same time within SCR-7.4SP but occur within a week of each other. Possible correlations for FB28 may occur between SCR-7.1SP, SCR-7.6SP, SCR-7.7SP, and WS-7.5SW for Weeks 17 and 18 and SCR-7.1SP, and SCR-7.7SP for Weeks 14 and 15. However, if FB-28 and RWT were present, concentrations did not exceed 0.2 ppb and 0.92 ppb, respectively.

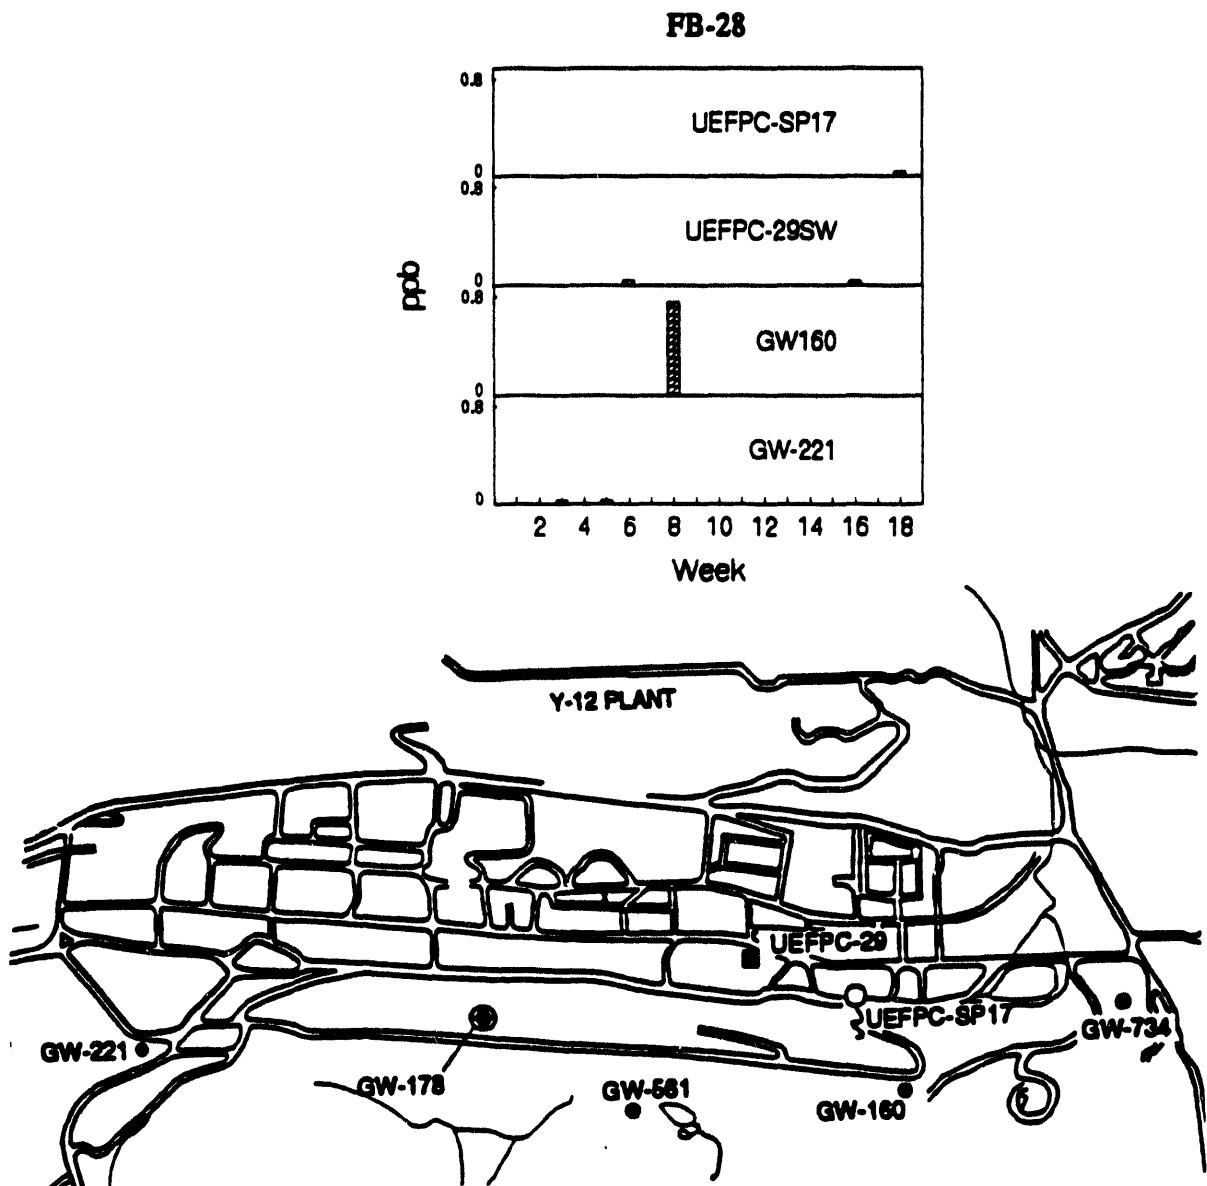
Figure 3.8: Second test monitoring sites in the UEFPC drainage and Wells 160 and 221 with fluorescence concentrations above the detection criteria.

In the area of UEFPC, apparent FB28 concentrations above the detection criteria were reported from UEFPC-SP17 and UEFPC-29SW (Fig. 3.8; Table 3.3). No apparent RWT concentration above the detection criteria were reported from this area. If FB28 dye was present in UEFPC, concentrations were 0.04 ppb or less.

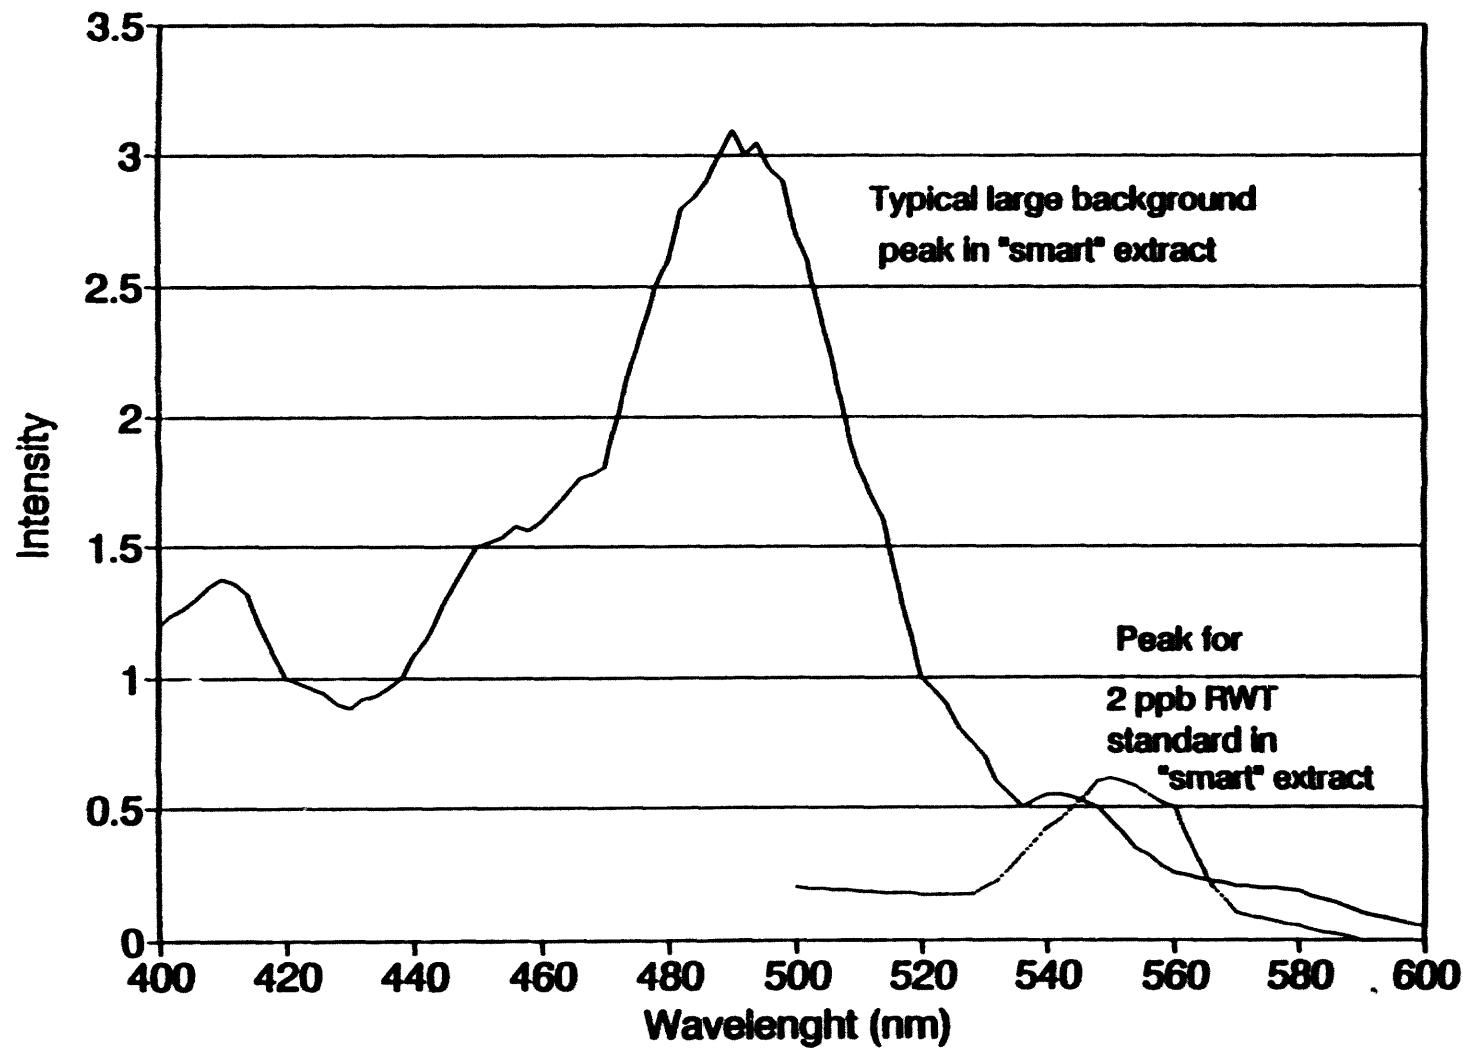
Figure 4.1: Schematic diagram of the possible effects of interference fluorescence spectral peaks on concentration values with natural background fluorescence peak at about 500 nm and a 2 ppb RWT excitation peak at 550 nm. The high background peak could give an apparent fluorescein signature in the range of 490 nm.

Figure 4.1 is a spectrograph showing a natural background interference at an intensity of 3.1 (approximately equivalent to 10 ppb) at about 500 nm and a smaller RWT peak at 550 nm corresponding to a 2 ppb concentration. The tailing effects of this 10 ppb interference peak could completely mask and cause apparently high concentrations in the excitation range of fluorescein at 490 nm (Fig. 4.1). In this hypothetical example, where no true fluorescein dye is present, the high natural background peak would give an apparent fluorescein concentration of approximately 10 ppb.

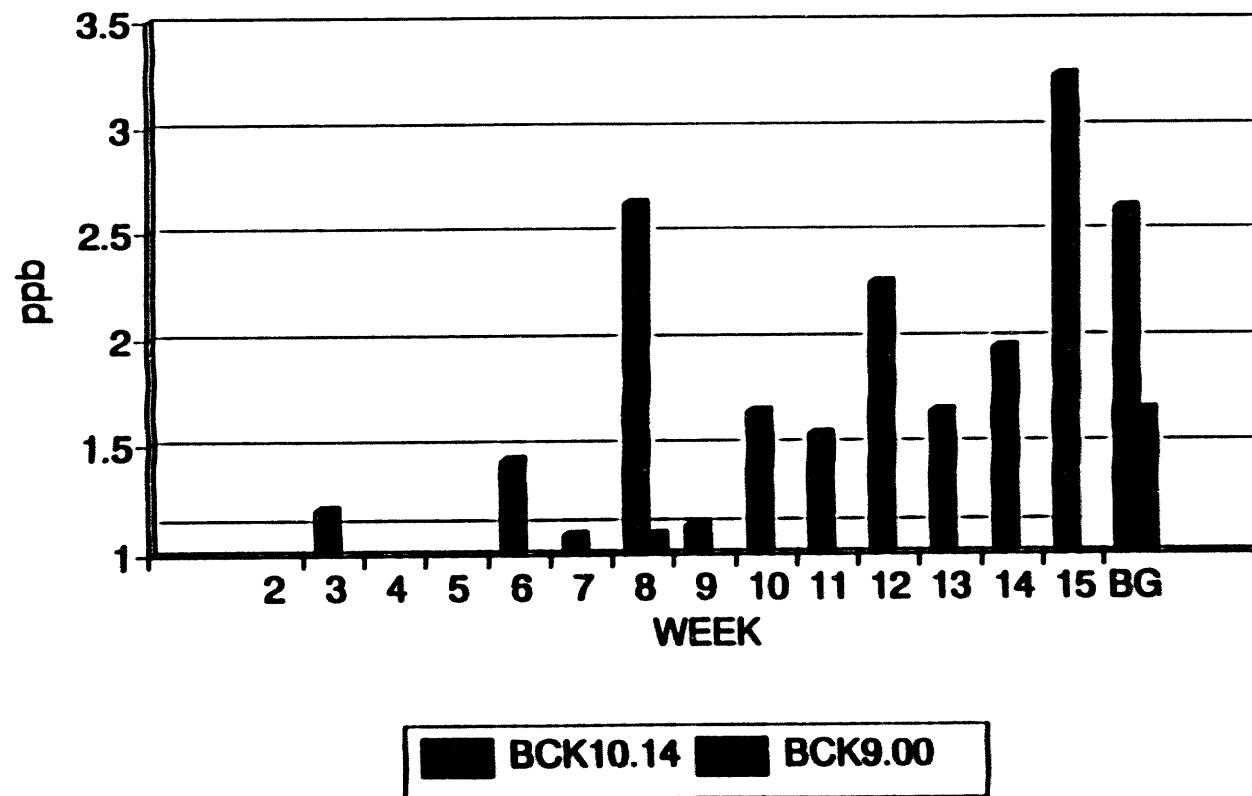
Figure 4.2: Initial test monitoring sites in Bear Creek Valley with fluorescein concentrations reported above the detection limit (1 ppb) for BCK-9.00 and background fluorescence (1.1 ppb) for BCK-10.14. BG = apparent RWT concentrations at 550 nm related to background interference at 500 nm.

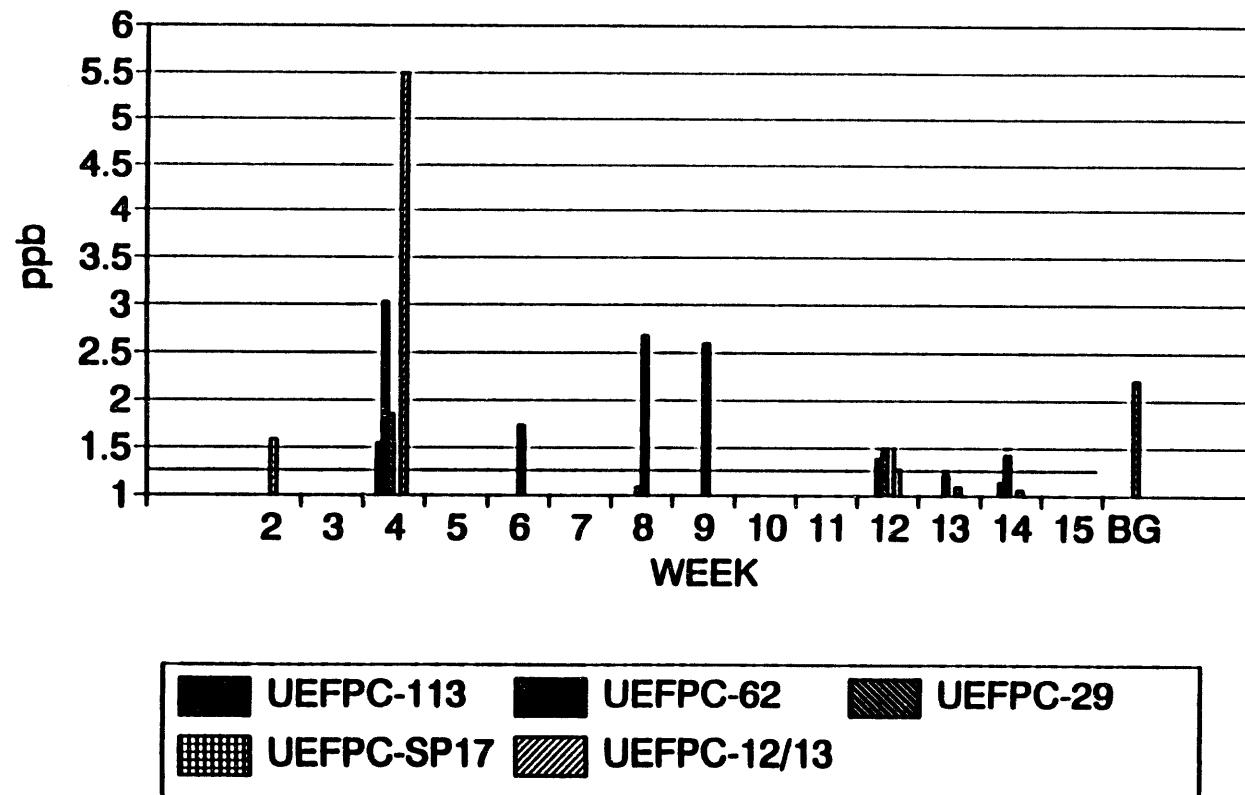
Figure 4.3: Initial test monitoring sites in UEFPC with fluorescein concentrations reported above the detection limit (1ppb) for UEFPC-113, UEFPC-62, UEFPC-29, UEFPC-12/13 and background fluorescence (1.3 ppb) for UEFPC-SP17. BG = apparent RWT concentrations at 550 nm related to background interference at 500 nm.

fluorescence (Fig. 4.3).

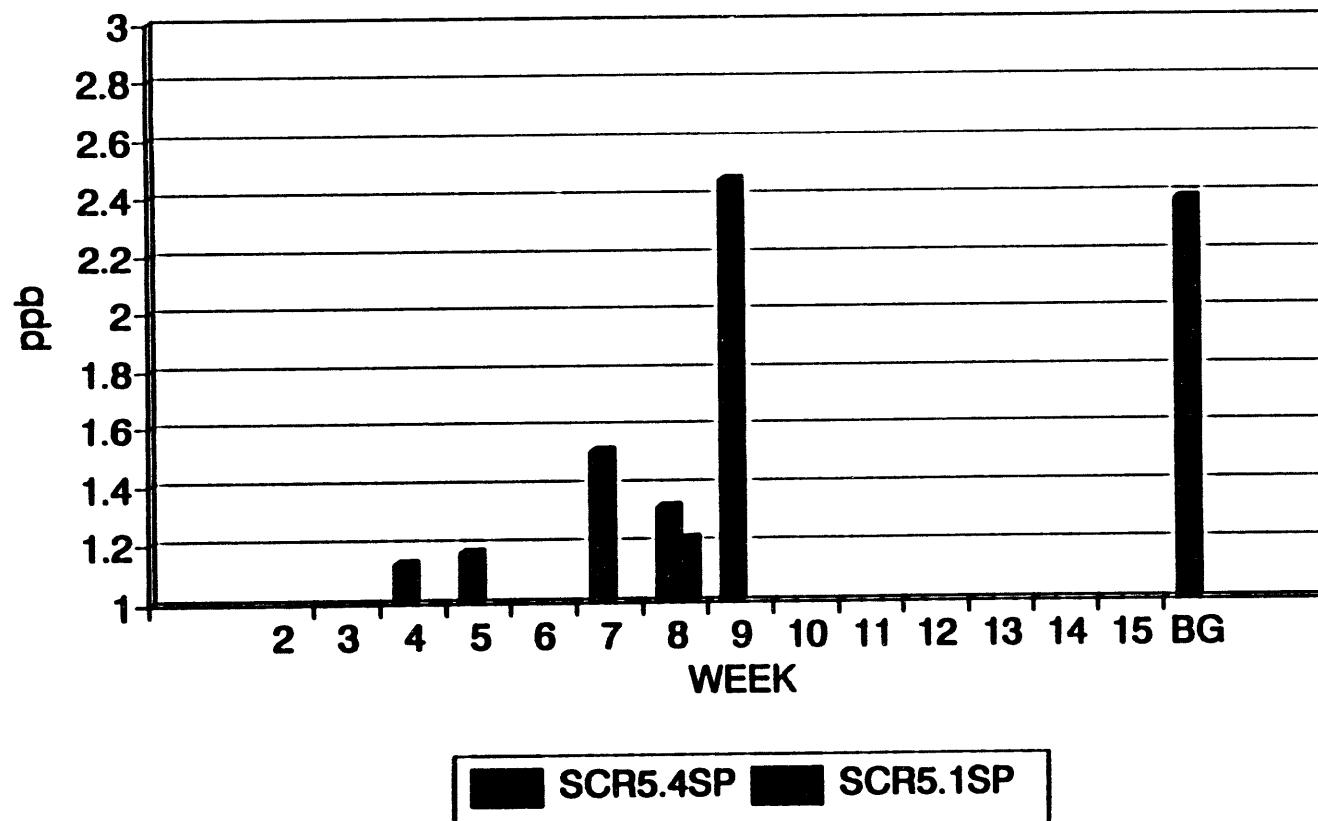
Figure 4.4: Initial test monitoring sites on south Chestnut Ridge with fluorescein concentrations reported above the detection limit (1ppb). BG = apparent RWT concentrations at 550 nm related to background interference at 500 nm.

Both SCR-5.1SP and SCR-7.1SP had no detected interference peaks during the second test, but SCR-5.4SP had four peaks which gave RWT an apparent concentration between 1.16 and 2.38 ppb. The apparent fluorescein noted at the SCR Sites during the initial test could be artifacts of high background fluorescence in the 500 nm range (Fig. 4.4).

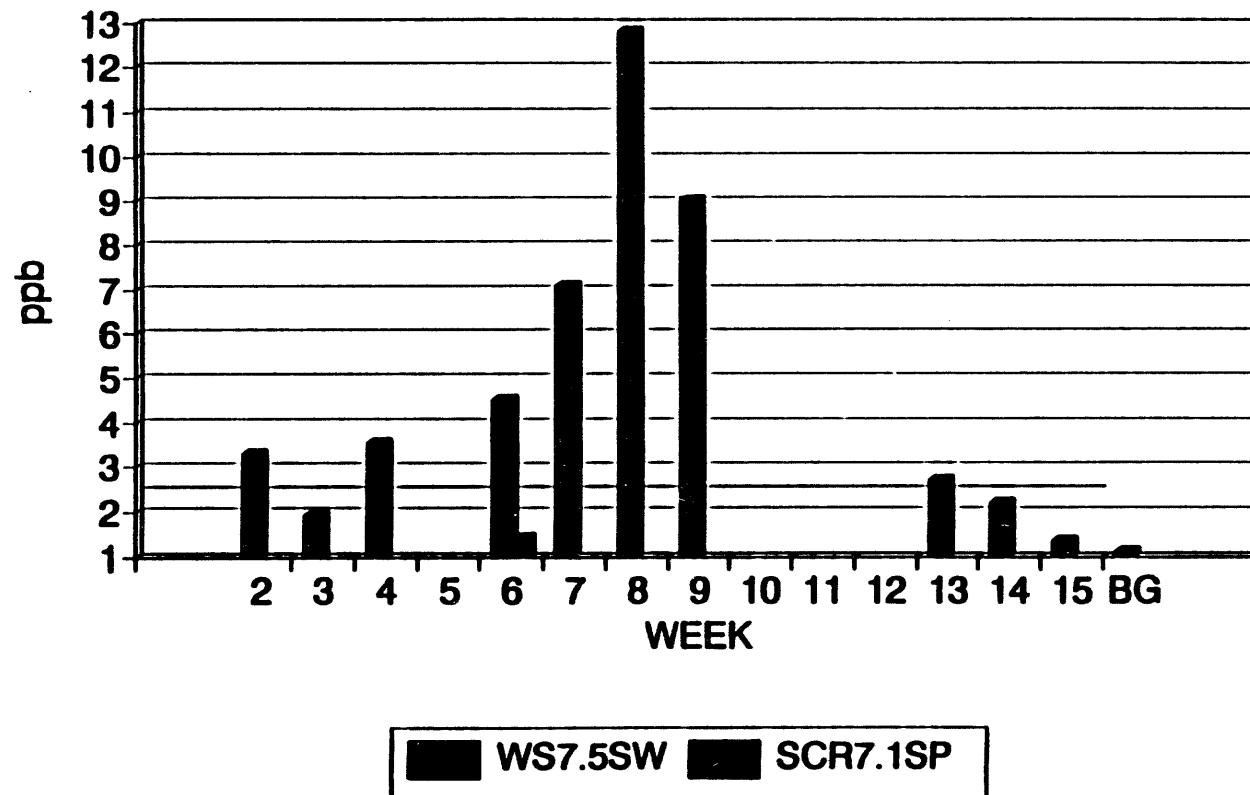
Figure 4.5: Initial test monitoring sites at Scarboro Creek with fluorescein concentrations reported above the detection limit (1ppb) for SCR-7.1SP and background fluorescence (dotted line at 2.6 ppb) for WS-7.5SW. BG = apparent RWT concentrations at 550 nm related to background interference at 500 nm.
