COMPARISON OF RESULTS OF TWO DYE-TRACER TESTS AT THE
CHESTNUT RIDGE SECURITY PITS, Y-12 PLANT, OAK RIDGE, TENNESSEE

P. M. Goldstrand
Environmental Sciences Division
Oak Ridge National Laboratory

January 1994

Oak Ridge Y-12 Plant
Oak Ridge, Tennessee 37831

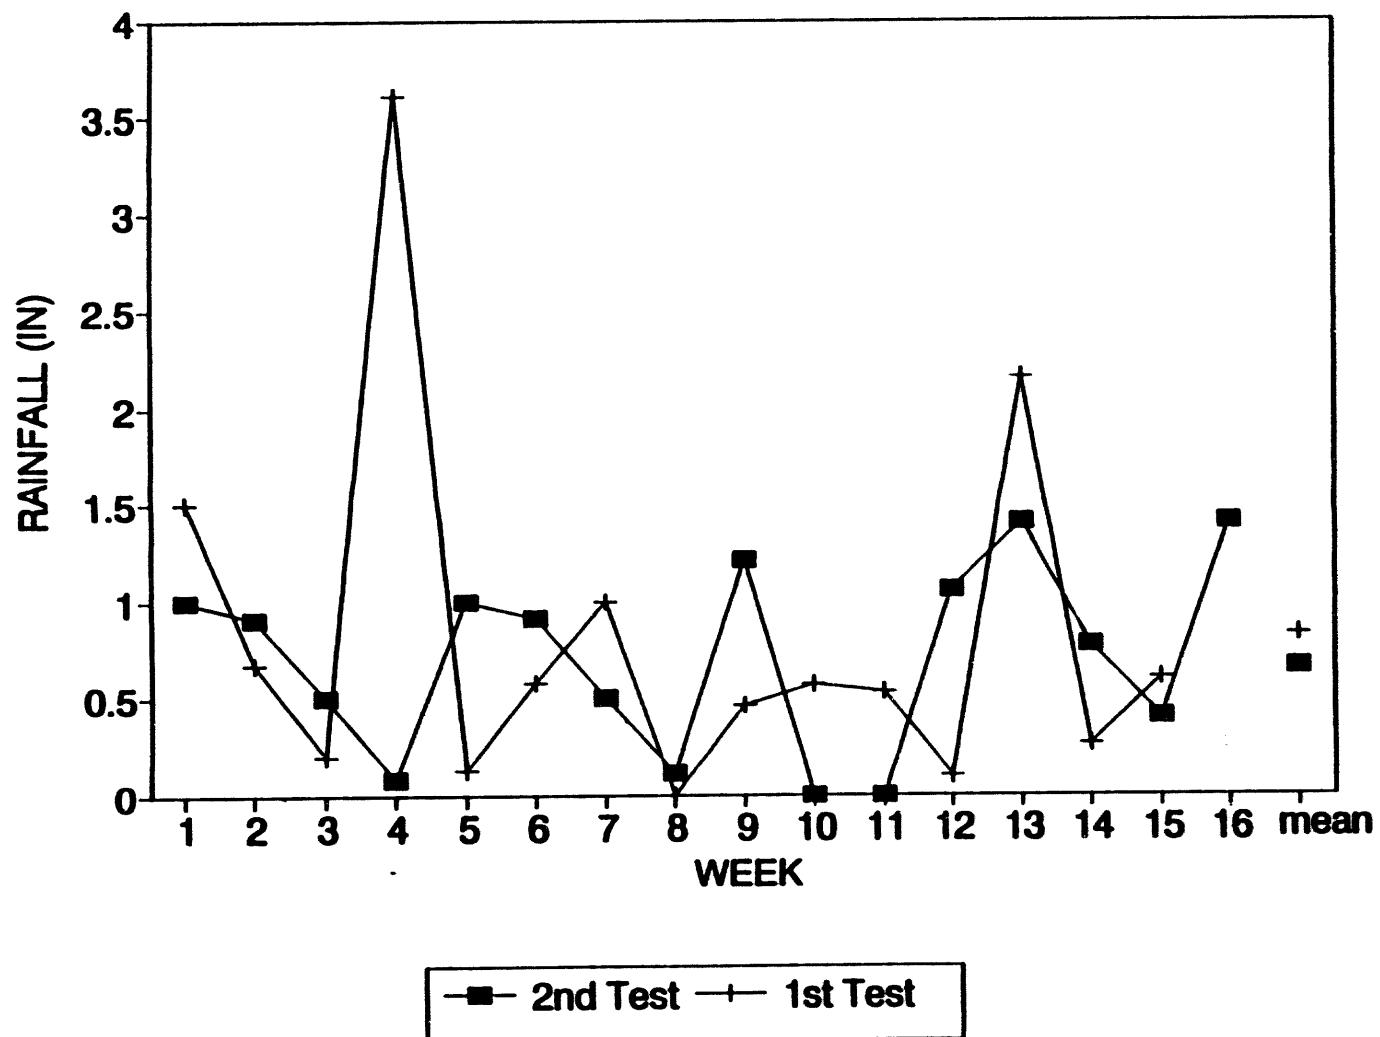
Figure 4.6: Comparison of weekly rainfall (in inches) during weeks after dye injection for the first and second dye-tracer tests. The mean rainfall for 15 weeks after dye injection for both tests is shown at the right to the figure.

amounts of precipitation between tests; however, the mean precipitation during the second test was only slightly lower (0.16 inches) than on the first test (Fig. 4.6). Therefore, travel velocities during the second test should be approximately equal to those of the initial test. However, in all but one of the initial test sites, the estimated travel velocities were significantly greater than those of the second test (Table 4.1). Theoretically, both the RWT and FB28 dyes should travel the same pathway and at the same velocity within the aquifer; however, the apparent travel velocities for these two dyes differ significantly where both spectral peaks were observed at the same location (Table 4.1). For example, at BCK-11.6&SW, FB-28 had an estimated travel velocity of 109 ft/day whereas at the same location, RWT had an estimated velocity of 1314 ft/day.
