# EVALUATING PLASTIC ASSEMBLY PROCESSES FOR HIGH RELIABILITY APPLICATIONS USING HAST AND ASSEMBLY TEST CHIPS\*

John A. Emerson, James N. Sweet, David W. Peterson,  
 Sandia National Laboratories  
 P. O. Box 5800  
 Albuquerque, NM 87185-0958

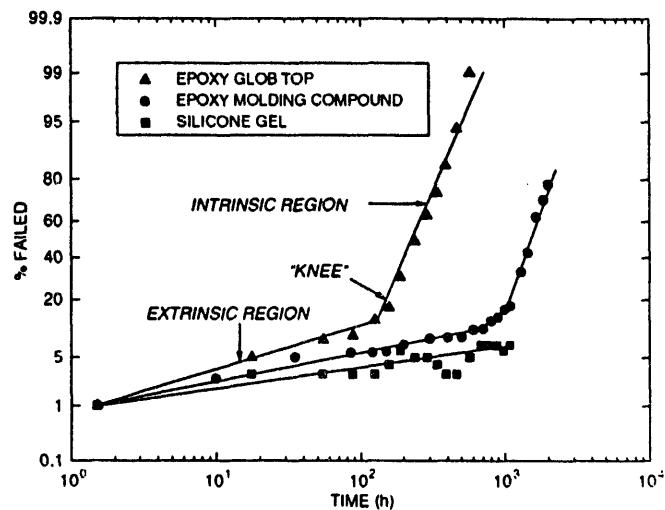
Fig. 1. Typical experimental data from HAST of ATC01 corrosion test chips coated with silicone and epoxy liquid encapsulants. Tests were performed at 140°C, 85% RH and 40 VDC track bias, and data is for anodic tracks only. The curves show characteristic intrinsic and extrinsic failure regions. Straight lines have been drawn to aid the reader in observing the distribution of the data, not to represent a data fit.

Referring to Fig. 1, the epoxy glob top curve clearly shows the three regions with the knee of the curve at about 150 h. The data for the epoxy molding compound shows a similar extrinsic failure rate, but the knee is extended further in time  $\approx 1000$  h. In the case of the silicone gel, the knee has not been reached during the accessible test times, but may be starting at 2000 h. The position of the knee is primarily dependent on intrinsic failure modes and can be moved further in time by selection of increasingly superior materials and processes. This is illustrated in Fig. 1 by the replacement of liquid epoxy with a molded epoxy encapsulant.

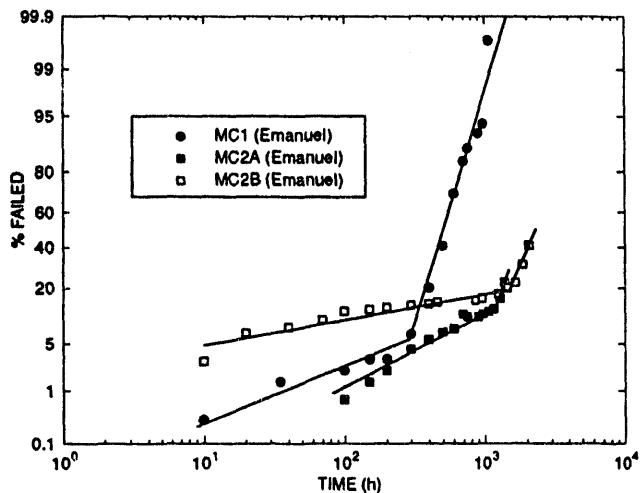
Fig. 2. Failure distribution of ATC01 triple tracks during HAST at 140 °C, 85% RH and 40 VDC. Data is shown for MC1 and MC2 anodic tracks only; cathodic track data is similar.

No electrical failures were observed after temperature cycling. The failure distributions for anodic tracks in the MC1 and MC2 groups assembled at Emanuel are shown in Fig. 2. Cathodic failure data have similar distributions, but with longer failure times. Note that the failure distributions in the extrinsic region are similar, but the knee occurs at ≈ 300 h for MC1 and has not appeared yet by 2000 h for the MC2A group. The MC2B group was not part of this experiment, but the assembly was done at the same time and place as the MC2A group using the same molding compound lot. In addition to thermal cycling, the MC2B group was subjected to salt spray. HAST was done in the same chamber, but at a different time. The MC2B group has a higher

failure rate in the extrinsic region than the MC2A group, but seems to be converging on the same knee.

Fig. 2 indicates that HAST can discriminate between molding compounds used for high reliability applications. The  $t_{50}$  for the MC2 compound is at least a factor of 2 greater than that of the MC1

compound. This is consistent with chemical analysis of the two materials showing that MC1 had a higher Br content [5],[6]. This difference is significant considering that both compounds are in a family of materials with very little variation in their formulation.

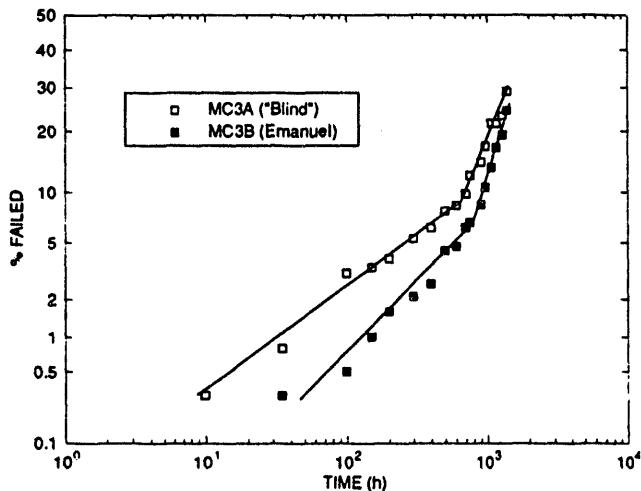
Fig. 3. Plot of MC3 data, "Blind" vs. Emanuel, showing slightly better overall HAST life expectancy of parts assembled at Emanuel.

Figs. 3 and 4 contain failure data for the MC3 and MC4 molding compounds. The open symbols represent the "blind" group and the solid symbols represent the controlled assembly (Emanuel) group. The MC3 data in Fig. 3 show that the controlled assembly process resulted in better HAST performance. The MC4 data in Fig. 4 show a similar relation, although the early failure distribution for the MC4B group appears quite different than the MC4A group. The reason for the disparity in the extrinsic region is not known at this time.

The data in Figs. 3 and 4 show that carefully controlled assembly performed by Emanuel resulted in slightly better HAST performance than the "blind" vendor. These data are consistent with the hypothesis that only the extrinsic failure distribution varies between the two molding contractors. The intrinsic portions of the failure distributions in Figs. 3 and 4 for the two molding contractors have approximately the same slope and mean value. We did not observe any difference in failure modes between the parts in these two populations. The fact that

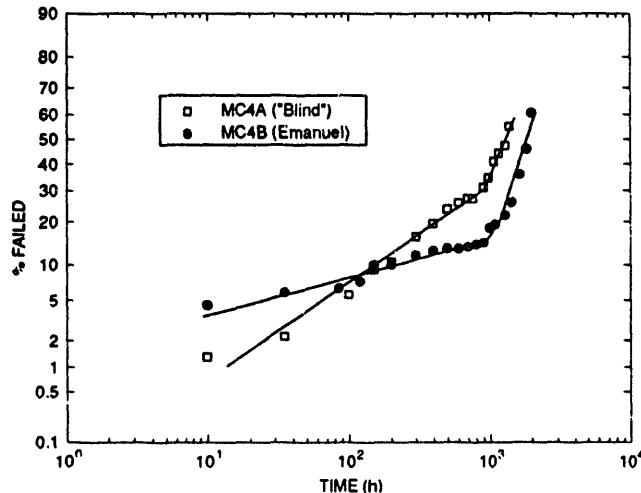
Fig. 4. Plot of MC4 data showing similar relation to Fig. 3 in the intrinsic region for parts assembled at "Blind" and Emanuel. The MC4B parts were assembled at the same time as MC4A but were tested to 2000 h during an unrelated experiment.

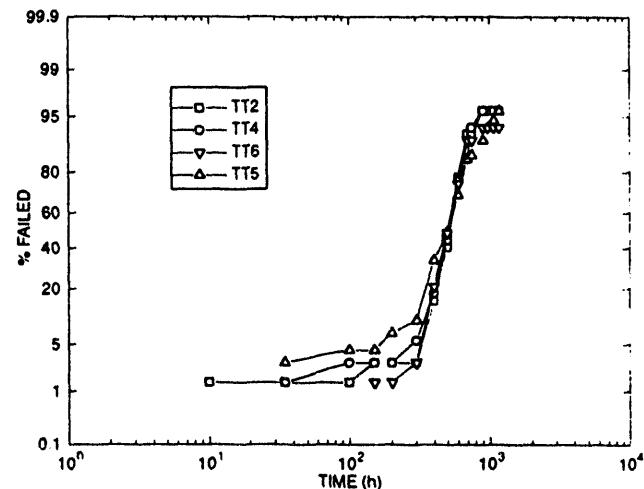
Fig. 5. Plot of MC1 anodic track data by triple track type. Order from top to bottom in legend is toward decreasing  $\epsilon$  field. Refer to Table III for track parameters.

The failure rate for the MC1 molding compound is shown as a function of triple track type, *i.e.*, track spacing. If the failure rate depended on the  $\epsilon$  field between adjacent tracks, there should be a dependence evident on track type. There is no obvious dependence of the failure rate in Fig. 5 on track type.

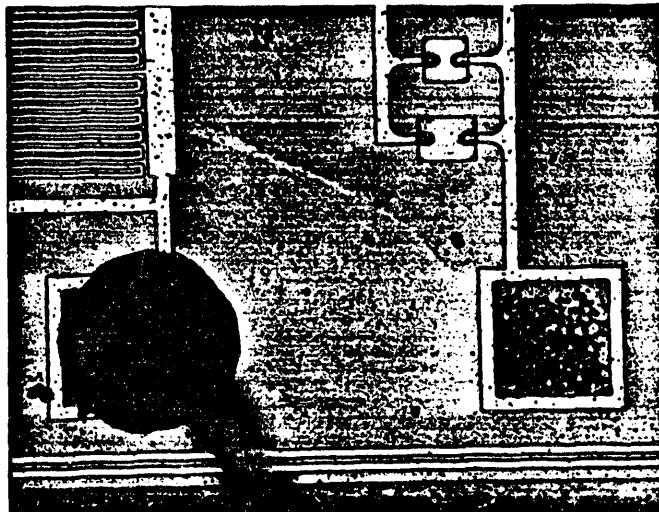
Fig. 6. Photomicrograph of MC4A part which failed after 10 h of HAST showing complete removal of Al on a Au ball-bonded pad. The bonded pad is to an unbiased test structure not used during this experiment. Corrosion and Al depletion is also evident on an adjacent unbonded pad.

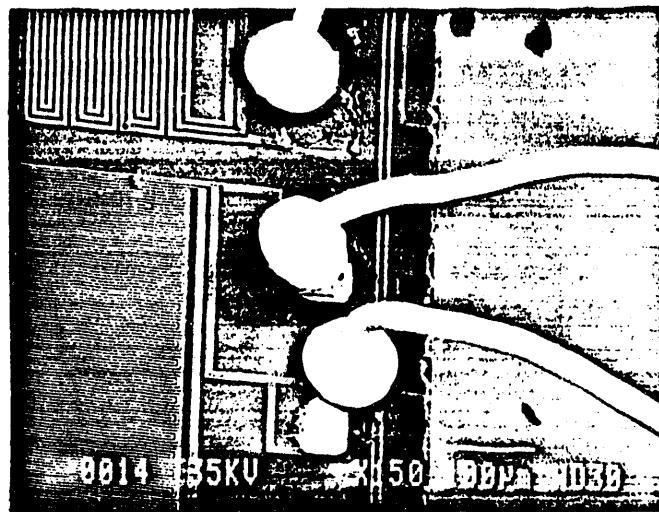
Fig. 7. SEM photomicrograph of MC4B part after 2000 h of HAST. Note depletion of Al in upper anodic bond pad and Au deposit on cathodic bond pad at bottom. Top triple track structure is TT6, bottom is TT2.

Beyond the knee, or in the intrinsic failure regime, failures were dominated by bond pad corrosion and bond wire separation. In some cases, corrosion extended underneath the chip passivation out into the triple track region. No dendrite growth or intertrack shorting was observed. Corrosion occurred at both anodic and cathodic biased bond pads and also at bonded but unbiased pads. The failure rate did not depend on track-to-track spacing as discussed above. Figs. 7-9 contain SEM photomicrographs of an MC4B part after 2000 h of HAST at 140 °C, 85% RH and 40 VDC bias. They are representative of virtually all the decapsulated parts at the completion of testing.

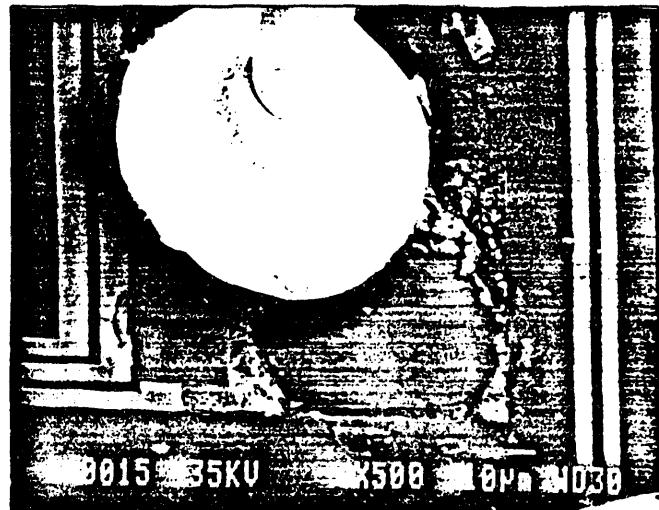
Fig. 8. SEM photomicrograph showing enlarged view of upper bond pad of MC4B part in Fig. 7. The cracked and delaminated P-glass visible adjacent to the bond pad is caused by corrosion of the underlying Al tracks.

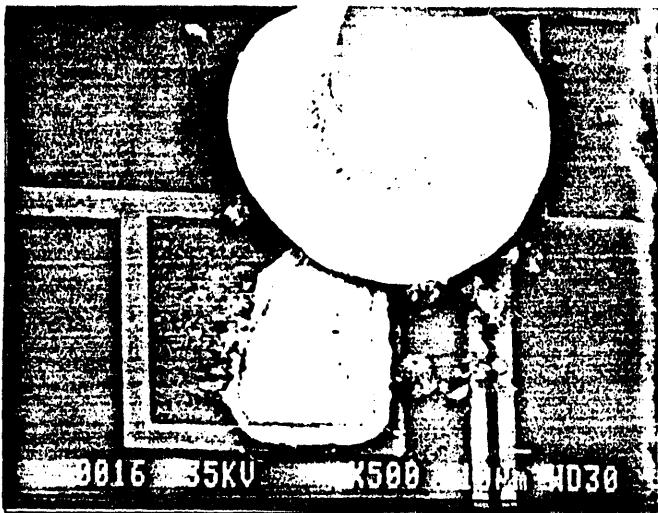
Fig. 9. SEM photomicrograph showing enlarged view of lower bond pad of MC4B part in Fig. 7. Note the presence of Au intermetallics on the Al bond pad.
