UCRL-ID-117158

Exploratory Study on H13 Steel Dies

Anne J. Sunwoo

April 1994

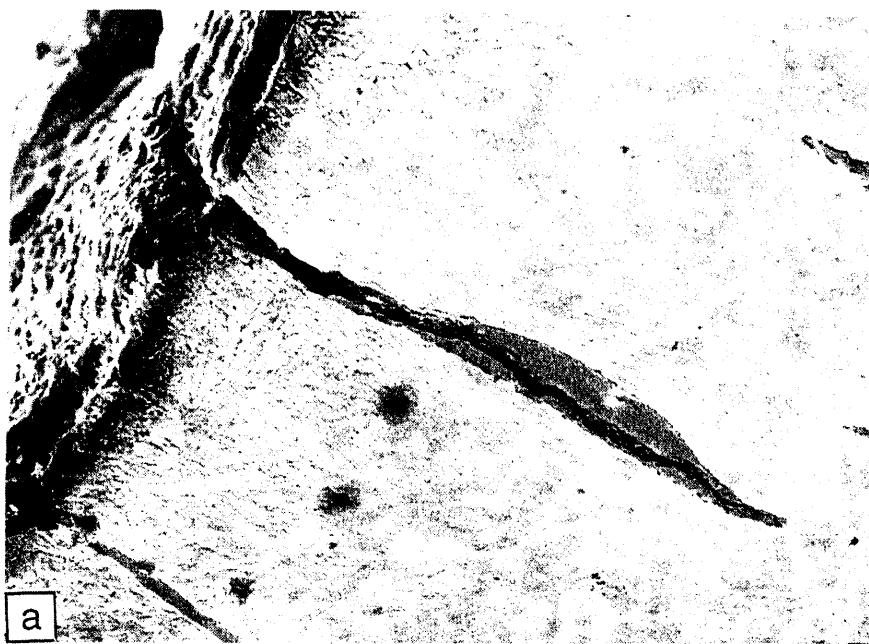
Figure 2. SEM micrographs: a) a cross-sectional view of a crack following the sulfide stringer; b) corresponding fracture surface showing crack path into the die through sulfide (dark region).

The composition of H13 steel in wt-% is 0.4C-0.5Mn-1.0Si-5.0Cr-1.5Mo-1.0V- bal. Fe. The sulfur content in H13 is limited to no more than 0.04 wt-%, which is an innocuous amount if the sulfides are homogeneously distributed in the steel as spheroidized particles. However, because the H13 steel has been heavily hot worked, the resulting morphology of sulfides is stringers aligned in the rolling direction. Since there is high surface energy associated with these high aspect ratio stringers, they provide a preferential crack path into the die. Figure 2 shows a cross-sectional view of a crack following the stringer and its fracture surface. Cracks can also propagate along the weakest interface in both an intergranular as well as a transgranular mode (Figure 3). Moreover, the resistance to fracture of the steel is greatly compromised due to the presence of the stringers. In Figure 4a, the fracture surface reveals a uniform distribution of the stringers, and because the cracks initiate externally, the crack surfaces become heavily oxidized, displaying a distinct interface (Figures 3b and 4b).
