Project: " DEVELOPMENT & TESTING OF INDUSTRIAL SCALE,  
COAL FIRED COMBUSTION SYSTEM, PHASE 3"

### Eighth Quarterly Technical Progress Report

Period Covered by Report: October 1, 1993 to December 31, 1993

Contractor: Coal Tech Corp.  
P.O.Box 154, Merion Station, PA 19066

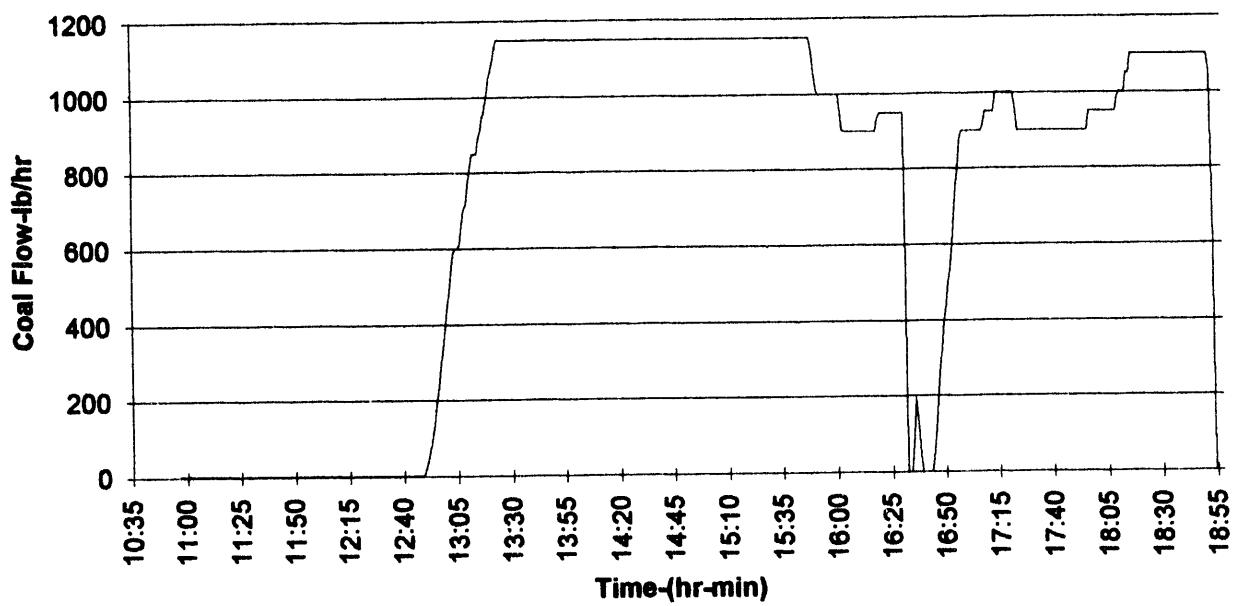
**Figure 3: Coal Flow-11/2/93 Test**

Figure 3 shows the coal feed rate versus time for this test. This test was also the first one in which additional transport air controls were added to the pneumatic feed lines in order to balance the feed to all injection points. After 3 hours of operation, the input to the pneumatic feed line began to back up with coal forcing a cutback in coal feed. This was not implemented fast enough and a flameout occurred, as shown in figure 3. On restart, the gypsum injection test was performed in which various levels of  $\text{CaSO}_4 \cdot 2\text{H}_2\text{O}$  was injected to test sorbent and slag desulfurization. These data have not yet been analyzed.

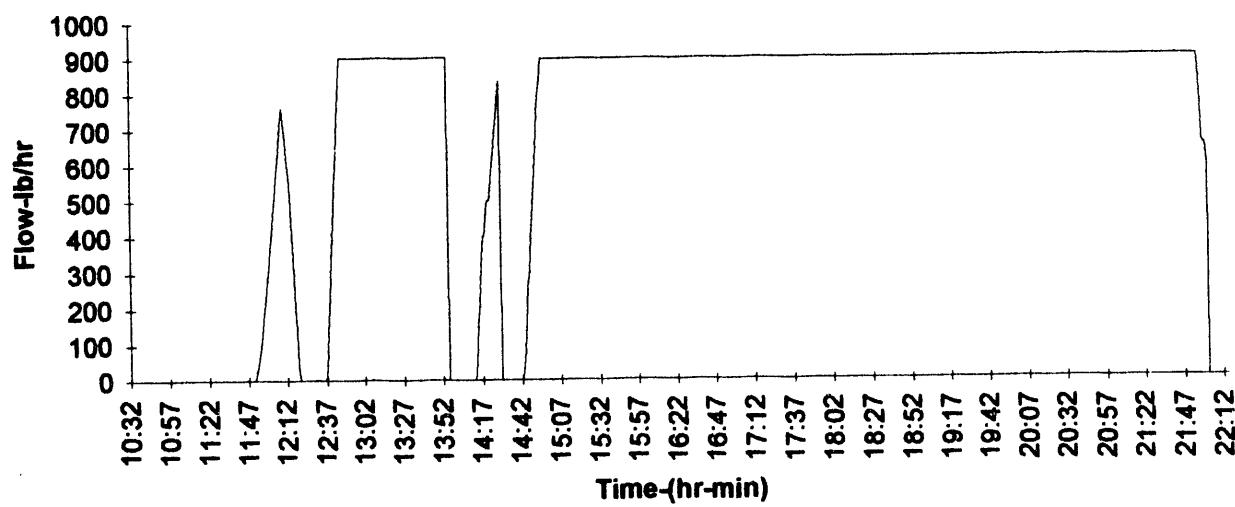
Figure 4:Coal Flow-11/9/93 Test

Figure 4 shows the coal feed rate for the DP 17 test day. Two flameouts early in the test day were caused by a trip in the high pressure fan controller. This problem recurred several more times during the remaining tests. It was partly resolved by increasing the rating of the heater elements on the motor controller. However, it appears that there is some random defect in this controller, and if it continues to recur in task 5 testing, the controller will be replaced. The computer data collected for the next day's test, DP18 was lost during its retrieval at the end of the test day. Only the last hour's test data was saved. However, as all the test conditions until the last hour remained unchanged this data loss is not important.

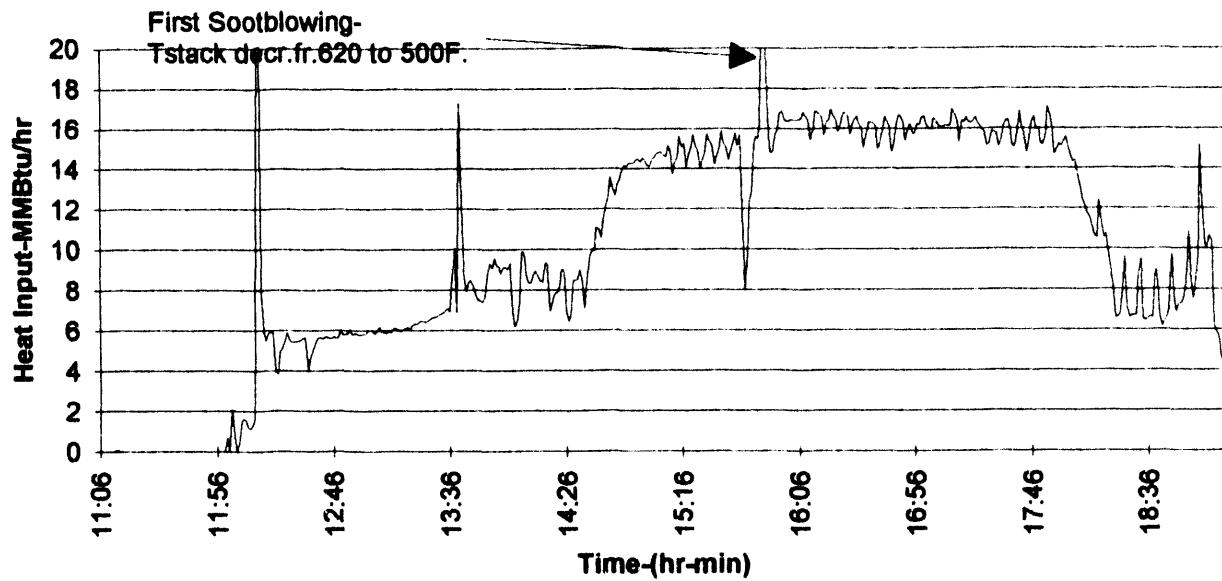
**Figure 7: Heat Input from Steam Flow & Based on 450F Stack Temp. -9/23/93**  
**Test**  
**Results not adjusted for boiler efficiency change due to soot on boiler tubes**

d) Boiler Performance- Soot Blowing: Another measure of the impact of this combustor on the boiler is the effect of sootblowing on boiler performance. All oil designed package boilers have soot blowers in the downstream end of the convective tube bank. In this boiler the sootblowers use steam from the boiler. Due to oversight, the sootblowers were not used in the task 2 tests and in the task 3 tests prior to the September 23rd test. By that time well over 100 hours of coal fired operation had been accumulated. As the task 3 tests proceeded, it was noted that the gas temperature at the boiler outlet, i.e. the base of the stack, gradually increased from about 500F to over 600F. This compares with a 450F stack temeprature with oil. During the 9/23/93 test, a short 10 second burst of sootblowing was implemented about 15:45 hours. This immediately decreased the stack gas temperature from 620F to 500F. A second 10 second burst near the end of the test decreased the temperature to 450K, the same as with oil. The impact of the sootblowing can be seen in figures 6 and 7. Figure 6 shows the increase in steam flow from about 12,000 lb/hr to 13,000 lb/hr after sootblowing at 15:45 hours. Figure 7 shows that the corresponding total heat input as computed from the steam flow.

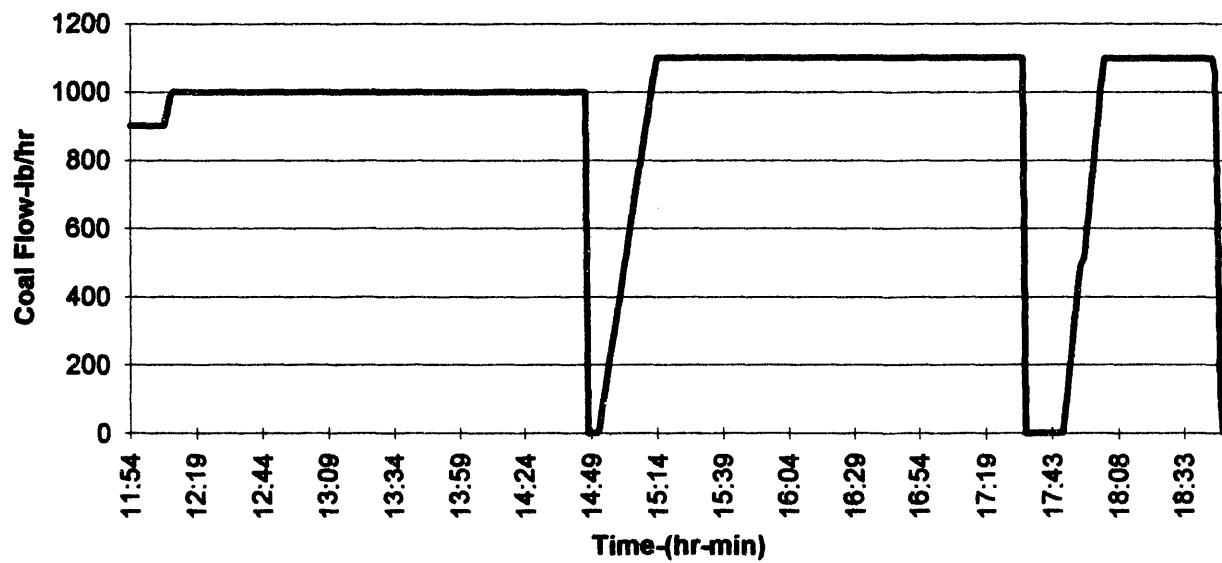
**Figure 15: Coal Flow-12/2/93 Test**  
**Coal on-10:07, Coal Off 18:45, Power Failure-14:30, Fan Trip-17:30**

Figure 15 shows the coal feed rate, 1000 lb/hr and 1100 lb/hr, for the final test day, 12/2/93, Test DP24. The major events of that day, where a general local power failure at 14:40 hours that shut everything down, and a repeat of the combustion air fan trip at 17:30 hours. The test terminated when the coal supply in the 4 ton bin was consumed. There was no ash replenishment on this test day, and as a result the wall temperature was somewhat higher than on the previous day. It was in the 1300-1400F range, which is still lower than prior to initiating ash replenishment.

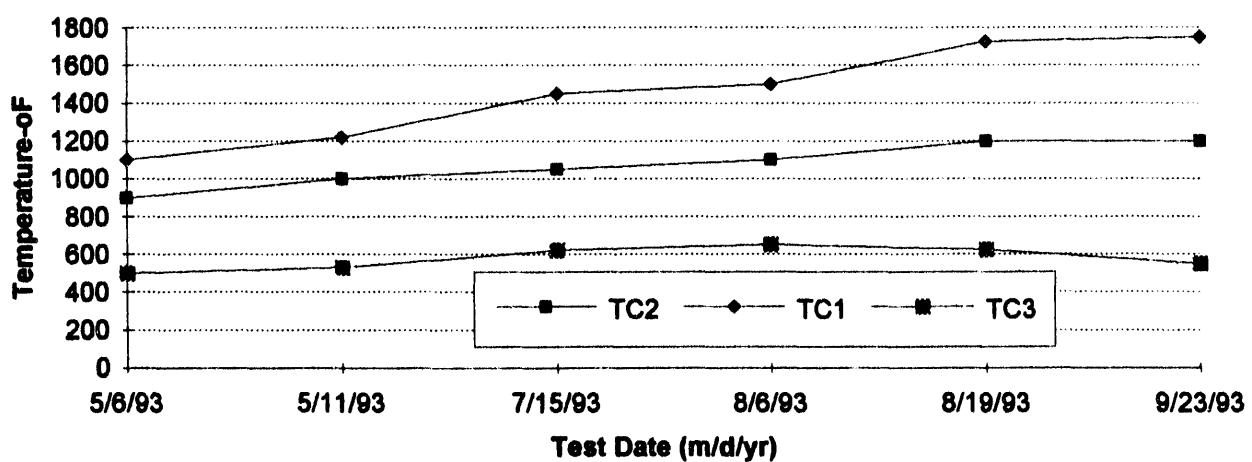
**Figure 19: Exit Nozzle Temperatures since Installation of Air Cooling  
(For location of T.C 1,2,3-See fig.18 )**

increased from 1100-1200F to 1800F. This indicated that the inner wall material was melting due to slag action. This was confirmed by internal measurement between tests and by accurate measurement after disassembly of the combustor. It was determined that the entire alumina section that had been inserted inside the fused refractory liner had dissolved in the slag. The fused refractory remained intact with the exception of the usual radial and longitudinal cracks due to thermal cycling.
